<div>Block</div>		<h1>POLARIS MINE</h1>	
INDIAN RPT.		DB	GEOREFERENCED RPT.		<div>2150 SECTION THROUGH SINKHOLE AREA</div>		
STRIPPED RPT.		DATA	REVISION/REMARKS				
POLARIS M.T.S.				DATA

APPENDIX C

**SITE VISIT
TO
COMINCO LTD.'S
POLARIS MINE**

February 1994

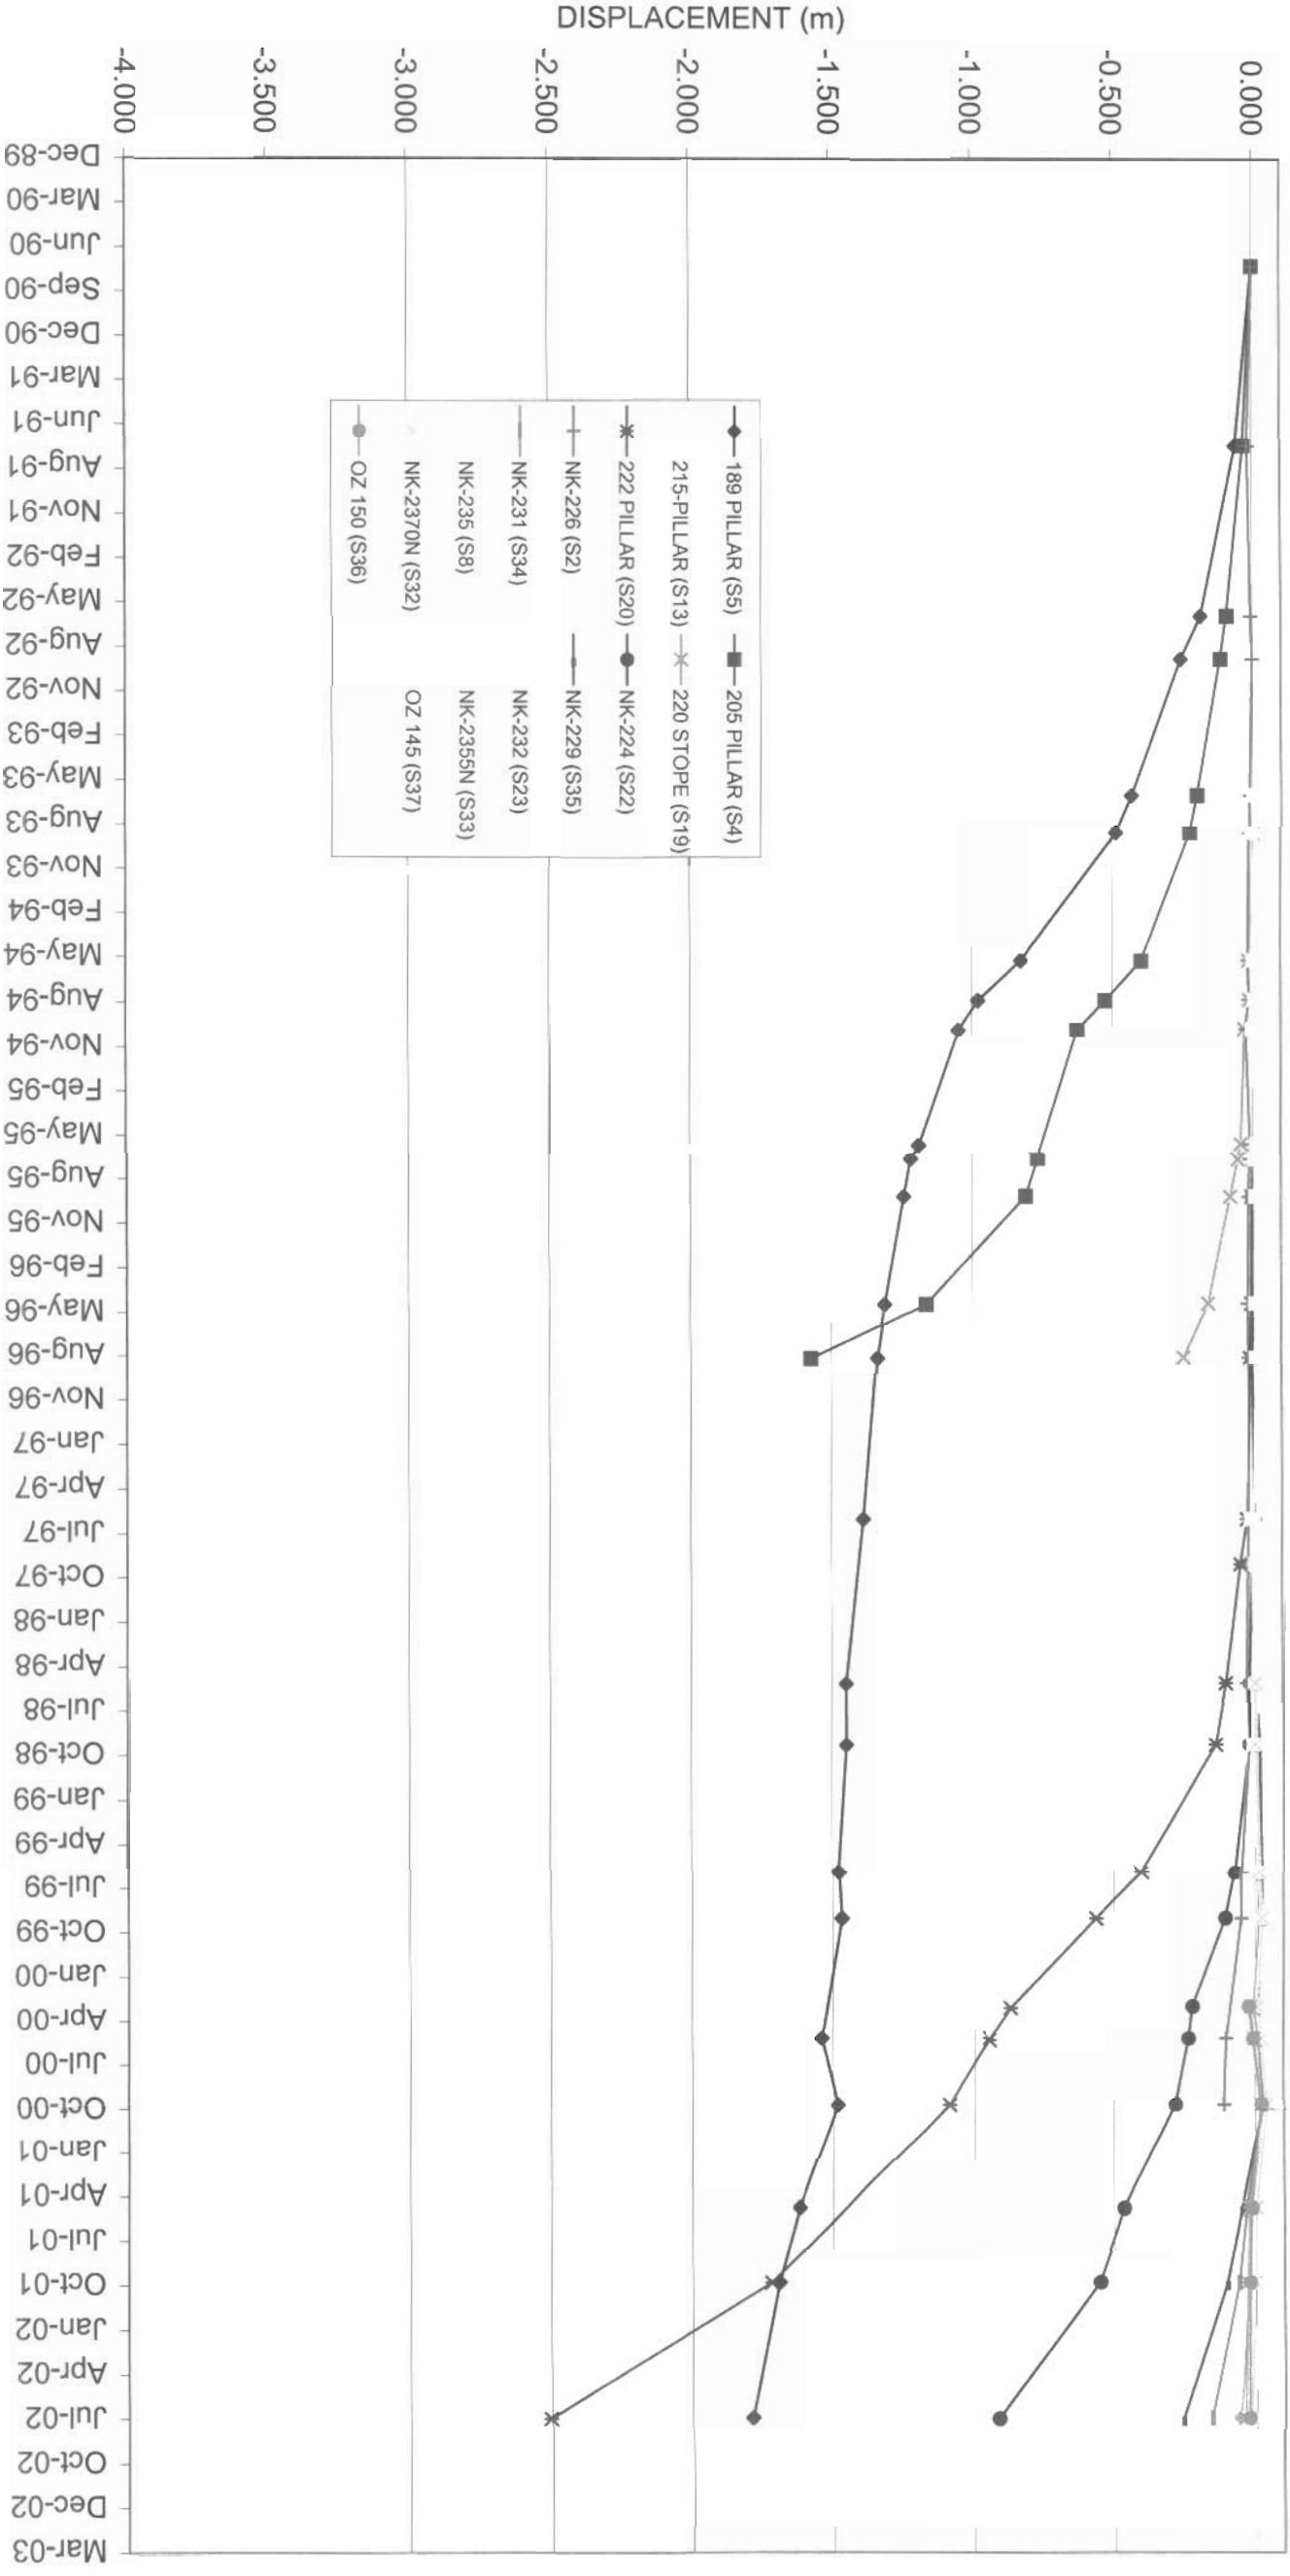
SUBSIDENCE DISPLACEMENT
WEST OF SINKHOLE AREA
AT 2150 N SECTION
