**REPORT ON**

**VISIT TO POLARIS MINE  
NOVEMBER AND DECEMBER 1995**

Cominco Ltd.  
Polaris Operation  
Polaris, NWT  
XOE 0Y0

May 31, 1996

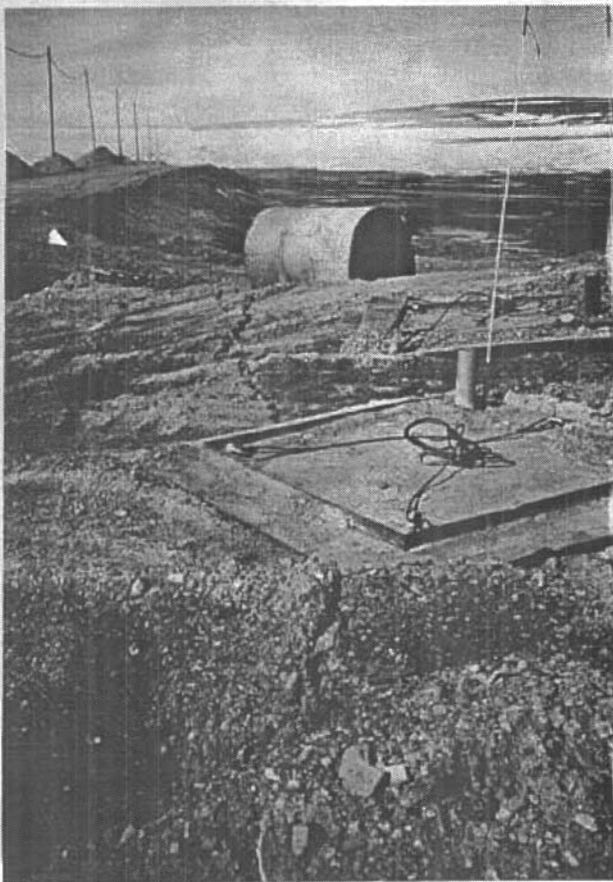
**PHOTOGRAPH 44**

- Subsidence induced cracks have appeared on surface (see Photographs 44 to 48).

- Subsidence induced cracking has been observed at surface over and adjacent to the Keel mining area. The location of the cracks is shown in Figure 5.
- Surface cracking appears to be closely associated with those areas in the Keel where there has been 100% ore extraction. No cracking has been *observed* over the Panhandle mining area or over partially extracted areas of the Keel. The cracks appear to be located near vertically over the mined out outline on the 850/820 level.

Surface subsidence cracks.

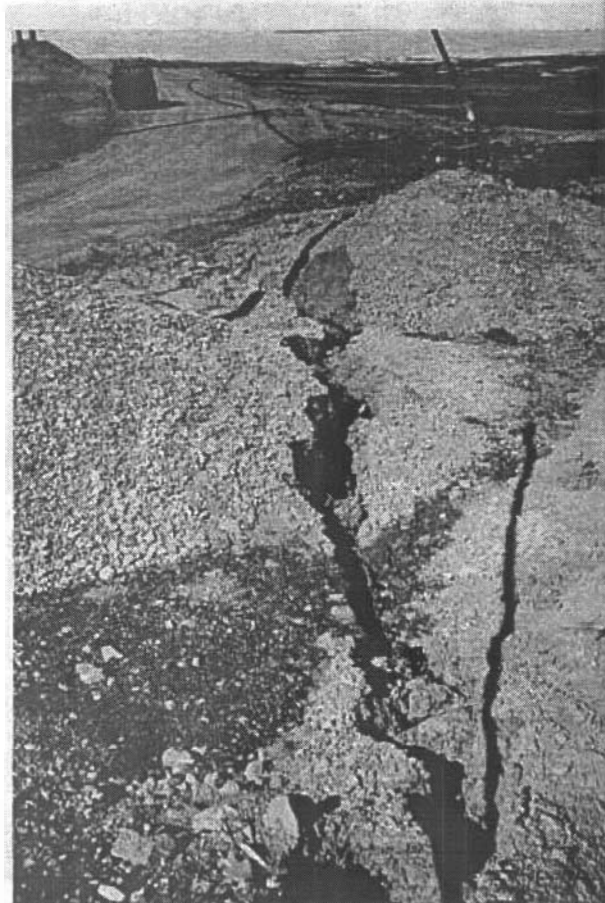
**PHOTOGRAPH 43**

Surface subsidence cracks.

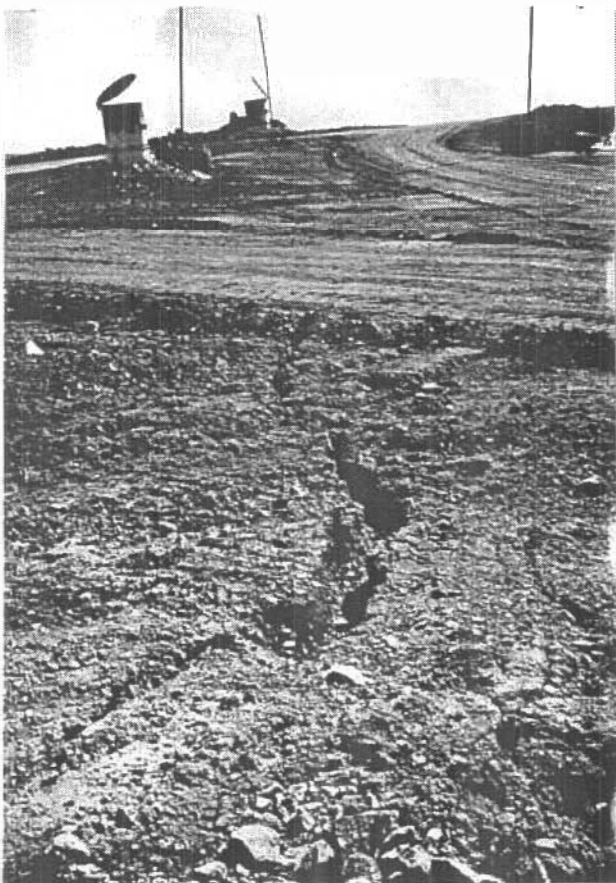
**PHOTOGRAPH 46**

Surface subsidence cracks.

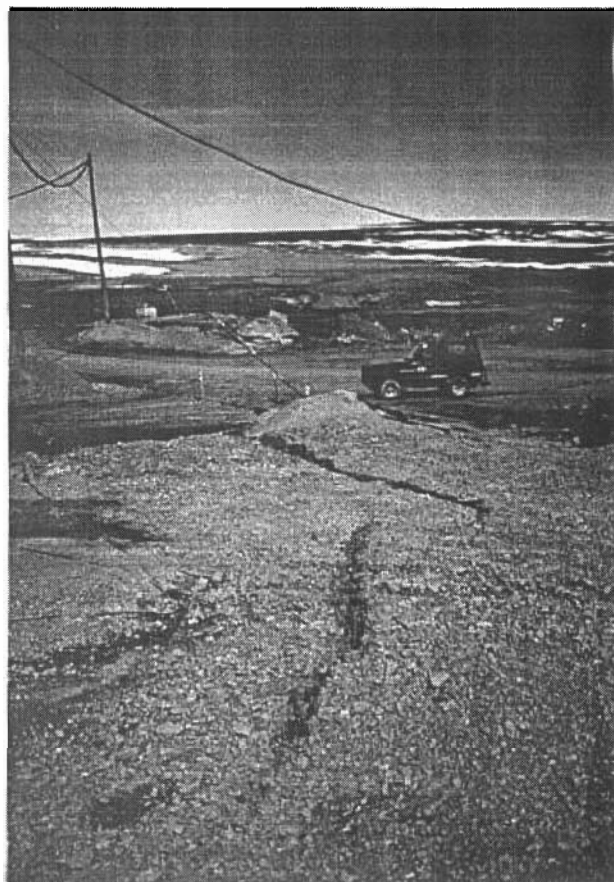
**PHOTOGRAPH 45**

Surface subsidence cracks.

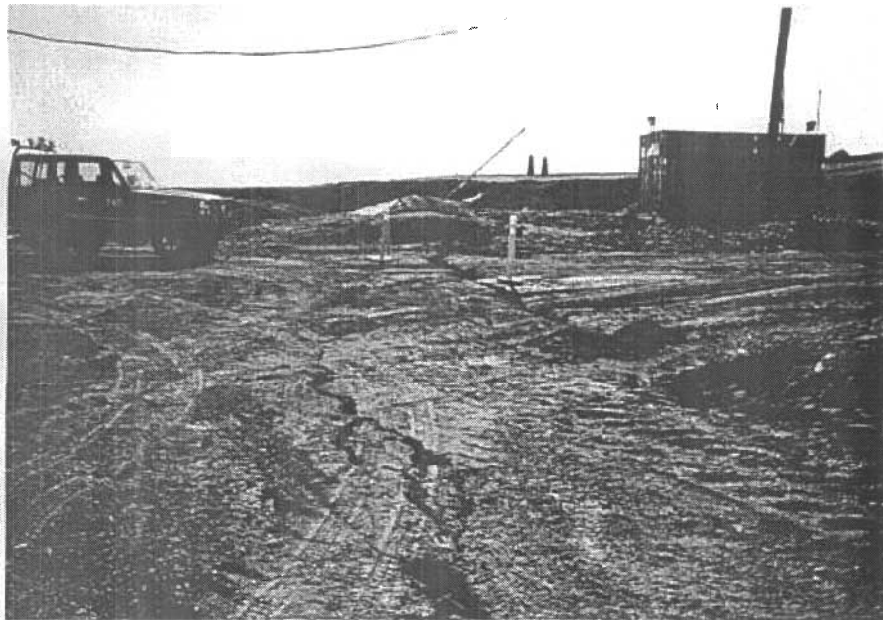
**PHOTOGRAPH 47**

Surface subsidence cracks.

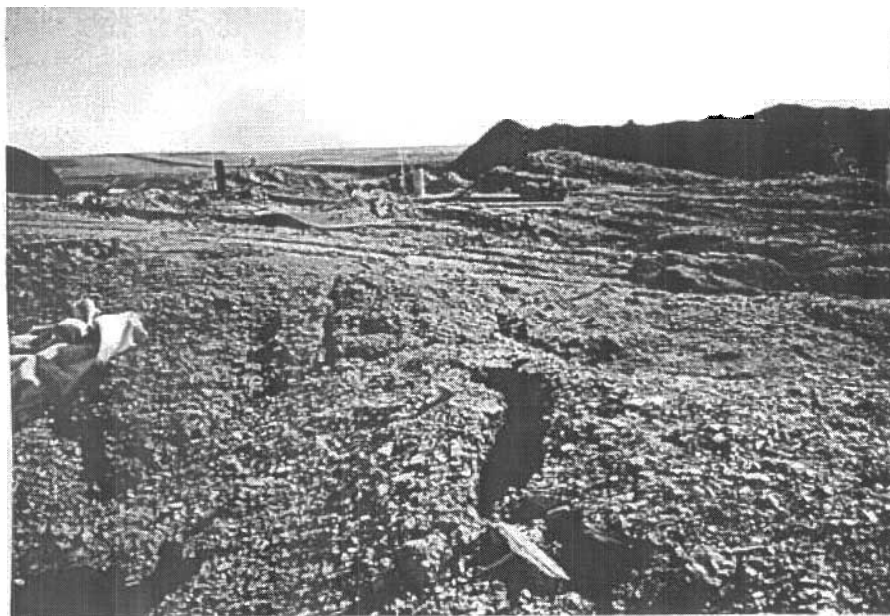
**PHOTOGRAPH 48**

Surface subsidence cracks.
