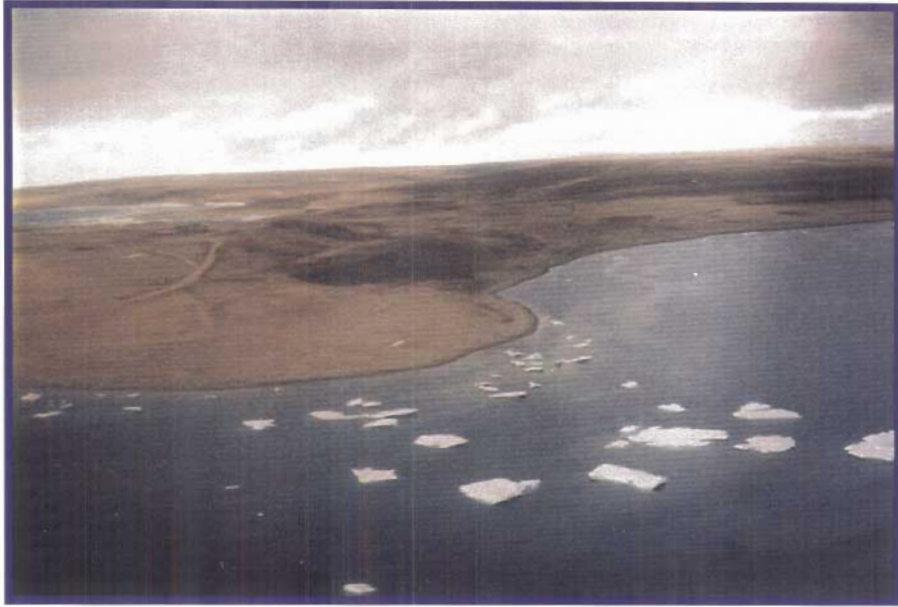
Photo 1 Aerial view of Operational Landfill and Polaris Bay.

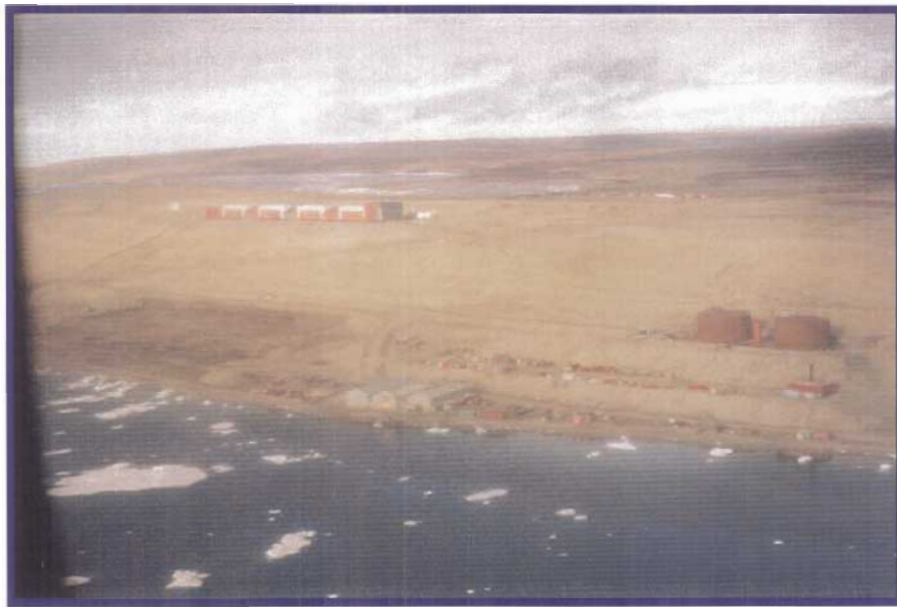
Photo 2 Aerial view of tank farm, accommodations complex, concentrate storage shed and temporary dock area.

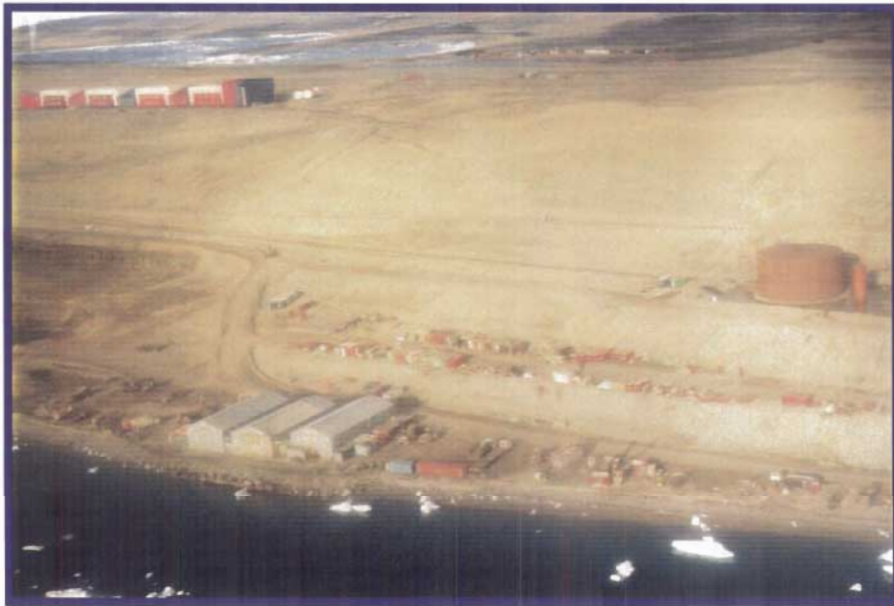
Photo 3 Aerial view of former dock area, foldaway buildings and tank farm area

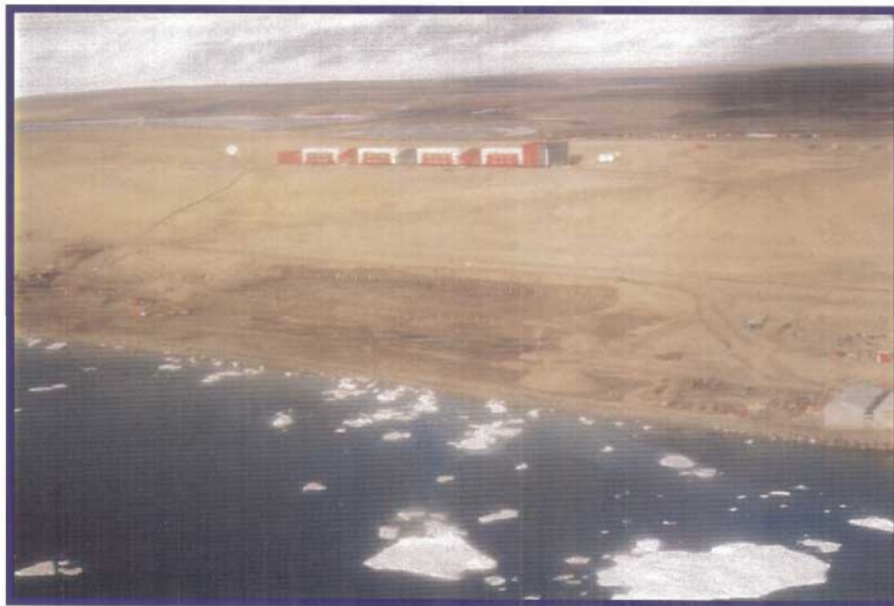
Photo 4 Aerial view of concentrate storage area footprint and accommodations complex.

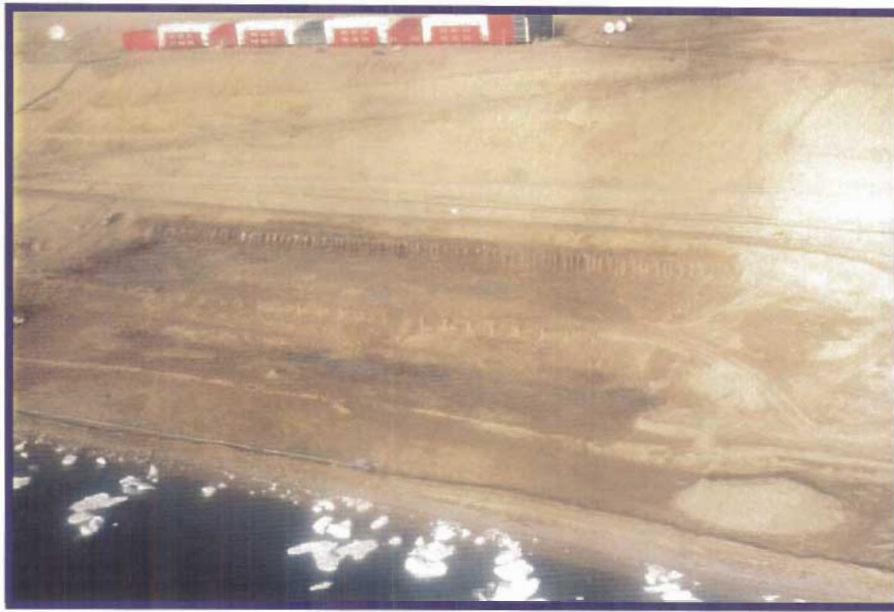
Photo 5 Aerial view of concentrate storage area footprint.

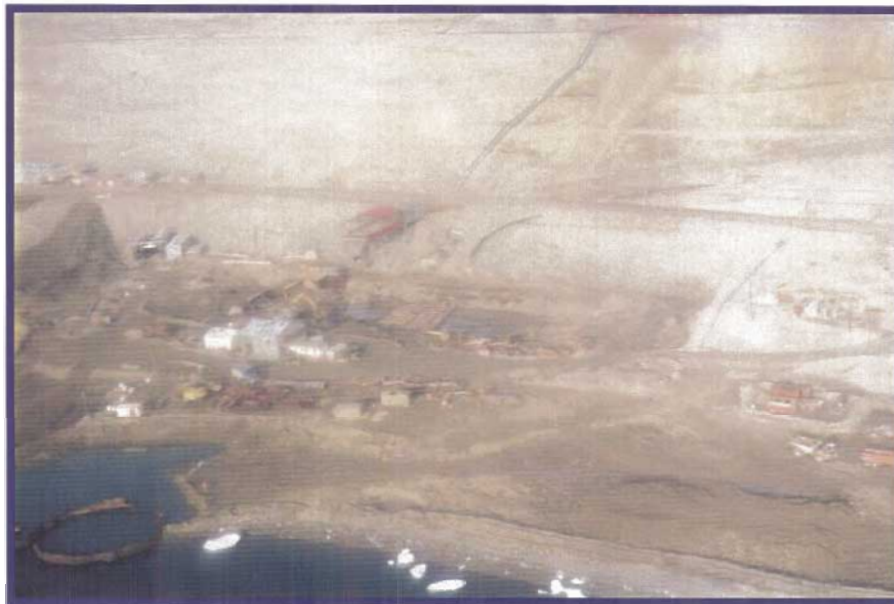
Photo 6 Aerial view of barge excavation.

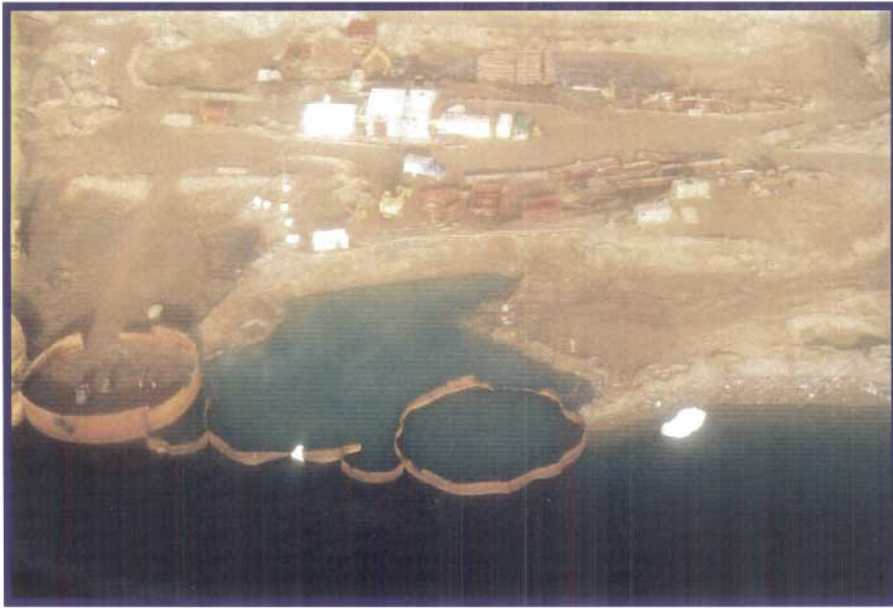
Photo 7 Aerial view of dock cell removal.

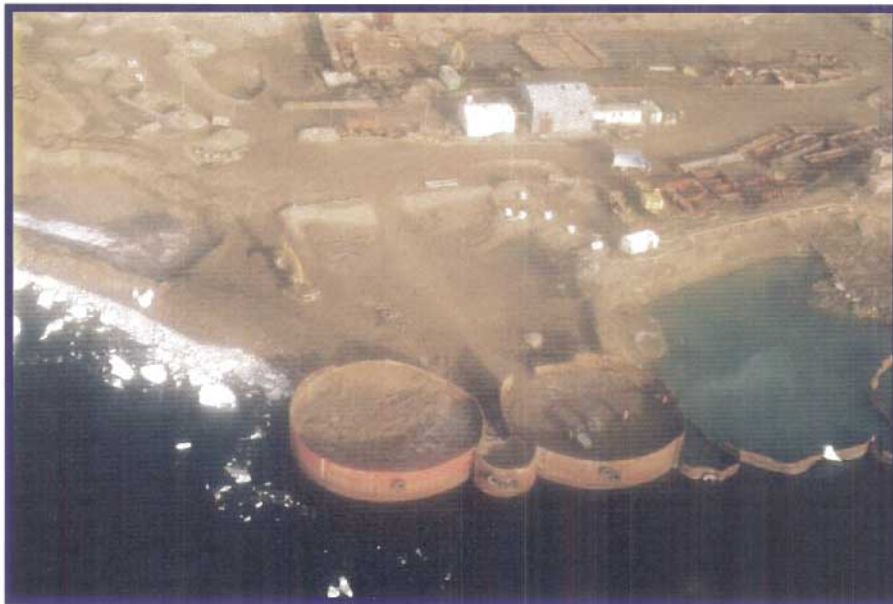
Photo 8 Aerial view of dock cell removal.

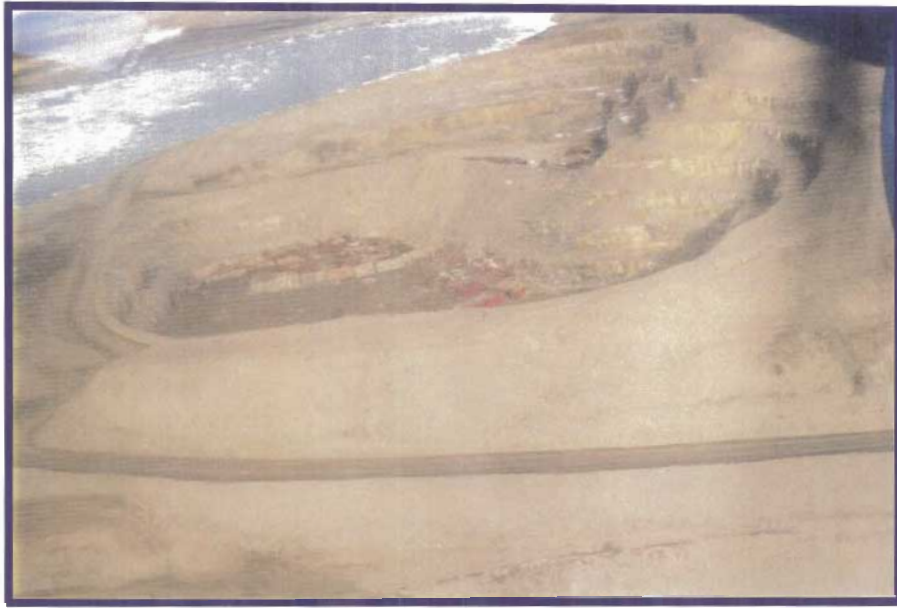
Photo 9 Aerial view of LRD Quarry - looking east.

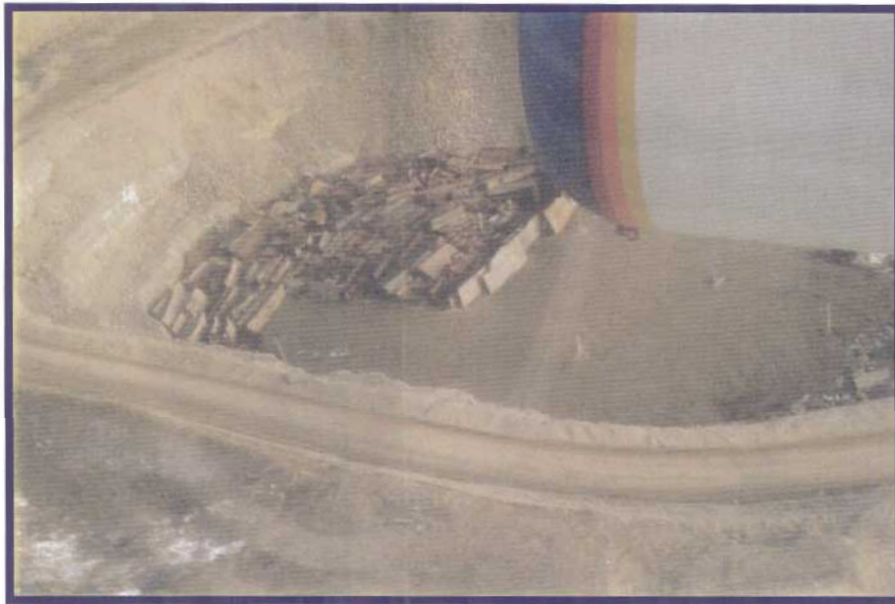
Photo 10 LRD Quarry - aerial view. Disposal of barge hull sections cut up by demolition contractor.

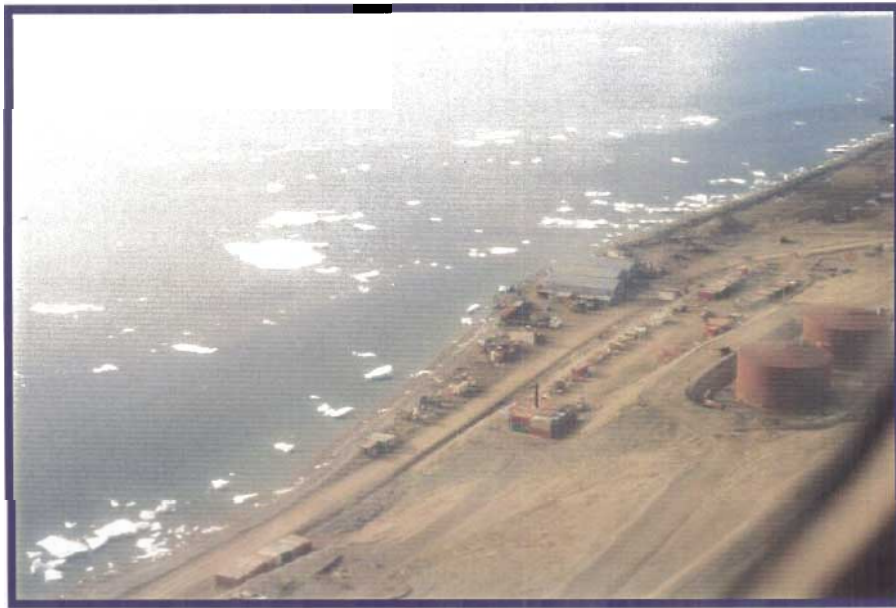
Photo 11 Aerial view of tank farm, former dock area and foldaway buildings

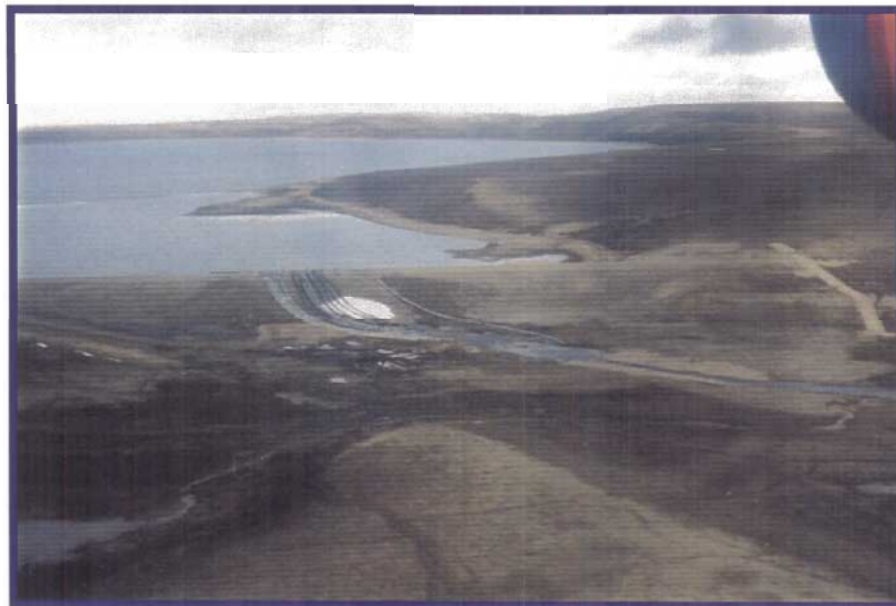
Photo 12 Aerial view of downstream side of Garrow Lake Dam.

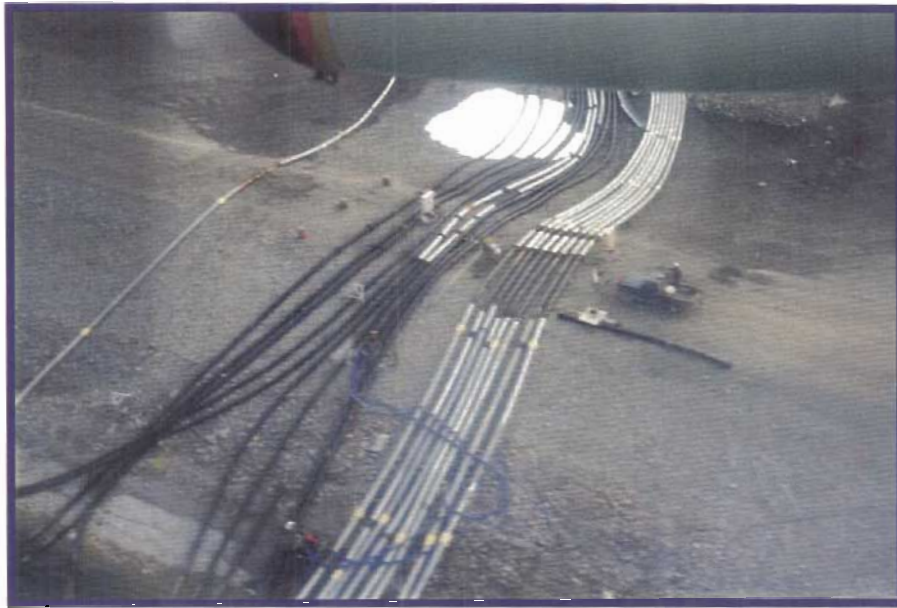
Photo 13 Aerial view of siphon pipes over Garrow Lake Dam.

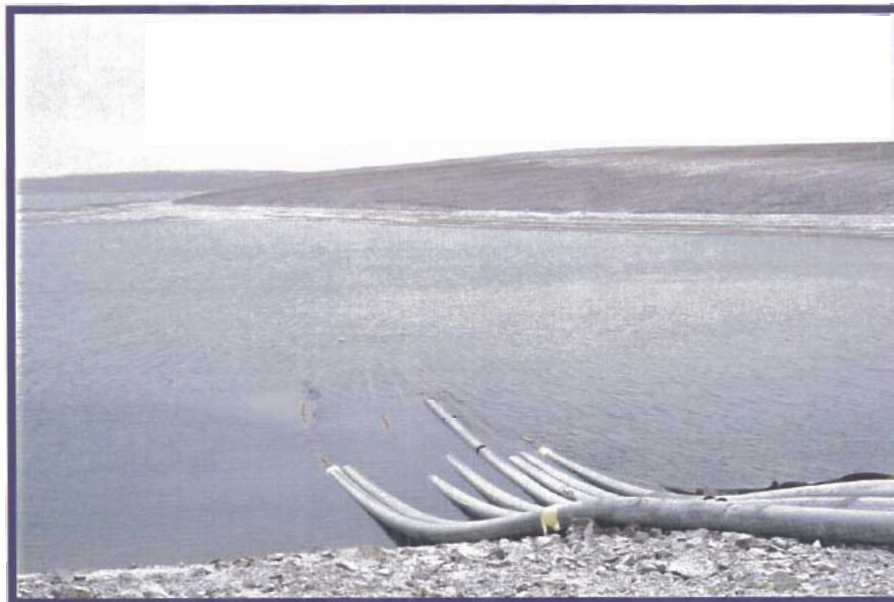
Photo 14 Garrow Lake Dam intake area of siphon pipes.

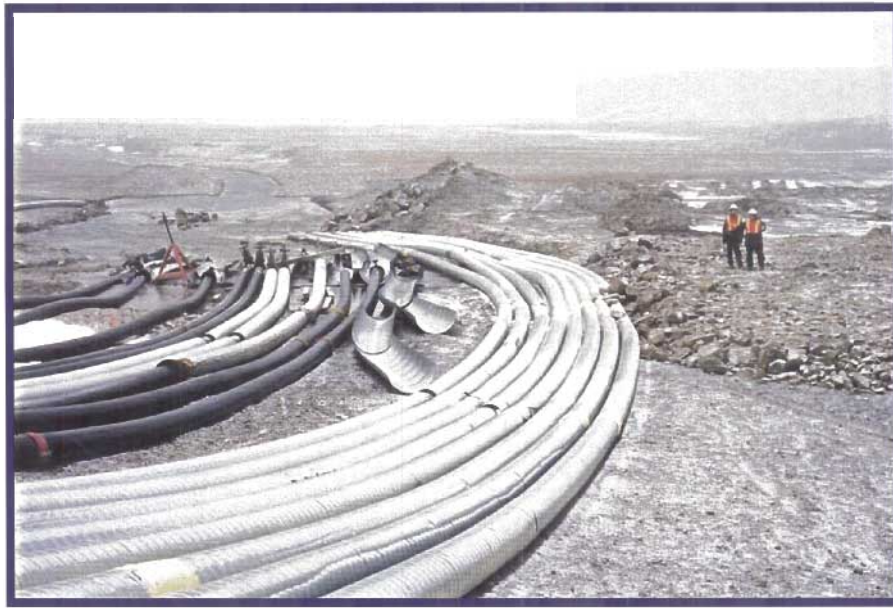
Photo 15 Discharge end of siphon pipes at downstream toe of Garrow Lake Dam. Garrow Creek flows in natural channel in background.

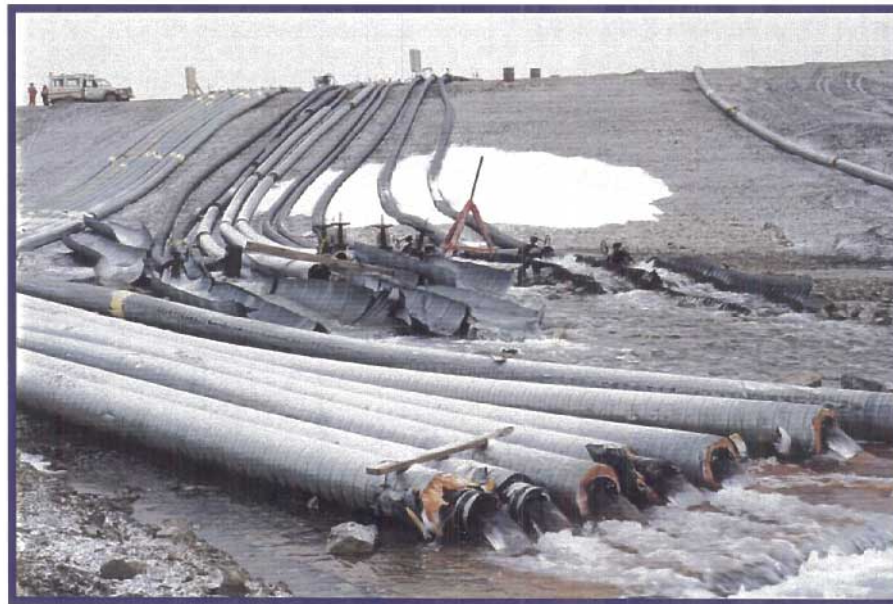
Photo 16 Looking upstream at siphon pipes on downstream slope of Garrow Lake Dam.

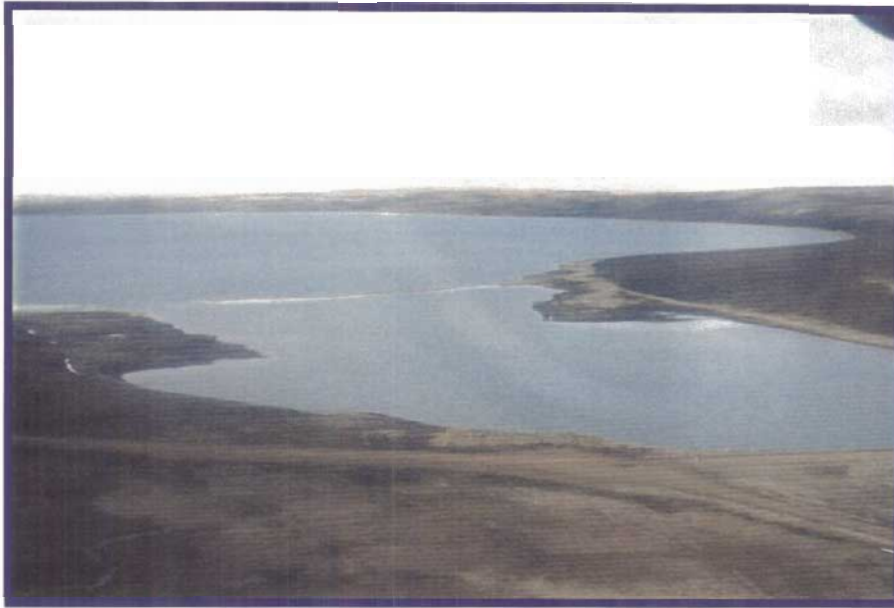
Photo 17 Aerial view of Garrow Lake and wave break structure.

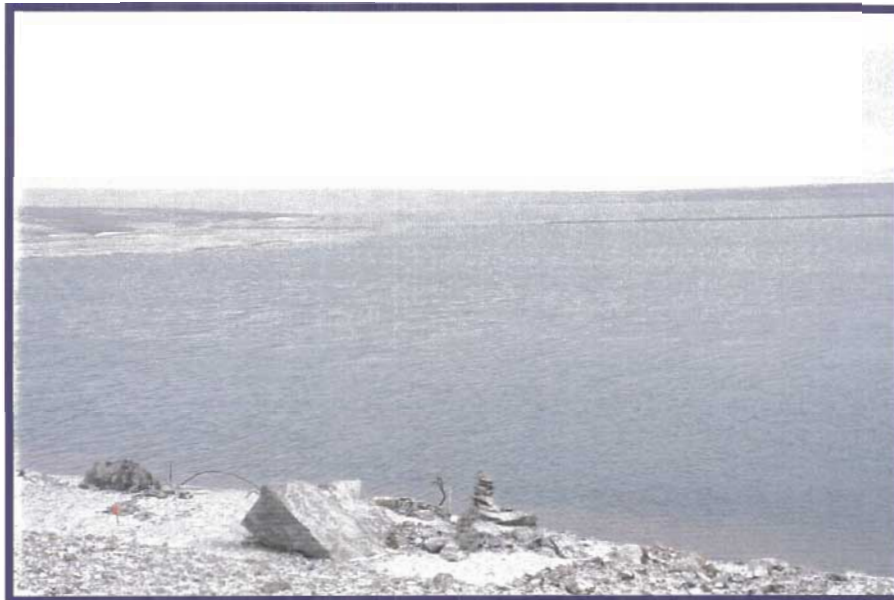
Photo 18 View of Garrow Lake and west end of wave break structure, looking upstream from top of dam.

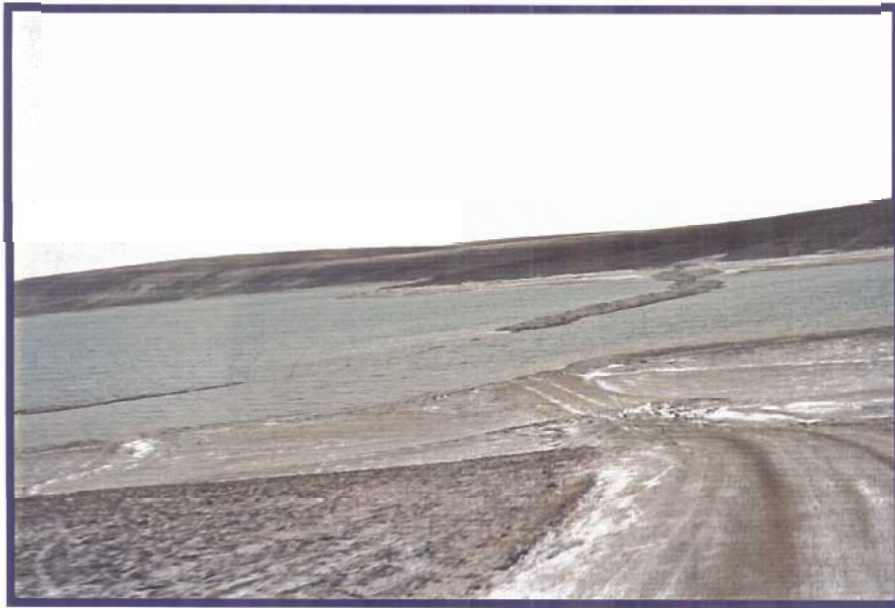
Photo 19 View of wave break structure from west shoreline of Garrow Lake

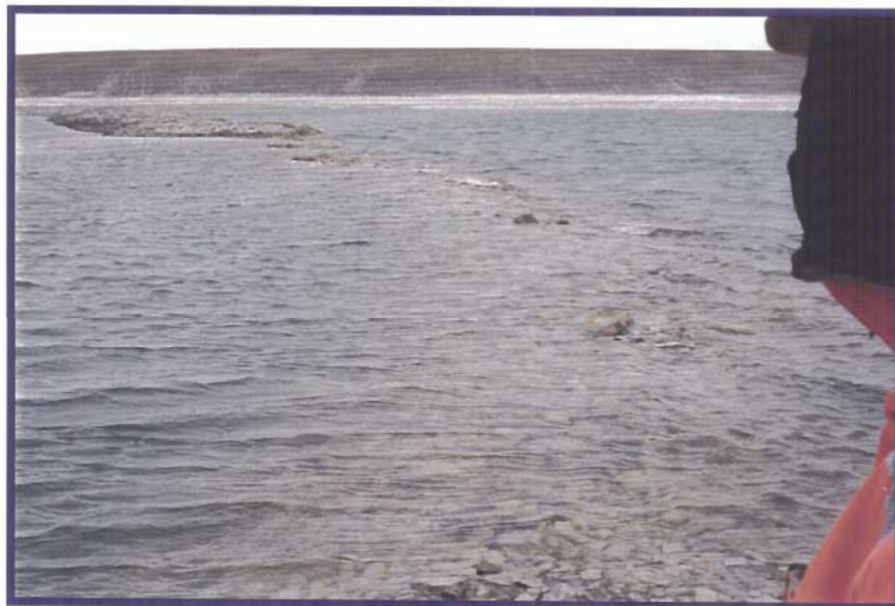
Photo 20 Outlet of Garrow Lake at wave break structure.

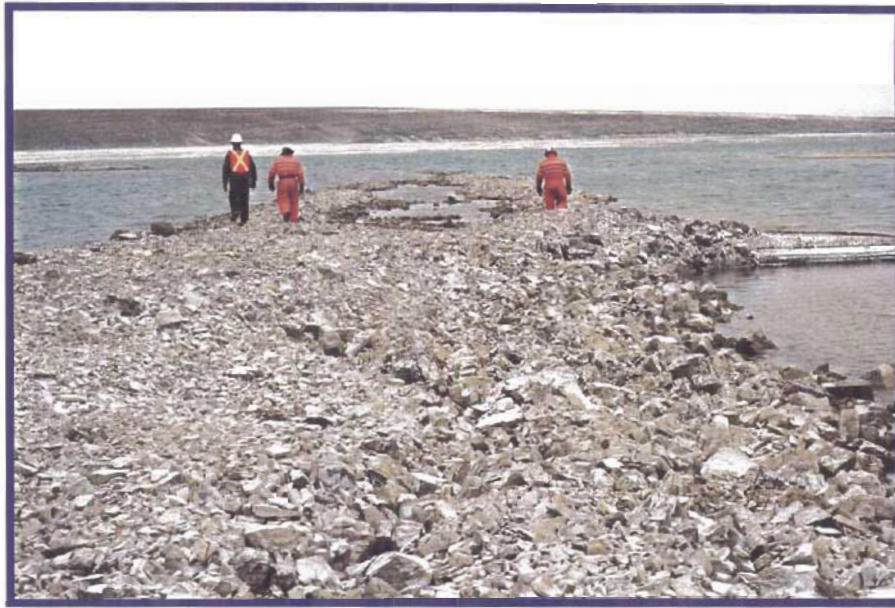
Photo 21 Top of Garrow Lake wave break structure. Open water portion is approximately 0.4 m deep and is located in vicinity of original lake outlet to Garrow Creek.

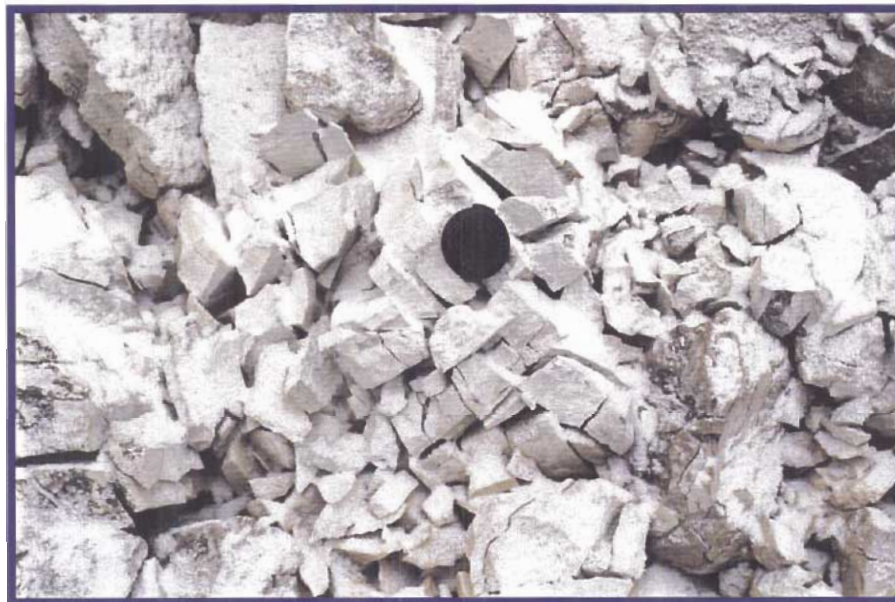
Photo 22 Limestone boulder in rockfill of Garrow Lake wave break structure. Rock has been completely shattered by freeze-thaw action.

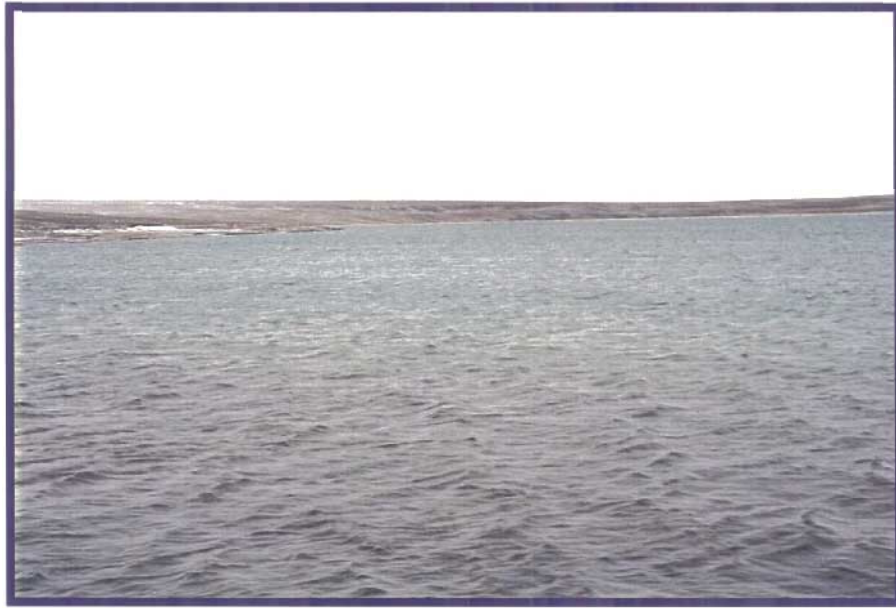
Photo 23 Looking across Garrow Lake from wave break structure.

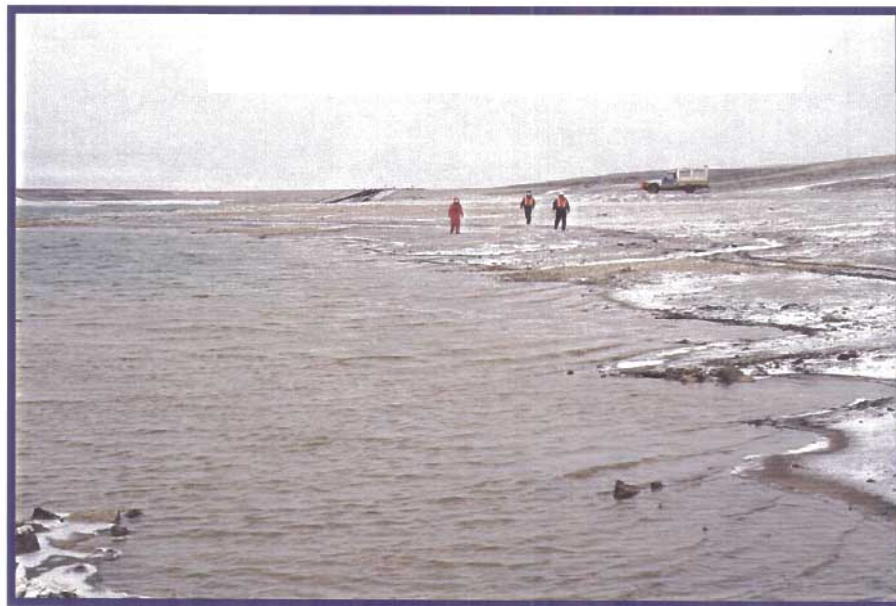
Photo 24 West shoreline of Garrow Lake at wave break structure.

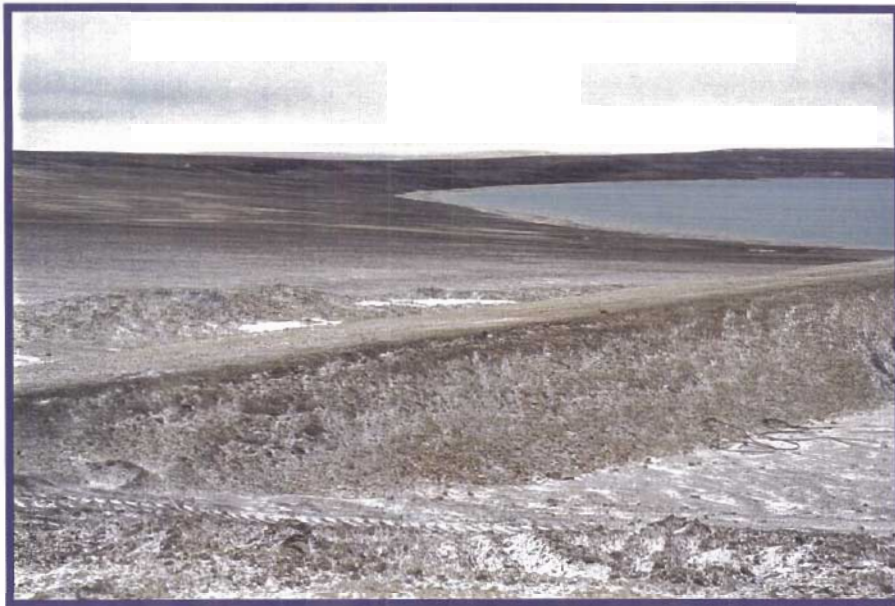
Photo 25 View of Garrow Lake from tailings thickener.

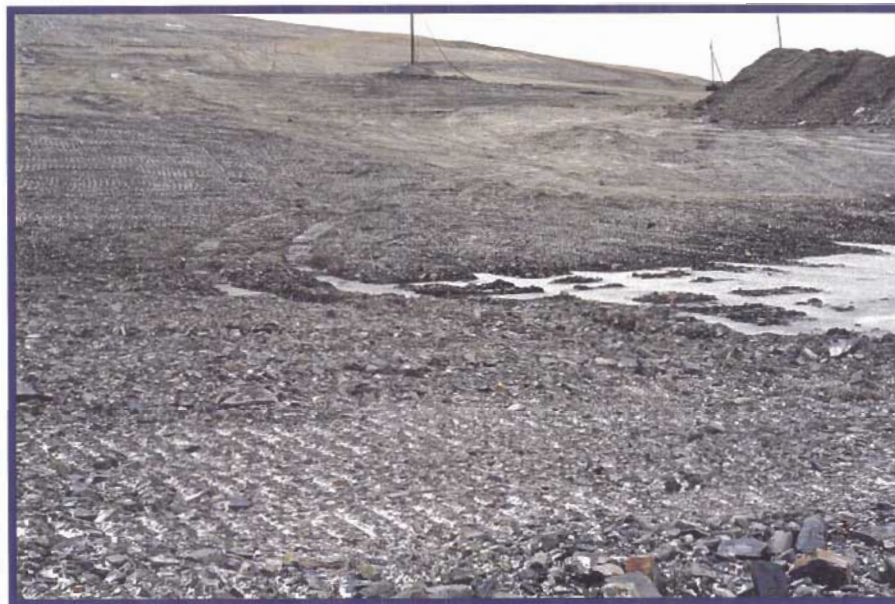
Photo 26 Shale backfill and standing water in center of subsidence zone.

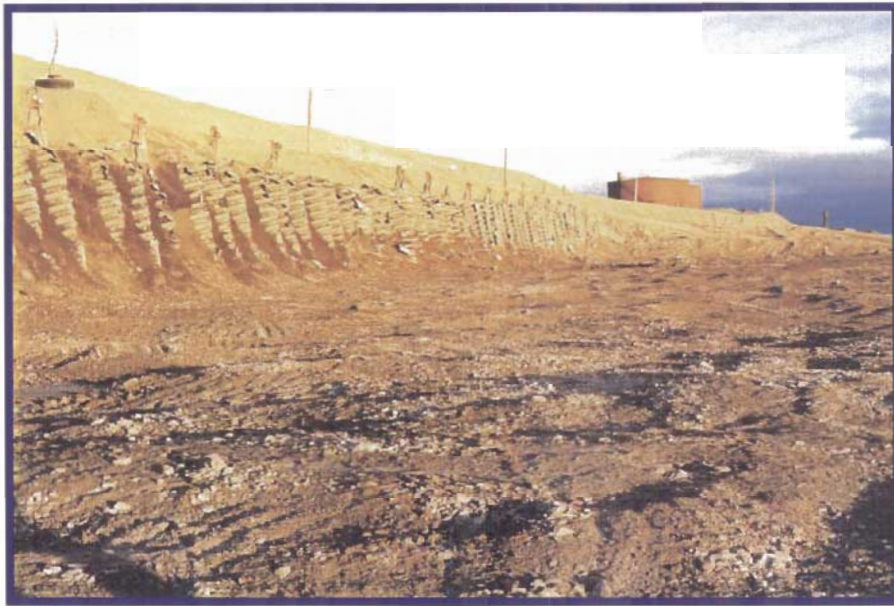
Photo 27 Partially excavated bin wall retaining wall along east side of concentrate storage shed.

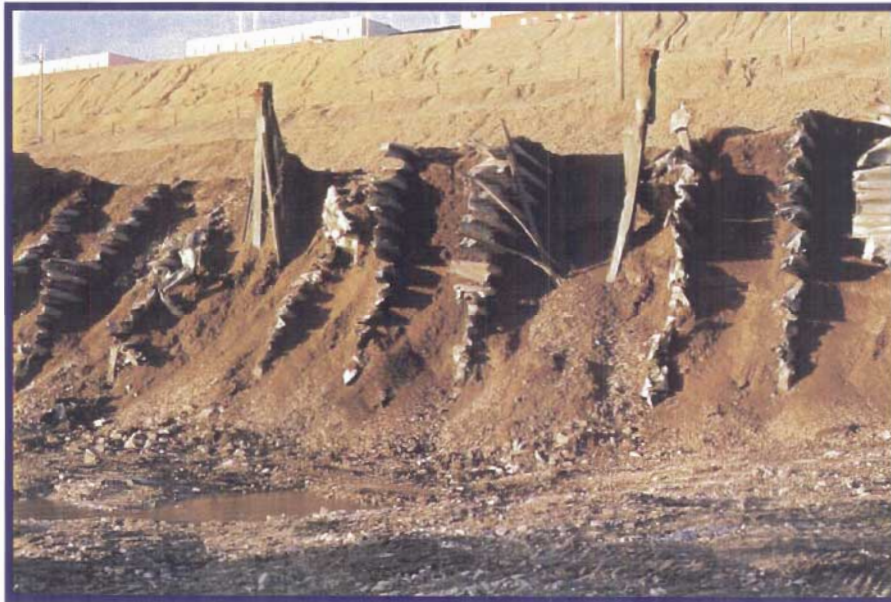
Photo 28 Partially excavated bin wall retaining wall along east side of concentrate storage shed.

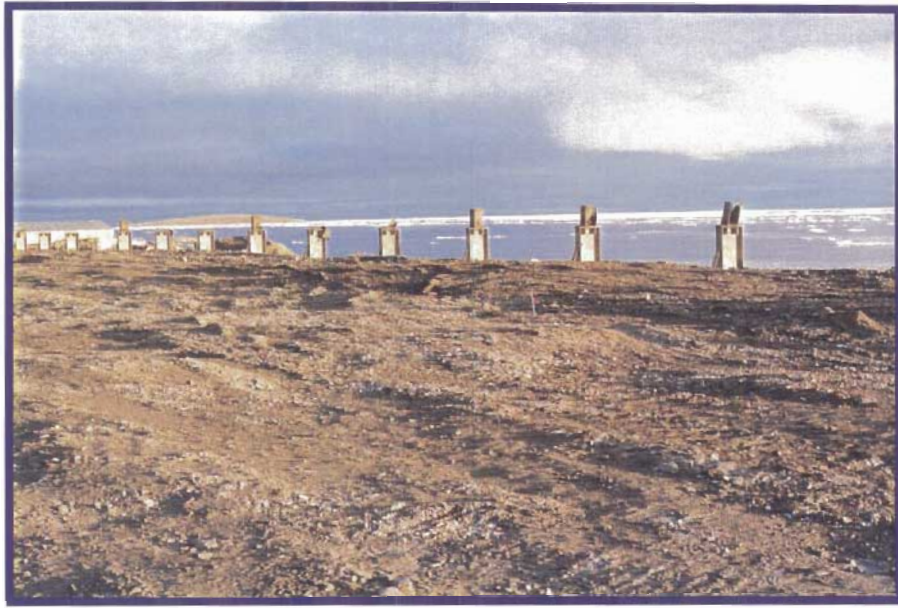
Photo 29 Lower ends of steel columns which supported the concentrate storage shed. Soil in floor of shed has been excavated to bedrock.

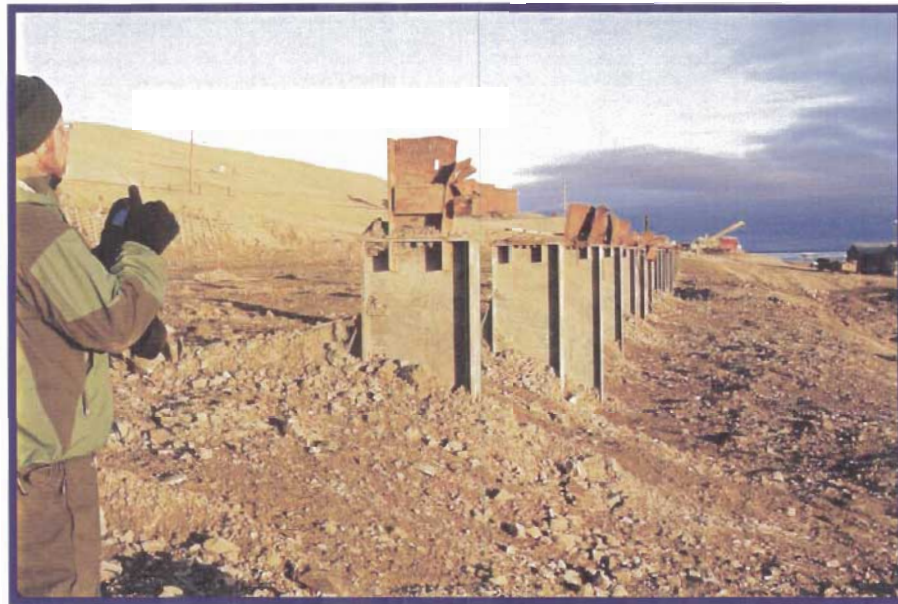
Photo 30 Columns along west side of concentrate storage area.

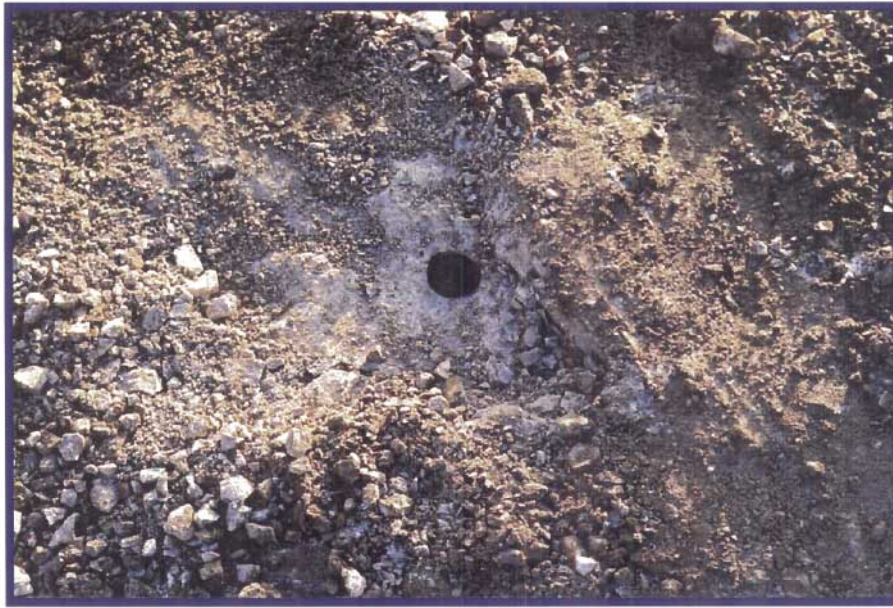
Photo 31 Close up of limestone bedrock exposed in floor of concentrate storage shed. Some 10-15 cm of rock has been removed by contractor to collect residual metals contaminated soils.

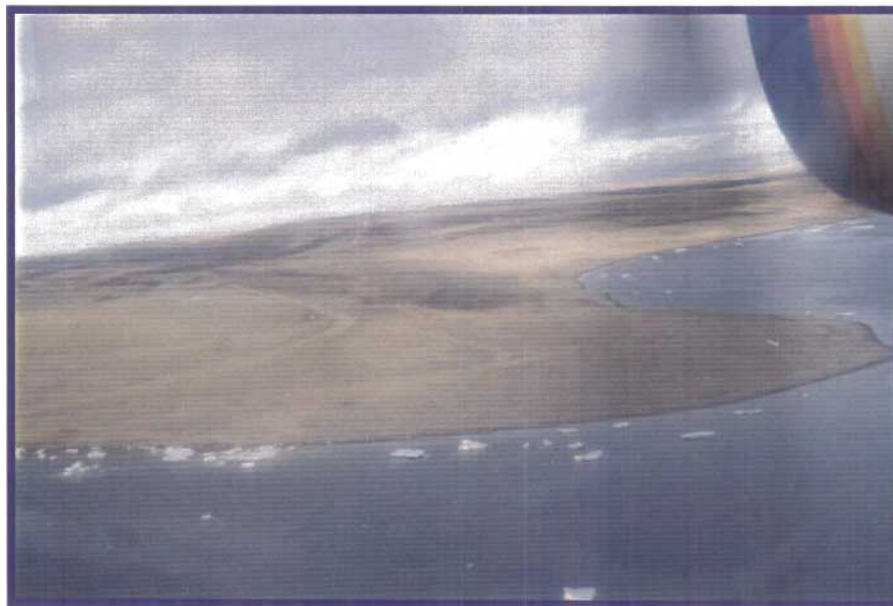
Photo 32 Aerial view of Operational Landfill area, looking east.

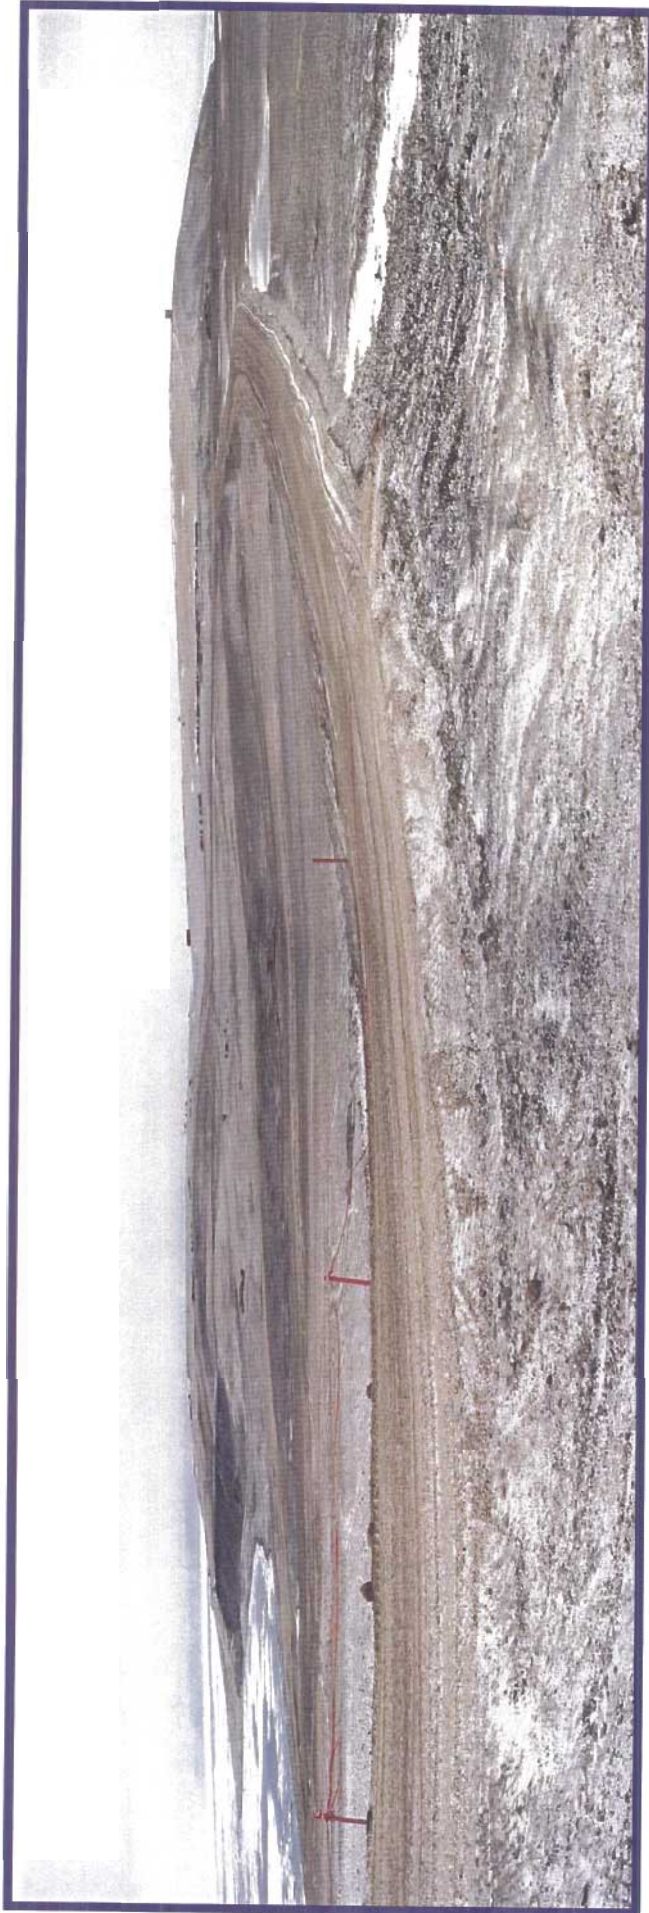
Photos 33 View towards Operational Landfill (black area on left), from tailings thickener.

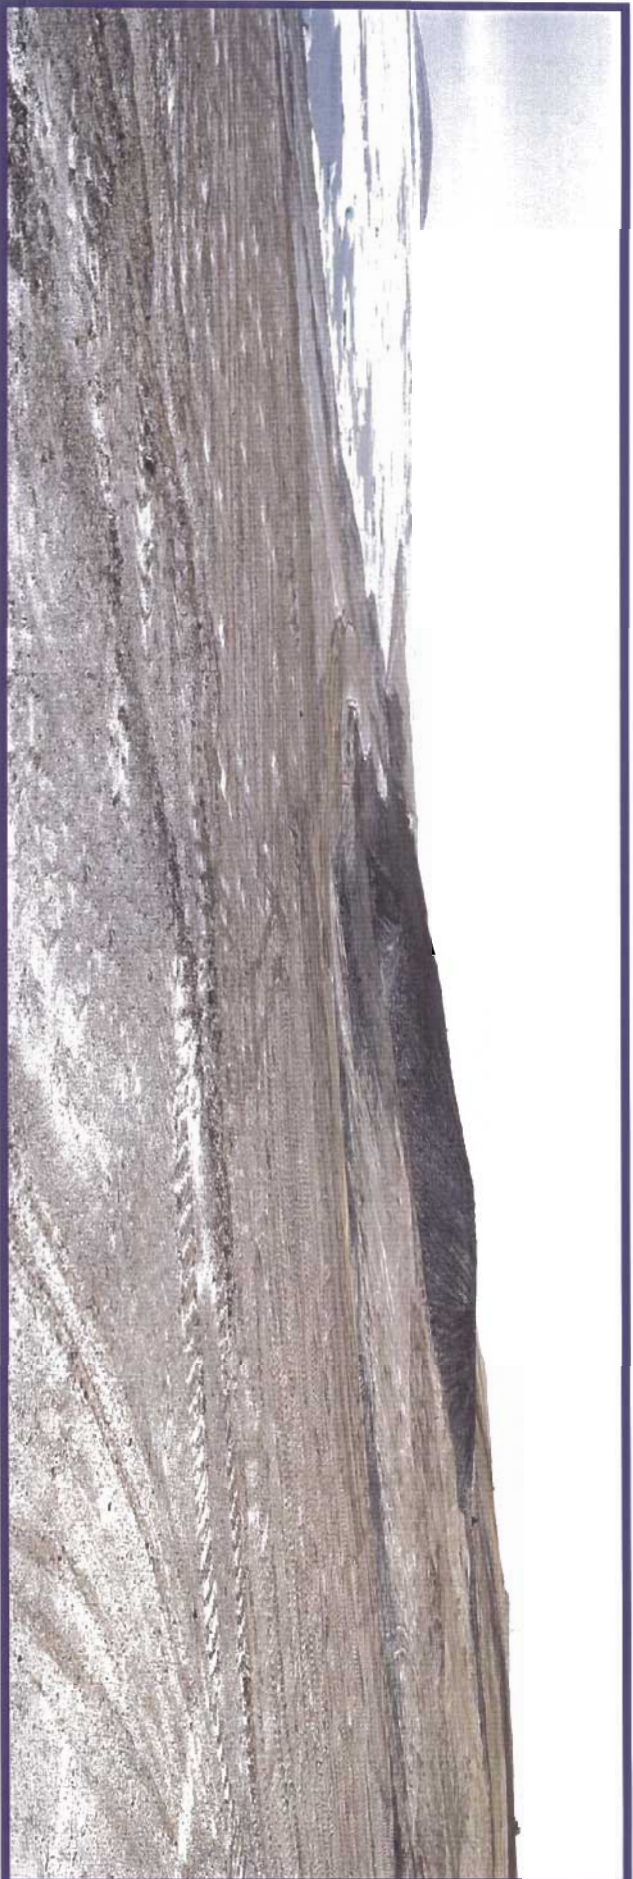
Photos 34 Operational Landfill - view of east side from explosives storage area.
