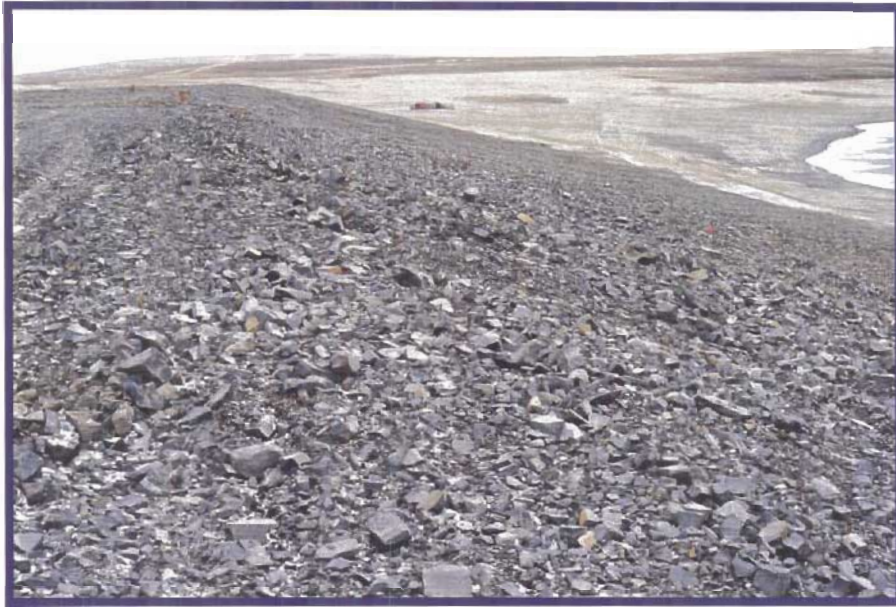
Photo 35 Looking east along crest of Operational Landfill shale covered slope.

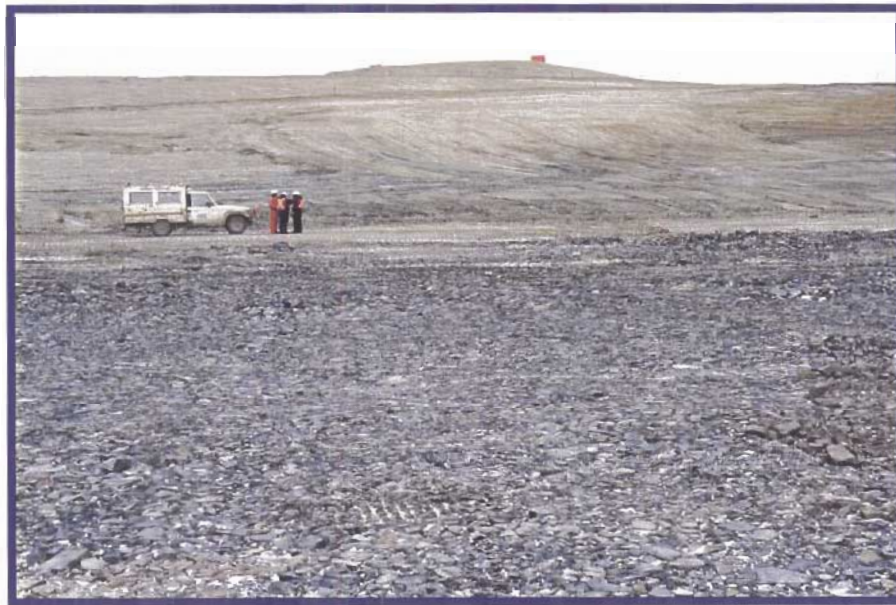
Photo 36 Looking north over top of Operational Landfill towards re-graded natural backslope area.

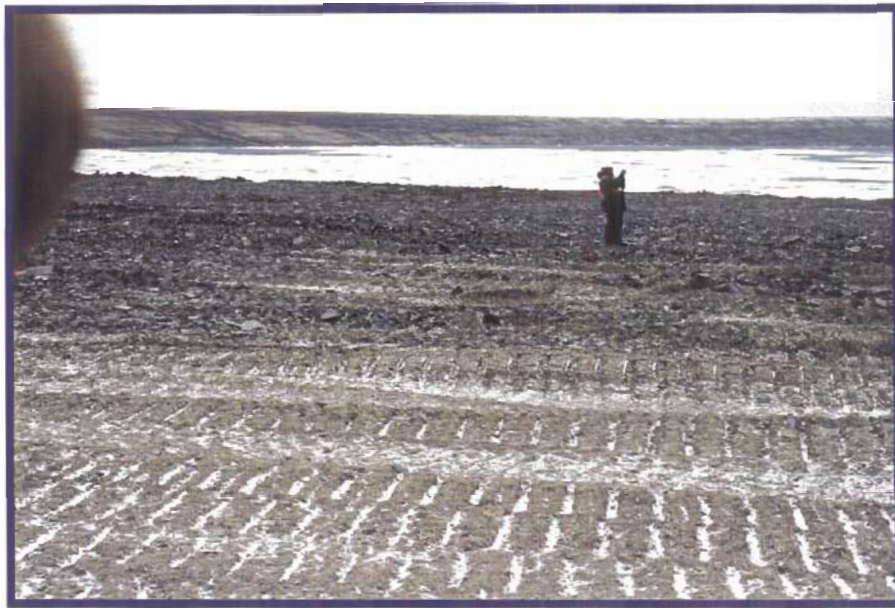
Photo 37 Surface of 1.2 m of shale cover on top of Operational Landfill.

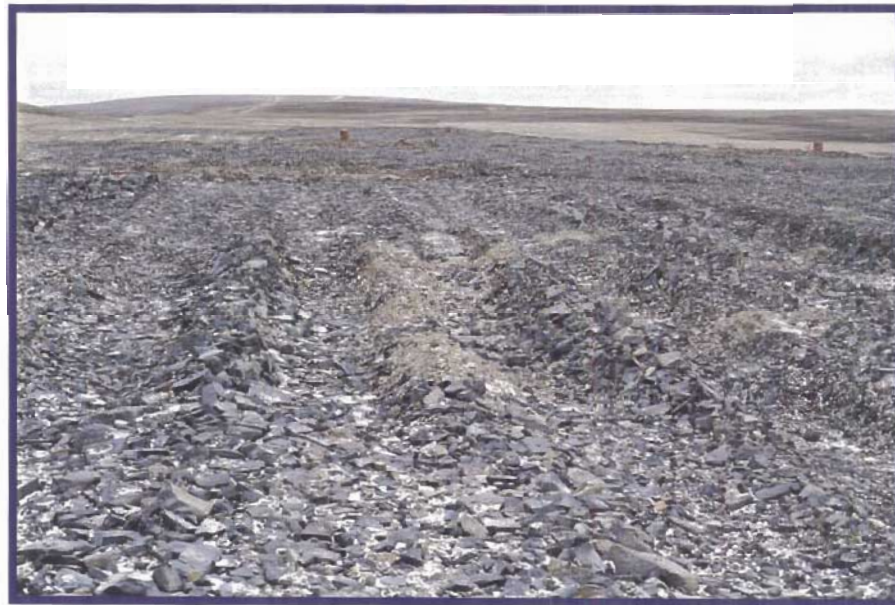
Photo 38 Minor rutting due to compaction of shale cover into soft underlying foundation materials.

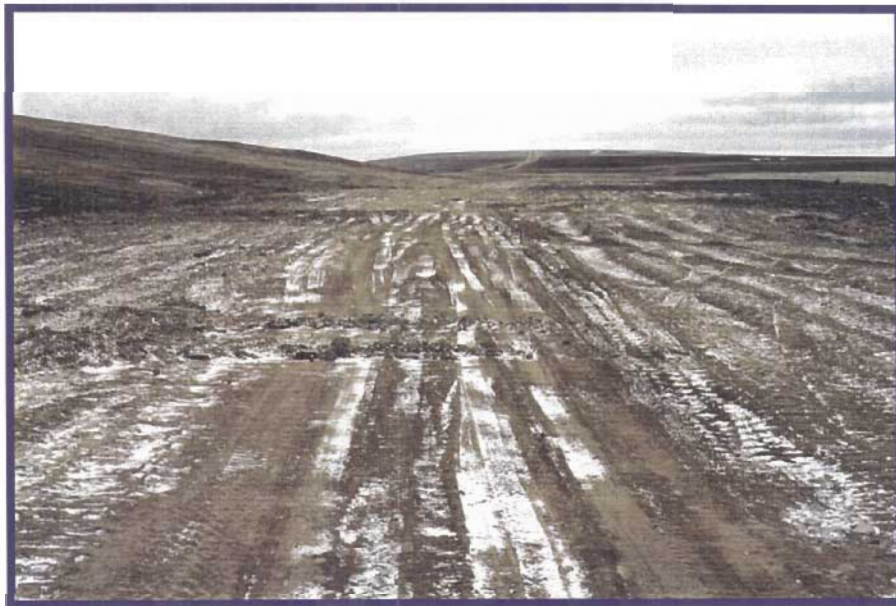
Photo 39 Top of Operational Landfill/contact zone with backslope where backfill was placed level with top of shale cover.

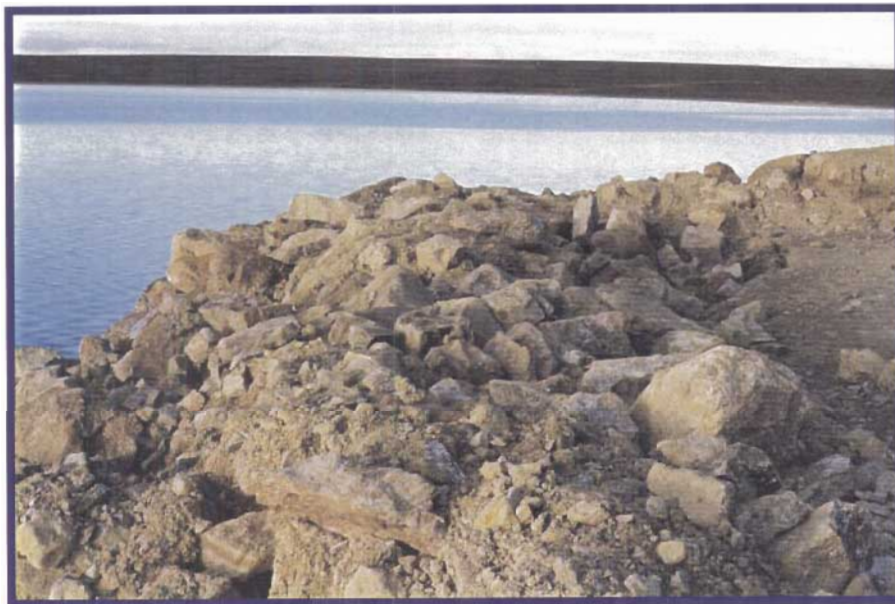
Photo 40 Jetty materials, Frustration Lake water intake.

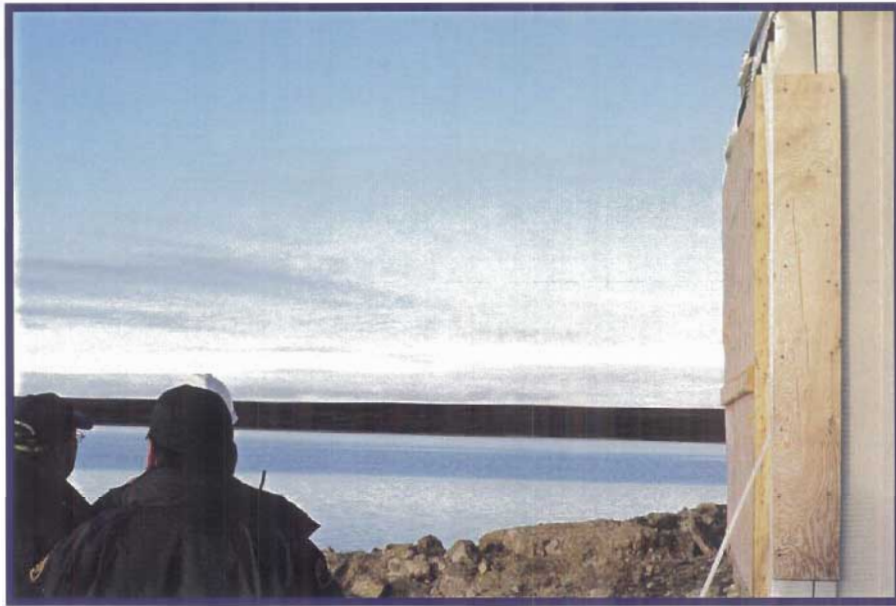
Photo 41 Frustration Lake freshwater intake pump house. Wall damaged by wind driven ice from lake.

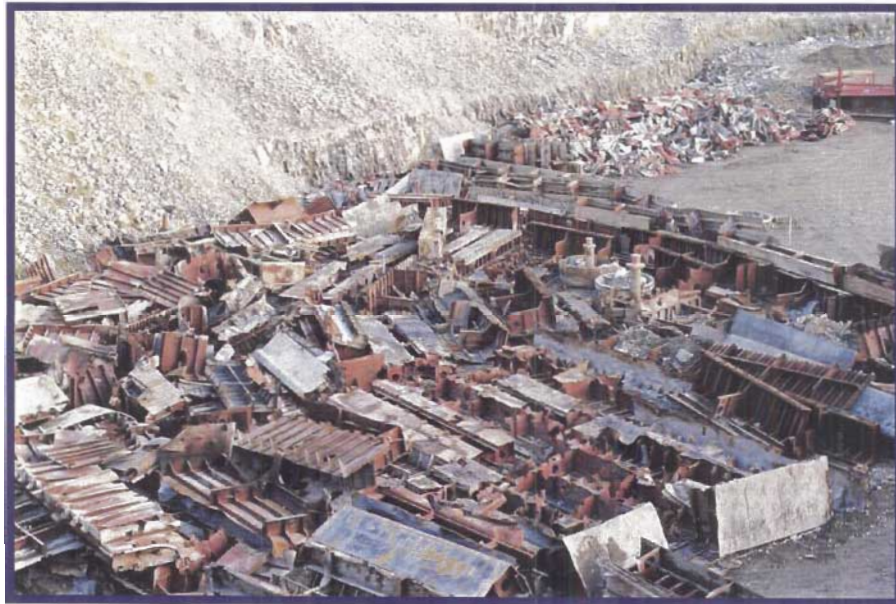
Photo 42 LRD Quarry with cut-up barge hull sections.

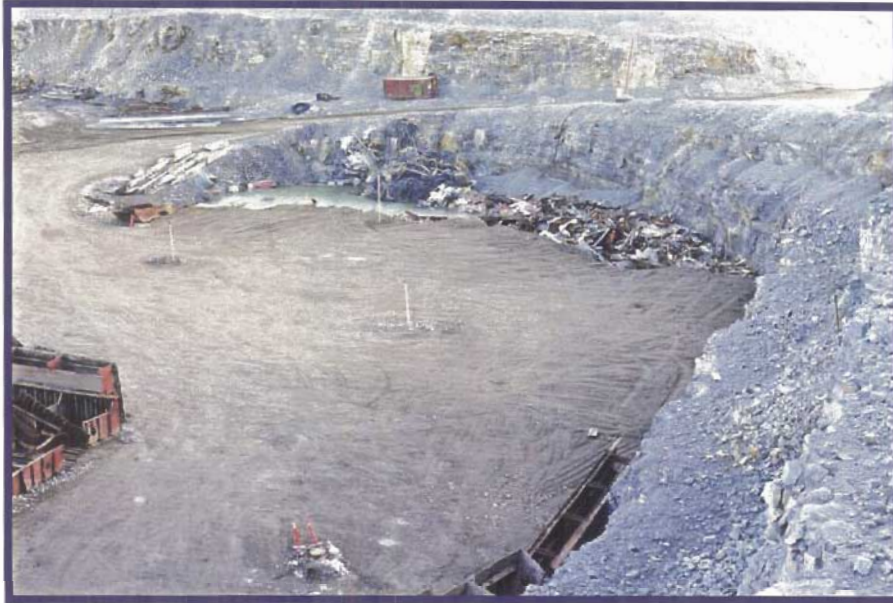
Photo 43 LRD Quarry, thermistor pipes and backfill cover, with new lift of demolition debris.

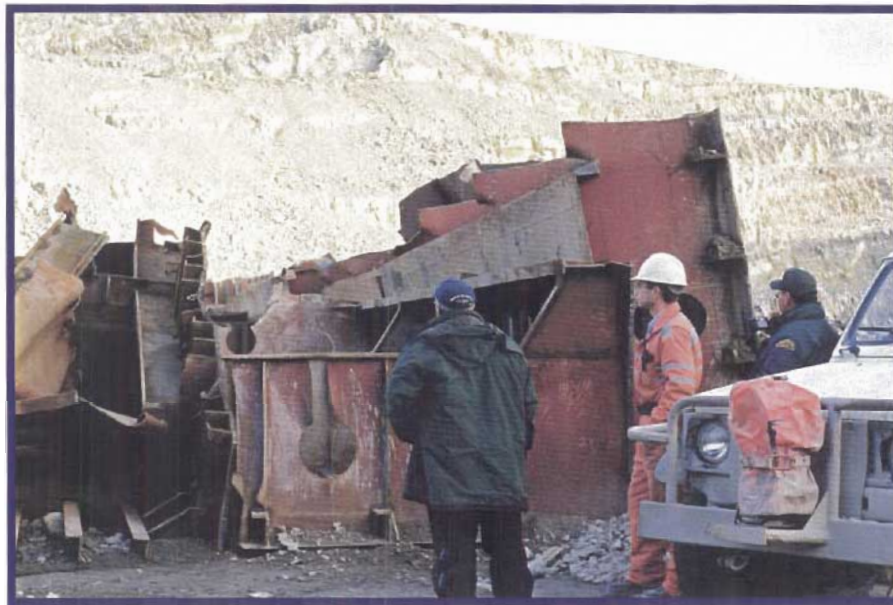
Photo 44 Cut up barge sections stacked on end to minimize voids. Insides of hull sections will be filled with cover material.

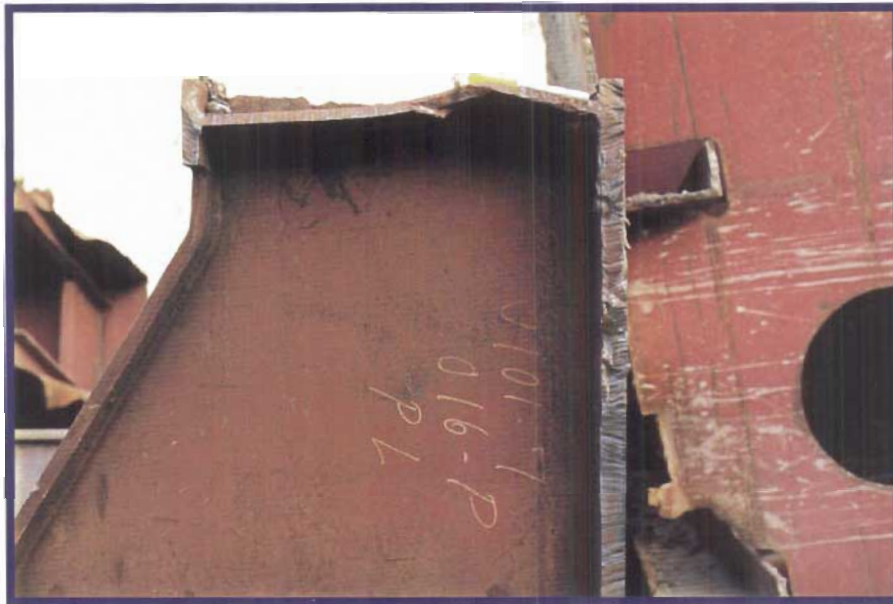
Photo 45 Close up view of cut section of barge hull. (Note pen for scale).

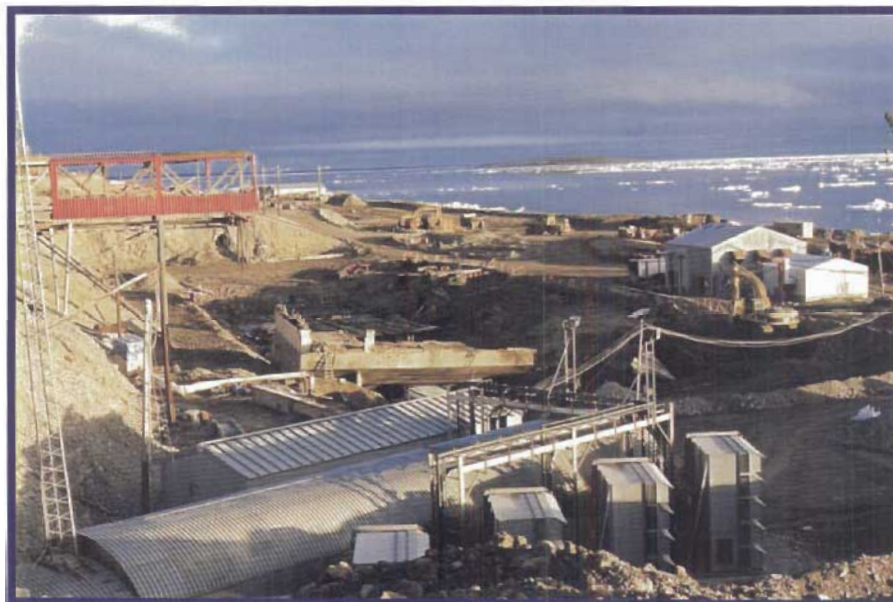
Photo 46 Excavation of process barge with one hull section remaining to be removed.

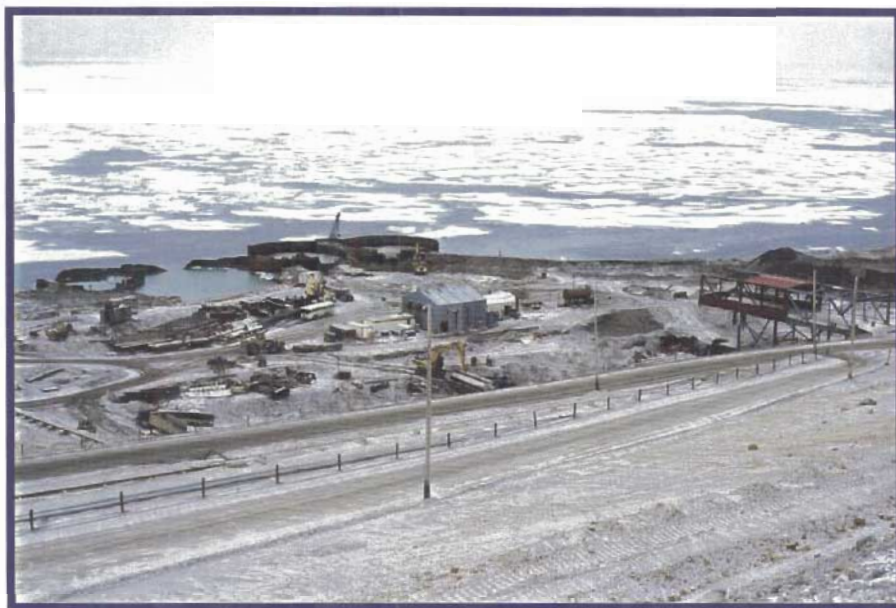
Photo 47 View of dock cell area after night of high (120 km/hr) winds. Note flooded cells with more damage to sheet piles.

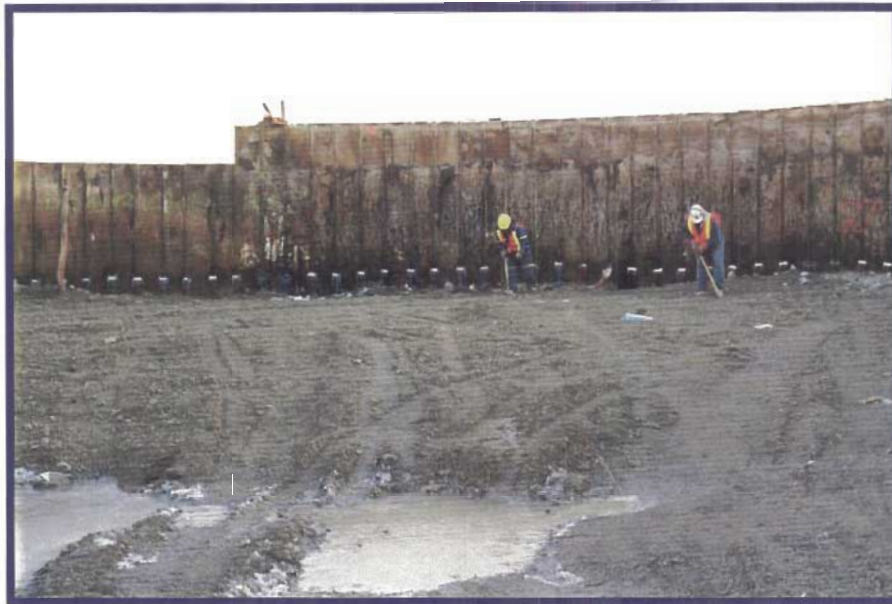
Photo 49 Workers inside dock cells exposing glycol freeze pipes by hand shovelling.

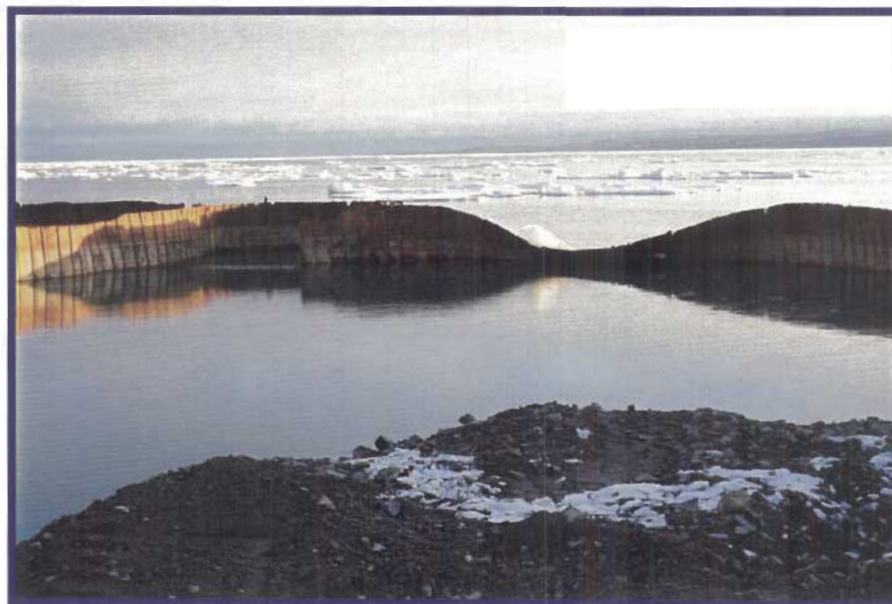
Photo 50 Dock cell, partially excavated below water line. Bent piles caused by drifting pans of ice.

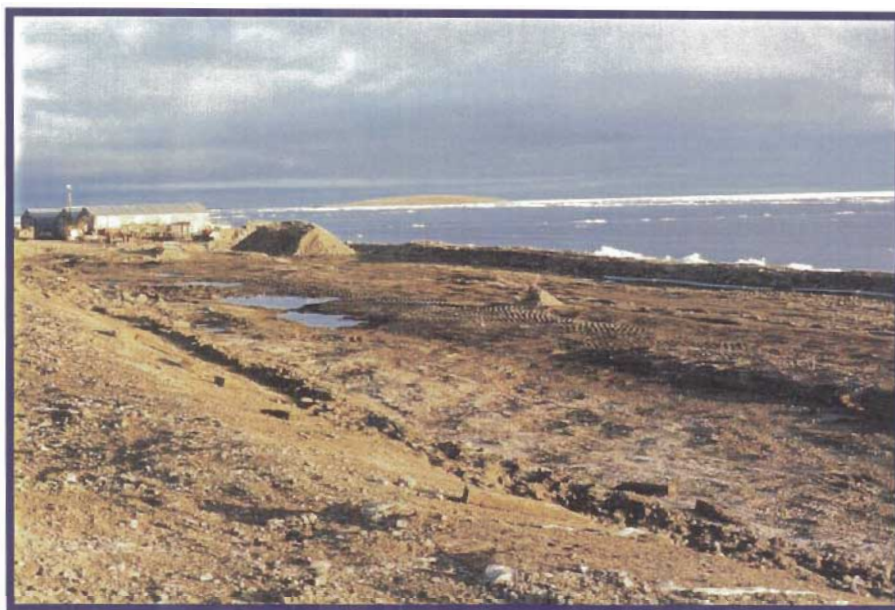
Photo 51 Foreshore area in front of concentrate storage shed. Ongoing removal of contaminated soils. Note berm along shoreline.

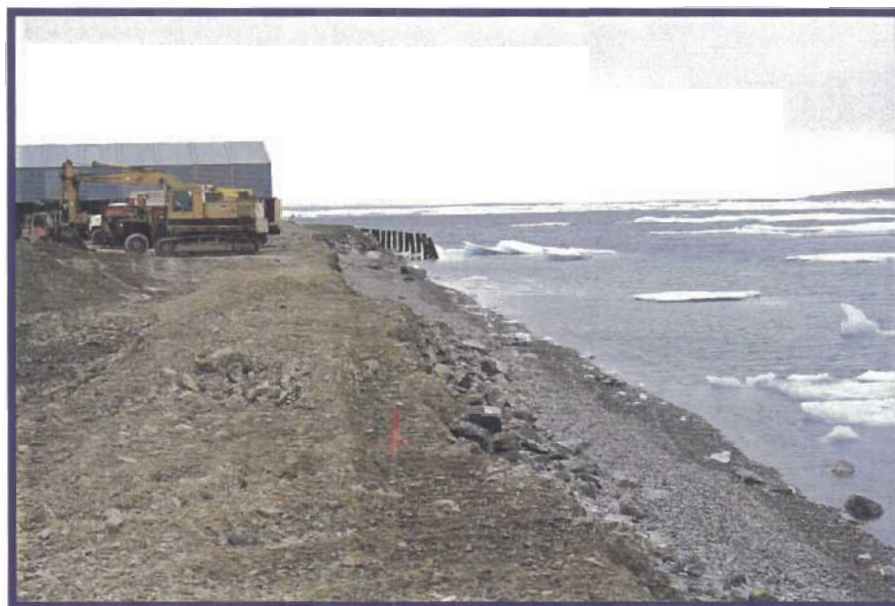
Photo 52 Looking south along marine foreshore area towards former dock area and foldaway buildings.

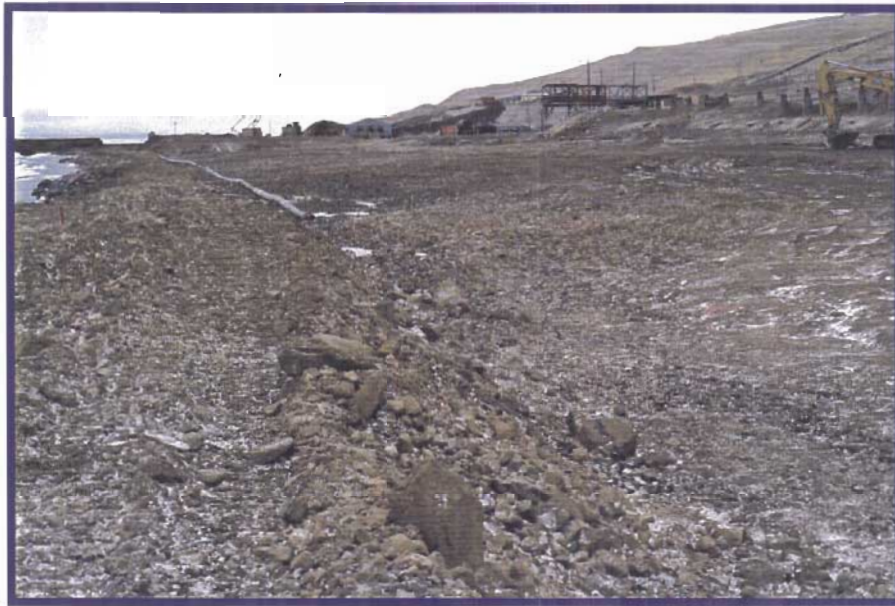
Photo 53 Looking north over marine foreshore area from top of protective berm.

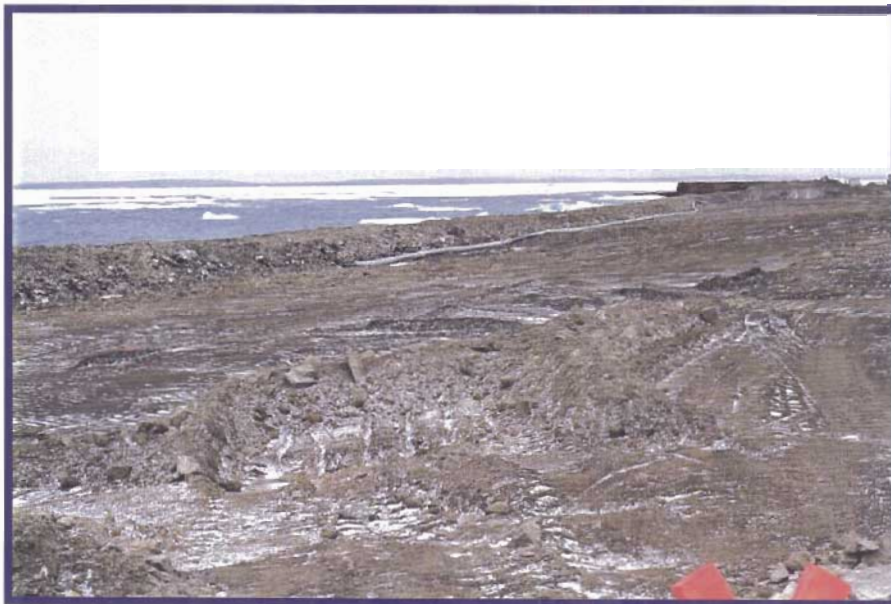
Photo 54 Marine foreshore area, with small berm to prevent runoff into ocean from potentially contaminated soils in excavation.

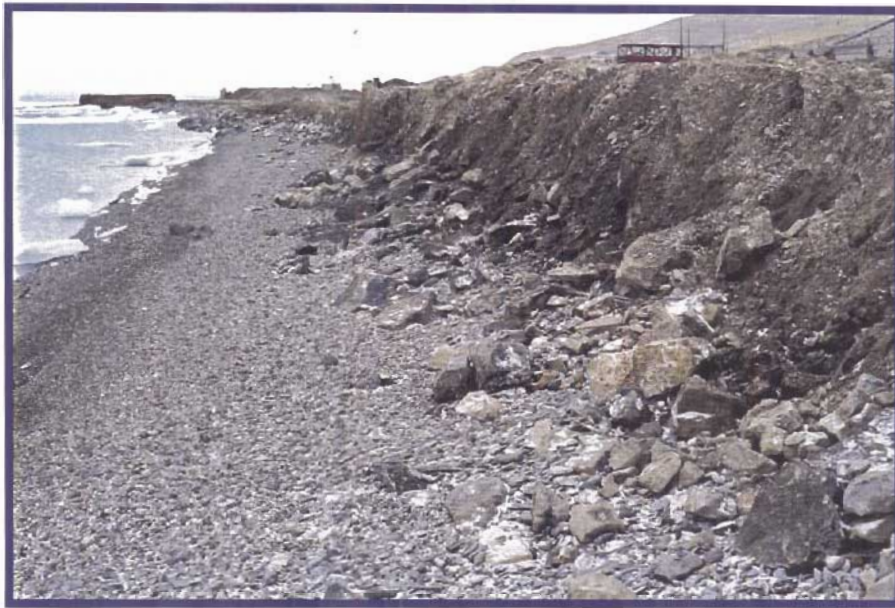
Photo 55 Beach, looking north towards dock cells.

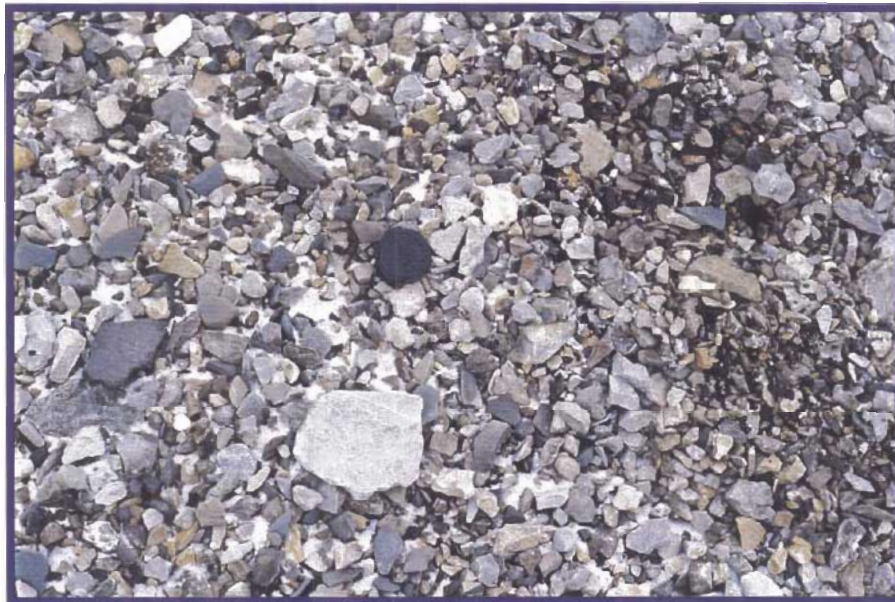
Photo 56 Typical beach gravel on ocean side of berm in marine foreshore area.

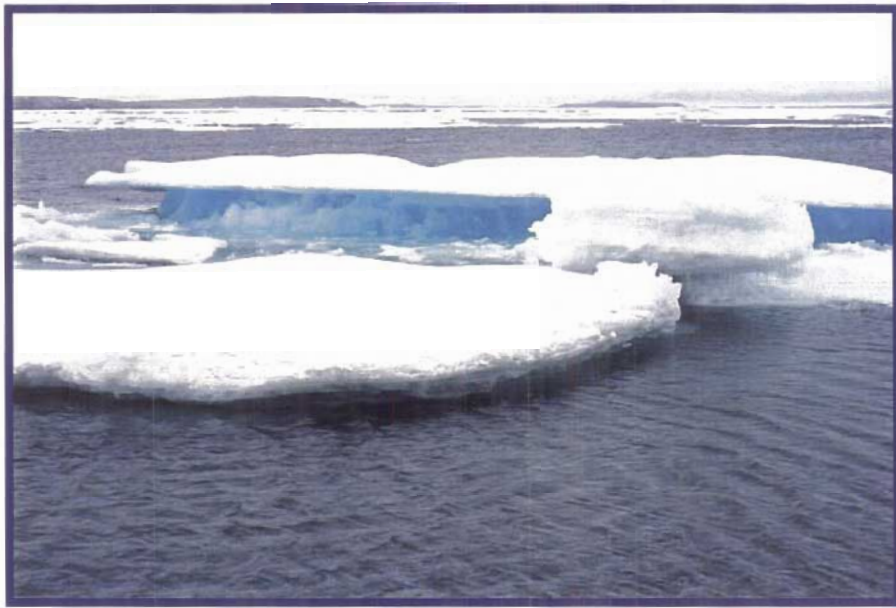
Photo 57 Pans of sea ice in Crozier Strait.

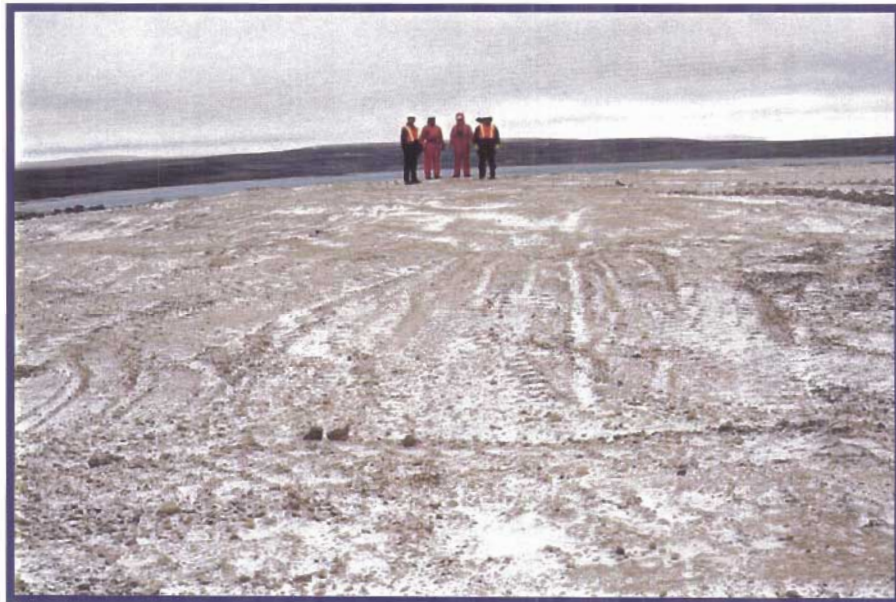
Photo 58 Inspection team on tailings thickener pad foundation.

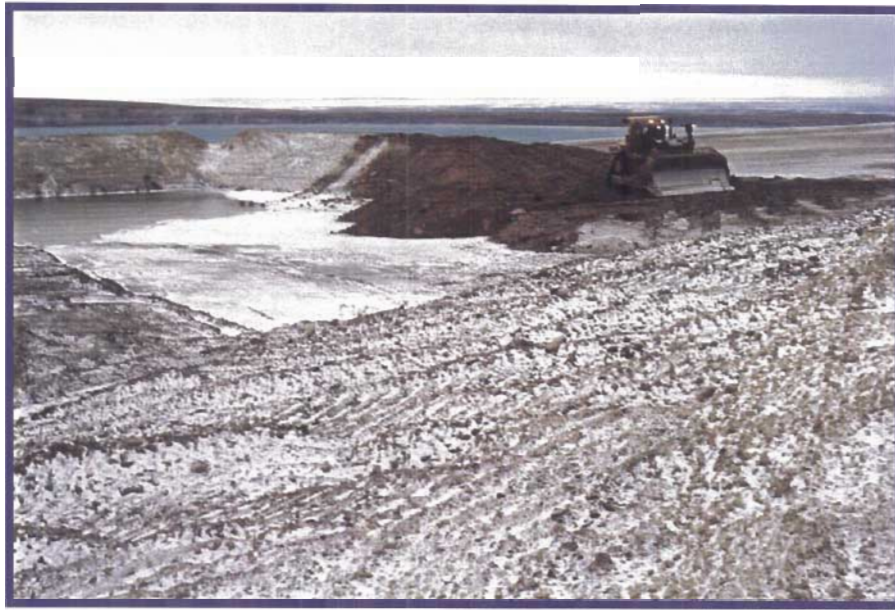
Photo 59 Tailings thickener - overflow pond dikes in process of removal.

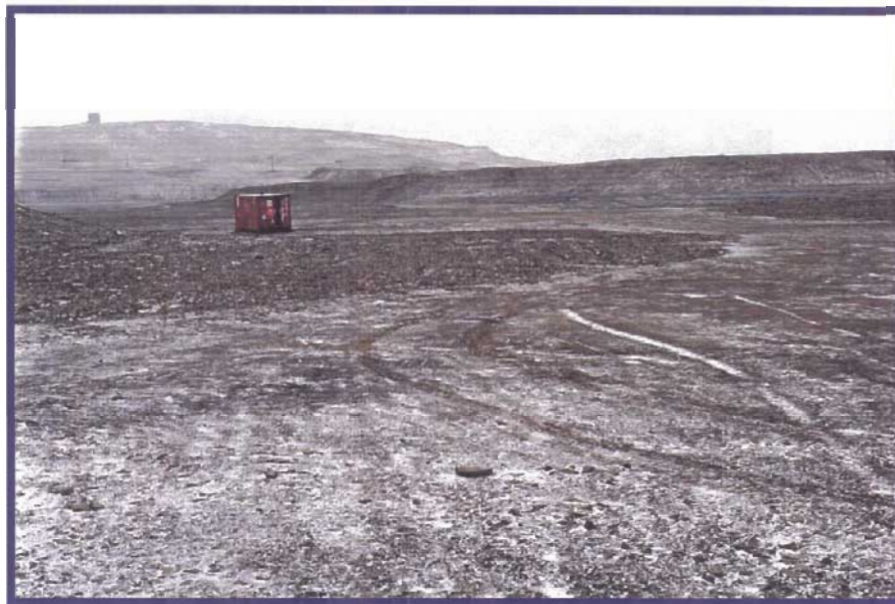
Photo 60 New Quarry with final reclaimed side slopes.

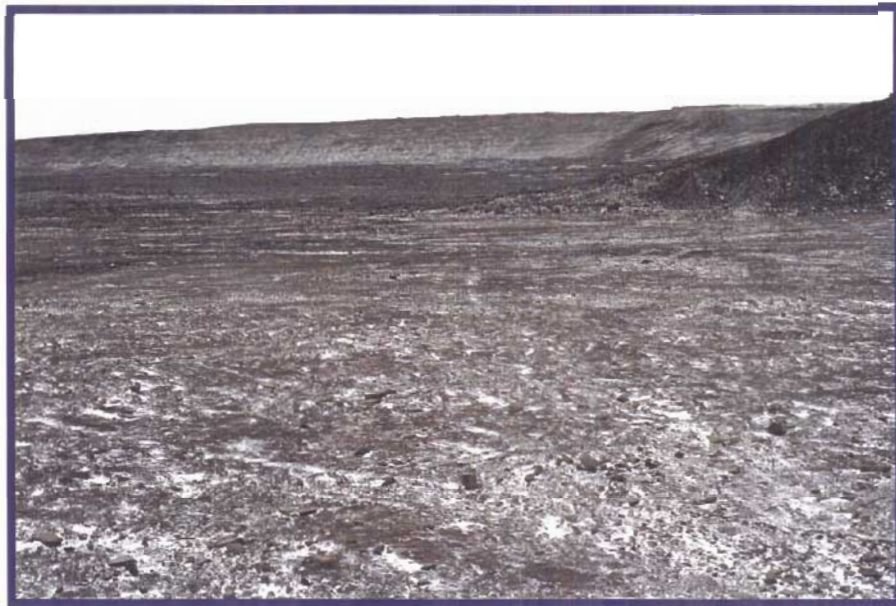
Photo 61 New Quarry with final reclaimed side slopes.

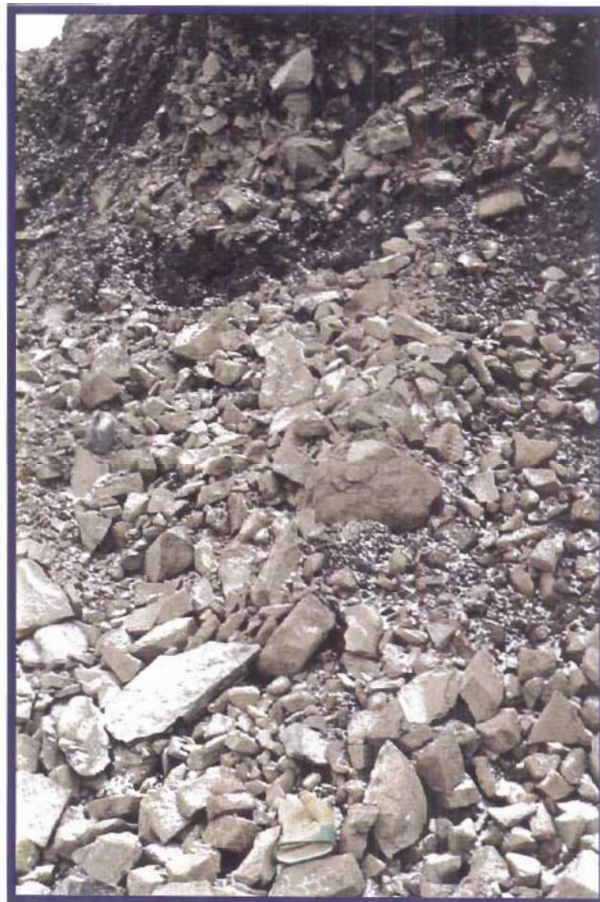
Photo 62 Shale stockpile in New Quarry.

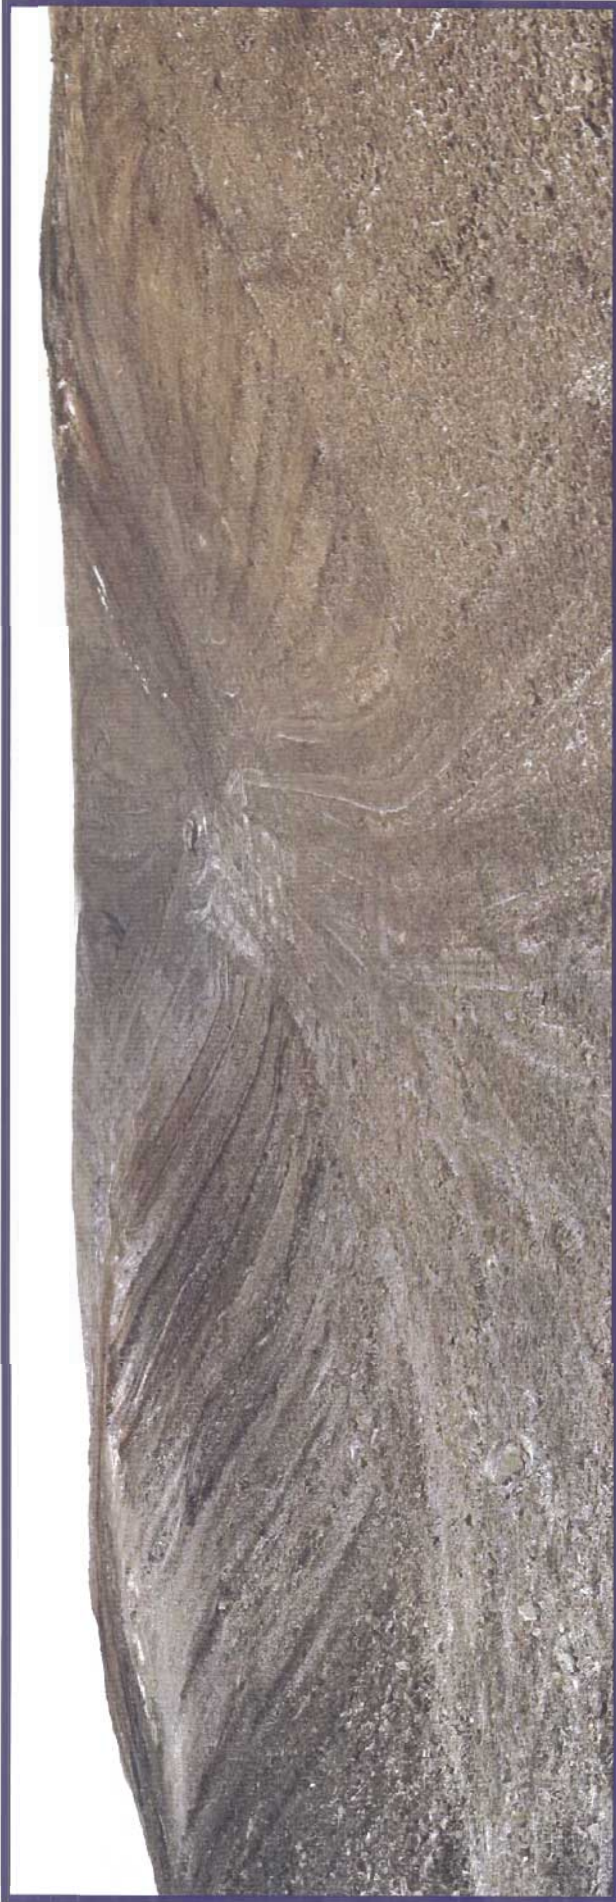
Photos 63 Re-contoured side slopes in North pit area.

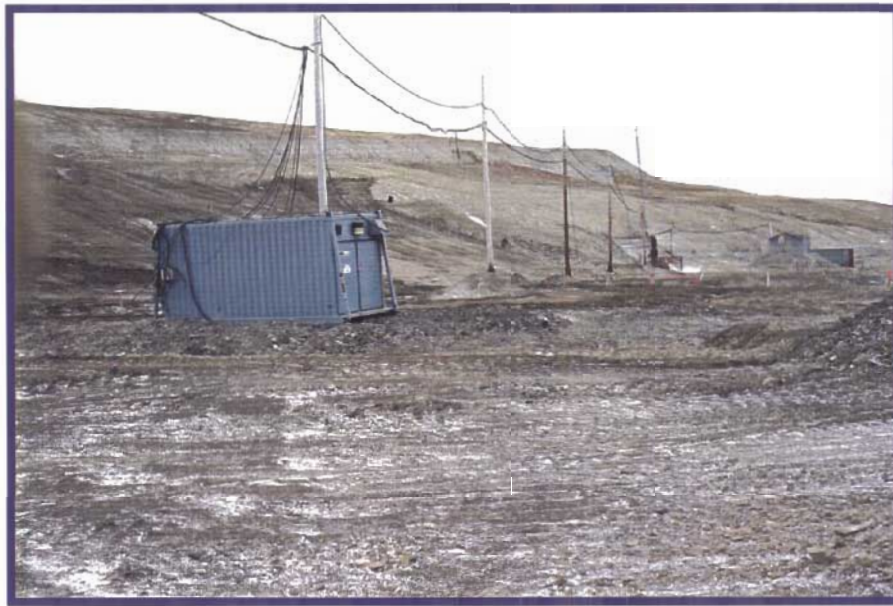
Photo 64 Re-contouring in progress around North Portal area.

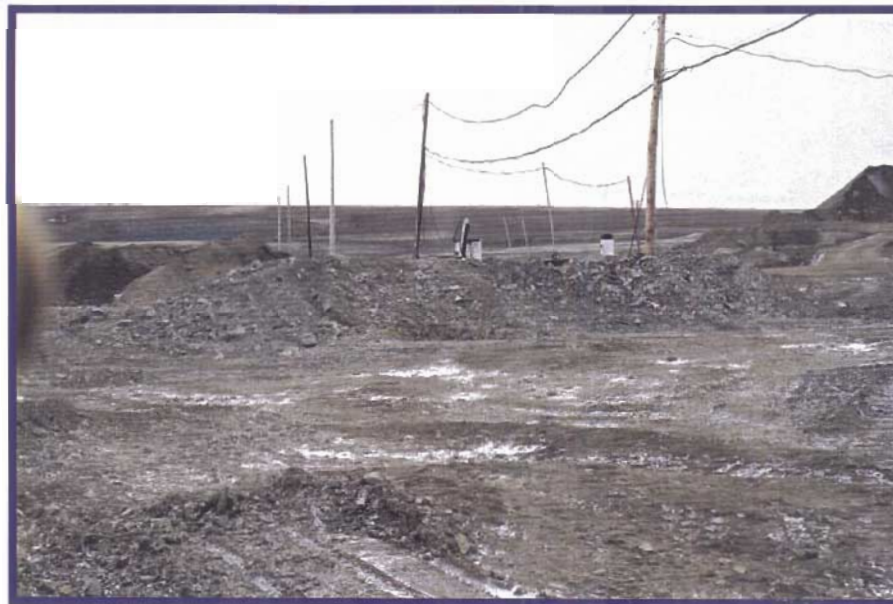
Photo 65 Some contaminated soil stock piles waiting to be placed underground via the raise boreholes.

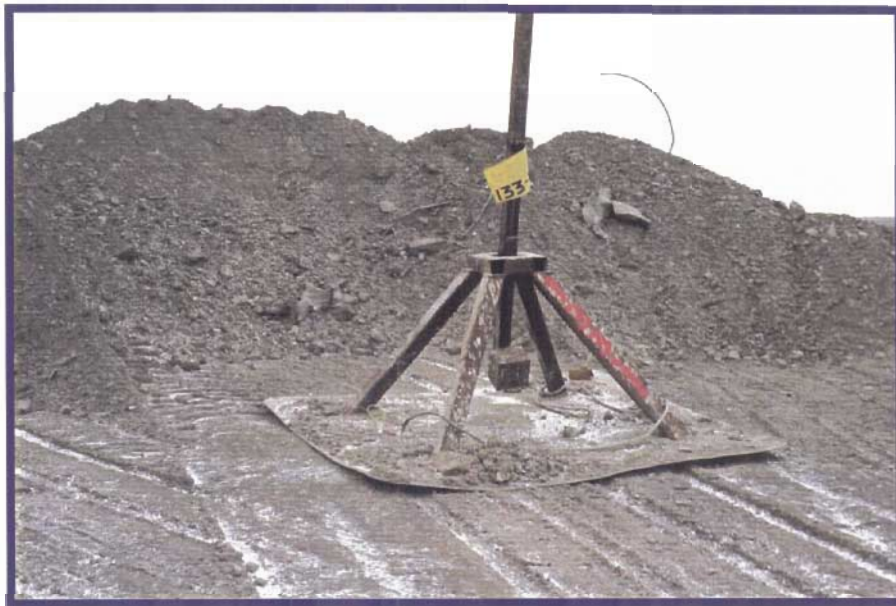
Photo 66 Protective cover over raise borehole used to drop contaminated soil into underground storage area.

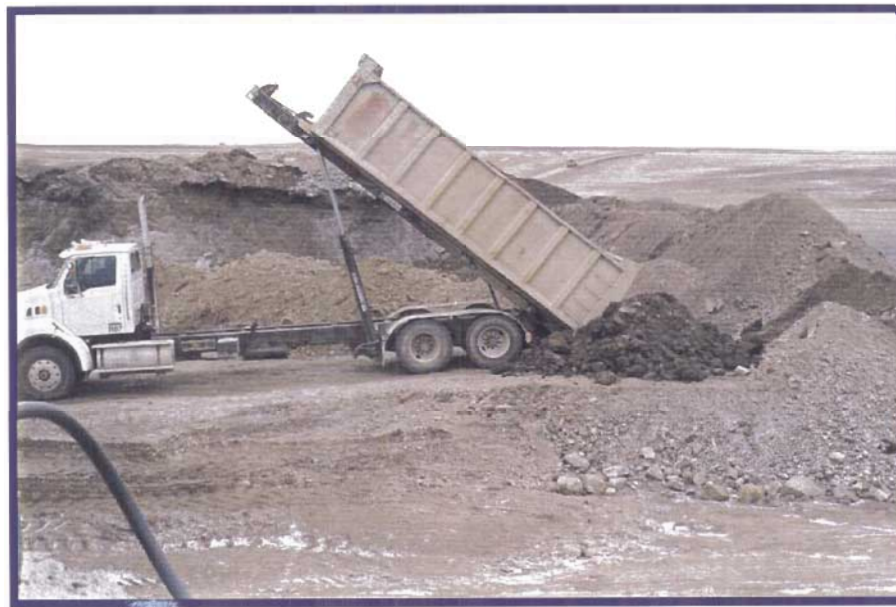
Photo 67 Dumping contaminated soils with an open raise borehole.

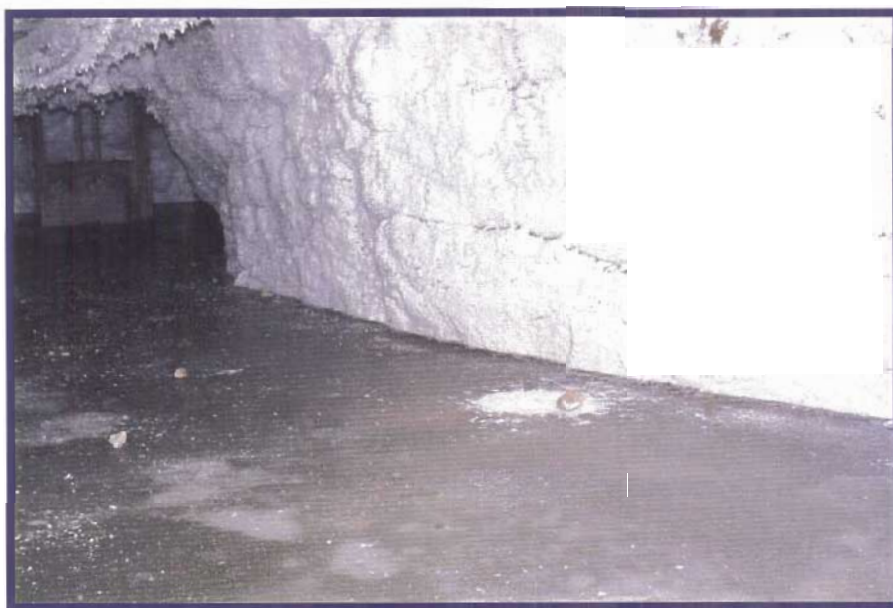
Photo 68 Flooded drift used to store melt water runoff.

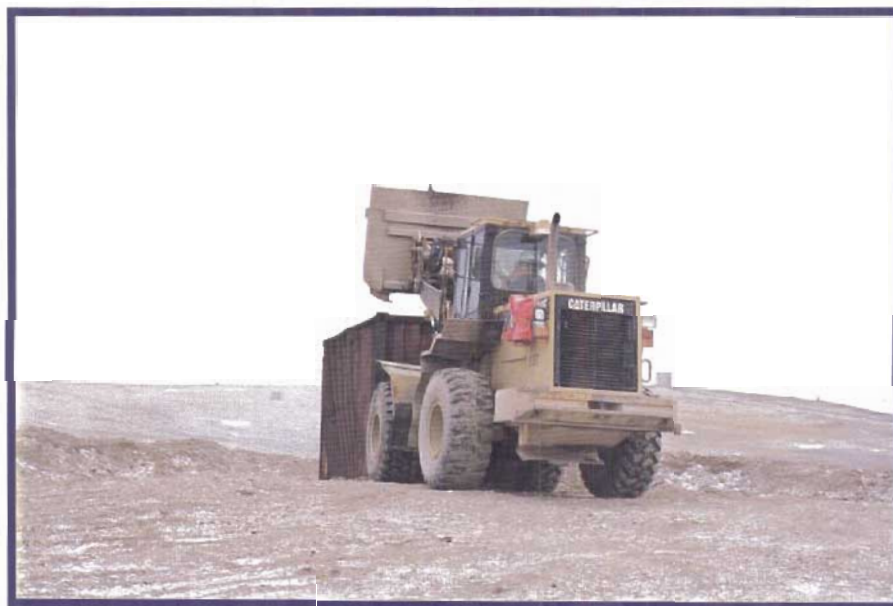
Photo 69 Loader bringing in a container with garbage for burning.
