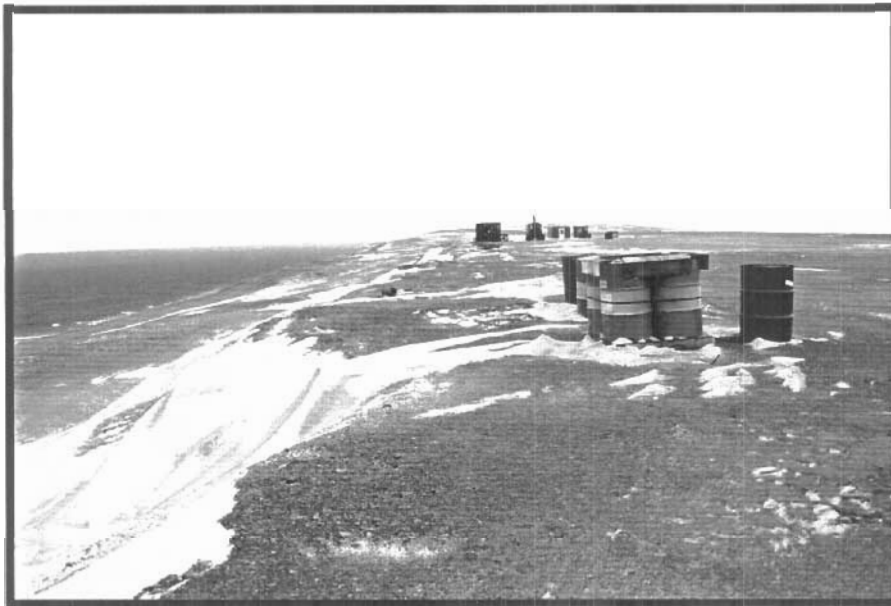
Photo 11 View looking north along west side of airstrip towards former site of accommodation complex.

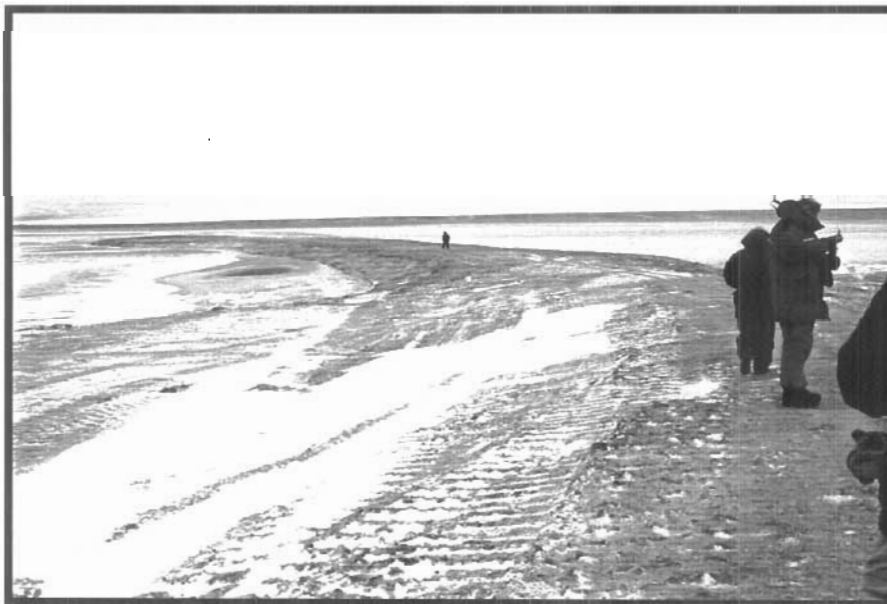
Photo 12 Causeway to Frustration Lake water intake. Piping and pump/intake building have been removed.

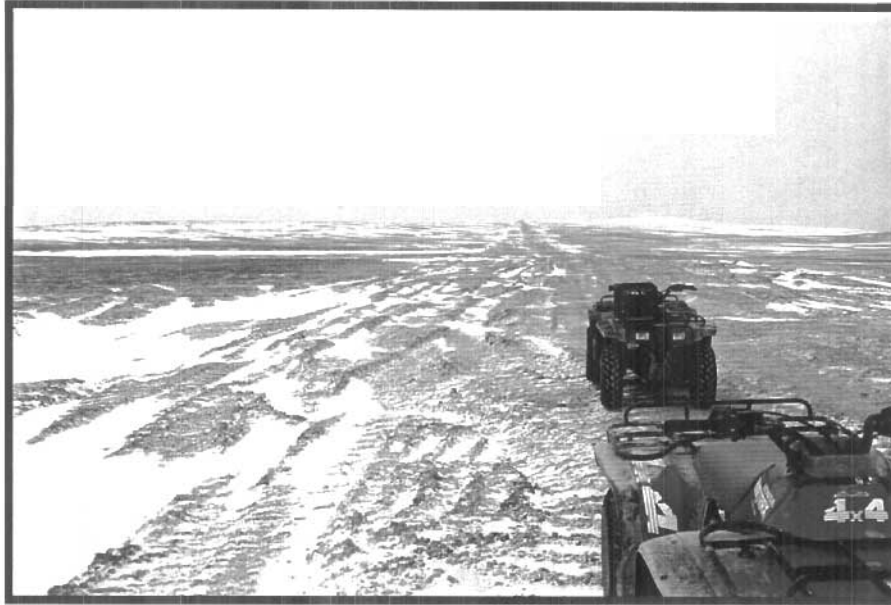
Photo 13 View (towards camp) along access road to Frustration Lake water intake.

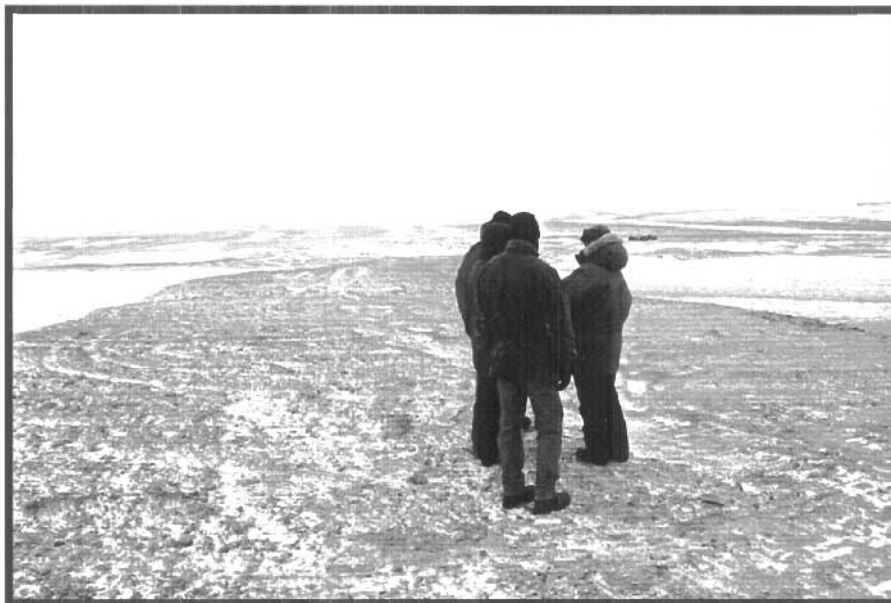
Photo 14 View along Frustration Lake causeway from site of pump/intake building.

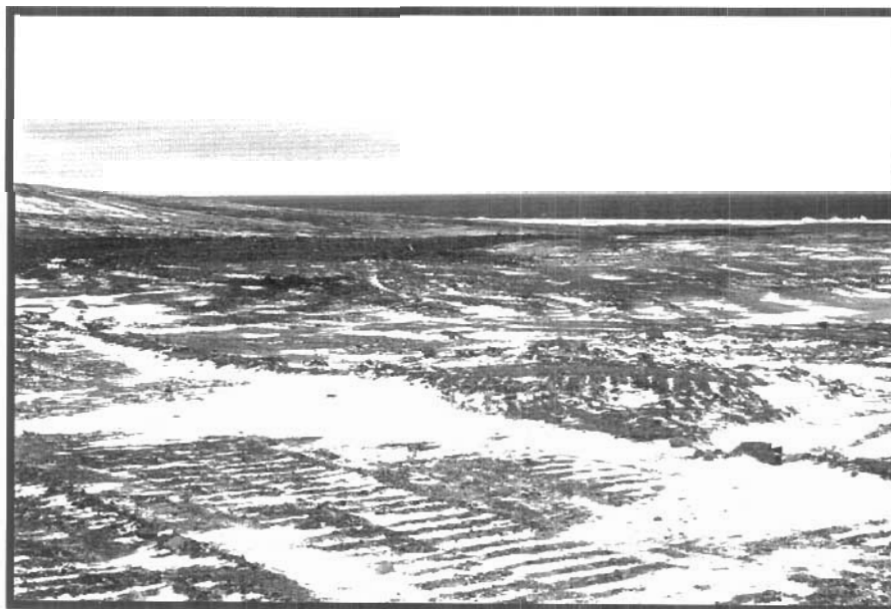
Photo 16 View looking north of re-contoured area in vicinity of former CRF plant.

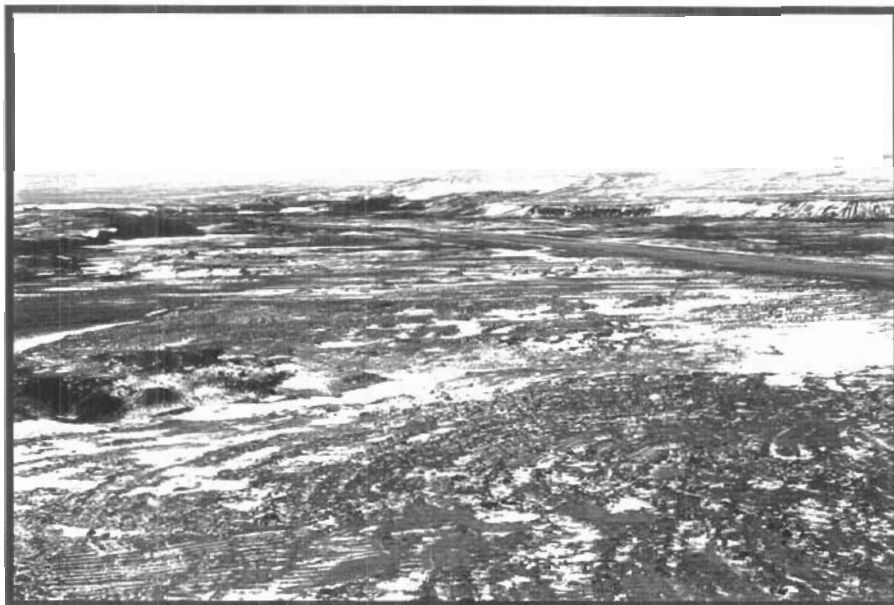
Photo 17 View of New Quarry. Some material was recently removed to complete site reclamation.

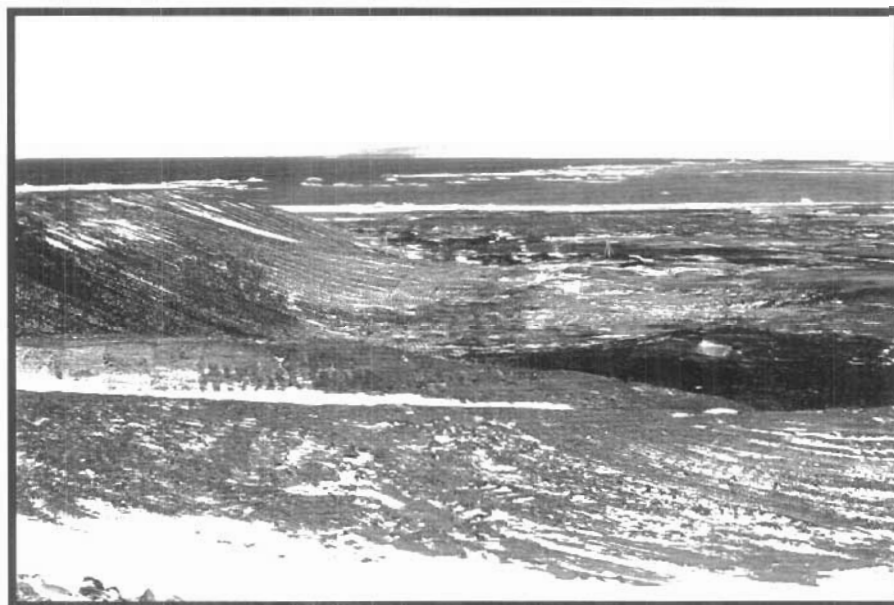
Photo 18 View to north of subsidence area and Reclamation Landfill. Tripod is location of survey point to measure subsidence.

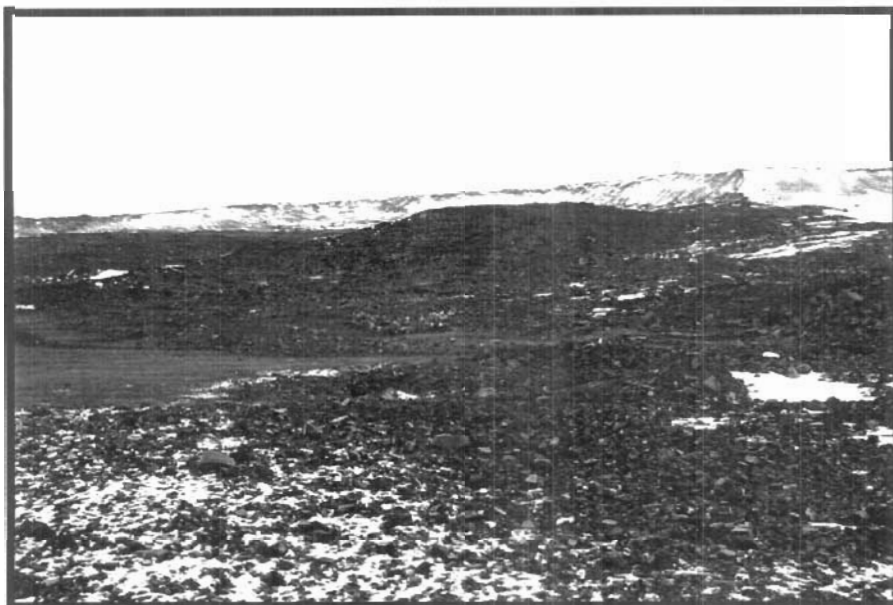
Photo 19 Berm of excavated shale with oversteepened slope in New Quarry. This slope should be flattened to conform to the remaining pit side slopes.

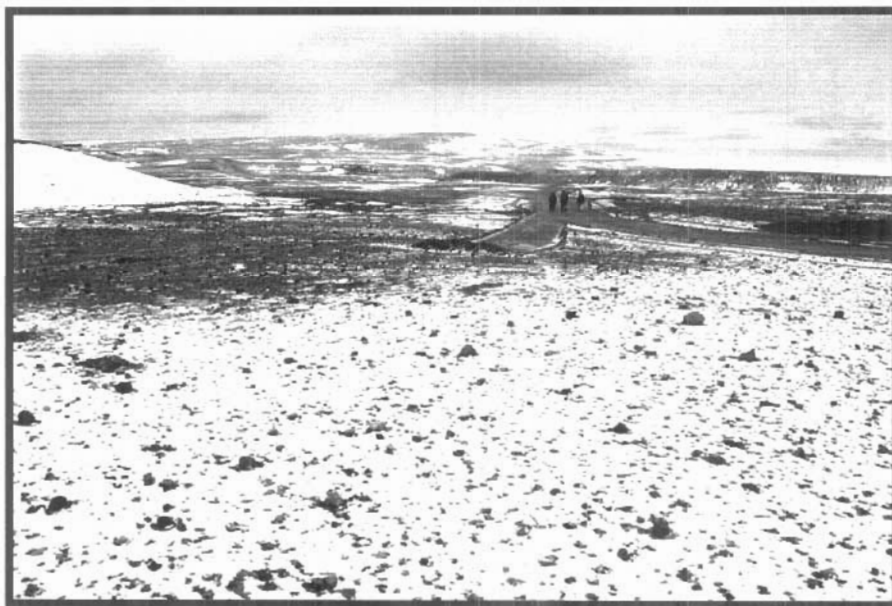
Photo 20 View to west from inside New Quarry.

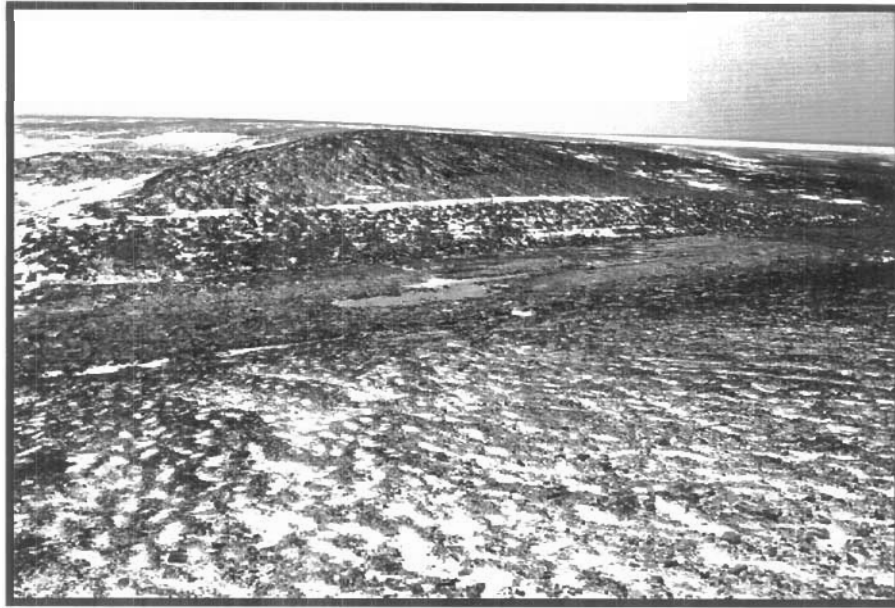
Photo 21 Garrow Lake Dam breach. View across channel to left abutment area.

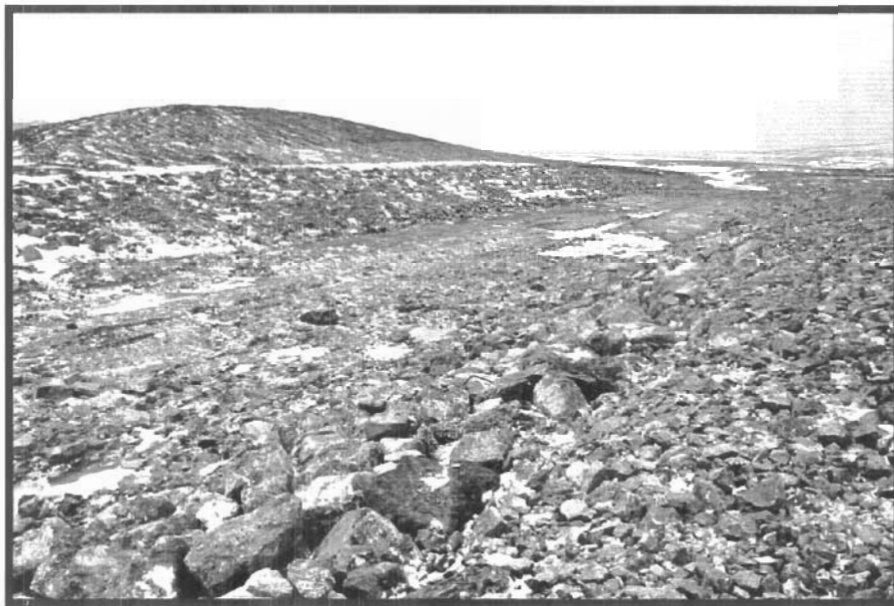
Photo 22 View looking downstream along re-established channel through Garrow Lake Dam. Note coarse rip rap lining channel. A finer grade of rip rap was added above the channel rip rap to protect the lower exposed cuts through the dam embankment against erosion.

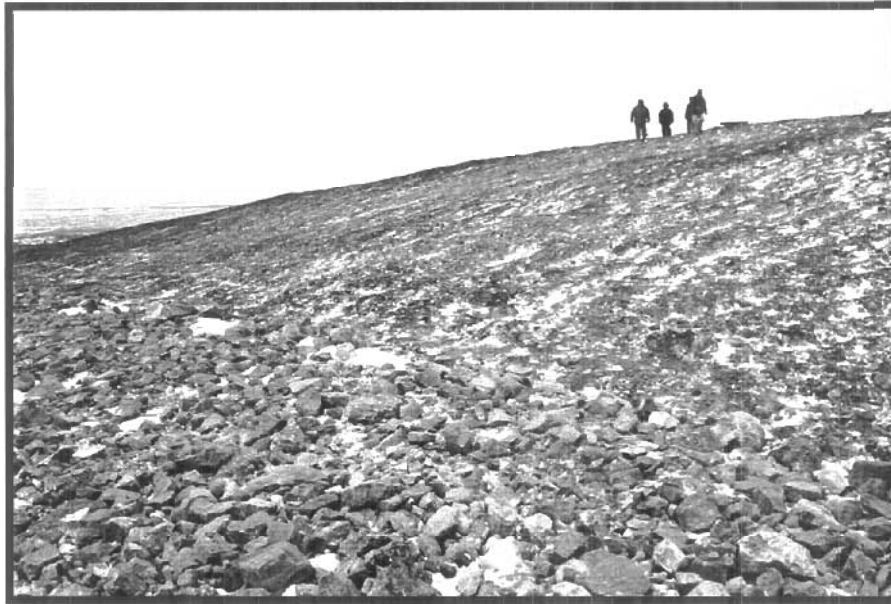
Photo 23 View along right bank cut slope through dam embankment.

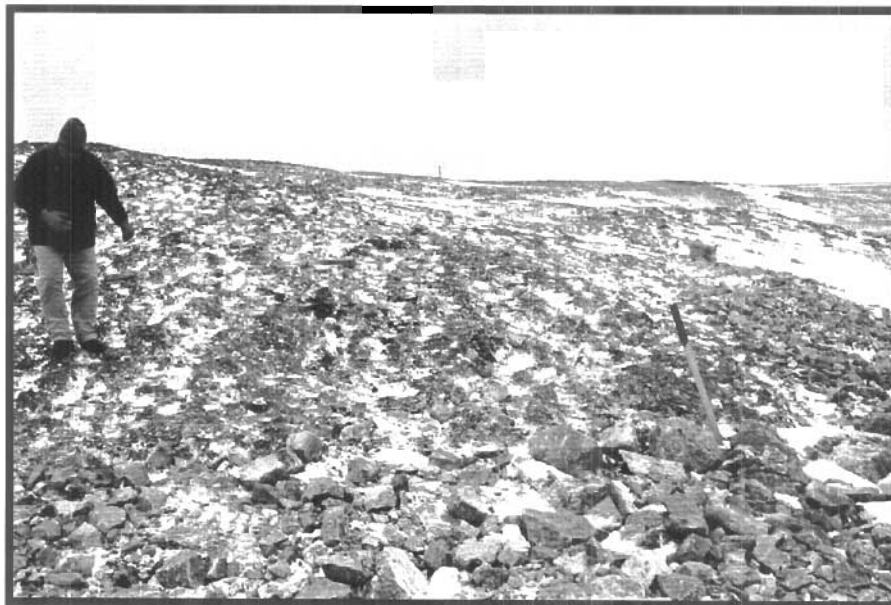
Photo 24 View along upstream face of right bank of Garrow Lake Dam. Some of the material on the slope contains entrained ice and snow and will have to be removed over the next few years as it melts and drains out .

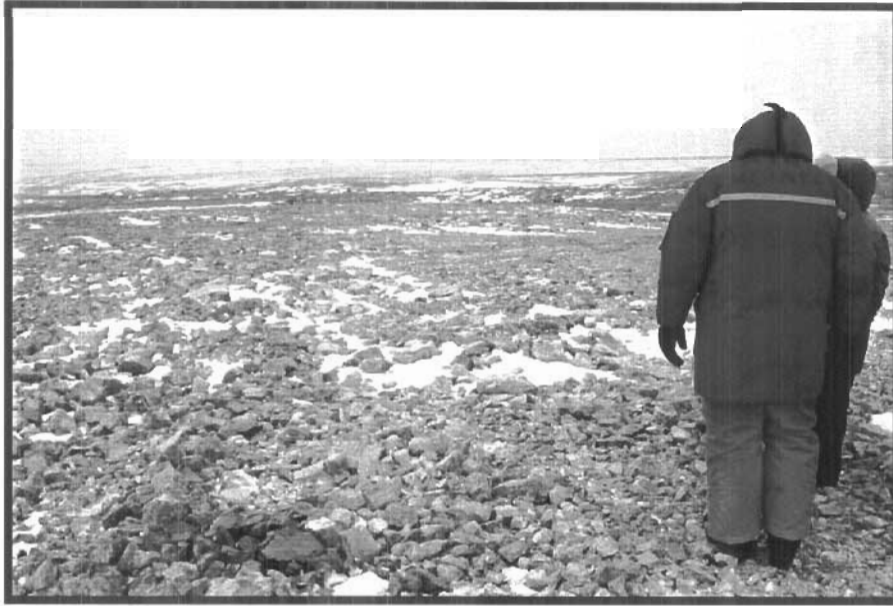
Photo 2 Rip rap cover placed on exposed erodible soils downstream of dam on right bank.

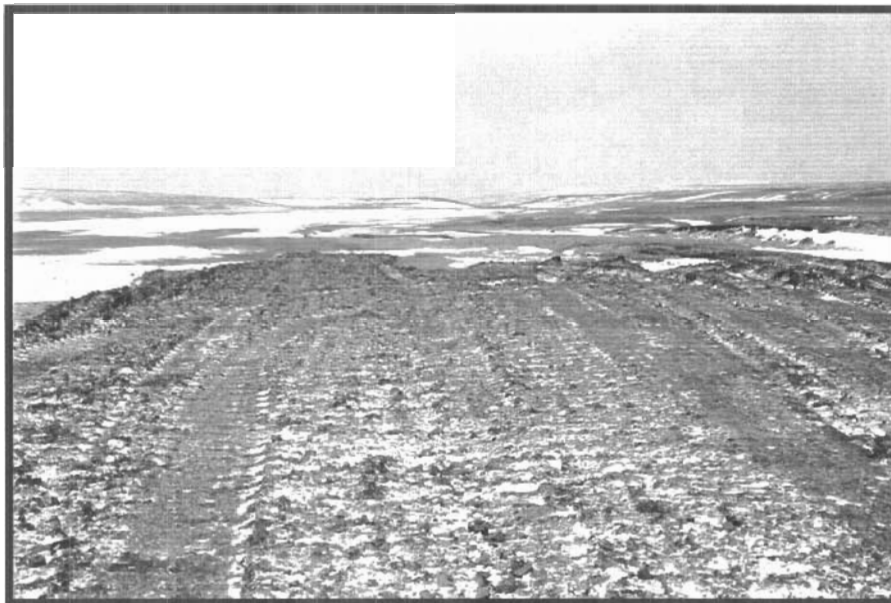
Photo 3 View of breached Garrow Lake Dam in distance from top of wave break structure. Note rusty colour of exposed lake bed.

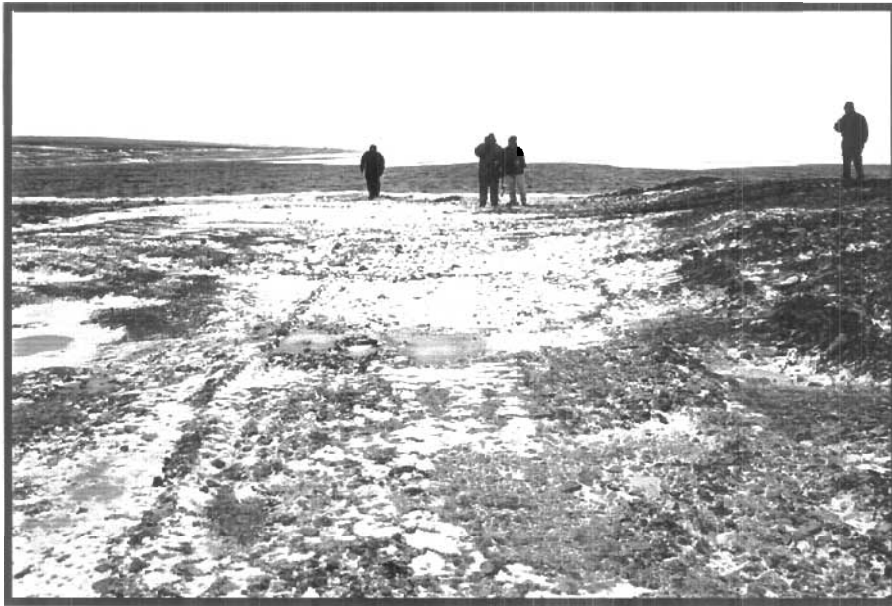
Photo 4 Looking upstream towards Garrow Lake along the channel excavated through wave break structure.

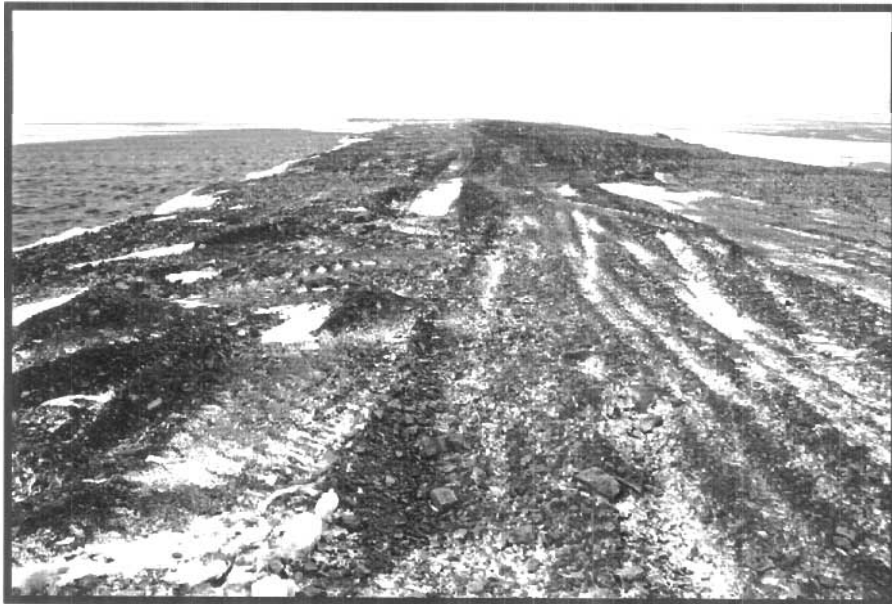
Photo 5 Looking east along crest of wave break structure. Garrow Lake on left.

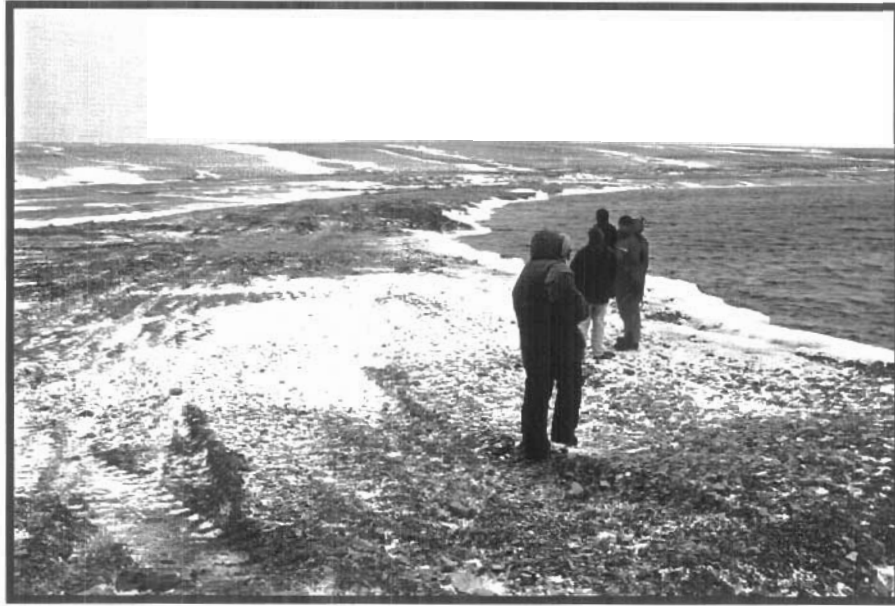
Photo 6 Looking west along wave break structure. Channel in foreground. Garrow Lake on right. Garrow Lake level is about 0.76 m below former natural lake level.

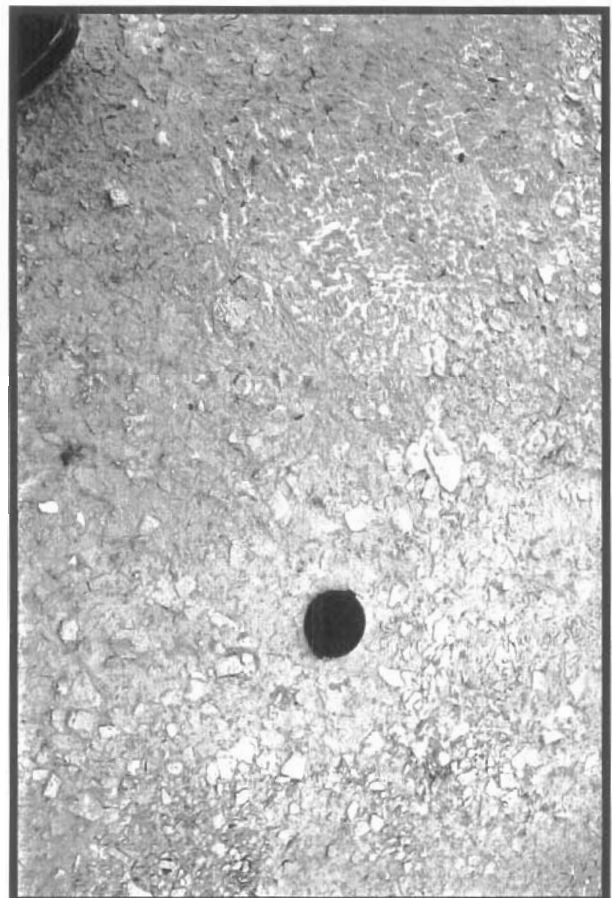
Photo 7 Close-up view of rusty coloured sediments in exposed lakebed. Samples were taken of this material by Teck Cominco as well as DIAND staff for analysis.

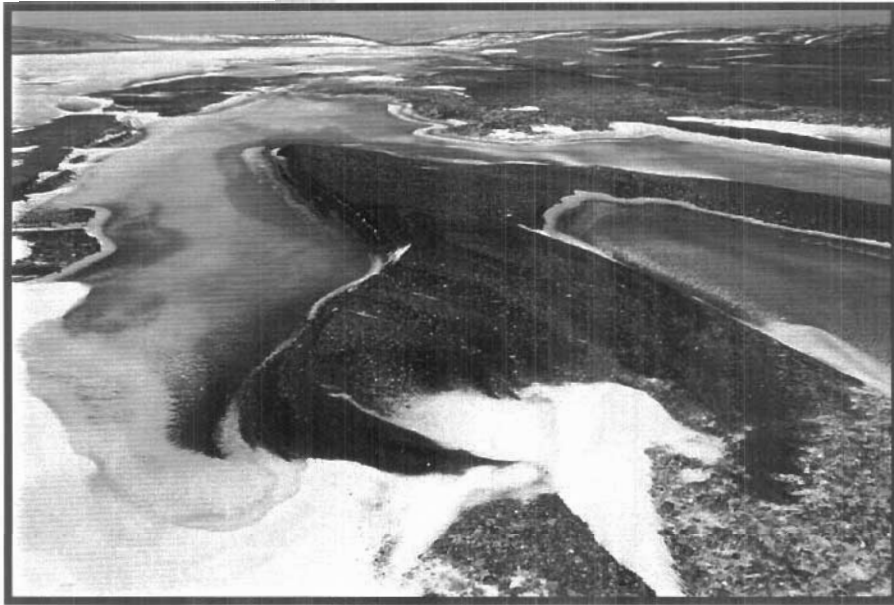
Photo 8 Re-established channel in lakebed downstream of wave break structure.

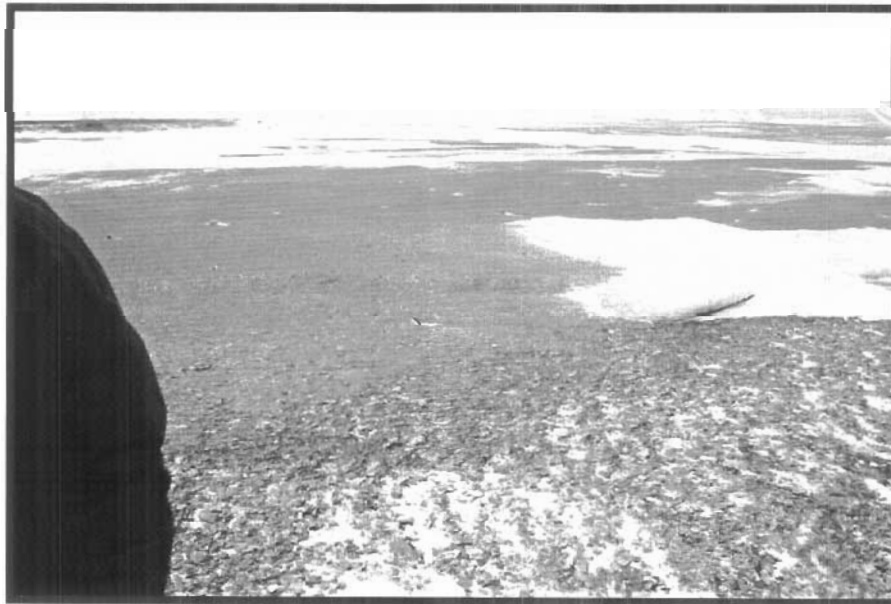
Photo 9 View of exposed lakebed downstream of wave break structure, with rusty coloured sediments.

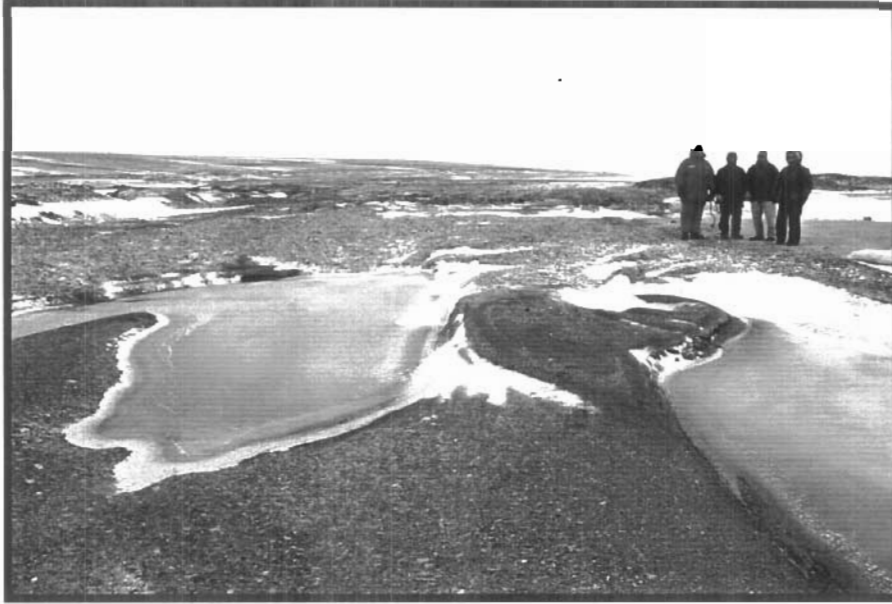
Photo 10 Looking upstream along channel excavated through wave break structure. Teck Cominco added some fill into the breach to bring water level in Garrow Lake back up to former natural level.

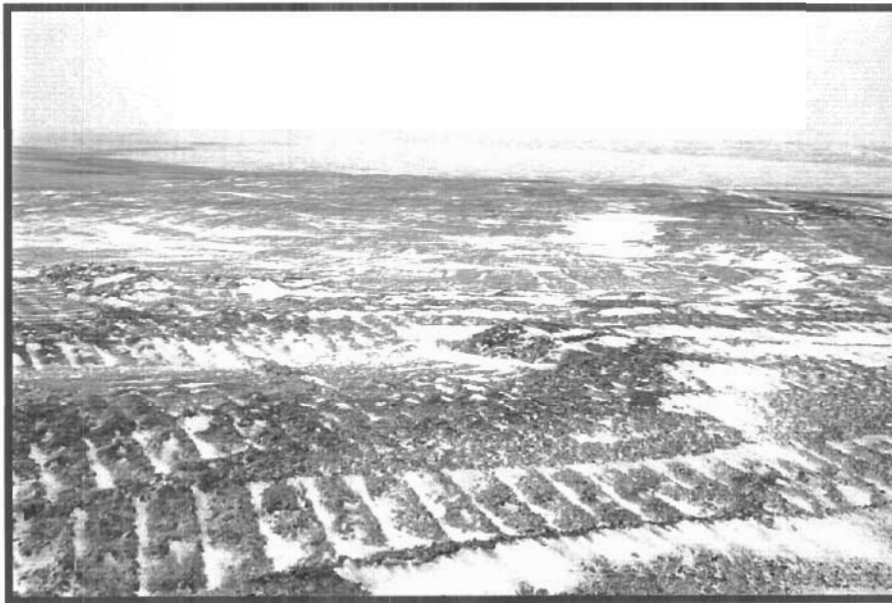
Photo 11 View of reclaimed settling pond area adjacent to tailings thickener. Garrow Lake in background.

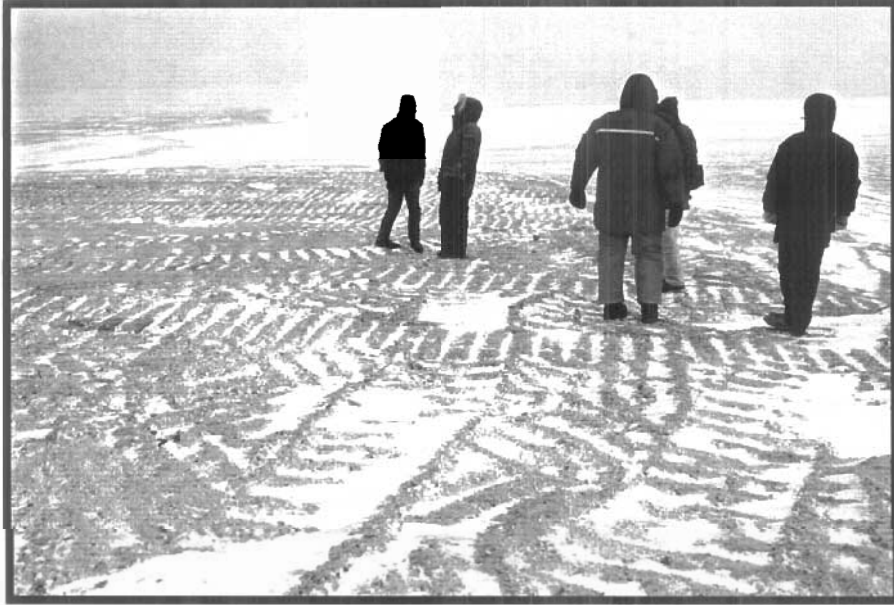
Photo 12 Reclaimed pad of former tailings thickener.

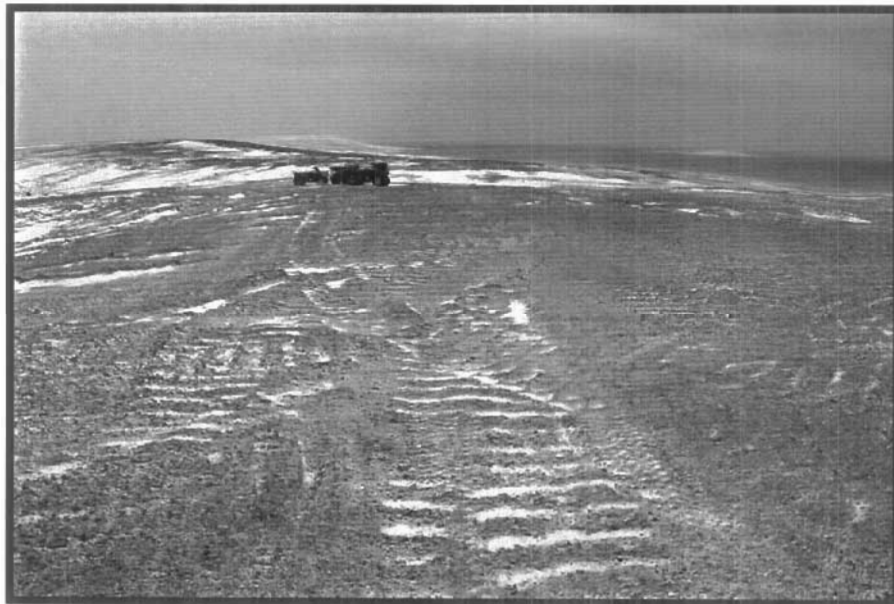
Photo 13 Tailings thickener pad, looking south.

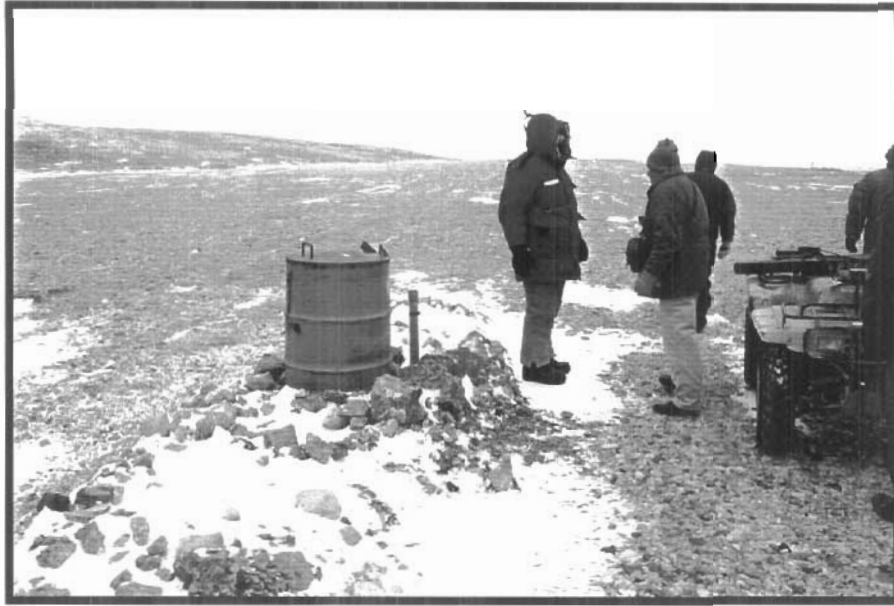
Photo 14 Operational Landfill- cover with thermistor installation.

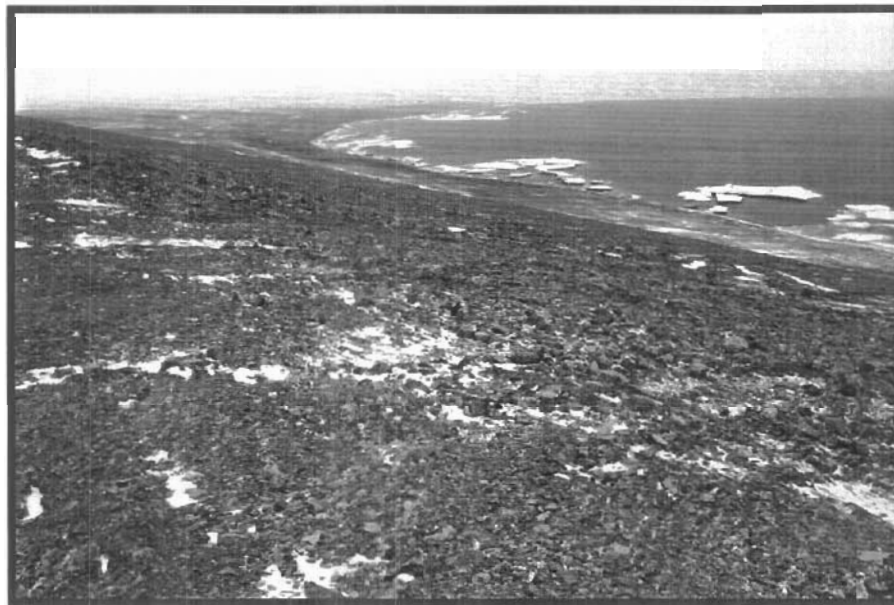
Photo 15 South slope of Operational Landfill. A 30 cm layer of finer grained cover material was placed to repair the cracks and settled areas noted in this area in the previous visit.

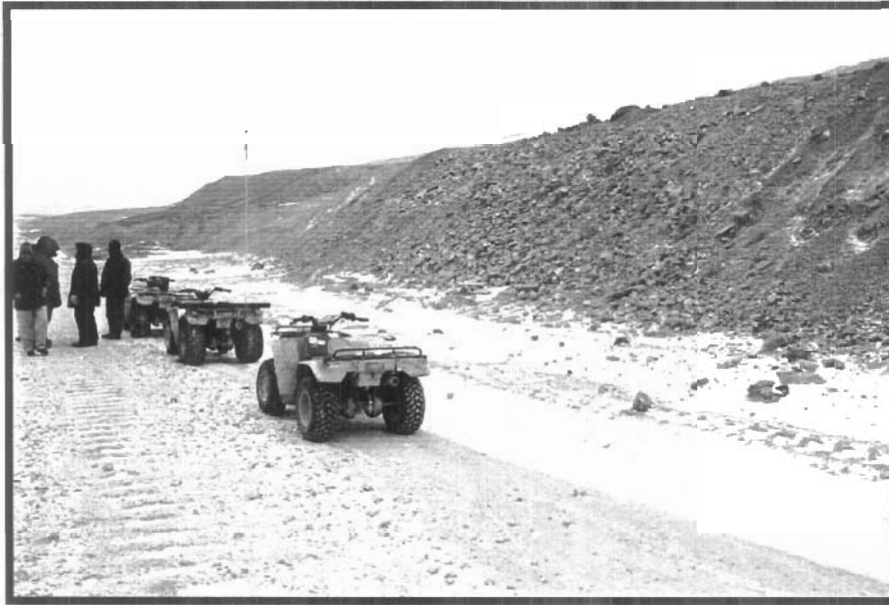
Photo 16 Slope of fill material below site of incinerator. This slope needs to be flattened.

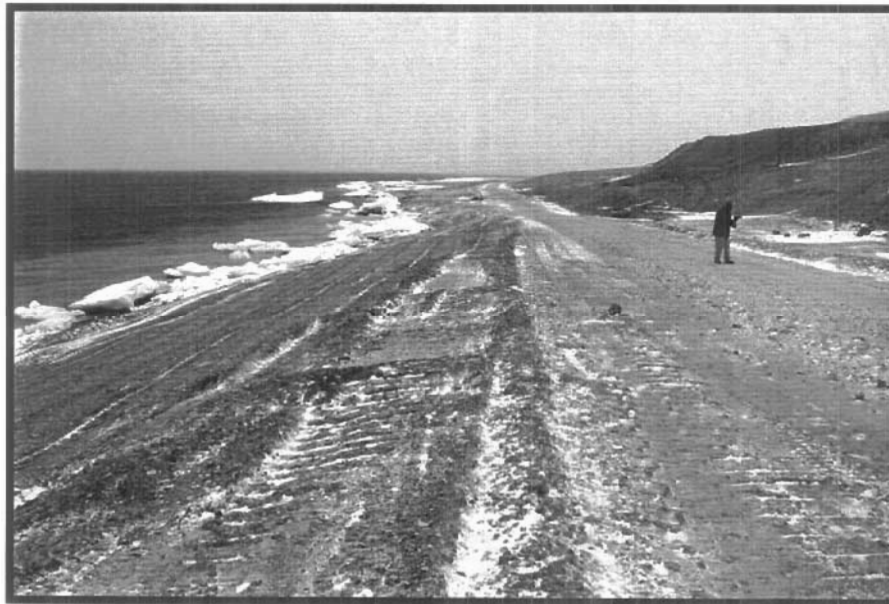
Photo 17 View of shoreline, looking north in vicinity of former foldaway buildings. Note minor plume of suspended sediment along shoreline.
