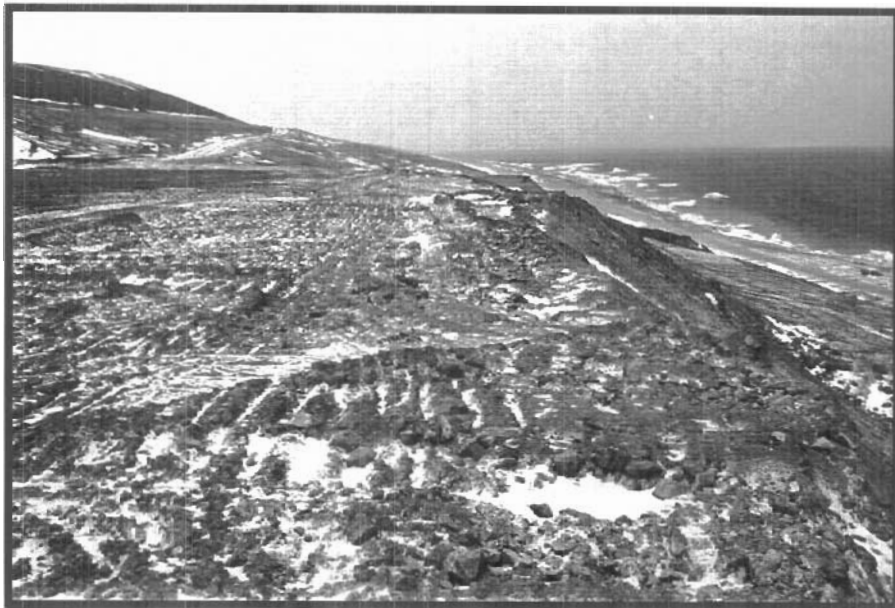
Photo 18 Looking south along crest of slope where tank farm was located. The slope to the right needs to be flattened and re-contoured.

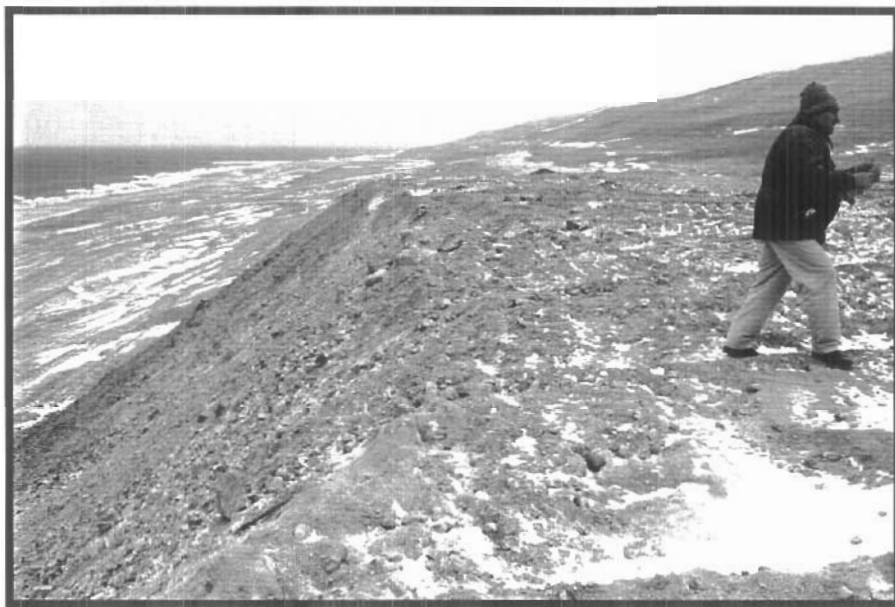
Photo 19 Looking north along crest of slope below tank farm area. Slope needs to be flattened.

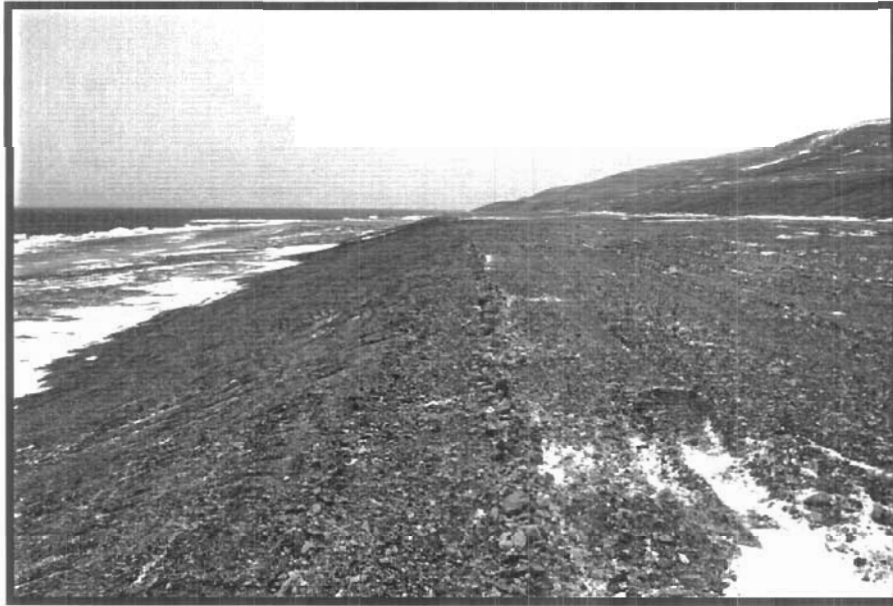
Photo 20 Looking north across former product storage building foundation.

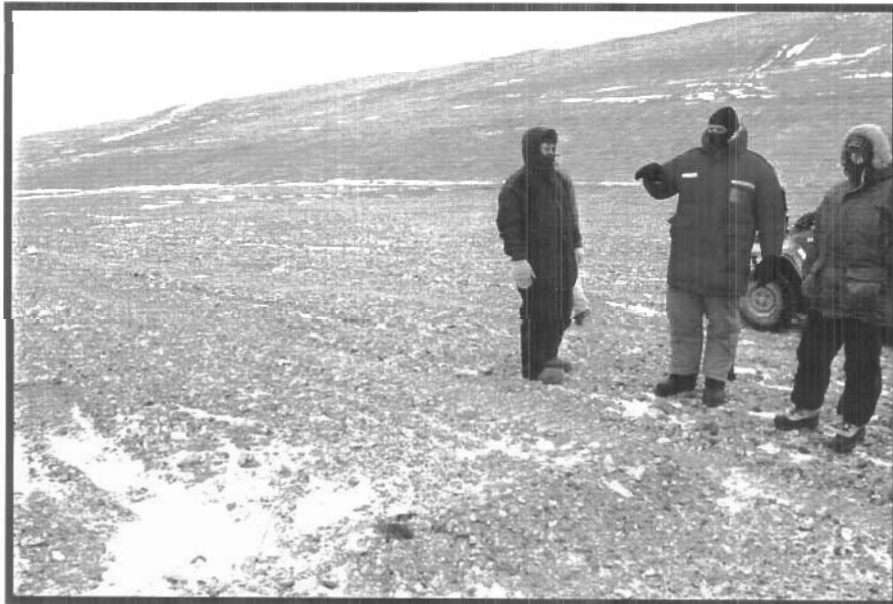
Photo 21 View of cover over product storage area, towards reclaimed slope above.

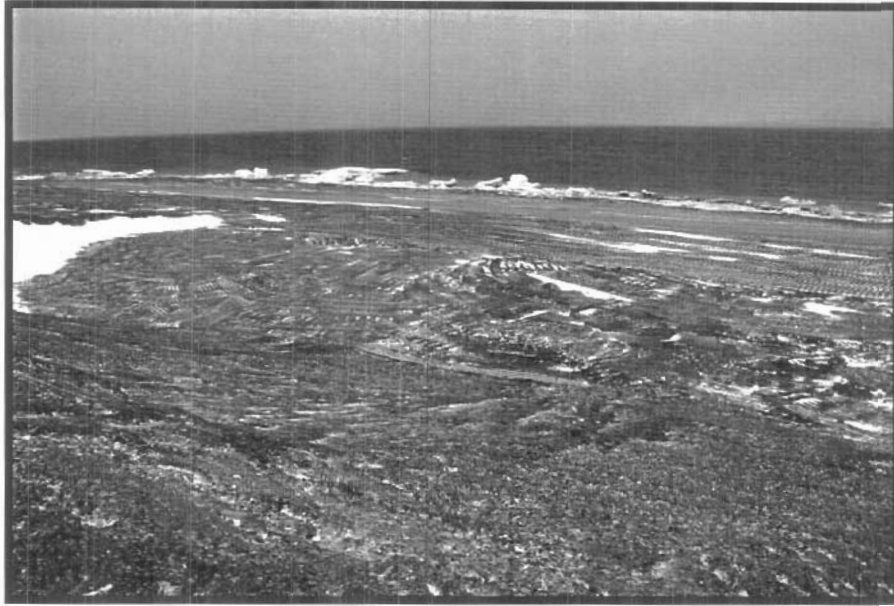
Photo 22 View of shoreline area in front of product storage building area.

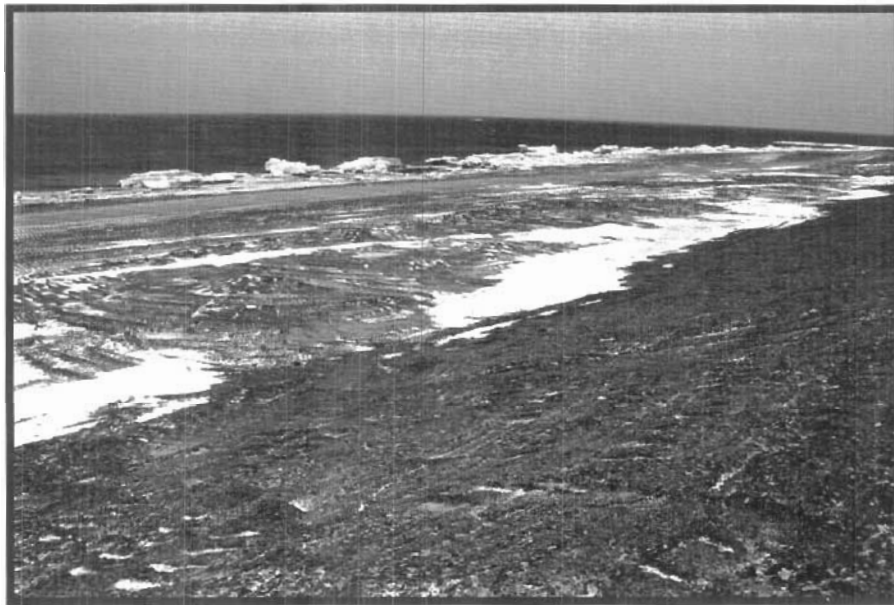
Photo 23 View towards former dock cell area, from product storage building.

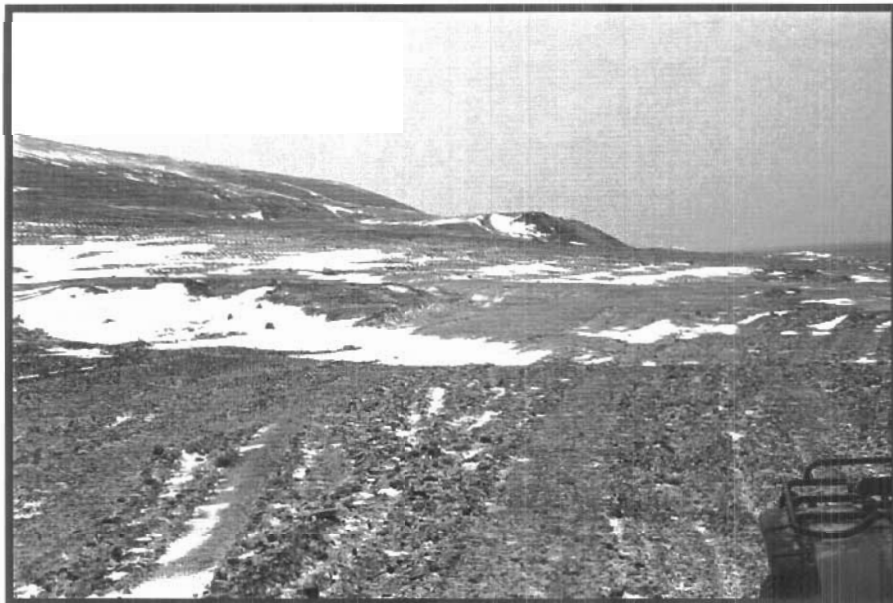
Photo 24 Looking south towards bench which contained tank farm. Note steepness of slope below tank farm bench compared with reclaimed and re-contoured slope above.

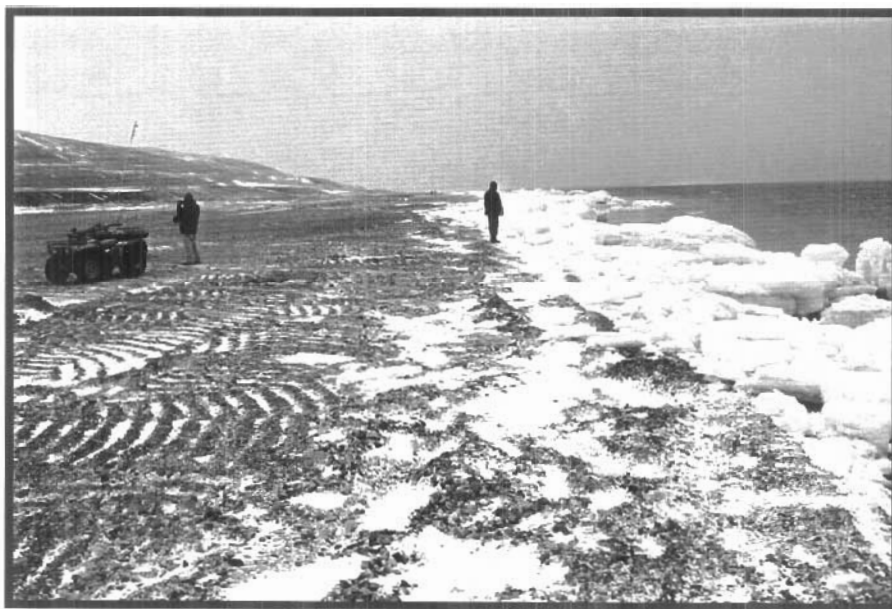
Photo 25 Looking south along former dock cell area.

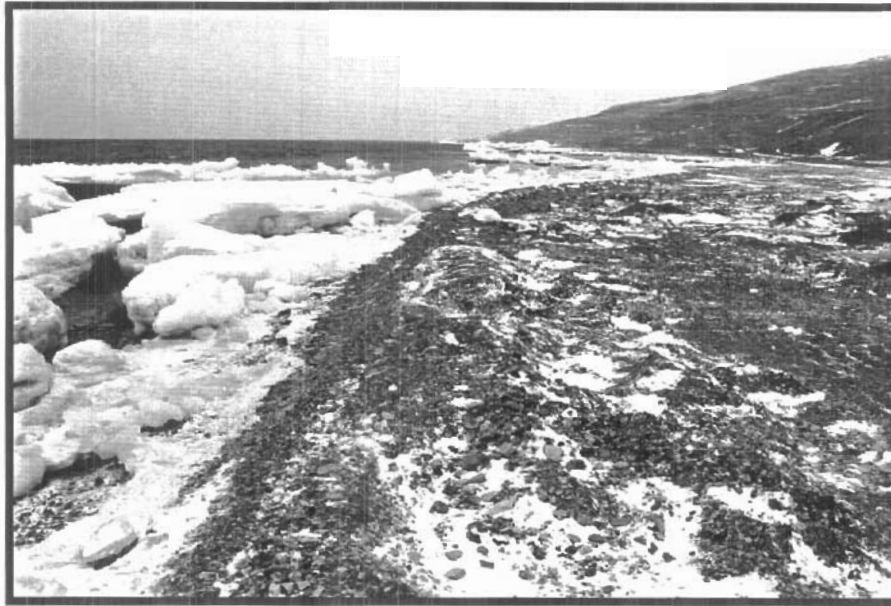
Photo 26 Shoreline to north of former dock cell area.

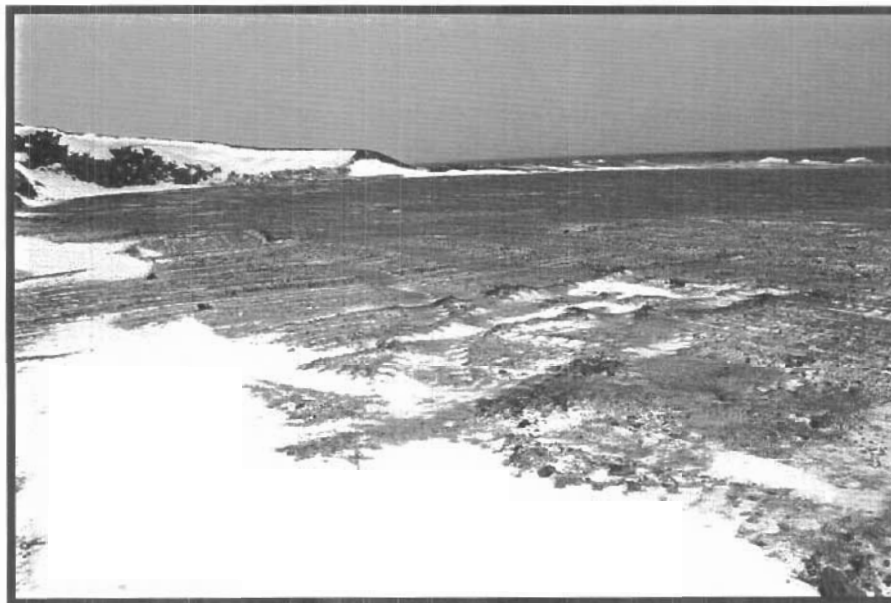
Roll 5 Photo 1 View of former barge area.

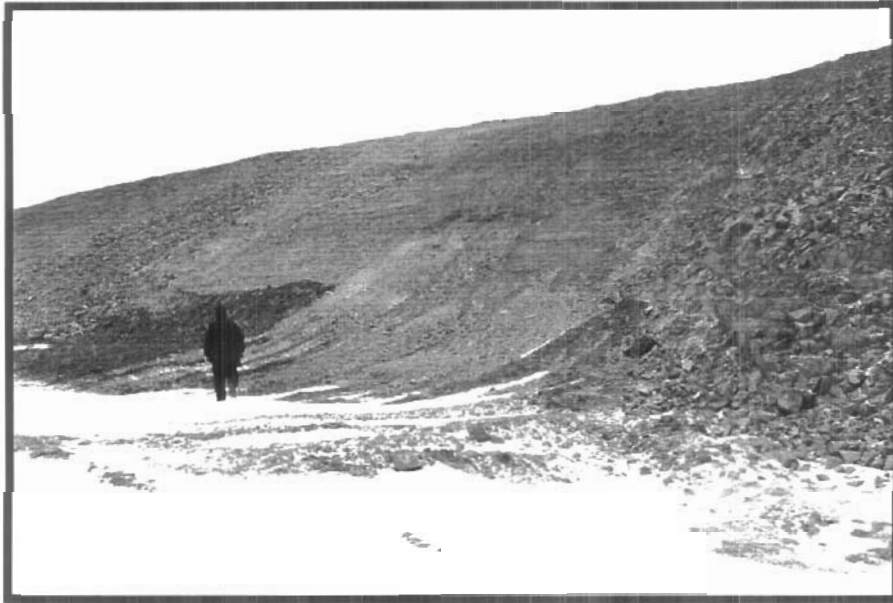
Photo 2 Main portal area backfilled.

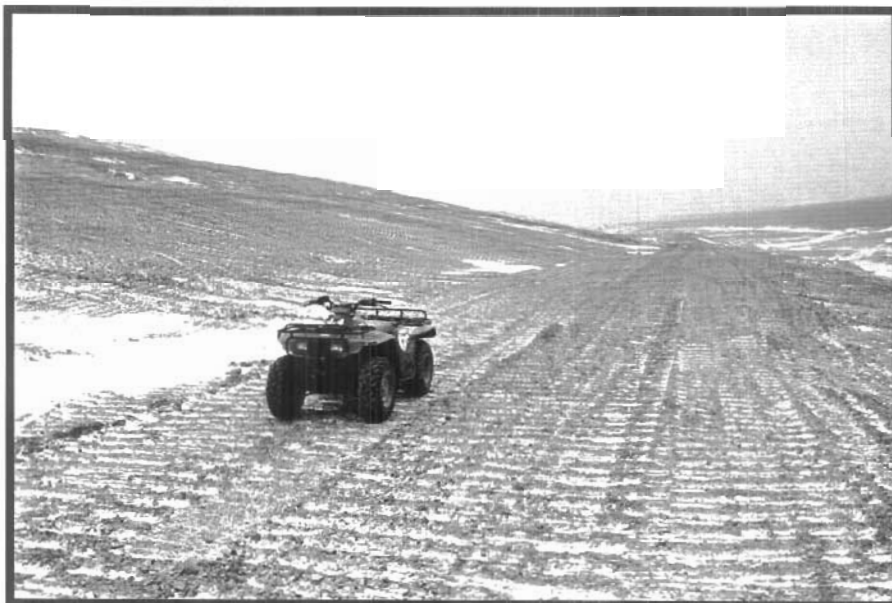
Photo 3 Looking south towards Main Portal area from road to LRD Quarry.

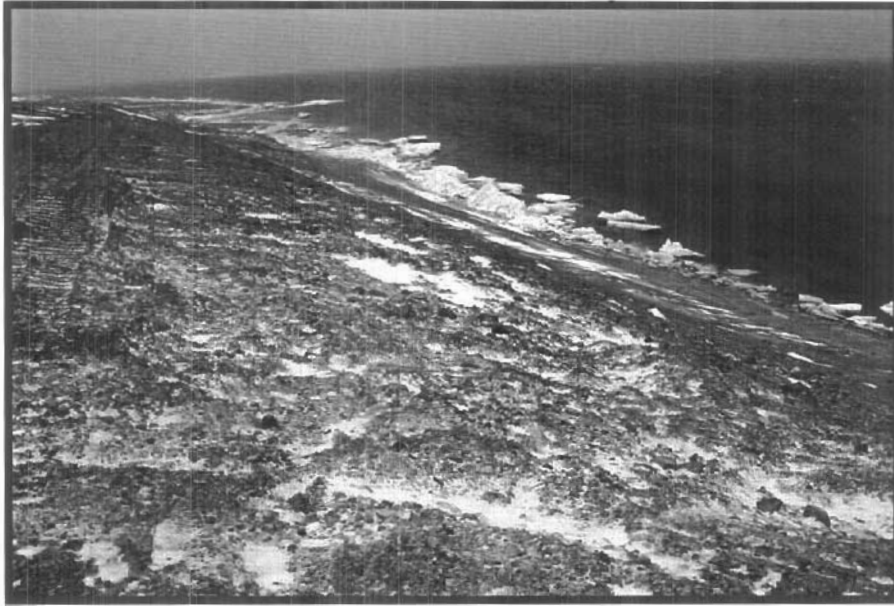
Photo 4 Looking south from road to LRD Quarry, along shoreline north of dock area.

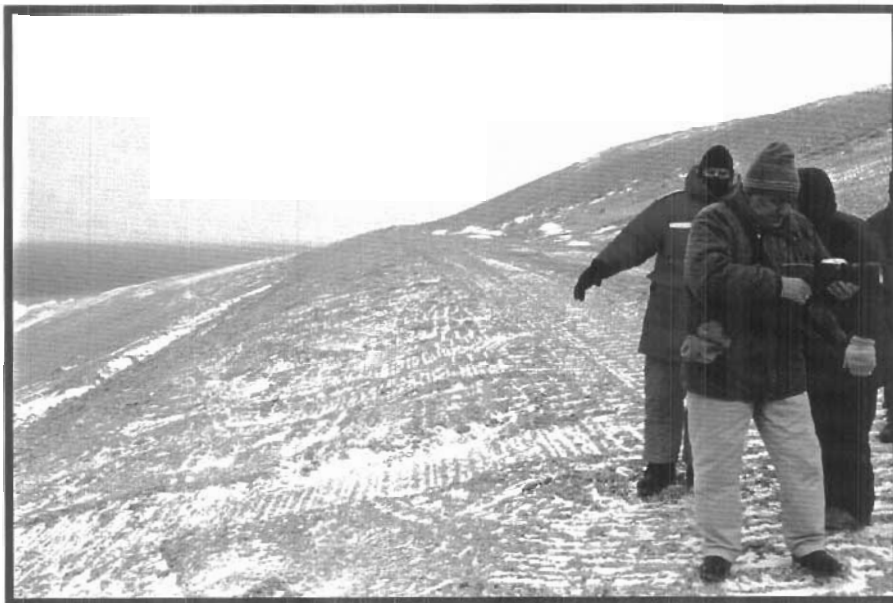
Photo 5 Looking north along road to LRD Quarry. Note reclaimed slopes.

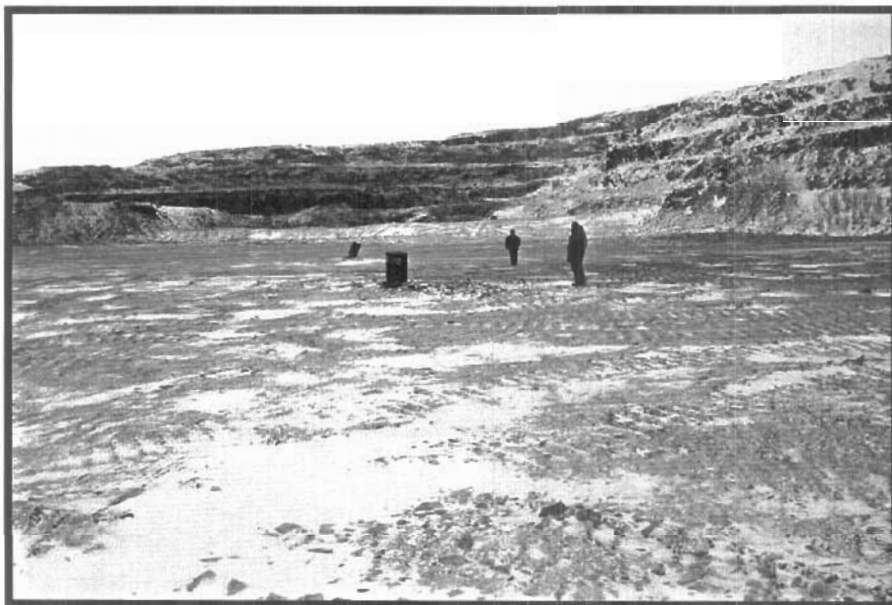
Photo 6 LRD Quarry with thermistors inside barrels.

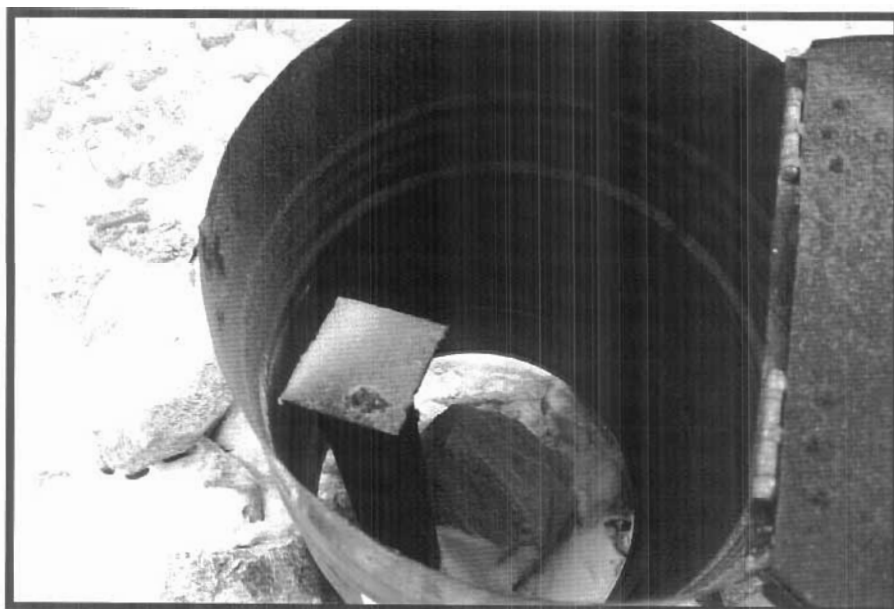
Photo 7 View of steel casing to house thermistors inside barrels.

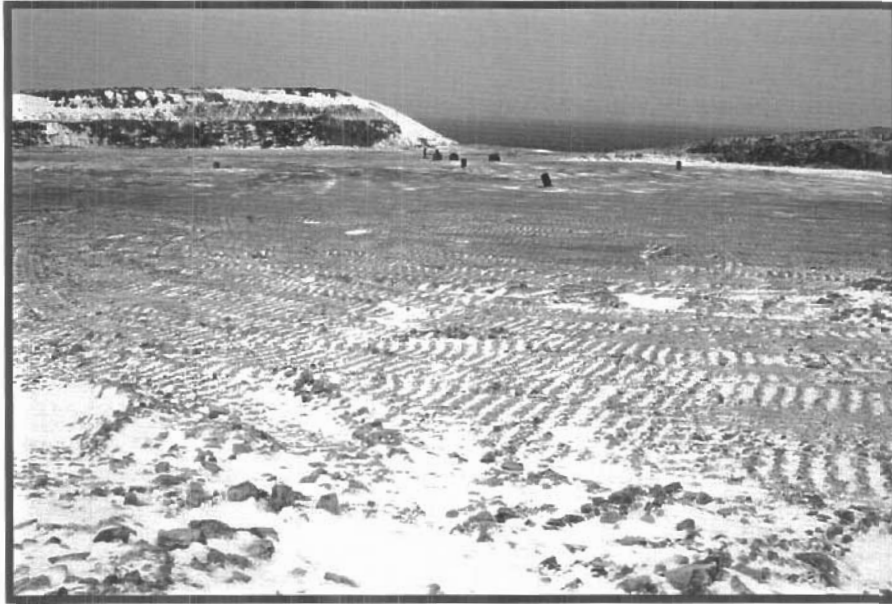
Photo 8 View to northwest across LRD Quarry Landfill cover. Note notch cut out of rock at far end for drainage.

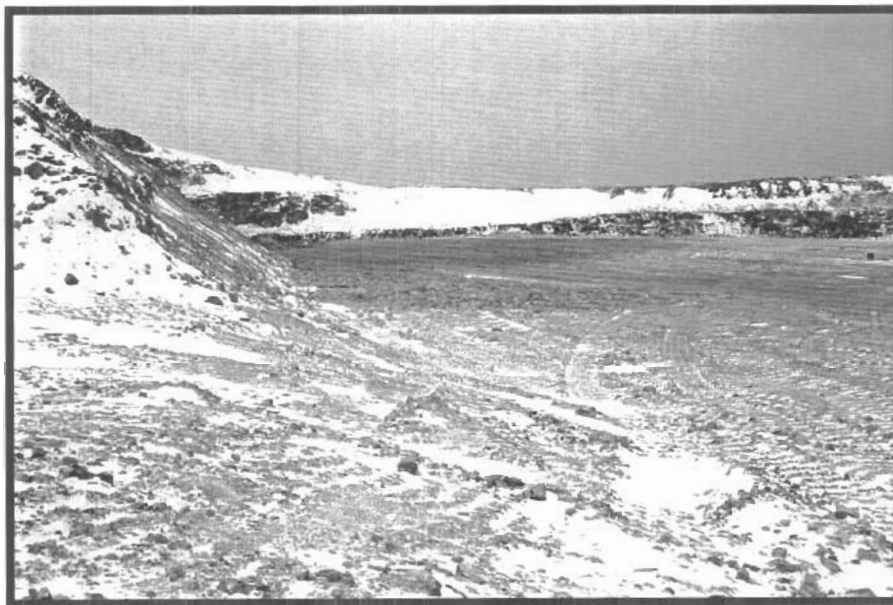
Photo 9 Edge of cover along south side of quarry.

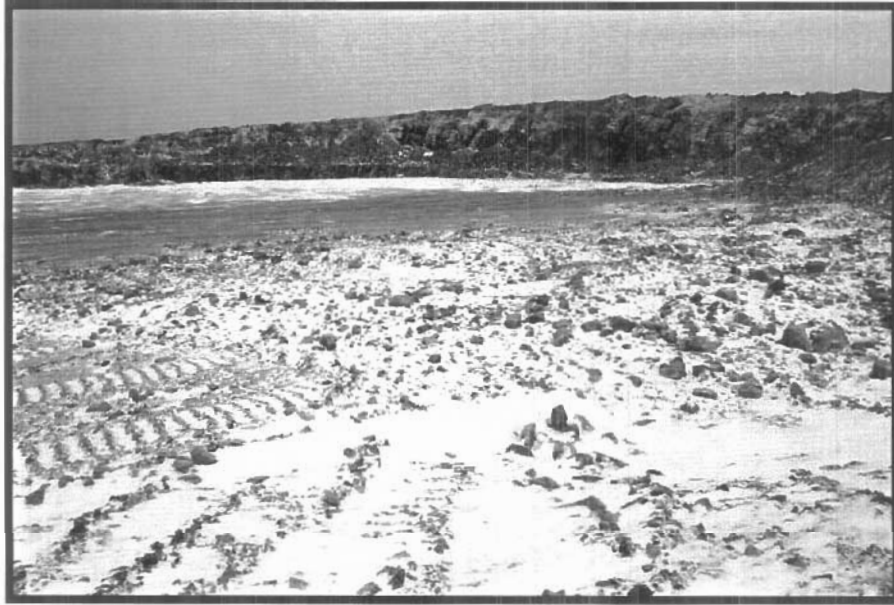
Photo 10 Edge of cover along east side of quarry.

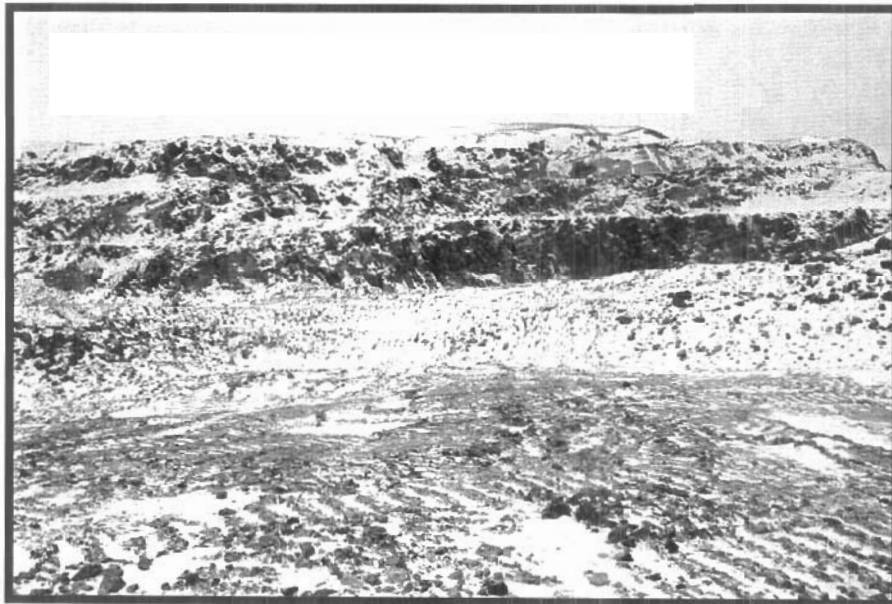
Photo 11 South side slopes of quarry. Mound at the top of the slope is the north end of the Polaris runway.

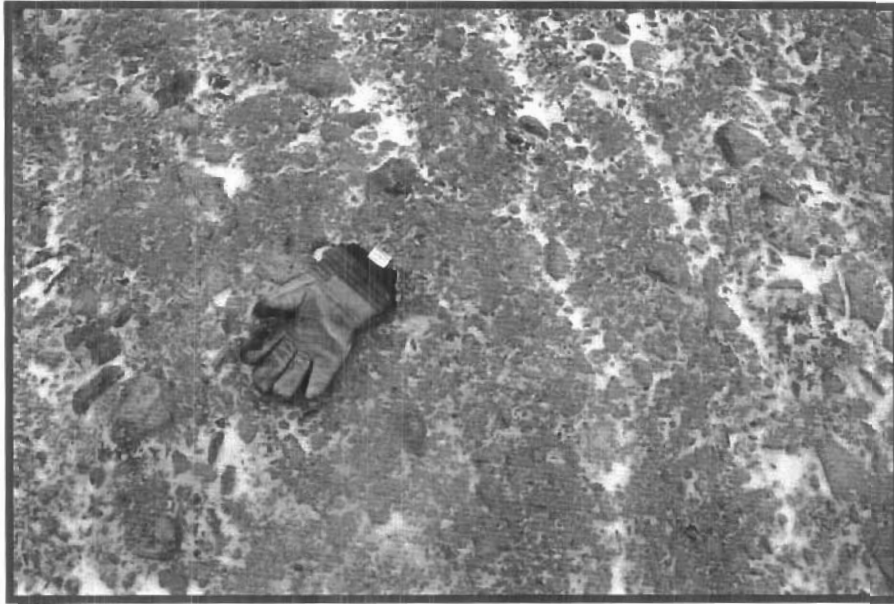
Photo 12 Close-up view of LRD Landfill cover material, composed of limestone obtained from LRD Quarry.

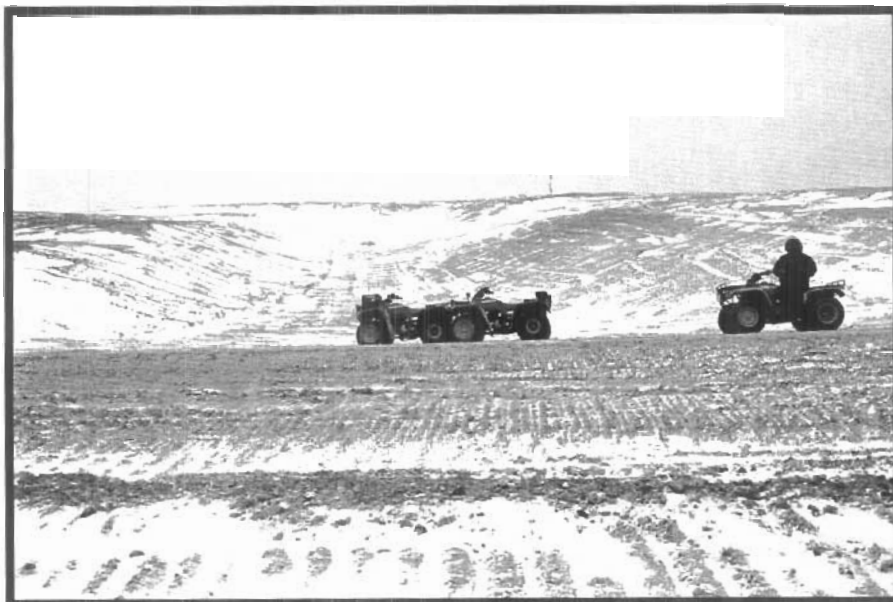
Photo 13 Reclaimed slopes in former open pit area, located above the North Portal.

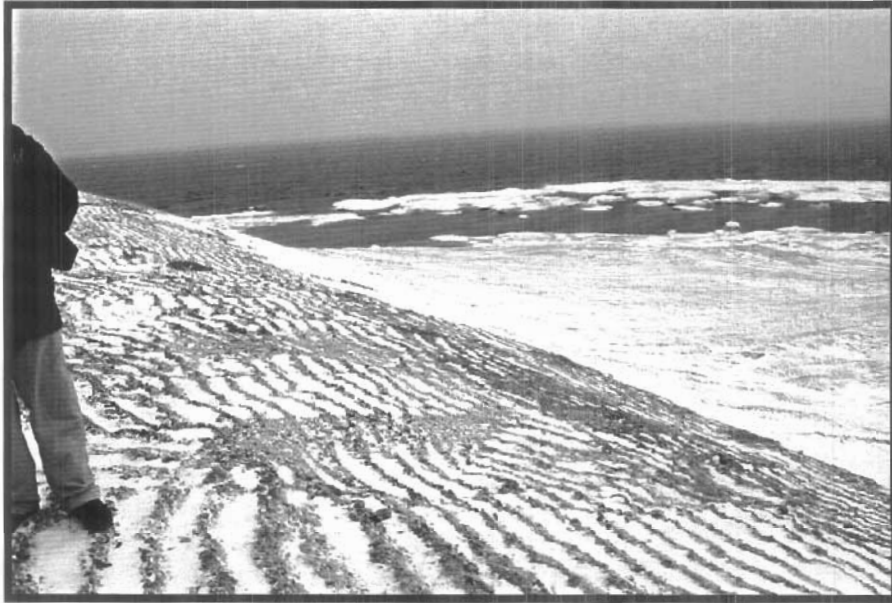
Photo 14 Reclaimed slope above the North Portal.

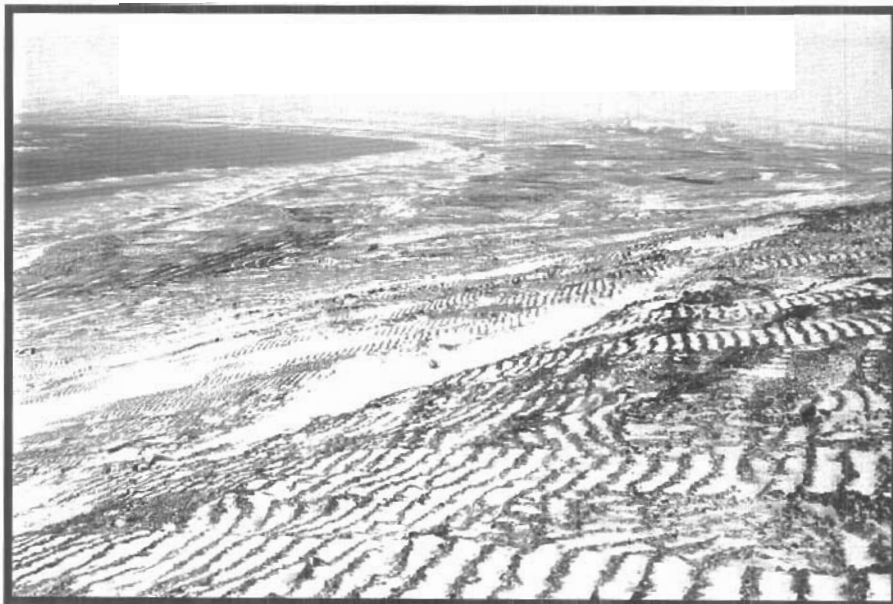
Photo 15 Looking east along re-contoured slopes east of North Portal area.

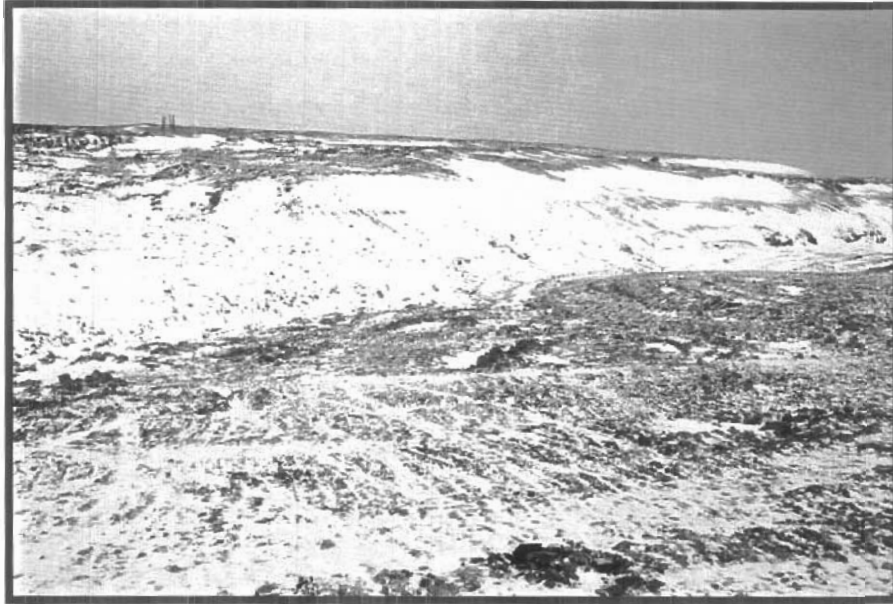
Photo 16 Backfilled North Portal.

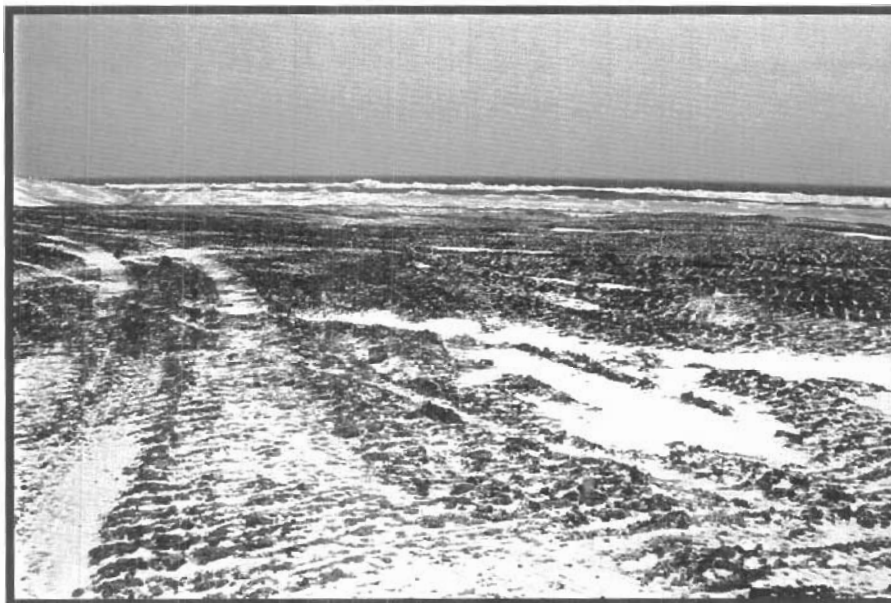
Photo 17 Reclaimed shoreline area in front of North Portal.

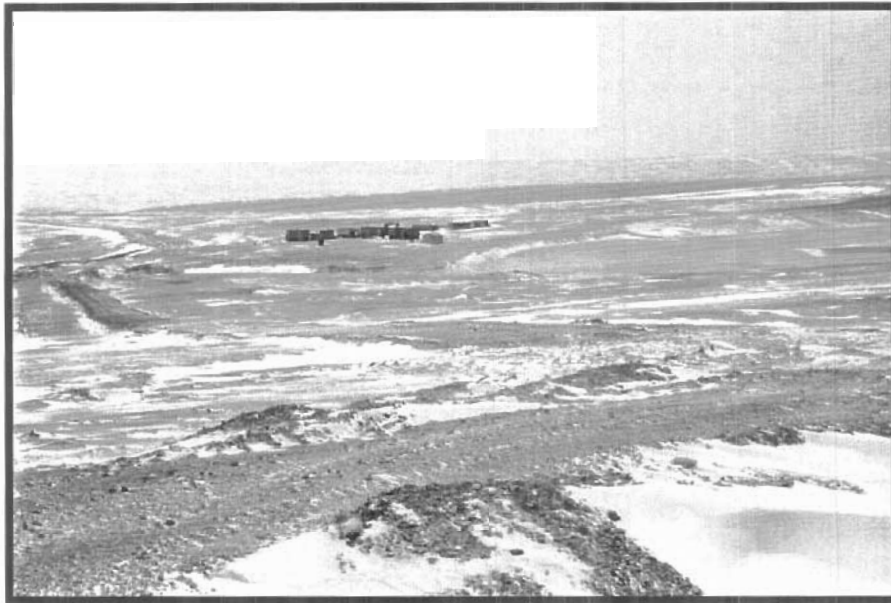
Photo 18 View of temporary trailer camp set up in vicinity of former CRF Plant area.

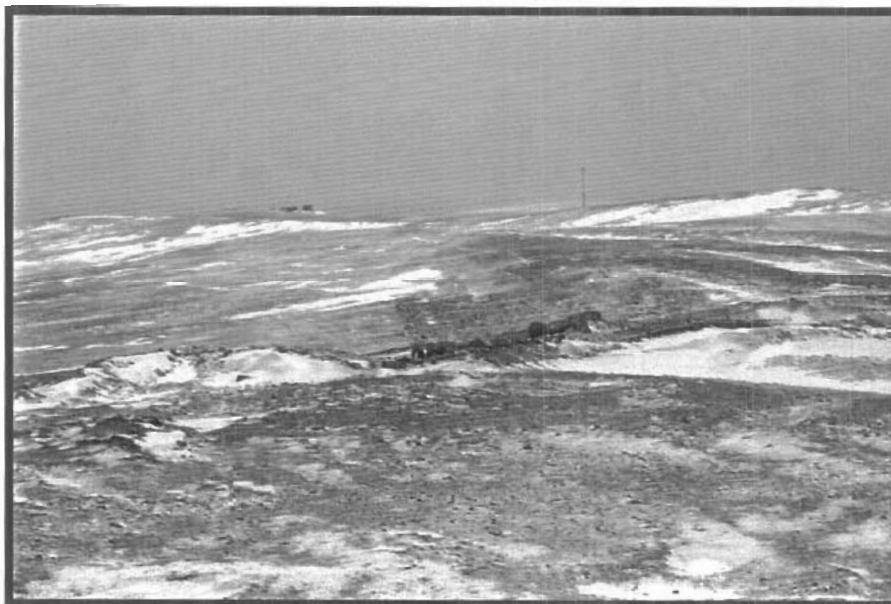
Photo 19 View to south of airstrip area.

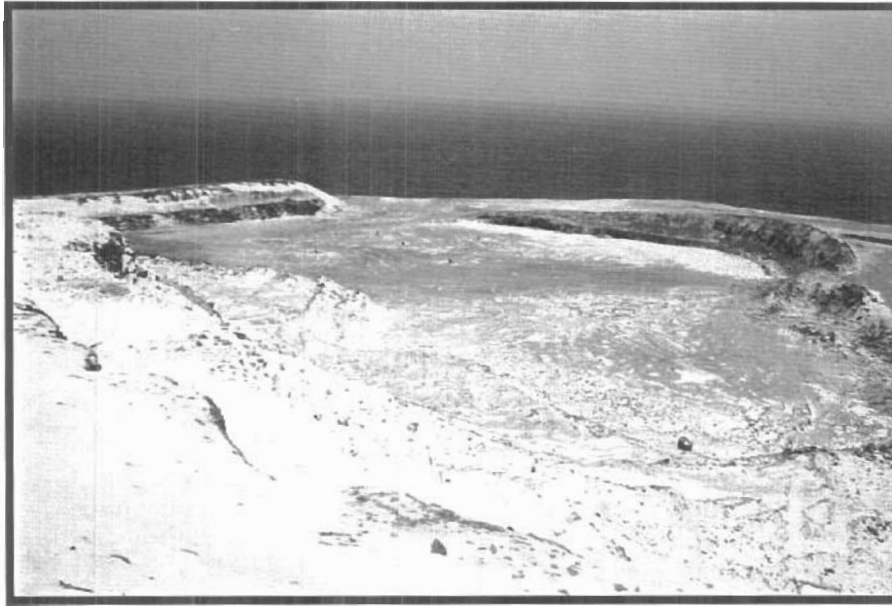
Photo 20 Looking north from end of runway across LRD Quarry.

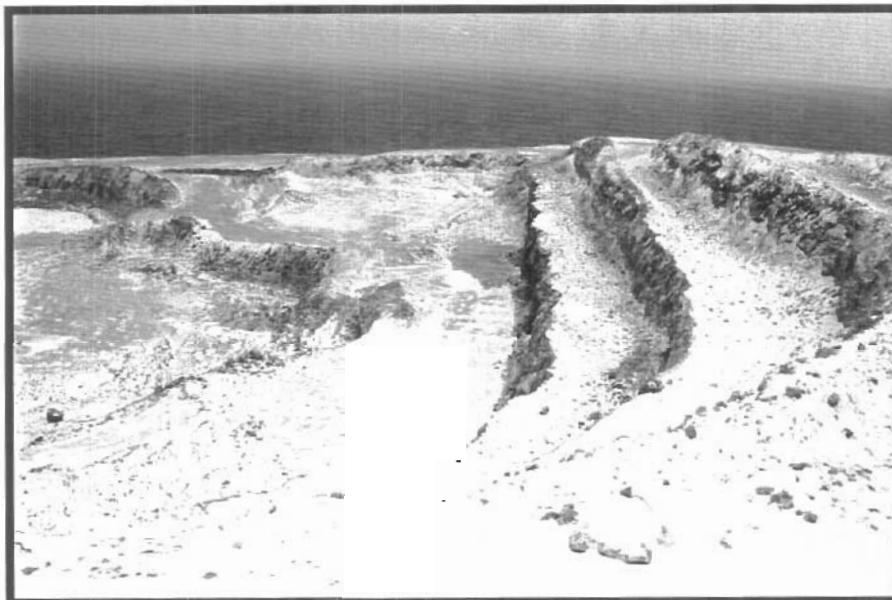
Photo 21 Benches along east side of LRD Quarry.

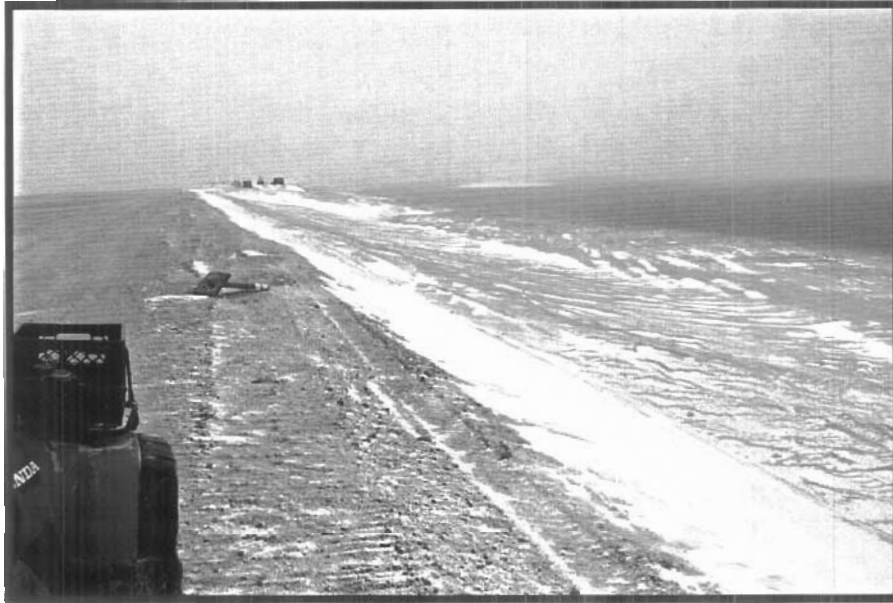
Photo 22 View along runway in vicinity of accommodation complex.

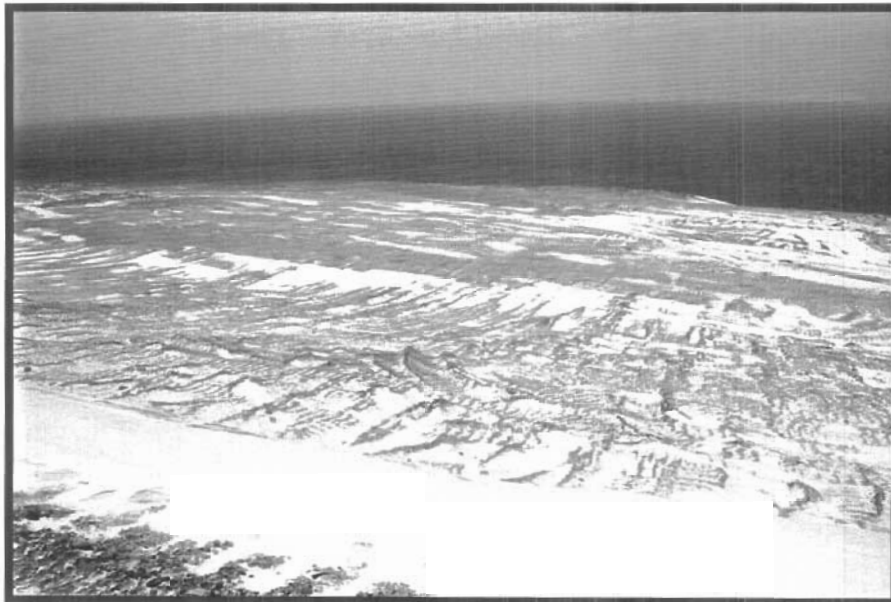
Photo 23 Reclaimed site of former accommodation complex.

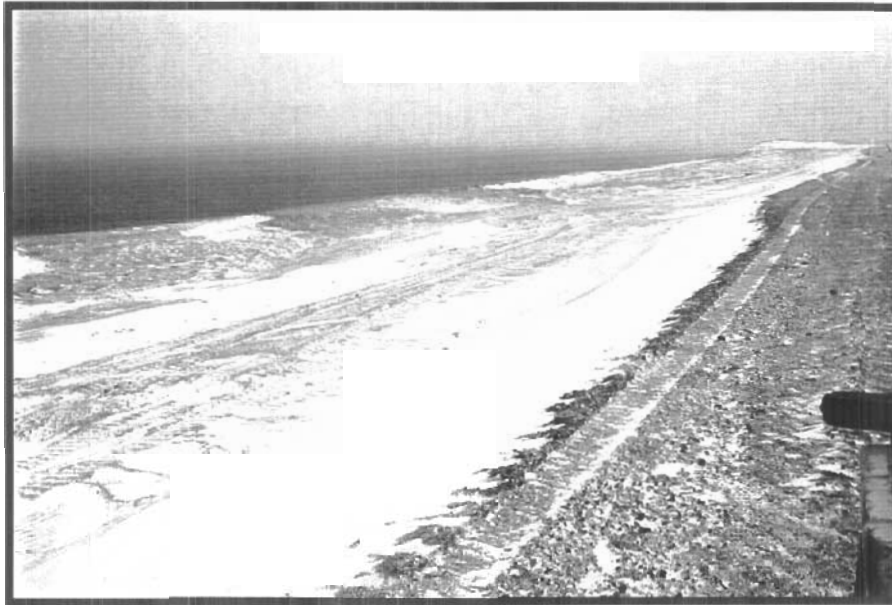
Photo 24 Looking north along west side of runway towards area to the north of the accommodation complex.

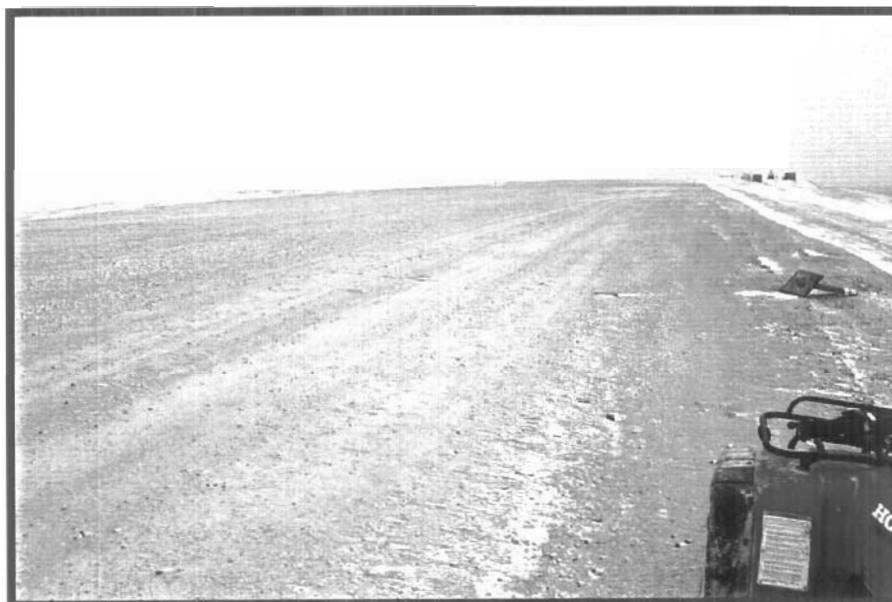
Photo 25 Runway, looking south.

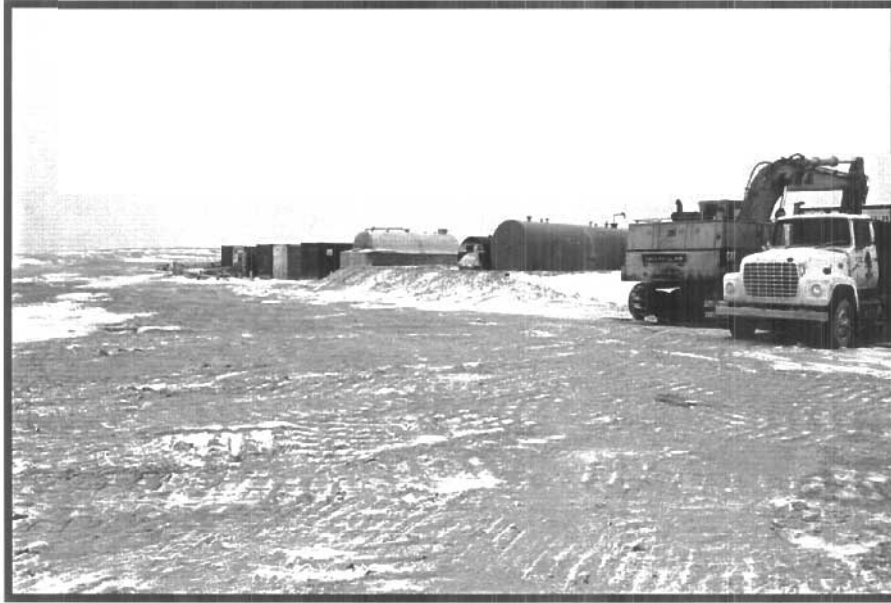
Photo 26 Miscellaneous equipment left on site at the trailer camp for ongoing remedial repairs.
