## FORMER POLARIS MINE SITE, NUNAVUT

# Proposed Long-Term Geotechnical Monitoring Program

**Report Number:** 12-1118-0022

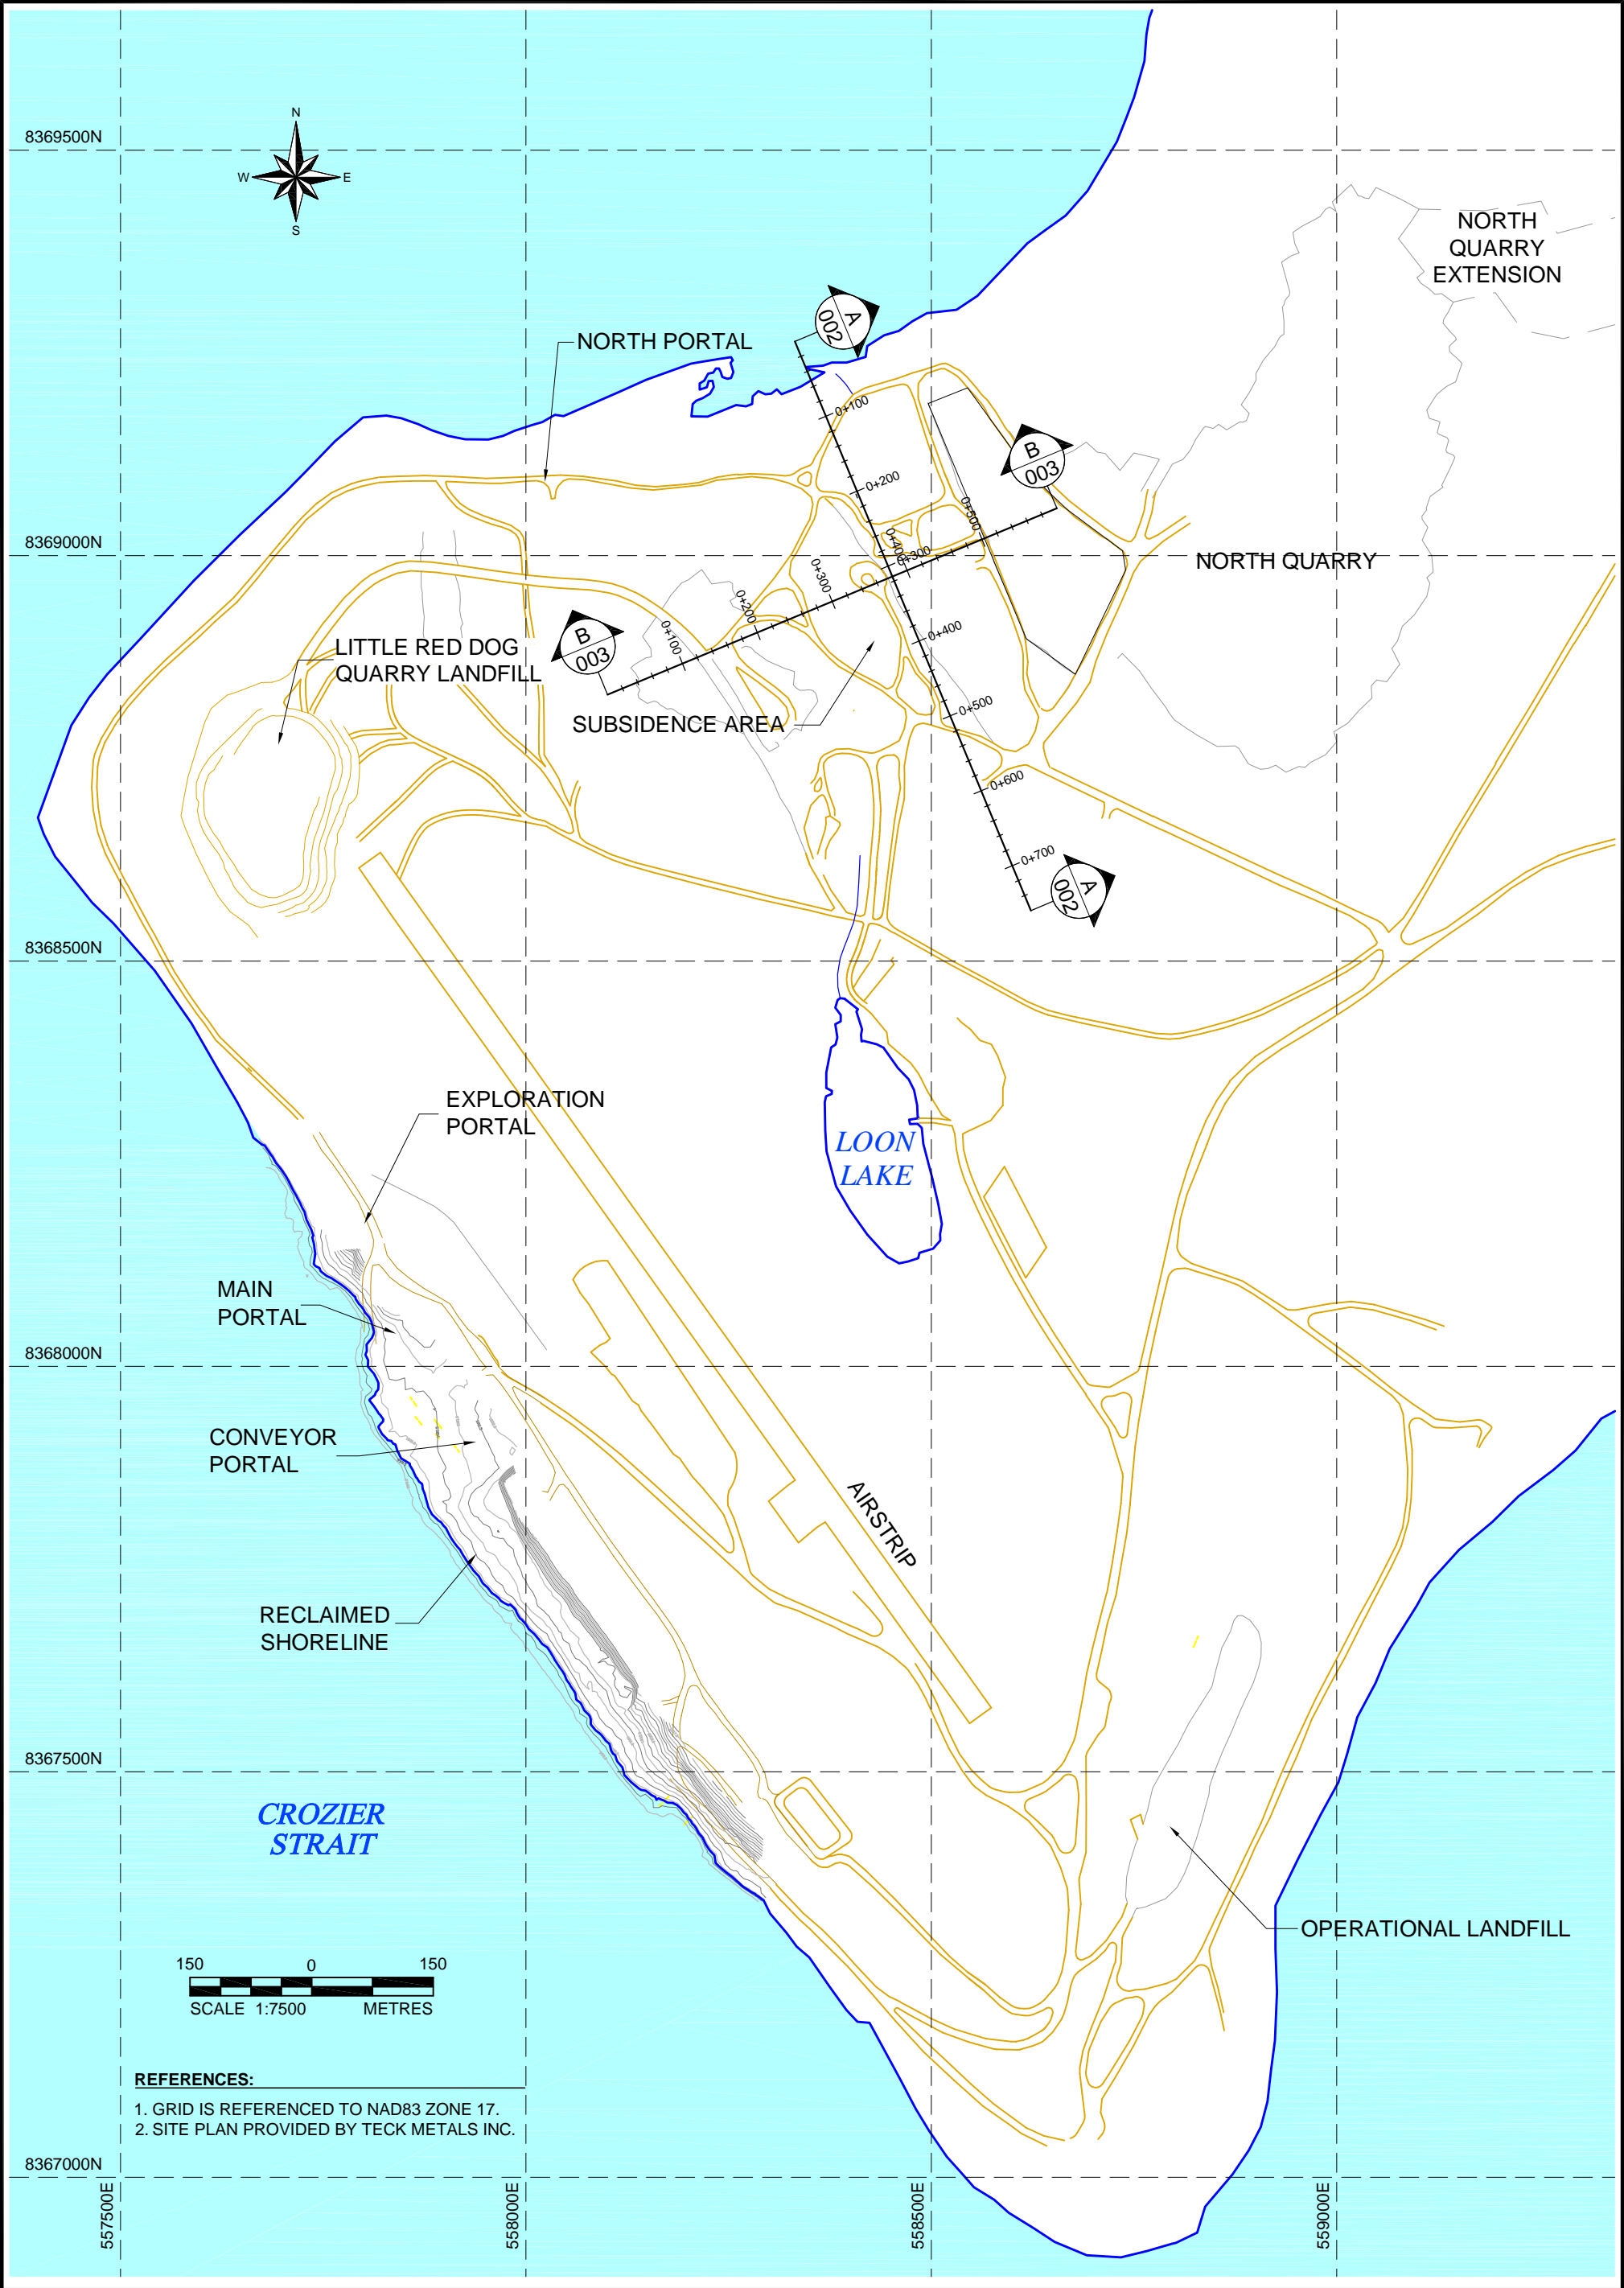
The decommissioned Polaris mine site is located on Little Cornwallis Island approximately 120 km northwest of Resolute, Nunavut. Figure 1 presents the general arrangement of the decommissioned former Polaris mine site (the Site) and the area where subsidence has been previously observed.

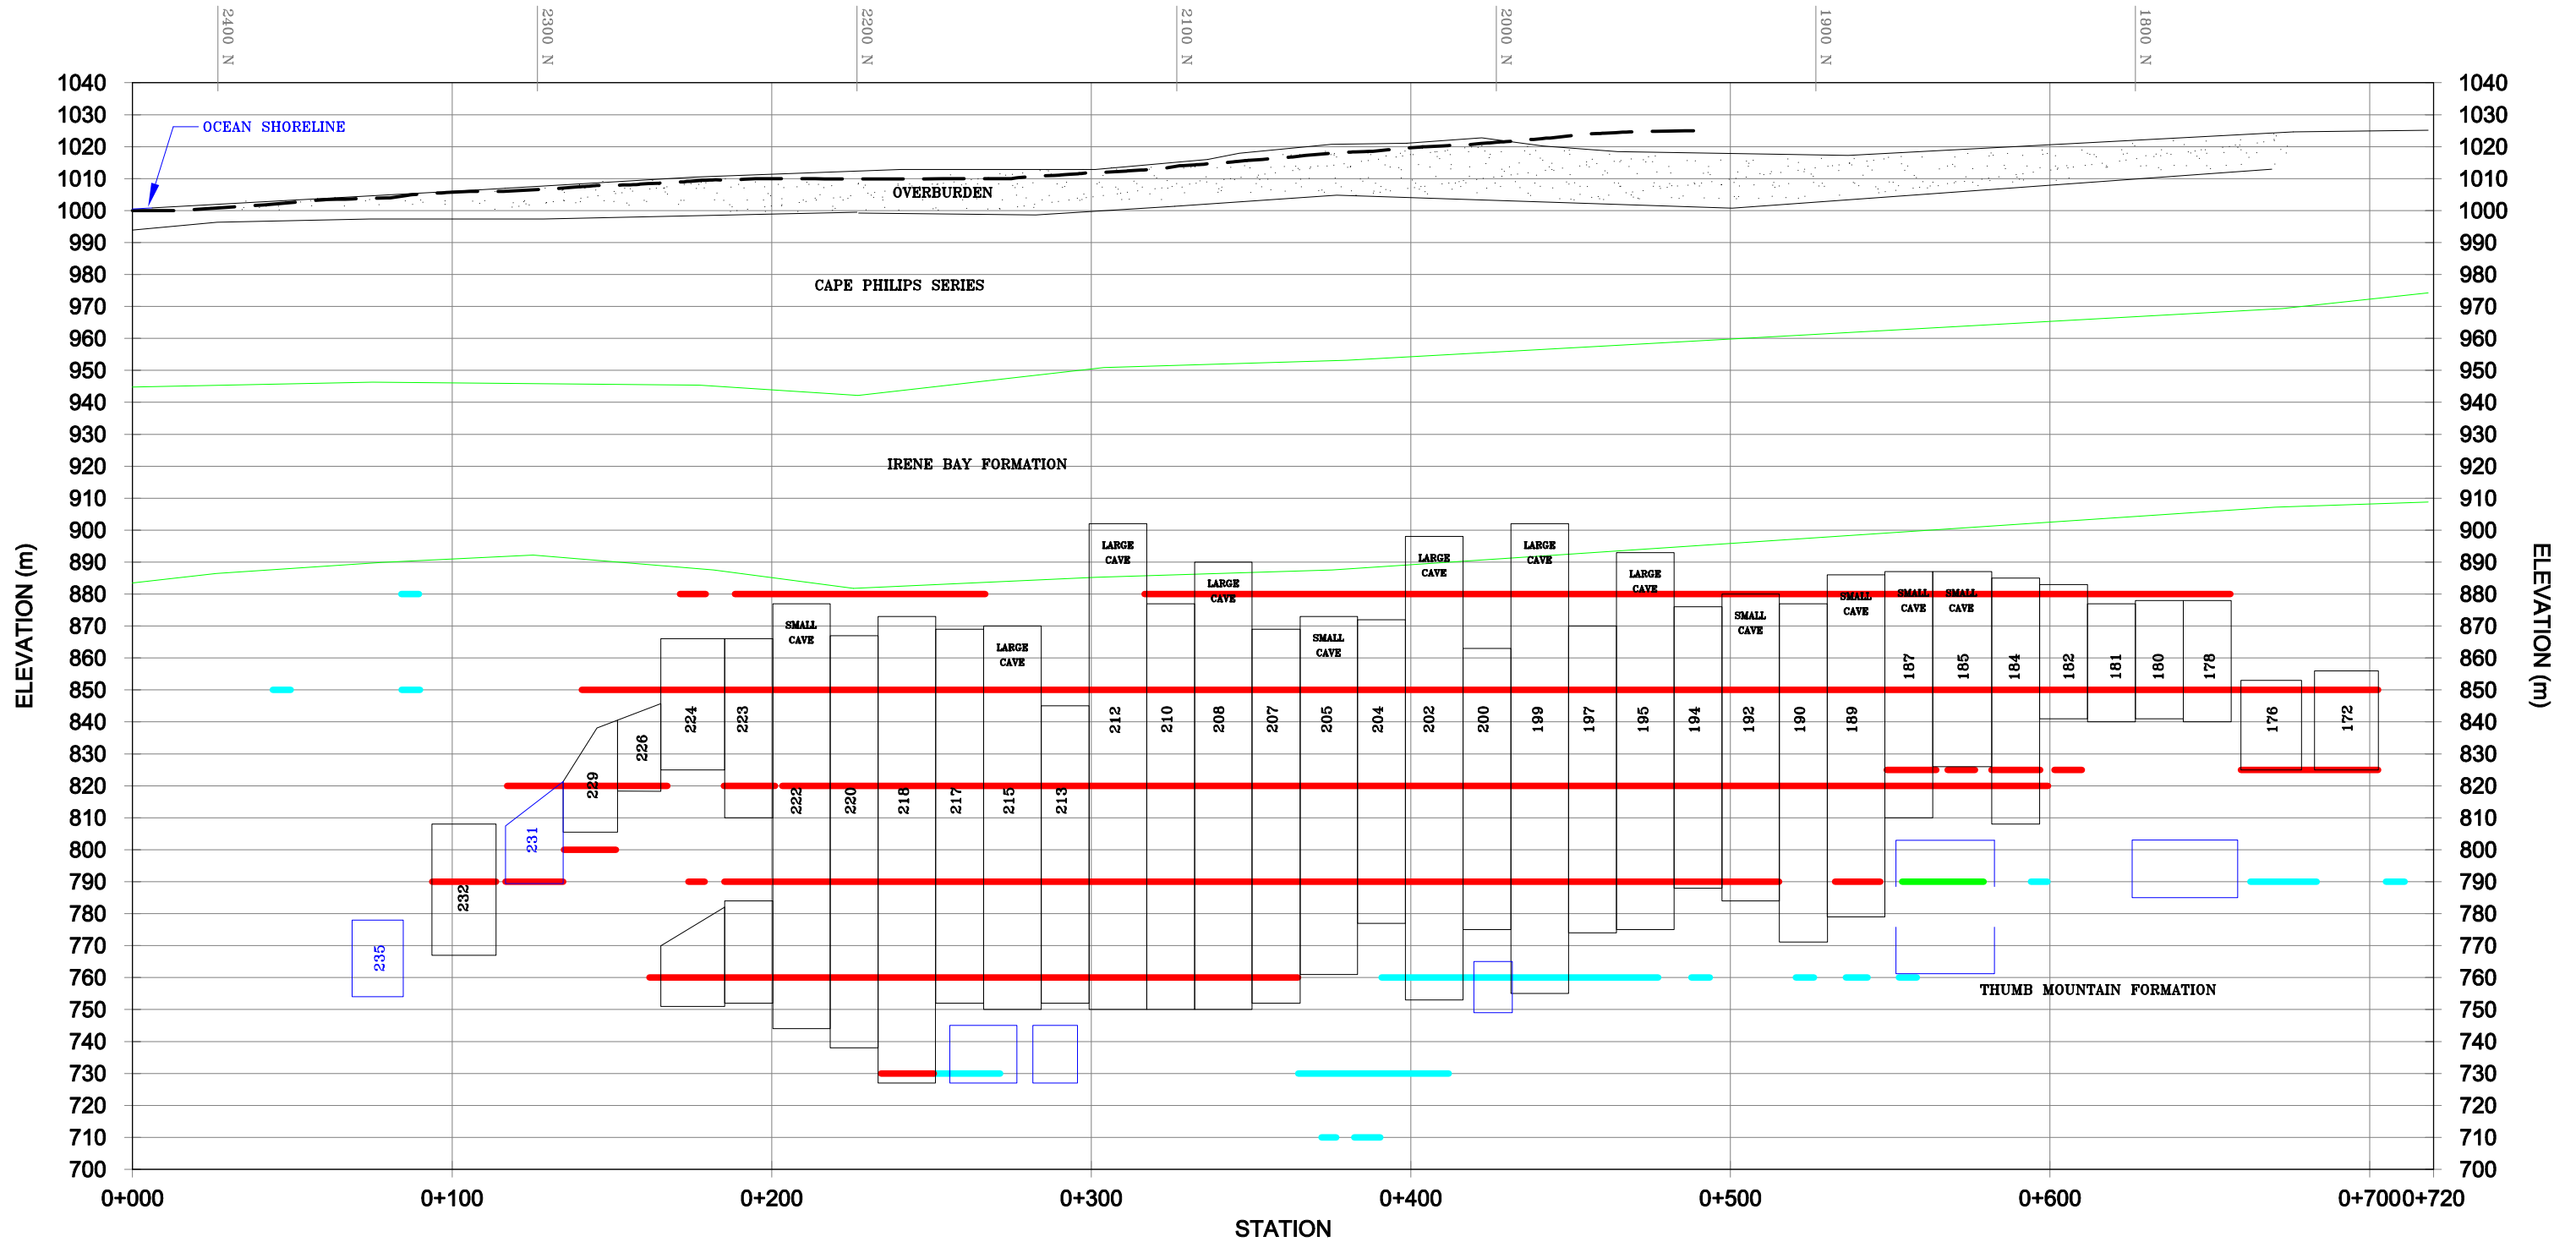
| <br>Mississauga, Ontario, Canada | | SCALE | AS SHOWN | <b>CROSS-SECTION A-A' (1500 EAST)</b> | |

210 Stope (see Stope numbers noted on Figures 2 and 3). These back failures stabilized above the stopes and were backfilled to the maximum extent possible, and generally fairly completely, to facilitate ongoing mining.

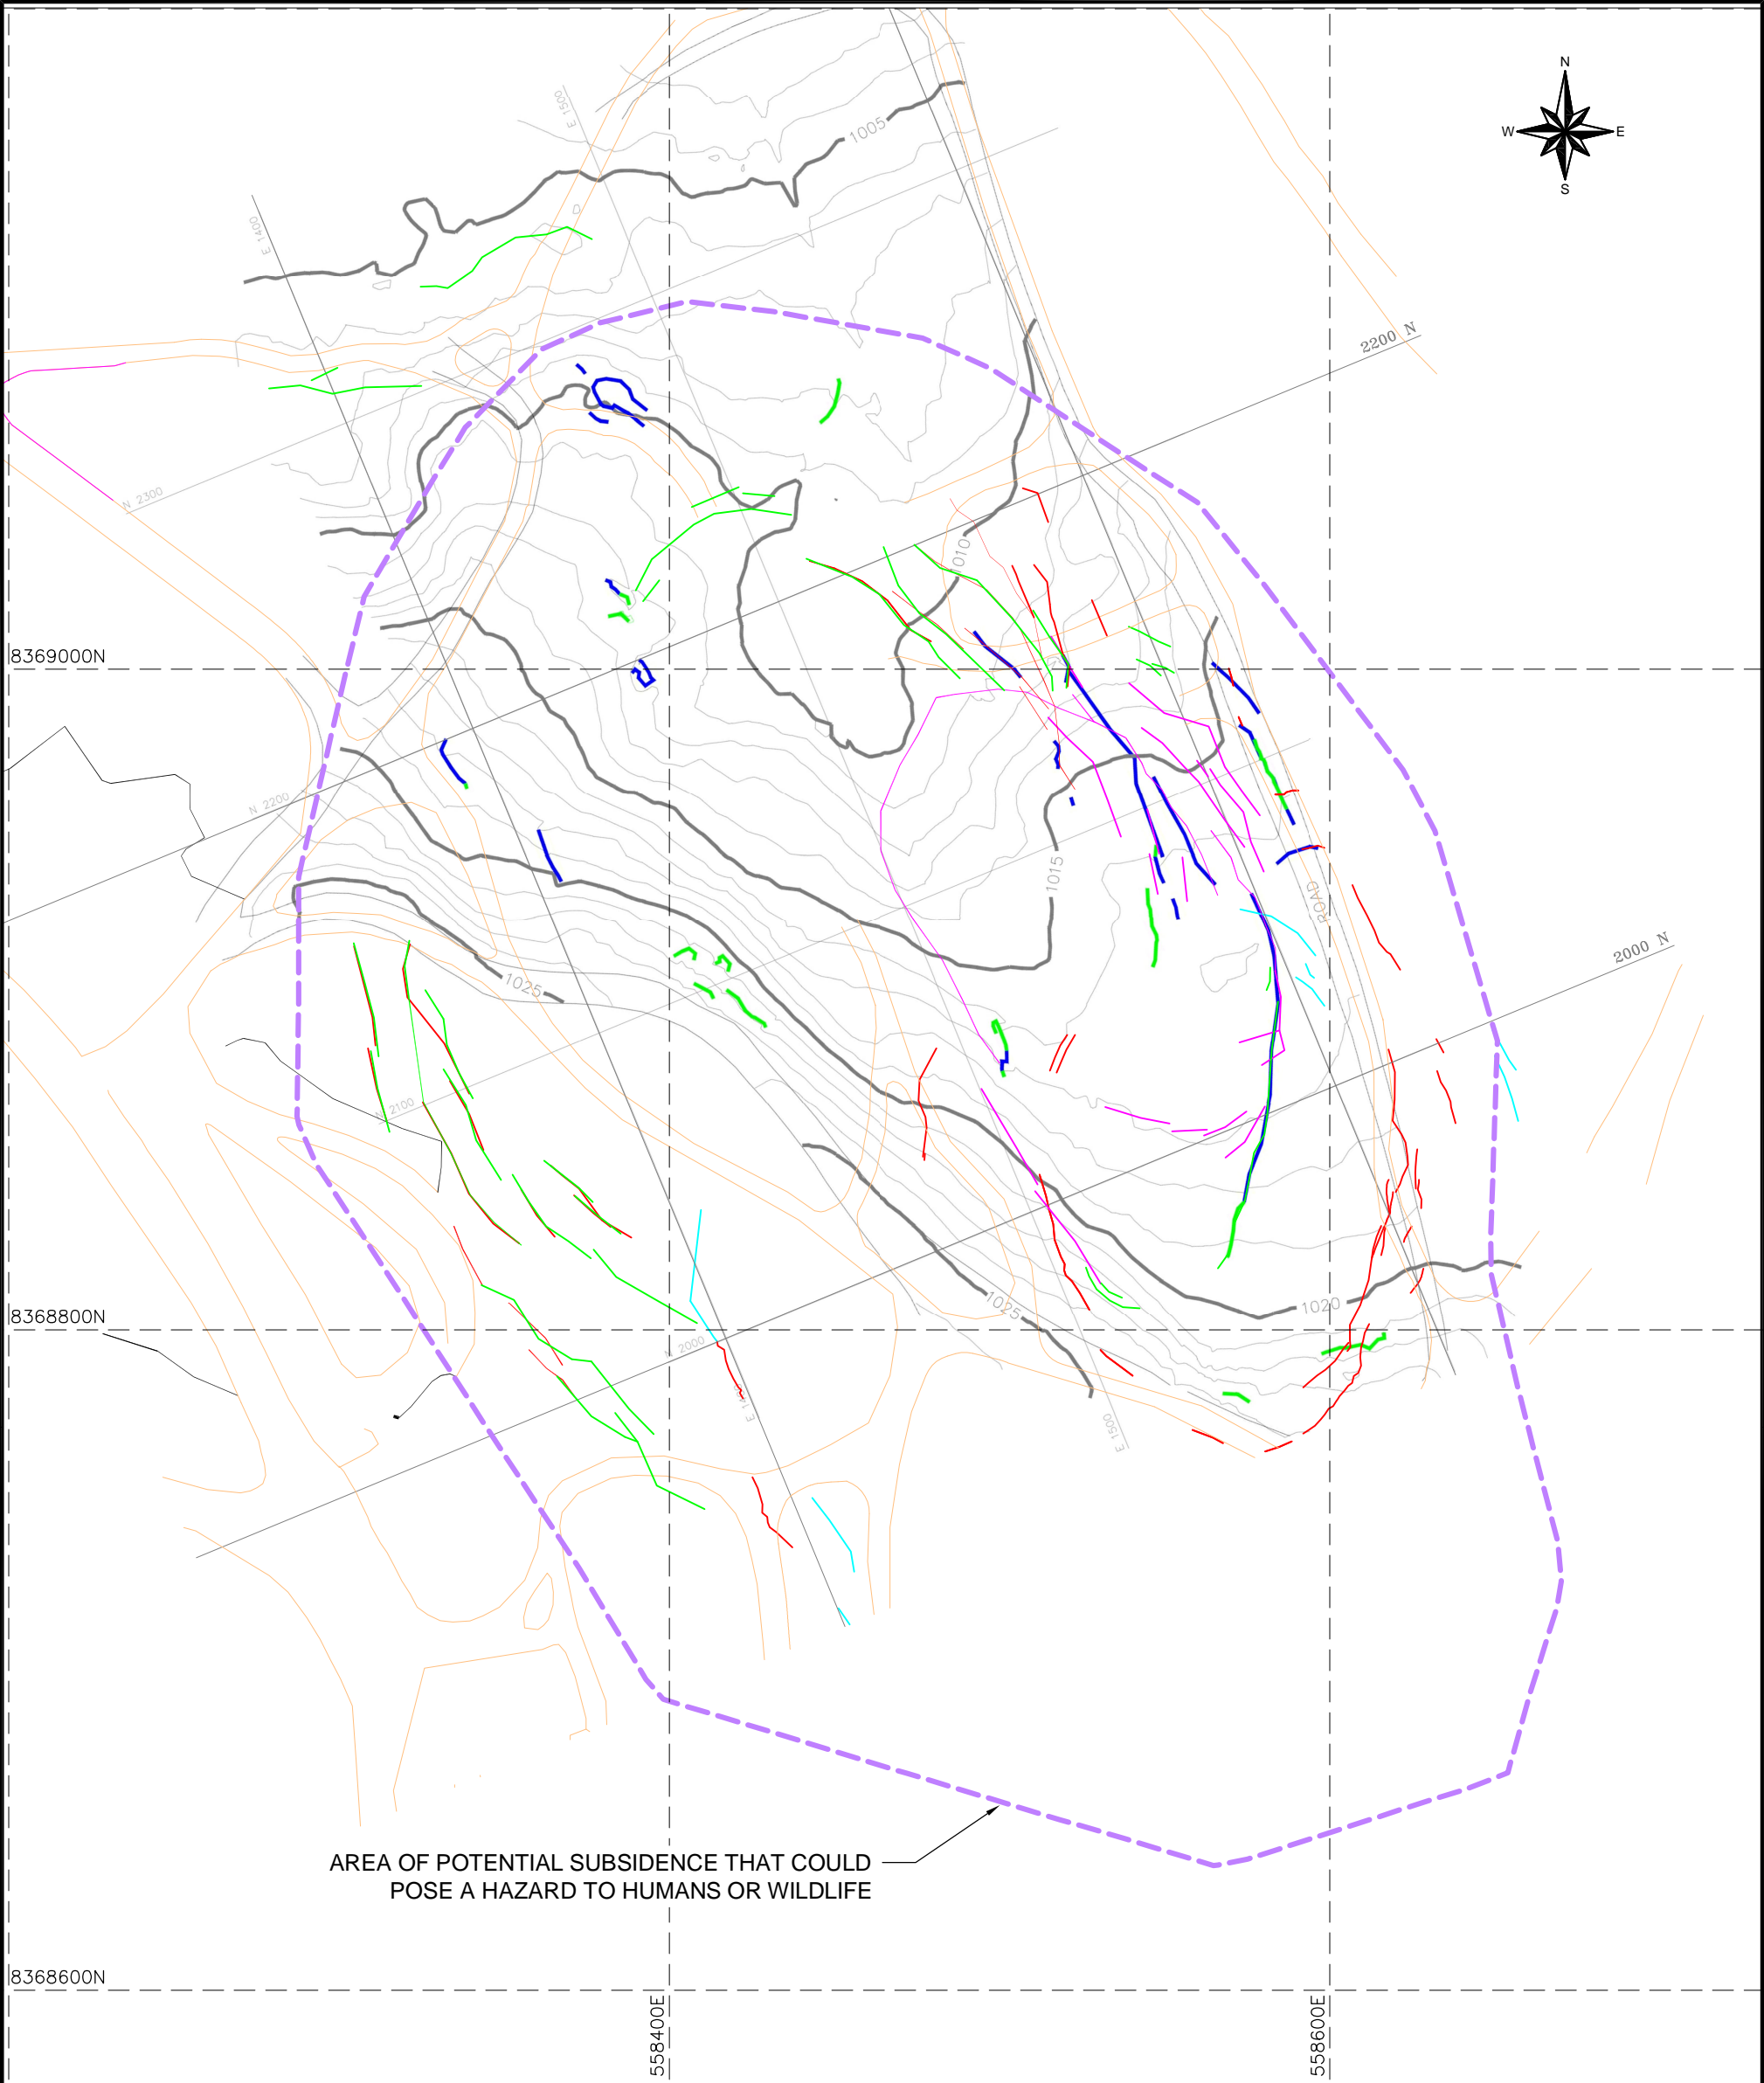
| <br>Mississauga, Ontario, Canada | | SCALE | AS SHOWN | <b>PREVIOUSLY OBSERVED SURFACE CRACKS<br/>RELATED TO SUBSIDENCE</b> | |

In mid-2002, just prior to the completion of mining, the subsidence monuments that were being surveyed indicated that some areas were subsiding at a relatively fast rate as the overlying rock displaced down, compressing the backfill. The cracks that appeared on surface during the entire mining period were mapped on a regular basis until mining ceased in 2002. The pattern of cracks that were evident on surface conformed reasonably well with the outer limits of the integrated Panhandle and Keel mining, with the cracks associated with the graben-type trough being prominent on the east of the Keel Zone. Mining was completed in 2002, and the ground surface profile was re-contoured soon after this. Post-closure monitoring was established in 2005 in the area of previous subsidence. No additional significant surface deformations were surveyed during the post-closure monitoring of the Subsidence Area from 2005 to 2011. Figure 4 presents a plan view of surface cracks that were surveyed during mine operation prior to 2002 compared to cracks surveyed post-closure from 2005 through 2011.

The general subsidence profile that developed on surface above the mined area, and the pattern of surface cracking that was mapped on surface prior to re-contouring, conform well with the footprint of the mining and backfilling activities that were undertaken, and with the overall mechanism of the overlying rock moving down onto the backfill and compressing it. The Keel and Panhandle areas were almost completely extracted over an area of approximately 500m by 250m and the rock above the mined area has almost certainly completely subsided onto the fill by now without any bridging or arching.

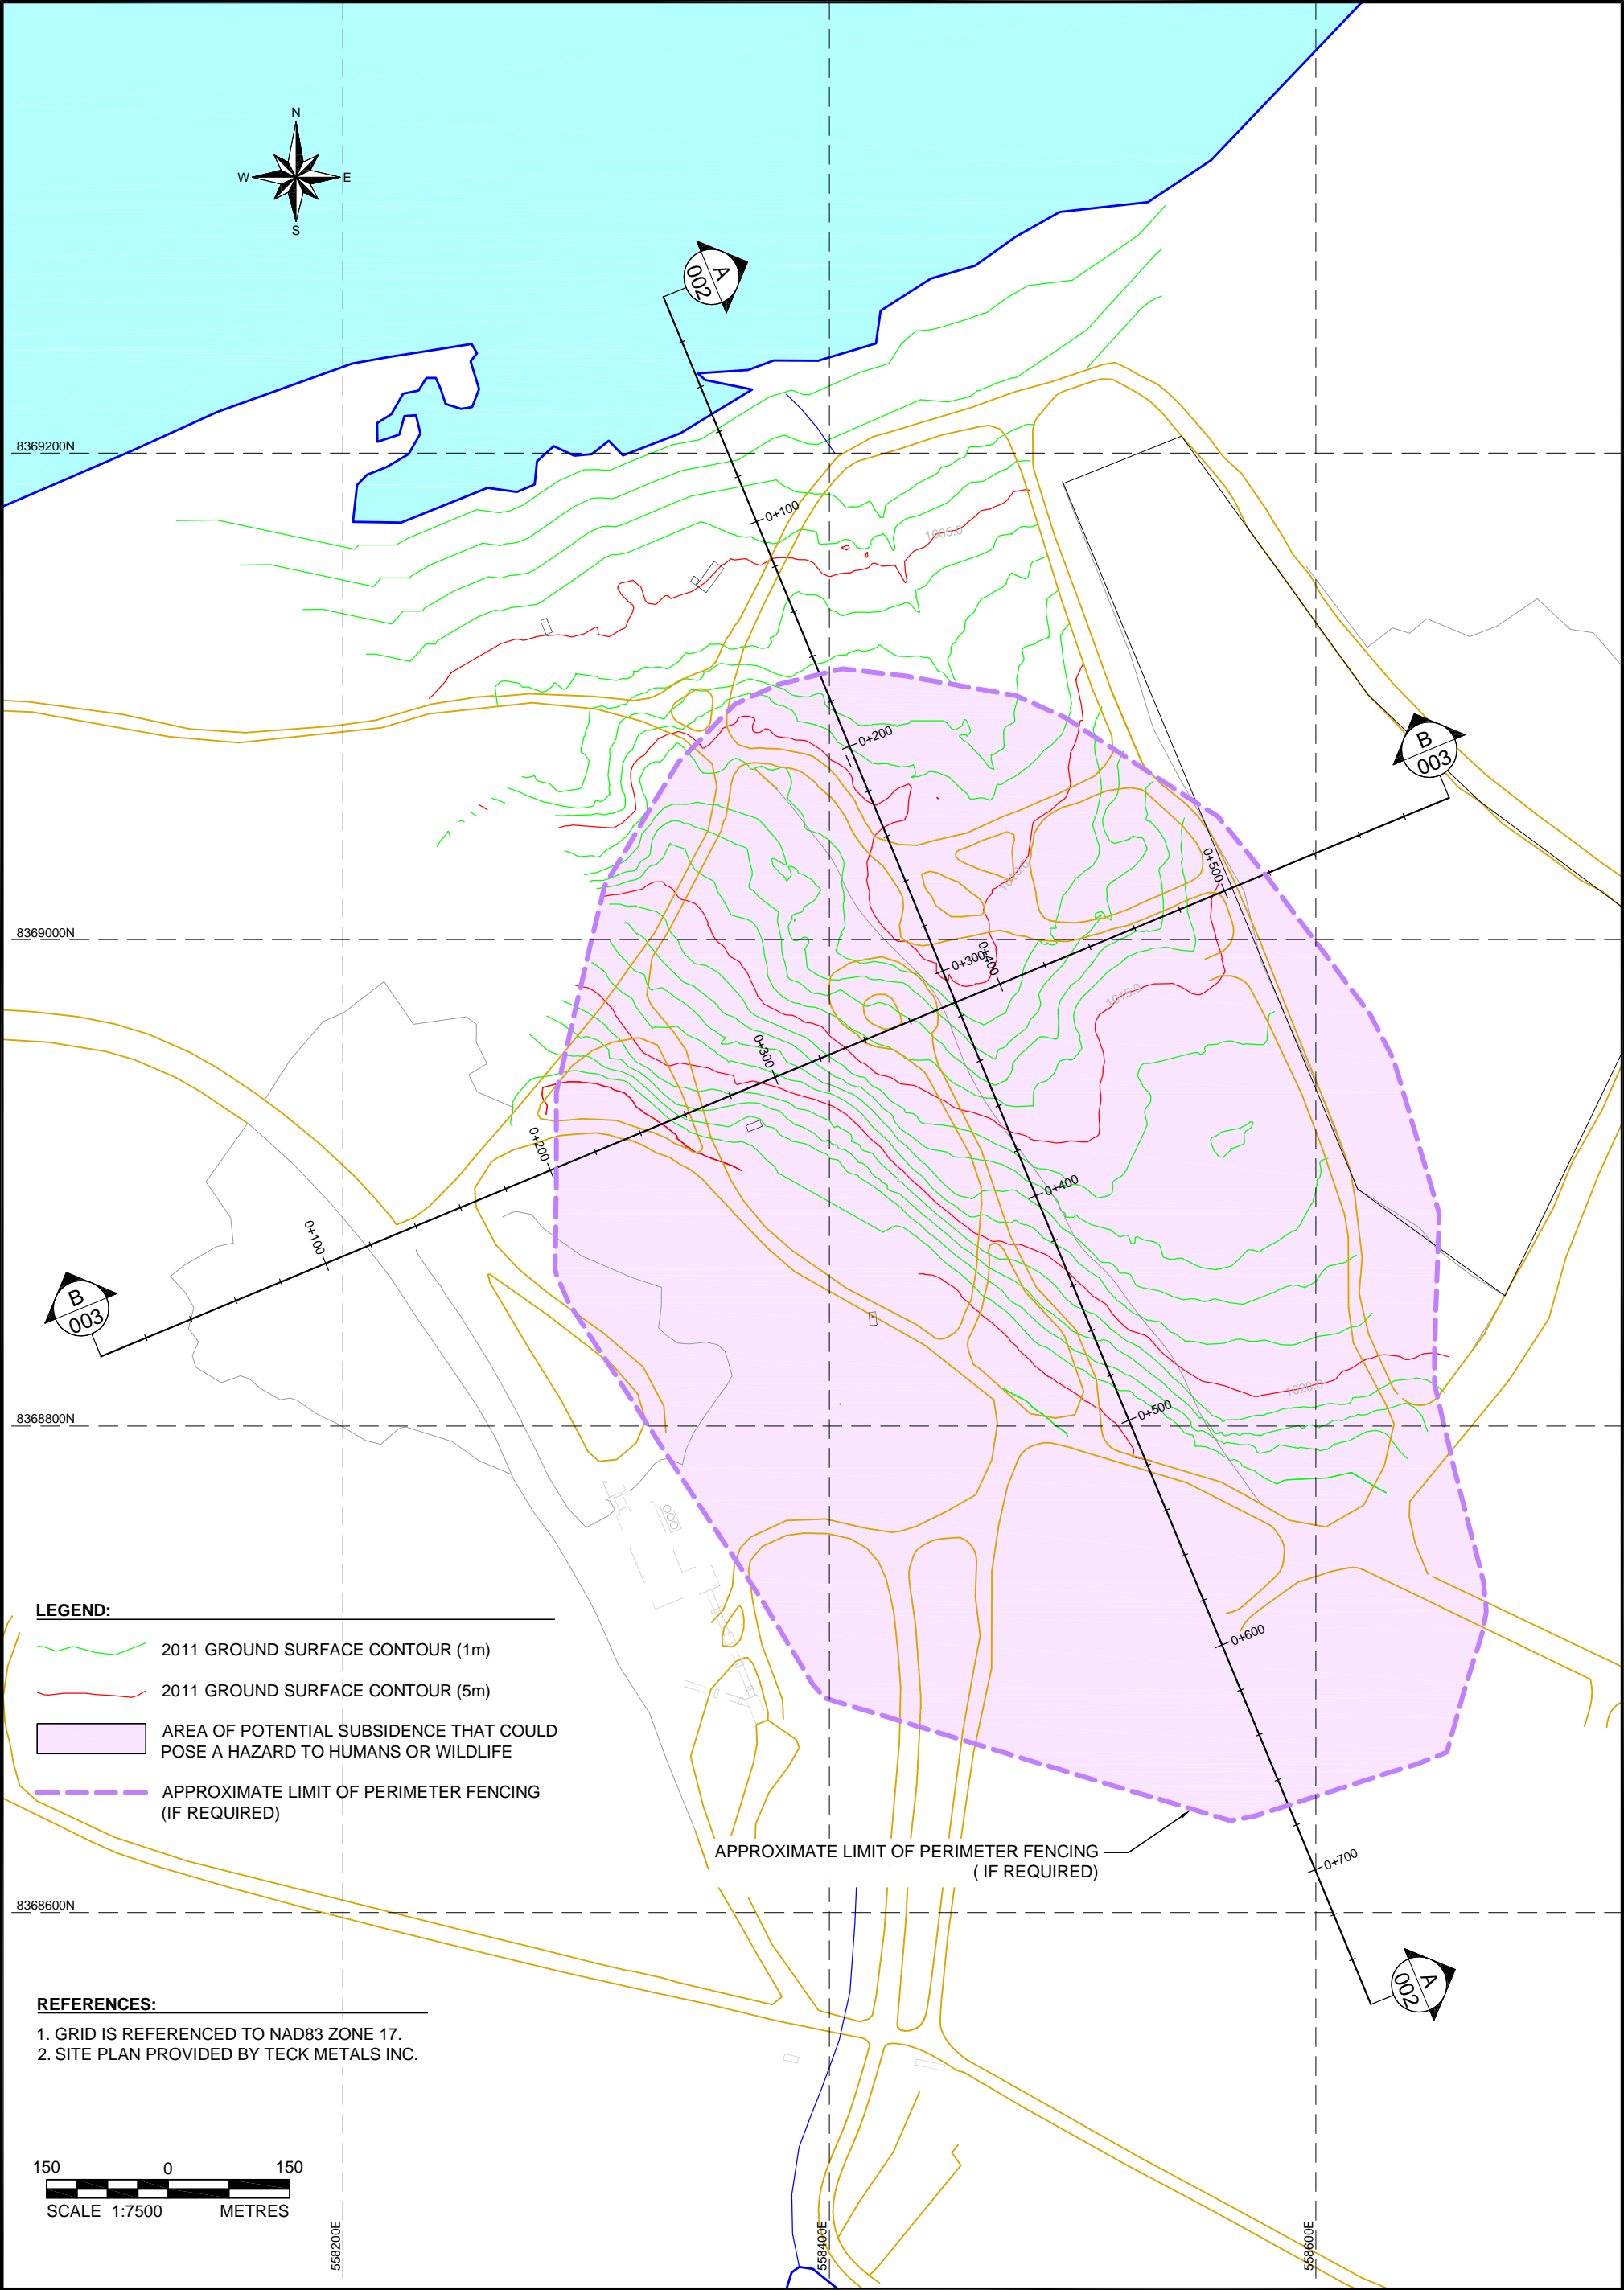
| <br>Mississauga, Ontario, Canada | SCALE | AS SHOWN | <b>AREA OF POTENTIAL SUBSIDENCE THAT COULD REQUIRE FUTURE PERIMETER FENCING</b> | |

Because all mining ceased approximately 10 years ago and most of the voids underground are backfilled, the most lateral extent of any potential additional subsidence that may pose a safety concern, if it occurs, will likely be just slightly beyond the previously observed surface cracks. Figure 4 presents a plan view of previously observed and surveyed surface cracks and the potential area of subsidence that may pose a hazard to humans or wildlife. If cave mining methods had been undertaken as opposed to open stoping, then surface subsidence could have extended further out than the limit shown on Figure 4, but with the type of stoping and backfilling that was undertaken at the Polaris mine, the peripheral extent of effects on surface are less. Although it may be possible to detect minor settlement at surface beyond this limit using very accurate surveying systems, any subsidence beyond this limit should not pose a hazard to humans or wildlife.

If future geotechnical inspections observe additional surface cracking and depressions, these will need to be investigated and a decision made on how to mitigate the hazards and safety concerns. The recommended mitigation measure, should additional subsidence be observed that poses a hazard to humans or wildlife be observed, is construction of a perimeter safety fence. Installation of perimeter safety fencing around mine hazards is a common mitigation measure in populated mining communities and is considered a suitable mitigation measure for the former Polaris mine site, if required. The location and extent of such a perimeter safety fence will need to be based on the actual extent of subsidence and observations made at the time. For planning and financial assurance cost estimation purposes, the maximum extent of potentially required perimeter safety fence could be as shown on Figure 5. The recommended safety fence would be 1.8m (6 ft) high, galvanized steel, industrial-quality fencing. The total length of fencing shown on Figure 5 is 1360m.

subsidence and observations made at the time. The maximum expected area of potential subsidence and perimeter fencing that may be required in the future to protect human and wildlife safety is shown on Figure 5. The calculated financial assurance associated with long-term geotechnical inspections and future installation/repair of this safety fencing is estimated to be approximately \$1.2M (in 2012 dollars).
