Re: Water Licence Application for Hydrostatic Testing of Fuel Storage Tank #3 Repairs, Coral Harbour

CORAL HARBOUR FUEL STORAGE TANK 3 BOTTOM REPLACEMENT

Above Ground Storage Tank 3
Coral Harbour, Nunavut

Client:	Inukshuk Construction Ltd PO Box 645 Rankin Inlet, NU X0C 0G0	Report No:	622024-0002-T-NT-REP-0001	Rev.	0
Description:	Tank 3 Coral Harbour Fuel Storage Facility AST Condition Survey API 653 internal/out-of-service inspection program.	Codes/ Specifications:	Technical Examination API 653 Add.3, 2013- Sect. 6.4 Internal Inspection		
		Insp. Date:	August, 2014	API 653 Inspector:	R. Arenburg Cert. # 3016

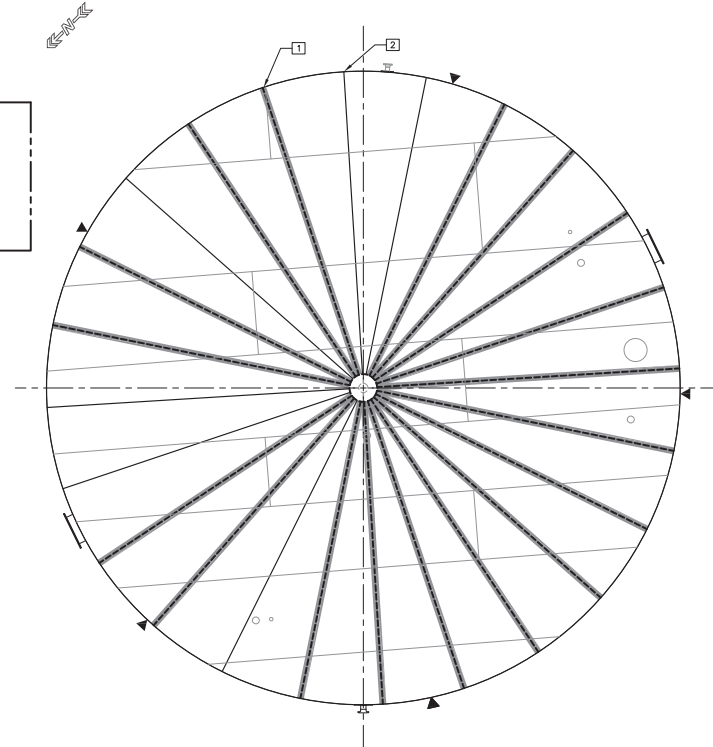
1 ROOF RAFTER AND PLATE LAYOUT
SCALE: 1:50

1. NEW RAFTER SIZE IS BASED UPON API CODE REQUIREMENTS AND ESTIMATION FROM API INSPECTION PHOTOS. CONFIRM EXACT SIZES ON SITE AND NOTIFY ENGINEER OF DISCREPANCY PRIOR TO START OF WORK.
2. IF RAFTER SIZE DIFFERS FROM SPECIFIED MATERIAL, NOTIFY ENGINEER FOR REQUIRED FIELD MODIFICATIONS TO COLUMN RAFTER CLIP DETAIL.
3. CONFIRM EXACT NUMBER AND LOCATION OF RAFTERS TO BE REPLACED WITH ENGINEER PRIOR TO START OF WORK.

1. REPLACE EXISTING RAFTER WITH NEW. PROVIDE NEW CLIPS AND BOLTING MATERIAL AS PER DETAILS THIS SHEET. 18 TOTAL TO BE REPLACED.
2. EXISTING RAFTER TO REMAIN, 6 TOTAL.

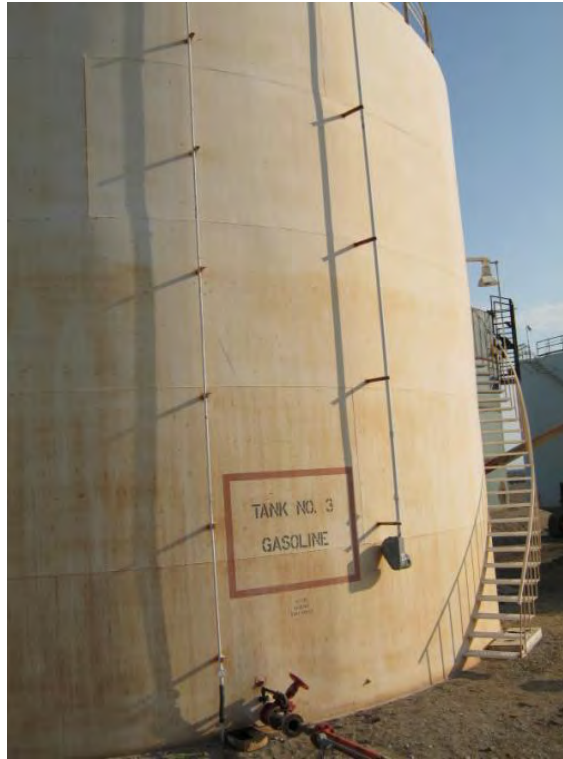
External protective coating was noted in poor condition, faded and worn, with some bare lightly corroded areas.

Photo 1713: Tank 3 Exterior View – Protective coating worn, light rusting.

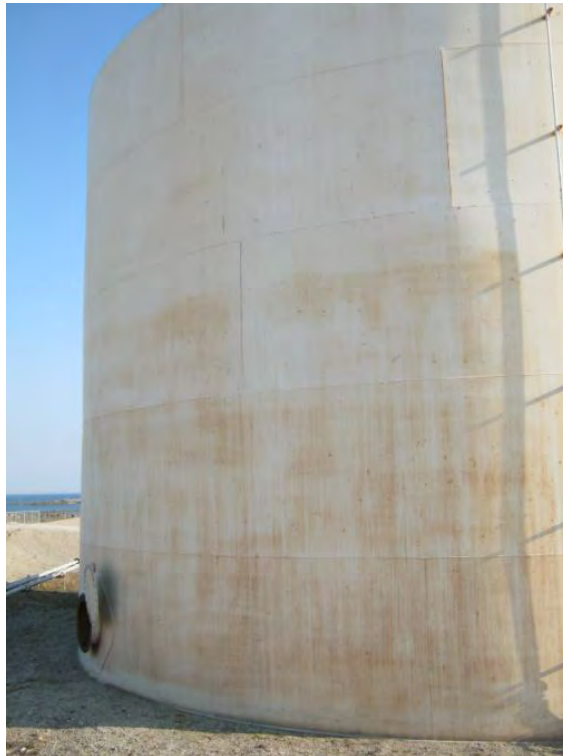
Photo 1714: Tank 3 Exterior View – Protective coating worn, light rusting.

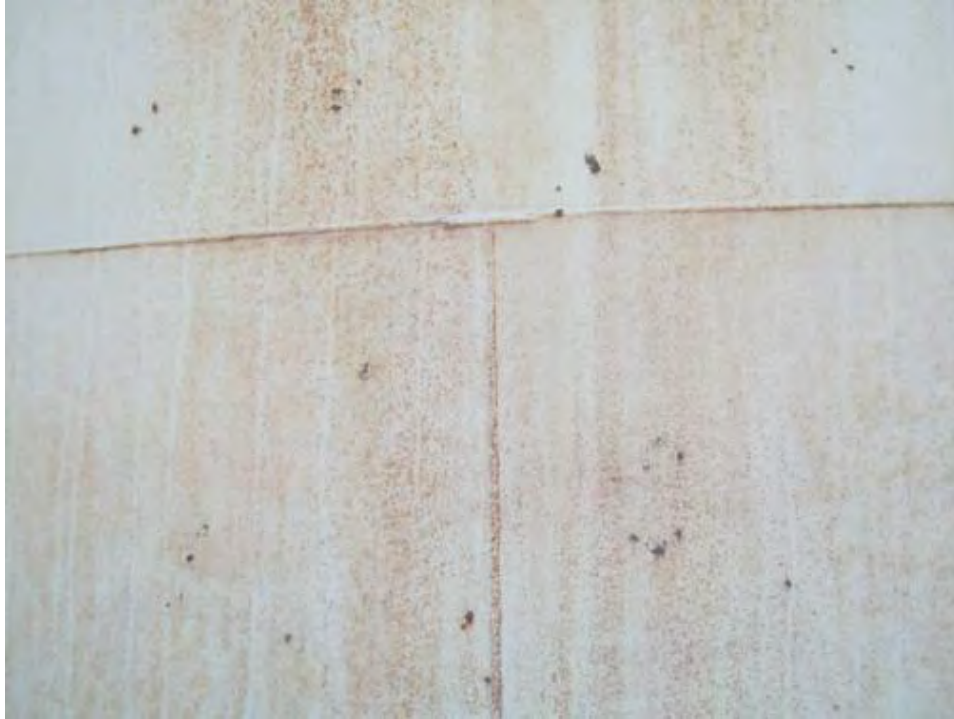
Photo 1718: Close-up of coating condition of shell, typical throughout.

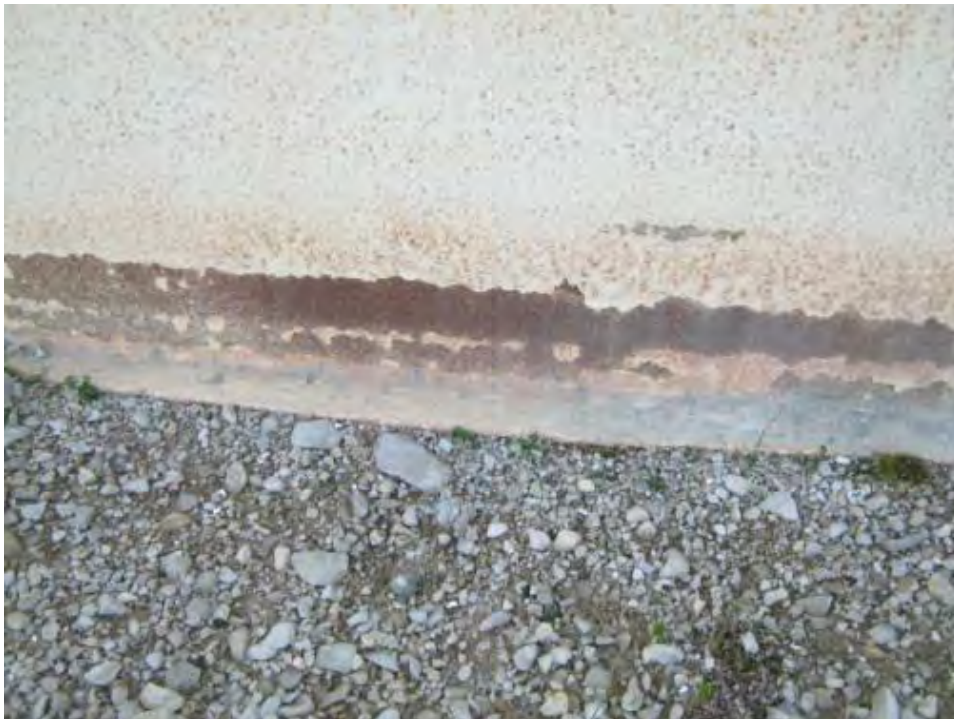
External bottom plate projection (chime) in fair condition, around the tank perimeter, no significant underside/topside corrosion noted at plate projection, some bent/deformed areas noted at projecting plate likely from jacking or moving the tank in past years, see attached photographs (App. E).

Photo 1719: Close-up of shell to bottom plate projection, coating peeling and light corrosion.

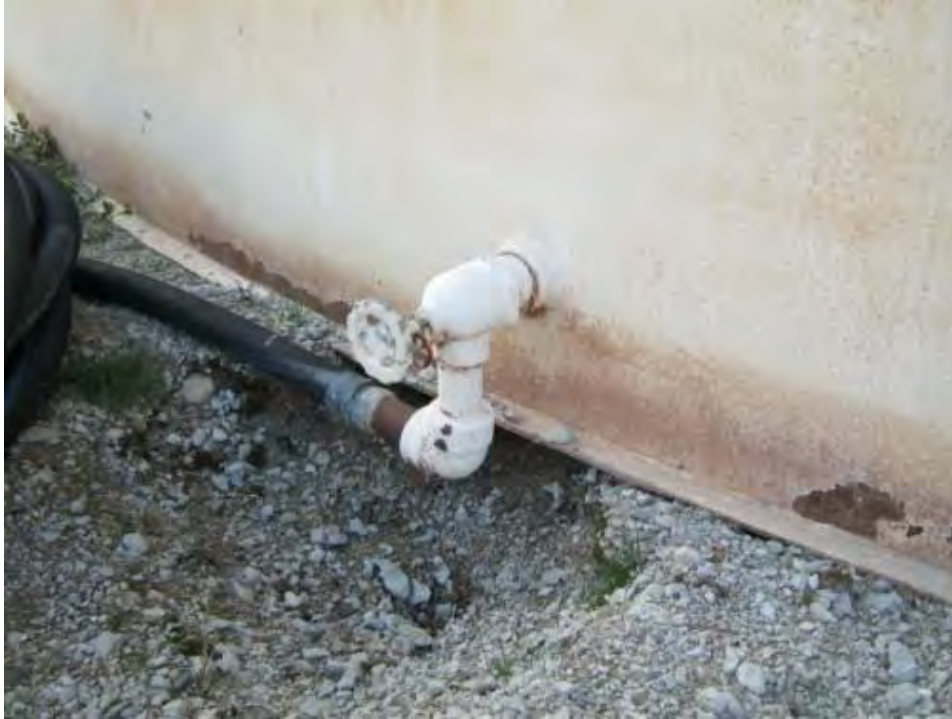
The soil side of the internal bottom plates were inspected visually and by magnetic flux leakage examination. Underside visual examination was carried out where the drain nozzle area was excavated to help drain the tank- no significant underside corrosion noted. MFL scan of bottom plates resulted in no detectable underside pitting.

Photo 1720: Drain nozzle area excavated for draining tank

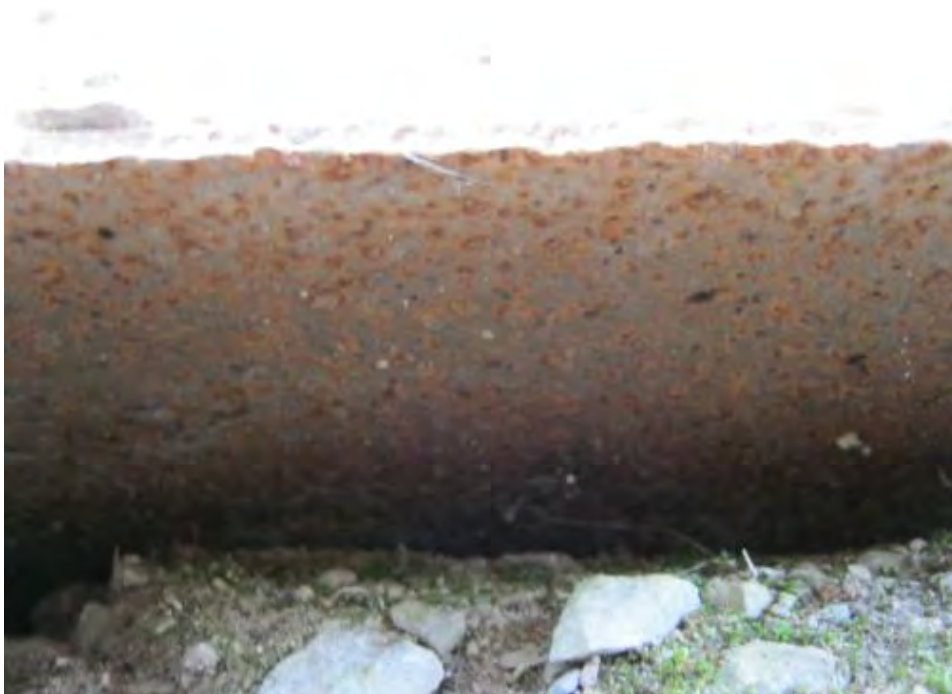
Photo 1723: View under tank bottom plate, minimal corrosion noted $<0.020''$.

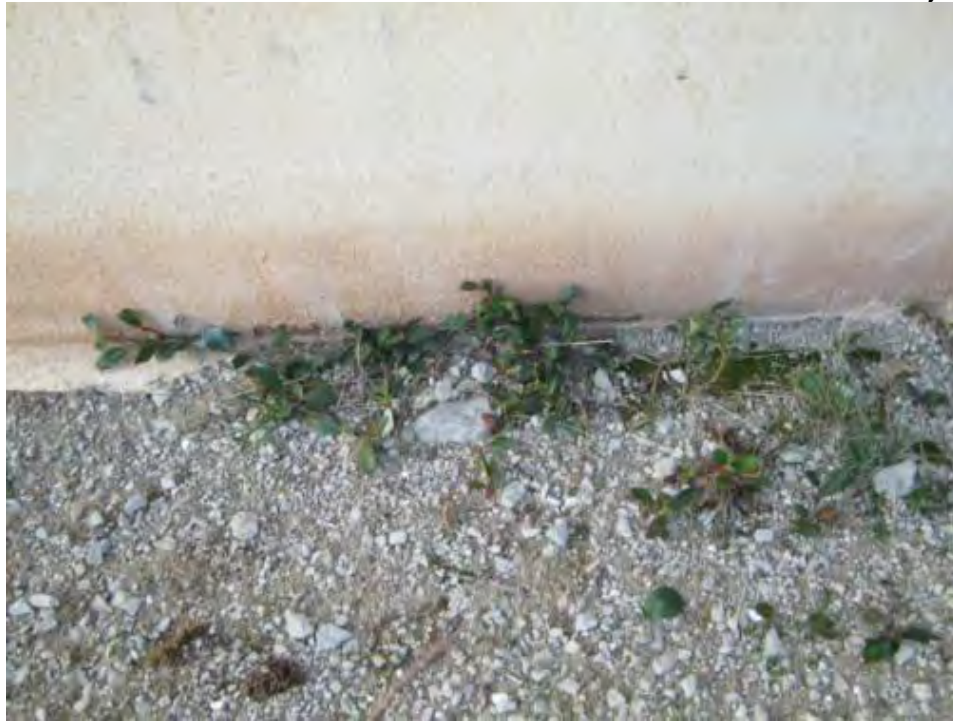
Photo 1724: Minor vegetation at foundation.

- Based on the external inspection, the foundation appeared acceptable, although the settlement/profile of base is not acceptable, as noted in section 2.2.3.
- Maintenance / on-going clean-up of moss and light vegetation and repacking of base material around the bottom plate projection is recommended on a regular basis/annually.

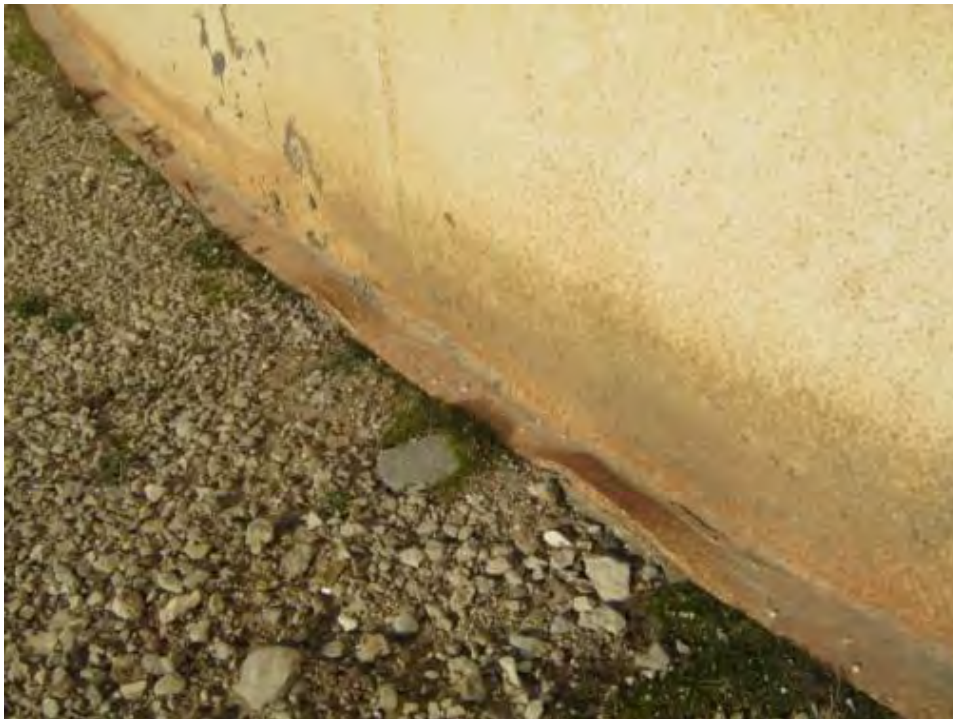
Photo 1728: Deformations at bottom plate projection at random.

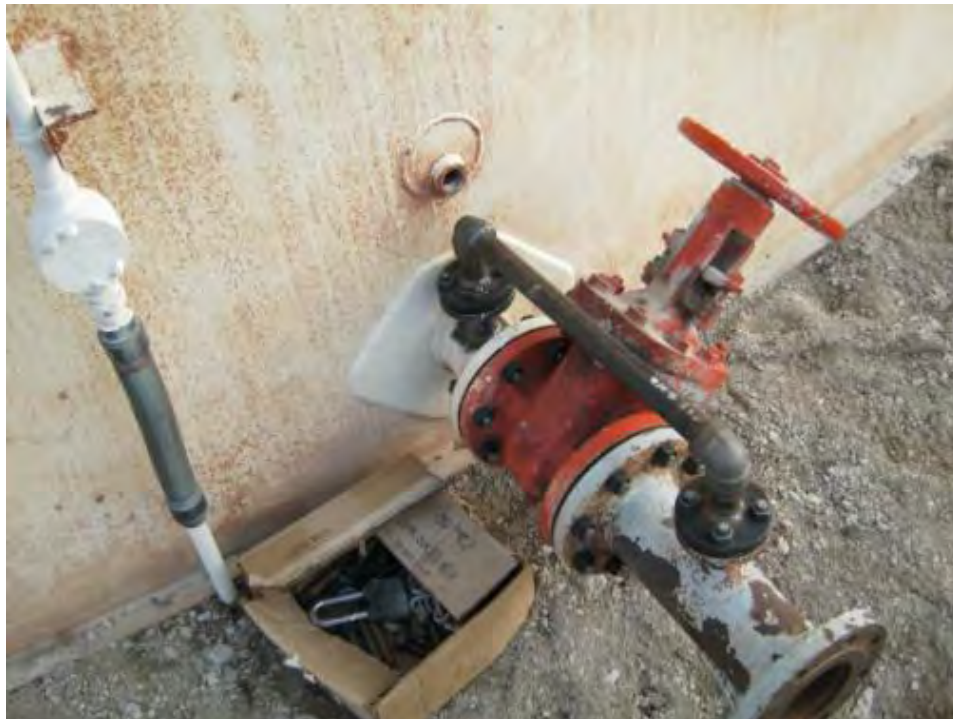
Old nozzle insert plate noted above fill line with coupling welded in insert, not per current API, and was MT tested per API 653 (Section 4.3.9.1), for close weld spacing.

Photo 1738: Fill/discharge line nozzle, non-standard shell insert above, later cleaned and MT tested.

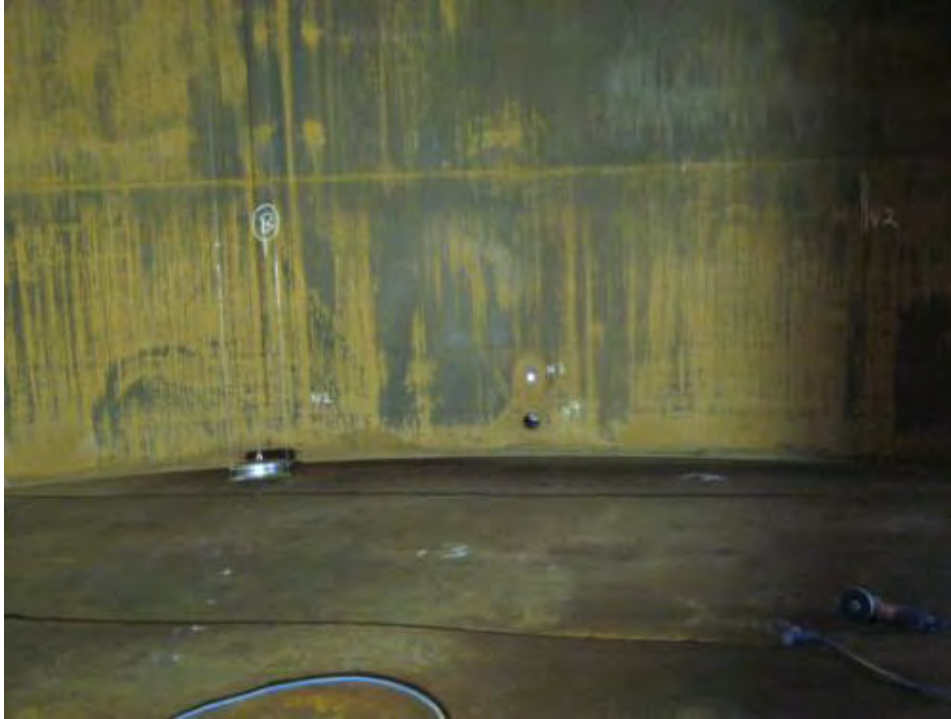
Some deformations noted first foot from bottom, from previous tank moving- dented areas from cable being used around shell to haul tank.

Photo 1774: Shell interior in good general condition, some minor shell denting/distortion at lower 1 foot from moving operations in the past.

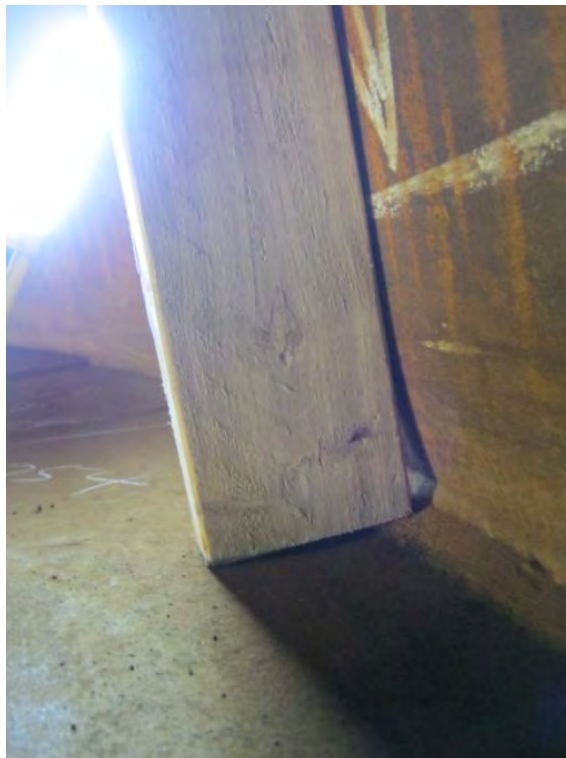
Photo 1777: Close-up of shell distortion noted above.

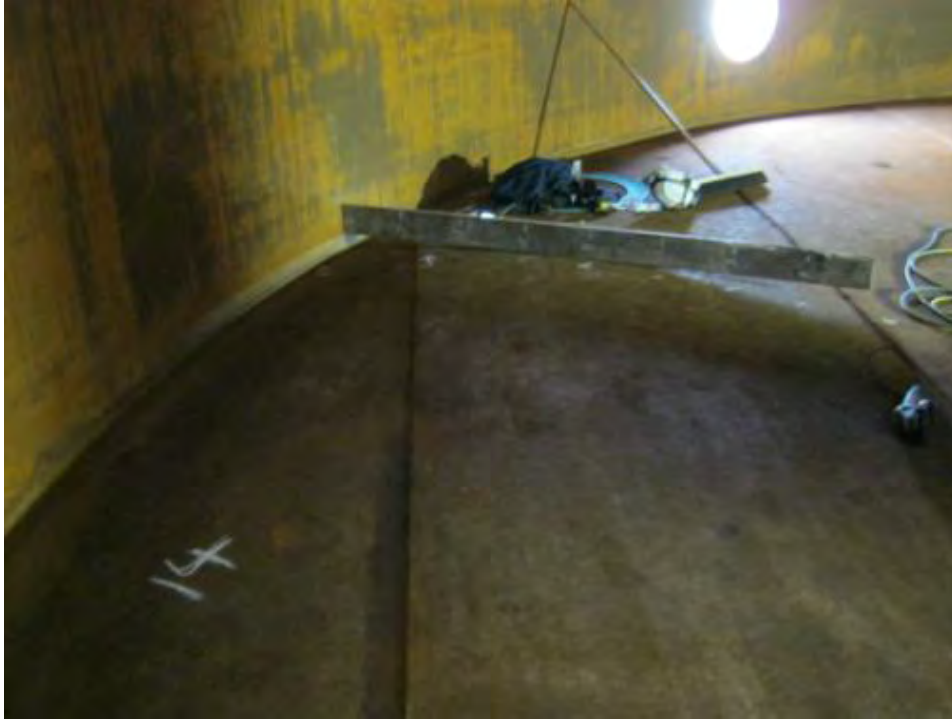
Photo 1775: Bottom/floor plate settlement distortion plate 13 and 14 area.

- Based on bottom plate examinations/survey, additional magnetic particle inspection (MT) was carried out at areas exceeding 75% of allowable settlement at time of inspection with no crack indications noted.
- Foundation levelling and bottom plate replacement is recommended, or a detailed engineering analysis in areas exceeding 100% of allowable limits if not repaired. Note that one centreline bottom plate is only 3/16" thick and should be considered for replacement along with the other excessively deformed plates. A complete bottom replacement would facilitate under-floor foundation/shell re-levelling.

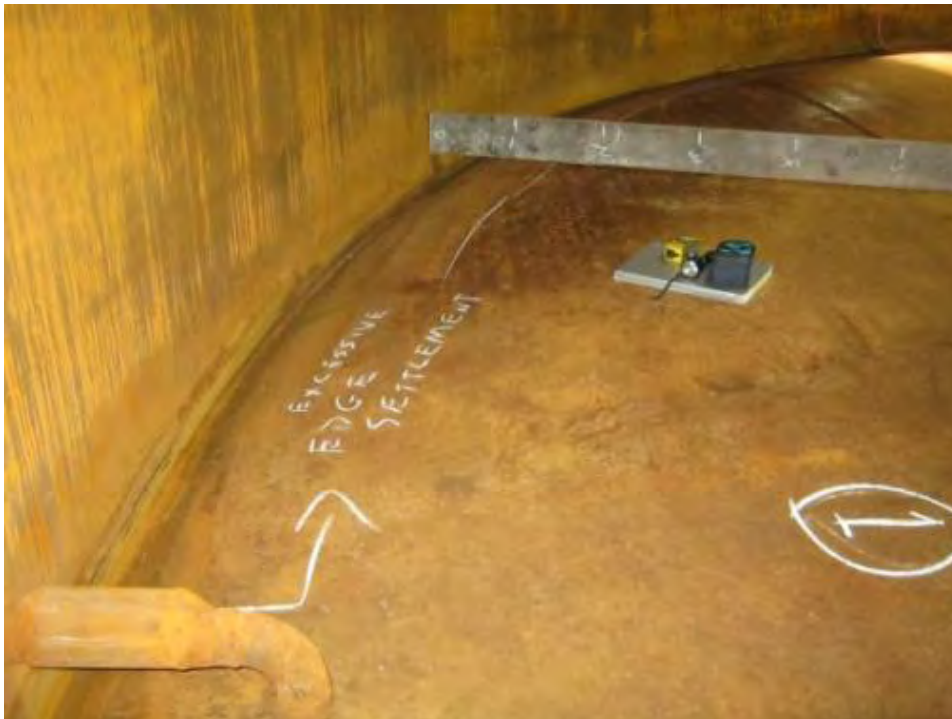
Photo 1751: Edge settlement plate 1 areas, 4'-5' first 3' from shell.

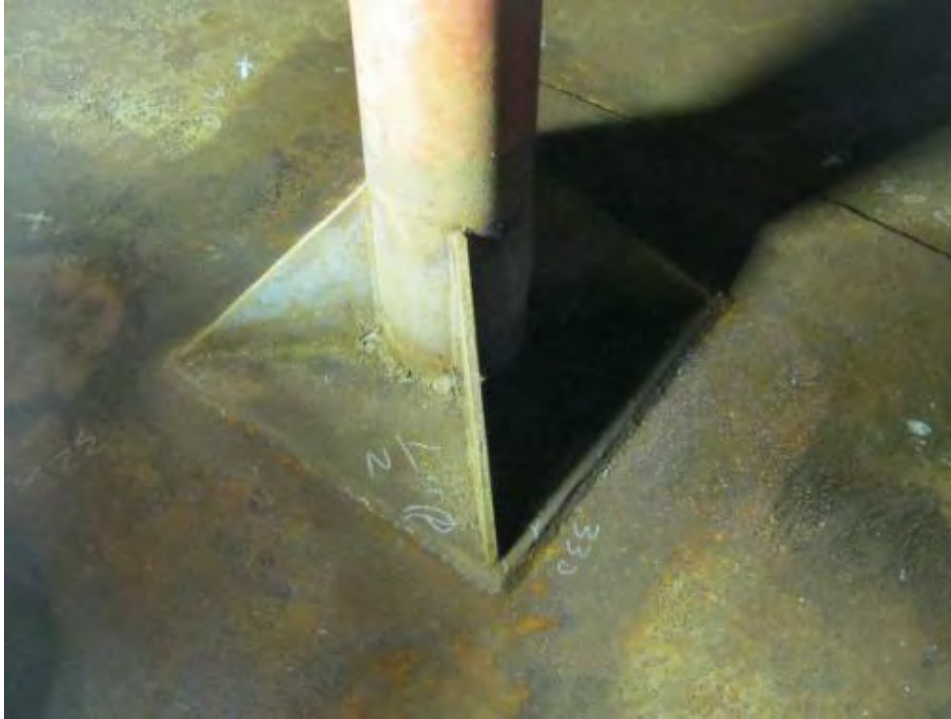
Photo 1752: Column base welded to floor, no significant settlement/heave issue noted.

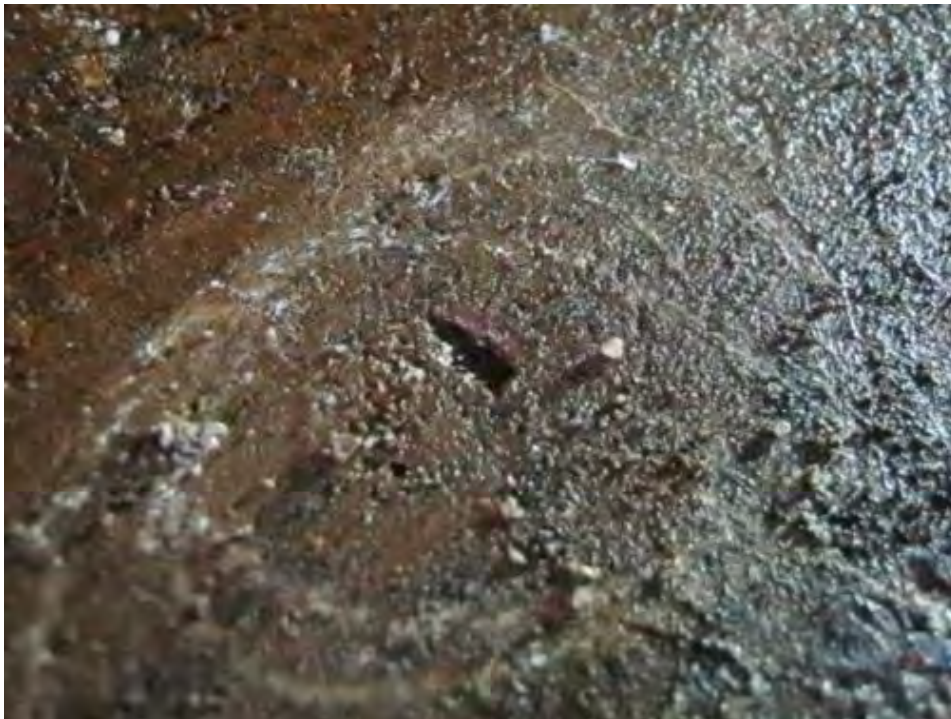
Light to moderate localized pit type corrosion was observed throughout most plates – top side, with 0.020” - 0.066” of thickness loss or wastage. Pits were measured and recorded as part of the inspection, for future reference, the remaining life assessments and “*minimum remaining thickness*” (MRT) calculations.

Photo 1756: Pit at bottom plate – repair welded.

- Based on inspections completed, the tank bottom plate remaining thickness was acceptable for return to service for a ten year period.
- To extend the remaining useful life (especially because one plate was thinner than normal) all top side pits deeper than 0.030” were repair welded at time of inspection.

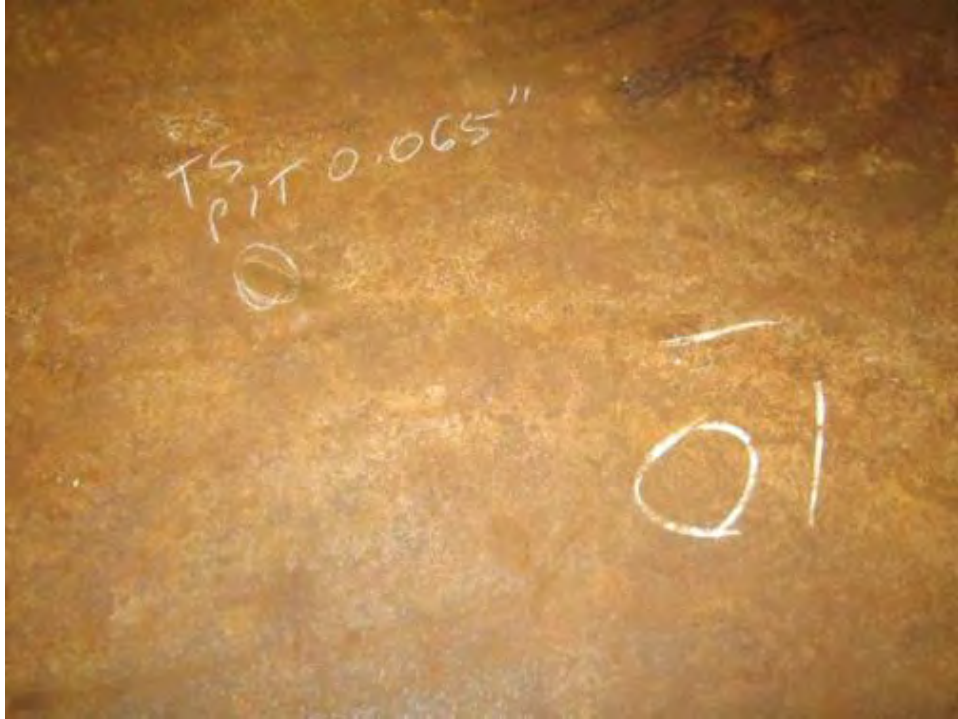
Photo 1757: Random/isolated deeper pit 0.065".

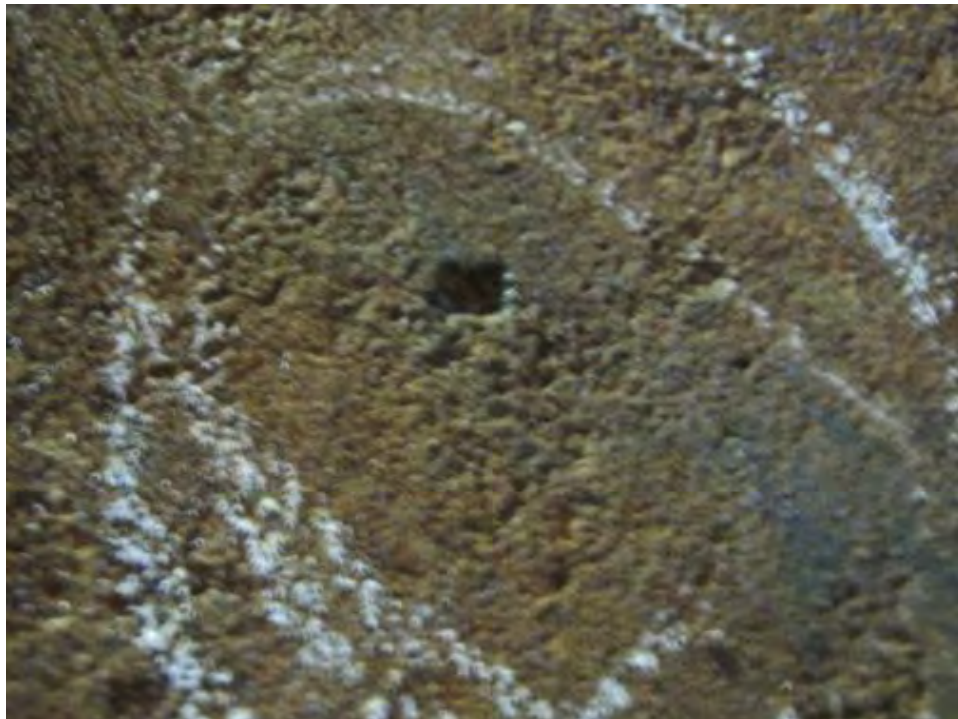
Photo 1759: As above deep pit repair welded, general shallow pitting corrosion 0.030" and less, around deeper pit.

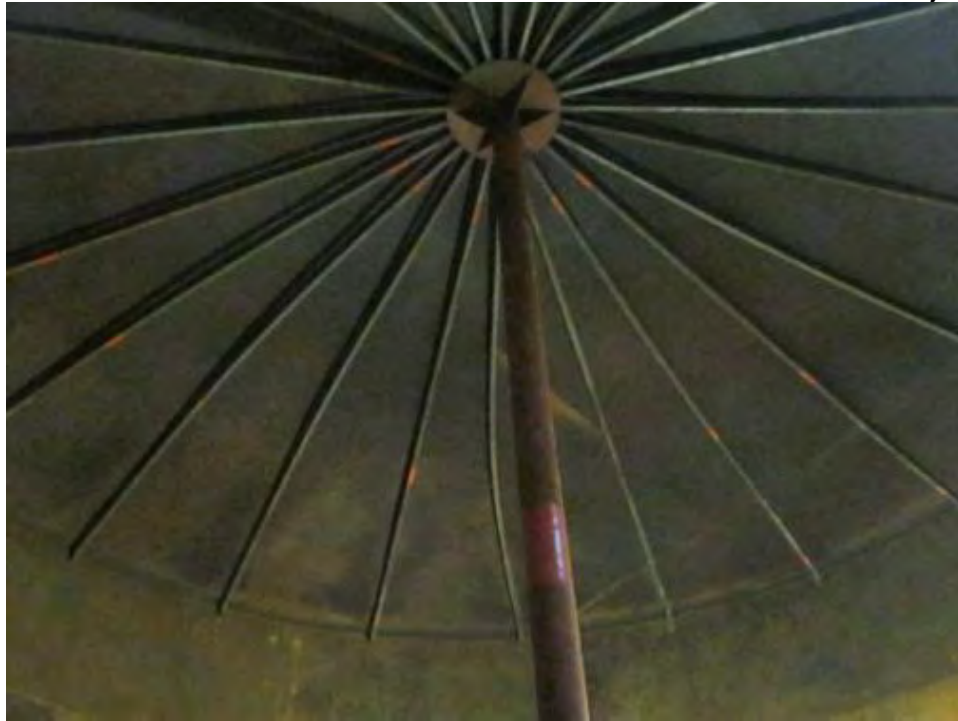
Rafters noted bowed/deformed as per photos attached (Appendix E), estimated up to 6" bow/distortion at several rafters. All rafters appeared welded or attached at both ends.

Photo 1810: View of roof rafter deformations, estimated up to 6".

- Based on inspections carried out for the exterior/interior of roof plate, structure was in fair condition. The underside support structure with rafter deformations should be reviewed by engineering for structural adequacy.
- Renew column base per API 650, during bottom plate renewal.
- External protective coating should be renewed.

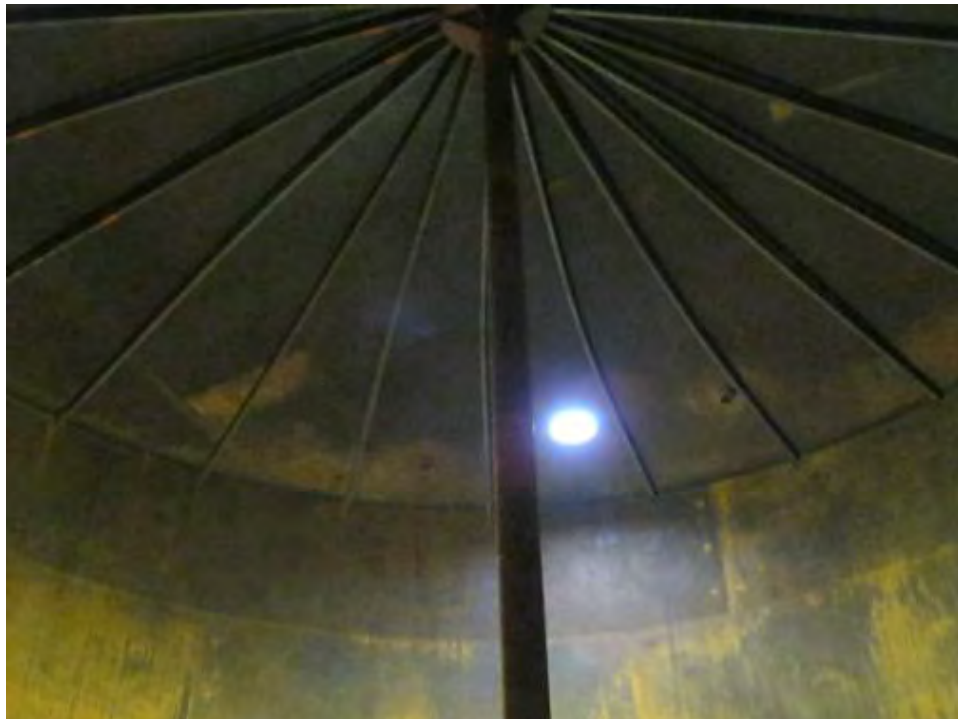
Photo 1808: As above, opposite side of roof.

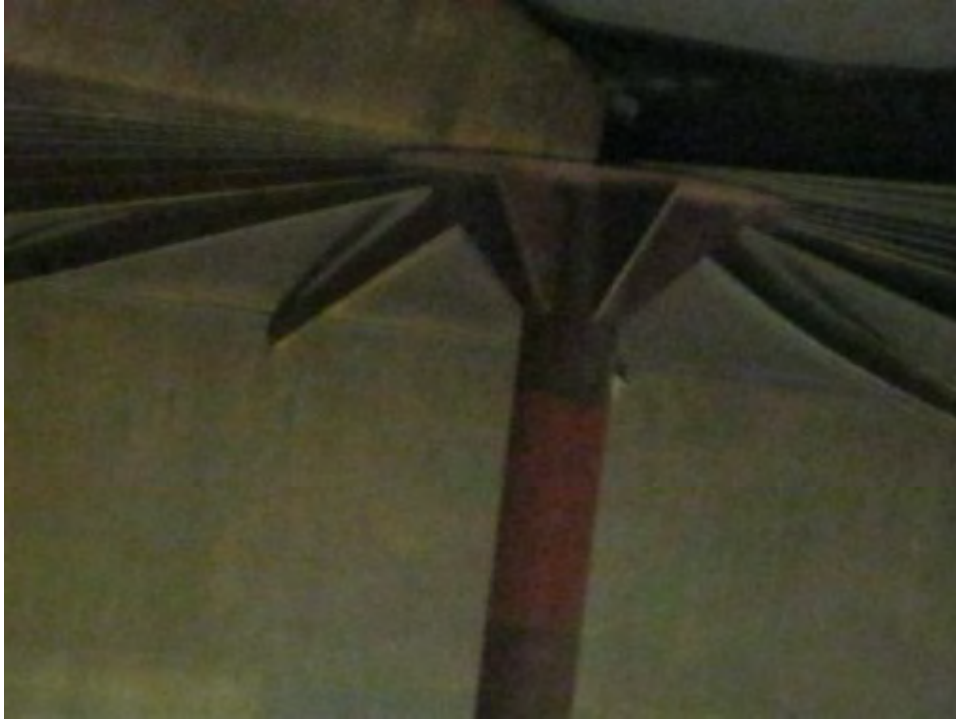
Photo 1801: View of rafters on column top plate, note roof plate not laying flat on rafters.

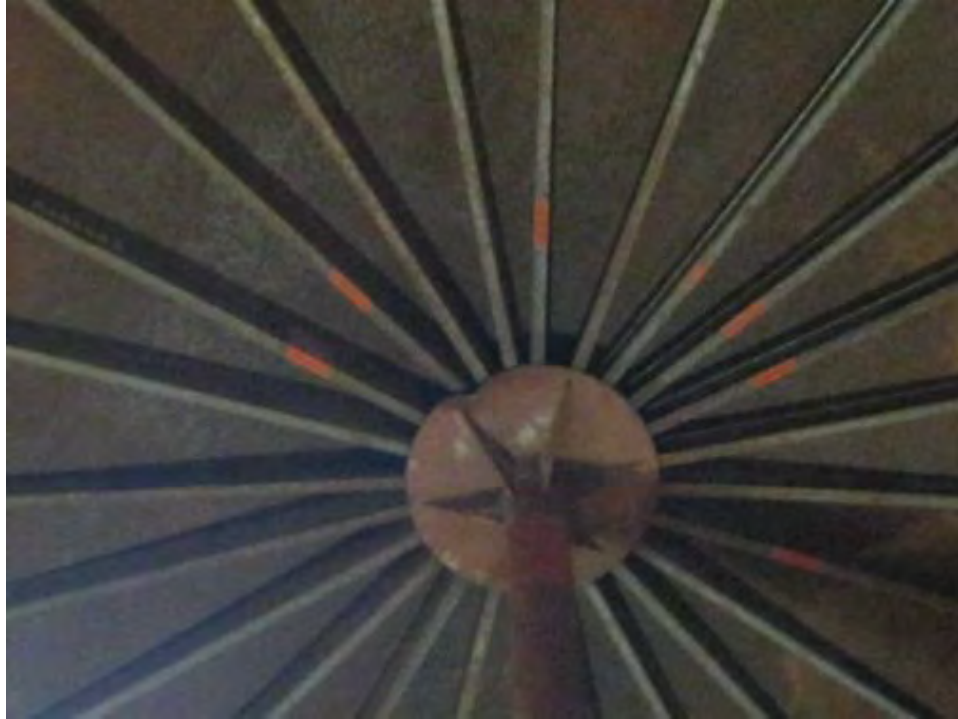
Photo 1745: Bent area at edge on column centre plate.

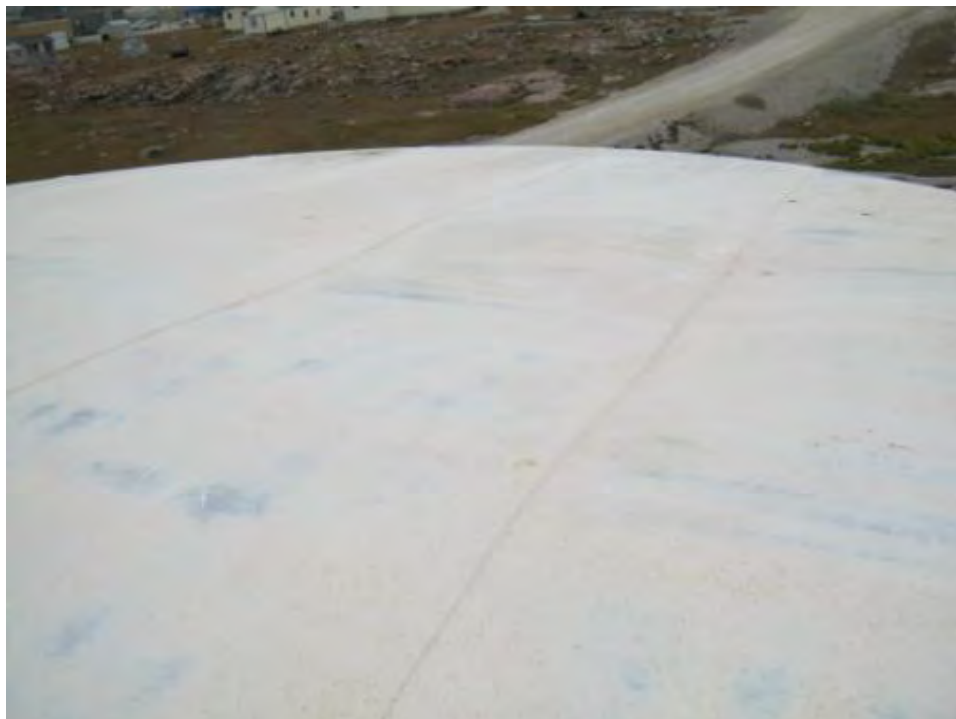
Photo 1781: Roof plate undulating not flat on rafters as noted in photo 1801.

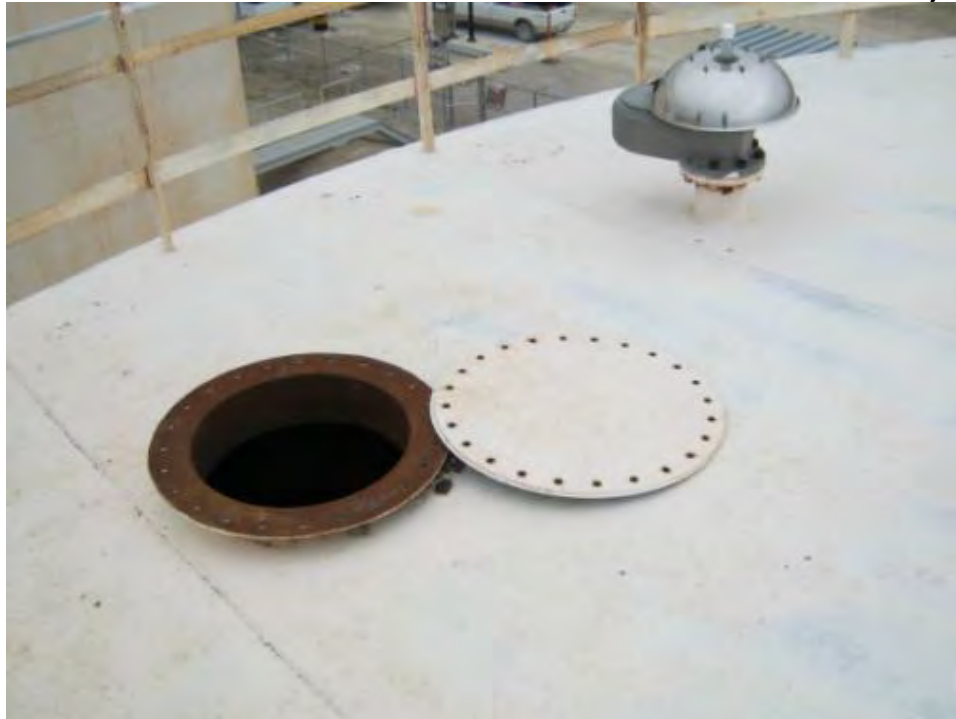
Photo 1787: Roof PV vent and manway, note roof plate protective coating worn.
