**THE COLLECTION OF LANDFILL  
MONITORING DATA AT THE FORMER  
PIN-4 DISTANT EARLY WARNING LINE SITE**

Byron Bay, Nunavut

FINAL REPORT - 2014  
(O/Ref.: CD3654) (Y/Ref.: DLC MON (KITIK 13))

**DEFENCE CONSTRUCTION CANADA**

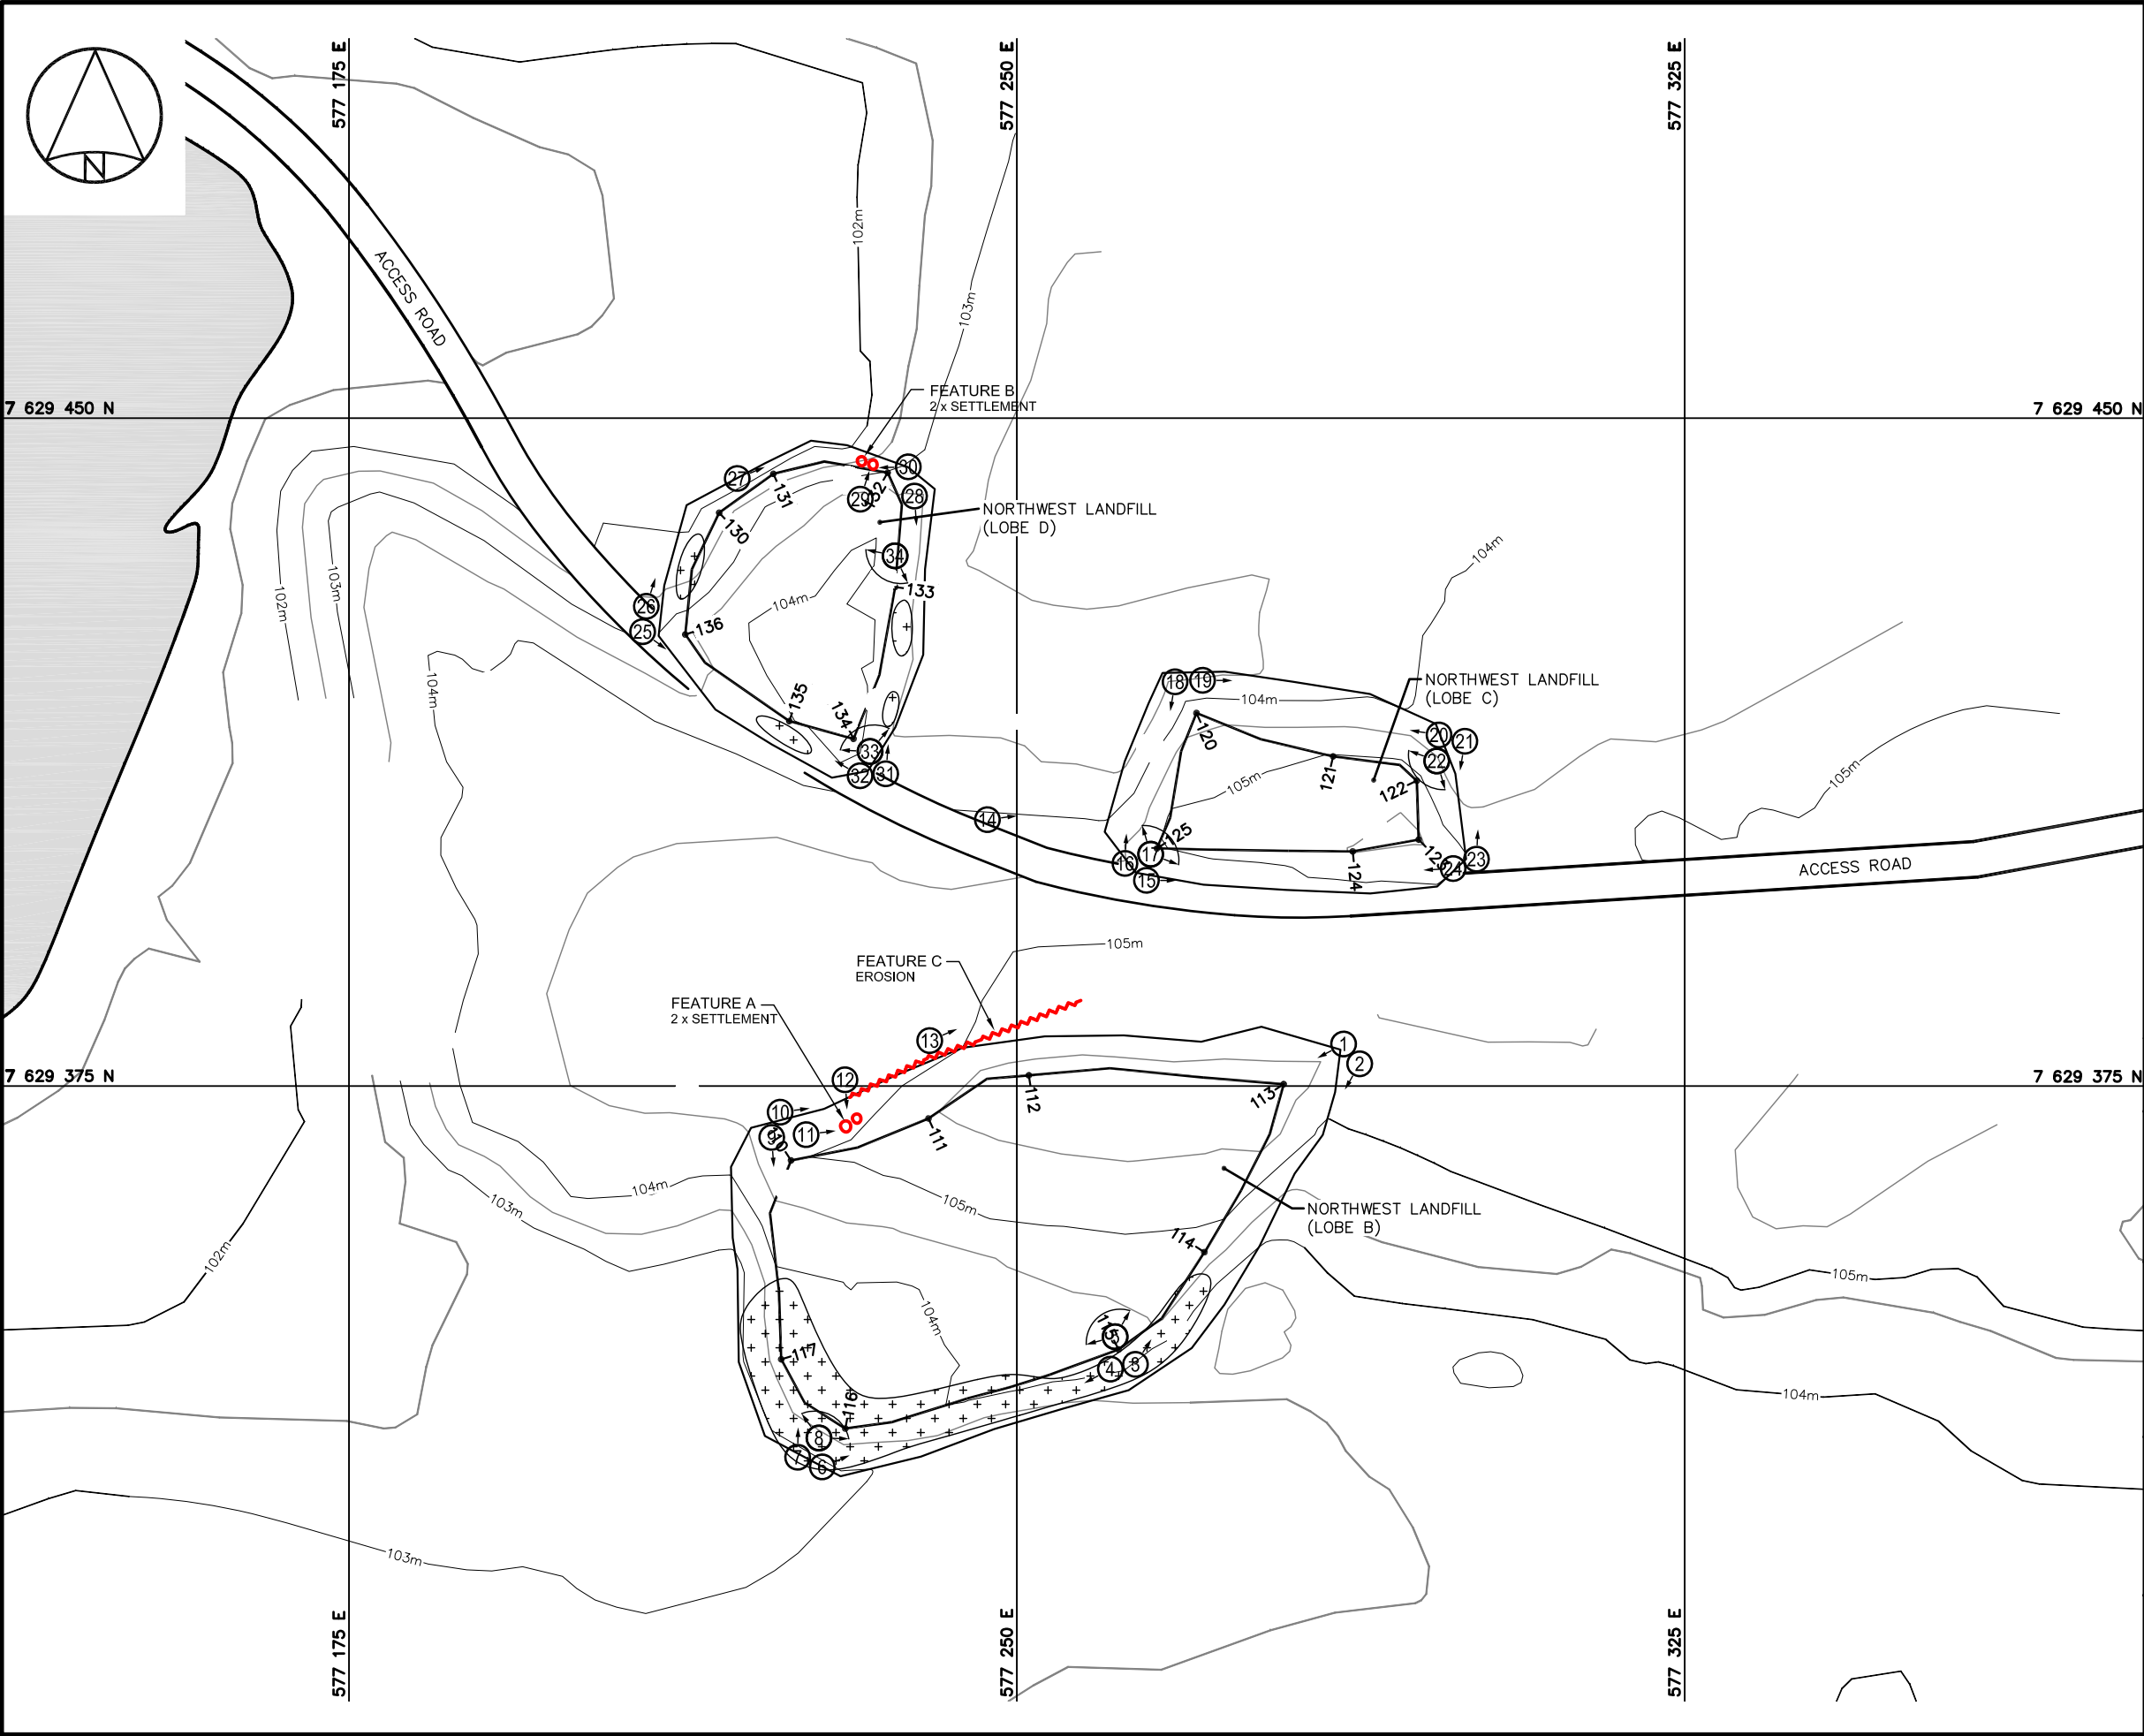
The Location Plan for the Northwest Landfill has been completed as per the ToR and is presented in Figure PIN-4.2.

As of 2014, no erosion features with “significant” or “unacceptable” severity ratings were identified in the Preliminary Stability Assessment of the Northwest Landfill. Indications of minor settlement were noted at two locations, including two minor depressions on the northwest cover of Lobe B. Several smaller linear and pot-hole type depressions were also noted on the north side of Lobe D. These features were not noted during the previous 2013 assessment. One isolated area of erosion was noted along the north side of Lobe B. The erosion extended along the toe of the lobe. The area was not in direct contact with the landfill and appears to be the result of directed runoff and washing of fines along the toe. This feature was not noted during the previous 2013 assessment. No exposed debris is present at the lobes.

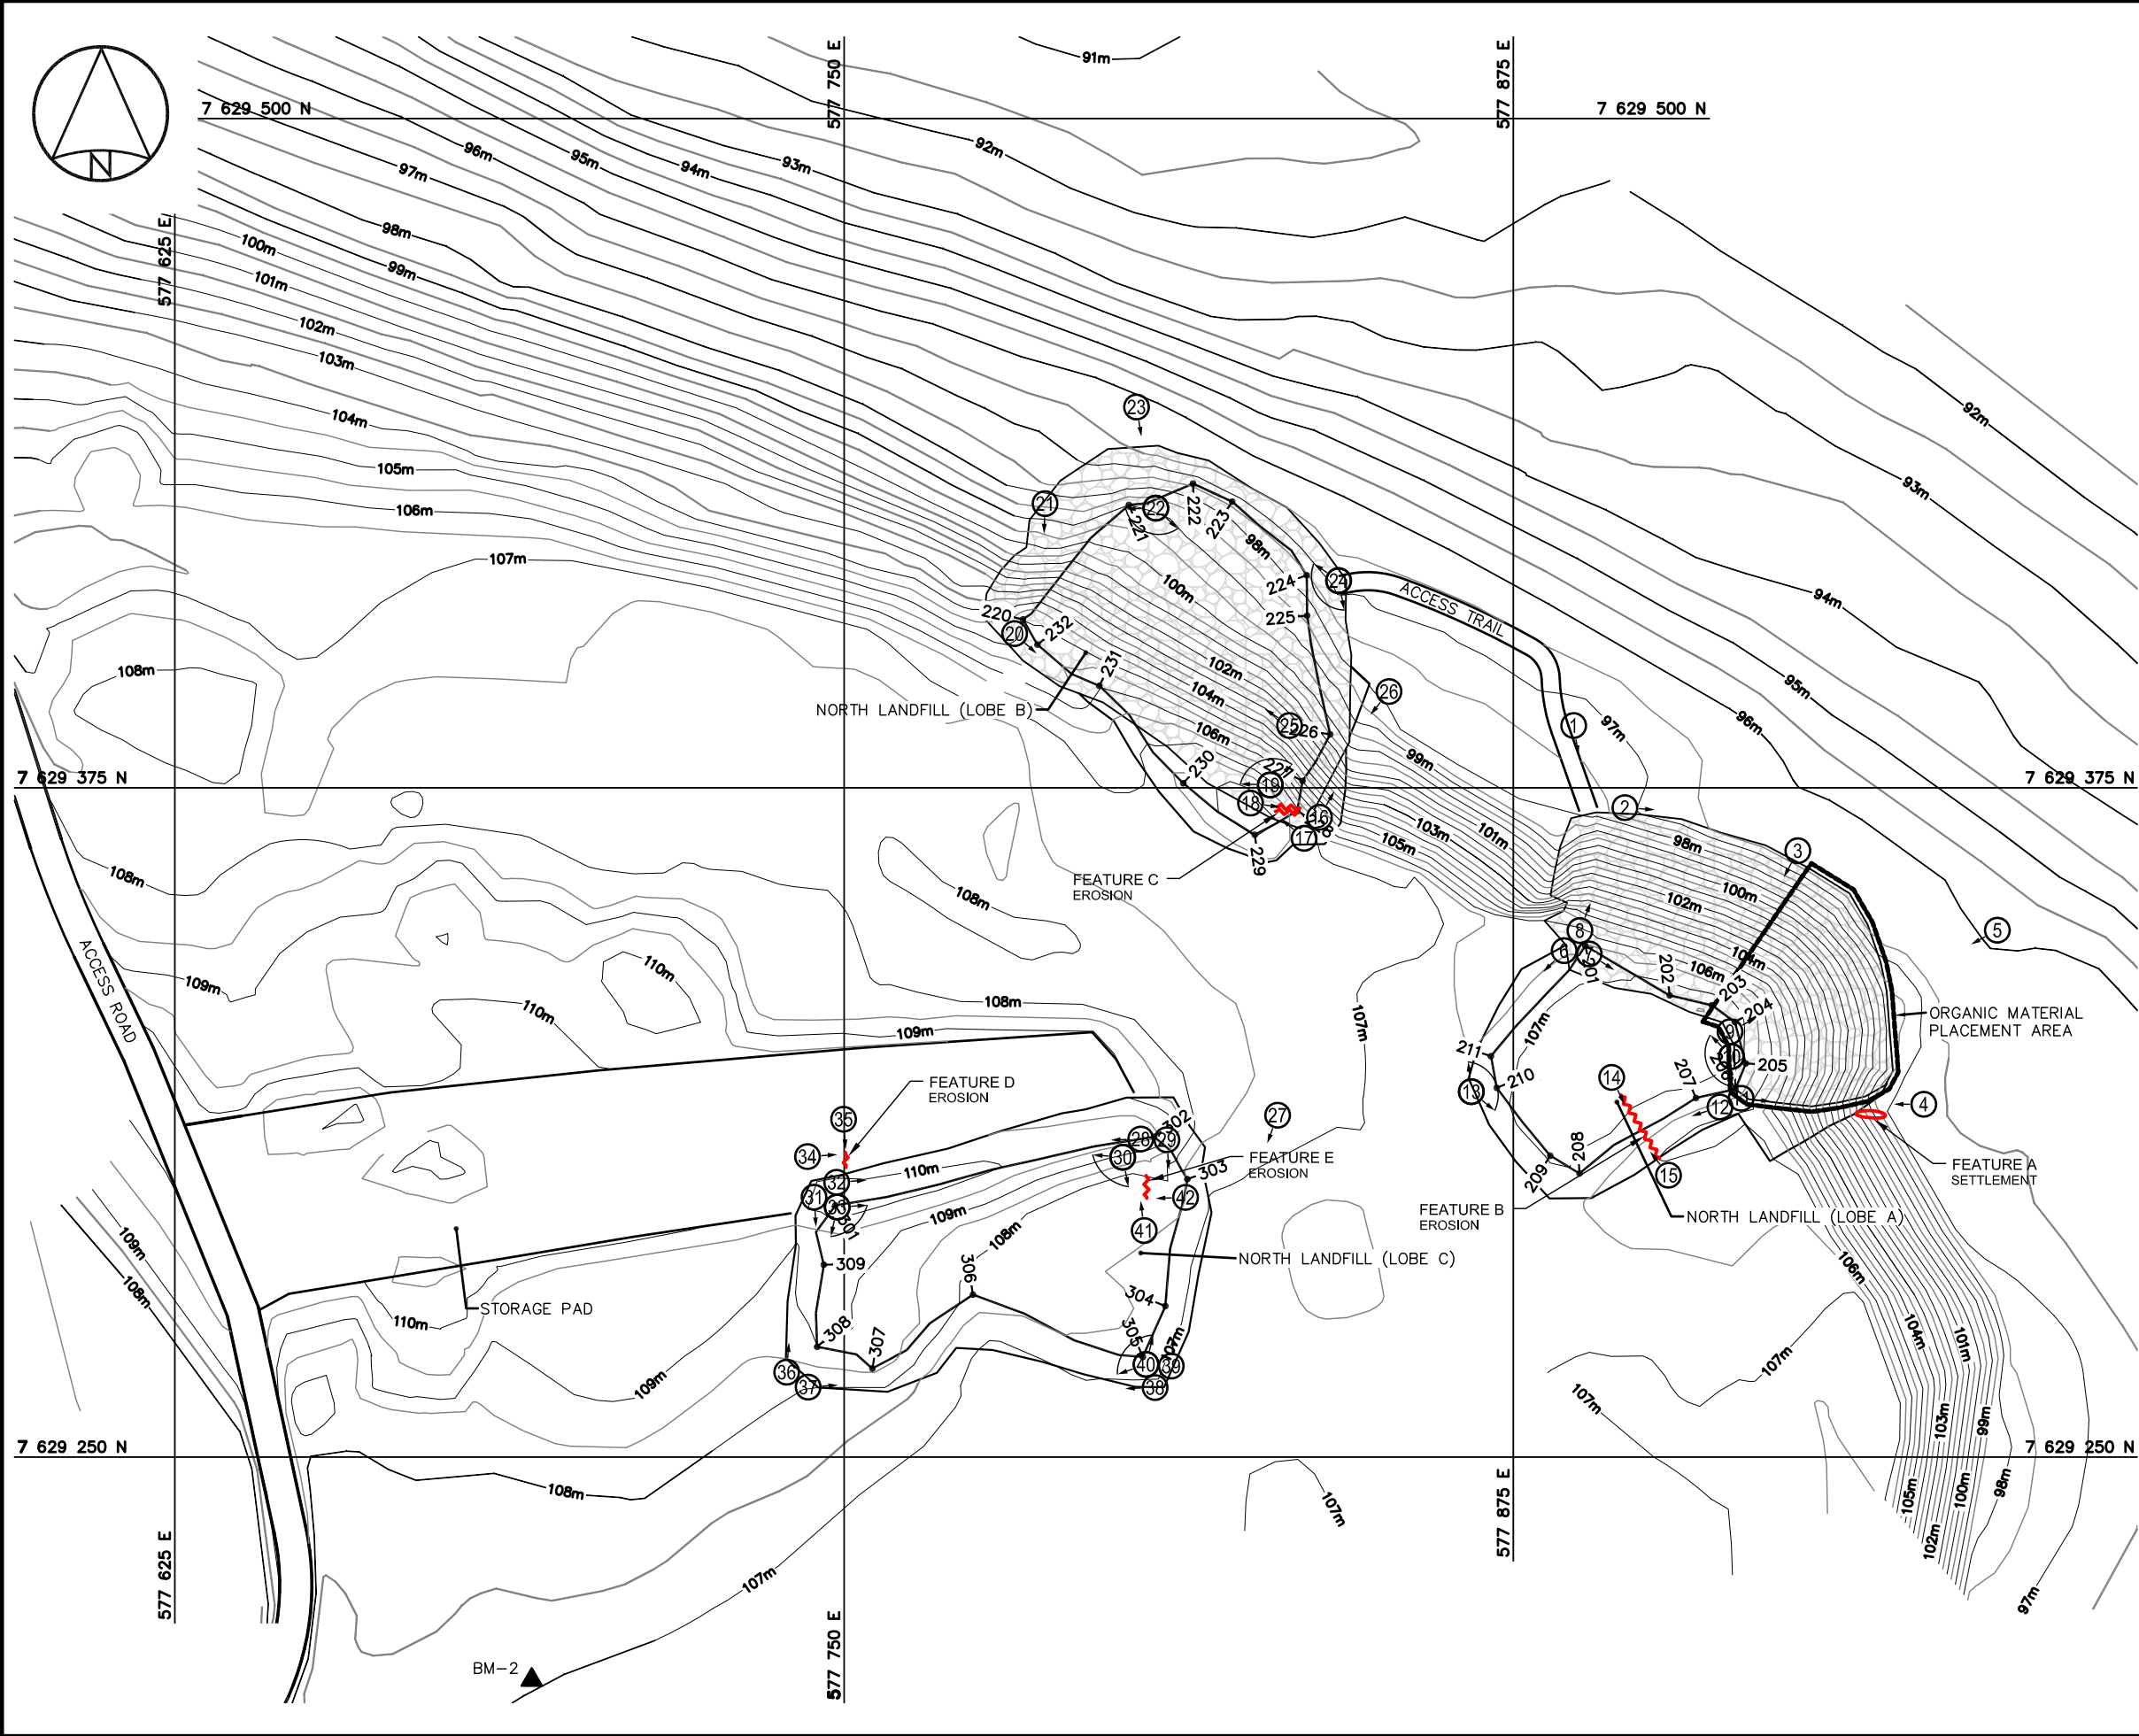
The Location Plan for the North Landfill has been completed as per the ToR and is presented in Figure PIN-4.3.

As of the 2014 monitoring event, no features were identified with “significant” or “unacceptable” severity ratings. Minor settlement was noted at one location on the south side of Lobe A. The settlement area extends along the base of the side slope. This feature was not noted during the previous 2013 assessment. Minor erosion features were observed in four areas on Lobes A, B and C at the North Landfill, including; localized areas on the south cover of Lobe A, southeast crest of Lobe B , northwest corner of Lobe C and east side of Lobe C. Surface runoff in each area has resulted in the washing and re-deposition of finer grained materials. All features appear to be self-armouring and were not noted during the previous 2013 assessment. No exposed debris was noted.

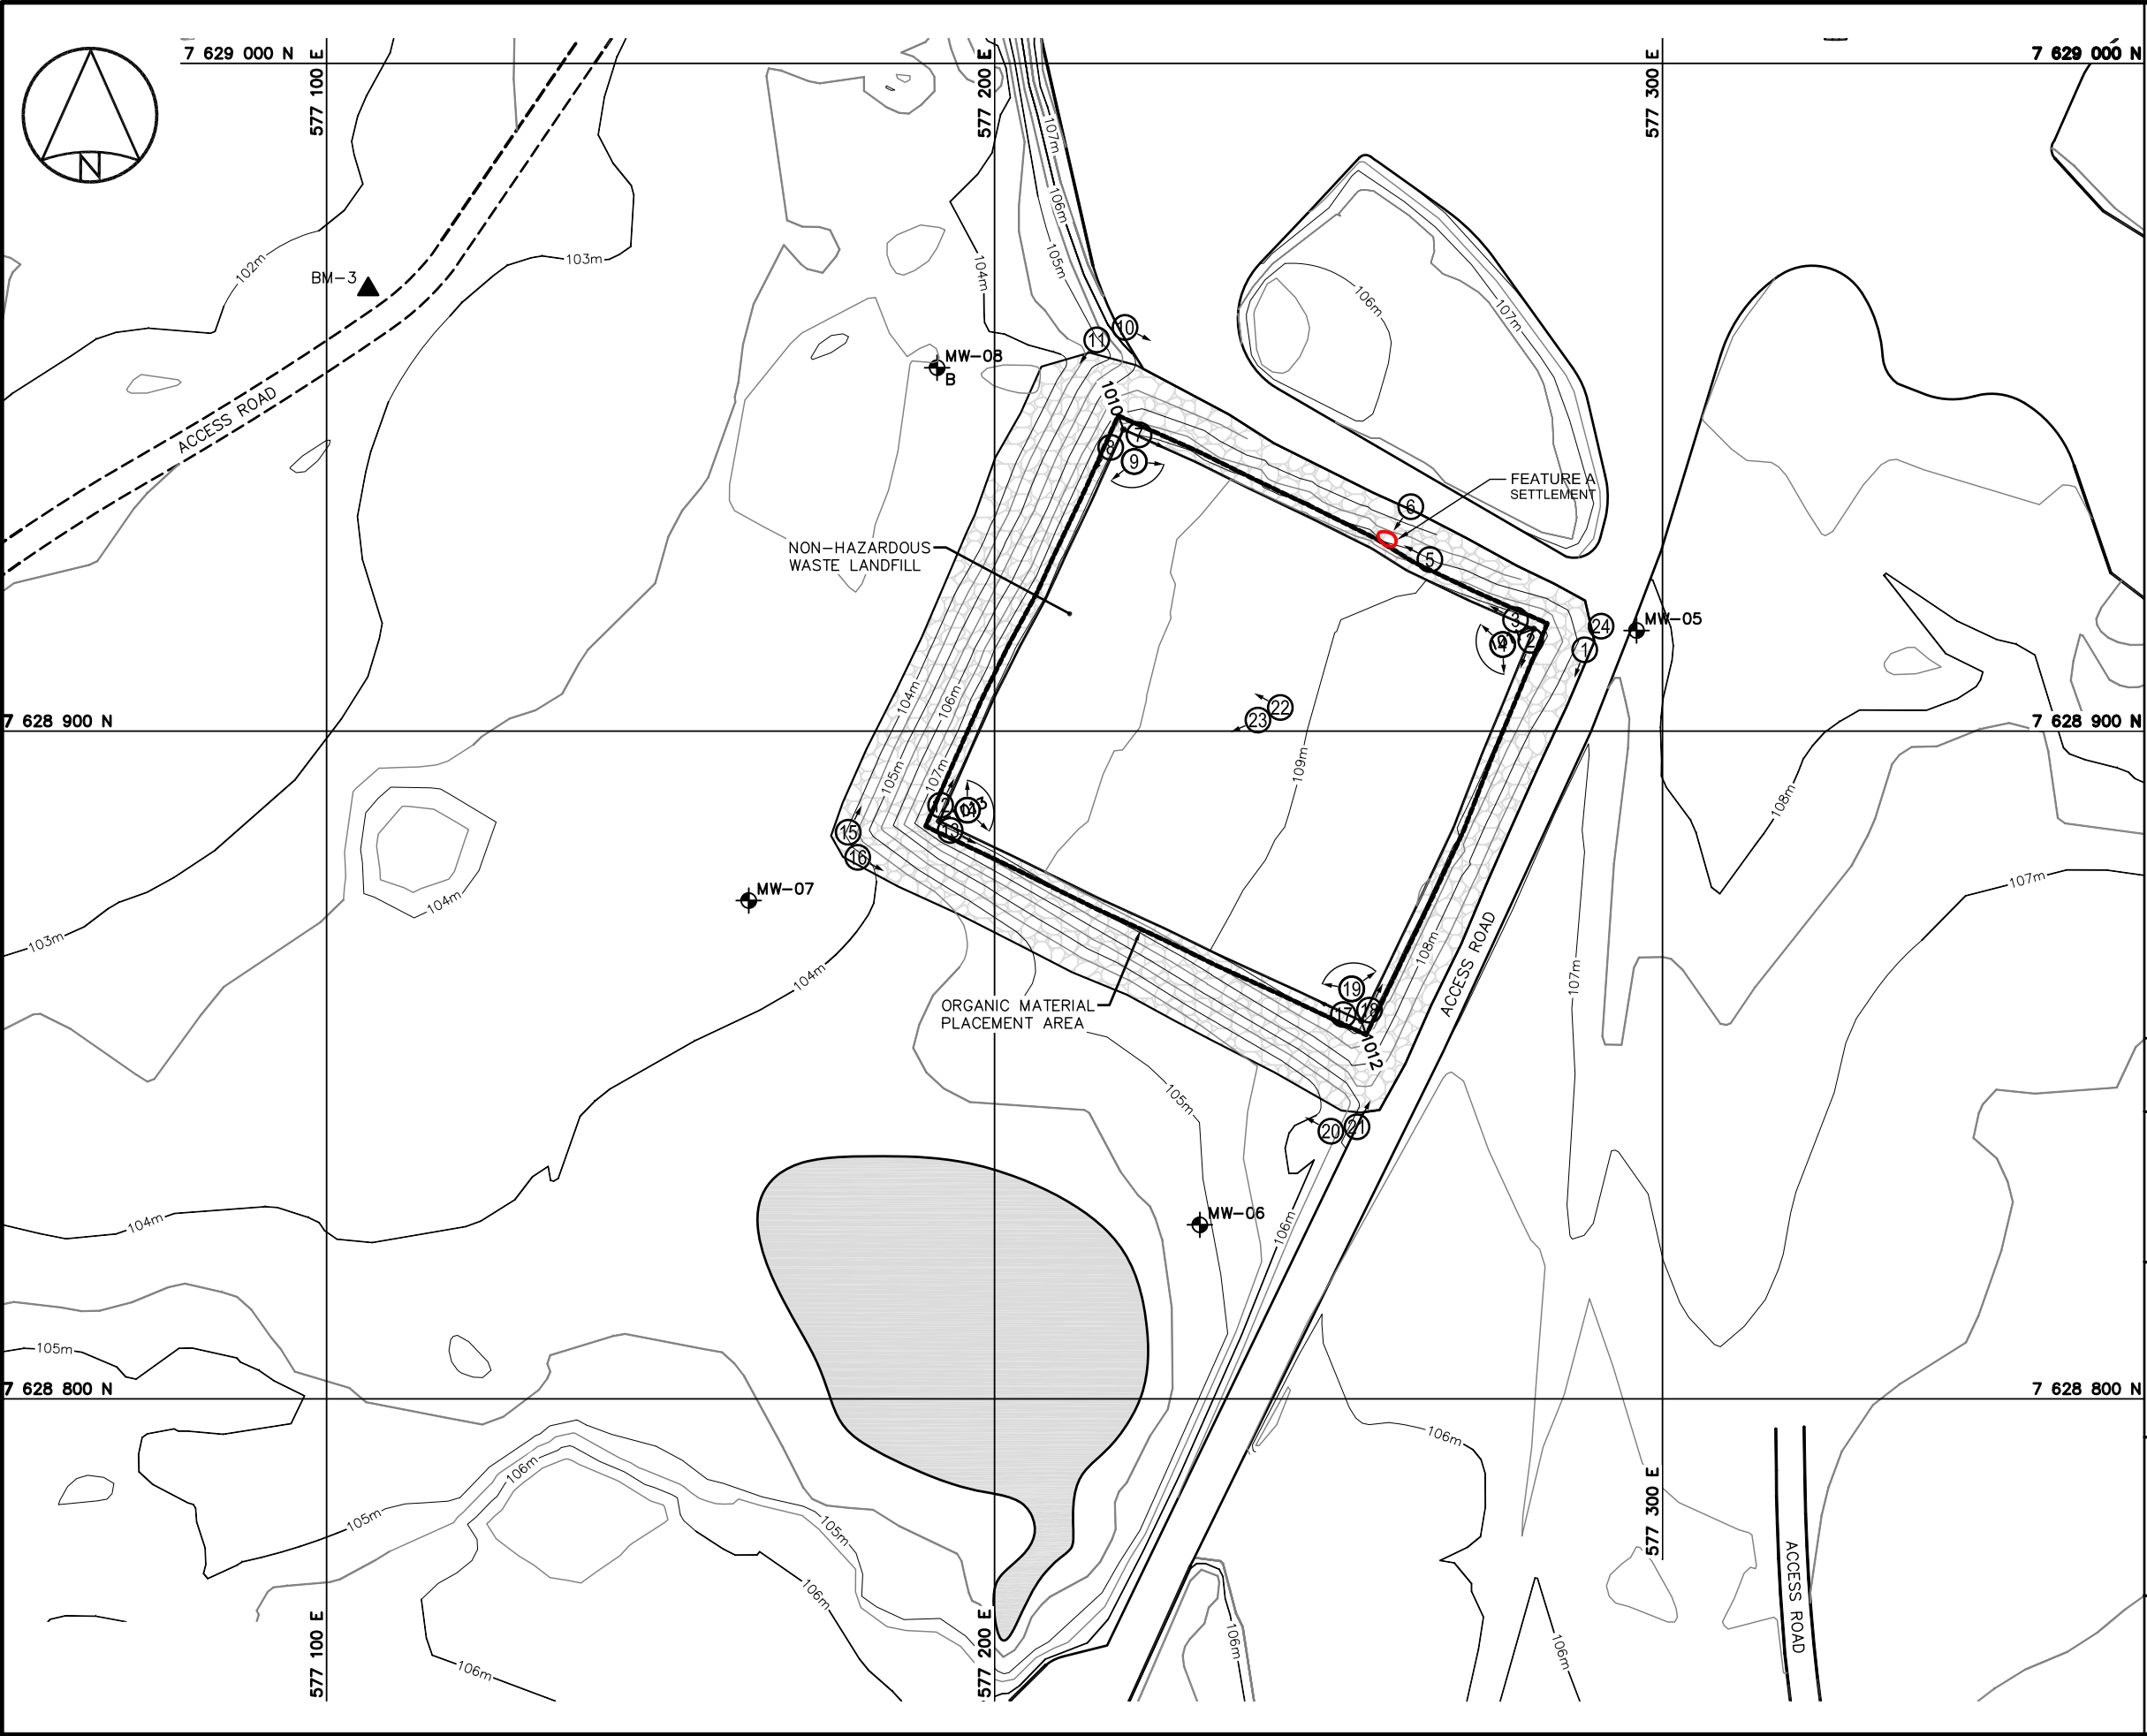
The Location Plan for the NHWLF has been completed as per the ToR and is presented in Figure PIN-4.4.

As of the 2014 monitoring event, no features were identified with “significant” or “unacceptable” severity ratings. One isolated area of minor settlement was noted on the north crest of the Non-Hazardous Waste Landfill. This feature was not noted during the previous 2013 assessment. Several shallow ridges and depressions were also noted across the cover of the landfill. These features appear to be associated with final rough grading of organic material on the landfill surface and are consistent with previous observation.

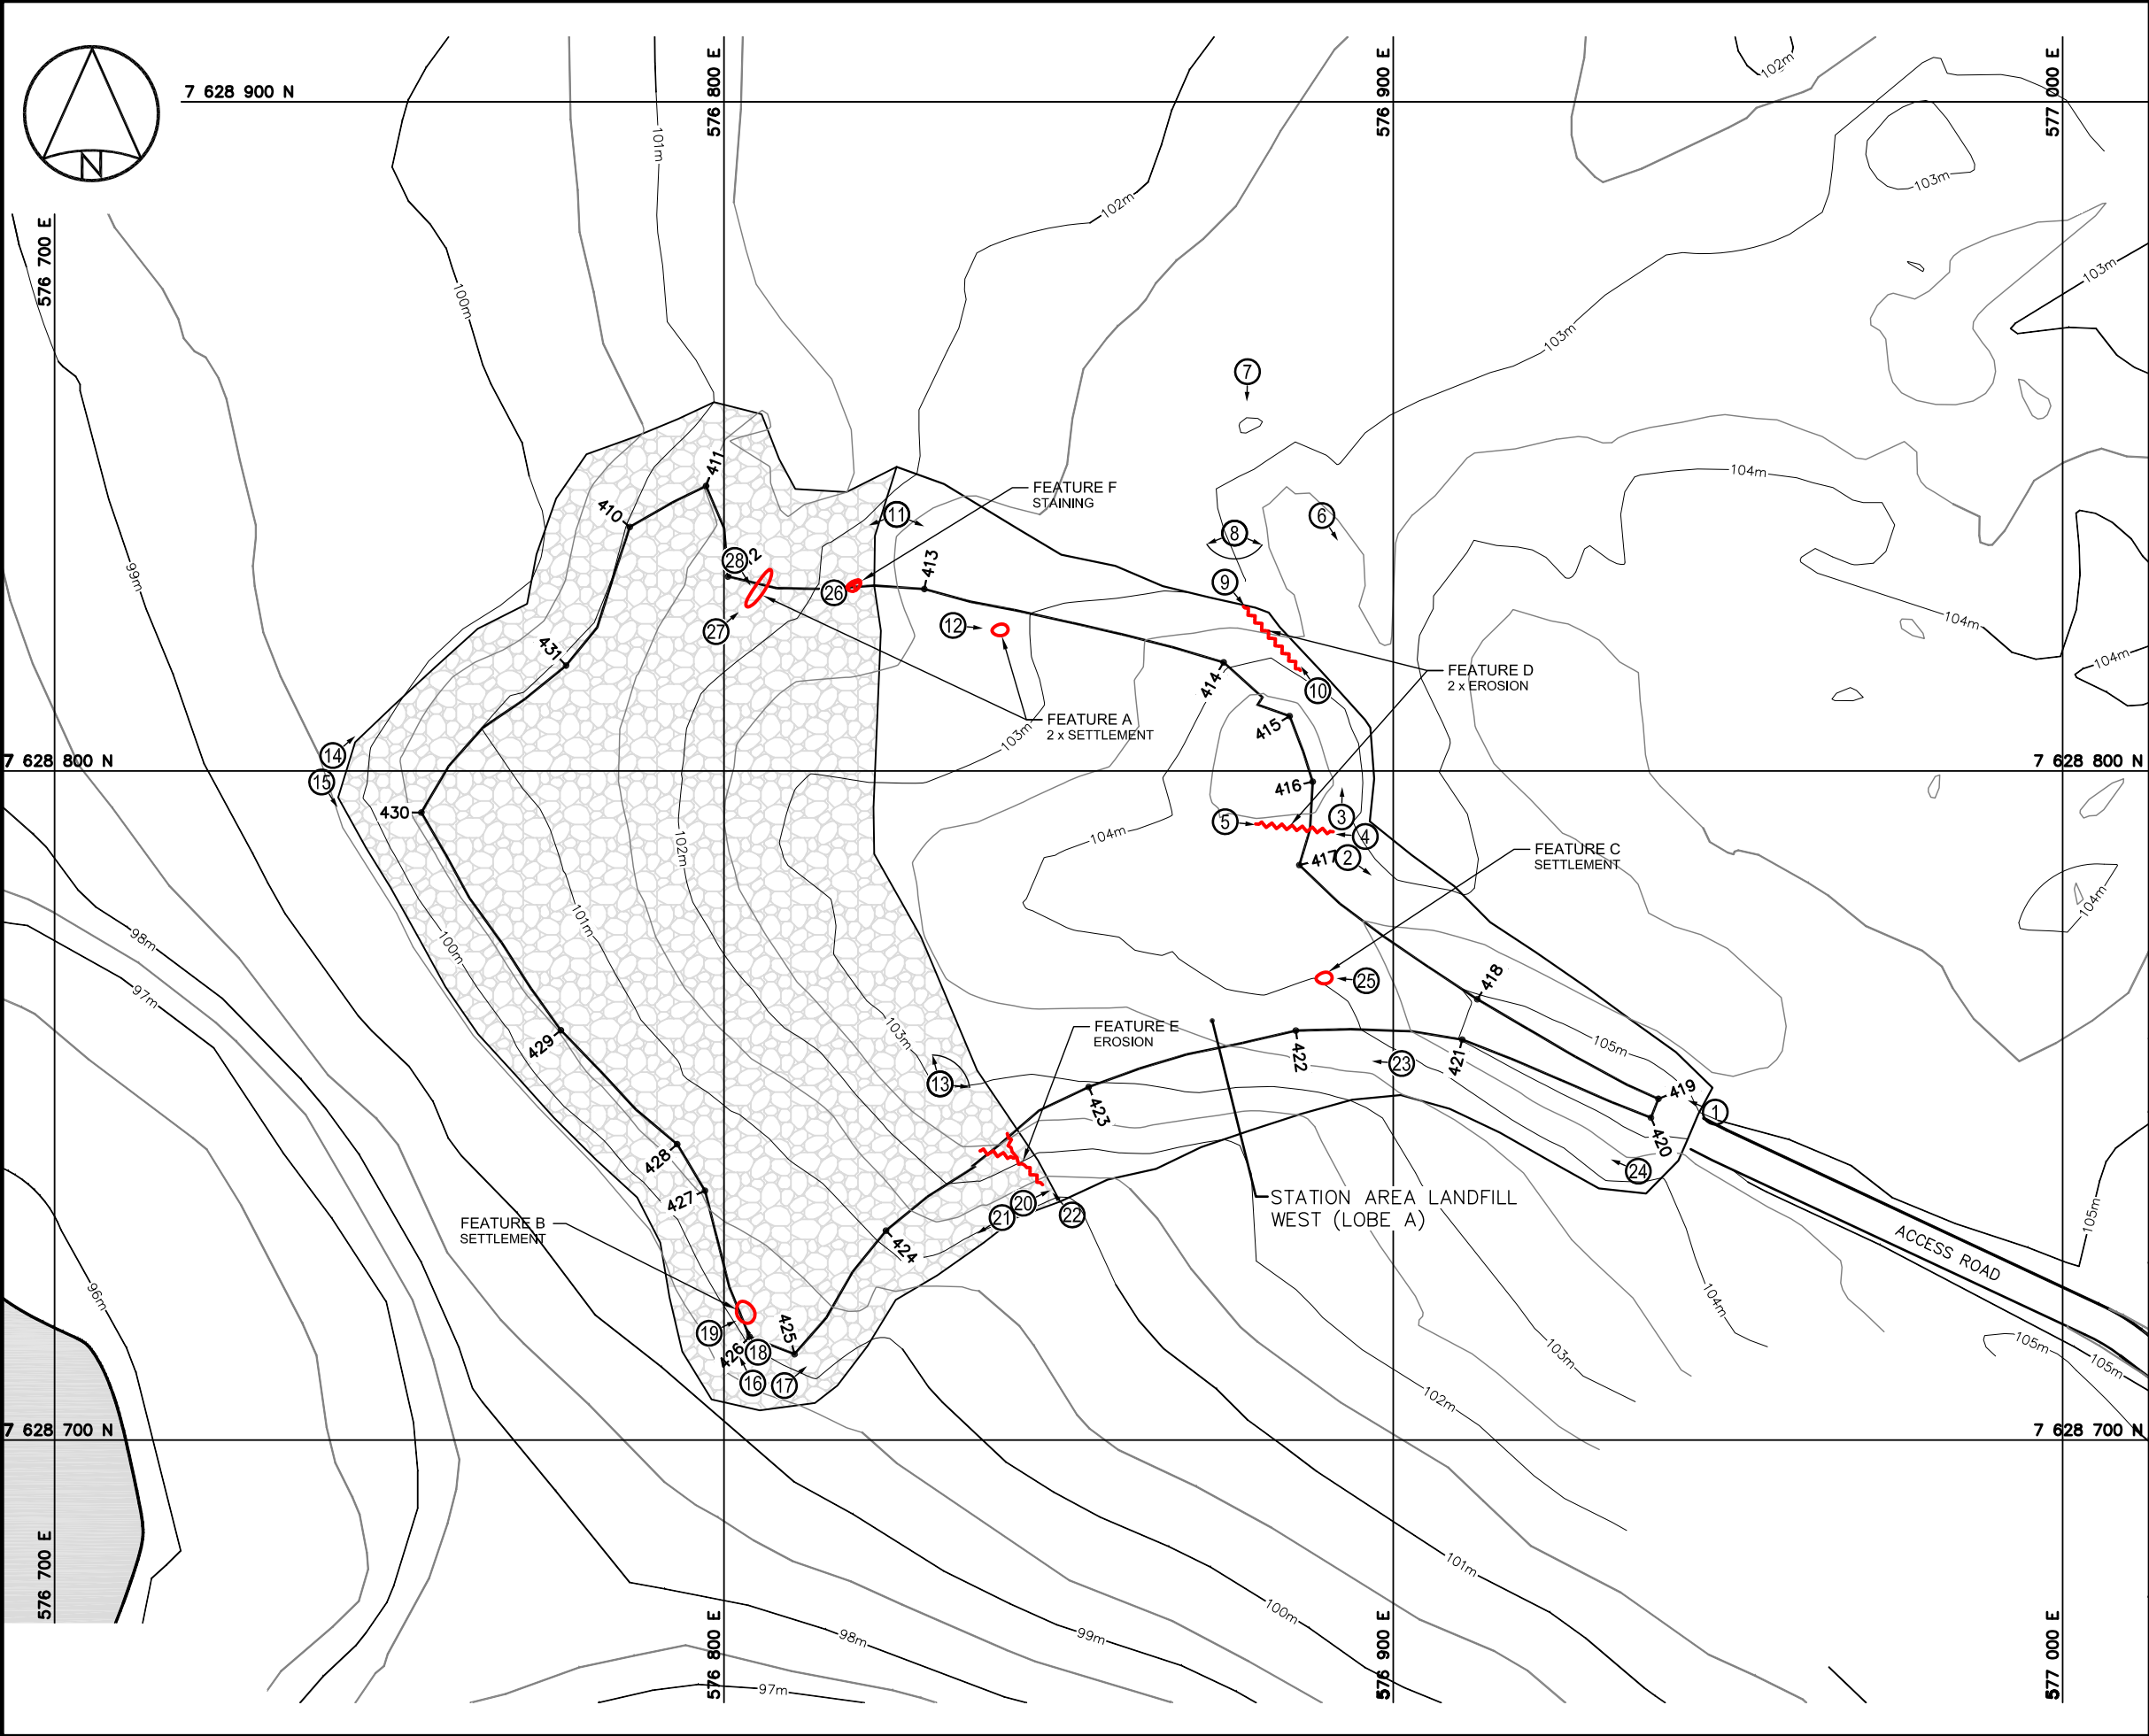
The Location Plan for the Station Area Landfill has been completed as per the ToR and is presented in Figure PIN-4.5.

As of the 2014 monitoring event, no features were identified with “significant” or “unacceptable” severity ratings. Several new localized areas of settlement and erosional features were noted on the northwest cover, the west side, the south crest, the northeast cover and side slope, and south cover and side slope. These features were not noted during the previous 2013 assessment. One area of minor staining was also noted on the north cover of the landfill and has not significantly changed since the last observation. No exposed debris was noted.

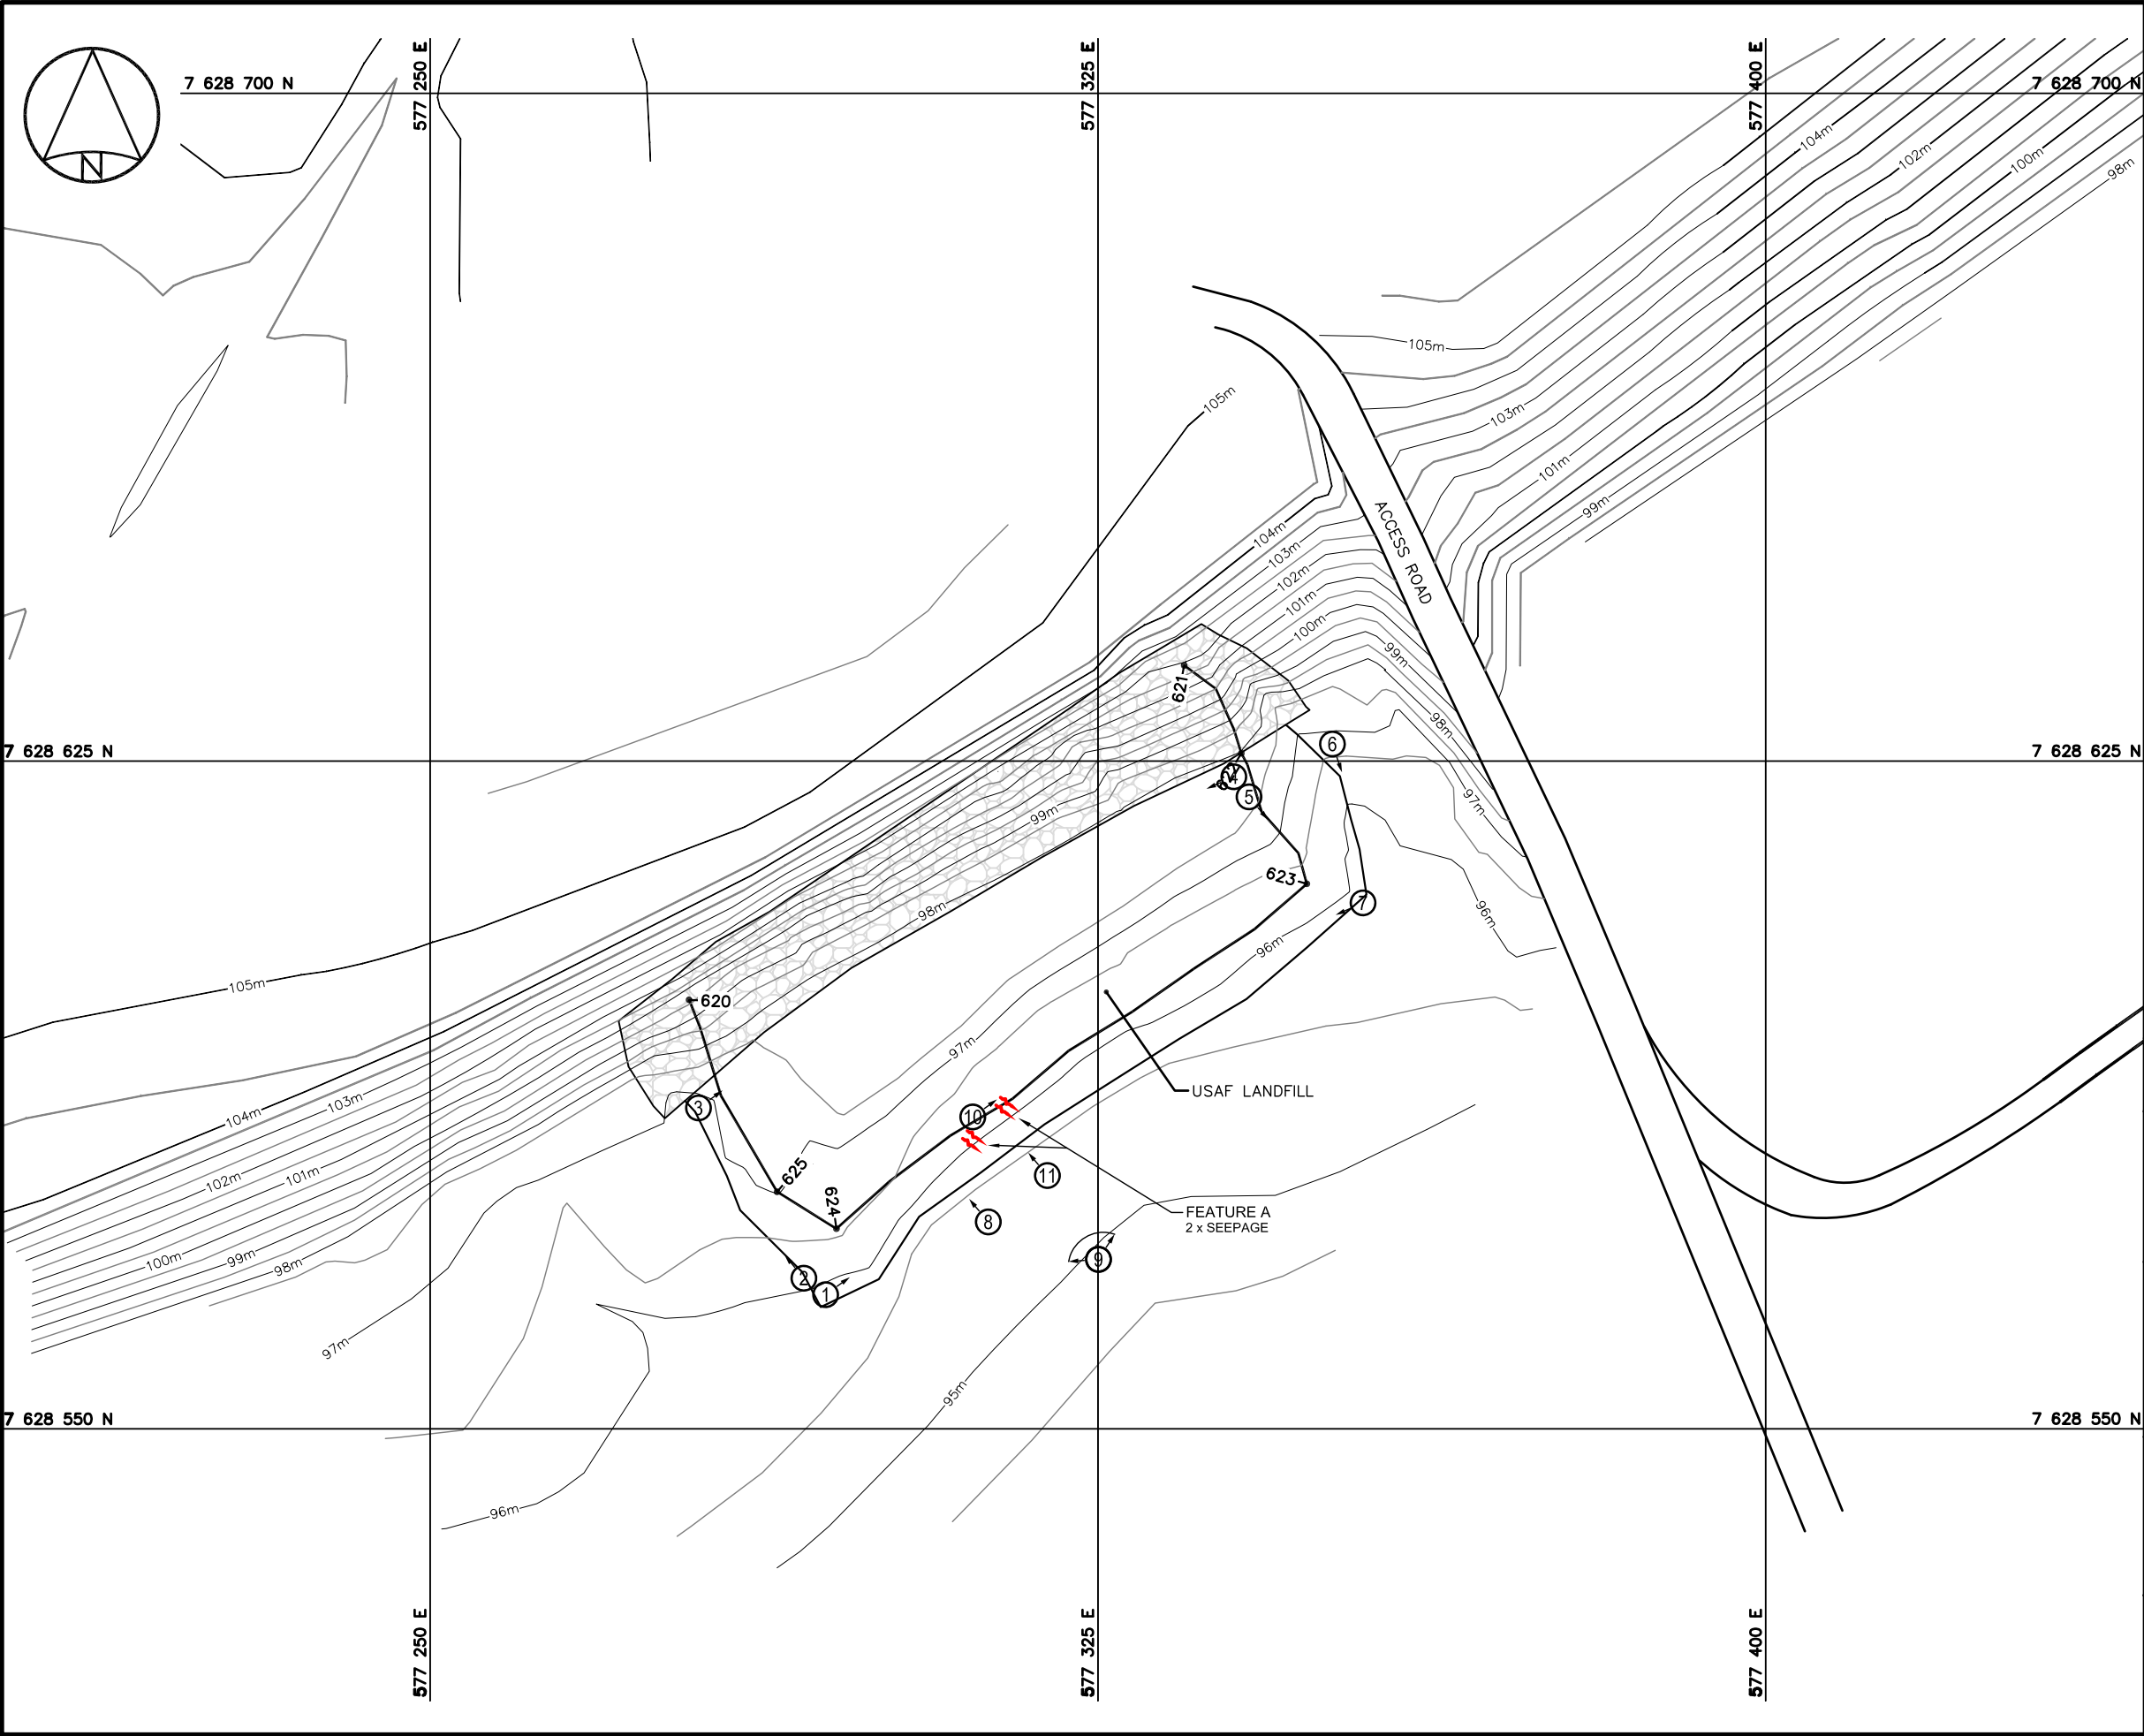
The Location Plan for the USAF Landfill has been completed as per the TOR and is presented in Figure PIN-4.6.

As of the 2014 monitoring event, no features were identified with “significant” or “unacceptable” severity ratings. Indications of settlement or erosion were not observed, however two localized areas of seepage were observed along the south toe of the landfill. No exposed debris was noted.
