**THE COLLECTION OF LANDFILL  
MONITORING DATA AT THE FORMER  
PIN-4 DISTANT EARLY WARNING LINE SITE**

Byron Bay, Nunavut

FINAL REPORT - 2014  
(O/Ref.: CD3654) (Y/Ref.: DLC MON (KITIK 13))

**DEFENCE CONSTRUCTION CANADA**

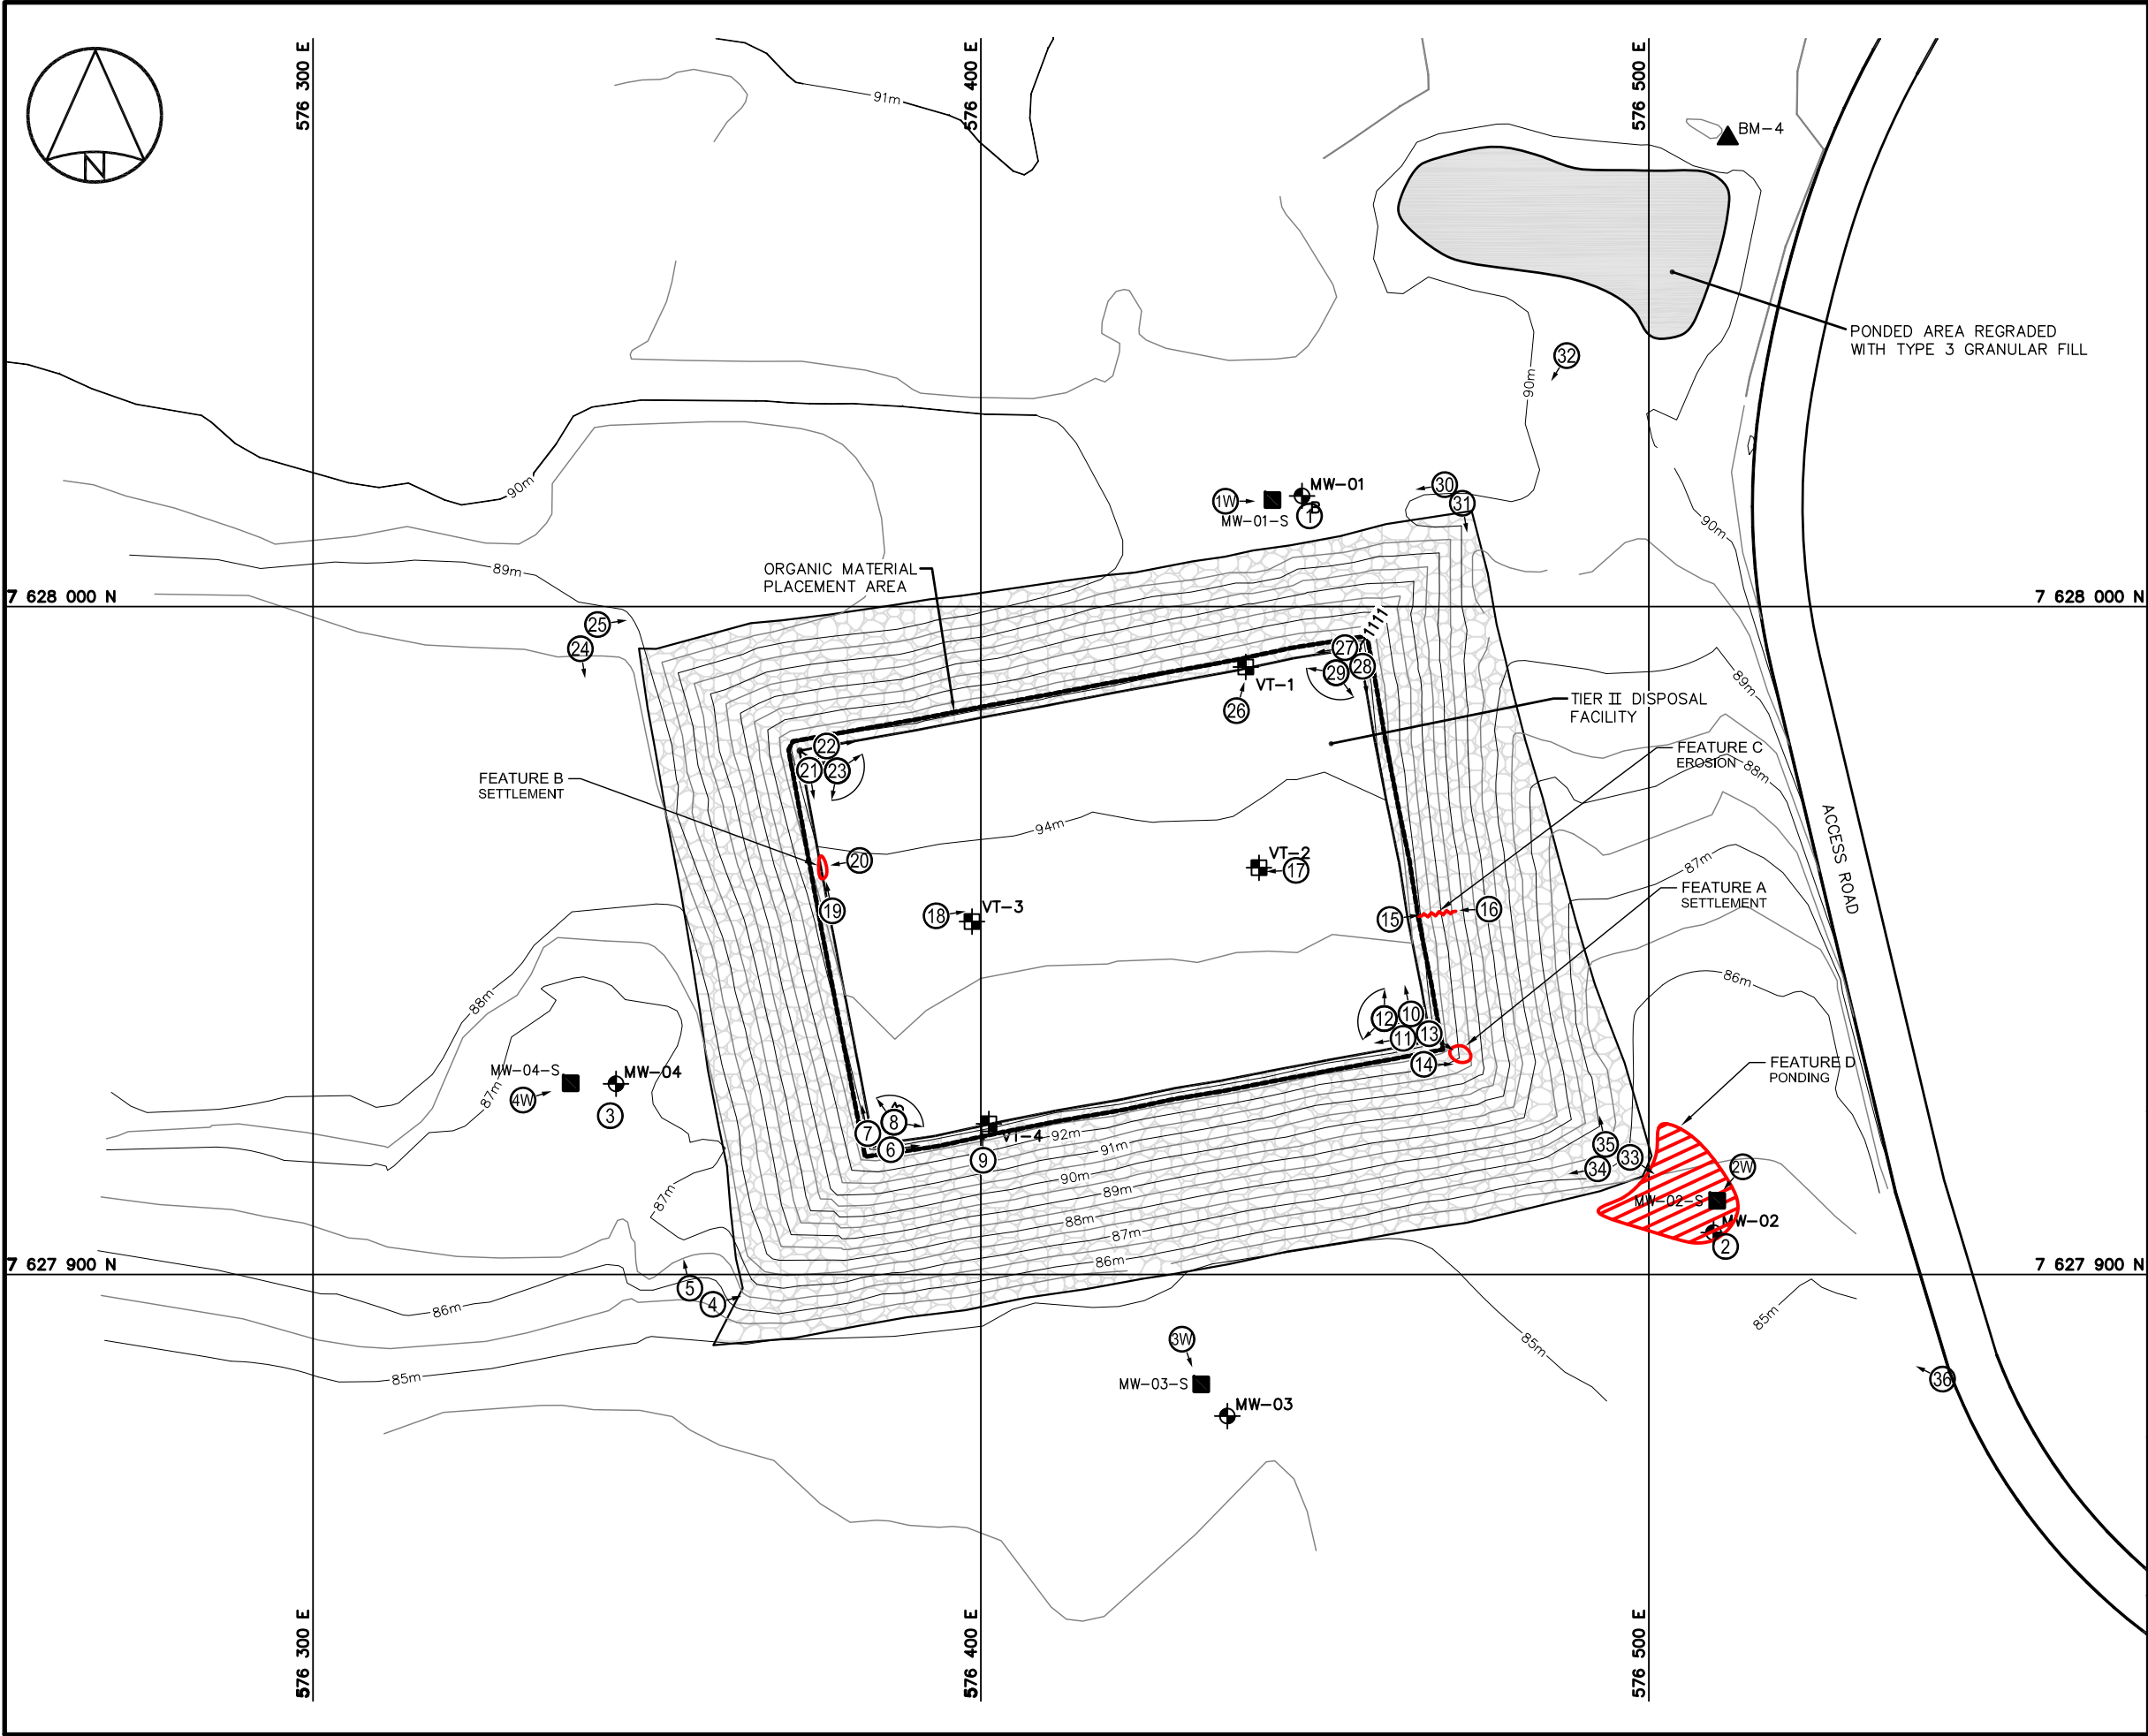
The Location Plan for the Tier II Disposal Facility has been completed as per the ToR and is included in the following page as Figure PIN-4.7.

All thermistors at the Tier II Soil Disposal Facility were inspected and found to be in good condition with no significant concerns identified. Data from all thermistors was successfully retrieved with the exception of VT-2, where all communication failed. Data logger was taken south for repair.

As of the 2014 monitoring event, no features were identified with “significant” or “unacceptable” severity ratings. Indications of minor settlement were noted at two locations on the Tier II Disposal Facility, including: one localized depression on the top southeast corner and one small linear type feature on the west crest. Both features were not observed during the previous 2013 inspection. Evidence of minor surface erosion was noted at a single location on the east crest and upper slope. A moderate sized area of ponded water was noted in a low lying area adjacent to the southeast corner of the facility. No exposed debris were noted.
