WATER LICENCE INSPECTION FORM

Licensee		Licensee Representative	
DND-Raytheon		Don Beattie	
Licence No. / Expiry		Representative's Title	
1BR-CAM0520		Environmental Officer	
Land / Other Authorizations		Land / Other Authorizations	
Date of Inspection		Inspector	
July 7, 2017		Baba Pedersen	
Activities Inspected			
<input type="checkbox"/> Camp	<input type="checkbox"/> Drilling	<input type="checkbox"/> Mining	<input type="checkbox"/> Construction
<input type="checkbox"/> Roads/Hauling	<input checked="" type="checkbox"/> Other: Long Term Monitoring	<input type="checkbox"/> Reclamation	<input type="checkbox"/> Fuel Storage

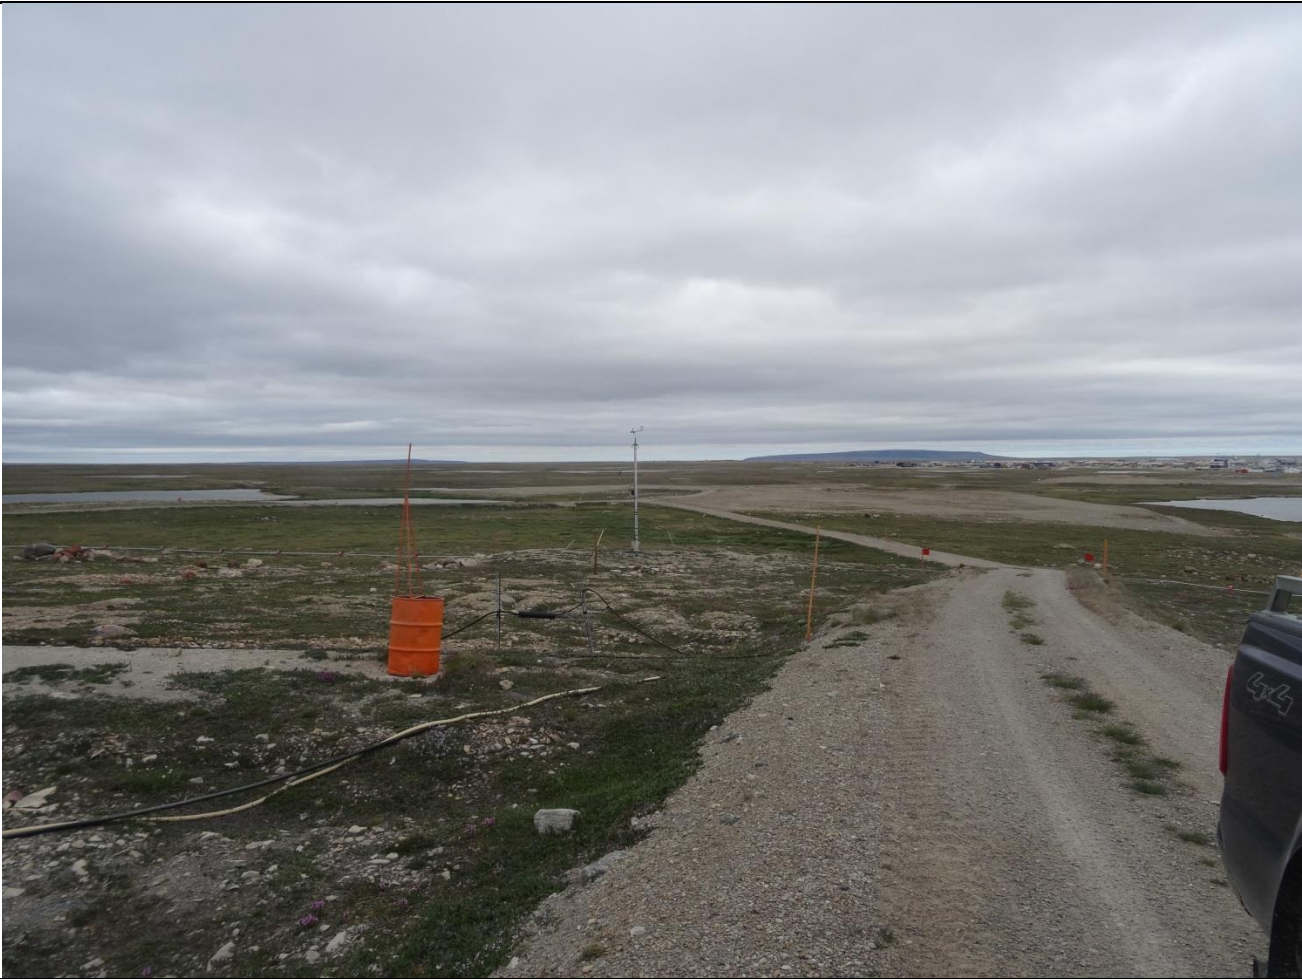
Photo 1

Description: 2 Separate Covered Waste Sites, 1 on the Left and 1 on the Right

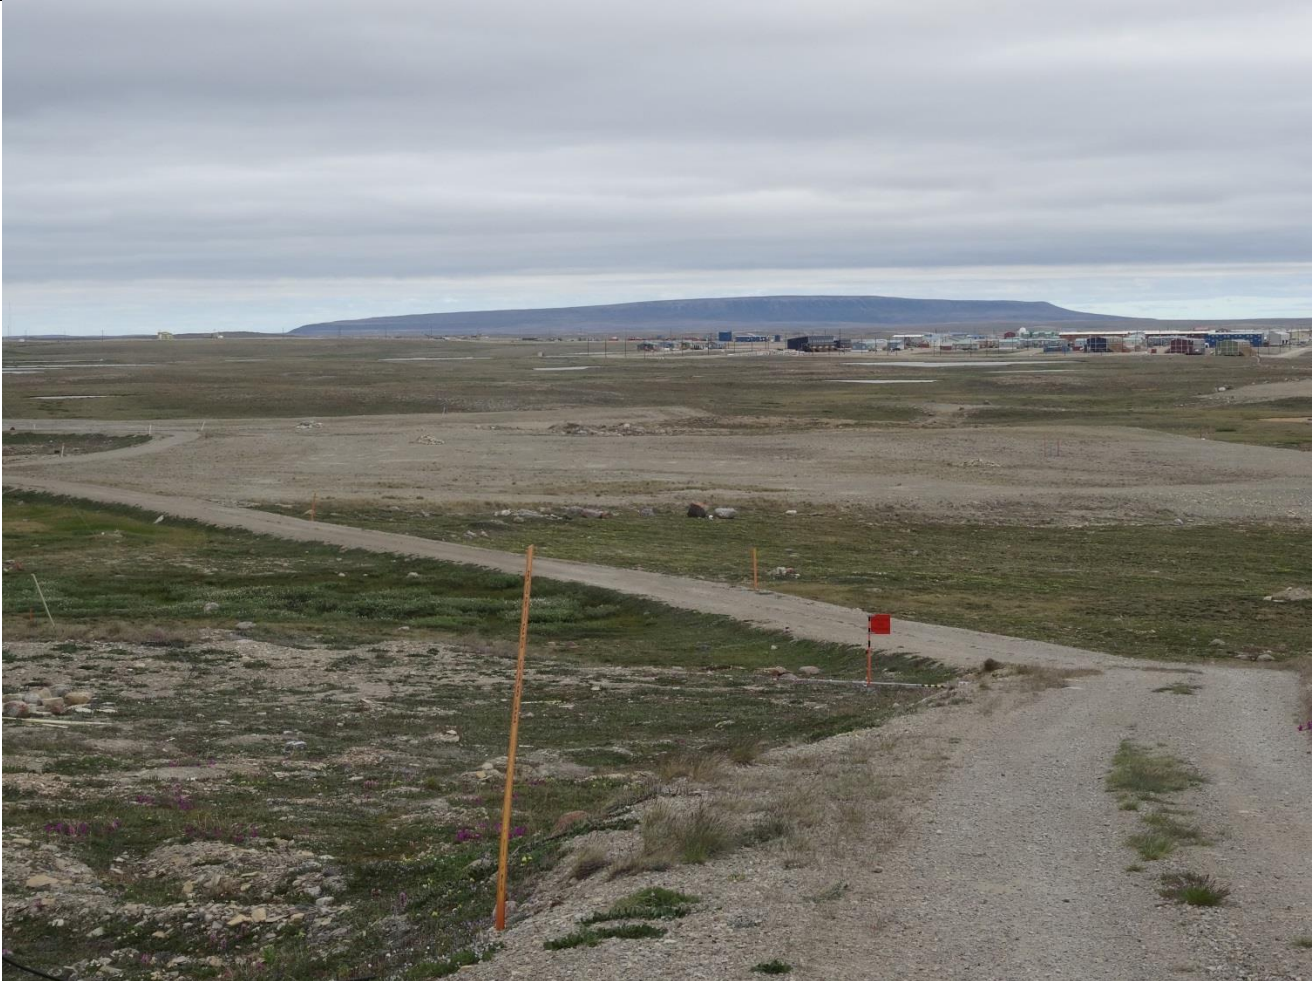
Photo 2

Description: Covered Waste Site on the Right Hand Side

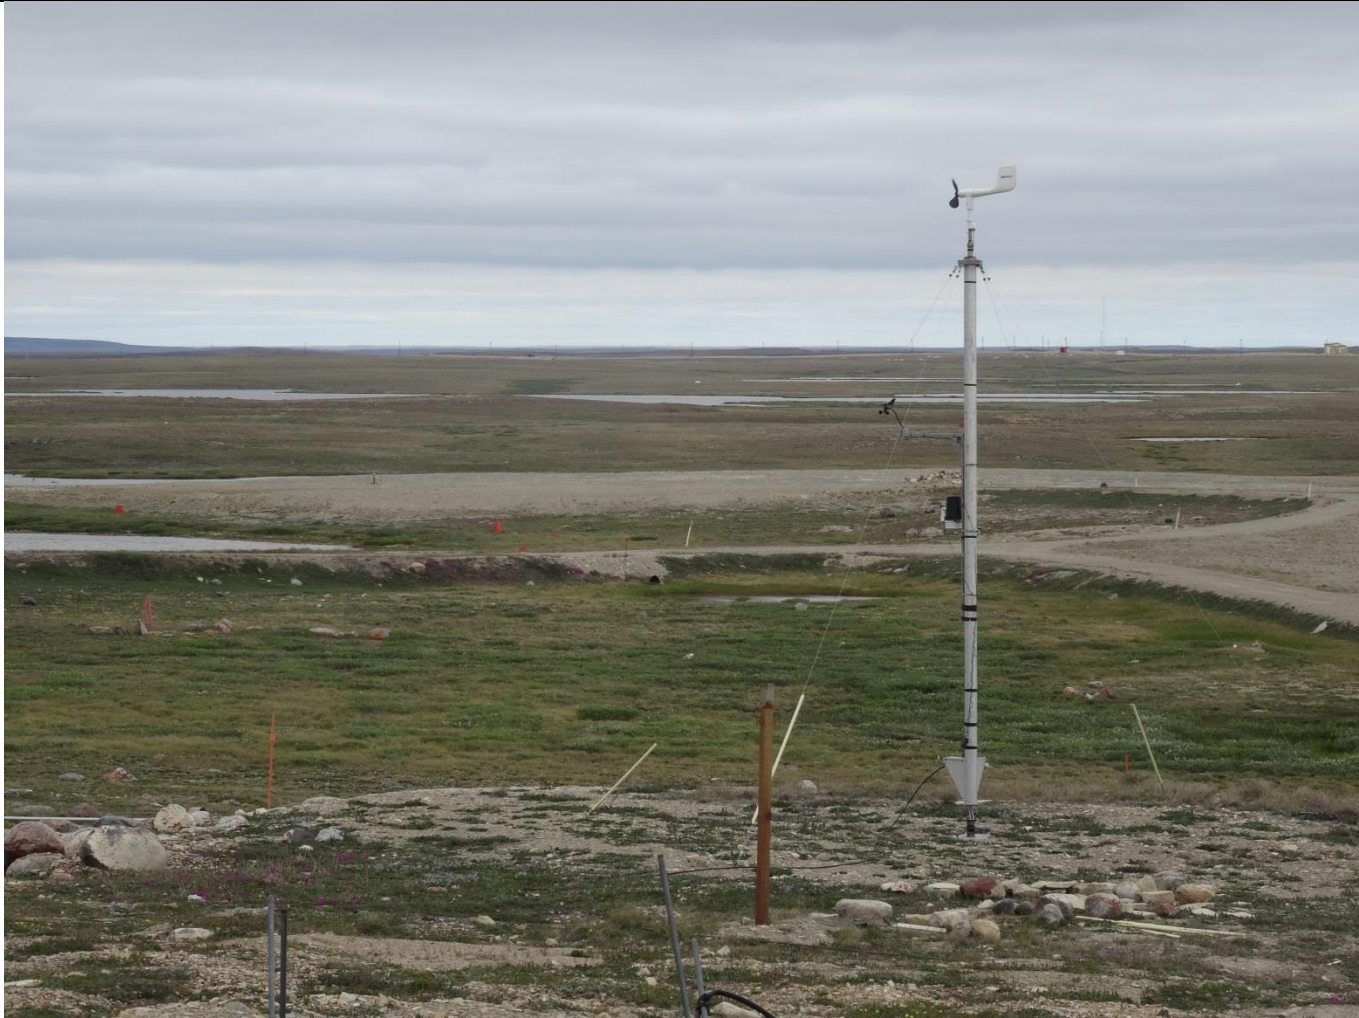
Photo 3

Description: Covered Waste Site on the Left Hand Side
