THE COLLECTION OF LANDFILL MONITORING DATA AT THE FORMER **CAM-M DISTANT EARLY WARNING LINE SITE**

Cambridge Bay, Nunavut

Final report (2015)

DEFENCE CONSTRUCTION CANADA

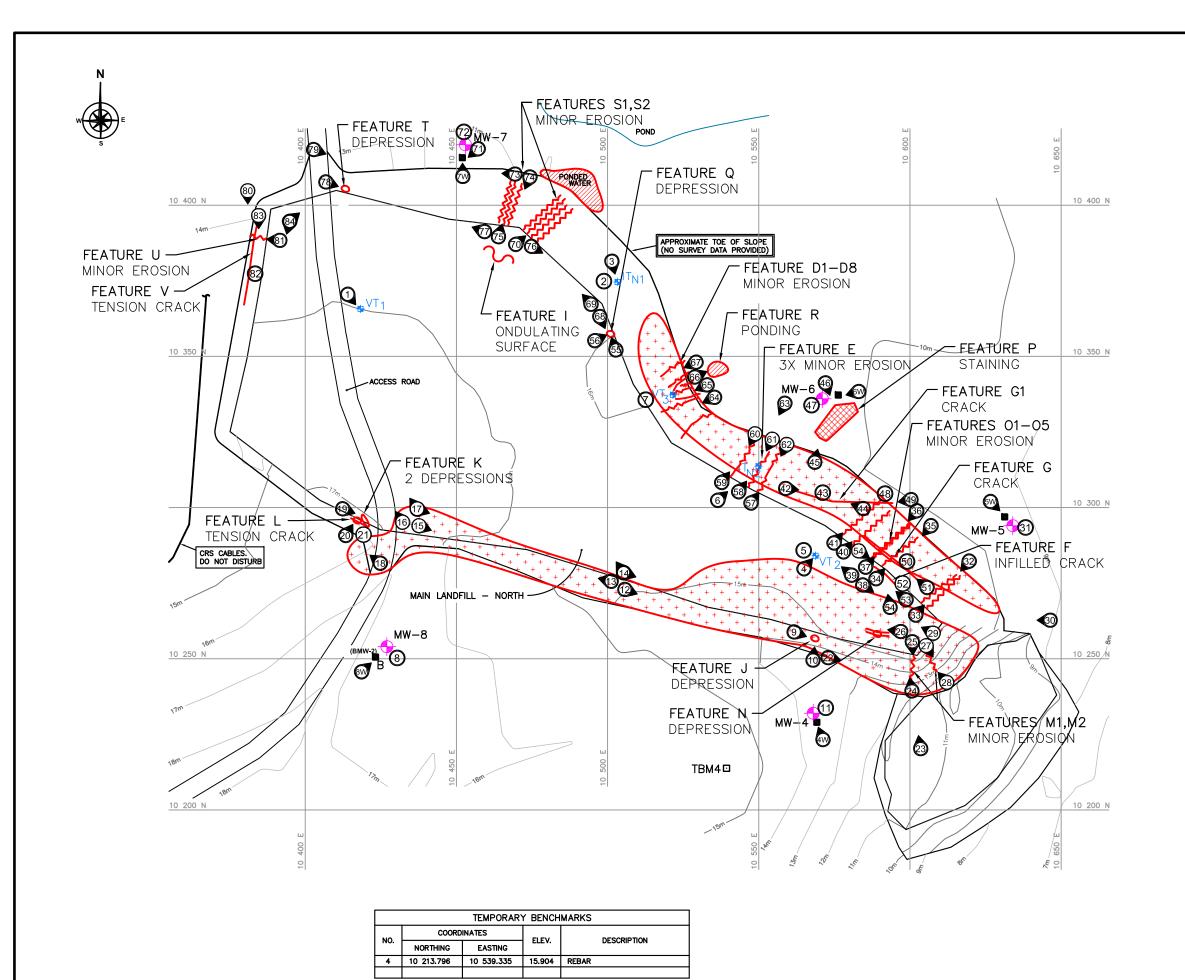
As of 2015, no features with "significant" or "unacceptable" severity ratings were identified in the Preliminary Stability Assessment of the Main Landfill North. Indications of minor settlement were noted at six areas, including: one previously observed unchanged undulating area on the north cover (Feature I); a new pothole depression on the south crest (Feature J); two new depressions on the southwest crest (Feature K); a new localized depression in an area of vehicle rutting on the east cover (Feature N); and two new localized depressions on the northeast and north crests (Features Q and T) of the landfill. Former features A, B and H were not visible during the 2015 assessment.

Six general areas of surface erosion were noted on the side slopes at the Main Landfill North, including two previously observed areas on the northeast side slope and four new areas on the southeast, northeast (2) and north side slopes. The two previously observed areas, including eight closely spaced locations at Feature D (D1 to D8) and three locations at Feature E appear consistent with previous observations with no significant changes noted. New areas of erosion included: two locations on the southeast side slope (Features M1 and M2), five locations on the northeast side slope (Features O1 to O5); seven locations on the north side slope (Feature S1 and S2); and a single location on the northwest side slope (Feature U). All features appear to be relatively minor surface erosion, self-armouring and generally extend between the crest and toe at each location. All slopes appear stable.

One new localized area of rust-coloured staining (Feature P) was observed in a well vegetated wet area located northeast of the landfill toe. This feature was not observed during the previous 2010 assessment. One relatively small area of ponded water was also noted immediately north of the landfill. This area was observed during the previous assessment, however no notations were made regarding the size and/or depth.

Tension cracks were observed at five locations, including two previously observed and three new locations on the Main Landfill North. Previously observed locations on the east crest (Feature F) and northeast side slope (Feature G) were either partially or completely filled or difficult to determine confirmation from previous assessment findings. New tension cracks were noted on the southwest side slope (Feature L), one locations on the northeast side slope (Feature G1) and one location on the northwest crest (Feature V). One new ponded area was also noted on the northeast side slope (Feature R)
