Department of National Defence

# **LONG-TERM LANDFILL MONITORING AT THE CAM-M FORMER DEW LINE SITE**

Cambridge Bay, Nunavut

March 30, 2020

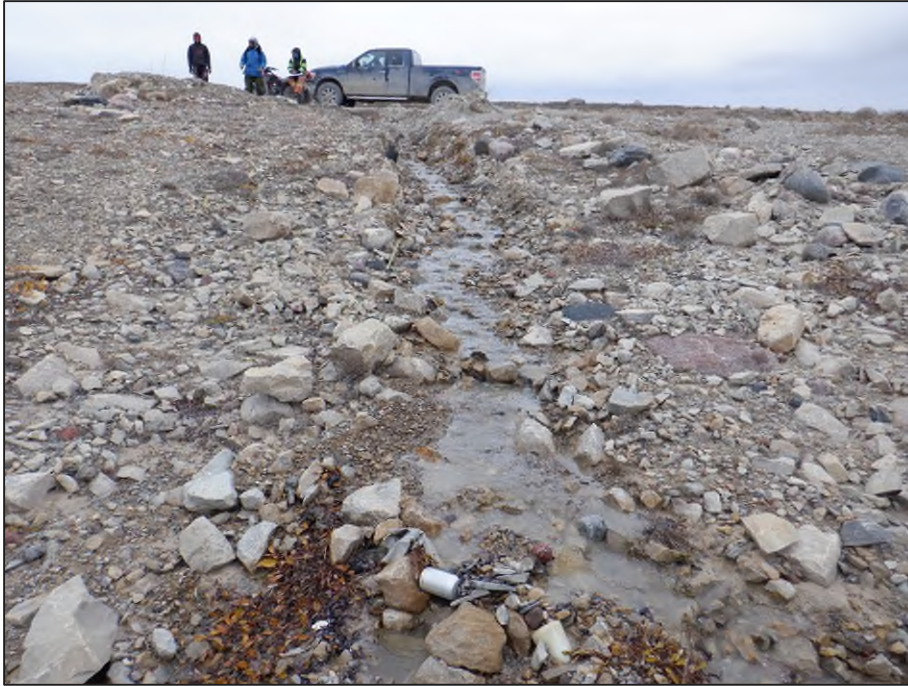
**Photo: CAM-M AIRS-002  
(Airstrip Landfill)**

**Description:**  
View of Feature U1-  
drainage channel-  
looking North.

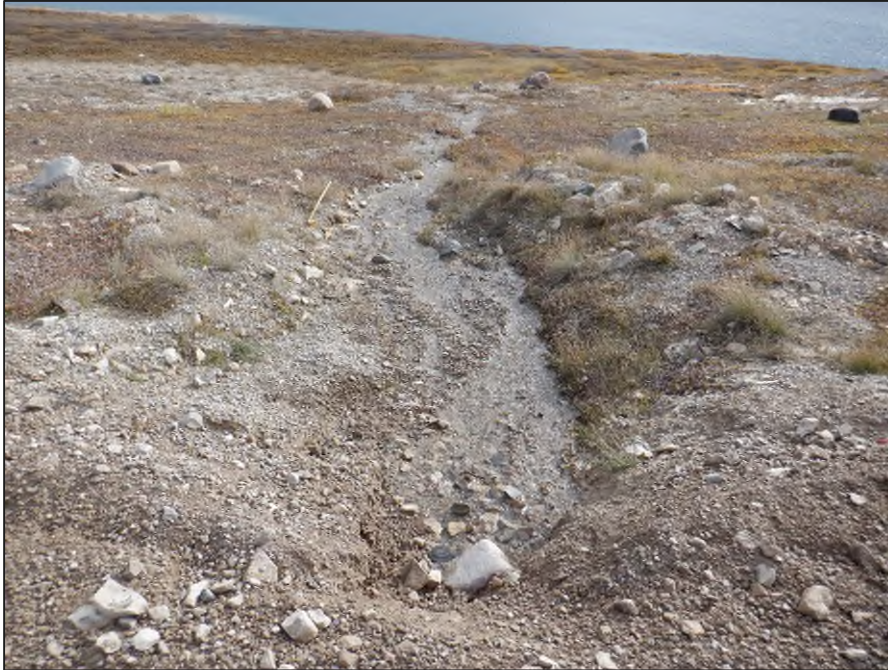
**Photo: CAM-M AIRS-012**  
**(Airstrip Landfill)**

**Description:**  
View of Feature "U2" -  
drain channel- looking  
South.

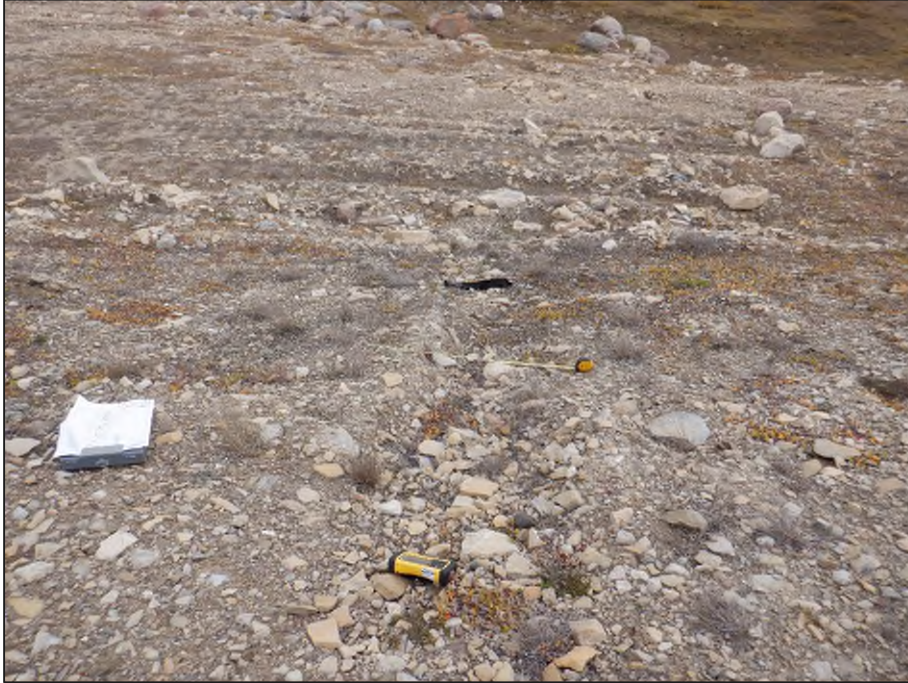
**Photo: CAM-M AIRS-025  
(Airstrip Landfill)**

**Description:**  
Feature "V"- minor  
erosion at Area 11  
Landfill – view towards  
south.

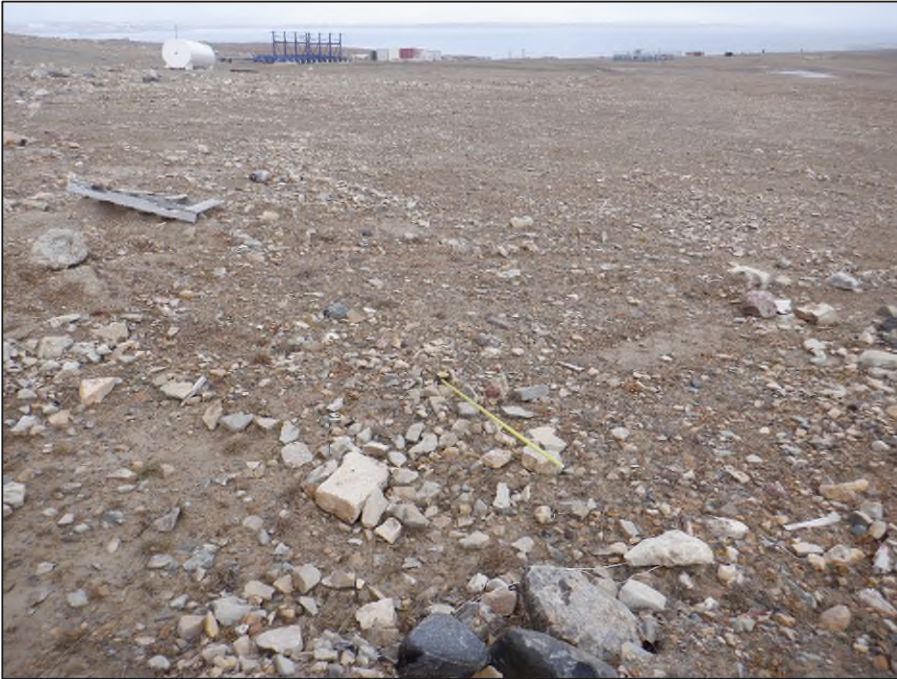
**Photo: CAM-M SSL-006**  
**(South Shore Landfill)**

**Description:**  
Looking E across  
Landfill from NW corner  
of Landfill

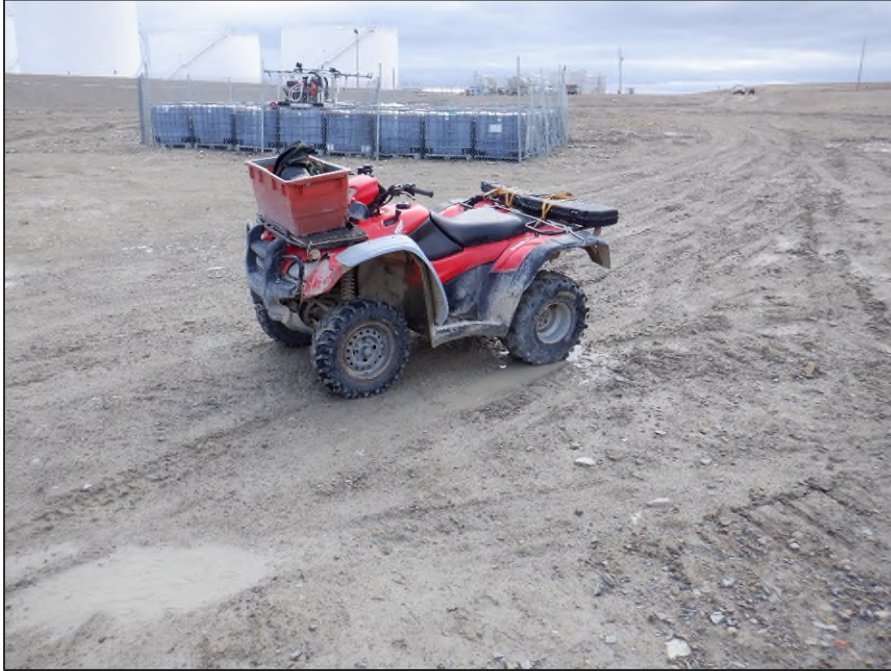
**Photo: CAM-M SSL-14**  
**(South Shore Landfill)**

**Description:**  
Looking S from middle  
east end of landfill  
(view of drum  
compound) from  
middle east end of  
landfill

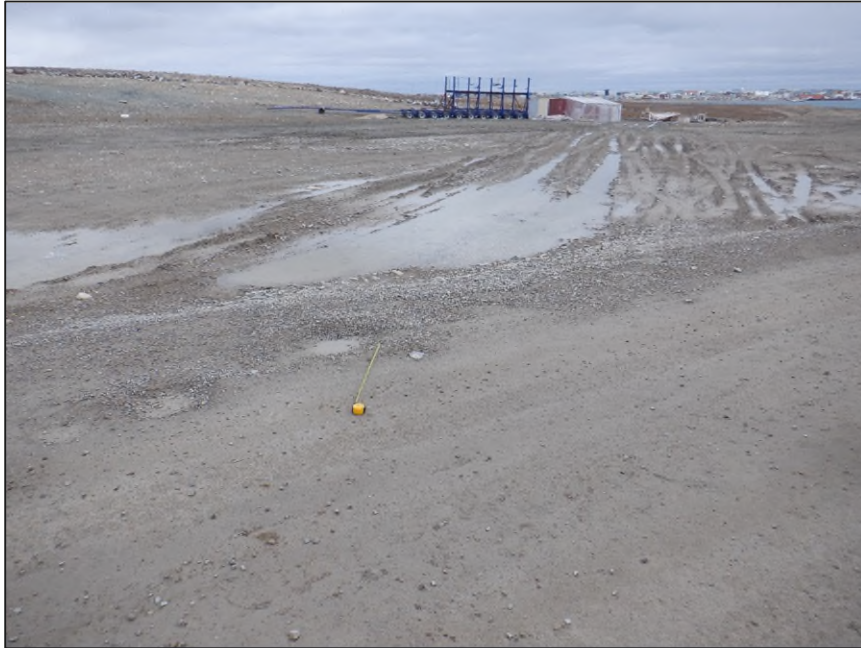
**Photo: CAM-M SSL-28**  
**(South Shore Landfill)**

**Description:**  
View of Feature "M2"-  
truck rutting / ponding  
-looking N from middle  
of landfill

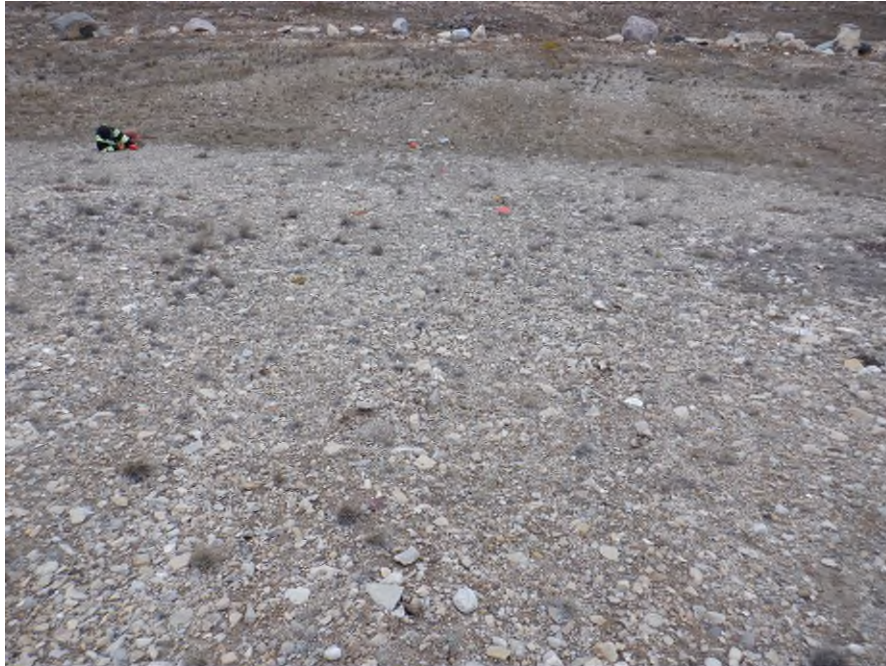
**Photo: CAM-M T2-003**  
**(Tier II Disposal Facility)**

**Description:**  
Tier II Disposal Facility-  
NE slope; west end of  
landfill –looking NE

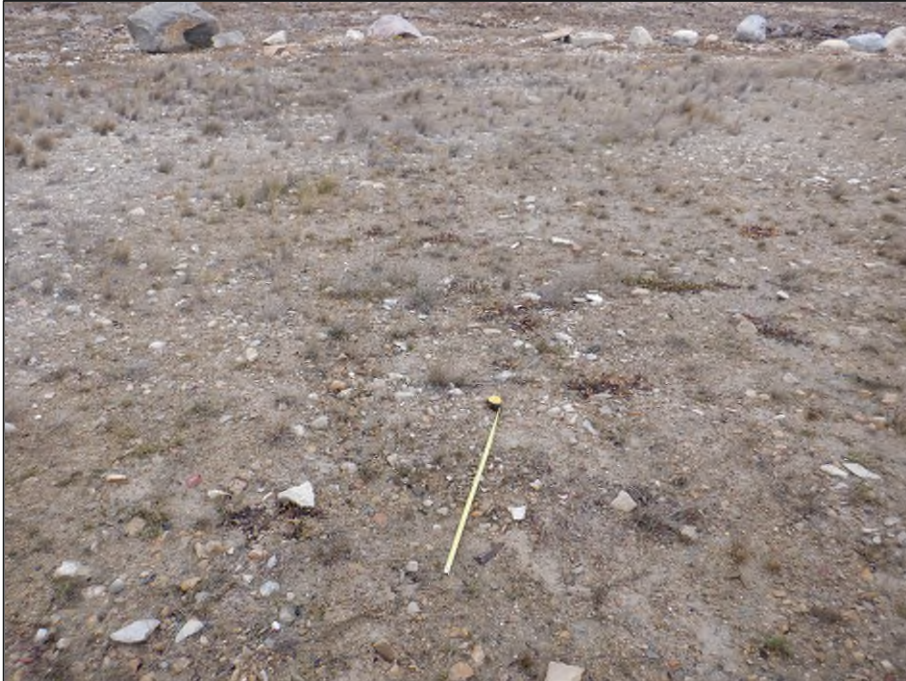
**Photo: CAM-M T2-009**  
**(Tier II Disposal Facility)**

Based on the results of the visual inspection occurring at Features N and B2, the Tier II Disposal Facility performance is acceptable. No remedial work or deviations from the monitoring plan are recommended at this time.

**Description:**  
NE slope; west end of landfill; note moist seepage area (Feature N) in foreground- looking North.

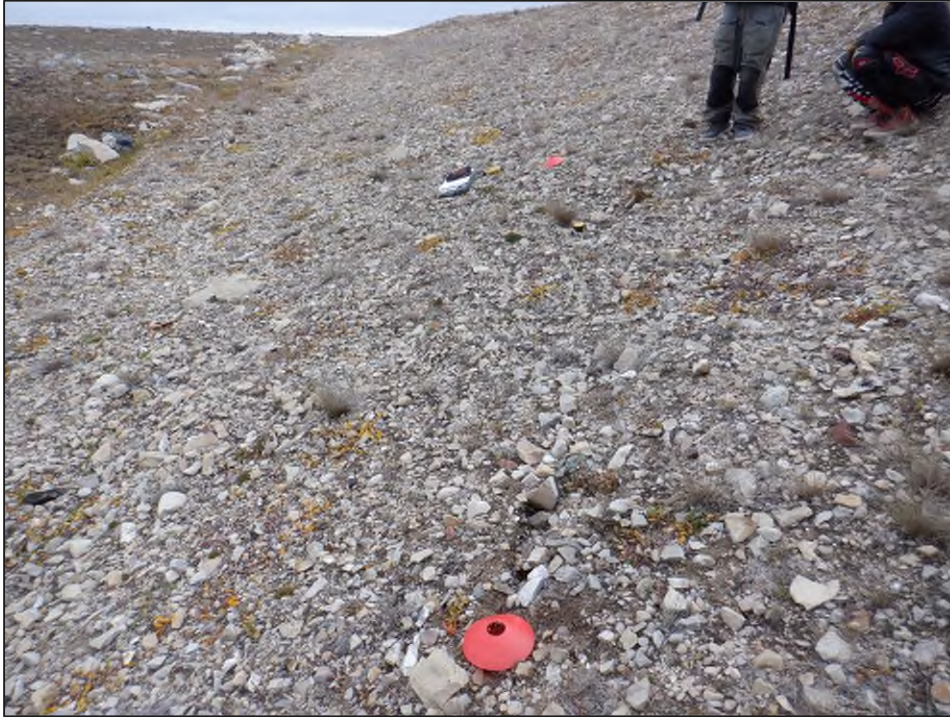
**Photo: CAM-M T2-019**  
**(Tier II Disposal Facility)**

**Description:**  
View of tension crack  
B2b on SE slope, east  
end, of landfill—  
looking SW.
