**THE COLLECTION OF LANDFILL
MONITORING DATA AT THE FORMER
PIN-2 DEW LINE SITE**

Cape Young, Nunavut

FINAL REPORT– 2013 SEASON

DEFENCE CONSTRUCTION CANADA

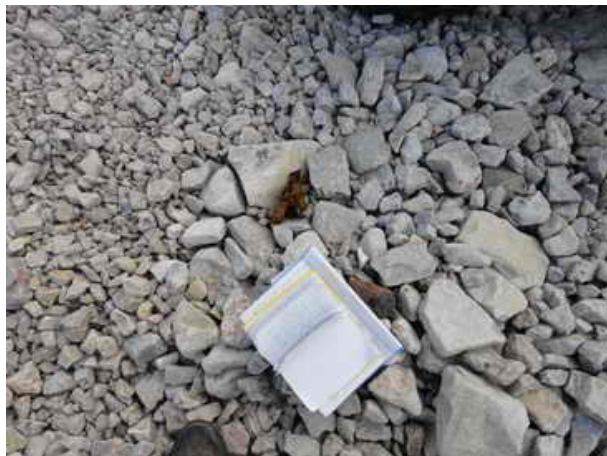
As noted above, three small pieces of miscellaneous metal debris (strapping) were noted on the gravel surface between the lobes (Feature A). The debris did not appear to be related to the landfill regrades.

ALF-25: (left) Miscellaneous metal debris on surface between Lobe A and Lobes E & F

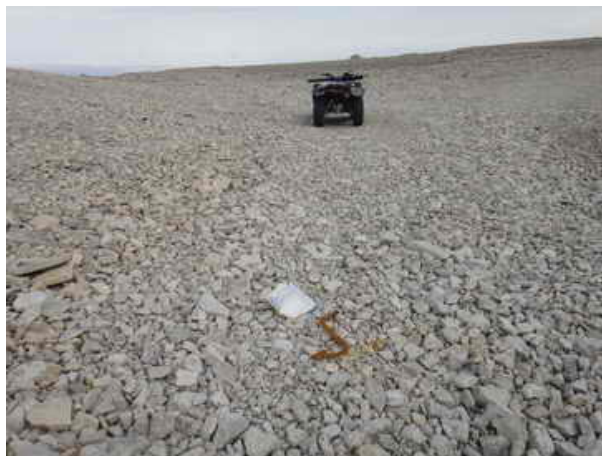
ALF-28: (right) View southeast at miscellaneous metal debris on surface between Lobe A and Lobes E & F

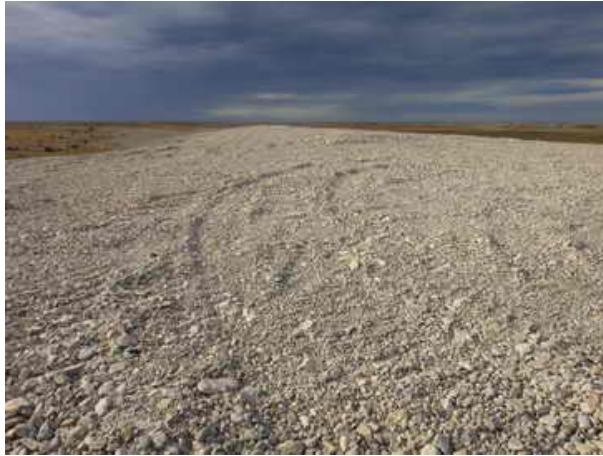
One set of vehicle tracks (shallow ruts) was noted on the south central cover of the landfill; Feature A. The ruts measured 4-8 m L, 0.3 m W and 0.05 m D. There were no other features of note at the landfill.

SWLF-12: View of vehicle tracks on south cover
(4-8 m L, 0.3 m W, 0.05 m D) - FEATURE A

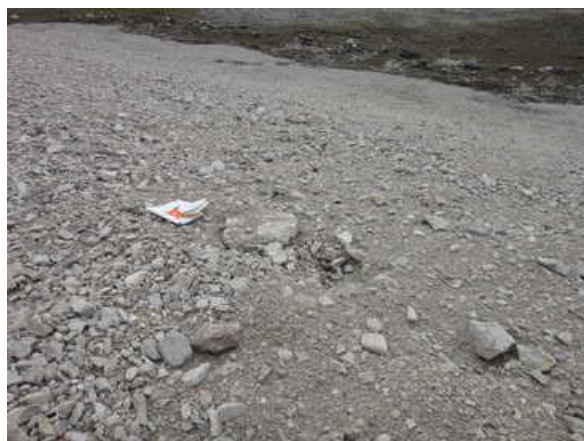
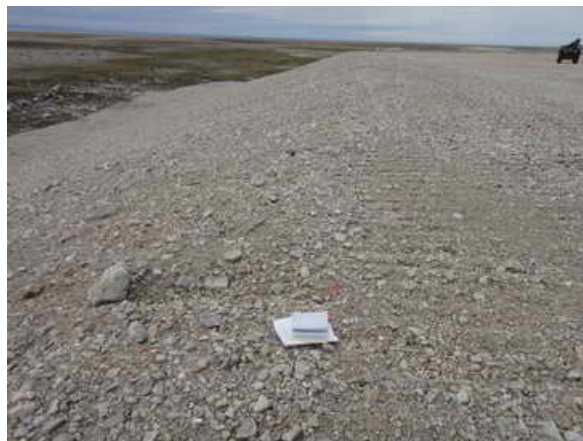
An indication of minor settlement was noted at two proximate locations along the southwest crest of the facility cover (Feature A), consisting of two isolated depression measuring 0.25-1.0 m long, 0.2-0.25 m wide and 0.1-0.15 m in depth. This feature has an acceptable severity rating. Indications of settlement in this area were not noted during the previous 2012 inspection.

Tier II-45 (left): View south at minor depression on southwest crest (0.25 m L, 0.25 m W, 0.15 m D) - FEATURE A
Tier II-47: (right) View northwest at linear depression on southwest crest (1 m L, 0.2 m W, 0.1 m D) - FEATURE A

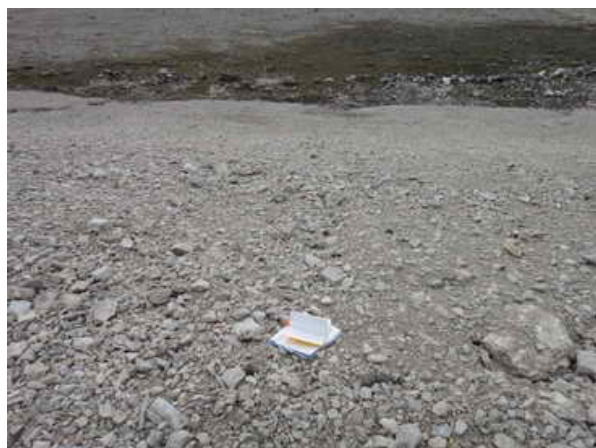
Evidence of minor surface erosion was noted at two locations on the southwest and southeast facing slopes (Features B and C) of the facility. Both locations consisted of shallow surface erosion that extended from the crest down slope between 7 to 25 m (Feature B) and 6 m (Feature C) in length, ranged between 0.1-0.5m in width and ranged between 0.02 to 0.1 m deep. The areas affected appear to be self-armouring and have an acceptable severity rating. Overall, the facility cover appears stable. Both features were not noted during the previous 2012 inspection.

Tier II-42: (left) View south-southwest at minor erosion on southwest side slope (25 m L, 0.3-0.5 m W, 0.02-0.05 m D) - FEATURE B

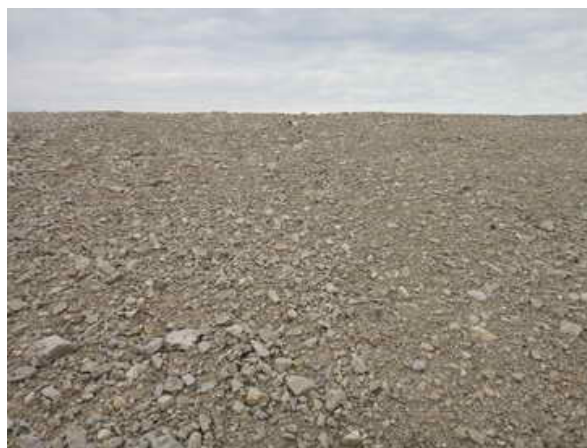
Tier II-24: (right) View northwest at minor erosion on southeast side slope (6 m L, 0.1-0.25 m W, 0.05 m D) - FEATURE C

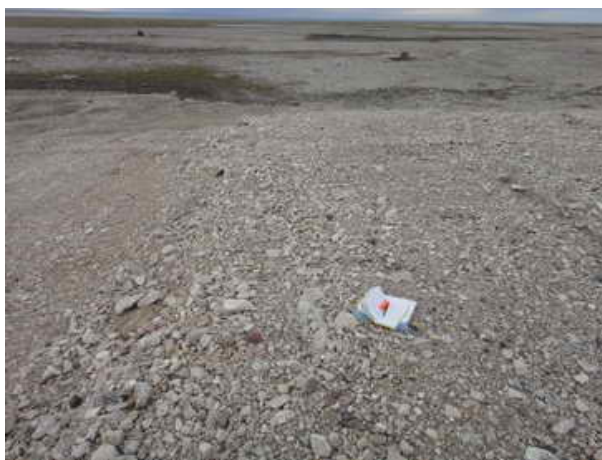
One area of minor settlement (Feature A) was noted on the southwest crest of the landfill, consisting of an isolated depression measuring 1.5 m long, 0.2-0.3 m wide and 0.05 m deep. This feature was not observed during the previous 2012 inspection.

NHWLF-19: View northwest at minor linear depression on southwest crest (1.5 m L, 0.2-0.3 m W, 0.05 m D) - FEATURE A

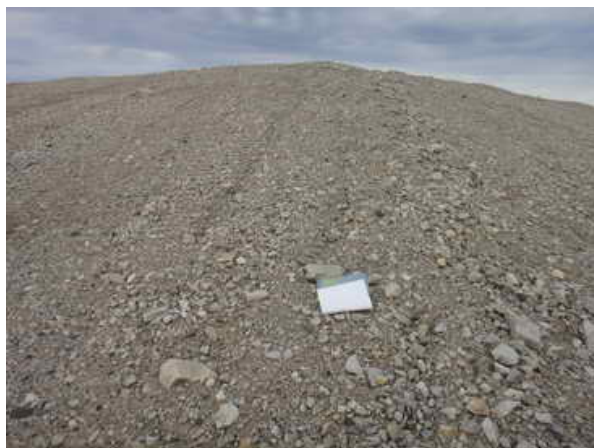
Evidence of minor surface erosion was noted at three locations on the southeast corner slope (Feature B) of the NHWLF. All locations consisted of shallow surface erosion that extended between 7 to 17 m down slope from the crest, ranged between 0.1-0.15m in width and were 0.05-0.07m deep. The areas affected appear to be self-armouring and have an acceptable severity rating. Overall, the landfill cover appears stable. This feature was not noted during the previous 2012 inspection.

NHWLF-26: (left) View northwest at minor erosion on southeast corner – FEATURE B

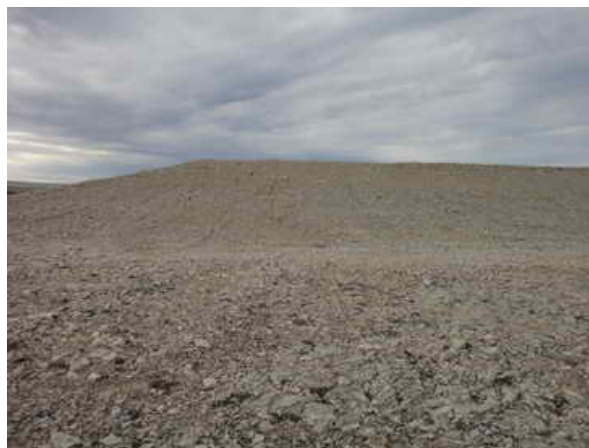
NHWLF-31 (right) View west-northwest at minor erosion on southeast corner (7-17 m L, 0.1-0.15 m W, 0.05-0.07 m D) - FEATURE B

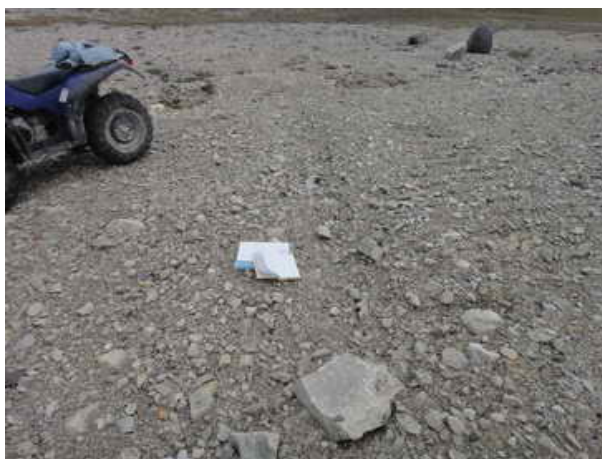
An indication of minor settlement was noted at a single location (Feature A) on the northeast corner of the landfill. The feature consisted of a linear depression measuring 5 m long, 0.2-.3 m wide and 0.05 to 0.07 m deep. This feature has an acceptable severity rating. This depression was not noted during the previous 2012 inspection.

SLE-8: View east at minor depression on northeast corner
(5 m L, 0.2-0.3 m W, 0.05-0.07 m D) - FEATURE A

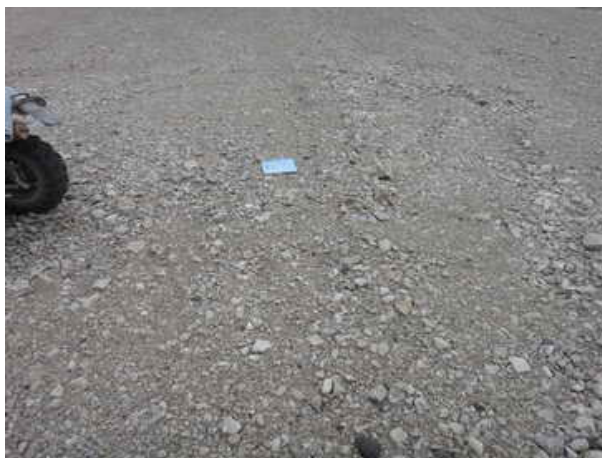
One area of minor erosion was noted on the central cover area of the landfill (Feature B). The erosion consisted of fines washing along approximately 7 linear meters across the cover, measuring 0.1 m wide and 0.02 to 0.07 m deep. This feature appears to be self-armouring with an acceptable severity rating. This feature was not noted during the previous 2012 inspection.

SLE-19: View southeast at minor erosion on central cover area
(7m L, 0.1m W, 0.02-0.05m D) - FEATURE B

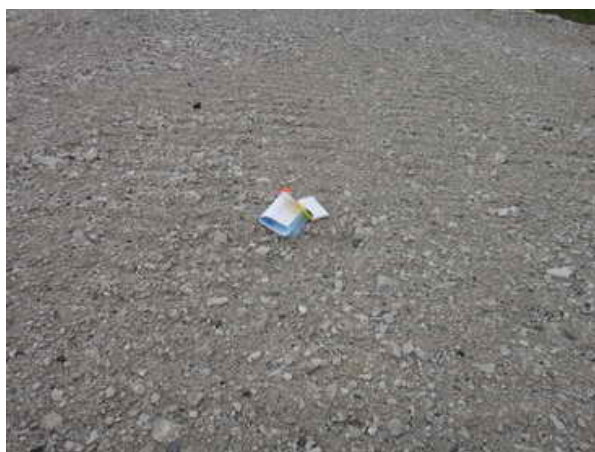
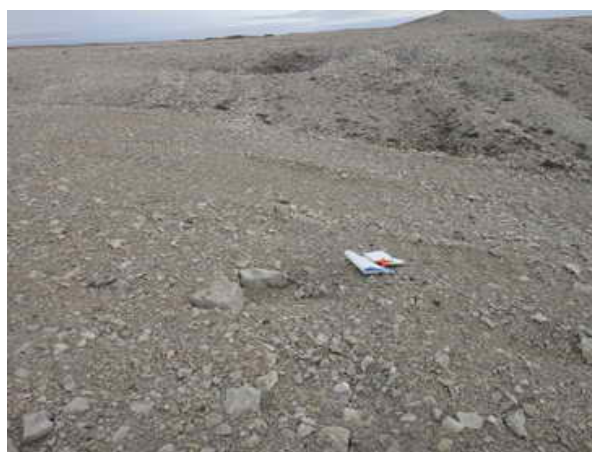
An indication of minor settlement was noted at two locations, consisting of pothole type depression on the north and east sides of the landfill (Feature A). The depressions ranged in size from 0.5 to 0.6 m long, 0.25 to 0.5 m wide and 0.1 m deep. This feature was not observed during the previous 2012 inspection.

SBLF-3: (left) View west at minor depression on north side slope (0.5m L, 0.5m W, 0.1m D) - FEATURE A
SBLF-21: (right) View west at localized pothole on east crest (0.6 m L, 0.25 m W, 0.1 m D) - FEATURE A

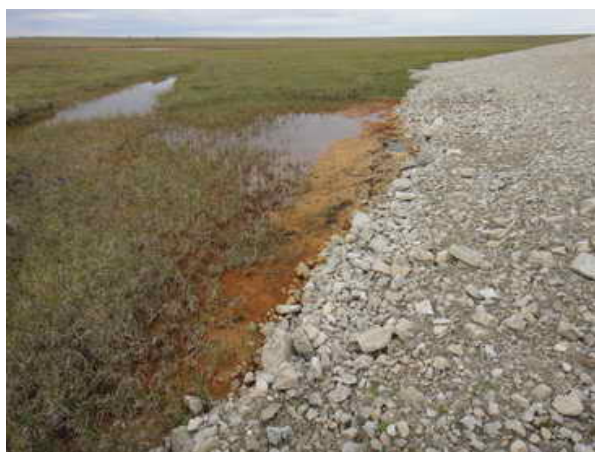
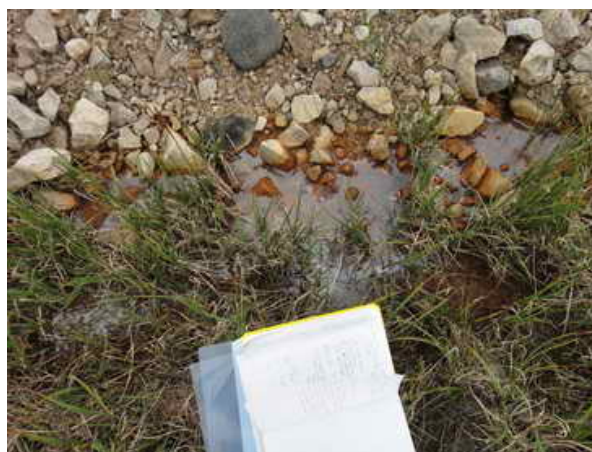
Evidence of minor staining was noted within a wetted area along the southwest toe of the landfill (Feature B). The staining was limited to a 10 m long by 0.2 to 1.0 m wide area. A non-hydrocarbon sheen was also noted in an isolated area along the toe. The area of staining was consistent with observations made during the previous 2012 inspection.

SBLF-15: (left) View northwest at staining in ponded area on southwest corner (10 m L, 0.2-1 m W) - FEATURE B
SBLF-16: (right) View of non-hydrocarbon sheen on water at southwest toe (10 m L, 0.2-1 m W) - FEATURE B
