**THE COLLECTION OF LANDFILL
MONITORING DATA AT THE FORMER
PIN-2 DISTANT EARLY WARNING LINE
SITE**

Cape Young, Nunavut

Final report 2015
(O/Ref.: CD3654)
(Y/Ref.: DLC MON (KITIK 13))

DEFENCE CONSTRUCTION CANADA

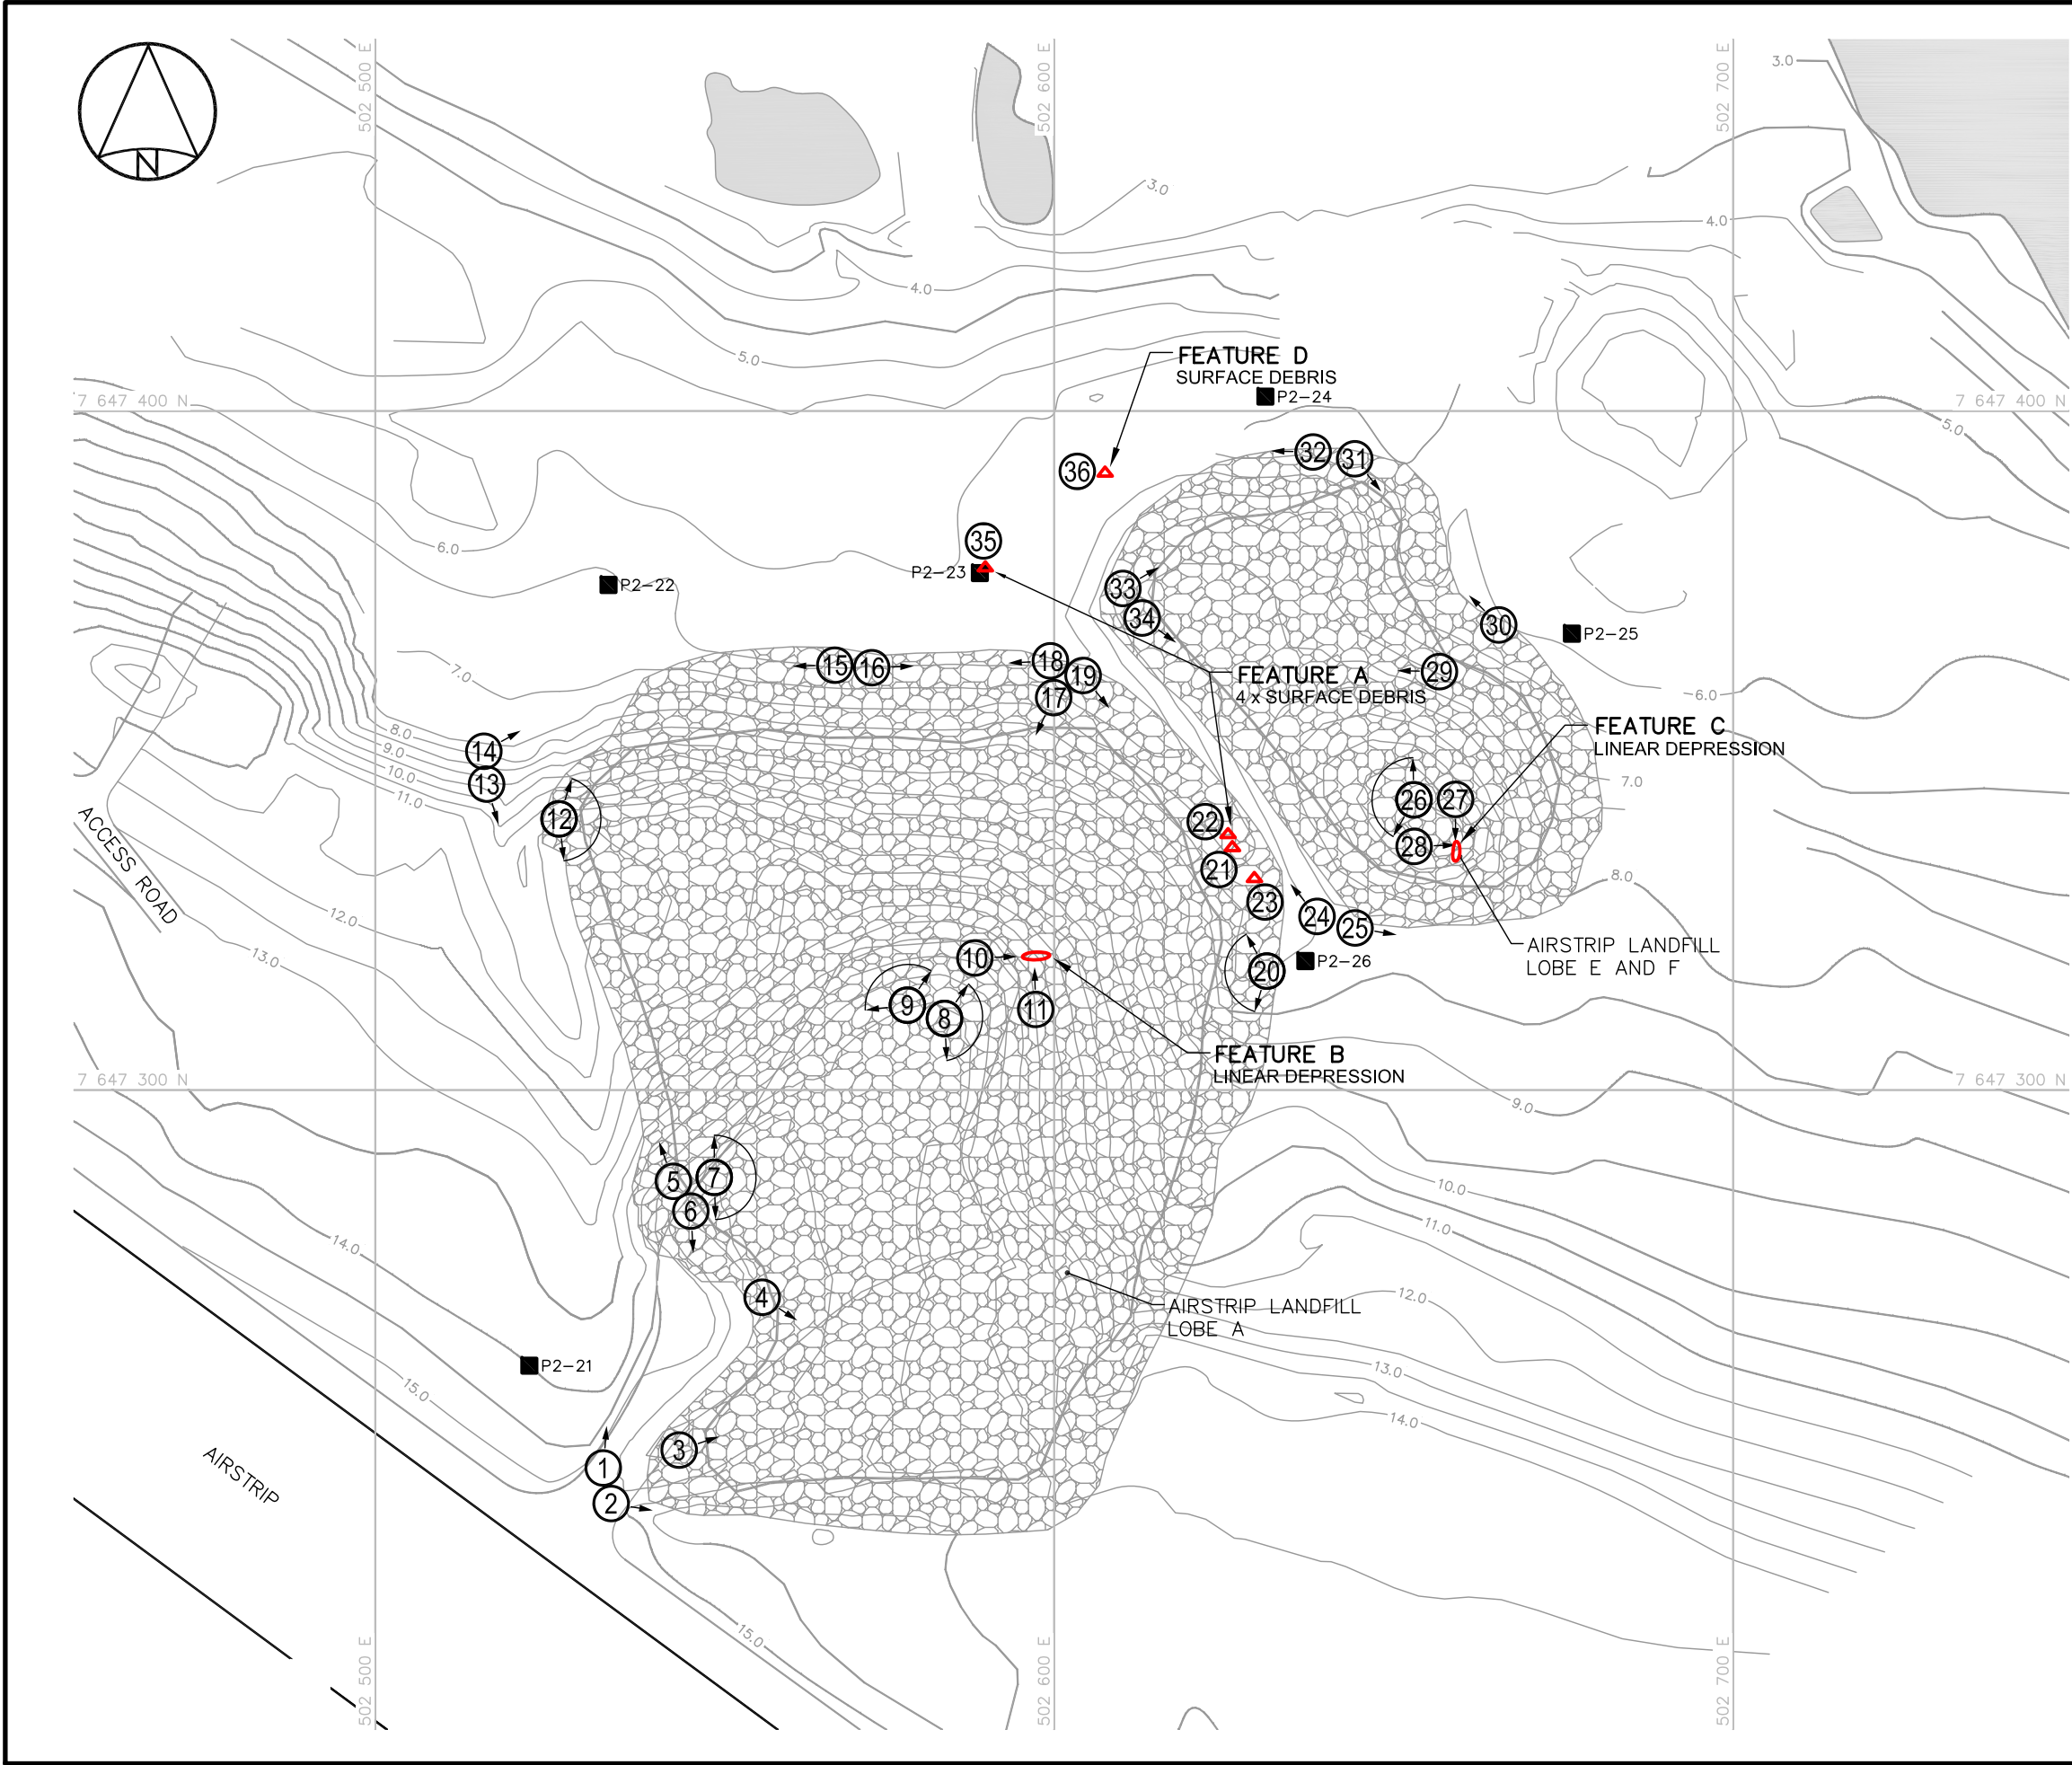
The Location Plan for the Airstrip Landfill has been completed as per the TOR and is presented in Figure PIN-2.2.

As of 2015, no erosion features with “significant” or “unacceptable” severity ratings were identified in the Preliminary Stability Assessment of the Airstrip Landfill. Indications of minor settlement were noted at two locations, including linear depressions on the northeast side slope of Lobe A (Feature B) and south side slope of Lobes E & F (Feature C). Feature B was previously observed during the 2014 assessment with no significant change noted. Feature C was not noted during the previous 2014 assessment. Evidence of exposed debris was not noted at the landfill, however five small pieces of miscellaneous metal debris were noted in proximity to the landfill, including four existing pieces (Feature A) located southwest and northwest of Lobes E & F and one newly observed piece (Feature D) located north of Lobes E & F.

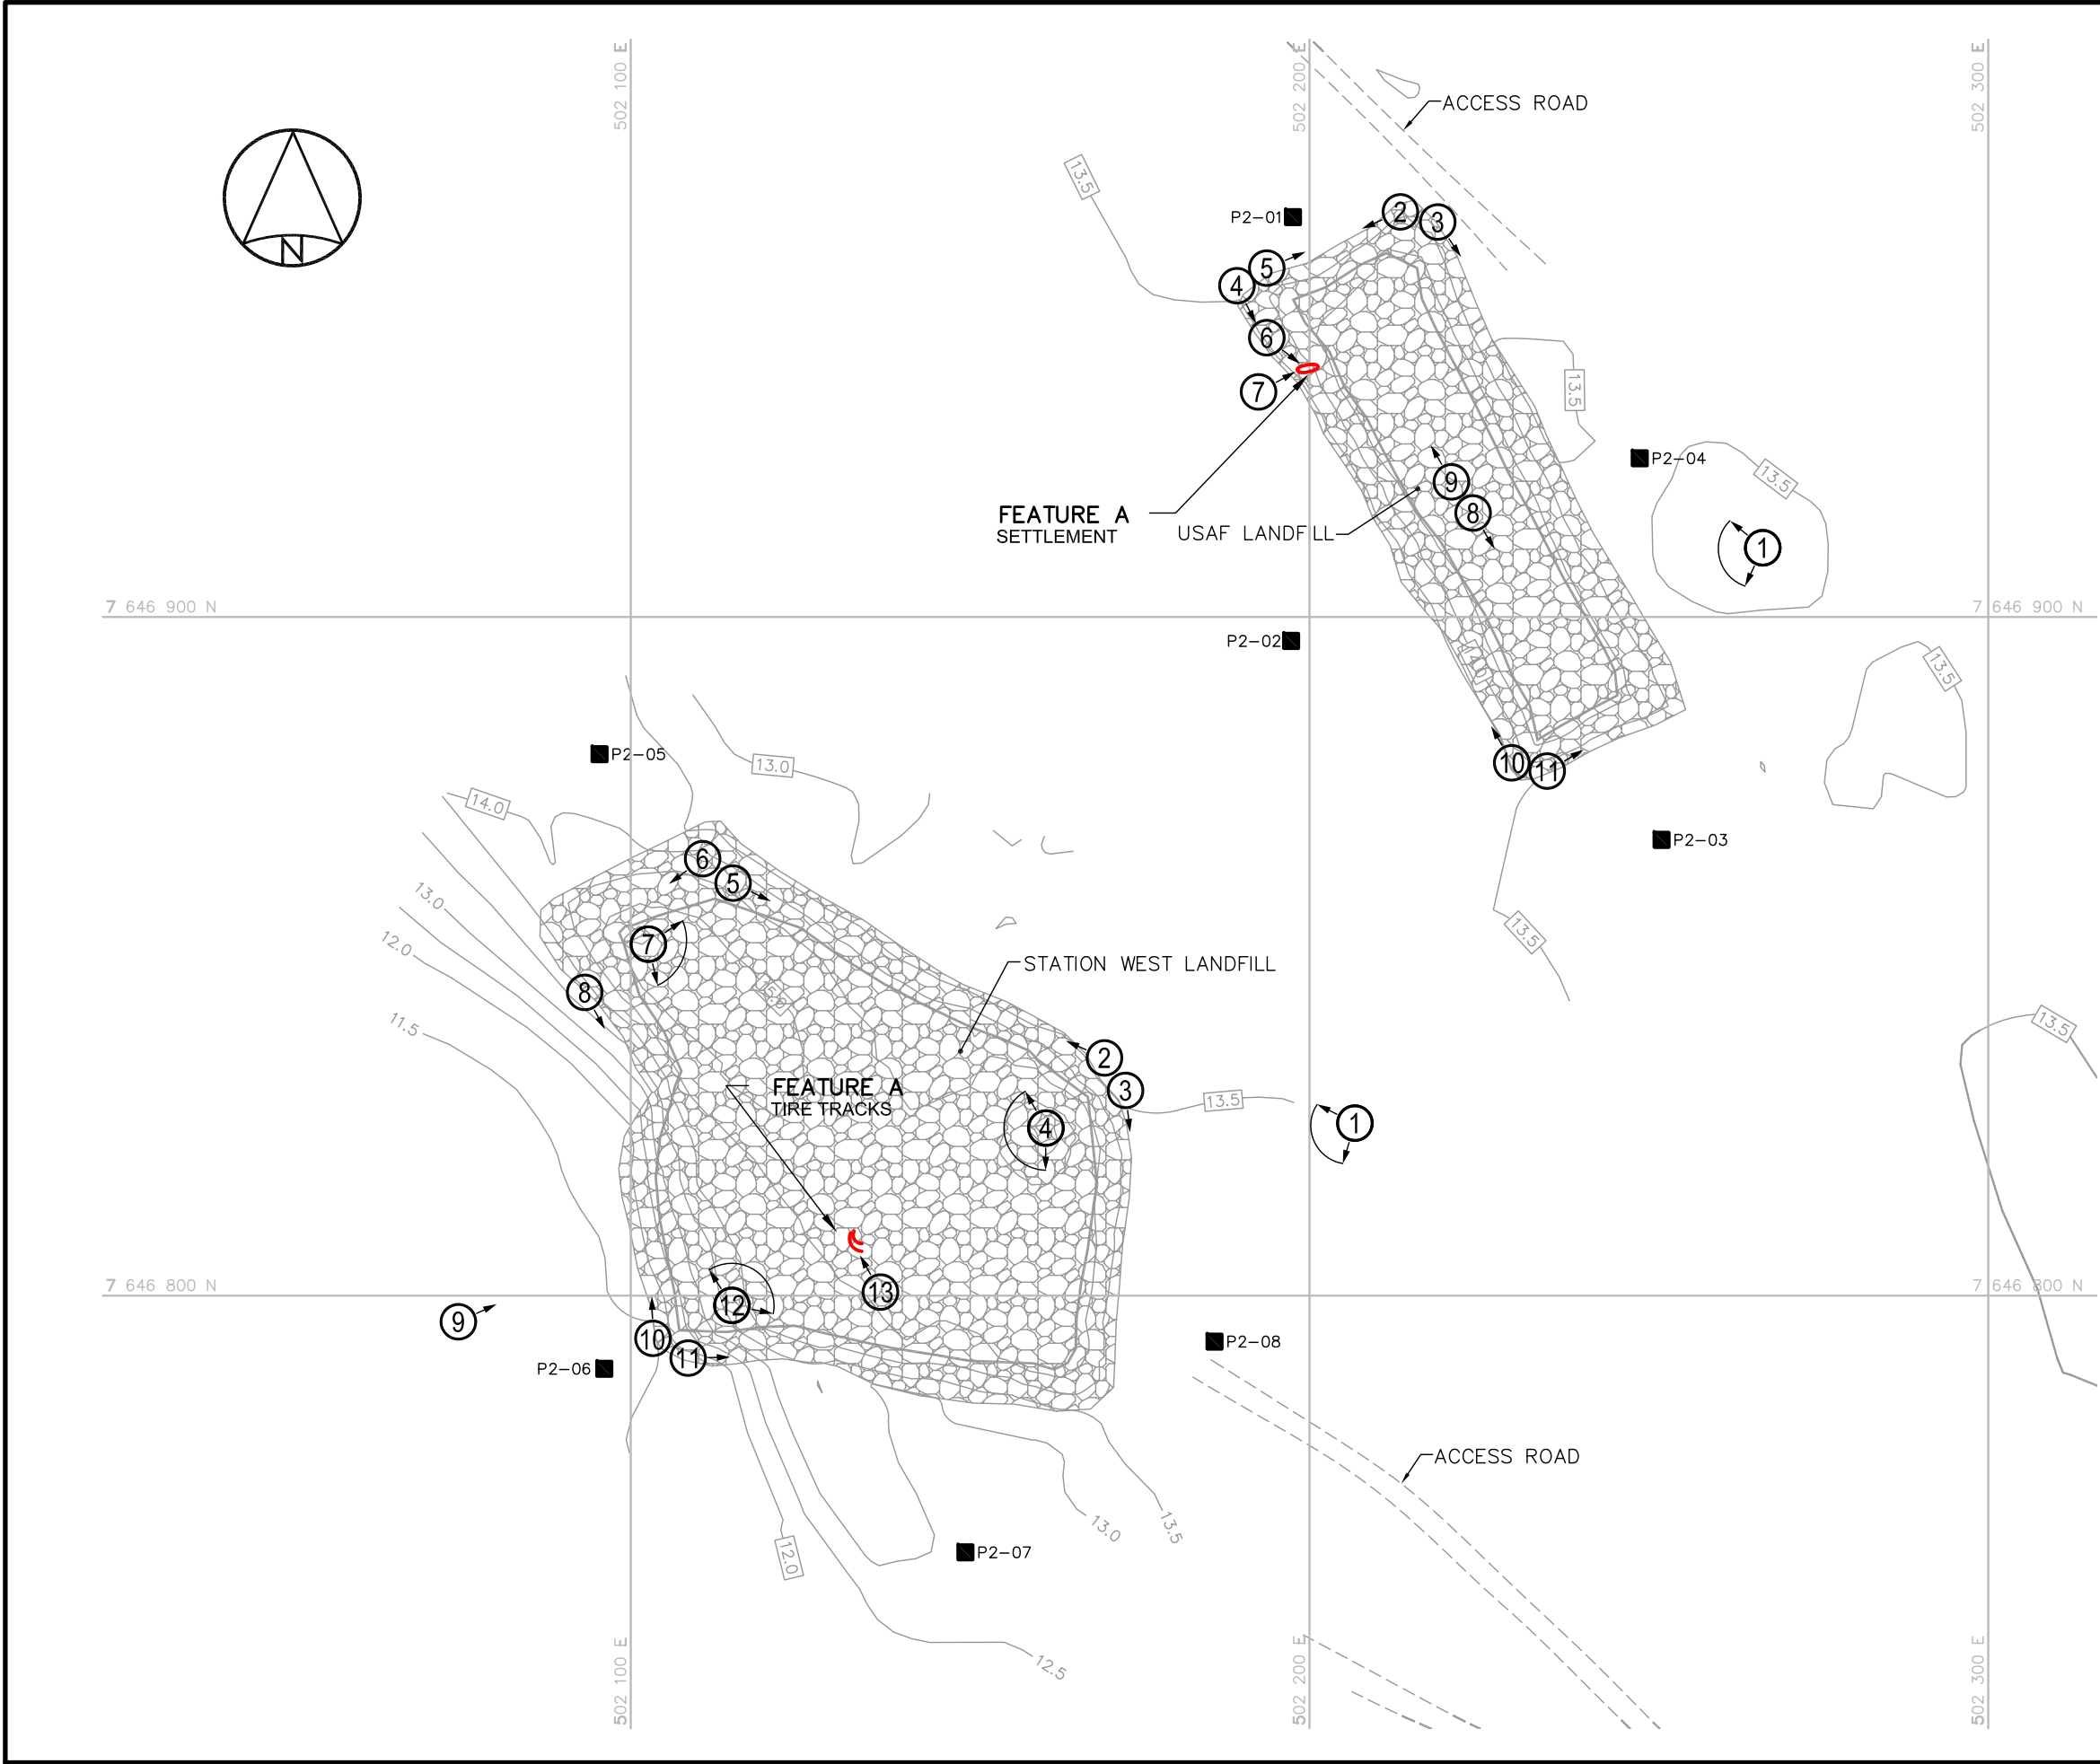
The Location Plan for the USAF Landfill has been completed as per the TOR and is presented in Figure PIN-2.3.

As of the 2015 monitoring event, no features were identified with “significant” or “unacceptable” severity ratings. Minor settlement was noted at one location on the west side slope of the landfill (Feature A) that was first observed during the previous 2014 inspection period. There were no significant changes noted in 2015.

Checklist Item	Present (Yes/No)	Location	Length	Width	Depth	Extent	Description	Photographic Record	Severity Rating	Additional Comments
Settlement	Yes	FEATURE A See Figure PIN-2.3 (W side slope)	0.4 m	0.3 m	0.15 m	< 1%	Minor depression	USAF-6, 7	Acceptable	Pothole-type depression. No significant change since observed in 2014.
Erosion	No	N/A	N/A	N/A	N/A	N/A	N/A	N/A	Not Observable	N/A
Frost Action	No	N/A	N/A	N/A	N/A	N/A	N/A	N/A	Not Observable	N/A
Animal Burrows	No	N/A	N/A	N/A	N/A	N/A	N/A	N/A	Not Observable	N/A
Vegetation	No	N/A	N/A	N/A	N/A	N/A	N/A	N/A	Not Observable	N/A
Staining	No	N/A	N/A	N/A	N/A	N/A	N/A	N/A	Not Observable	N/A
Vegetation Stress	No	N/A	N/A	N/A	N/A	N/A	N/A	N/A	Not Observable	N/A
Seepage Points	No	N/A	N/A	N/A	N/A	N/A	N/A	N/A	Not Observable	N/A
Debris Exposed	No	N/A	N/A	N/A	N/A	N/A	N/A	N/A	Not Observable	N/A
Presence/Condition of Monitoring Instruments	No	N/A	N/A	N/A	N/A	N/A	N/A	N/A	Not Observable	N/A

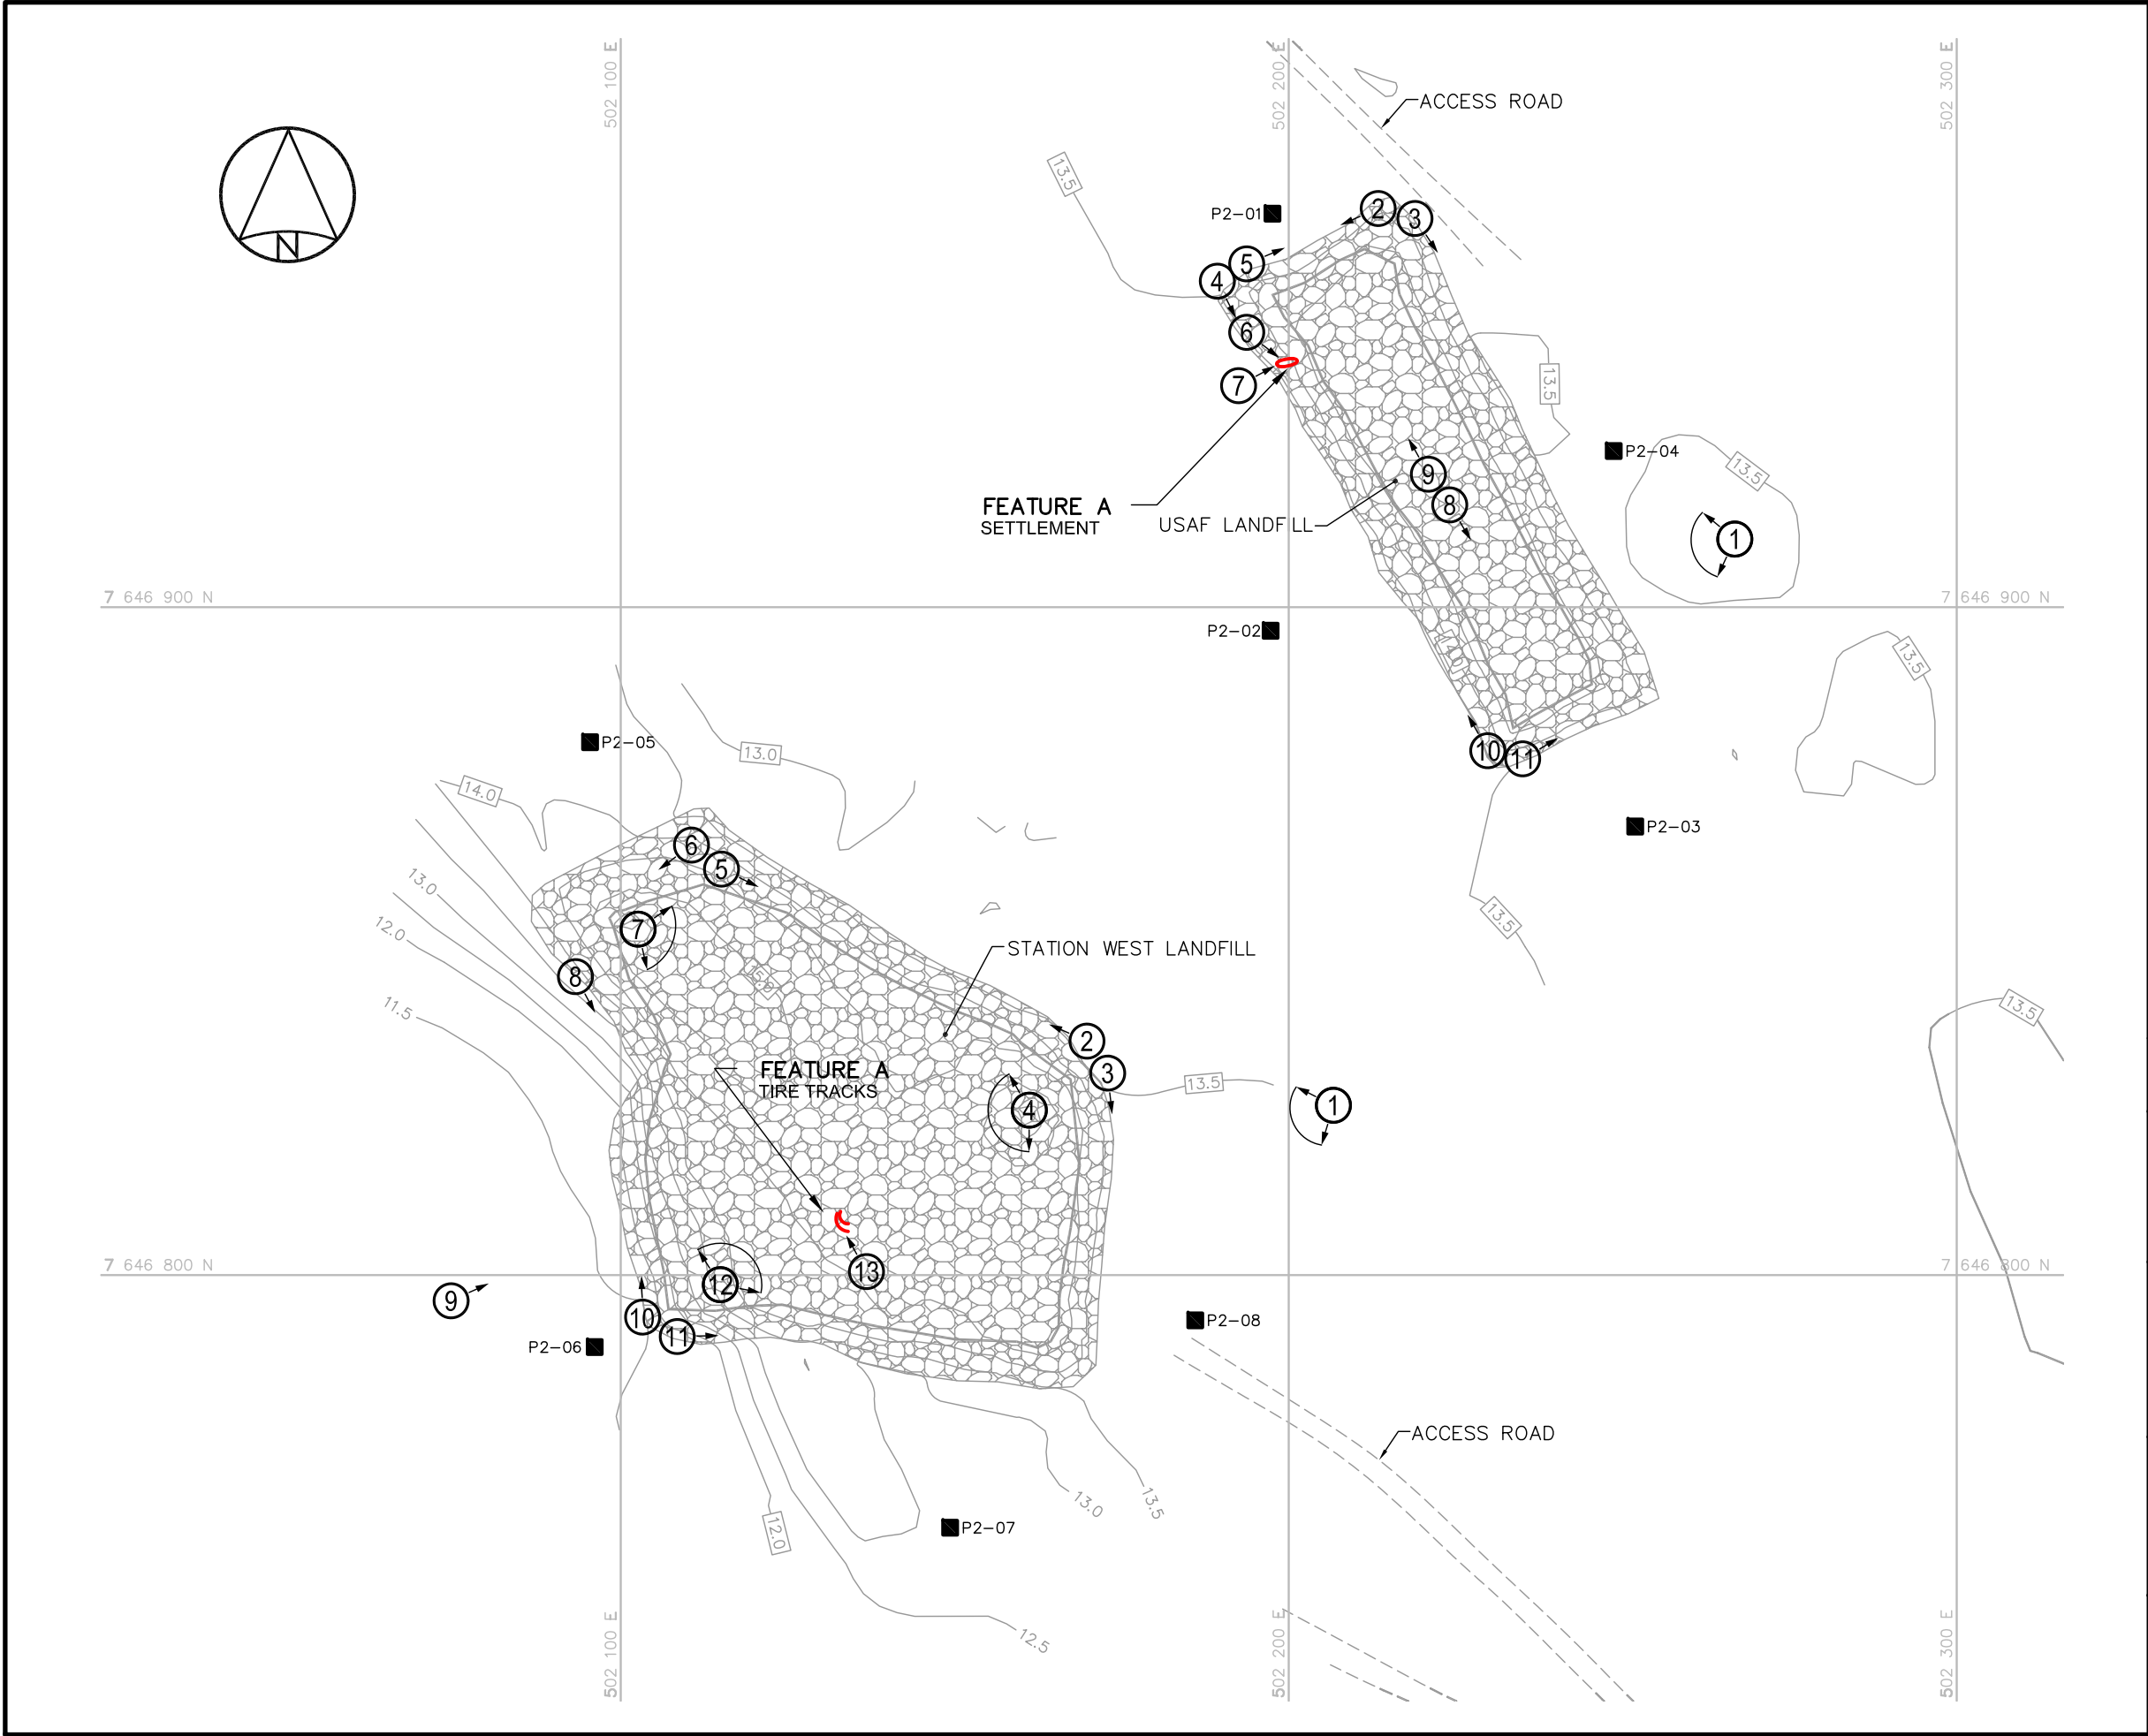
The Location Plan for the Station West Landfill has been completed as per the TOR and is presented in Figure PIN-2.3.

As of the 2015 monitoring event, no features were identified with “significant” or “unacceptable” severity ratings. One set of vehicle tracks (shallow ruts) was noted on the south central cover of the landfill (Feature A) and were consistent with observations noted during the previous 2013 and 2014 inspection periods. There were no other features of note at the landfill.

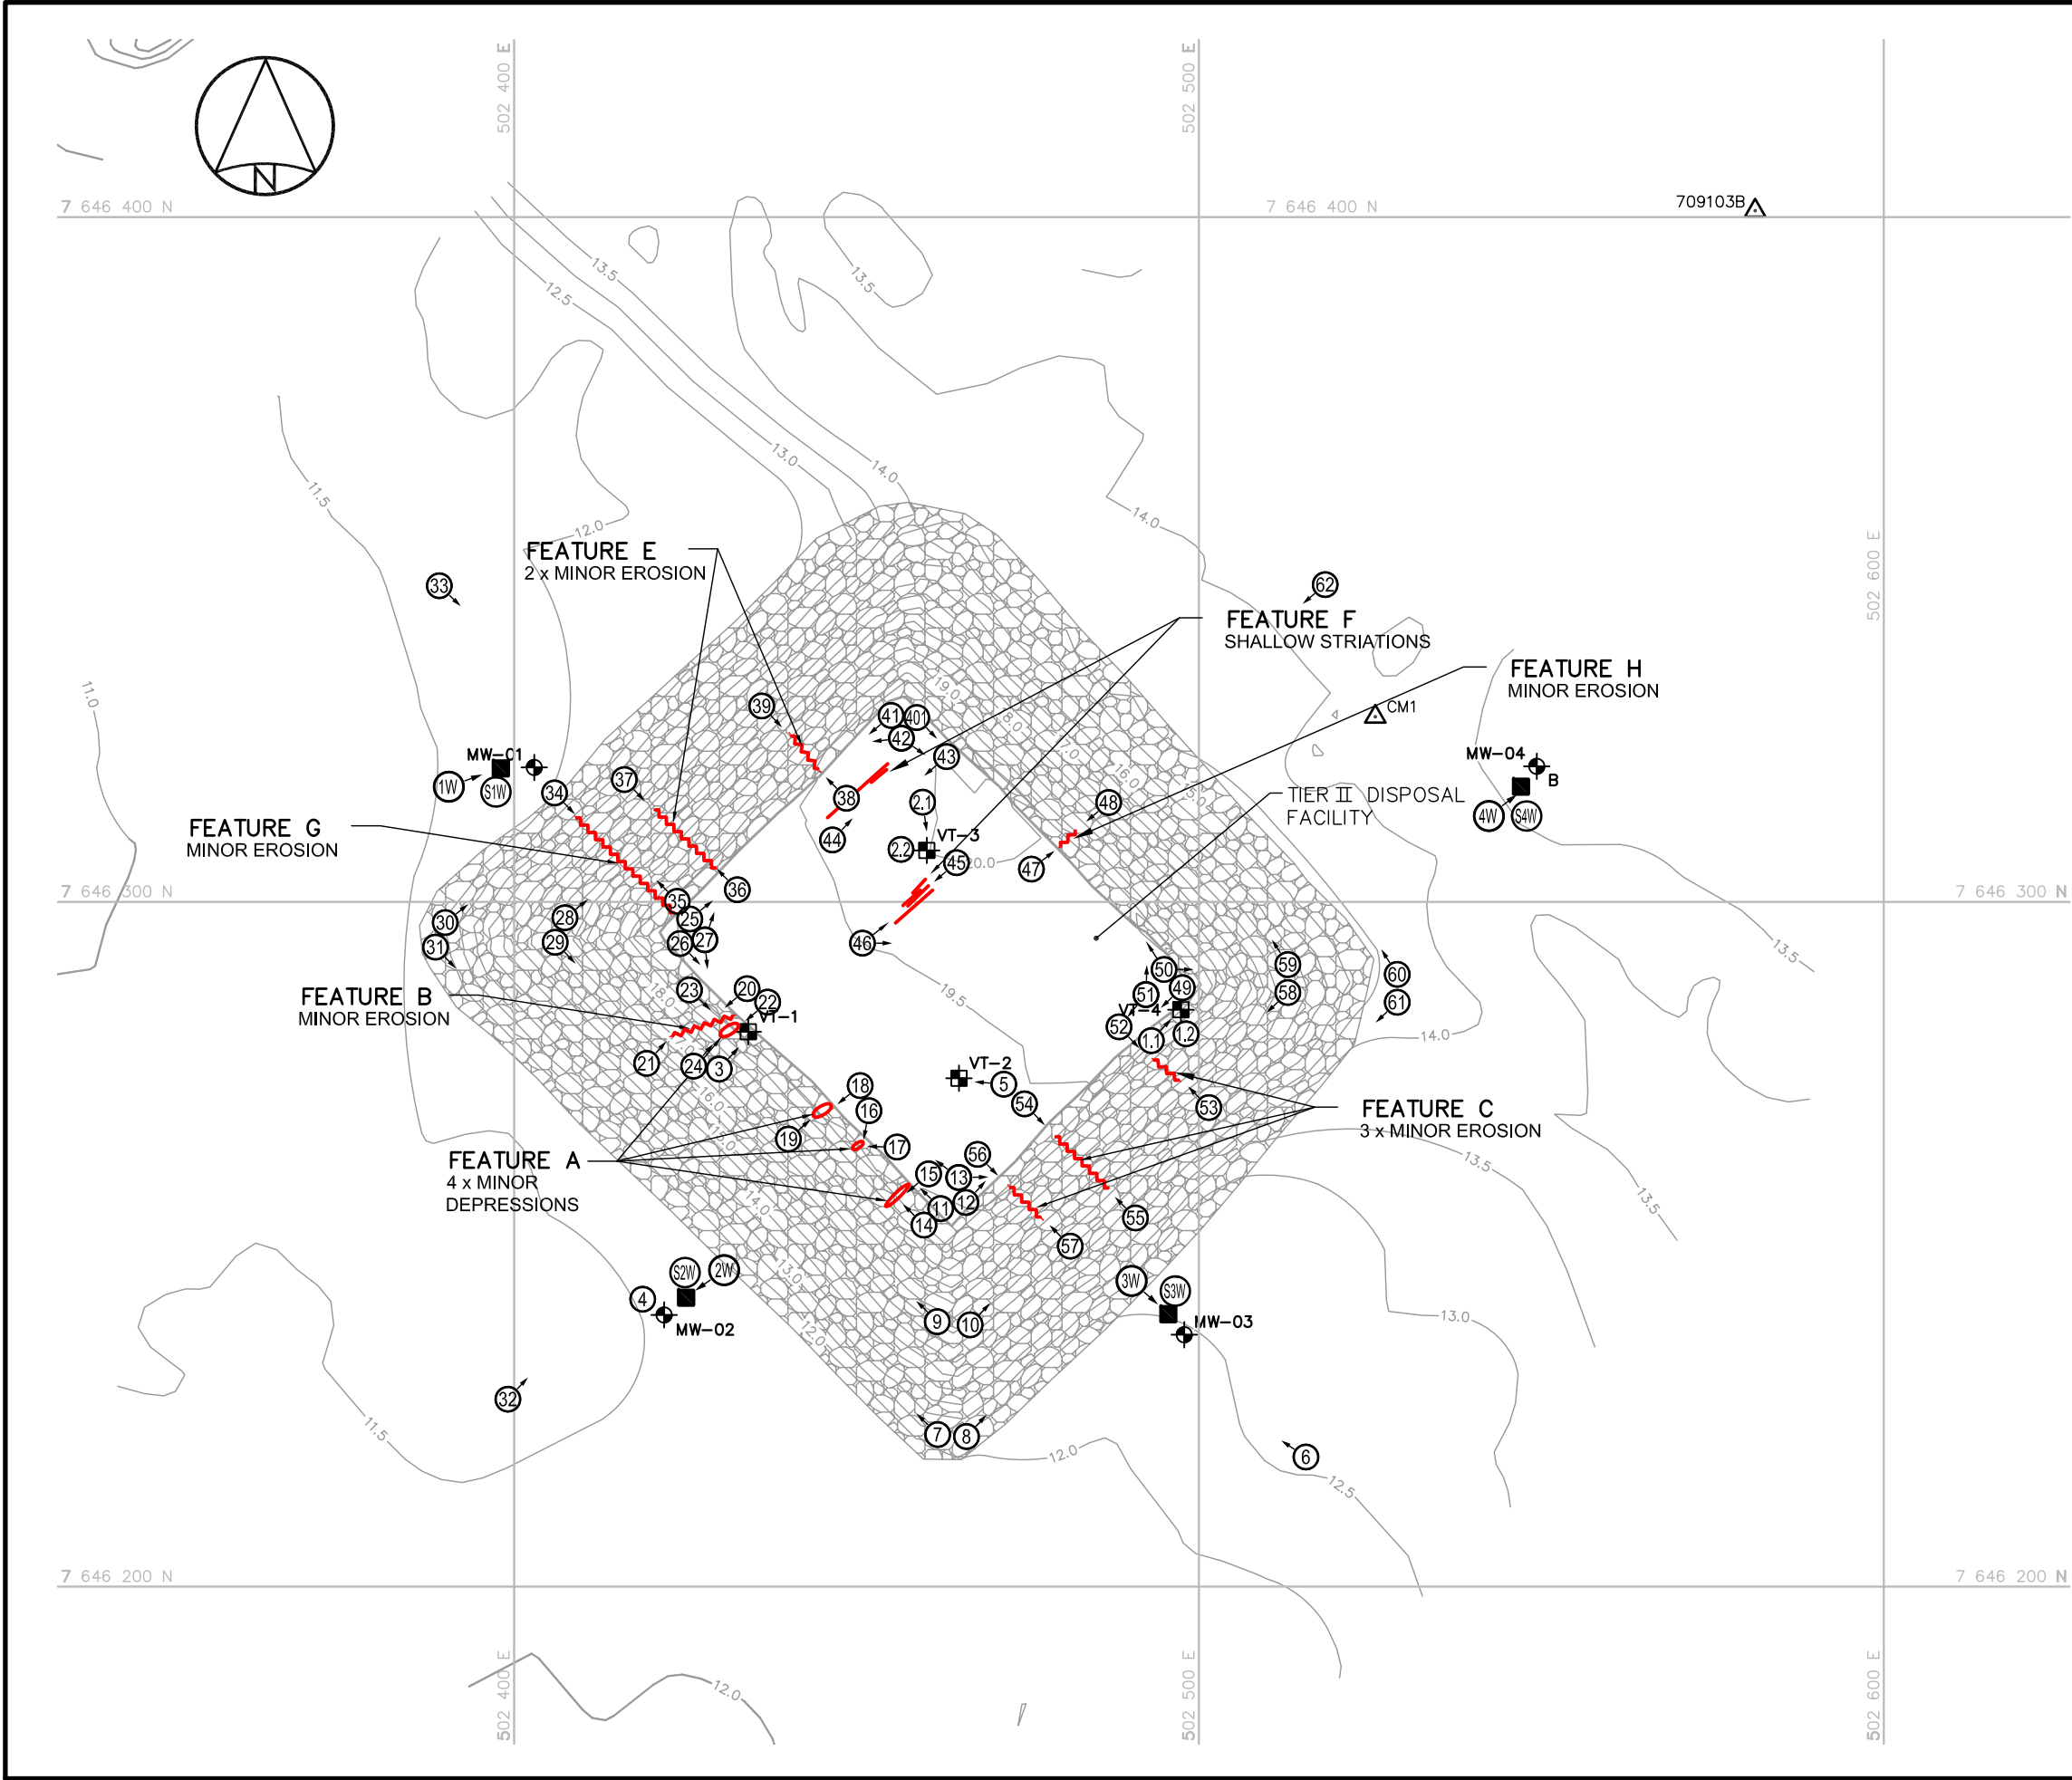
The Location Plan for the Tier II Soil Disposal Facility has been completed as per the TOR and is included in the following page as Figure PIN-2.4.

As of the 2015 monitoring event, no features were identified with “significant” or “unacceptable” severity ratings. Indications of minor settlement were noted at four locations on the Tier II Disposal Facility (Feature A), including: one linear depression below VT-1 and three localized oval-shaped depressions along the southwest crest. All depressions appear consistent with findings from the previous 2014 assessment, with the exception of the depression below VT-1, which notably increased in length from 0.6 to 3.0 m between the 2014 and 2015 inspection periods. Feature D, a single localized depression previously observed on the northeast crest, was not noted during the 2015 inspection.

Evidence of minor surface erosion was noted at eight locations on the Tier II Disposal Facility, including: a single location on the southeast side slope below VT-1 (Feature B); three locations on the southeast side slope (Feature C); two locations on the northwest side slope (Feature E); a newly observed single location on the northwest side slope (Feature G); and a newly observed single location on the NE side slope (Feature H). All locations consisted of shallow surface erosion of fines that extended from the crest down slope. The facility side slopes appear stable and self armouring at all erosion locations, with only minor washing of fines noted. With the exception of new Features G and H, all other erosional features appear consistent with findings from the 2014 assessment. Several northeast-southwest orientated linear striations were noted on the north cover of the facility (Feature F). The striations appear consistent with findings from the previous 2014 assessment. No exposed debris were noted.

Checklist Item	Present (Yes/No)	Location	Length	Width	Depth	Extent	Description	Photographic Record	Severity Rating	Additional Comments
Settlement	Yes	FEATURE A See Figure PIN-2.4 (SW crest)	0.4 -3.0 m	0.3 - 0.6 m	0.1 - 0.15 m	Occasional (< 2%)	4 Minor depressions	Tier II-14-19, 22-24	Acceptable	Linear and oval shaped depressions. Increase in length of feature southwest of VT-1. No other changes from 2014 assessment.
		FEATURE D See Figure PIN-2.4 (NE crest)	0.7 m	0.3 m	0.15 m	Isolated	Minor depression	-	Not Observable	Feature not observed during 2015 inspection.
Erosion	Yes	FEATURE B See Figure PIN-2.4 (SW side slope near VT-1)	7 m	0.1-0.15 m	0.02 m	Isolated (< 1%)	Minor erosion	Tier II-20, 21	Acceptable	Single location. Washing of fines, self armouring. Slope appears stable. Associated with settlement feature below VT-1 (Feature A). No significant change from 2014 assessment.
		FEATURE C See Figure PIN-2.4 (SE side slope)	5 - 12 m	0.1 - 0.3 m	0.05 m	Occasional (< 2%)	Minor erosion	Tier II-52-57	Acceptable	3 locations. Washing of fines, self armouring. Slope appears stable. No significant change from 2014 assessment.

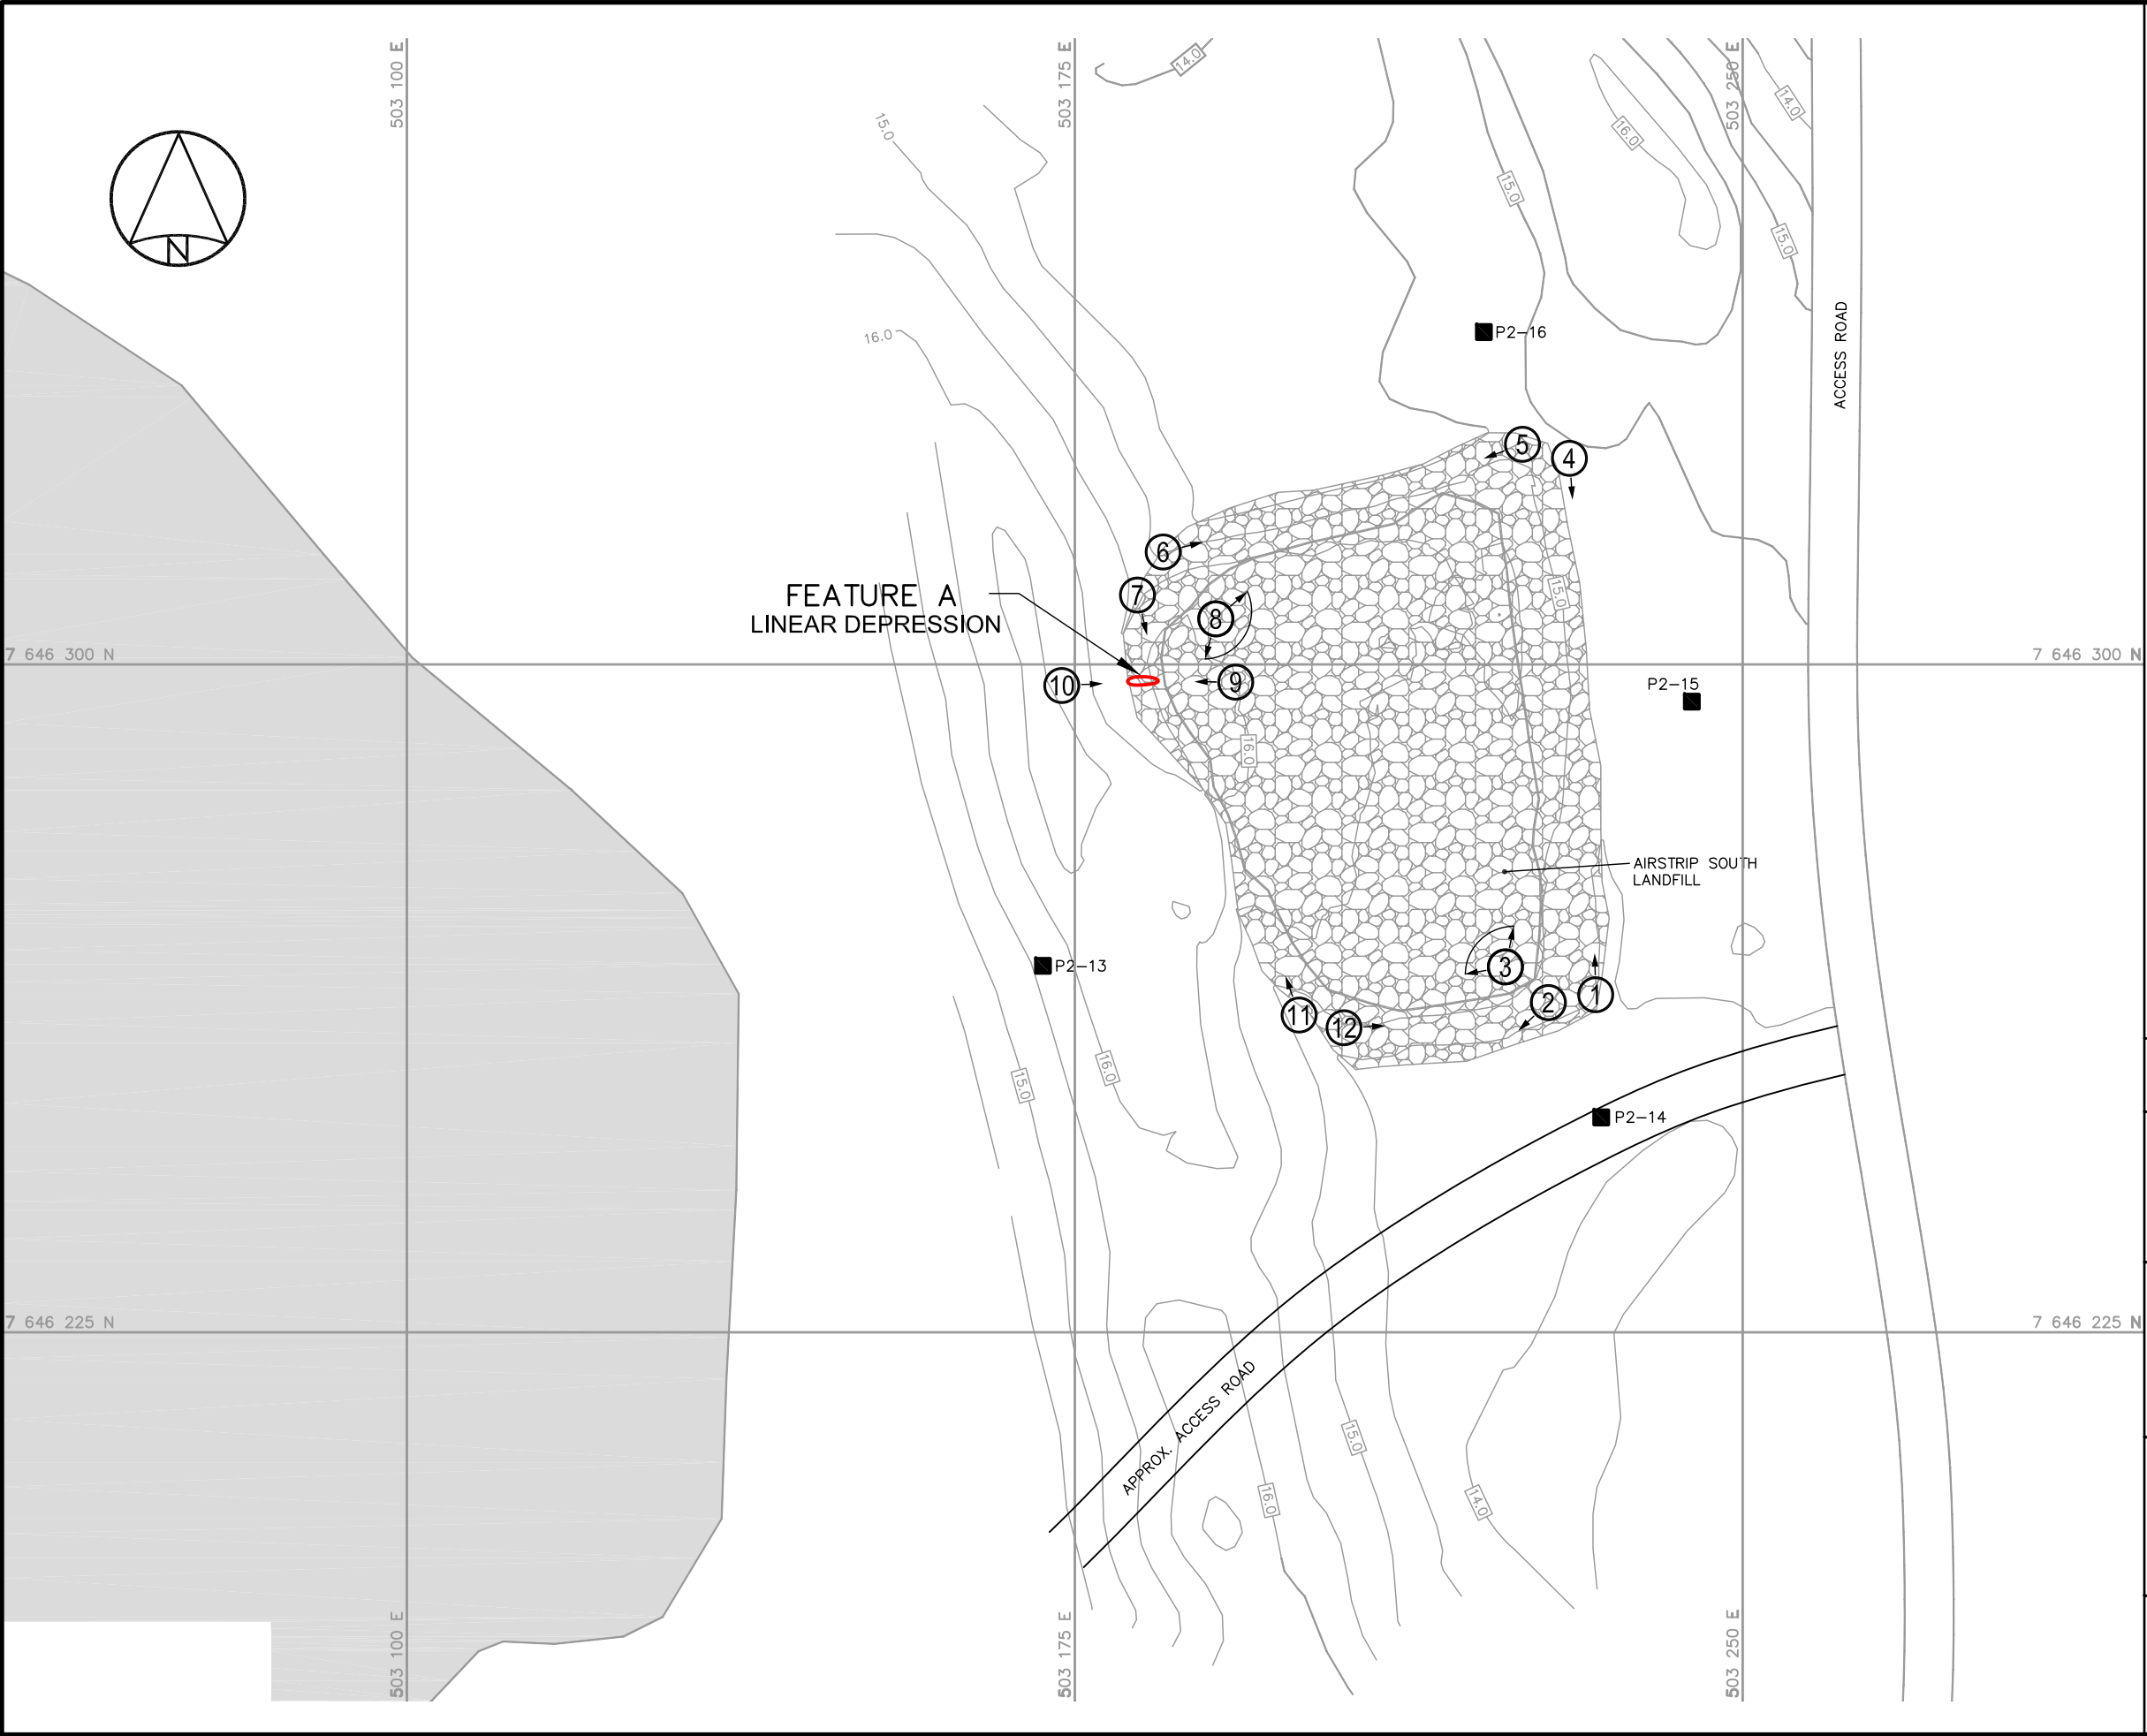
The Location Plan for the Airstrip South Landfill has been completed as per the TOR and is presented in Figure PIN-2.5.

As of the 2015 monitoring event, no features were identified with “significant” or “unacceptable” severity ratings. A single area of minor settlement (Feature A) was noted on the west side slope of the Airstrip South Landfill and was consistent with the previous 2014 observation.

Checklist Item	Present (Yes/No)	Location	Length	Width	Depth	Extent	Description	Photographic Record	Severity Rating	Additional Comments
Settlement	Yes	FEATURE A See Figure PIN-2.5 (W side slope)	6 m	0.3 m	0.1 m	Isolated < 1%	Linear depression	ASLF-9, 10	Acceptable	Shallow depression. Slope appears stable. No noteable change since initial observation in 2014.
Erosion	No	N/A	N/A	N/A	N/A	N/A	N/A	N/A	Not Observable	N/A
Frost Action	No	N/A	N/A	N/A	N/A	N/A	N/A	N/A	Not Observable	N/A
Animal Burrows	No	N/A	N/A	N/A	N/A	N/A	N/A	N/A	Not Observable	N/A
Vegetation	No	N/A	N/A	N/A	N/A	N/A	N/A	N/A	Not Observable	N/A
Staining	No	N/A	N/A	N/A	N/A	N/A	N/A	N/A	Not Observable	N/A
Vegetation Stress	No	N/A	N/A	N/A	N/A	N/A	N/A	N/A	Not Observable	N/A
Seepage Points	No	N/A	N/A	N/A	N/A	N/A	N/A	N/A	Not Observable	N/A
Debris Exposed	No	N/A	N/A	N/A	N/A	N/A	N/A	N/A	Not Observable	N/A
Presence/Condition of Monitoring Instruments	No	N/A	N/A	N/A	N/A	N/A	N/A	N/A	Not Observable	N/A
