Site Photographs

Long Term Monitoring, 2017
PIN-B, Clifton Point, Nunavut

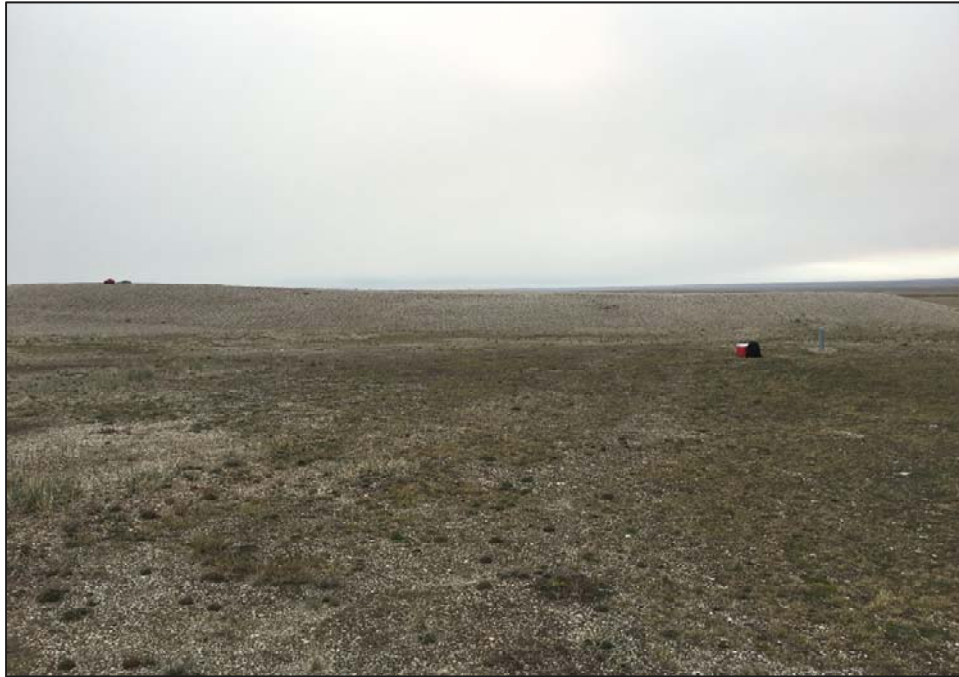
Photo: 1

Northwest side of the NHL.
Monitoring Well MW1 in
middle of photo, on right
hand side.

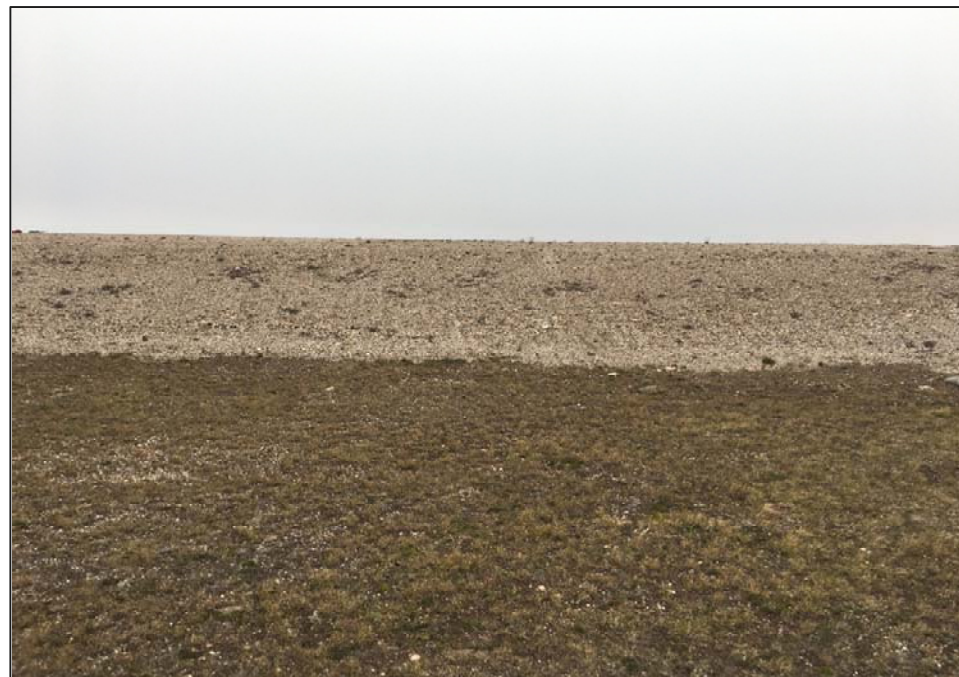
Photo: 2

Southwest side of the NHL.

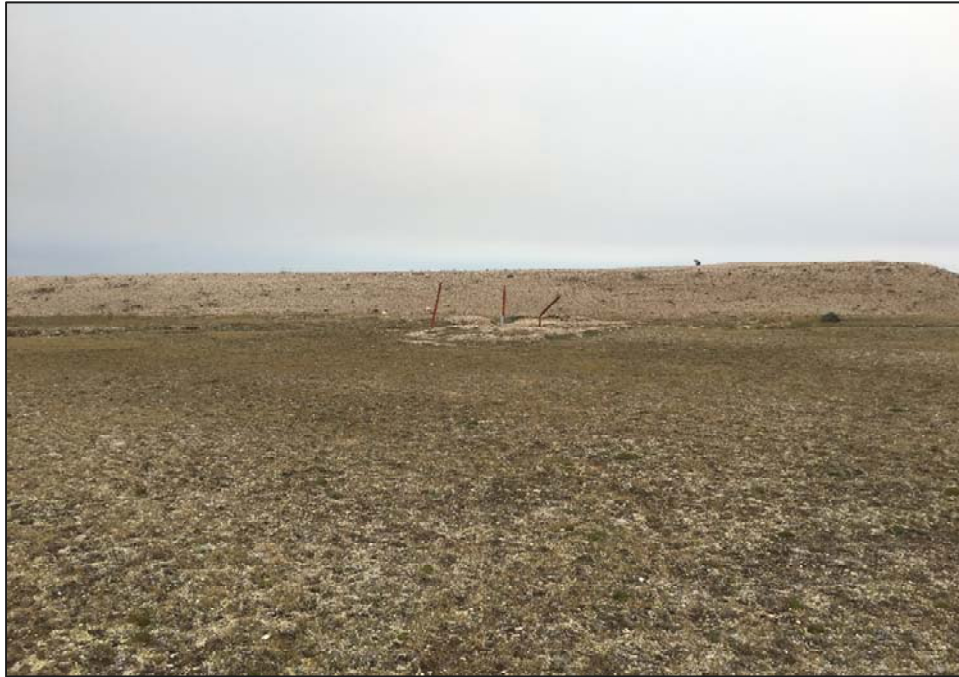
Photo: 3

Southeast side of the NHWL.
Monitoring Well MW3 in
foreground at red stakes.

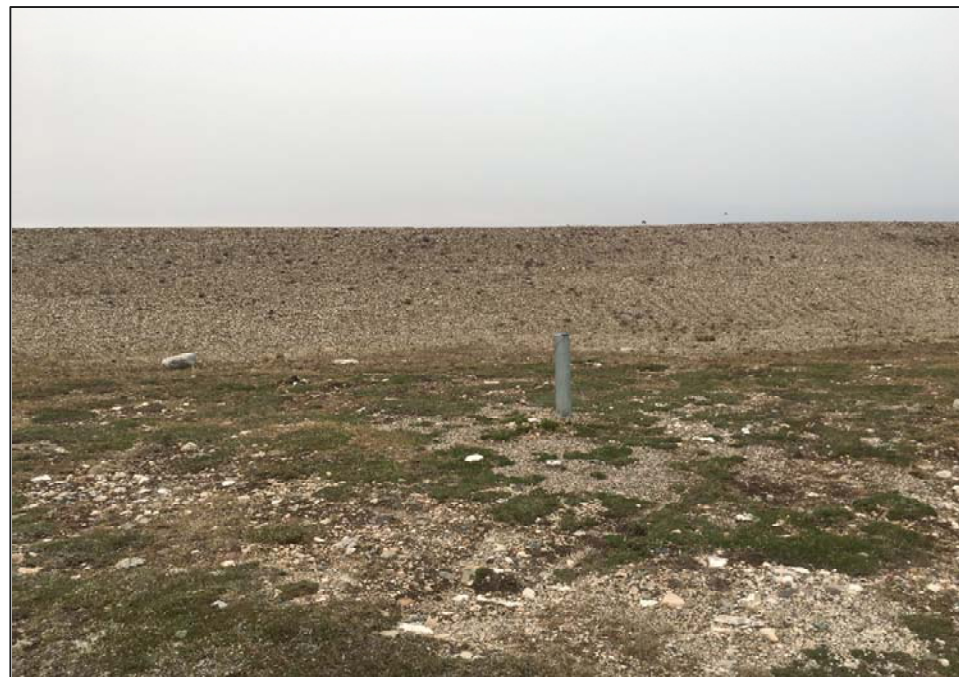
Photo: 4

Northeast side of the NHWL.
Monitoring Well MW4 in
foreground.

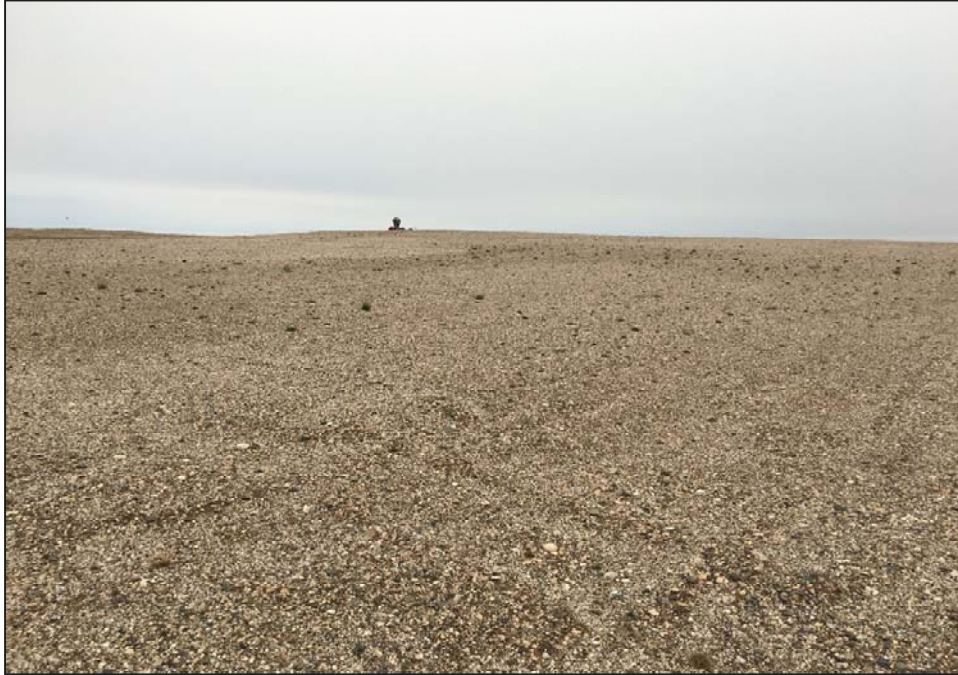
Photo: 5

View of grading on surface of
NHWL.

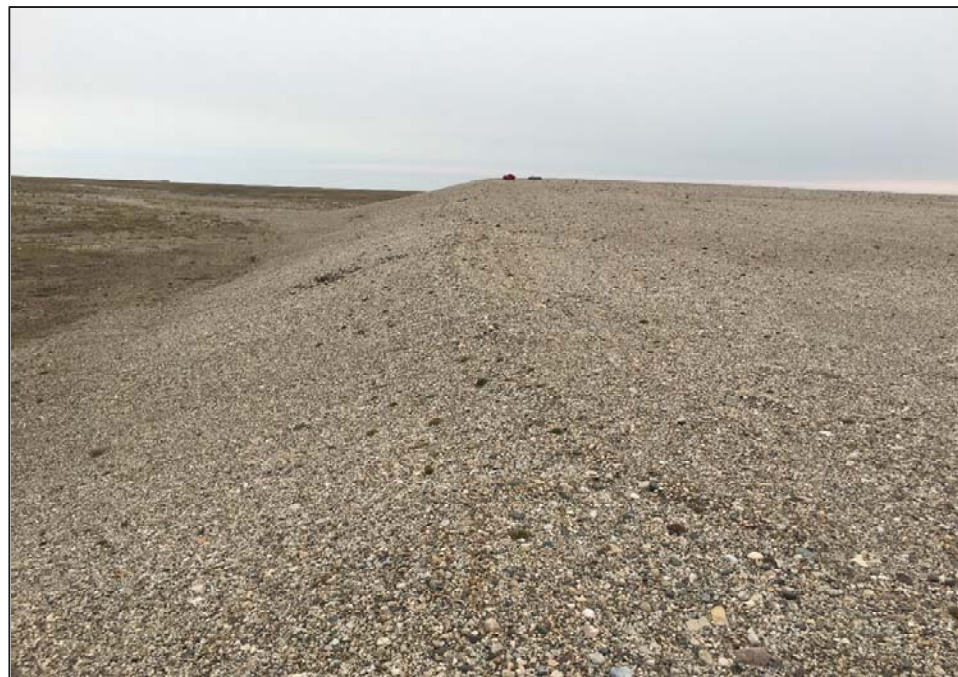
Photo: 6

View of grading of slope on
northwest side of NHWL.
Typical of all sides.

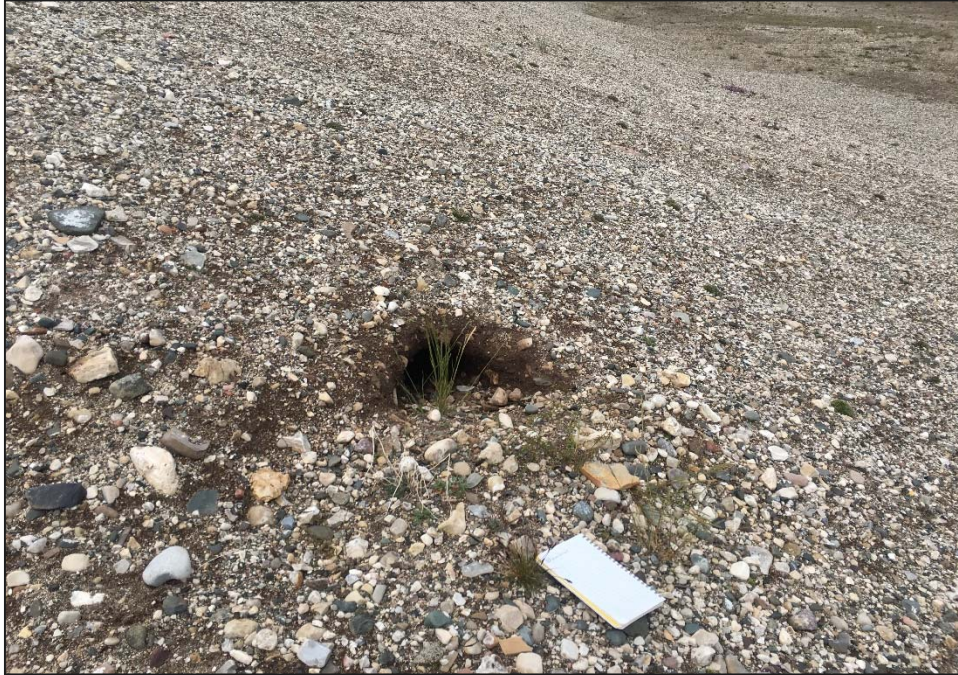
Photo: 7

View of an animal burrow near the north corner of the NHWL (Feature A).

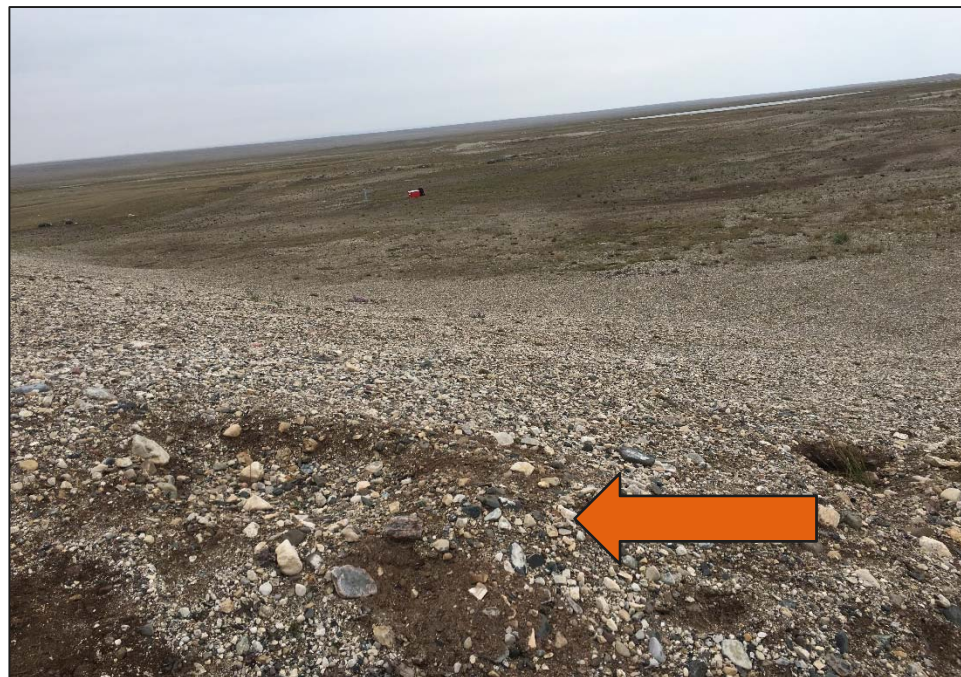
Photo: 8

View of attempted animal burrow, since filled in. Previously-noted animal burrow (Feature A) seen at right of photo.

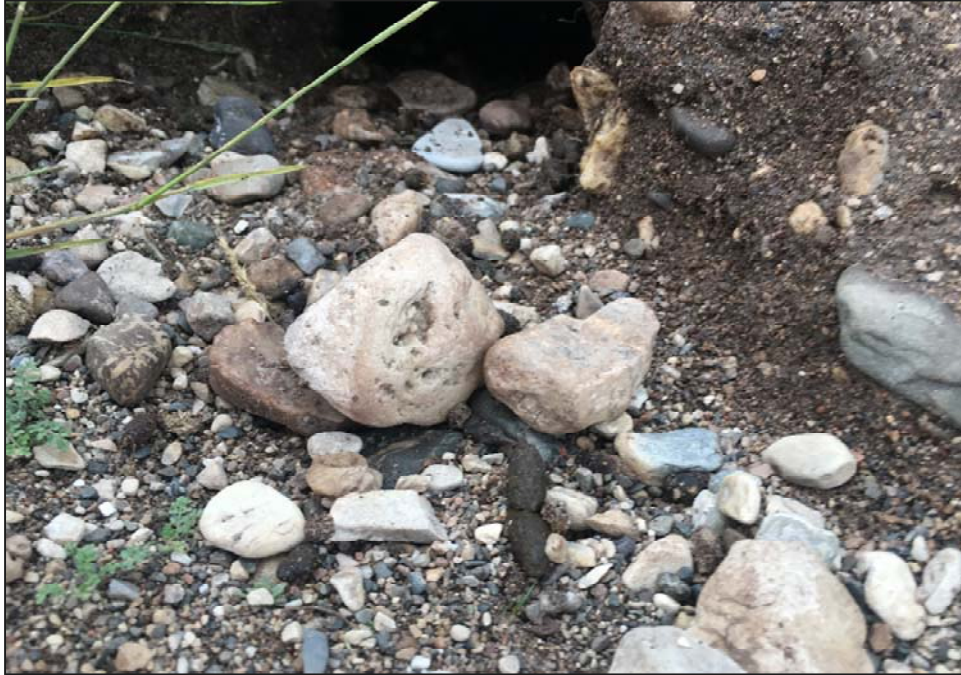
Photo: 9

View of droppings at animal burrow near the north corner of the NHWL (Feature A).

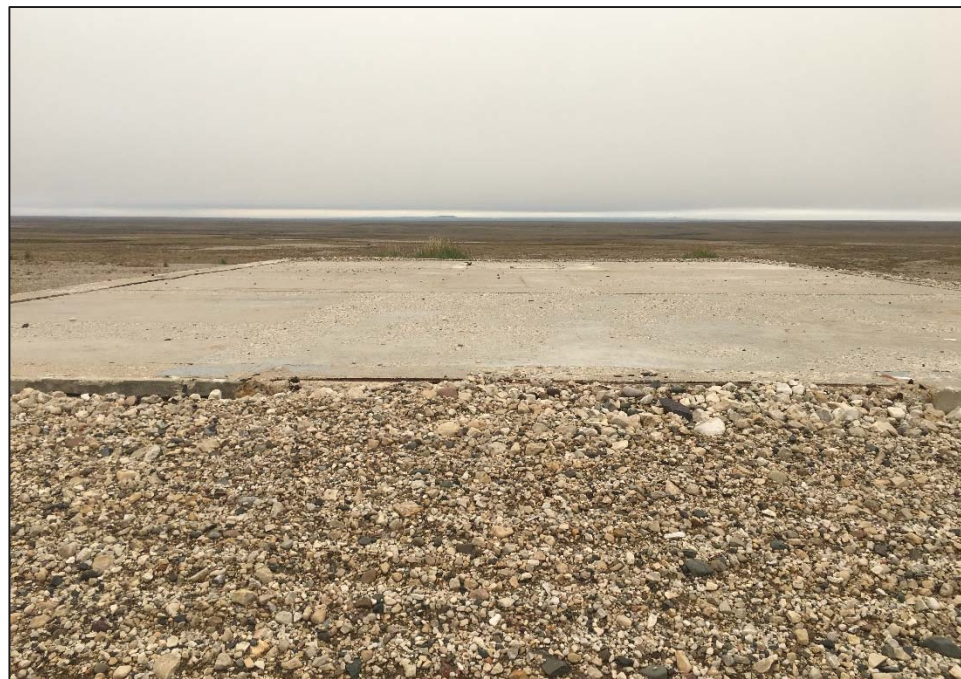
Photo: 10

One of four concrete pads at Main Station Area.

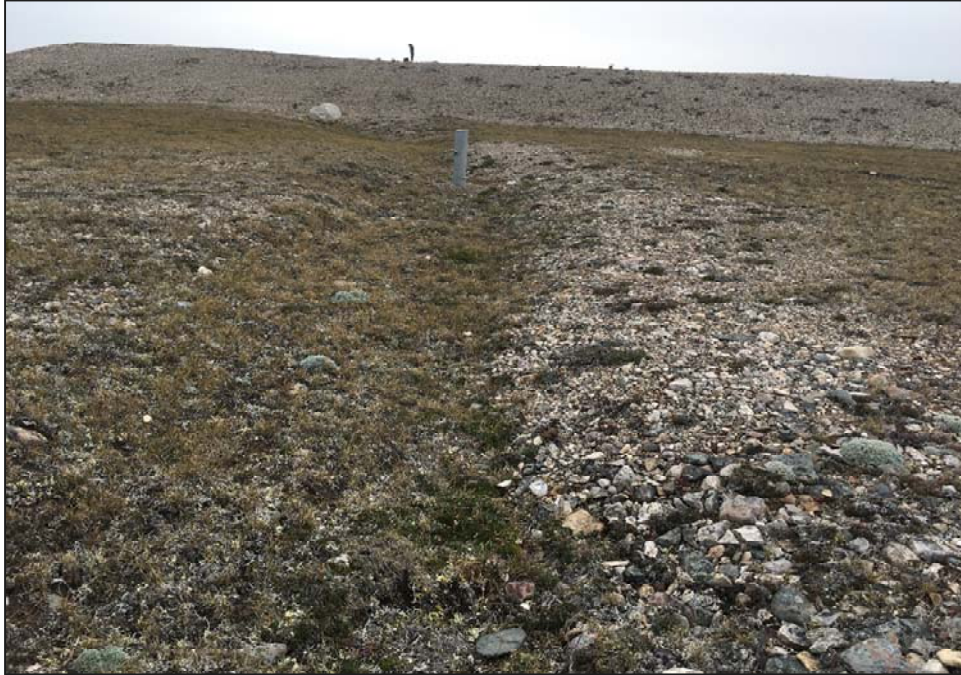
Photo: 11

View of natural drainage on the southwest side of NHWL (Feature B).

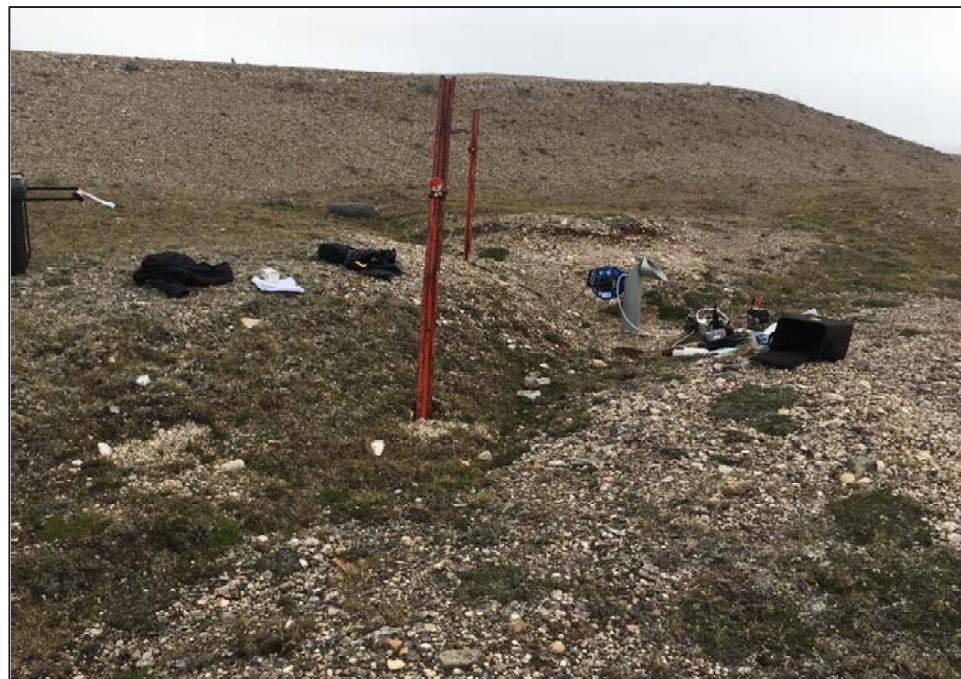
Photo: 12

View of drainage pathway on the southeast side of NHWL (Feature C).

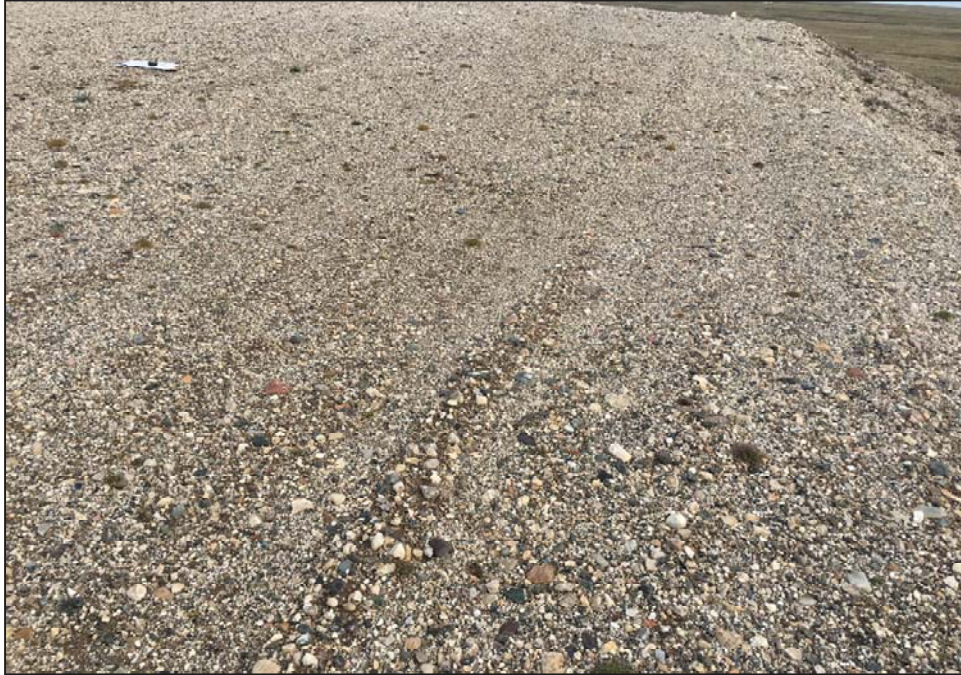
Photo: 13

View of previously identified settlement along the eastern side of the NHL (Feature D).

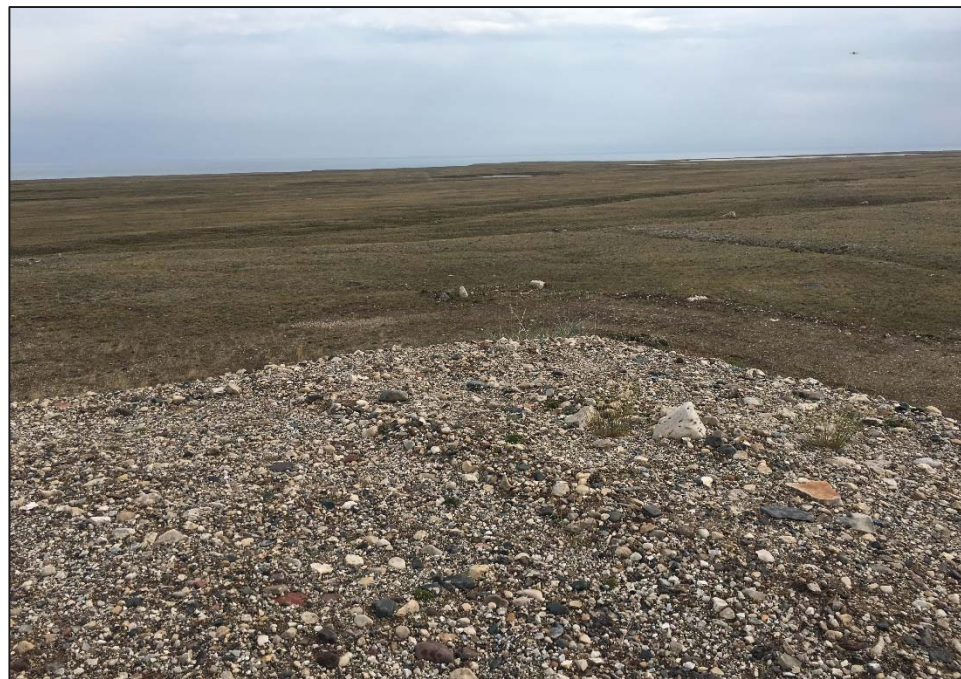
Photo: 14

View of newly identified settlement at the southeast corner of the NHL (Feature G)

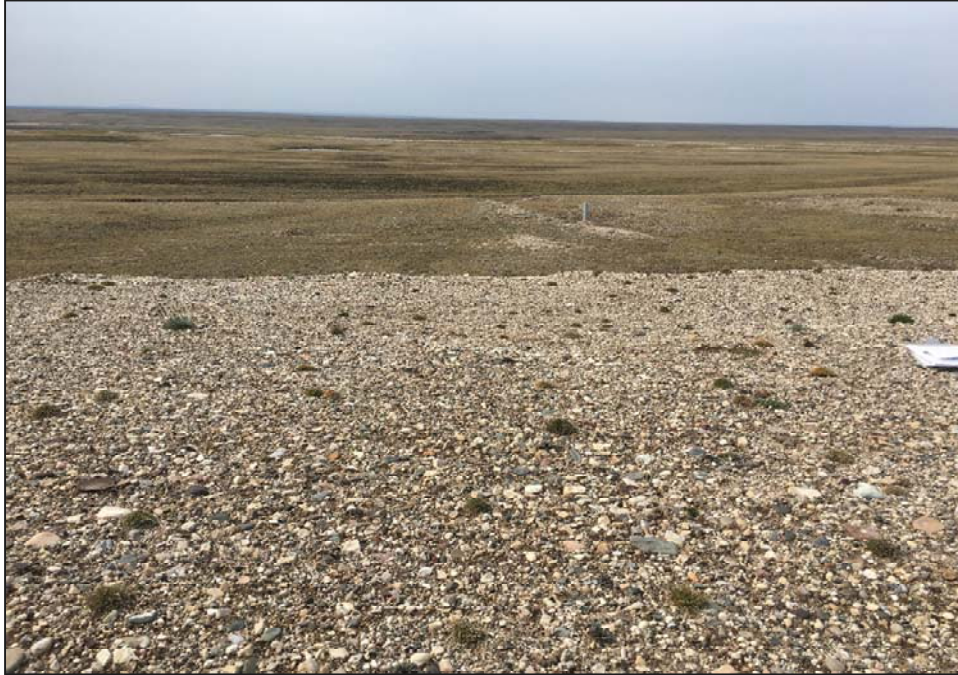
Photo: 15

View of newly identified settlement along the western side of the NHL (Feature I).

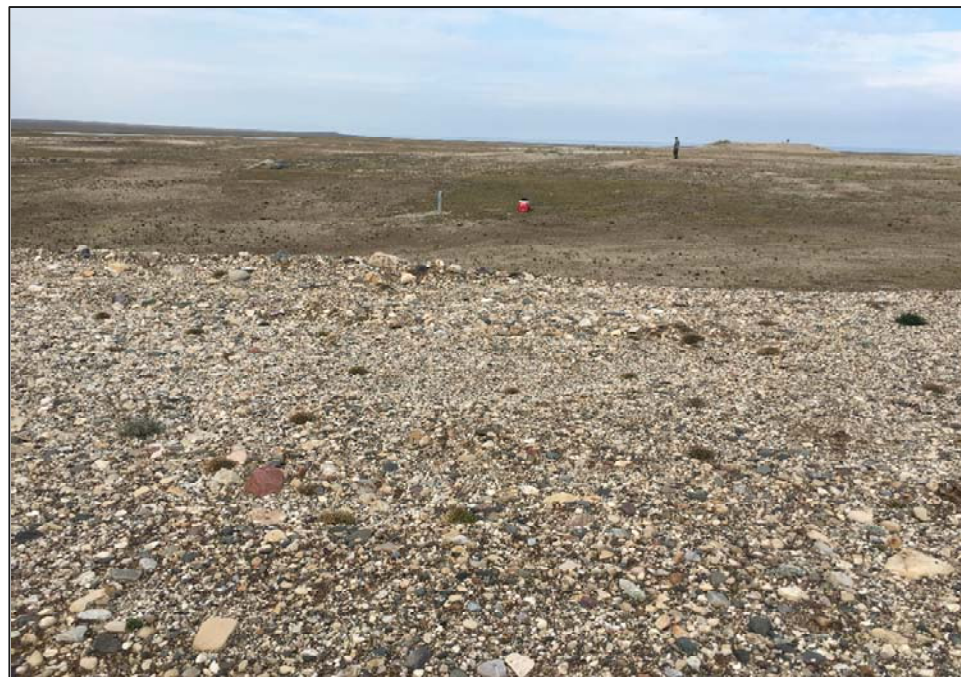
Photo: 16

View of newly identified settlement along the northwest side of the NHL (Feature H).
