Long Term Monitoring, 2011 PIN-B, Clifton Point, Nunavut

FINAL REPORT

Aboriginal Affairs and Northern Development Canada
Nunavut Regional Office
Iqaluit, Nunavut
X0A 0H0

Franz Environmental Inc.
329 Churchill Avenue, Suite 200
Ottawa, Ontario
K1Z 5B8
Tel. (613) 721-0555
Fax: (613) 721-0029

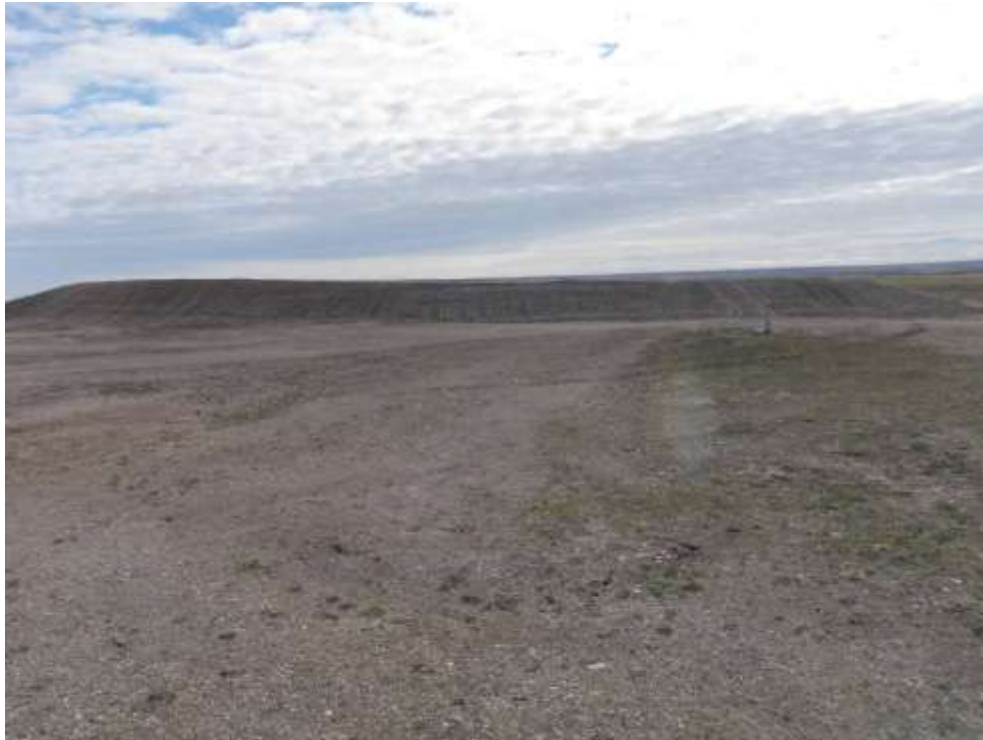
Northwest side of the NHWL. Monitoring Well 1 in foreground on right hand side. Viewpoint 42 (Figure A-2; Appendix A). Photograph reference 42 (CD-ROM). Direction photo taken: SE

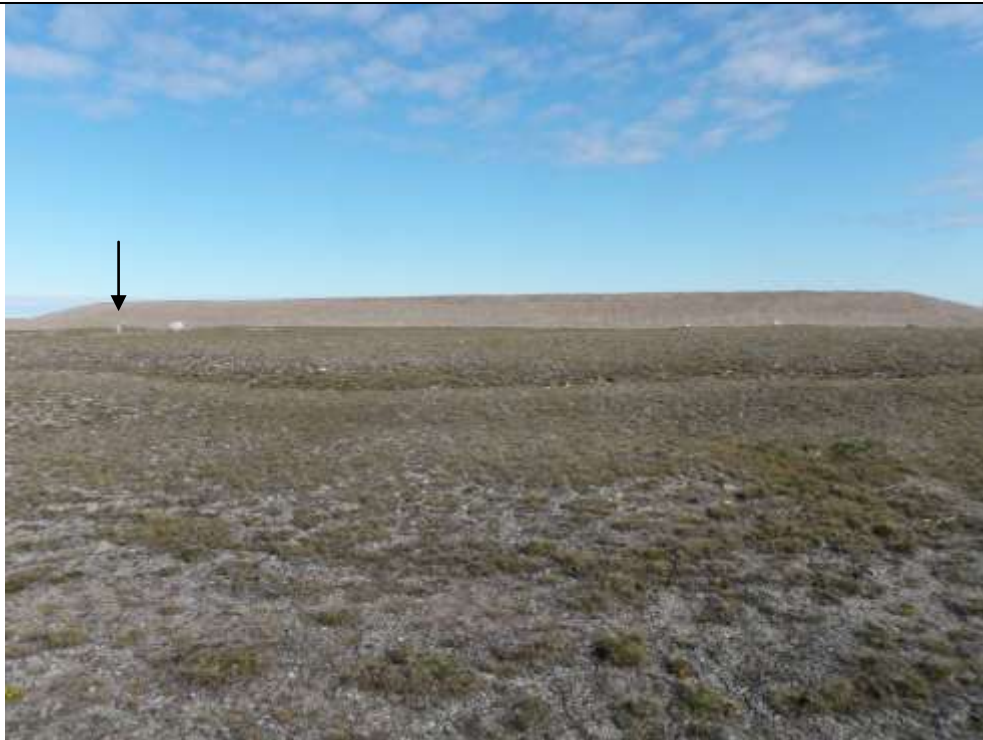
Southwest side of the NHWL. Monitoring Well 2 in foreground on left hand side (arrow). Viewpoint 31 (Figure A-2; Appendix A). Photograph reference 31 (CD-ROM). Direction photo taken: NE

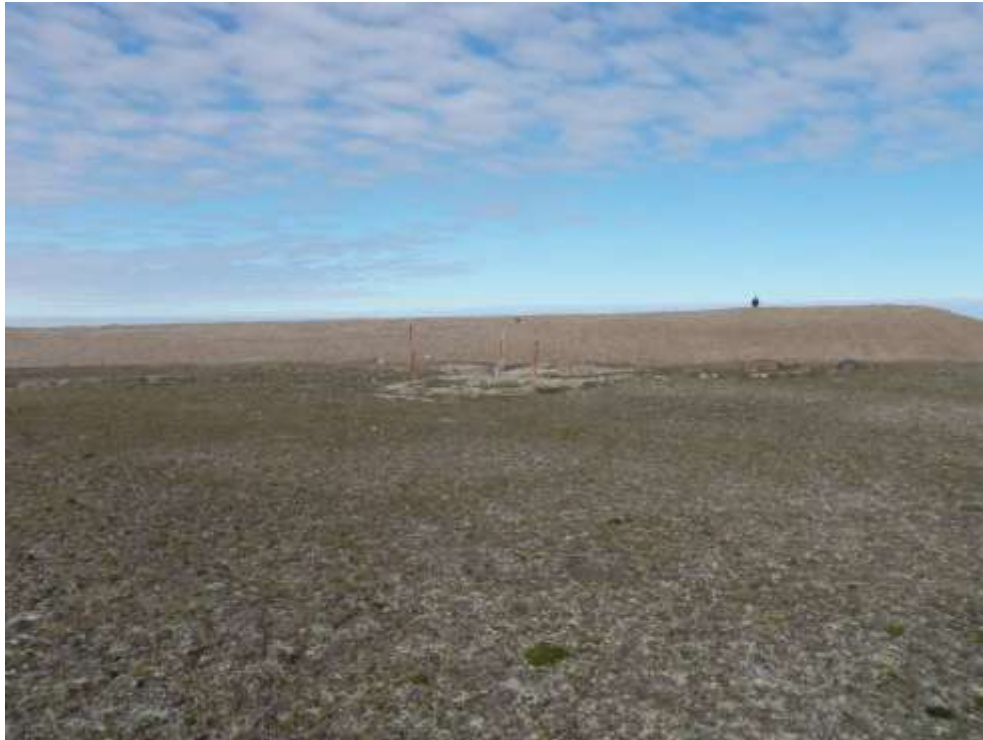
Southeast side of the NHL. Monitoring Well 3 in foreground at red stakes. Viewpoint 19 (Figure A-2; Appendix A). Photograph reference 19 (CD-ROM). Direction photo taken: NW

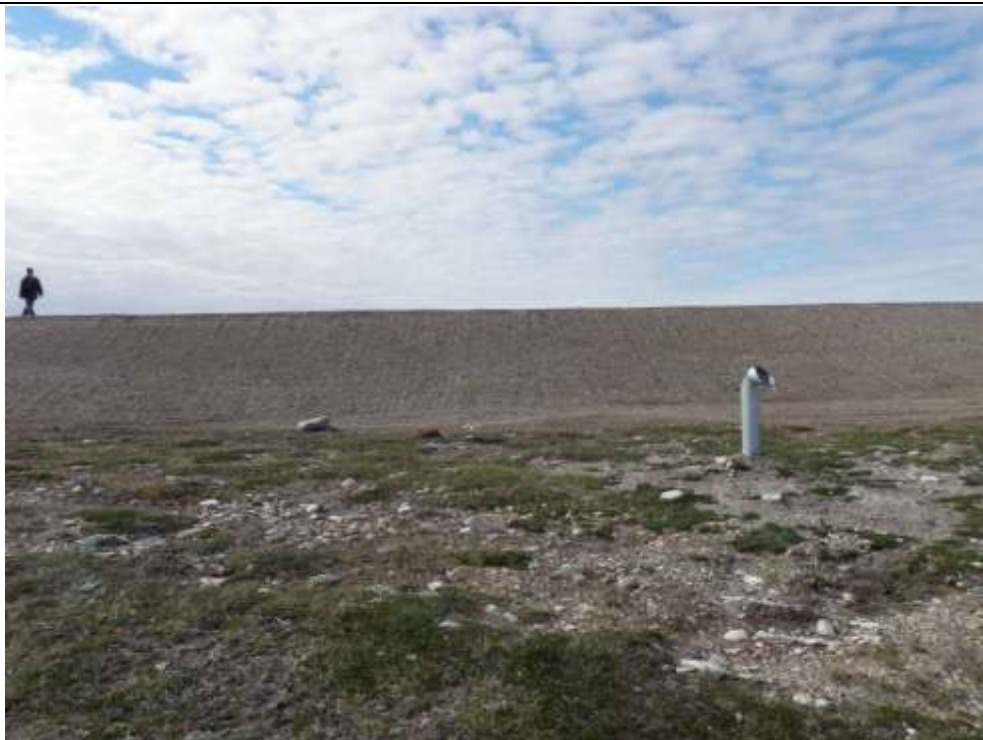
Northeast side of the NHL. Monitoring Well 4 in foreground. Viewpoint 17 (Figure A-2; Appendix A). Photograph reference 17 (CD-ROM). Direction photo taken: SW

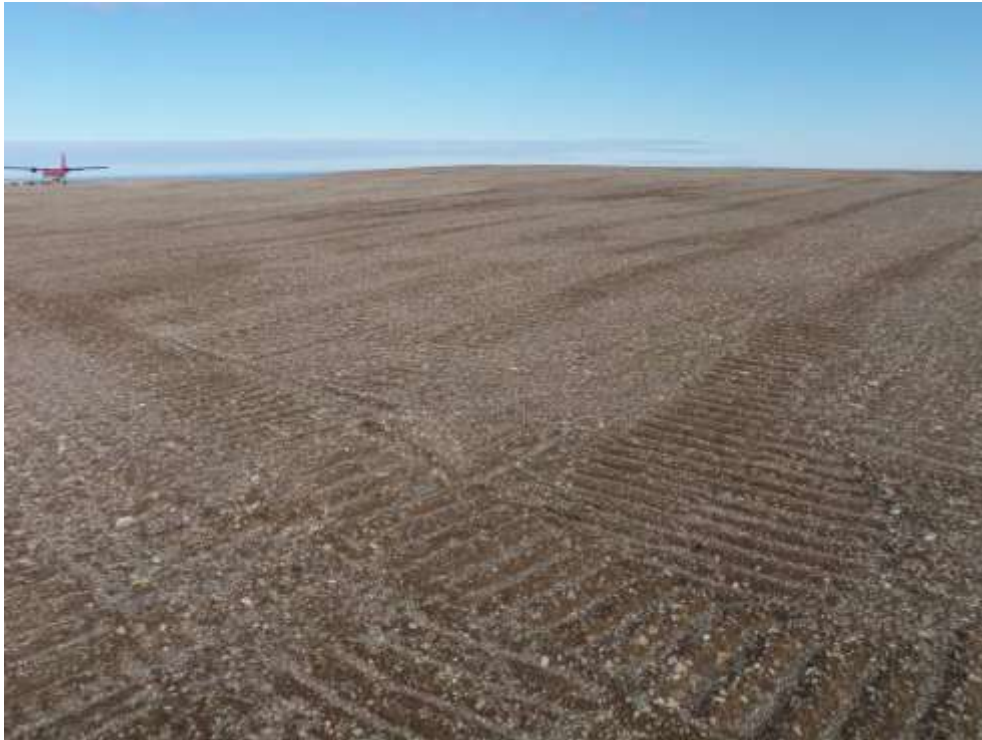
View of grading on surface of NHL. Viewpoint 25 (Figure A-2; Appendix A).
Photograph reference 25 (CD-ROM). Direction photo taken: N

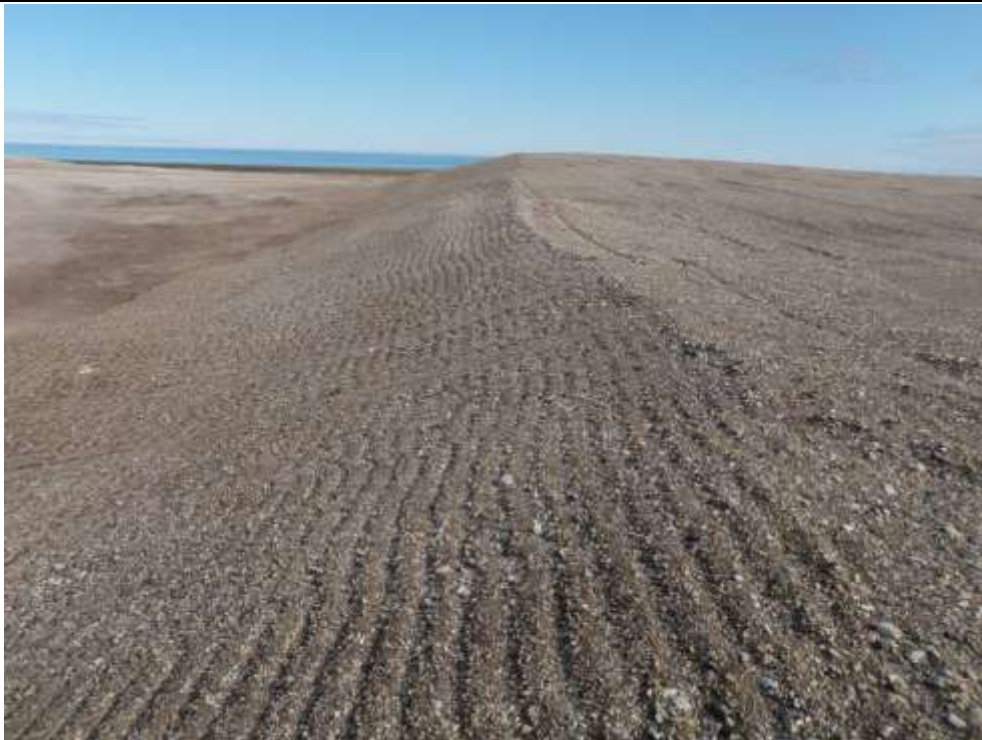
View of grading of slope on northwest side of NHL. Viewpoint 37 (Figure A-2; Appendix A).
Photograph reference 37 (CD-ROM). Direction photo taken: E

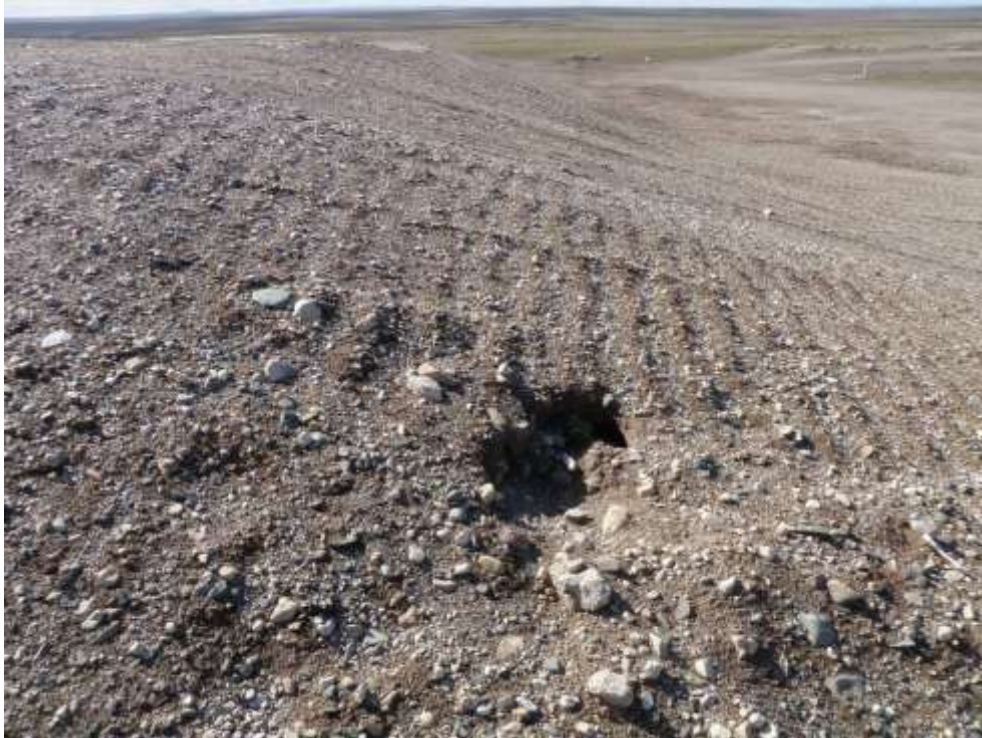
Evidence of a burrowing animal was observed in one location on the slope of north corner of the NHWL. It appeared as though an animal had attempted to dig a small burrow and deposited soil to one side, exposing larger cobbles (Photo 45, Appendix B). The volume of this burrow is

estimated at less than 1 m³. Animal tracks were not observed in the area. The integrity of the NHWL has not been impacted by the burrow.

View of an animal burrow near the north corner of the NHL. Viewpoint 45 (Figure A-2; Appendix A).
Photograph reference 45 (CD-ROM). Direction photo taken: SW

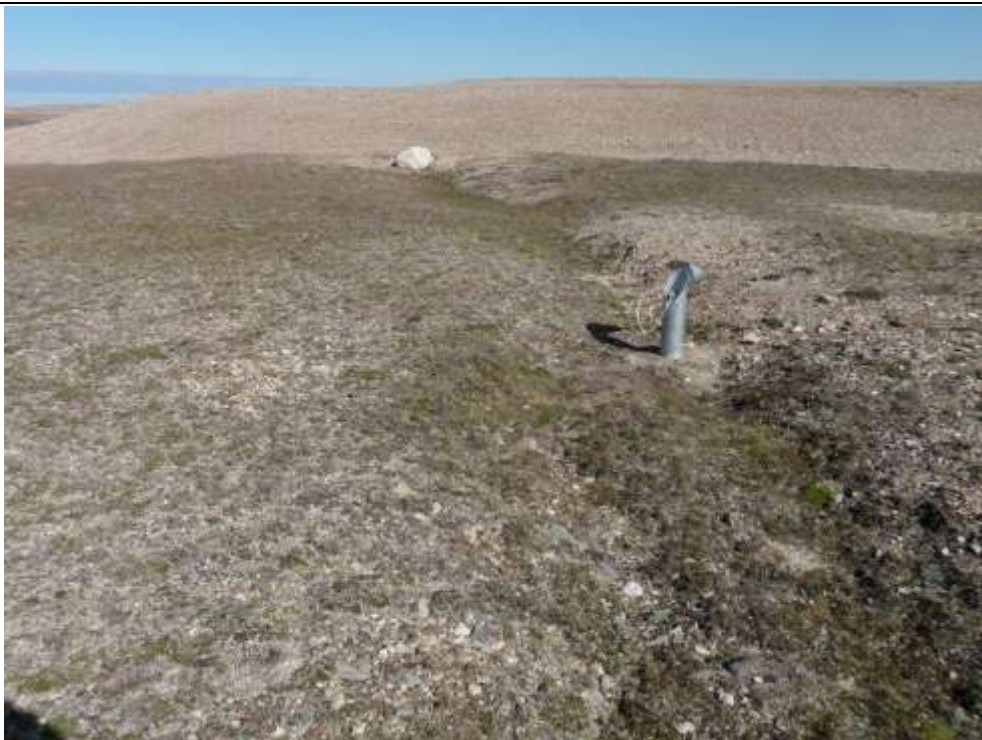
Two drainage pathways were noted during the NHWL inspection. One was observed on the southeast side of the landfill and one on the southwest side. Both drainage pathways appeared to be natural features of the topography in the area (Photo 46 and Photo 47, Appendix B). Erosion does not appear to be taking place in these drainage pathways, therefore the physical integrity of the NHWL has not been impacted.

View of natural drainage on the southwest side of NHL. Viewpoint 46 (Figure A-2; Appendix A). Photograph
reference 46 (CD-ROM). Direction photo taken: E

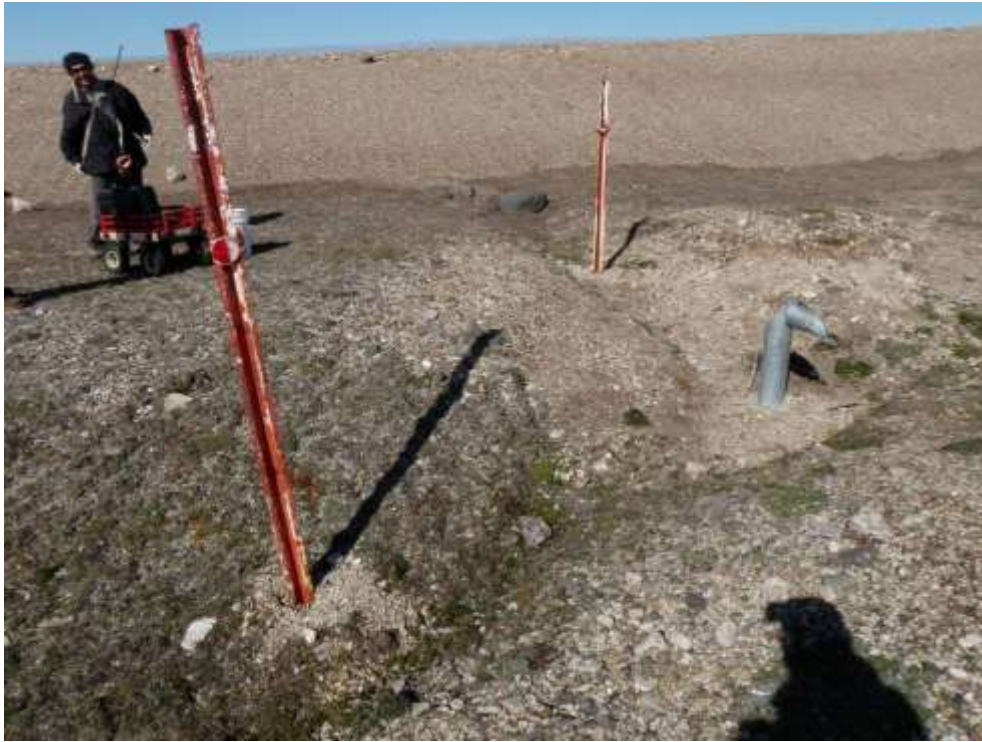
View of drainage pathway on the southeast side of NHWL. Viewpoint 47 (Figure A-2; Appendix A). Photograph reference 47 (CD-ROM). Direction photo taken: N

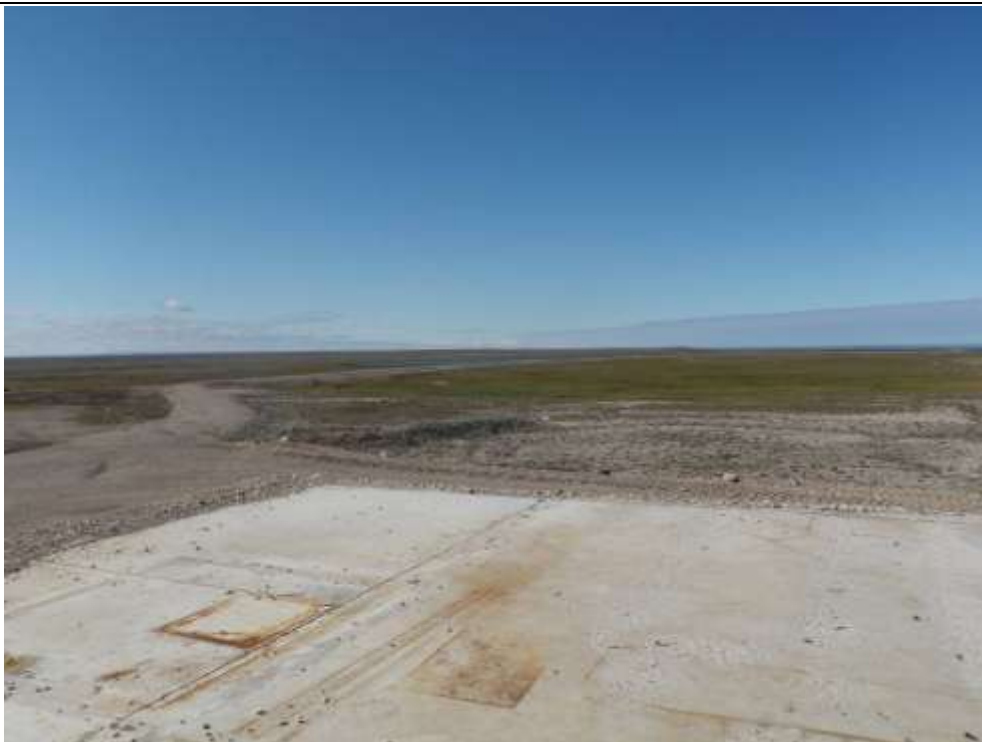
Concrete pad at Main Station Area. Photograph reference 49 (CD-ROM). Direction photo taken: N

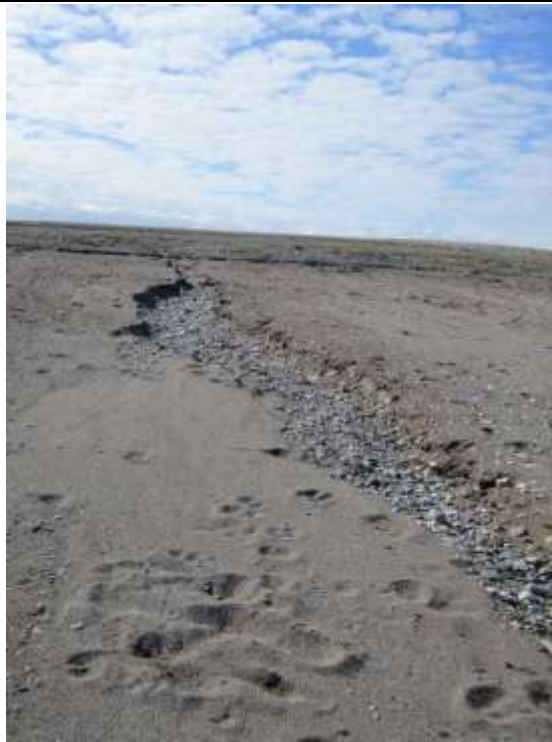
View of erosion channel at Beach Area. Photograph reference 50 (CD-ROM). Direction photo taken: SW

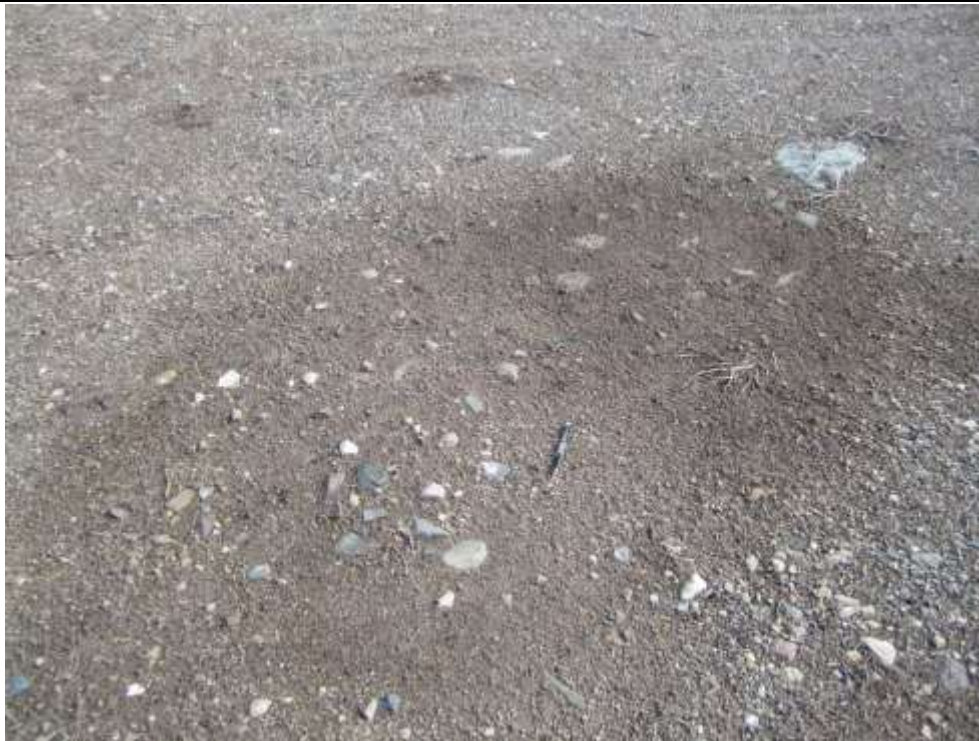
Soil staining at Area 7, the Station area, note pen at center for scale. Photograph reference 51 (CD-ROM). Direction photo taken: N/A

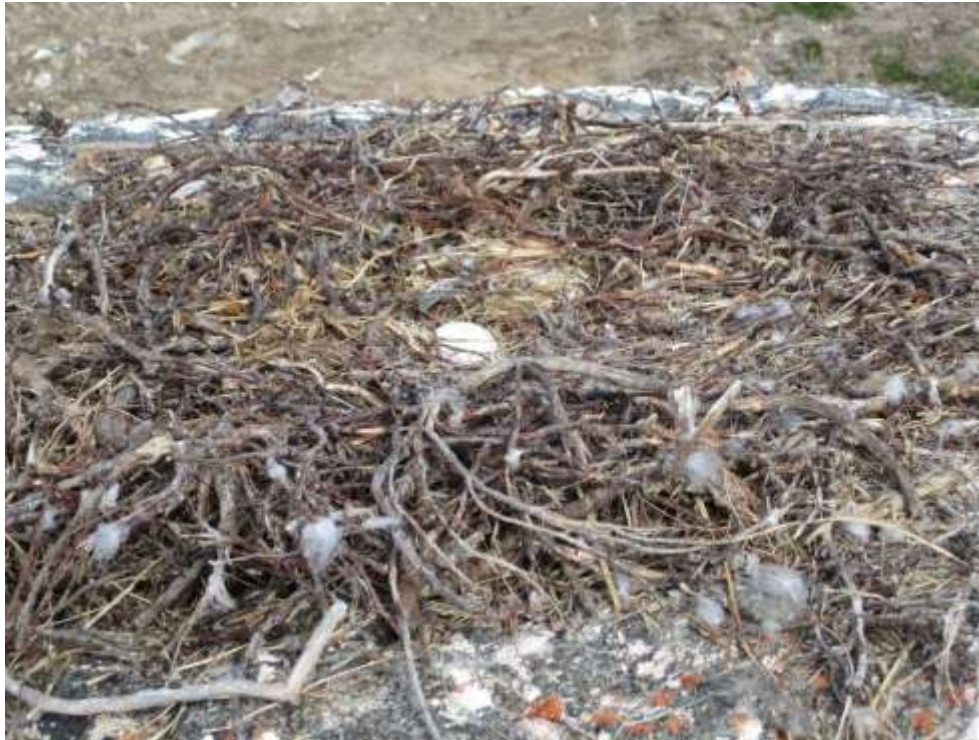
View of raptor nest at Construction Camp area. Photograph reference 54 (CD-ROM). Direction photo taken: N/A

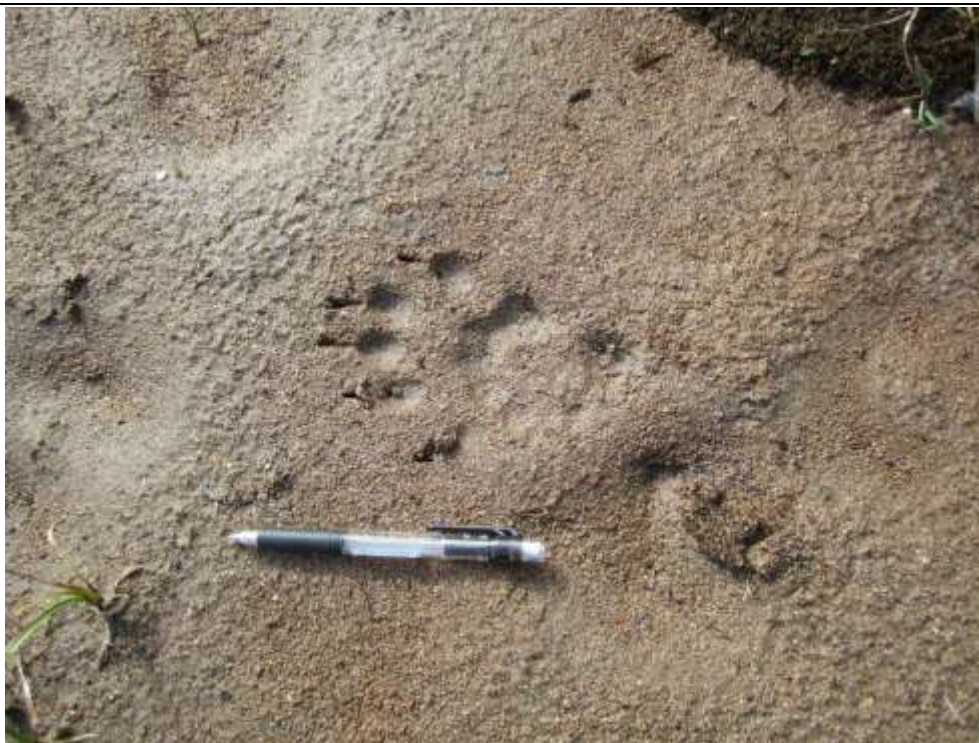
View of wolverine tracks at Construction Camp area. Photograph reference 55 (CD-ROM). Direction photo taken:
N/A

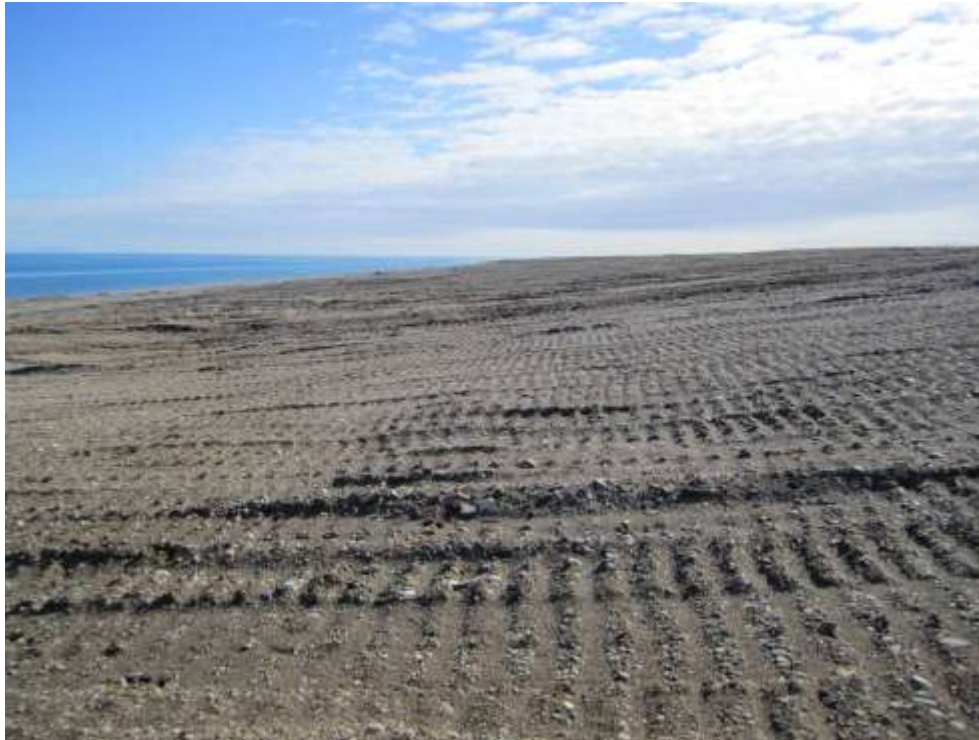
View of Beach Area re-graded after remediation. Photograph reference 56 (CD-ROM). Direction photo taken: SE
