Long Term Monitoring, 2013 PIN-B, Clifton Point, Nunavut

FINAL REPORT

Aboriginal Affairs and Northern Development Canada
Nunavut Regional Office
Iqaluit, Nunavut
X0A 0H0

Franz Environmental Inc.
329 Churchill Avenue, Suite 200
Ottawa, Ontario
K1Z 5B8
Tel. (613) 721-0555
Fax: (613) 721-0029

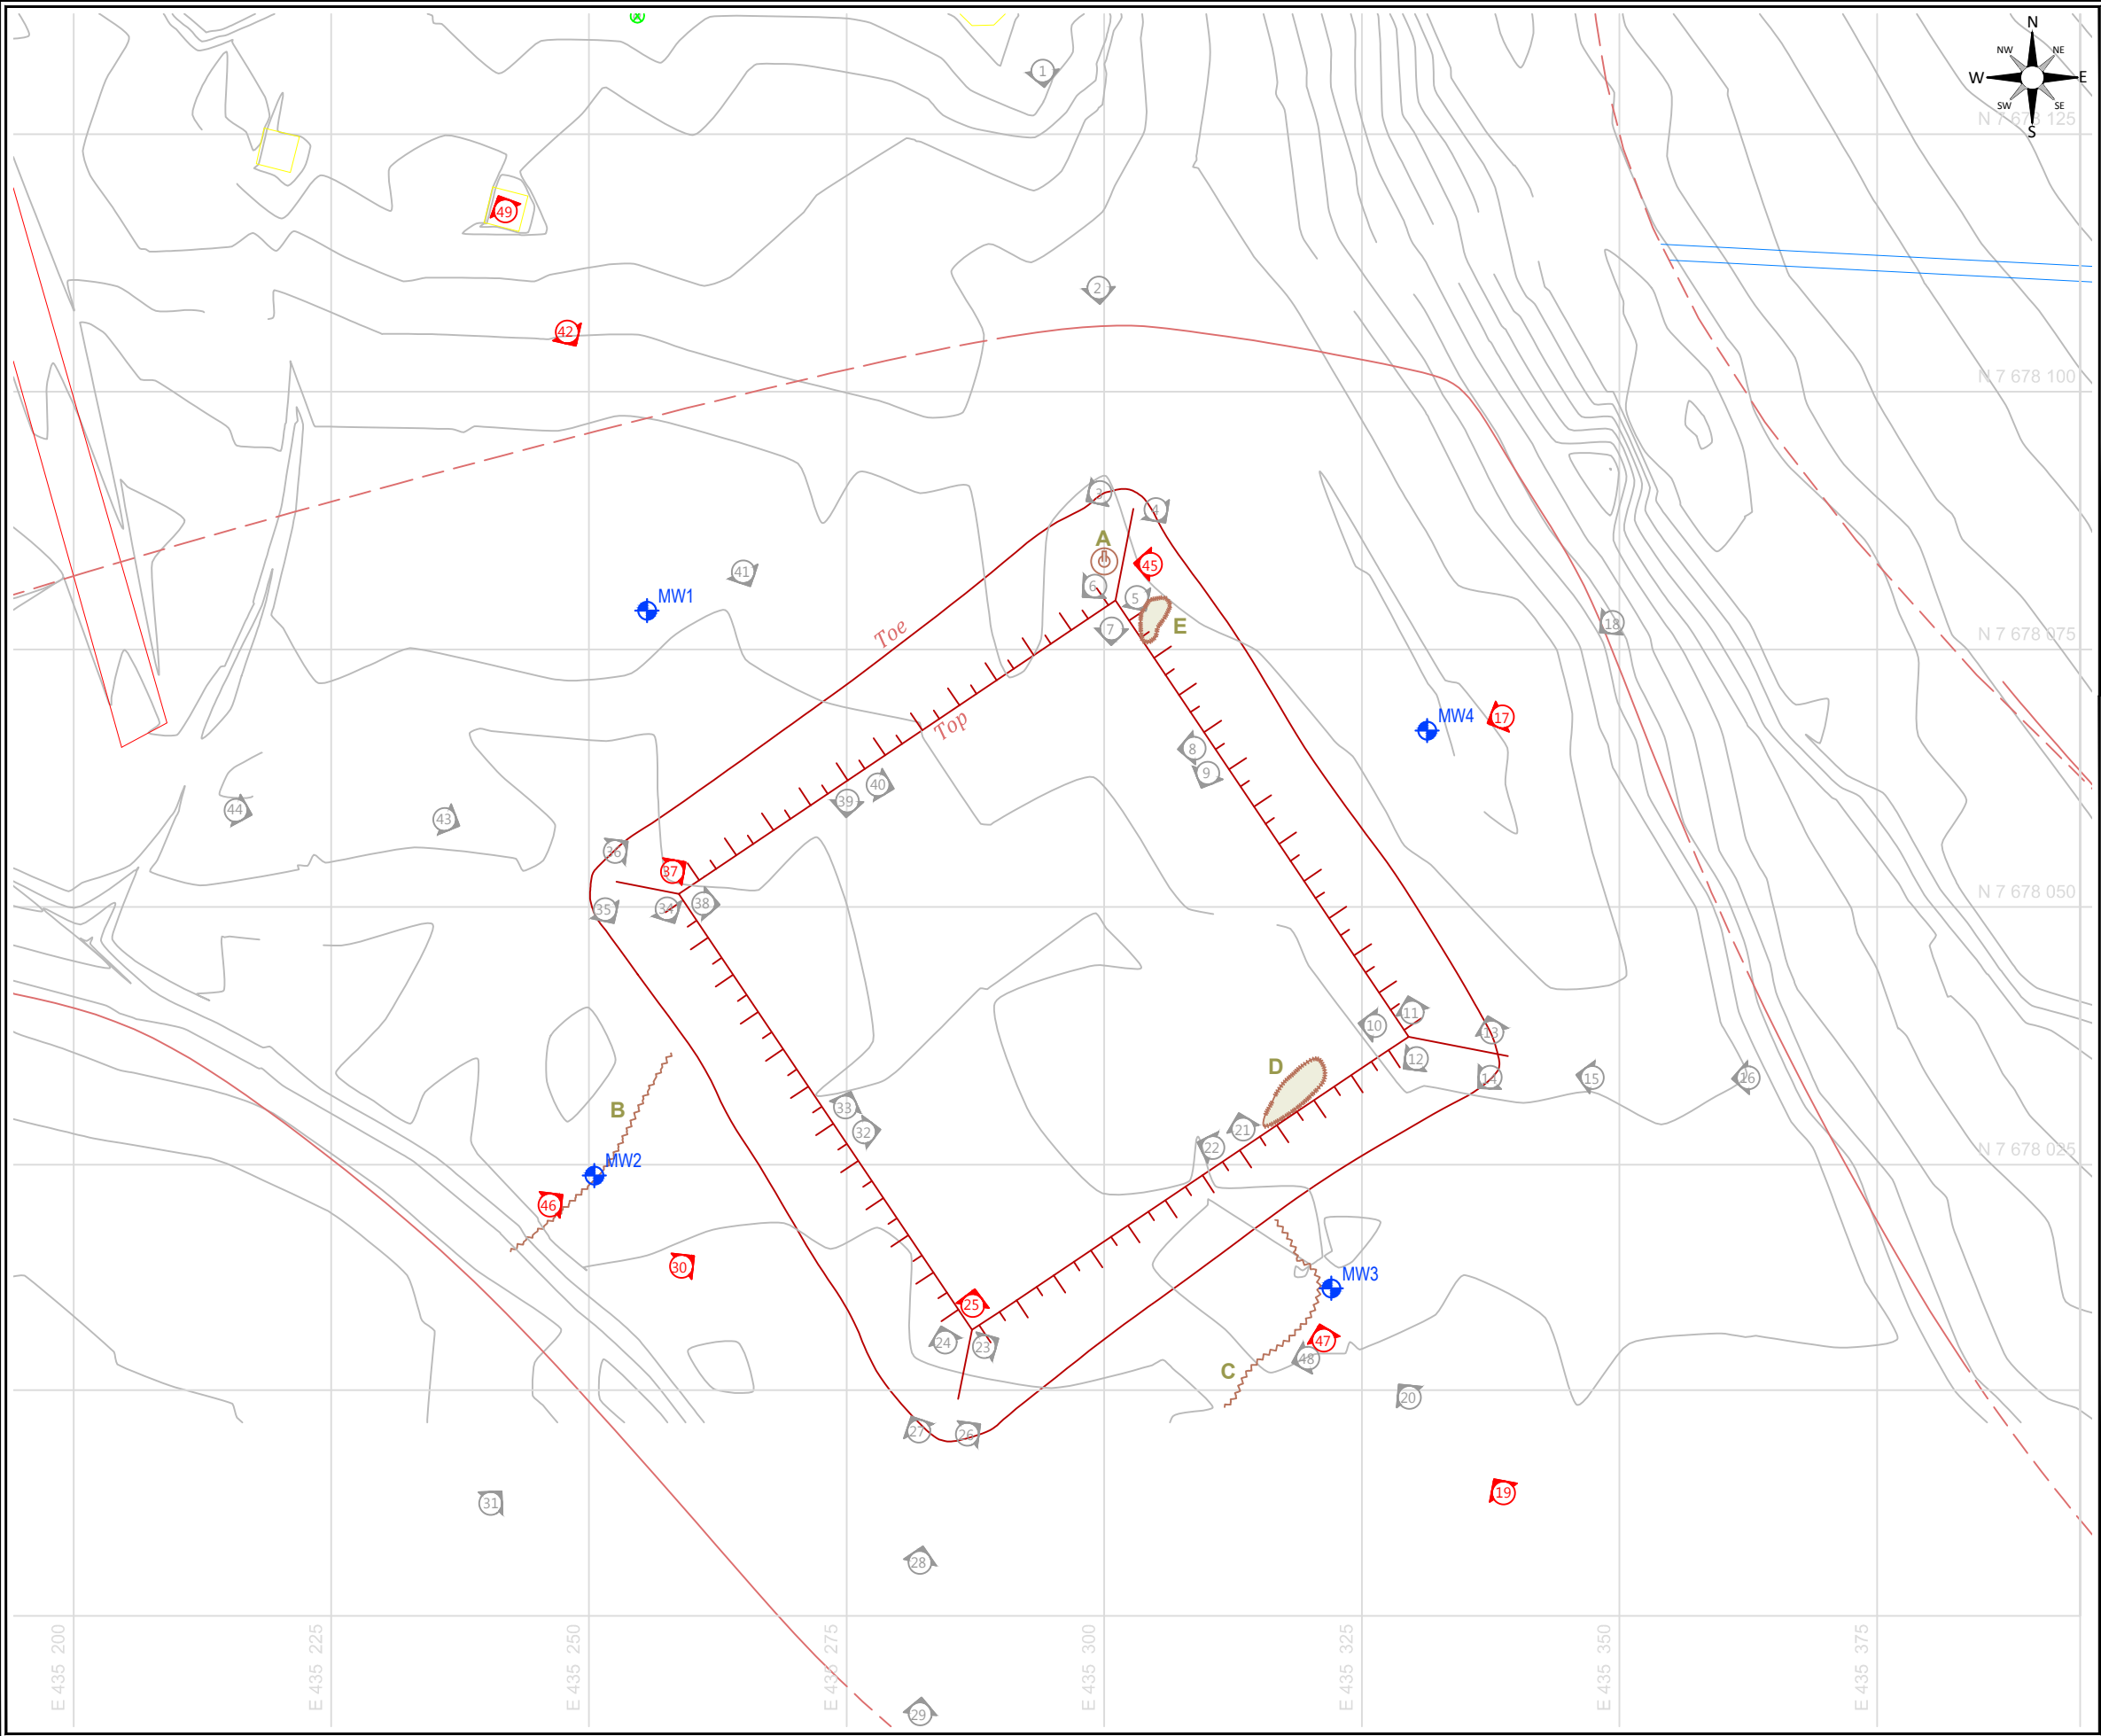
Title: Non-hazardous Waste Landfill

Two minor depressions were observed in the area of the NHWL. One small depression on the surface of the landfill at the southeast corner was noted. This depression appeared to be the result of final grading. Another small depression was noted on the northeast side berm of the landfill where this appeared to be the result of settlement. Both features are considered minor in scale (<1 m diameter and 0.1 m deep).

Evidence of a burrowing animal was observed in one location on the slope of north corner of the NHWL. It appeared as though an animal has dug a small burrow and deposited the soil to one side, exposing larger cobbles (Photo 45, Appendix C). The extent of the animal burrow has increased slightly since 2011 to approximately 0.5 to 1.0 m inwards. Sik sik tracks were observed leading into the burrow. The integrity of the NWHL has not been impacted by the burrow.

Two drainage pathways were noted during the NHWL inspections that have remained unchanged since 2011. One was observed on the southeast side of the landfill and one on the southwest side. Both drainage pathways appeared to be natural features of the topography in

the area (Photo 46 and Photo 47, Appendix C). Erosion does not appear to be taking place in these drainage pathways, therefore the physical integrity of the NHWL has not been impacted.

All physical observations suggest that the NHWL is performing as designed and is containing the enclosed waste. Care should be taken during future monitoring events to observe the condition of animal burrow (Feature A) at the north corner of the NHWL for increase size and depth and the potential of exposure of landfill debris.

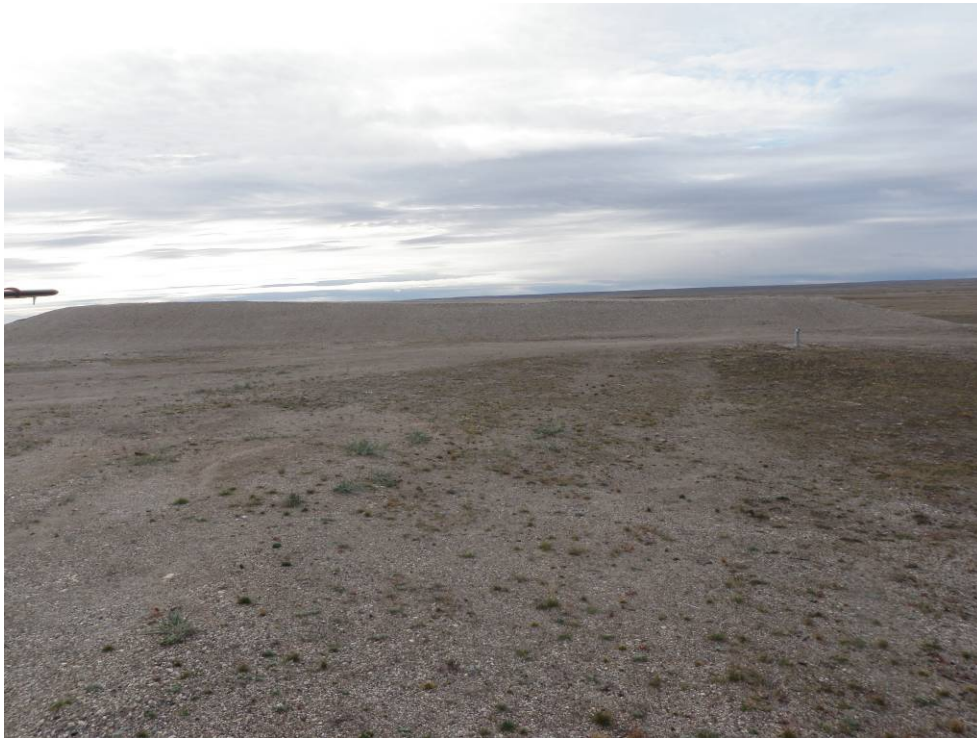
Northwest side of the NHL. Monitoring Well 1 in foreground on right hand side. Viewpoint 42 (Figure A-2; Appendix A). Photograph reference 42 (CD-ROM). Direction photo taken: SE

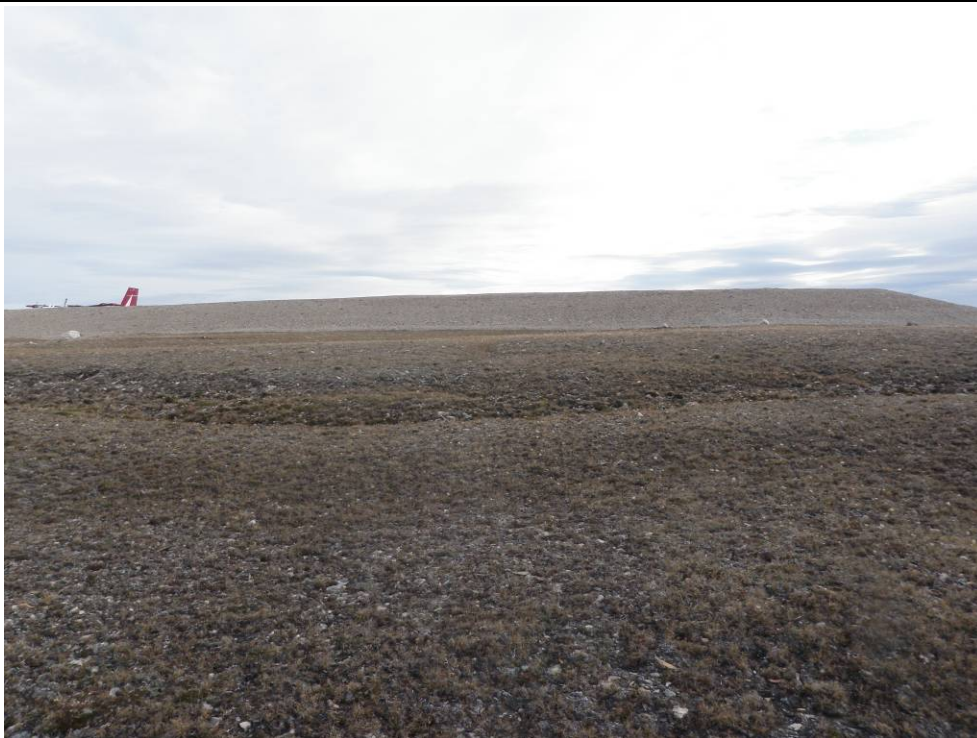
Southwest side of the NHL. Monitoring Well 2 in foreground on left hand side (arrow). Viewpoint 30 (Figure A-2; Appendix A). Photograph reference 30 (CD-ROM). Direction photo taken: NE
