APPENDIX E

SITE PHOTOGRAPHS

Client: PWGSC/AANDC-CARD	CONTWOYTO LAKE WEATHER STATION	Project No. 350600-508
Photo No. 1

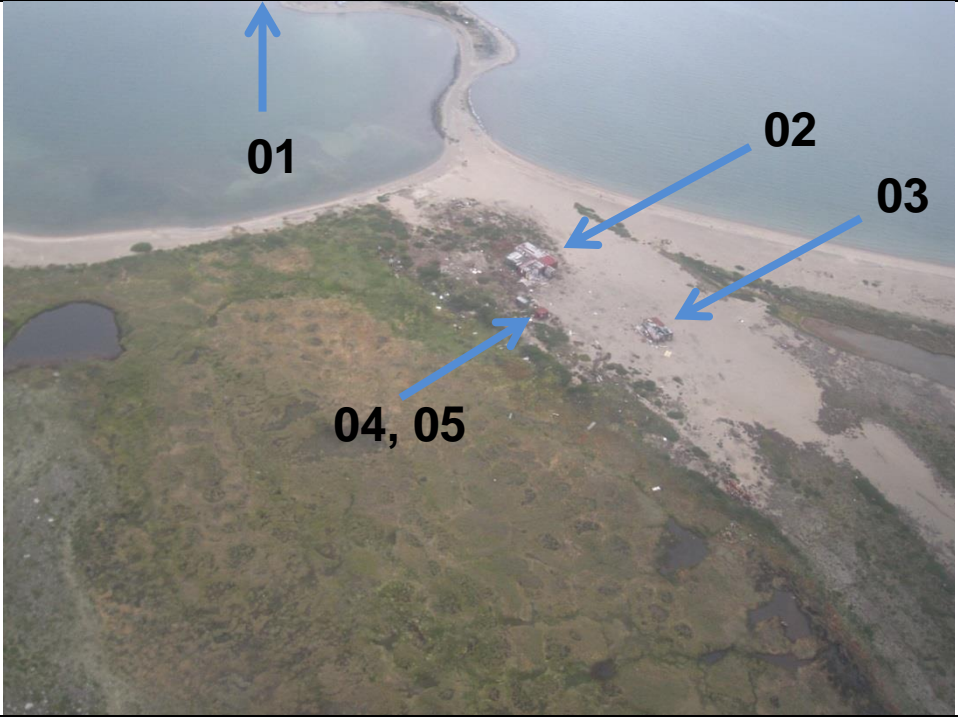
Date: August 6, 2012		
Direction Photo taken: Overview – west		
<p>Description: The main camp area of the former weather station as seen during the Phase III ESA.</p> <p>Arrows show locations of Structure 01 through Structure 05.</p> <p>Note the surface debris scattered in the general proximity of the former main camp area.</p>

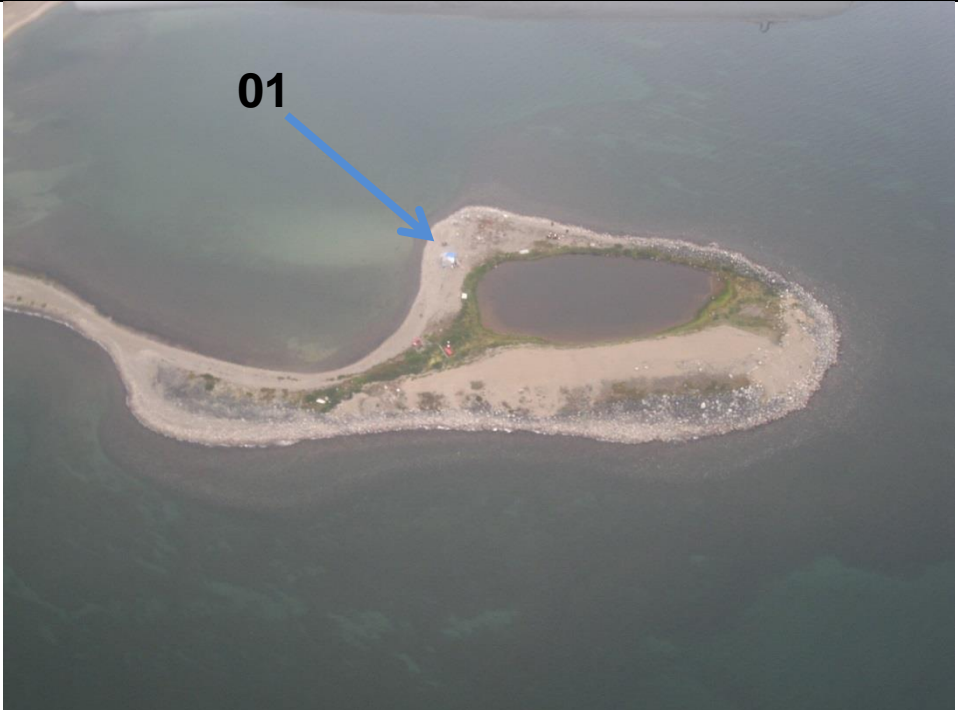
Client: PWGSC/ AANDC-CARD	CONTWOYTO LAKE WEATHER STATION	Project No. 350600-508
Photo No. 2

Date: August 6, 2012		
Direction Photo taken: Overview - south		
<p>Description: The Peninsula as seen during the Phase III ESA. The hunter's cabin (Structure 01) is on the peninsula.</p>

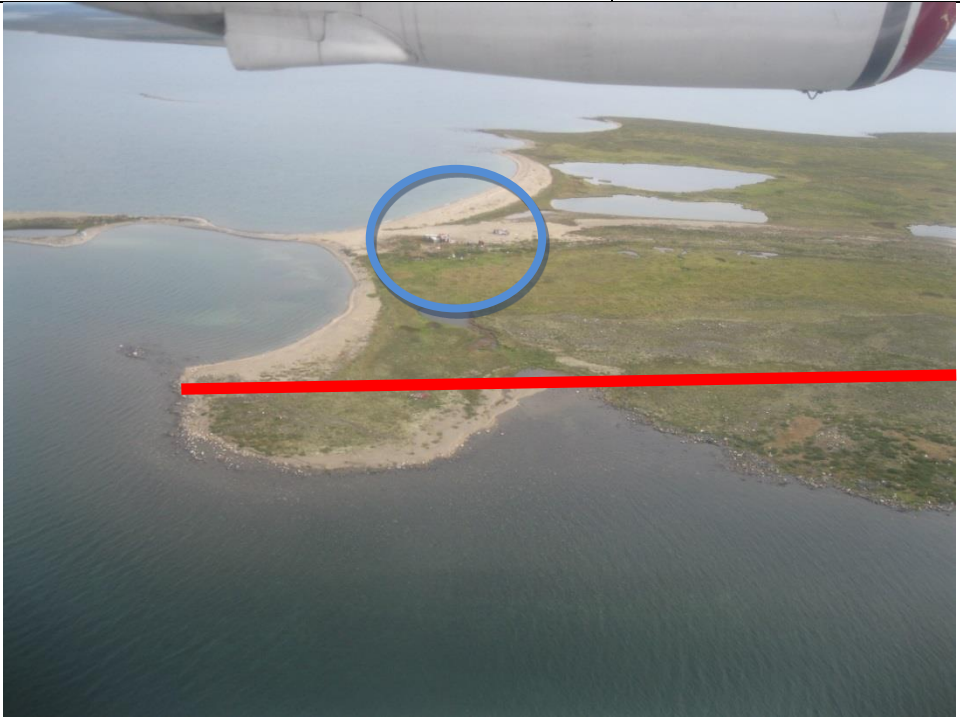
Client: PWGSC/ AANDC-CARD	CONTWOYTO LAKE WEATHER STATION	Project No. 350600-508
Photo No. 3

Date: August 7, 2012		
Direction Photo taken: Overview - north		
Description: The western half of the former weather station island. The former camp area is circled. Approximate boundary line of Inuit Owned Lands is shown.

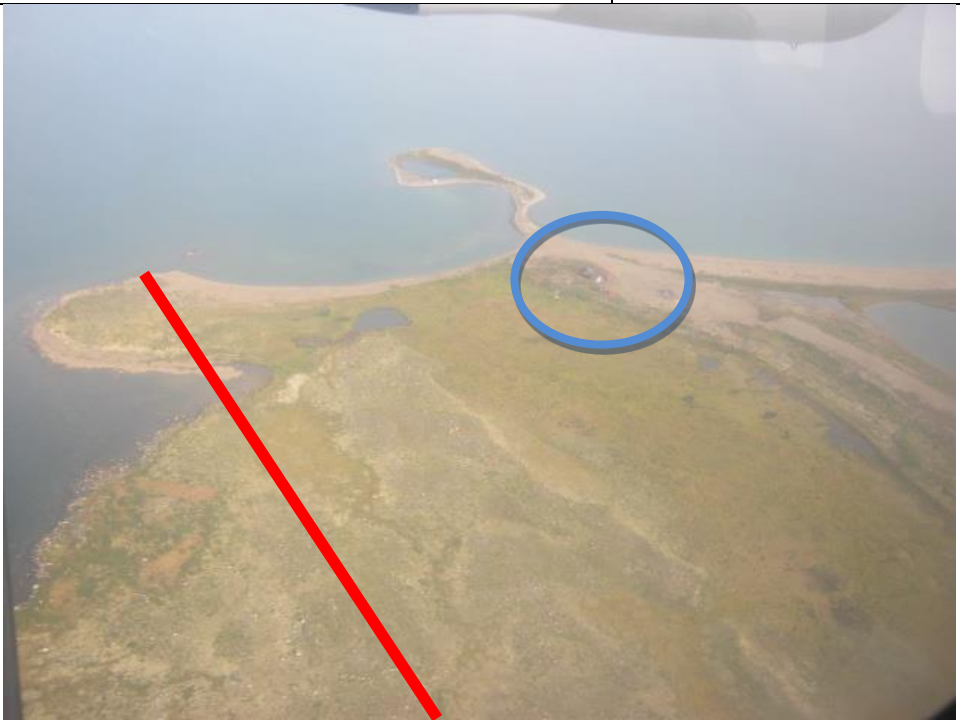
Client: PWGSC/ AANDC-CARD	CONTWOYTO LAKE WEATHER STATION	Project No. 350600-508
Photo No. 4

Date: August 9, 2012		
Direction Photo taken: Overview - northwest		
Description: The former weather station island as seen during the Phase III ESA. The former camp area is circled. Approximate boundary line of Inuit Owned Lands is shown.

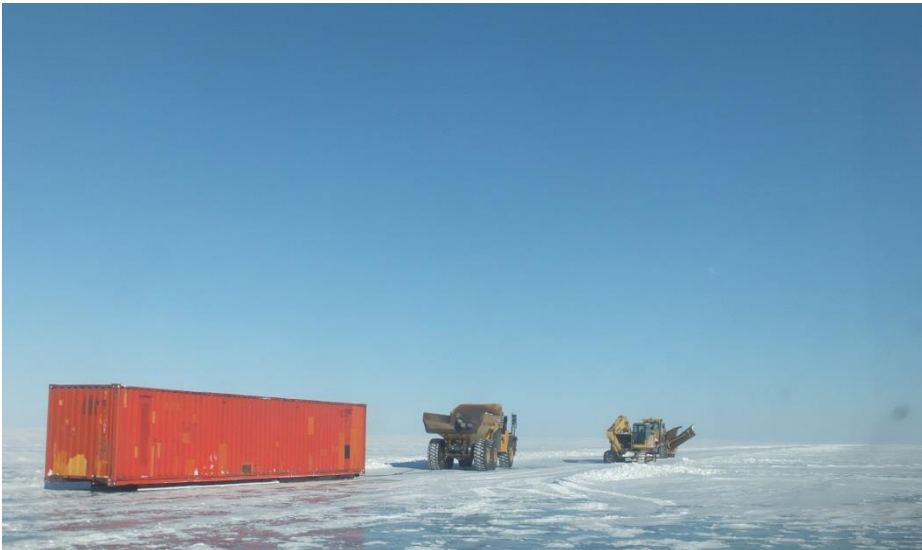
Client: PWGSC/ AANDC-CARD	CONTWOYTO LAKE WEATHER STATION	Project No. 350600-508
Photo No. 5

Date: April 10, 2014		
Direction Photo taken: southeast		
Description: Mobilization of equipment and materials. Winter road from Lupin mine site to the former weather station island.

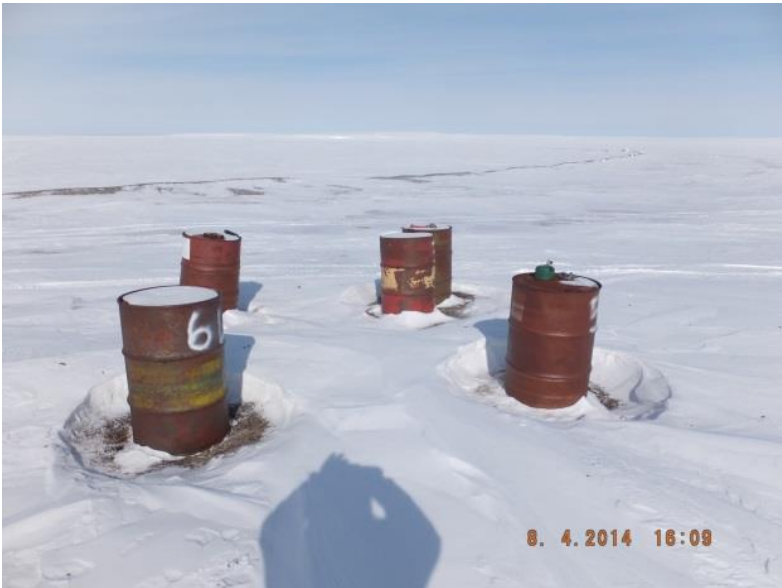
Client: PWGSC/ AANDC-CARD	CONTWOYTO LAKE WEATHER STATION	Project No. 350600-508
Photo No. 6

Date: April 8, 2014		
Direction Photo taken: north		
Description: Drums collected during the April 2014 mobilization event.

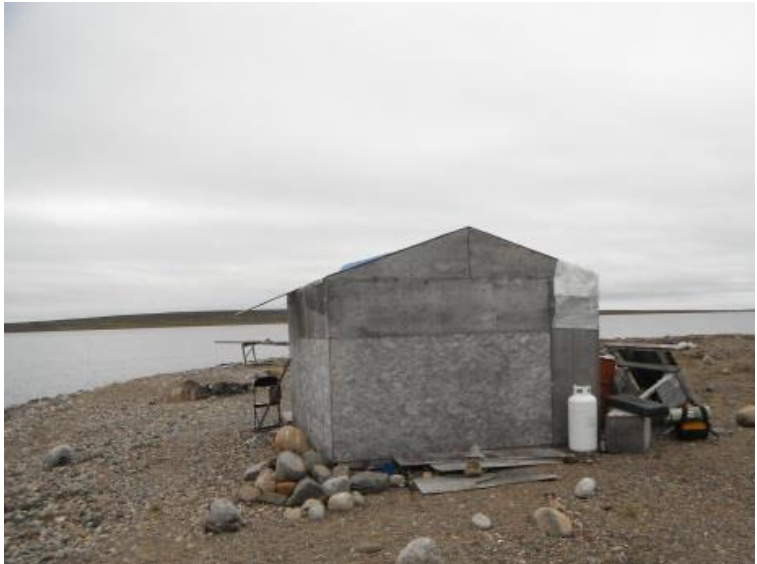
Client: PWGSC/ AANDC-CARD	CONTWOYTO LAKE WEATHER STATION	Project No. 350600-508
Photo No. 7

Date: August 8, 2012		
Direction Photo taken: south		
Description: The hunter's cabin (Structure 01) on the peninsula as seen during the Phase III ESA.

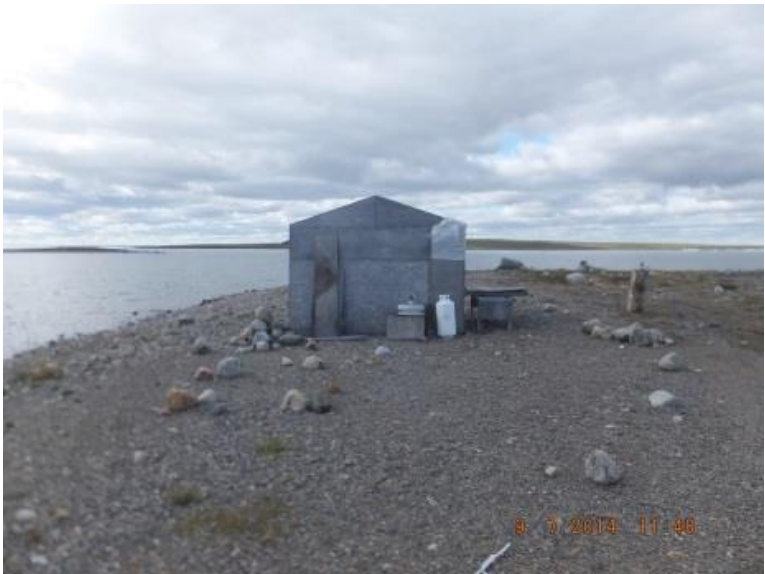
Client: PWGSC/ AANDC-CARD	CONTWOYTO LAKE WEATHER STATION	Project No. 350600-508
Photo No. 8

Date: July 9, 2014		
Direction Photo taken: south		
Description: The hunter's cabin after scattered debris was collected. Note that the old gas cylinder was also removed as part of remedial works.

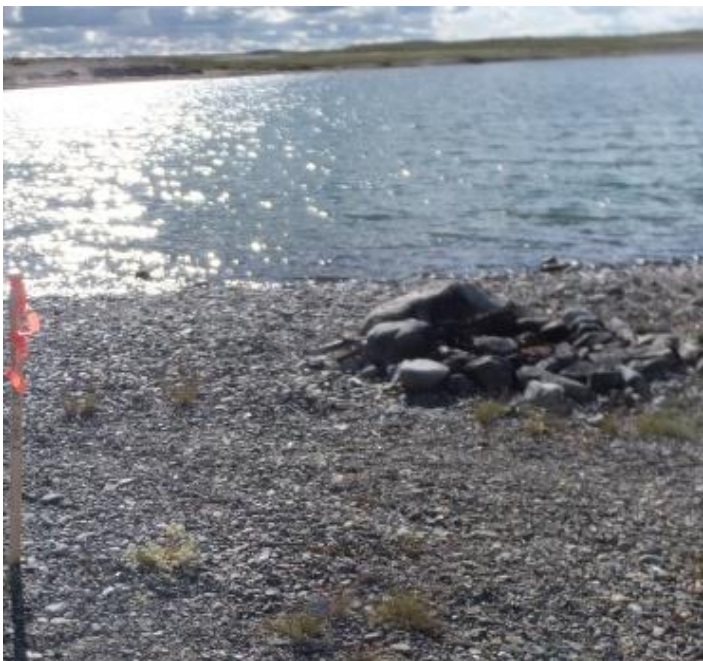
Client: PWGSC/ AANDC-CARD	CONTWOYTO LAKE WEATHER STATION	Project No. 350600-508
Photo No. 9

Date: July 9, 2014		
Direction Photo taken: southeast		
Description: Soil Impact Zone 02 before remedial works took place.

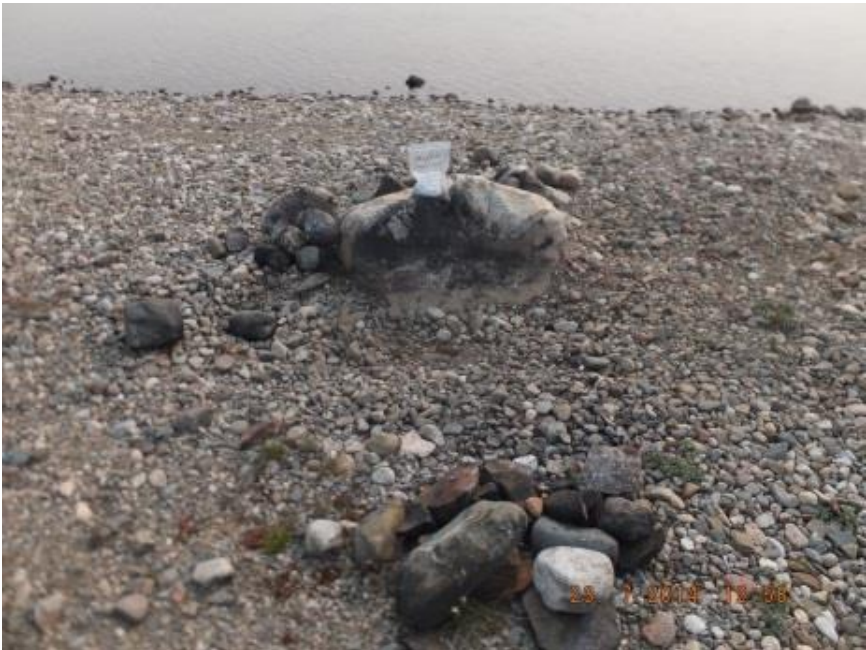
Client: PWGSC/ AANDC-CARD	CONTWOYTO LAKE WEATHER STATION	Project No. 350600-508
Photo No. 10

Date: July 27, 2014		
Direction Photo taken: southeast		
Description: Soil Impact Zone 02 after remedial works took place.

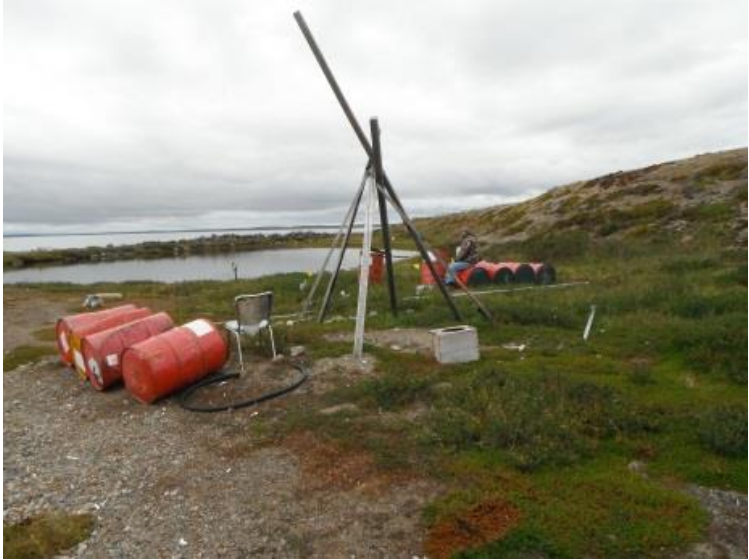
Client: PWGSC/ AANDC-CARD	CONTWOYTO LAKE WEATHER STATION	Project No. 350600-508
Photo No. 11

Date: August 8, 2012		
Direction Photo taken: west		
Description: Drum Cache 01 on the peninsula as seen during the Phase III ESA.

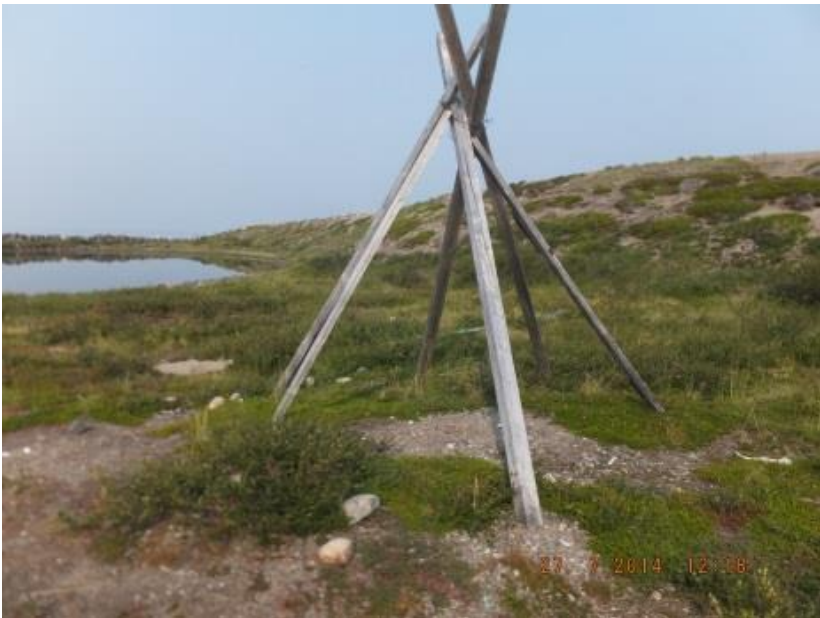
Client: PWGSC/ AANDC-CARD	CONTWOYTO LAKE WEATHER STATION	Project No. 350600-508
Photo No. 12

Date: July 27, 2014		
Direction Photo taken: west		
Description: Drum cache 01 after remedial works of collecting surface debris and old drums.

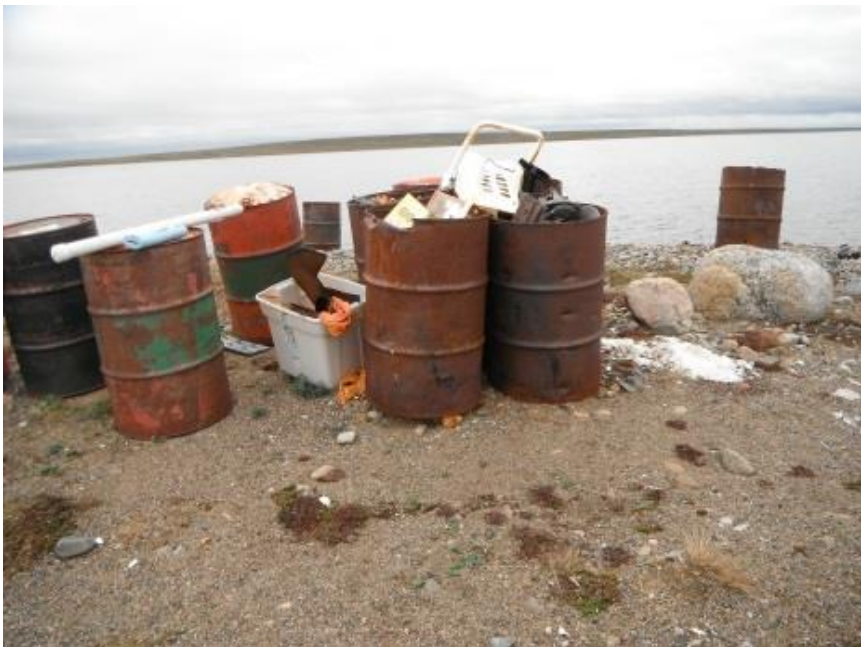
Client: PWGSC/ AANDC-CARD	CONTWOYTO LAKE WEATHER STATION	Project No. 350600-508
Photo No. 13

Date: August 8, 2012		
Direction Photo taken: North east		
Description: Drum cache 02 on the peninsula as seen during the Phase III ESA.

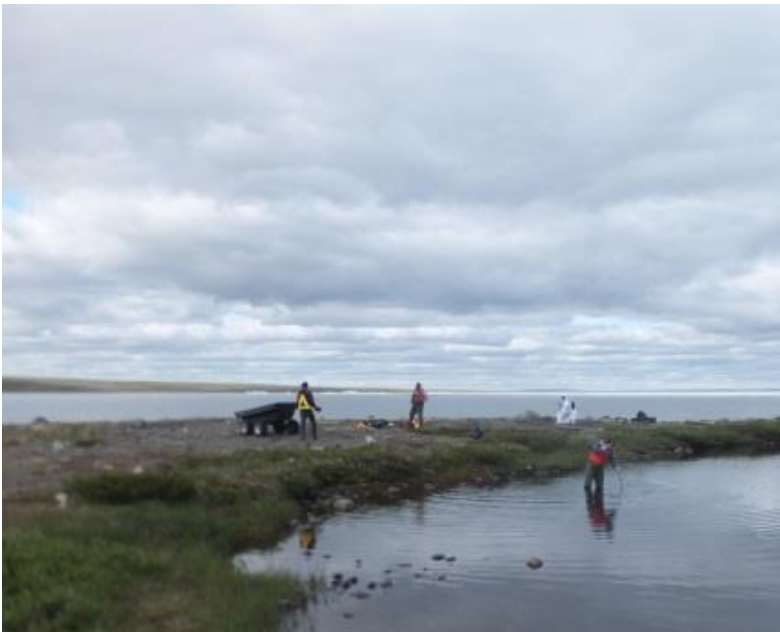
Client: PWGSC/ AANDC-CARD	CONTWOYTO LAKE WEATHER STATION	Project No. 350600-508
Photo No. 14

Date: July 9, 2014		
Direction Photo taken: northwest		
Description: Remedial works on Drum Cache 02 and surrounding area. Surface debris and old drums were collected.

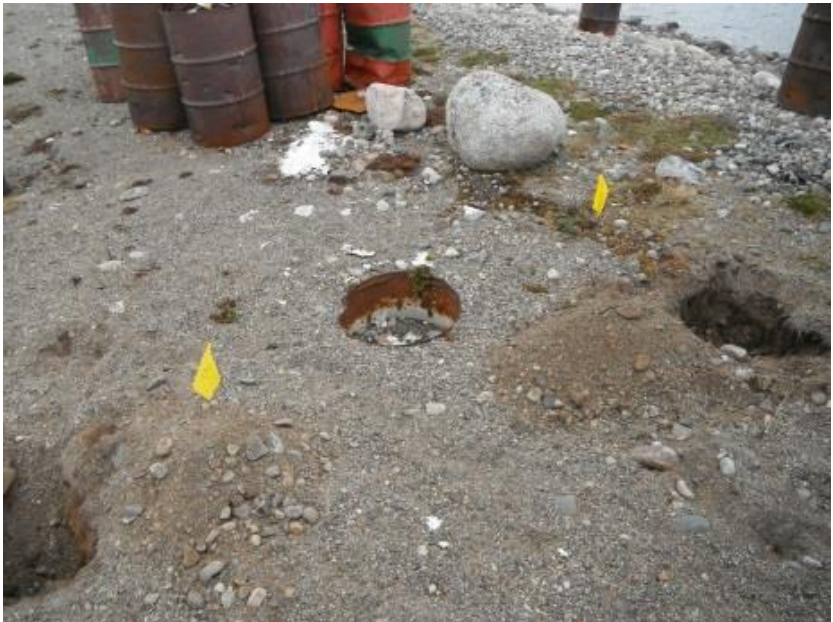
Client: PWGSC/ AANDC-CARD	CONTWOYTO LAKE WEATHER STATION	Project No. 350600-508
Photo No. 15

Date: August 8, 2012		
Direction Photo taken: East		
Description: Soil Impact 01 located at Burn Pit 01 on the peninsula as seen during the Phase III ESA.

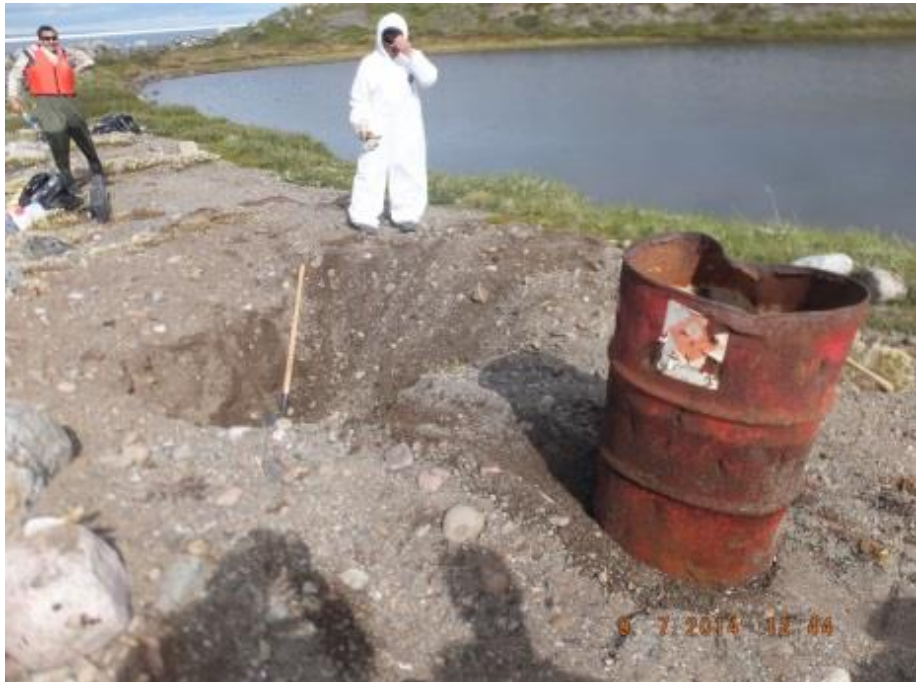
Client: PWGSC/ AANDC-CARD	CONTWOYTO LAKE WEATHER STATION	Project No. 350600-508
Photo No. 16

Date: July 9, 2014		
Direction Photo taken: northeast		
Description: Remedial works in progress at Soil Impact 01. Burn Pit 01 was dug out and scattered debris was collected.

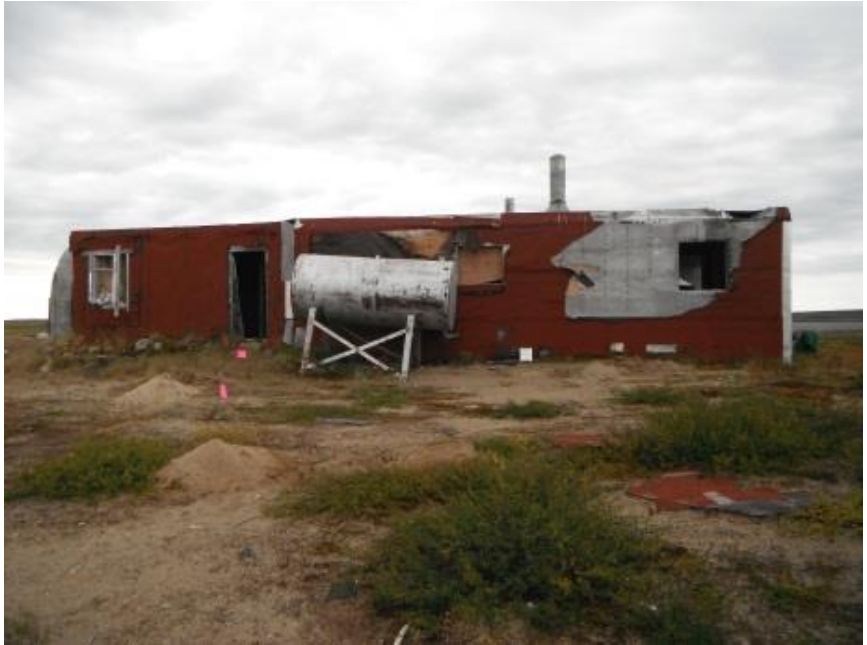
Client: PWGSC/ AANDC-CARD	CONTWOYTO LAKE WEATHER STATION	Project No. 350600-508
Photo No. 17

Date: August 8, 2012		
Direction Photo taken: south		
Description: Structure 02 as seen during the Phase III ESA.

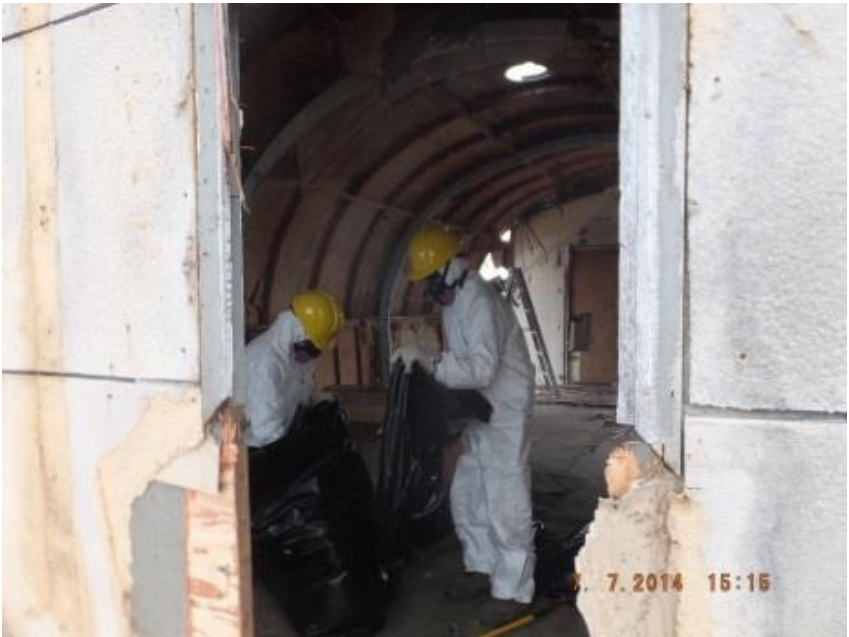
Client: PWGSC/ AANDC-CARD	CONTWOYTO LAKE WEATHER STATION	Project No. 350600-508
Photo No. 18

Date: July 7, 2014		
Direction Photo taken: southwest		
Description: Abatement work within Structure 02. Materials containing lead-amended paint and PCB-amended paint were removed prior to demolition.

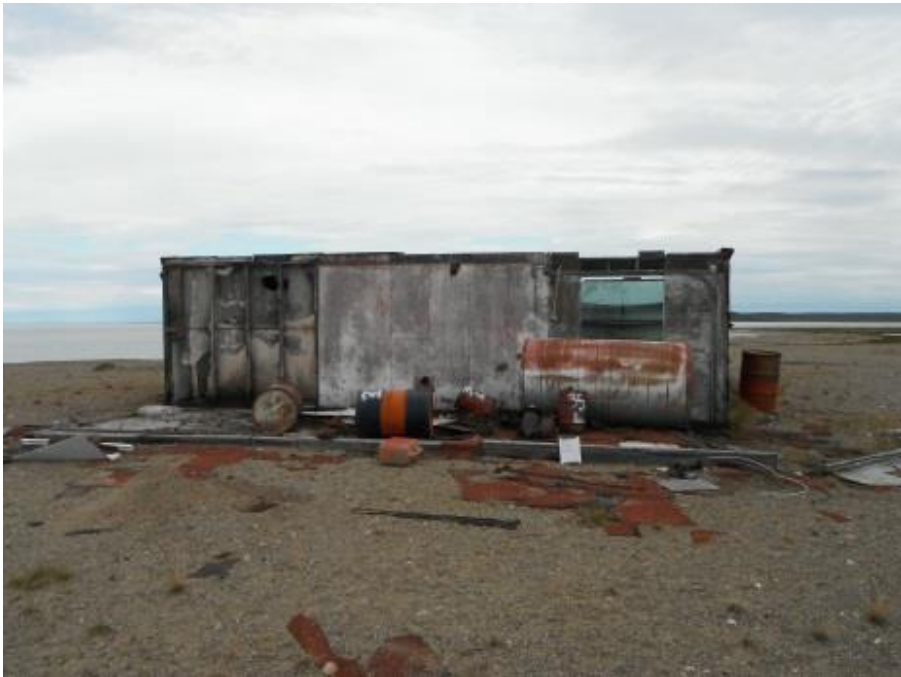
Client: PWGSC/ AANDC-CARD	CONTWOYTO LAKE WEATHER STATION	Project No. 350600-508
Photo No. 19

Date: August 8, 2012		
Direction Photo taken: southeast		
Description: Structure 03 as seen during the Phase III ESA.

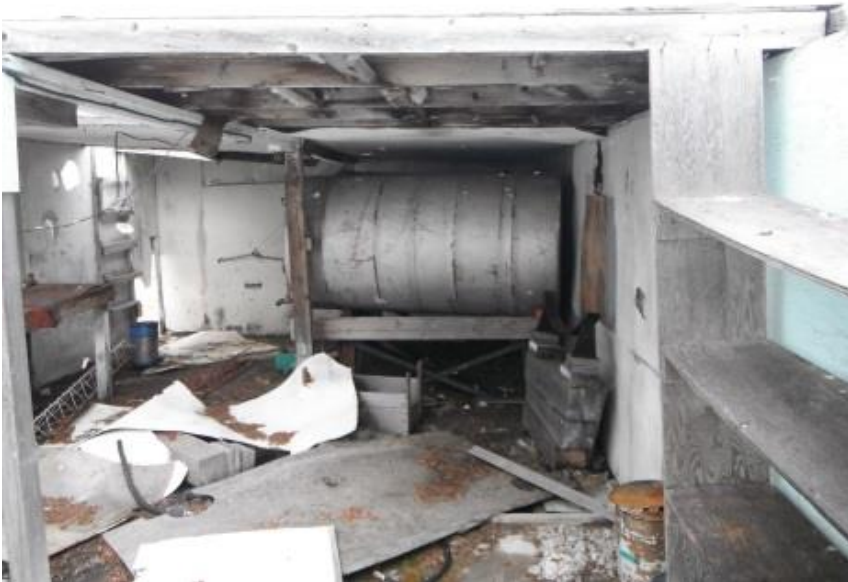
Client: PWGSC/ AANDC-CARD	CONTWOYTO LAKE WEATHER STATION	Project No. 350600-508
Photo No. 20

Date: August 8, 2012		
Direction Photo taken: east		
Description: Structure 03 interior as seen during the Phase III ESA.

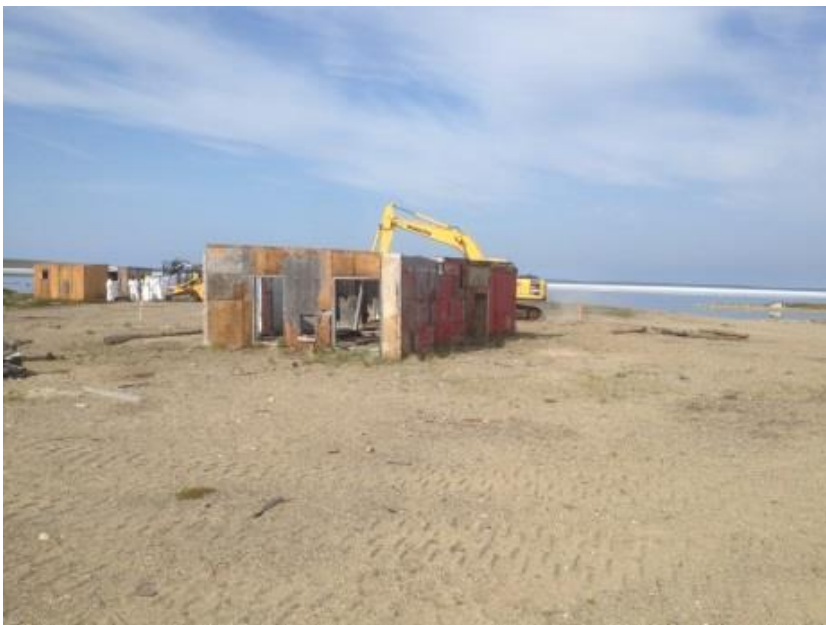
Client: PWGSC/ AANDC-CARD	CONTWOYTO LAKE WEATHER STATION	Project No. 350600-508
Photo No. 21

Date: July 5, 2014		
Direction Photo taken: south		
Description: Structure 03 during remedial works.

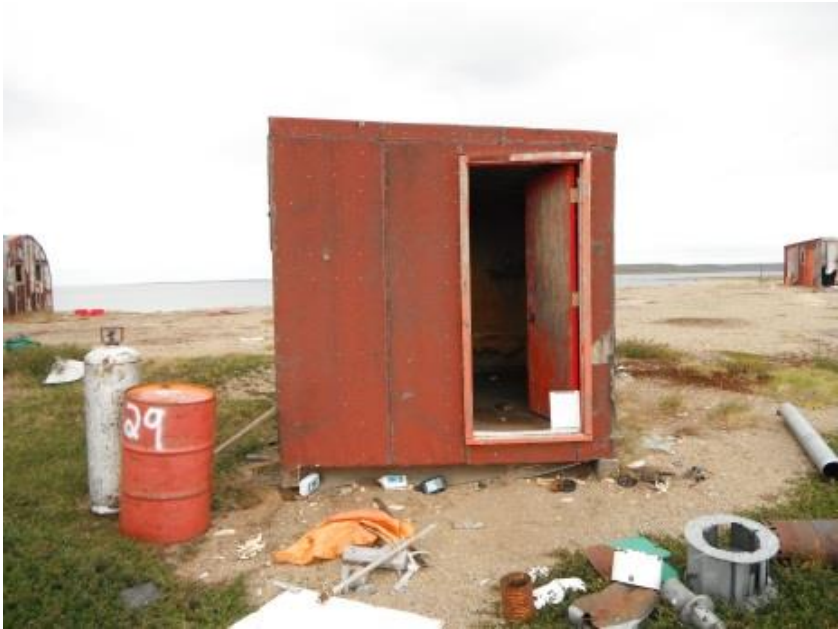
Client: PWGSC/ AANDC-CARD	CONTWOYTO LAKE WEATHER STATION	Project No. 350600-508
Photo No. 23

Date: August 9, 2012		
Direction Photo taken: north		
Description: Structure 04 as seen during the Phase III ESA.

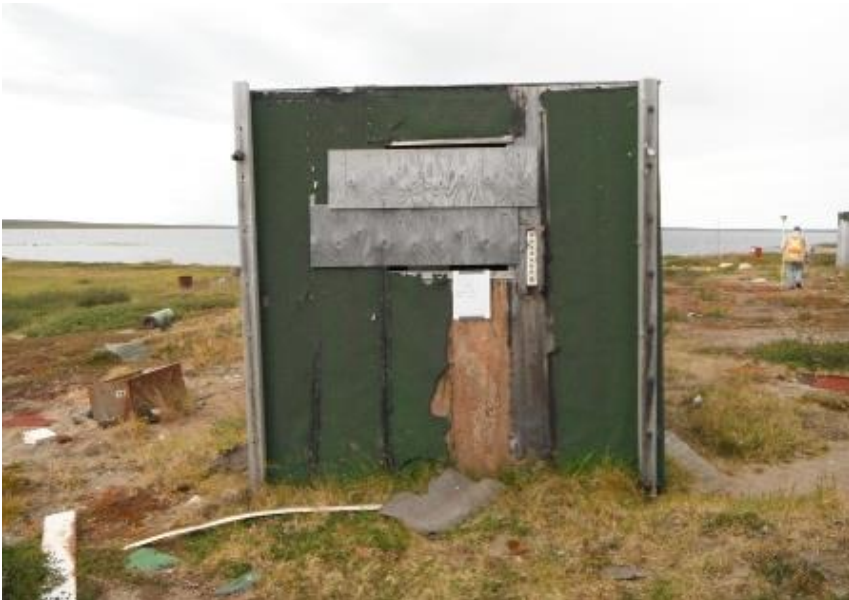
Client: PWGSC/ AANDC-CARD	CONTWOYTO LAKE WEATHER STATION	Project No. 350600-508
Photo No. 25

Date: August 7, 2012		
Direction Photo taken: south		
Description: Structure 05 as seen during the Phase III ESA.

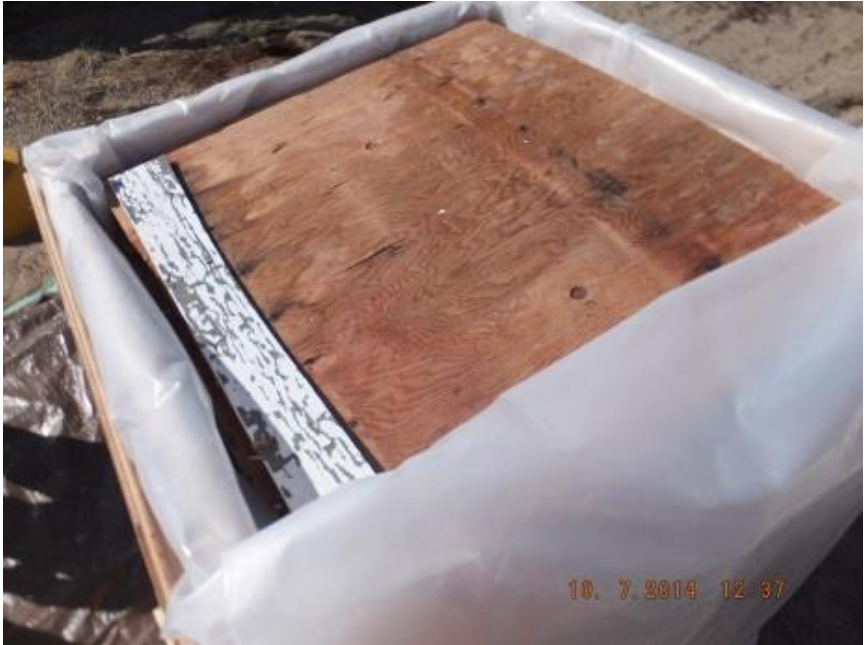
Client: PWGSC/ AANDC-CARD	CONTWOYTO LAKE WEATHER STATION	Project No. 350600-508
Photo No. 27

Date: July 10, 2014		
Direction Photo taken: overview		
Description: TDG crate shown. All the hazardous material that was removed from the structures was boxed up in TDG crates (4'x4'x4' plywood with 2x4" internal frame) which were lined with two layers of 10 mm poly, and placed into the seacan for storage and shipping.

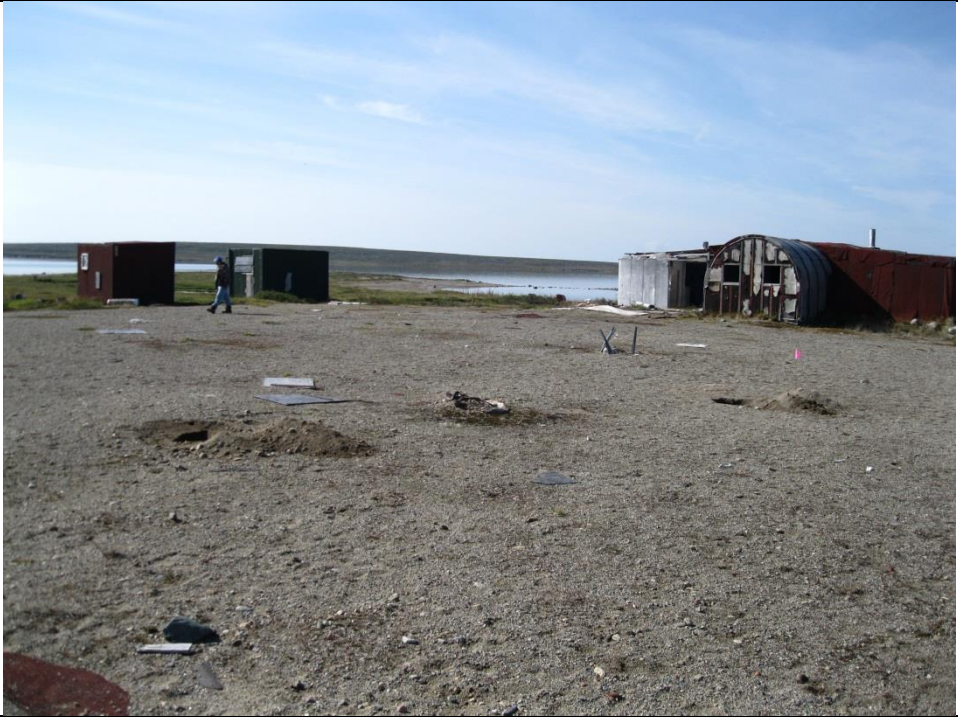
Client: PWGSC/ AANDC-CARD	CONTWOYTO LAKE WEATHER STATION	Project No. 350600-508
Photo No. 29

Date: August 8, 2012		
Direction Photo taken: northeast		
Description: The former camp area as seen during the Phase III ESA.

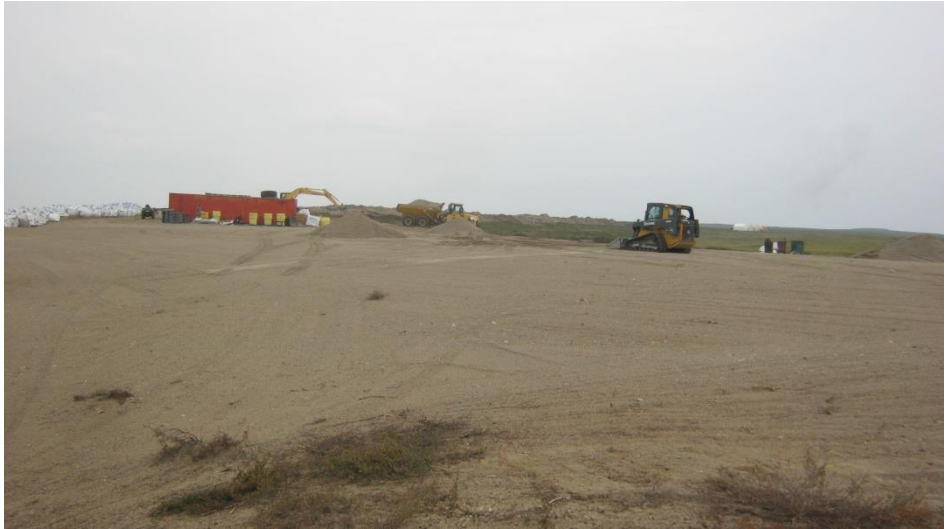
Client: PWGSC/ AANDC-CARD	CONTWOYTO LAKE WEATHER STATION	Project No. 350600-508
Photo No. 31

Date: August 10, 2014		
Direction Photo taken: east		
Description: Regrading activities at camp area: Soil Impact Zone 04 (near ground) and Soil Impact Zone 03 (far ground). Mounds seen are backfill material used in the regrading process.

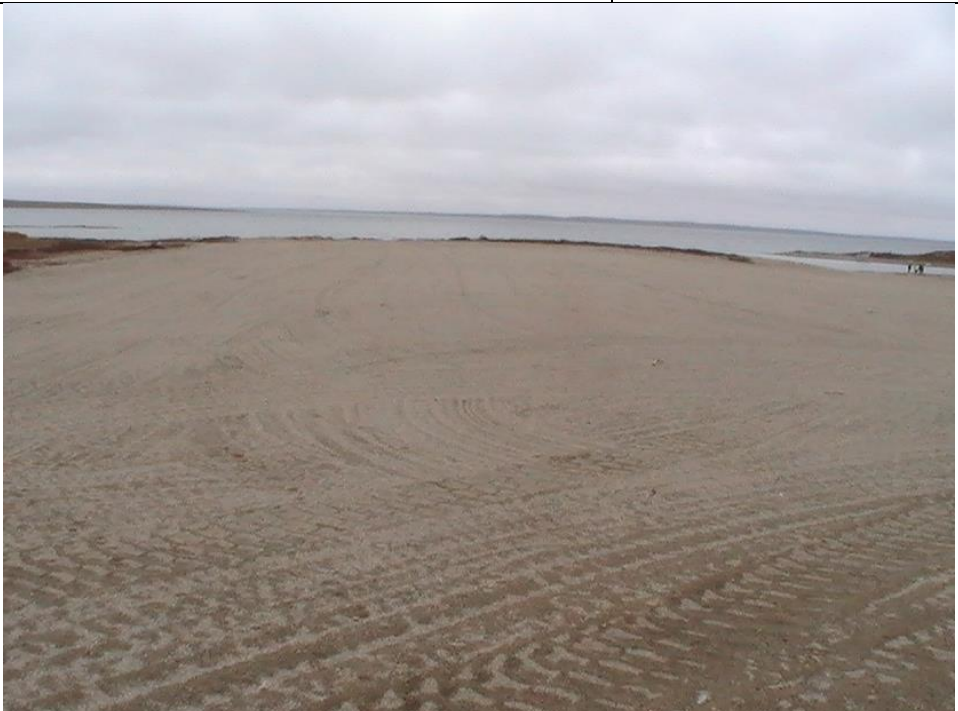
Client: PWGSC/ AANDC-CARD	CONTWOYTO LAKE WEATHER STATION	Project No. 350600-508
Photo No. 32

Date: September 18, 2014		
Direction Photo taken: Southwest		
Description: Former camp area after remedial work was completed.

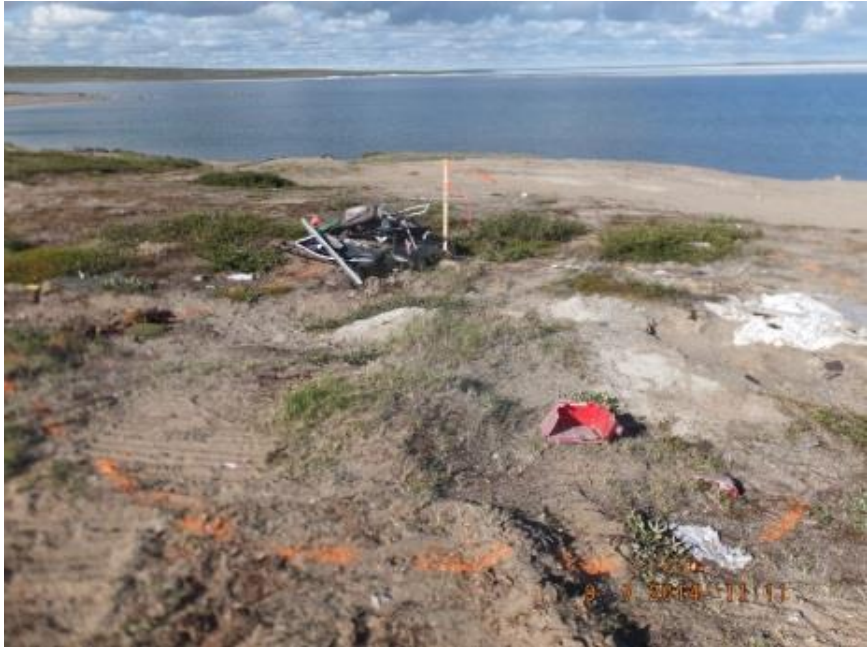
Client: PWGSC/ AANDC-CARD	CONTWOYTO LAKE WEATHER STATION	Project No. 350600-508
Photo No. 33

Date: July 9, 2014		
Direction Photo taken: southwest		
Description: Soil Impact Zone 05 before remedial works took place.

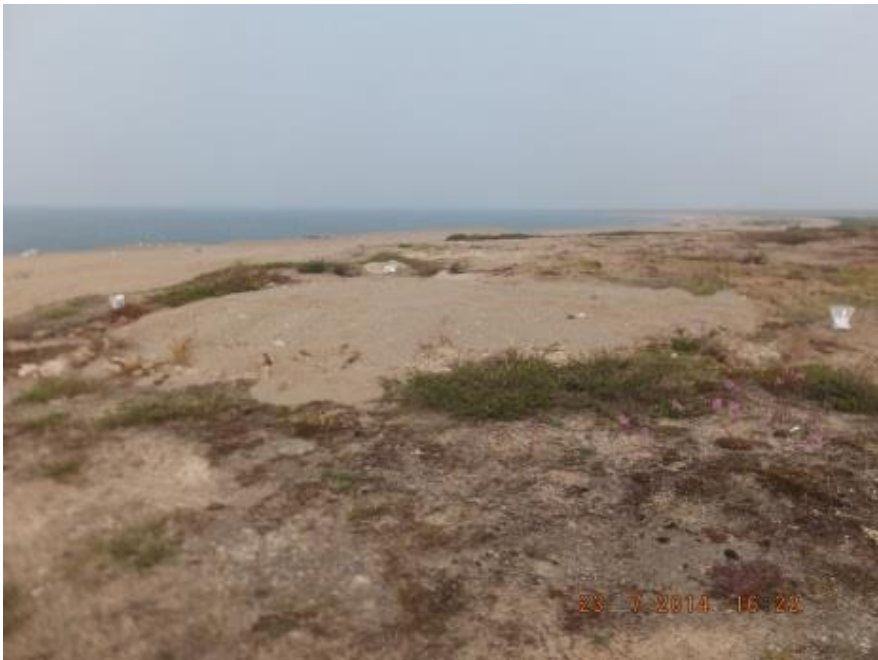
Client: PWGSC/ AANDC-CARD	CONTWOYTO LAKE WEATHER STATION	Project No. 350600-508
Photo No. 34

Date: July 23, 2014		
Direction Photo taken: west		
Description: Soil Impact Zone 05 after surface debris collection, excavation and backfill.

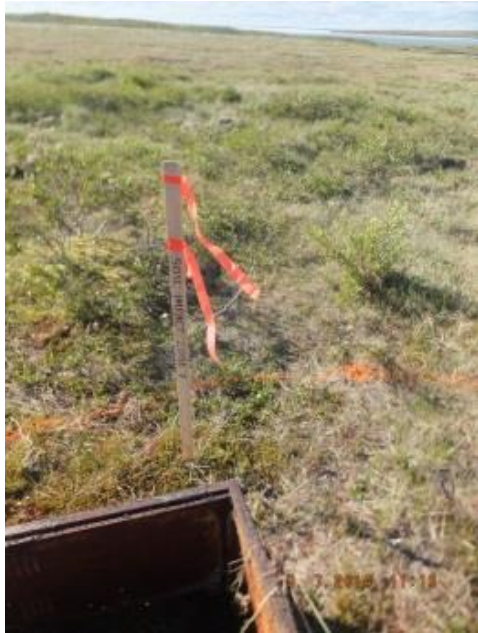
Client: PWGSC/ AANDC-CARD	CONTWOYTO LAKE WEATHER STATION	Project No. 350600-508
Photo No. 37

Date: July 9, 2014		
Direction Photo taken: southeast		
Description: Inside Soil Impact Zone 07 before remedial works took place.

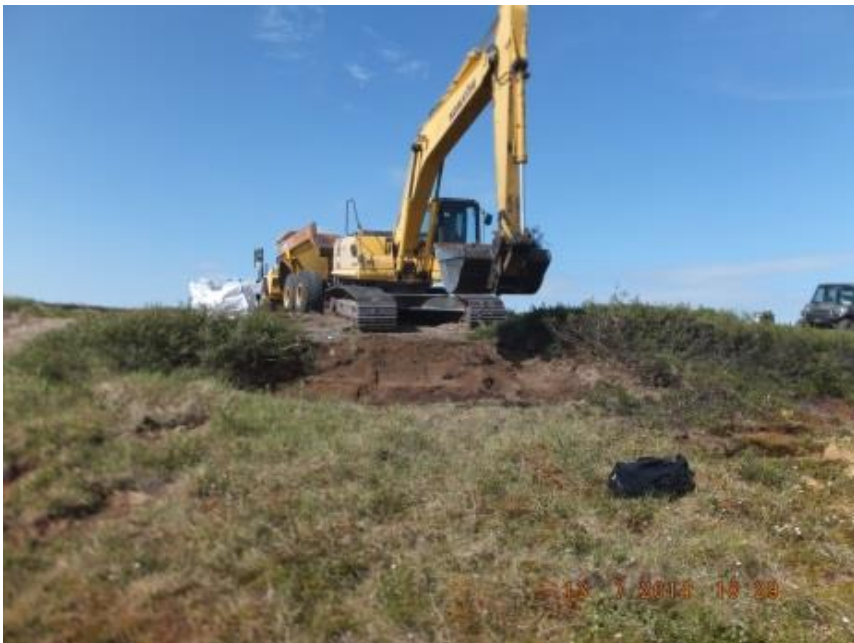
Client: PWGSC/ AANDC-CARD	CONTWOYTO LAKE WEATHER STATION	Project No. 350600-508
Photo No. 39

Date: July 13, 2014		
Direction Photo taken: north		
Description: Soil Impact Zone 08 during excavation.

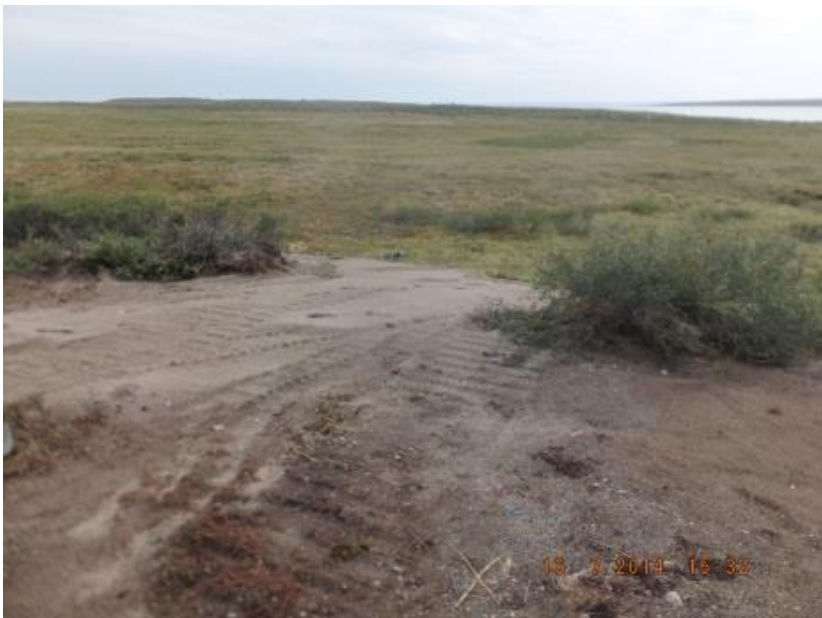
Client: PWGSC/ AANDC-CARD	CONTWOYTO LAKE WEATHER STATION	Project No. 350600-508
Photo No. 40

Date: July 16, 2014		
Direction Photo taken: south		
Description: Soil Impact Zone 08 after excavation and backfill.

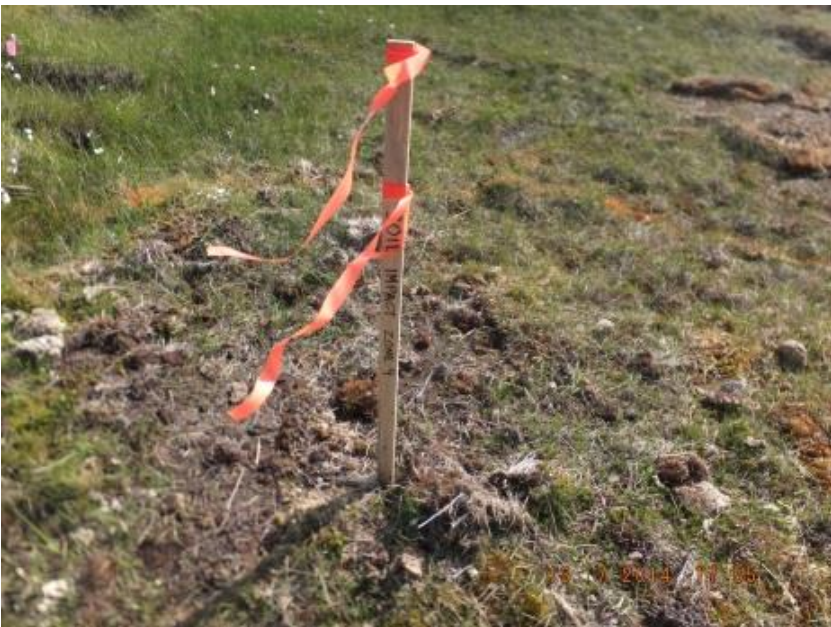
Client: PWGSC/ AANDC-CARD	CONTWOYTO LAKE WEATHER STATION	Project No. 350600-508
Photo No. 41

Date: July 13, 2014		
Direction Photo taken: south		
Description: Soil Impact Zone 09 prior to remedial activities.

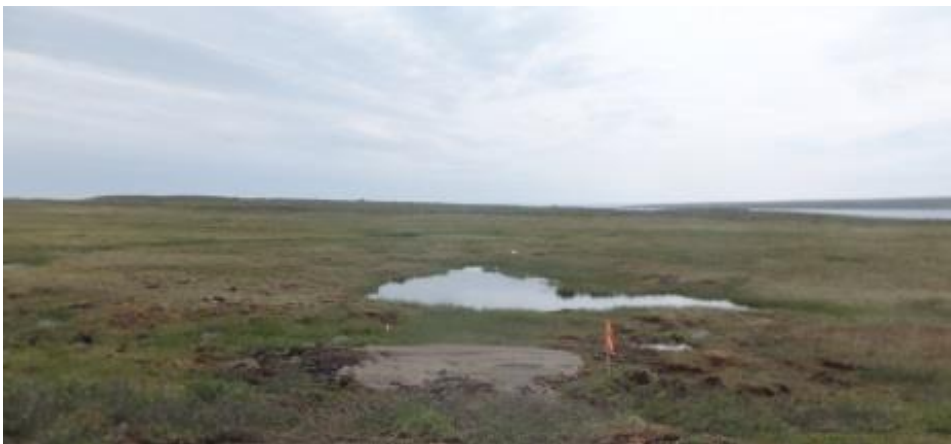
Client: PWGSC/ AANDC-CARD	CONTWOYTO LAKE WEATHER STATION	Project No. 350600-508
Photo No. 42

Date: July 16, 2014		
Direction Photo taken: south		
Description: Soil Impact Zone 09 after excavation and backfill.

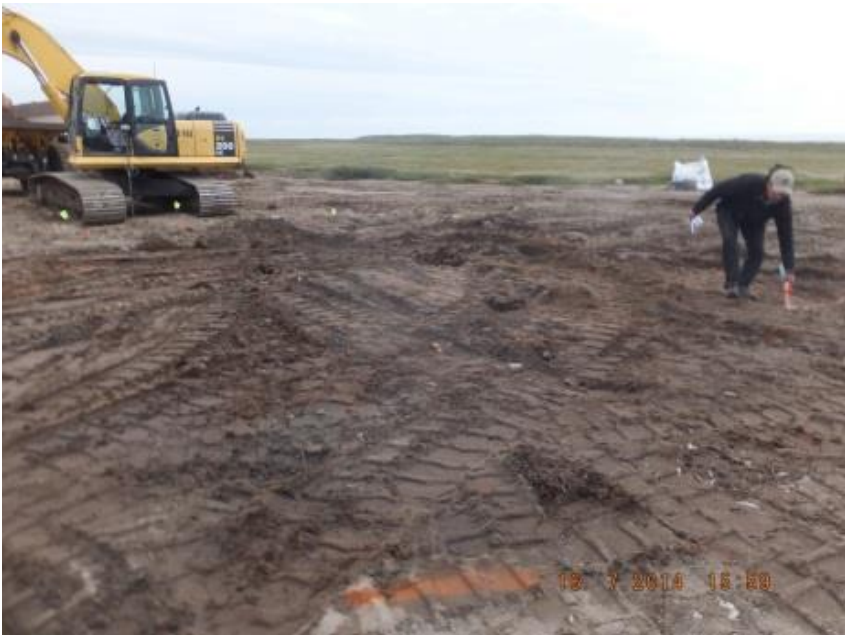
Client: PWGSC/ AANDC-CARD	CONTWOYTO LAKE WEATHER STATION	Project No. 350600-508
Photo No. 43

Date: July 16, 2014		
Direction Photo taken: southeast		
Description: Soil Impact Zone 10 prior to excavation.

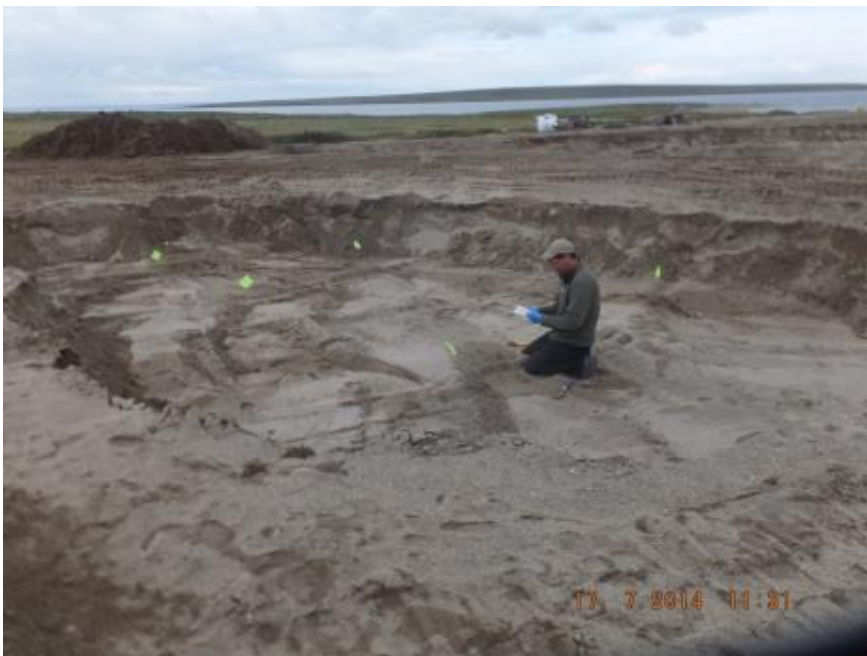
Client: PWGSC/ AANDC-CARD	CONTWOYTO LAKE WEATHER STATION	Project No. 350600-508
Photo No. 44

Date: July 17, 2014		
Direction Photo taken: northwest		
Description: Sampling the base of the excavation at Soil Impact Zone 10.

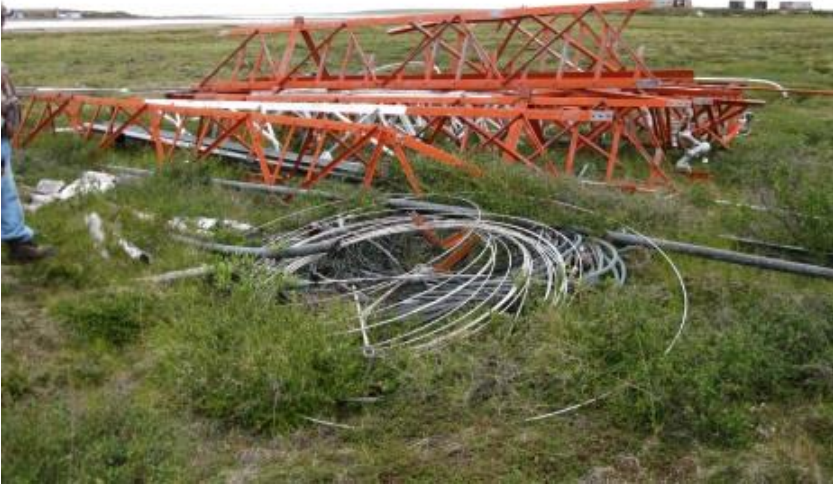
Client: PWGSC/ AANDC-CARD	CONTWOYTO LAKE WEATHER STATION	Project No. 350600-508
Photo No. 45

Date: August 9, 2012		
Direction Photo taken: north		
Description: Former radio tower segments as seen during the Phase III ESA.

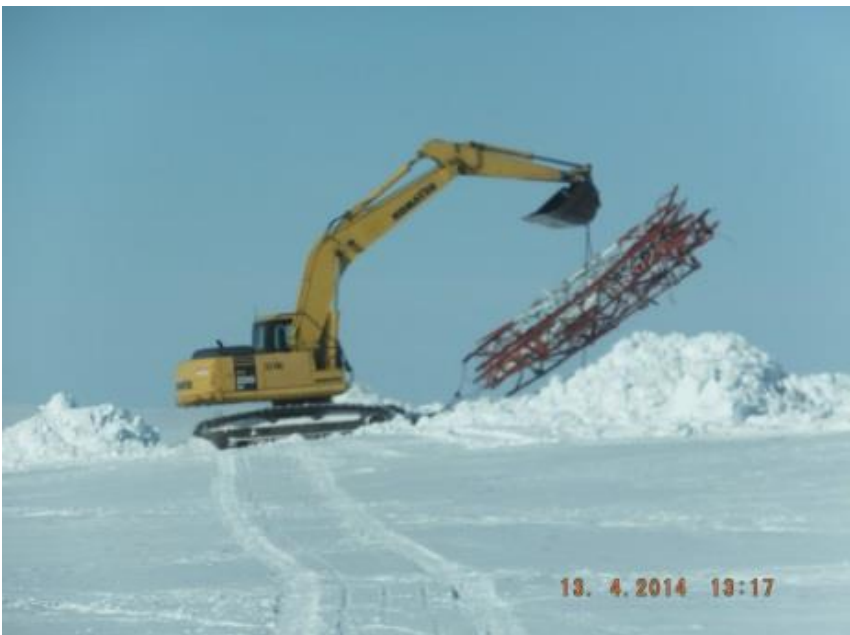
Client: PWGSC/ AANDC-CARD	CONTWOYTO LAKE WEATHER STATION	Project No. 350600-508
Photo No. 46

Date: April 13, 2014		
Direction Photo taken: south		
Description: Transporting the former tower segments from IOL to the former camp area. Segments were removed from IOL during winter to minimize damage to the tundra.
