APPENDIX E

SITE PHOTOGRAPHS

Client: PWGSC/AANDC-CARD	CONTWOYTO LAKE WEATHER STATION	Project No. 350600-508
Photo No. 1

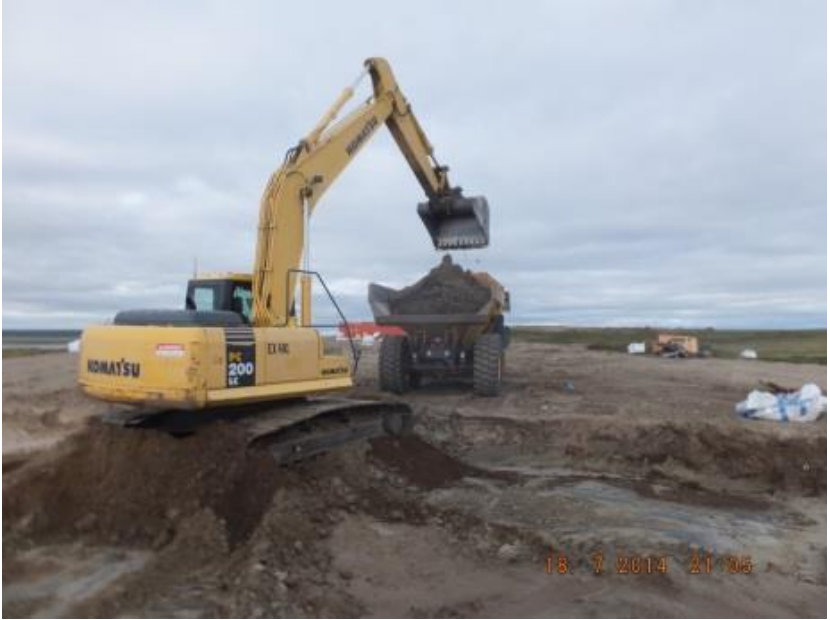
Client: PWGSC/ AANDC-CARD	CONTWOYTO LAKE WEATHER STATION	Project No. 350600-508
Photo No. 47

Date: July 18, 2014		
Direction Photo taken: northwest		
Description: Loading PHC-impacted soil from Soil Impact Zone 04 for transport to the Treatment Cell.

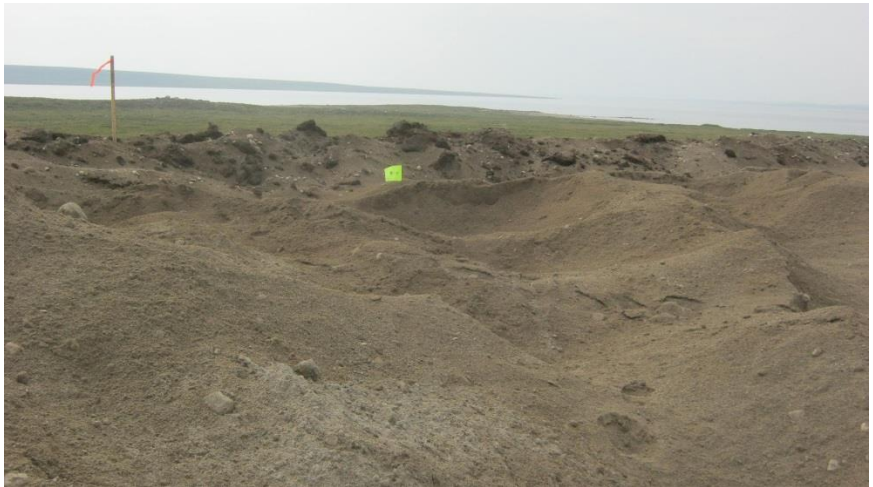
Client: PWGSC/ AANDC-CARD	CONTWOYTO LAKE WEATHER STATION	Project No. 350600-508
Photo No. 48

Date: August 10, 2014		
Direction Photo taken: southwest		
Description: Inside the Soil Treatment Cell. Cell in operation to treat PHC-impacted soils.

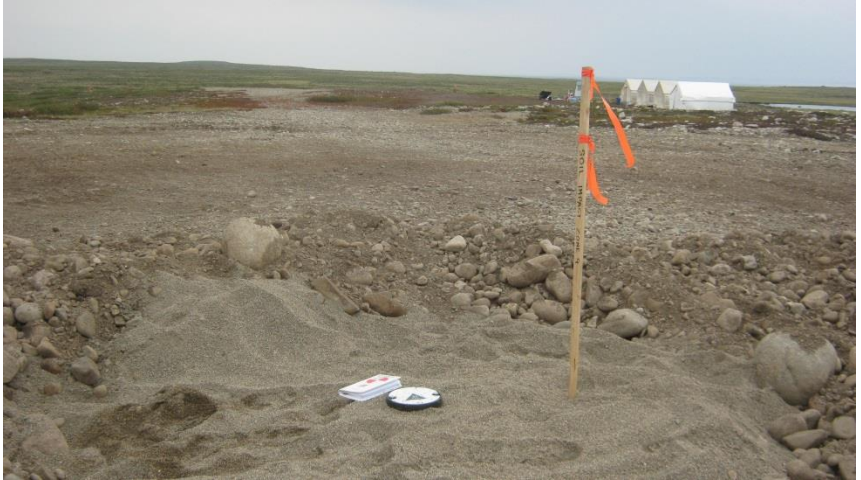
Client: PWGSC/ AANDC-CARD	CONTWOYTO LAKE WEATHER STATION	Project No. 350600-508
Photo No. 49

Date: August 10, 2014		
Direction Photo taken: east		
Description: Monitoring Well installation east of the treatment cell. The remedial contractor camp is seen in the background.

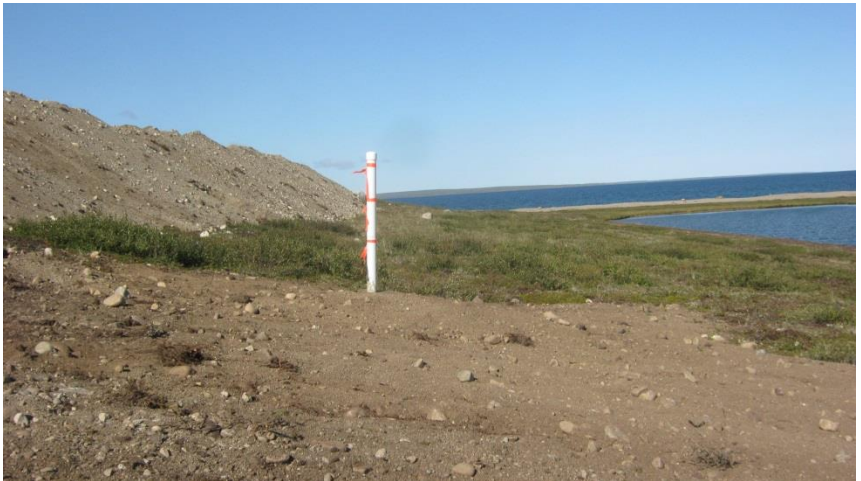
Client: PWGSC/ AANDC-CARD	CONTWOYTO LAKE WEATHER STATION	Project No. 350600-508
Photo No. 50

Date: August 10, 2014		
Direction Photo taken: west		
Description: Monitoring Well installation on the north side of the treatment cell.

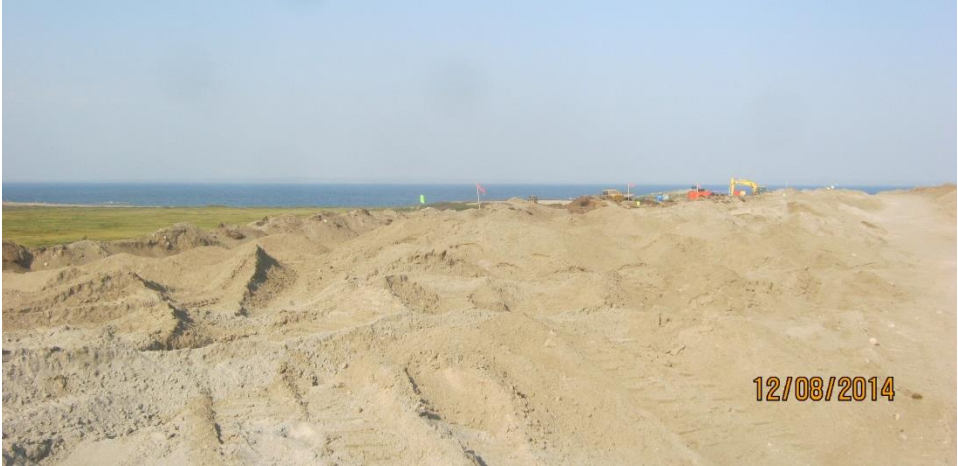
Client: PWGSC/ AANDC-CARD	CONTWOYTO LAKE WEATHER STATION	Project No. 350600-508
Photo No. 51

Date: August 12, 2014		
Direction Photo taken: west		
Description: The Treatment Cell. Access road is seen on the right hand side.

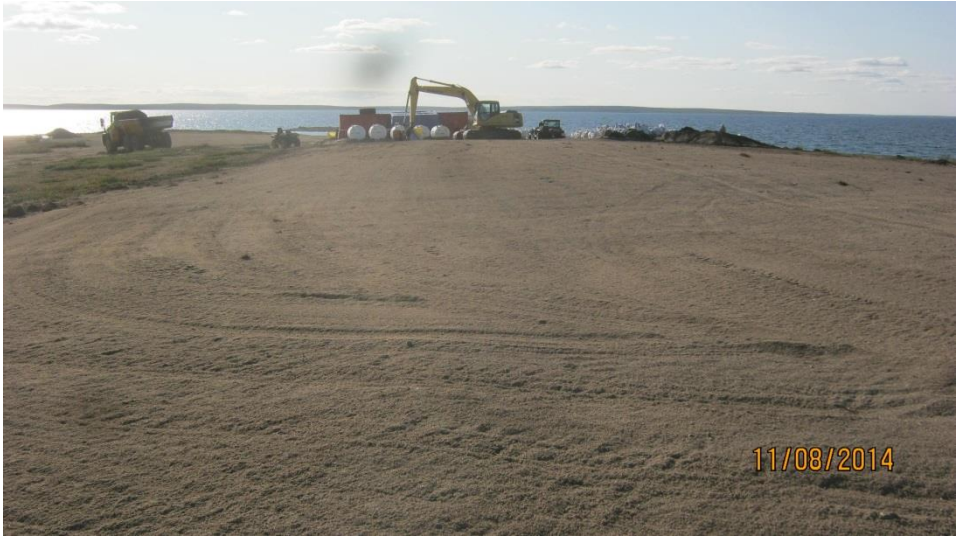
Client: PWGSC/ AANDC-CARD	CONTWOYTO LAKE WEATHER STATION	Project No. 350600-508
Photo No. 52

Date: August 11, 2014		
Direction Photo taken: west		
Description: Looking across former camp area during regrading activities. Fuel cache and temporary storage area is seen in the background

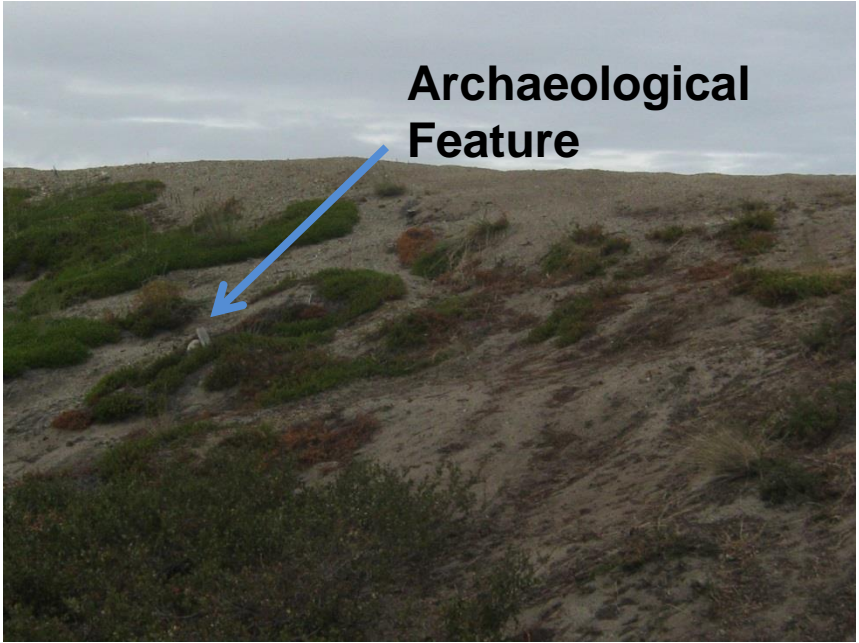
Client: PWGSC/ AANDC-CARD	CONTWOYTO LAKE WEATHER STATION	Project No. 350600-508
Photo No. 53

Date: July 31, 2014		
Direction Photo taken: west		
Description: A dog tie, the archaeological feature identified on the peninsula during the Archaeological Impact Assessment, remained untouched during the remedial works.

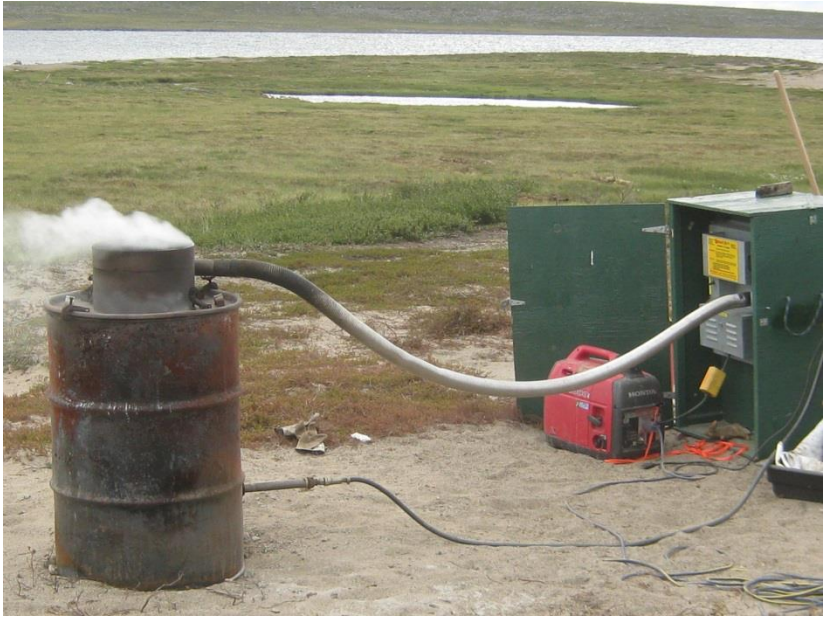
Client: PWGSC/ AANDC-CARD	CONTWOYTO LAKE WEATHER STATION	Project No. 350600-508
Photo No. 54

Date: July 31, 2014		
Direction Photo taken: south		
Description: Incineration of camp food waste occurred daily throughout the summer construction season.

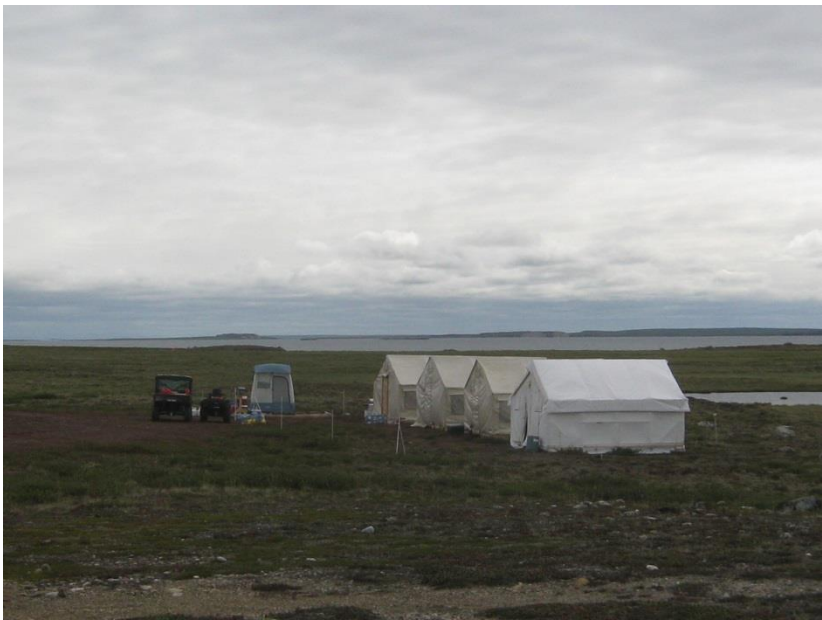
Client: PWGSC/ AANDC-CARD	CONTWOYTO LAKE WEATHER STATION	Project No. 350600-508
Photo No. 56

Date: July 31, 2014		
Direction Photo taken: east		
Description: The remediation contractor's camp at the east end of the esker. Note the bear fence surrounding the tents.

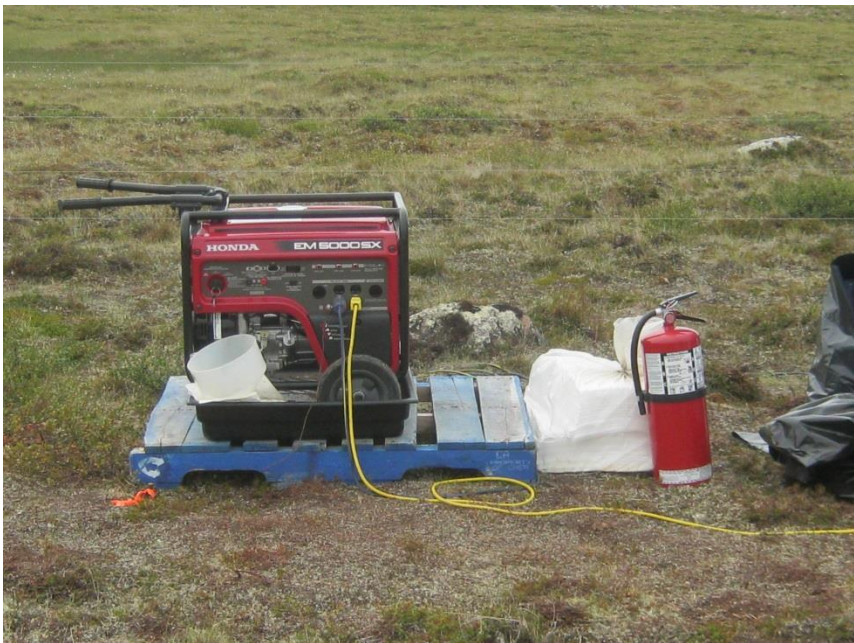
Client: PWGSC/ AANDC-CARD	CONTWOYTO LAKE WEATHER STATION	Project No. 350600-508
Photo No. 57

Date: July 31, 2014		
Direction Photo taken: east		
Description: The generator at the remedial contractor's camp area.

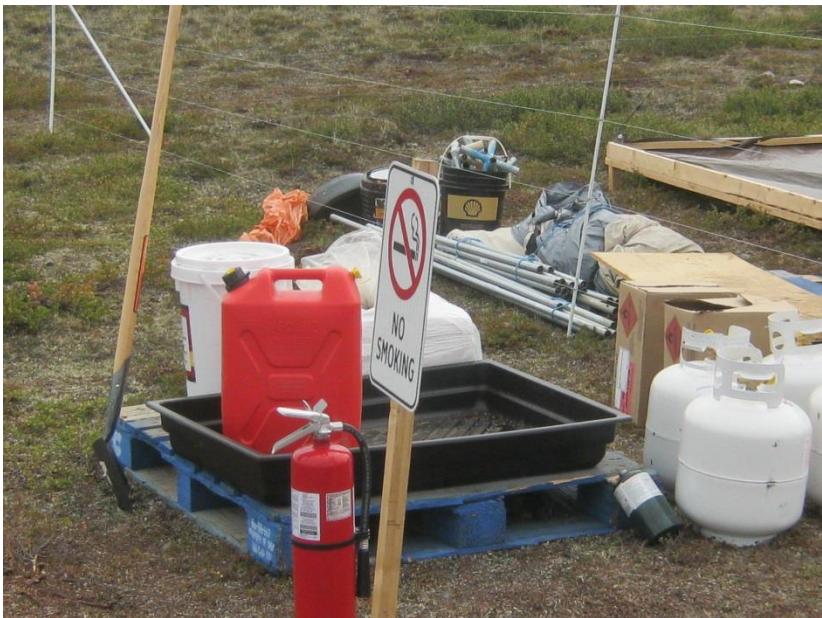
Client: PWGSC/ AANDC-CARD	CONTWOYTO LAKE WEATHER STATION	Project No. 350600-508
Photo No. 58

Date: July 31, 2014		
Direction Photo taken: southeast		
Description: The small fuel cache adjacent to the remedial contractor's camp area.

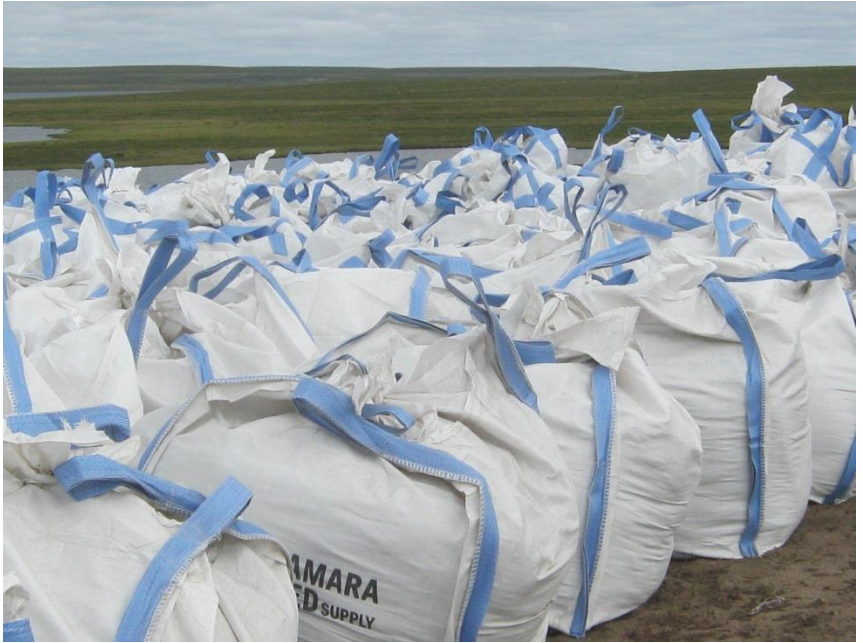
Client: PWGSC/ AANDC-CARD	CONTWOYTO LAKE WEATHER STATION	Project No. 350600-508
Photo No. 59

Date: July 31, 2014		
Direction Photo taken: north		
Description: Consolidated waste packaged and awaiting off-site transport.

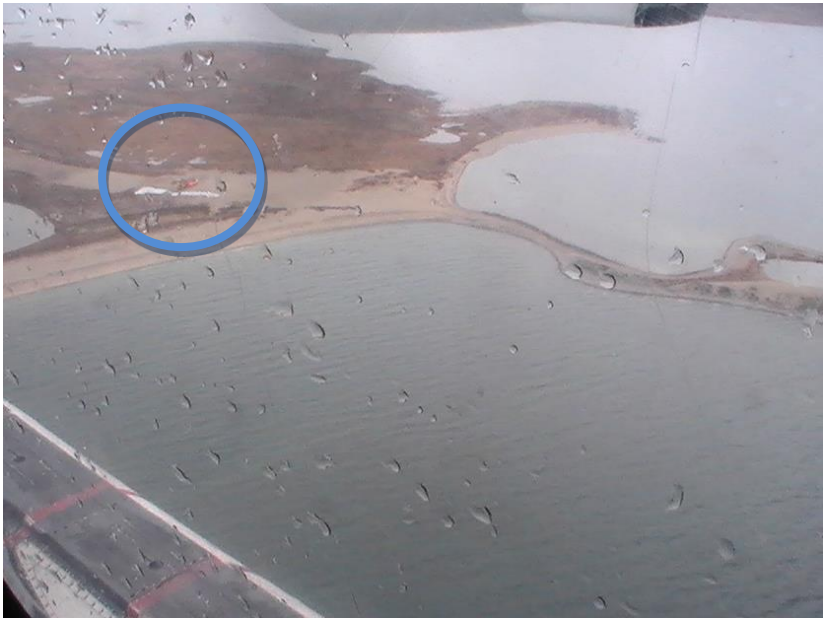
Client: PWGSC/ AANDC-CARD	CONTWOYTO LAKE WEATHER STATION	Project No. 350600-508
Photo No. 60

Date: September 18, 2014		
Direction Photo taken: Overview - south		
Description: Equipment, material, and packaged wastes are consolidated (circled) and awaiting off-site transport.

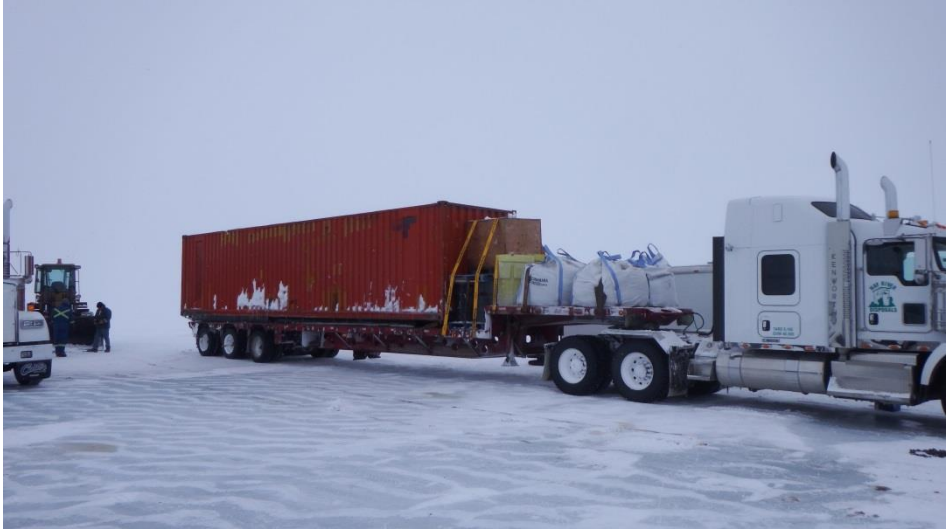
Client: PWGSC/ AANDC-CARD	CONTWOYTO LAKE WEATHER STATION	Project No. 350600-508
Photo No. 61

Date: March 27, 2015		
Direction Photo taken: south		
Description: Demobilization of the seacan which housed the hazardous waste (e.g. wood with lead amended paint, wood with PCB-amended paint, jerry cans, paint, batteries, etc.)

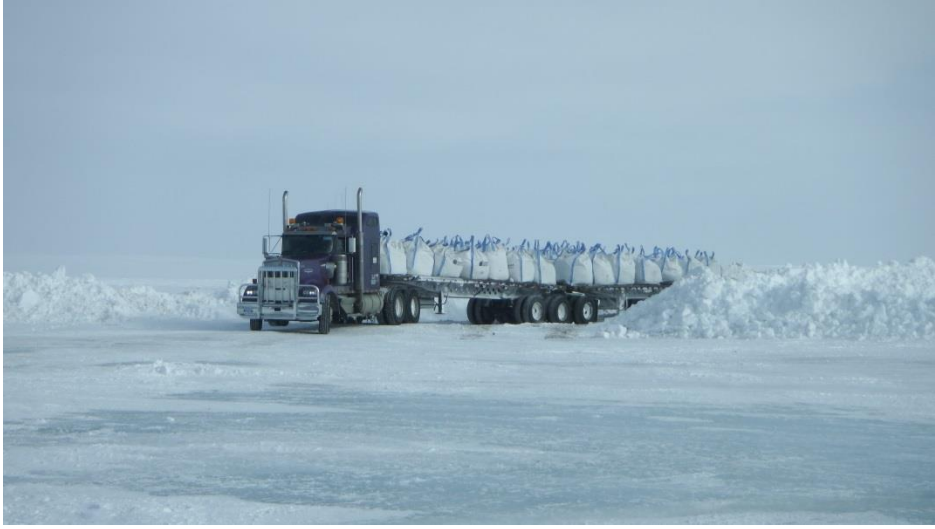
Client: PWGSC/ AANDC-CARD	CONTWOYTO LAKE WEATHER STATION	Project No. 350600-508
Photo No. 62

Date: March 28, 2015		
Direction Photo taken: northeast		
Description: The off-site transport of non-hazardous waste and metal-impacted soils.
