PWGSC		
CONTWOYTO LAKE REMEDATION PROJECT		
PREVIOUSLY IDENTIFIED AREAS OF ENVIRONMENTAL CONCERN		
Drawn By: P.A.F.	Approved By: J.M.	Project No: 350600-508
Date: NOV. 2015	Scale: 1:3500	Drawing No: FIGURE 3

### **SITE PHOTOGRAPHS**

## PHOTOGRAPHIC RECORD

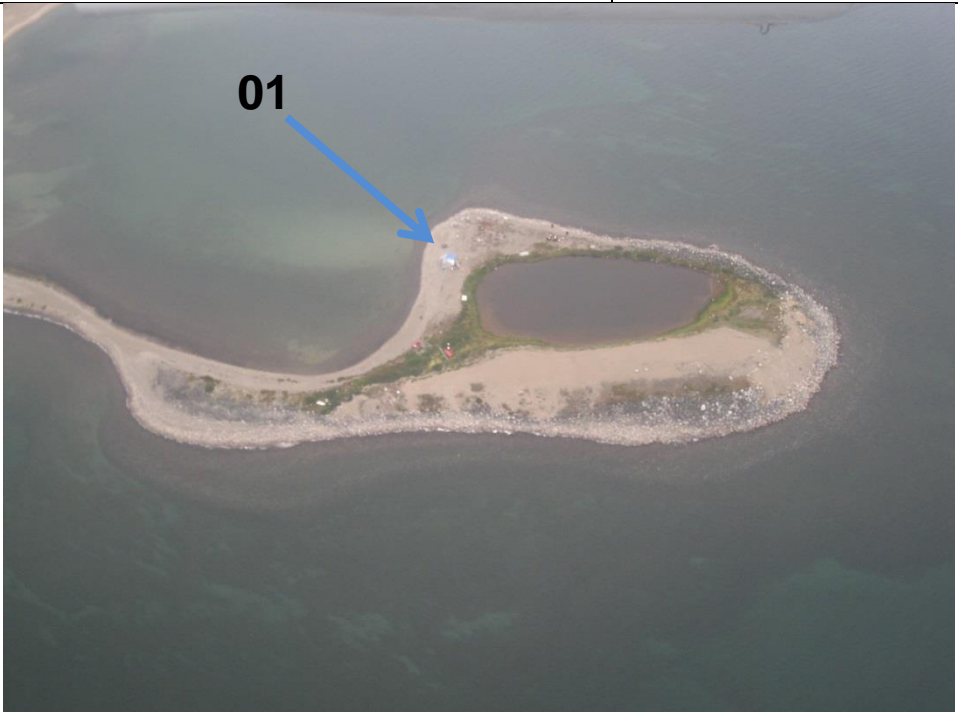
Client: PWGSC/ AANDC-CARD	CONTWOYTO LAKE WEATHER STATION	Project No. 350600-508
<b>Photo No. 2</b>

Date: August 6, 2012		
Direction Photo taken: Overview - south		
<p><b>Description:</b> The Peninsula as seen during the Phase III ESA. The hunter's cabin (Structure 01) is on the peninsula.</p>

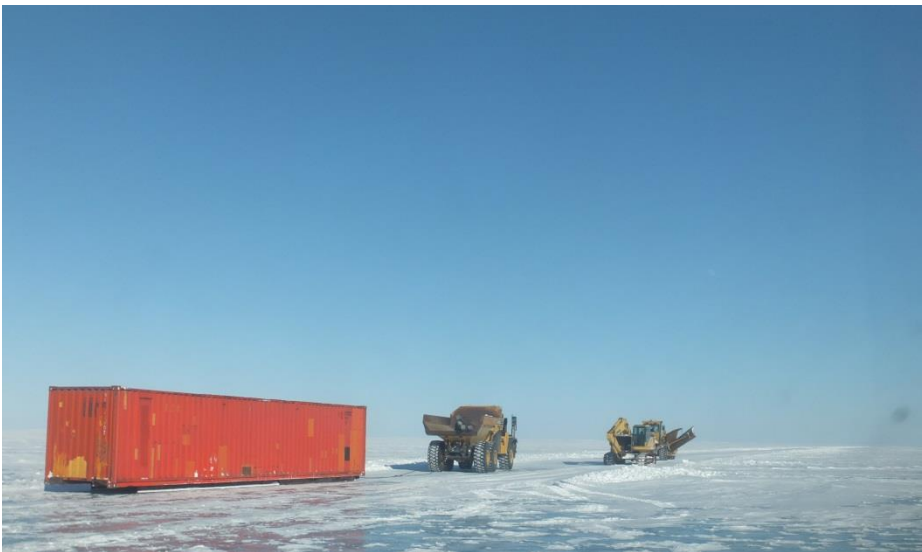
<b>Client:</b> PWGSC/ AANDC-CARD	<b>CONTWOYTO LAKE WEATHER STATION</b>	<b>Project No. 350600-508</b>
<b>Photo No. 5</b>

<b>Date:</b> April 10, 2014		
<b>Direction Photo taken:</b> southeast		
<b>Description:</b> Mobilization of equipment and materials. Winter road from Lupin mine site to the former weather station island.

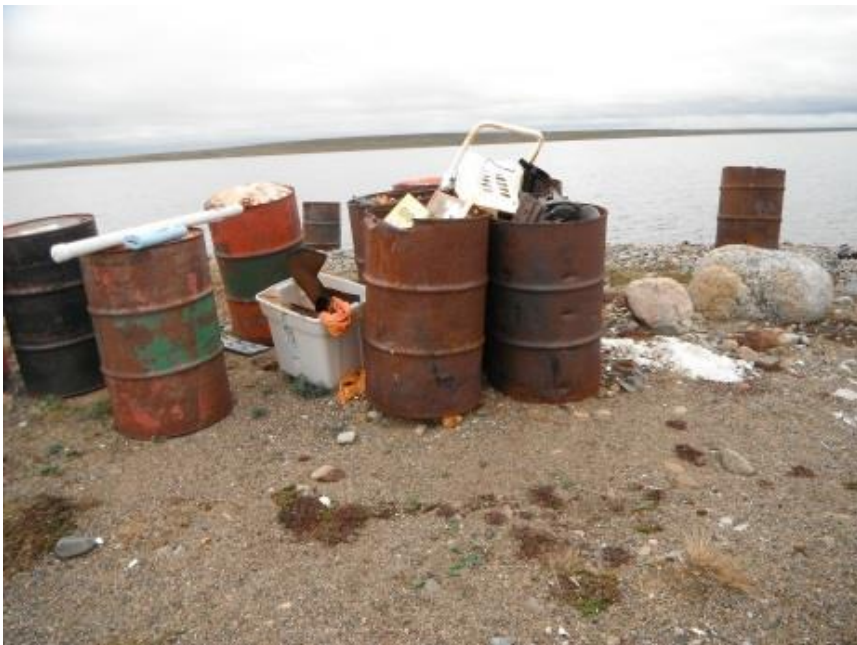
<b>Client:</b> PWGSC/ AANDC-CARD	<b>CONTWOYTO LAKE WEATHER STATION</b>	<b>Project No. 350600-508</b>
<b>Photo No. 13</b>

<b>Date:</b> August 8, 2012		
<b>Direction Photo taken:</b> North east		
<b>Description:</b> Drum cache 02 on the peninsula as seen during the Phase III ESA.

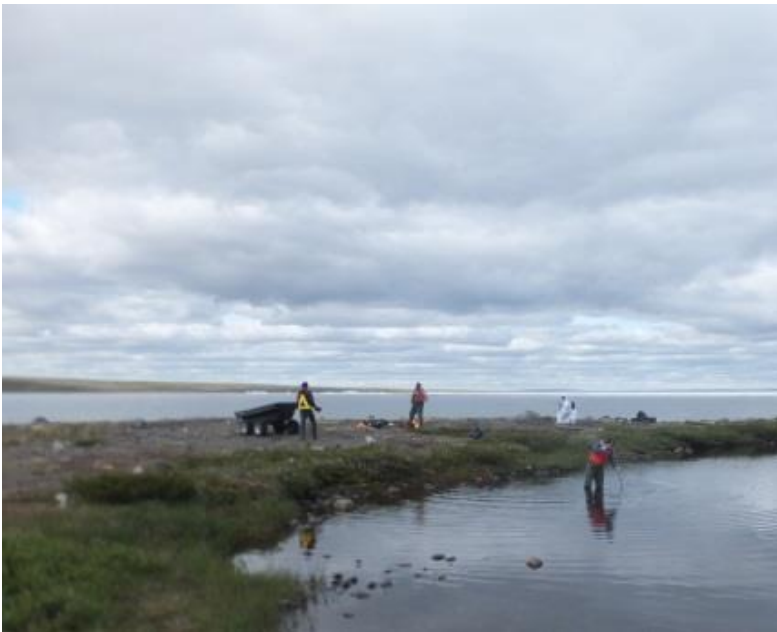
<b>Client:</b> PWGSC/ AANDC-CARD	<b>CONTWOYTO LAKE WEATHER STATION</b>	<b>Project No. 350600-508</b>
<b>Photo No. 14</b>

<b>Date:</b> July 9, 2014		
<b>Direction Photo taken:</b> northwest		
<b>Description:</b> Remedial works on Drum Cache 02 and surrounding area. Surface debris and old drums were collected.

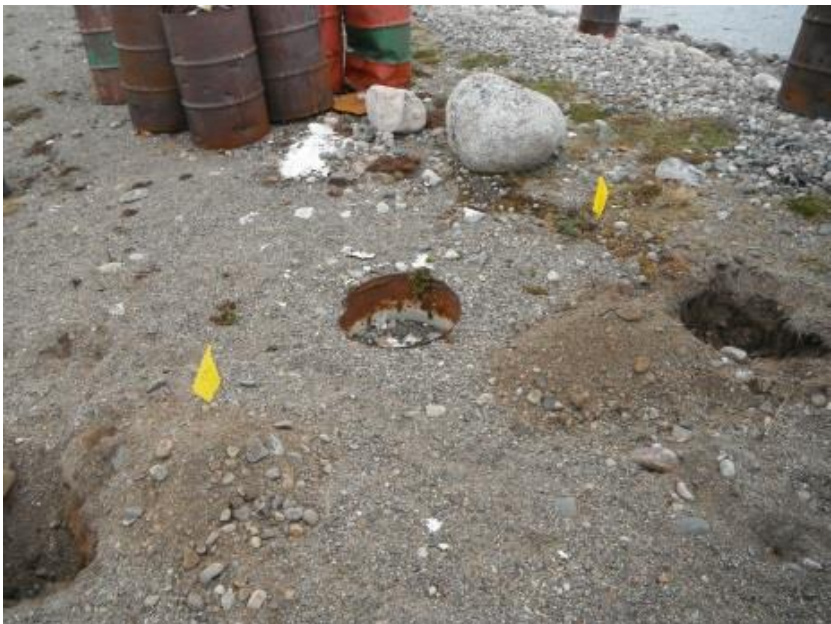
<b>Client:</b> PWGSC/ AANDC-CARD	<b>CONTWOYTO LAKE WEATHER STATION</b>	<b>Project No. 350600-508</b>
<b>Photo No. 15</b>

<b>Date:</b> August 8, 2012		
<b>Direction Photo taken:</b> East		
<b>Description:</b> Soil Impact 01 located at Burn Pit 01 on the peninsula as seen during the Phase III ESA.

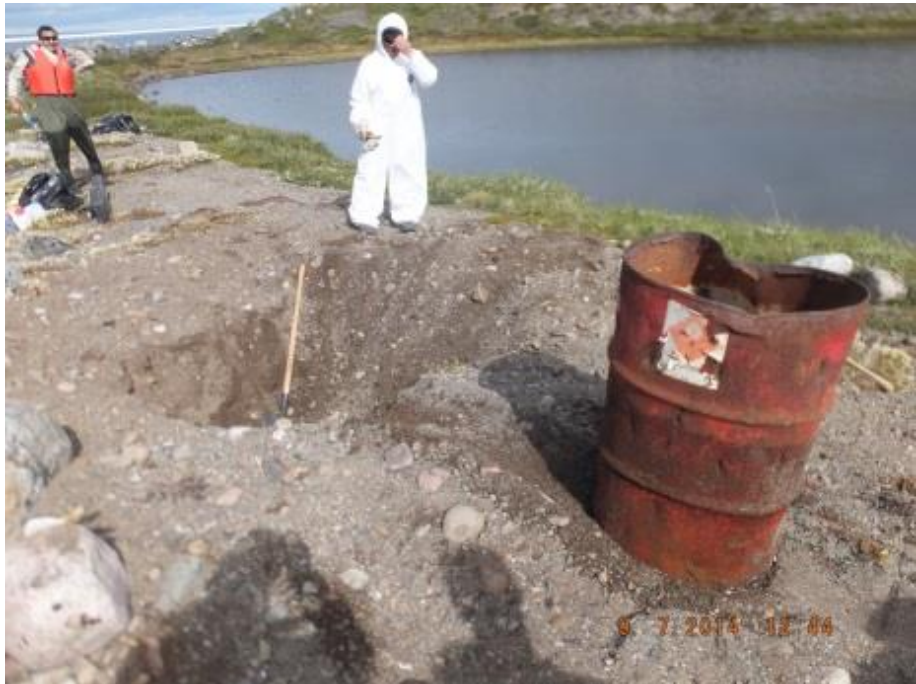
<b>Client:</b> PWGSC/ AANDC-CARD	<b>CONTWOYTO LAKE WEATHER STATION</b>	<b>Project No. 350600-508</b>
<b>Photo No. 16</b>

<b>Date:</b> July 9, 2014		
<b>Direction Photo taken:</b> northeast		
<b>Description:</b> Remedial works in progress at Soil Impact 01. Burn Pit 01 was dug out and scattered debris was collected.

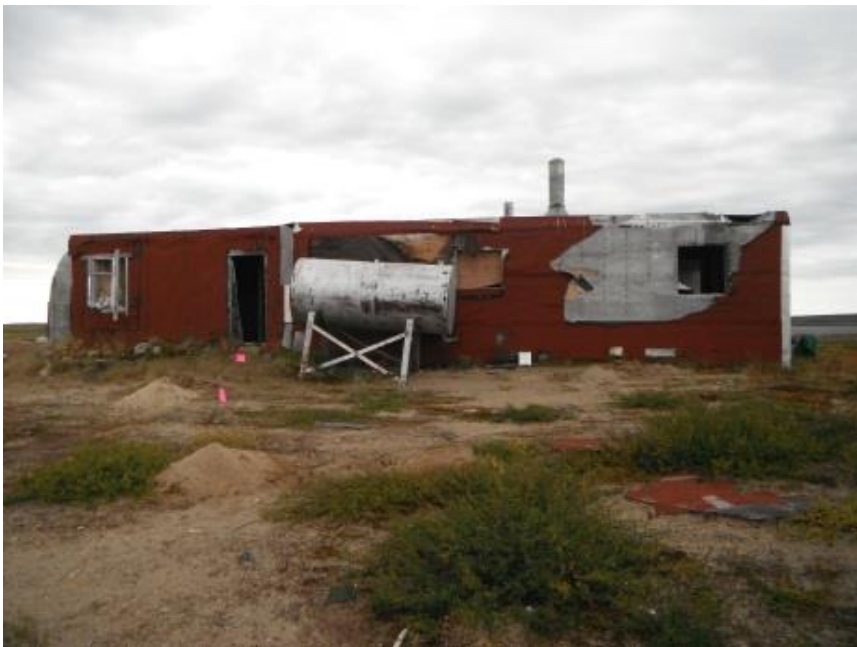
<b>Client:</b> PWGSC/ AANDC-CARD	<b>CONTWOYTO LAKE WEATHER STATION</b>	<b>Project No. 350600-508</b>
<b>Photo No. 17</b>

<b>Date:</b> August 8, 2012		
<b>Direction Photo taken:</b> south		
<b>Description:</b> Structure 02 as seen during the Phase III ESA.

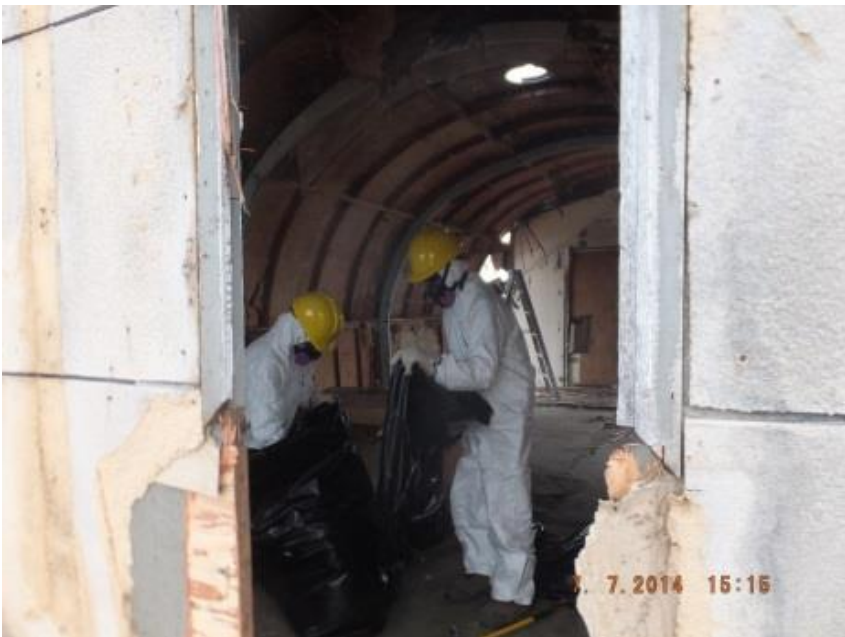
<b>Client:</b> PWGSC/ AANDC-CARD	<b>CONTWOYTO LAKE WEATHER STATION</b>	<b>Project No. 350600-508</b>
<b>Photo No. 18</b>

<b>Date:</b> July 7, 2014		
<b>Direction Photo taken:</b> southwest		
<b>Description:</b> Abatement work within Structure 02.  Materials containing lead-amended paint and PCB-amended paint were removed prior to demolition.

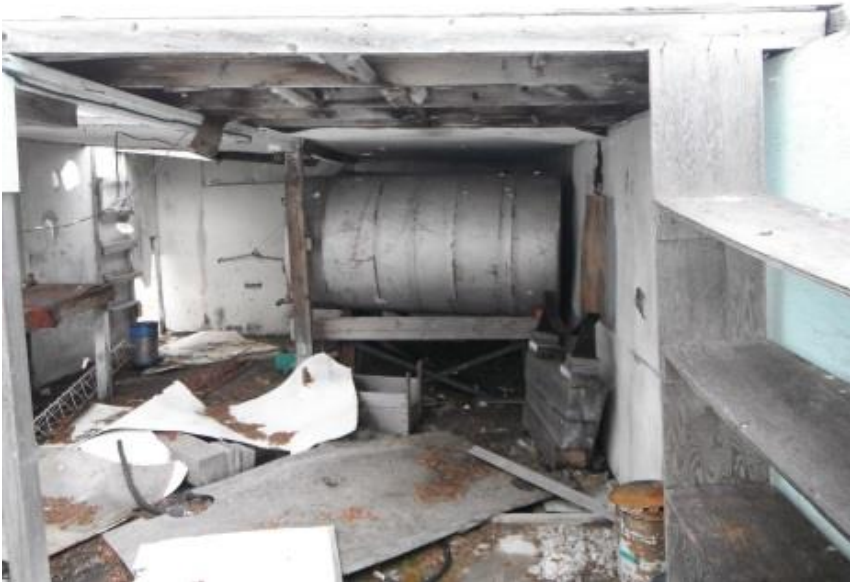
<b>Client:</b> PWGSC/ AANDC-CARD	<b>CONTWOYTO LAKE WEATHER STATION</b>	<b>Project No. 350600-508</b>
<b>Photo No. 20</b>

<b>Date:</b> August 8, 2012		
<b>Direction Photo taken:</b> east		
<b>Description:</b> Structure 03 interior as seen during the Phase III ESA.

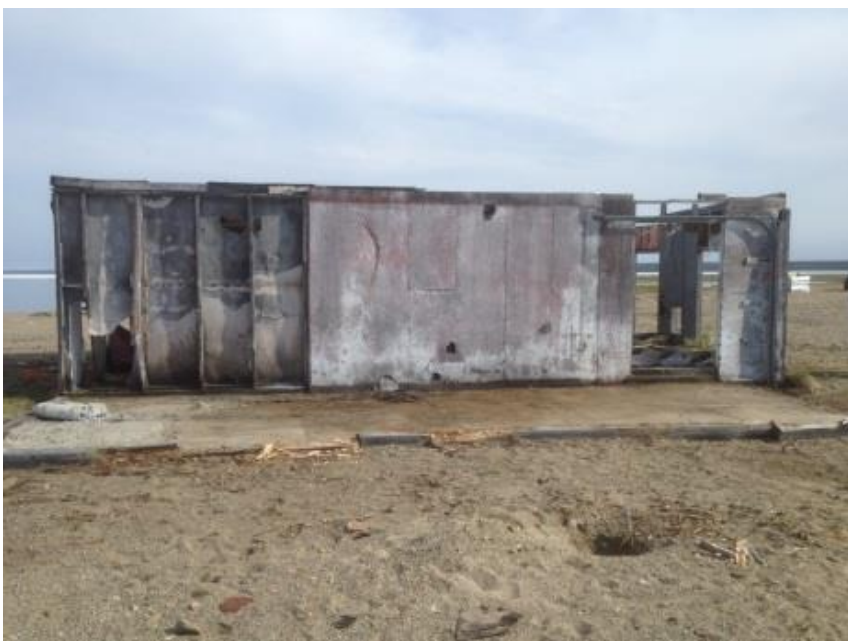
<b>Client:</b> PWGSC/ AANDC-CARD	<b>CONTWOYTO LAKE WEATHER STATION</b>	<b>Project No. 350600-508</b>
<b>Photo No. 22</b>

<b>Date:</b> July 5, 2014		
<b>Direction Photo taken:</b> southwest		
<b>Description:</b> Structure 03 after the removal of all painted wood surfaces.

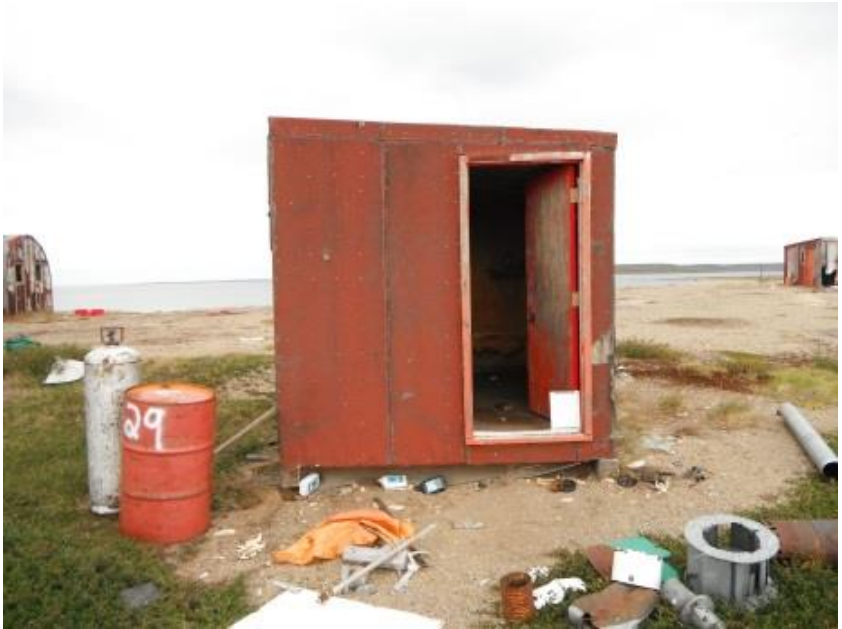
<b>Client:</b> PWGSC/ AANDC-CARD	<b>CONTWOYTO LAKE WEATHER STATION</b>	<b>Project No. 350600-508</b>
<b>Photo No. 23</b>

<b>Date:</b> August 9, 2012		
<b>Direction Photo taken:</b> north		
<b>Description:</b> Structure 04 as seen during the Phase III ESA.

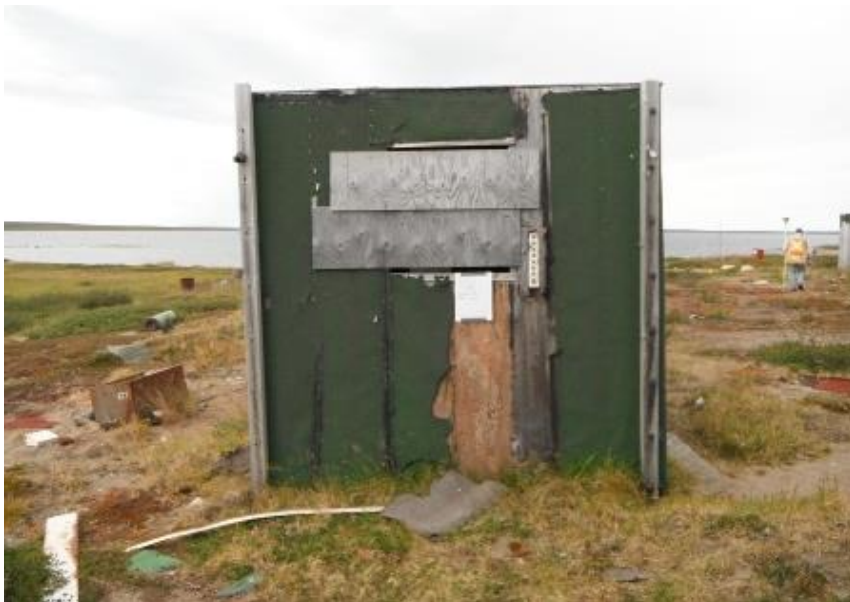
<b>Client:</b> PWGSC/ AANDC-CARD	<b>CONTWOYTO LAKE WEATHER STATION</b>	<b>Project No. 350600-508</b>
<b>Photo No. 25</b>

<b>Date:</b> August 7, 2012		
<b>Direction Photo taken:</b> south		
<b>Description:</b> Structure 05 as seen during the Phase III ESA.

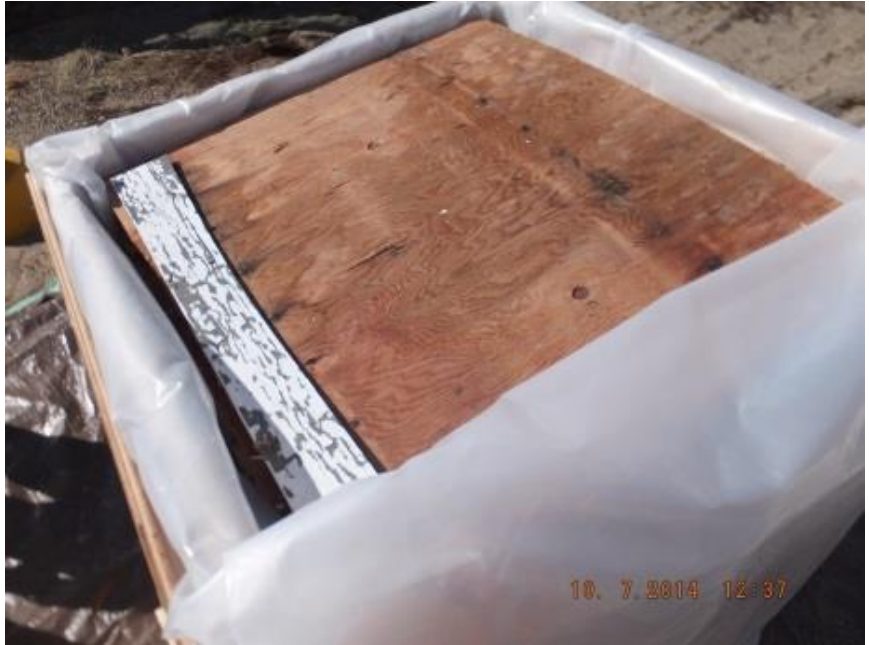
<b>Client:</b> PWGSC/ AANDC-CARD	<b>CONTWOYTO LAKE WEATHER STATION</b>	<b>Project No. 350600-508</b>
<b>Photo No. 27</b>

<b>Date:</b> July 10, 2014		
<b>Direction Photo taken:</b> overview		
<b>Description:</b> TDG crate shown. All the hazardous material that was removed from the structures was boxed up in TDG crates (4'x4'x4' plywood with 2x4" internal frame) which were lined with two layers of 10 mm poly, and placed into the seacan for storage and shipping.

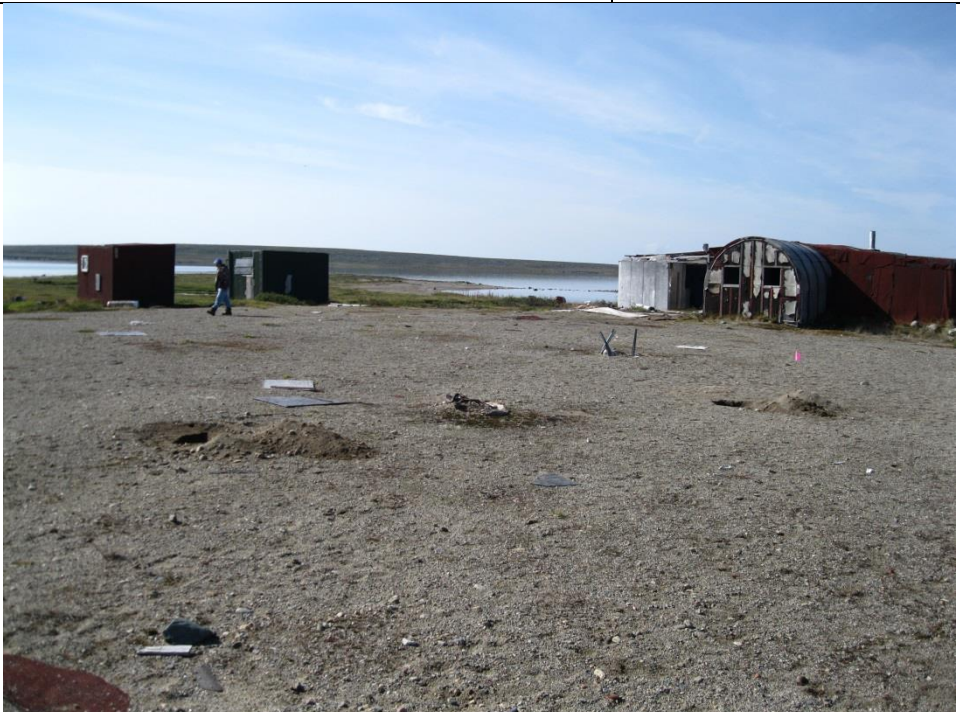
<b>Client:</b> PWGSC/ AANDC-CARD	<b>CONTWOYTO LAKE WEATHER STATION</b>	<b>Project No. 350600-508</b>
<b>Photo No. 29</b>

<b>Date:</b> August 8, 2012		
<b>Direction Photo taken:</b> northeast		
<b>Description:</b> The former camp area as seen during the Phase III ESA.

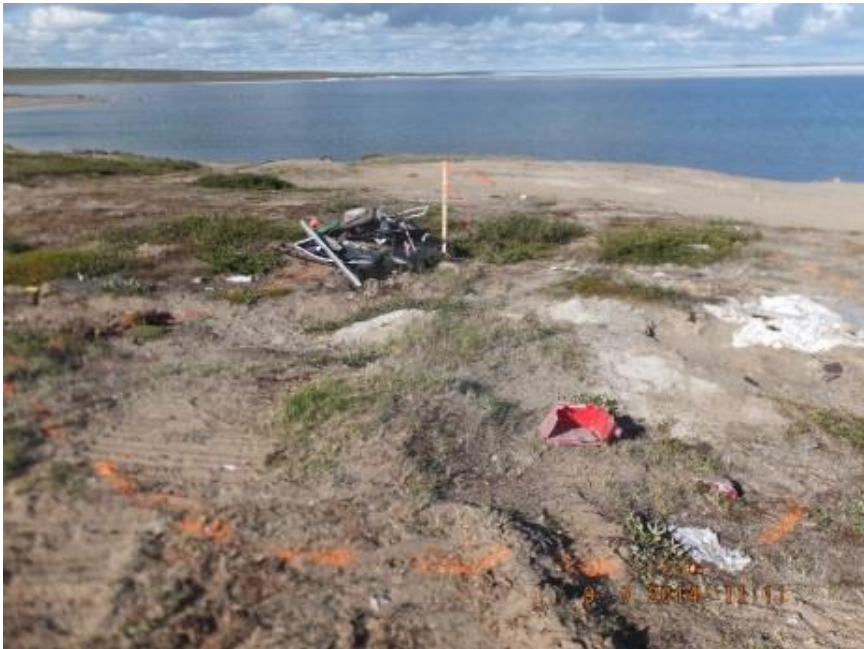
<b>Client:</b> PWGSC/ AANDC-CARD	<b>CONTWOYTO LAKE WEATHER STATION</b>	<b>Project No. 350600-508</b>
<b>Photo No. 33</b>

<b>Date:</b> July 9, 2014		
<b>Direction Photo taken:</b> southwest		
<b>Description:</b> Soil Impact Zone 05 before remedial works took place.

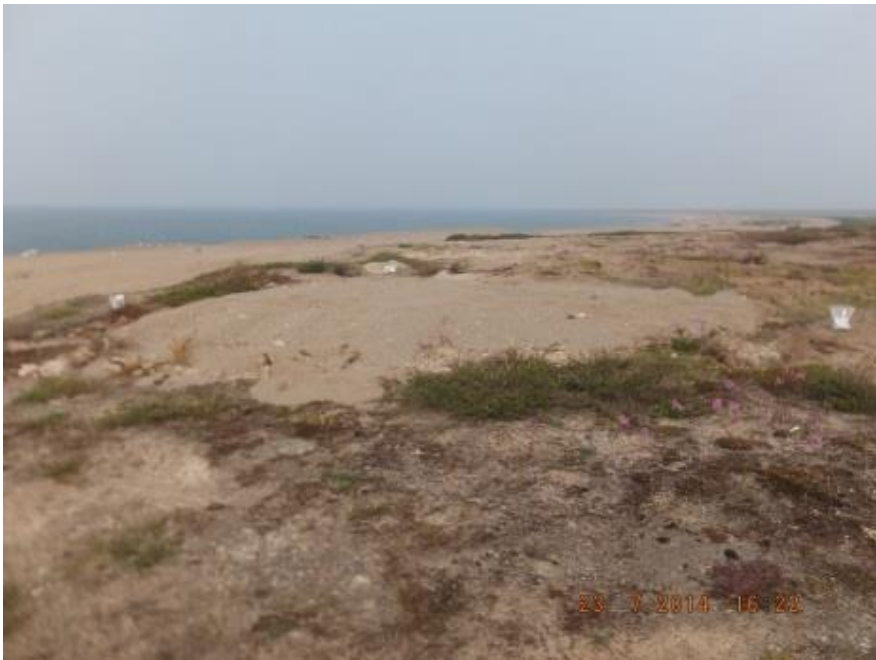
<b>Client:</b> PWGSC/ AANDC-CARD	<b>CONTWOYTO LAKE WEATHER STATION</b>	<b>Project No. 350600-508</b>
<b>Photo No. 34</b>

<b>Date:</b> July 23, 2014		
<b>Direction Photo taken:</b> west		
<b>Description:</b> Soil Impact Zone 05 after surface debris collection, excavation and backfill.

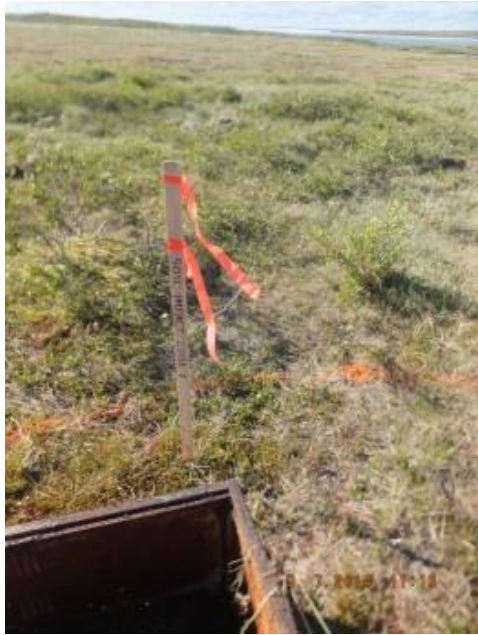
<b>Client:</b> PWGSC/ AANDC-CARD	<b>CONTWOYTO LAKE WEATHER STATION</b>	<b>Project No. 350600-508</b>
<b>Photo No. 37</b>

<b>Date:</b> July 9, 2014		
<b>Direction Photo taken:</b> southeast		
<b>Description:</b> Inside Soil Impact Zone 07 before remedial works took place.

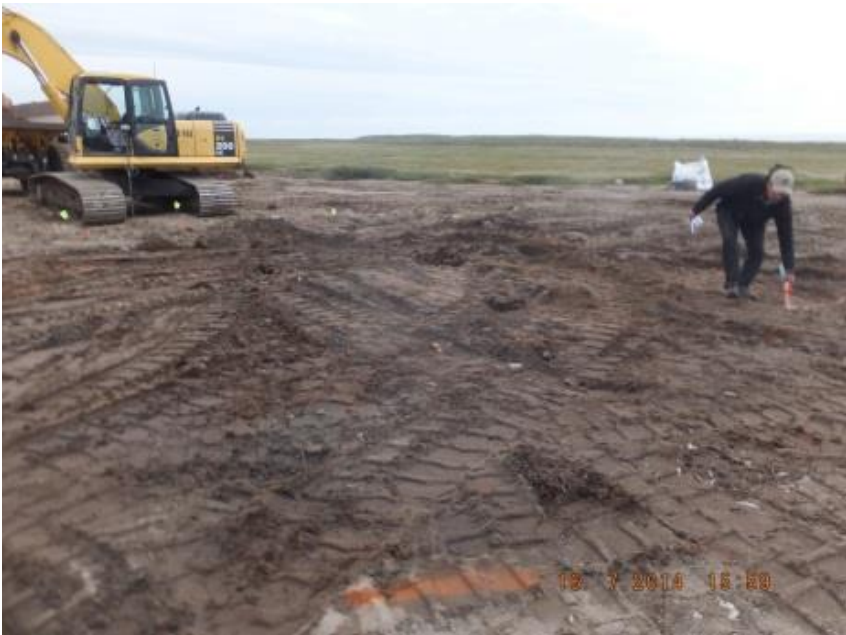
<b>Client:</b> PWGSC/ AANDC-CARD	<b>CONTWOYTO LAKE WEATHER STATION</b>	<b>Project No. 350600-508</b>
<b>Photo No. 43</b>

<b>Date:</b> July 16, 2014		
<b>Direction Photo taken:</b> southeast		
<b>Description:</b> Soil Impact Zone 10 prior to excavation.

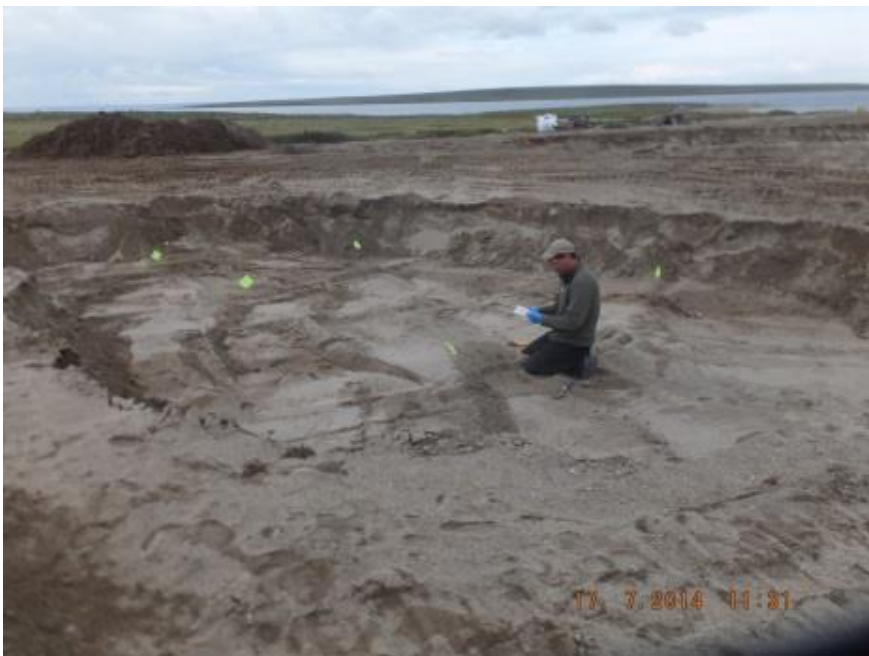
<b>Client:</b> PWGSC/ AANDC-CARD	<b>CONTWOYTO LAKE WEATHER STATION</b>	<b>Project No. 350600-508</b>
<b>Photo No. 44</b>

<b>Date:</b> July 17, 2014		
<b>Direction Photo taken:</b> northwest		
<b>Description:</b> Sampling the base of the excavation at Soil Impact Zone 10.

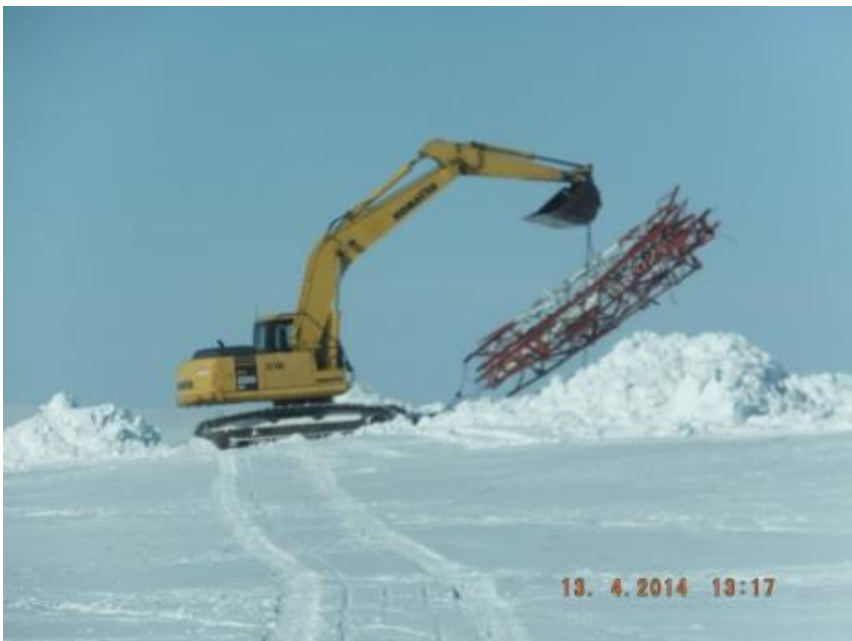
<b>Client:</b> PWGSC/ AANDC-CARD	<b>CONTWOYTO LAKE WEATHER STATION</b>	<b>Project No. 350600-508</b>
<b>Photo No. 46</b>

<b>Date:</b> April 13, 2014		
<b>Direction Photo taken:</b> south		
<b>Description:</b> Transporting the former tower segments from IOL to the former camp area. Segments were removed from IOL during winter to minimize damage to the tundra.

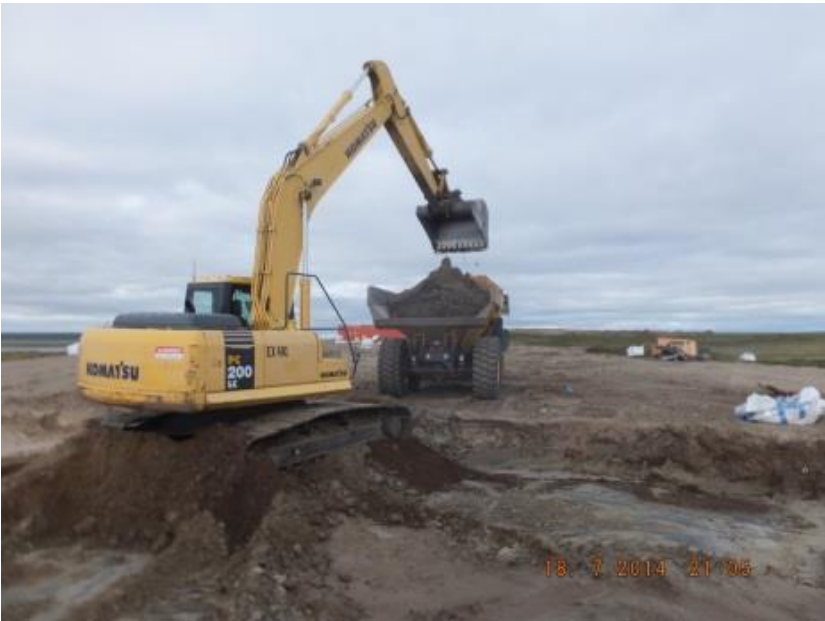
<b>Client:</b> PWGSC/ AANDC-CARD	<b>CONTWOYTO LAKE WEATHER STATION</b>	<b>Project No. 350600-508</b>
<b>Photo No. 47</b>

<b>Date:</b> July 18, 2014		
<b>Direction Photo taken:</b> northwest		
<b>Description:</b> Loading PHC-impacted soil from Soil Impact Zone 04 for transport to the Treatment Cell.

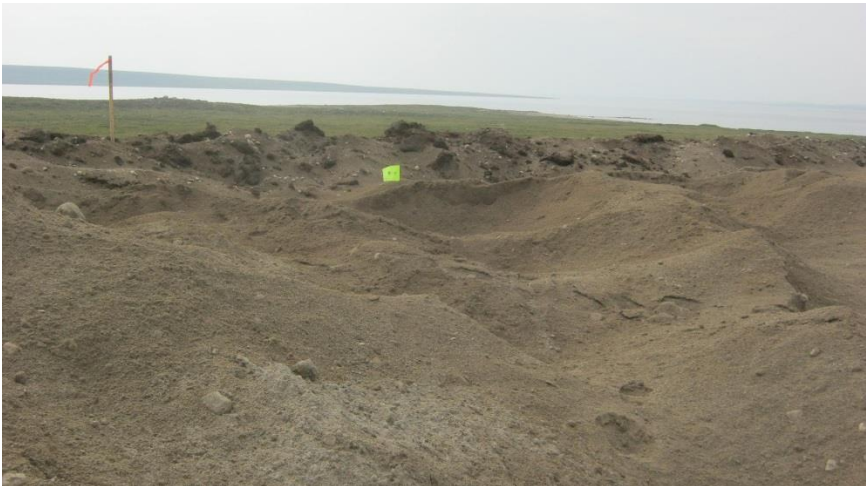
<b>Client:</b> PWGSC/ AANDC-CARD	<b>CONTWOYTO LAKE WEATHER STATION</b>	<b>Project No. 350600-508</b>
<b>Photo No. 48</b>

<b>Date:</b> August 10, 2014		
<b>Direction Photo taken:</b> southwest		
<b>Description:</b> Inside the Soil Treatment Cell.  Cell in operation to treat PHC-impacted soils.

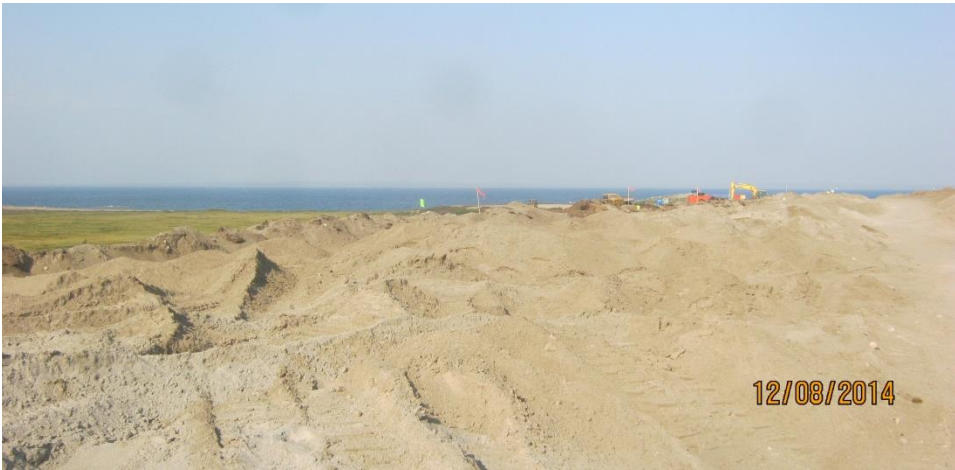
<b>Client:</b> PWGSC/ AANDC-CARD	<b>CONTWOYTO LAKE WEATHER STATION</b>	<b>Project No. 350600-508</b>
<b>Photo No. 51</b>

<b>Date:</b> August 12, 2014		
<b>Direction Photo taken:</b> west		
<b>Description:</b> The Treatment Cell. Access road is seen on the right hand side.

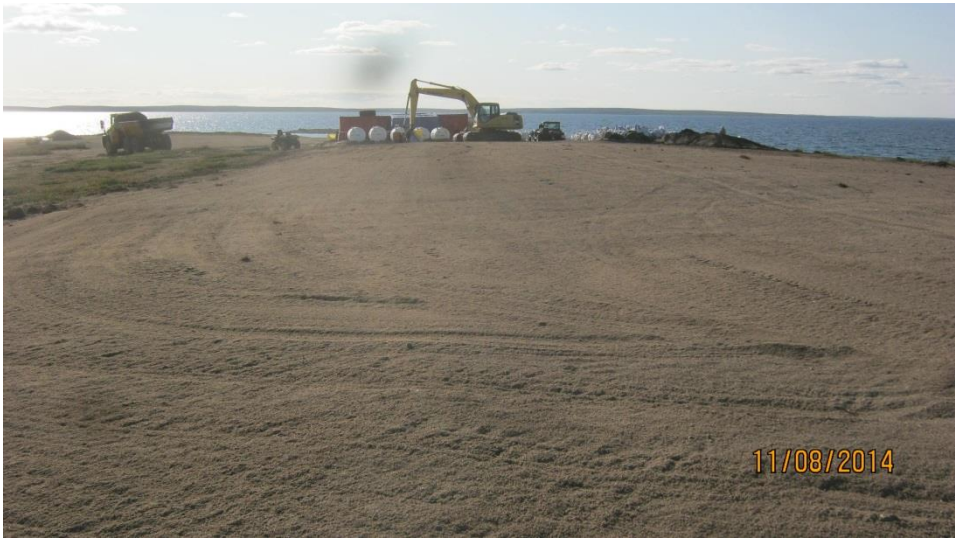
<b>Client:</b> PWGSC/ AANDC-CARD	<b>CONTWOYTO LAKE WEATHER STATION</b>	<b>Project No. 350600-508</b>
<b>Photo No. 52</b>

<b>Date:</b> August 11, 2014		
<b>Direction Photo taken:</b> west		
<b>Description:</b> Looking across former camp area during regrading activities. Fuel cache and temporary storage area is seen in the background

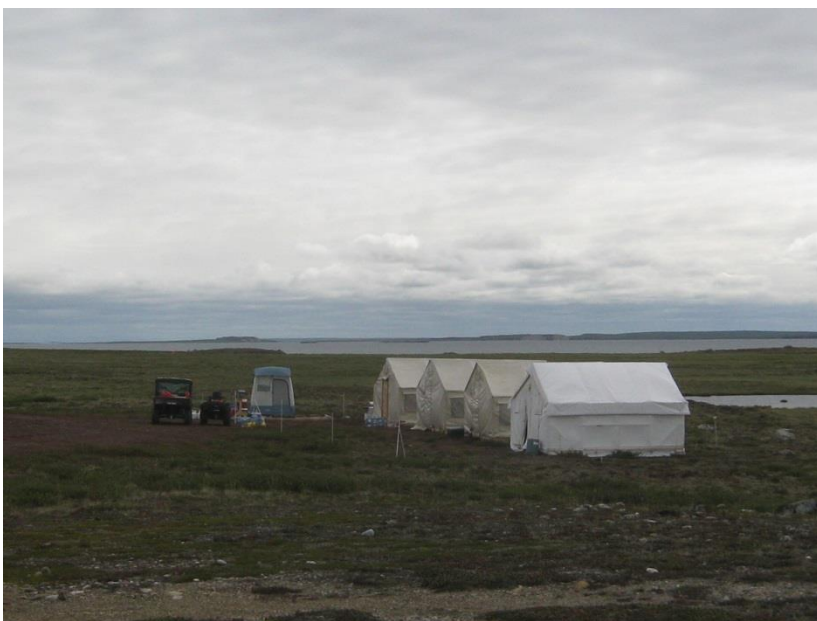
<b>Client:</b> PWGSC/ AANDC-CARD	<b>CONTWOYTO LAKE WEATHER STATION</b>	<b>Project No. 350600-508</b>
<b>Photo No. 56</b>

<b>Date:</b> July 31, 2014		
<b>Direction Photo taken:</b> east		
<b>Description:</b> The remediation contractor's camp at the east end of the esker. Note the bear fence surrounding the tents.

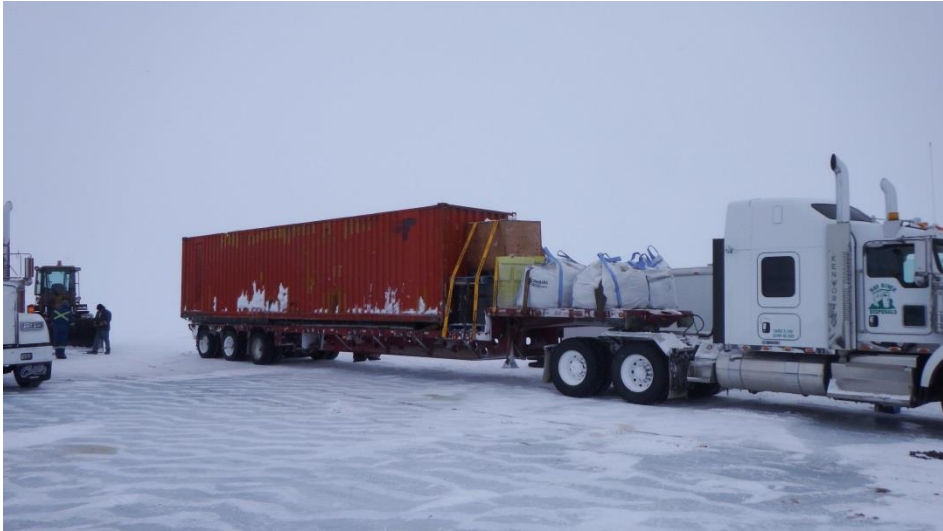
<b>Client:</b> PWGSC/ AANDC-CARD	<b>CONTWOYTO LAKE WEATHER STATION</b>	<b>Project No. 350600-508</b>
<b>Photo No. 61</b>

<b>Date:</b> March 27, 2015		
<b>Direction Photo taken:</b> south		
<b>Description:</b> Demobilization of the seacan which housed the hazardous waste (e.g. wood with lead amended paint, wood with PCB-amended paint, jerry cans, paint, batteries, etc.)

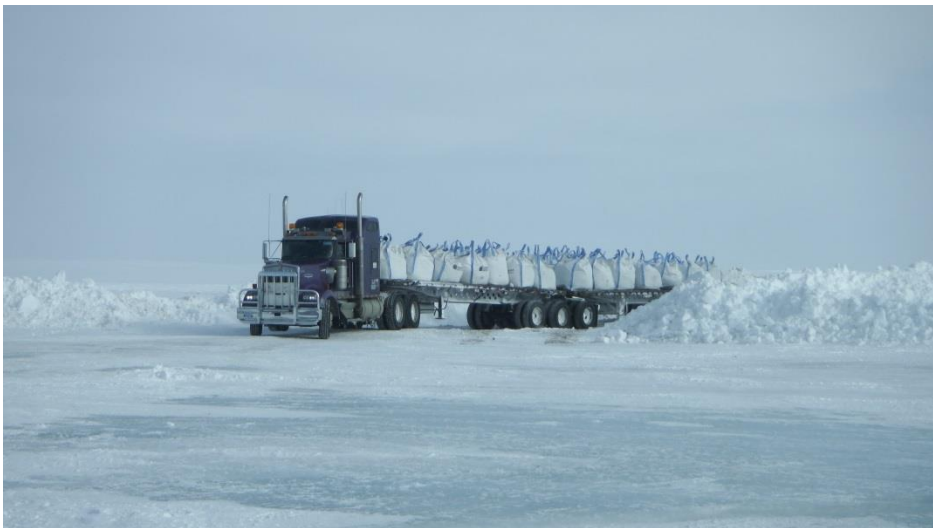
<b>Client:</b> PWGSC/ AANDC-CARD	<b>CONTWOYTO LAKE WEATHER STATION</b>	<b>Project No. 350600-508</b>
<b>Photo No. 62</b>

<b>Date:</b> March 28, 2015		
<b>Direction Photo taken:</b> northeast		
<b>Description:</b> The off-site transport of non-hazardous waste and metal-impacted soils.
