**RE: CORAL HARBOUR PROJECT NWB LLICENSE NO. 1BR-COR2325 ANNUAL
REPORT, 2024**

NWB Annual Report

Project Name: Coral Harbour Remediation Project

APPENDIX B
PHOTOGRAPHIC LOG

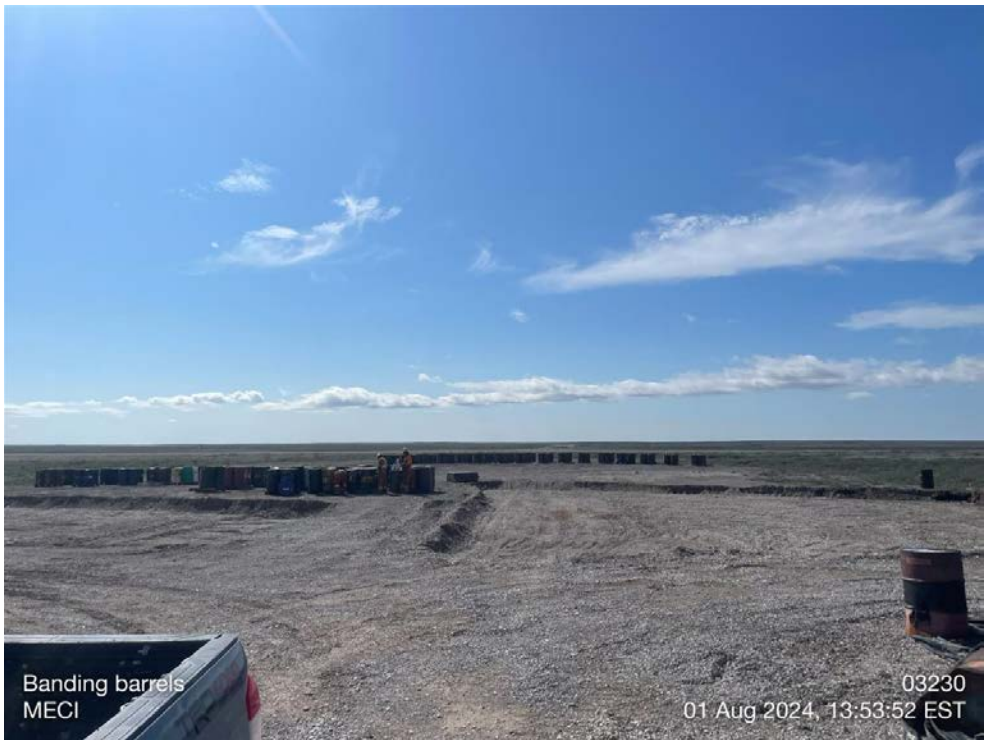
Photo Location: AEC 2			
Direction: W			
Survey Date: 8/1/2024			
Comments: View of stained surficial soil excavations 02-SO-001 and 02-SO-002. Contractor packaging barrels for off-site disposal in background.			
Photograph ID: 20

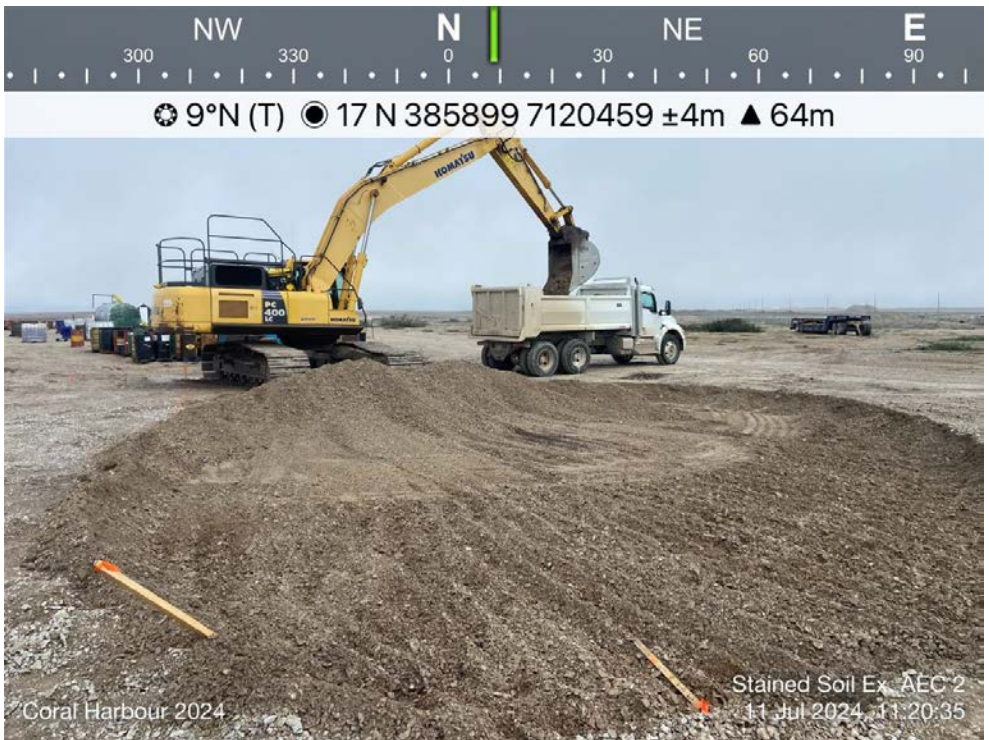
Photo Location: AEC 2			
Direction: N			
Survey Date: 7/11/2024			
Comments: Excavation of a stained surficial soil area in AEC 2.			
Photograph ID: 22

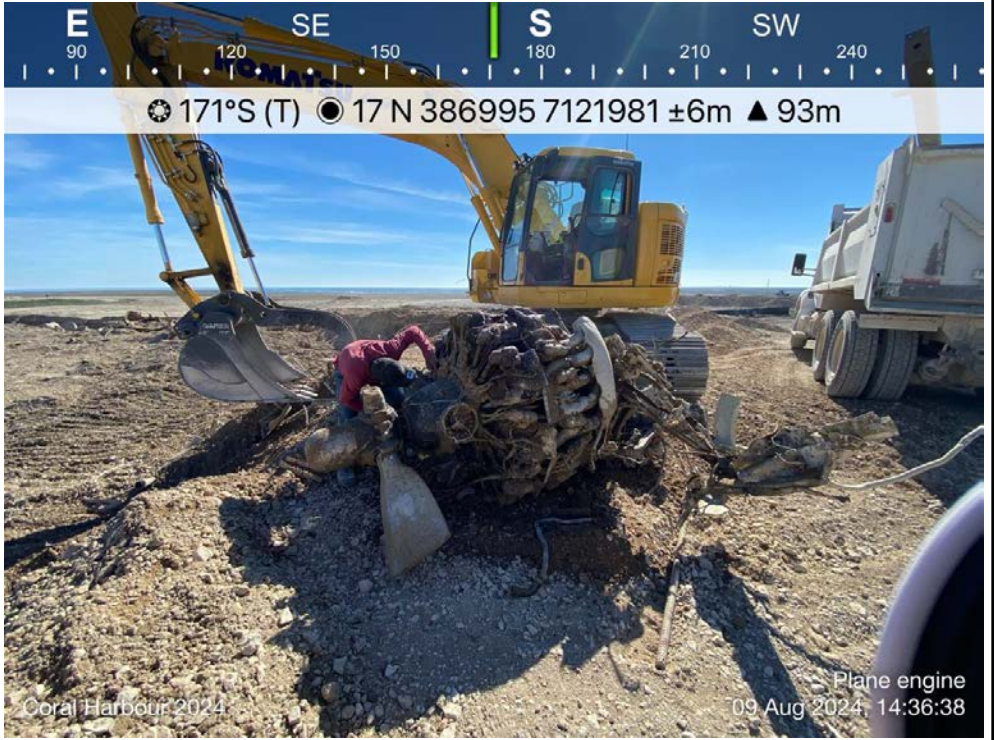
Photo Location: AEC 3			
Direction: S			
Survey Date: 8/9/2024			
Comments: Plane engine uncovered during the excavation of 03-BDA-002.			
Photograph ID: 32

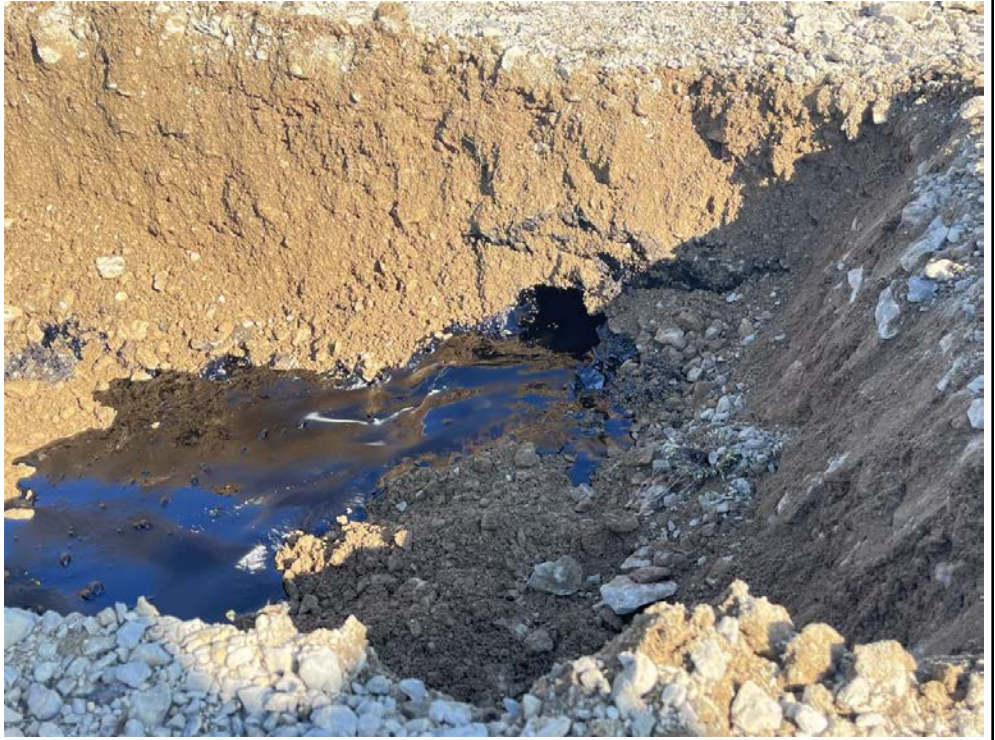
Photo Location: AEC 3			
Direction: N/A			
Survey Date: 8/1/2024			
Comments: Leaked tar material from the tar barrel cache in 03-BDA-002.

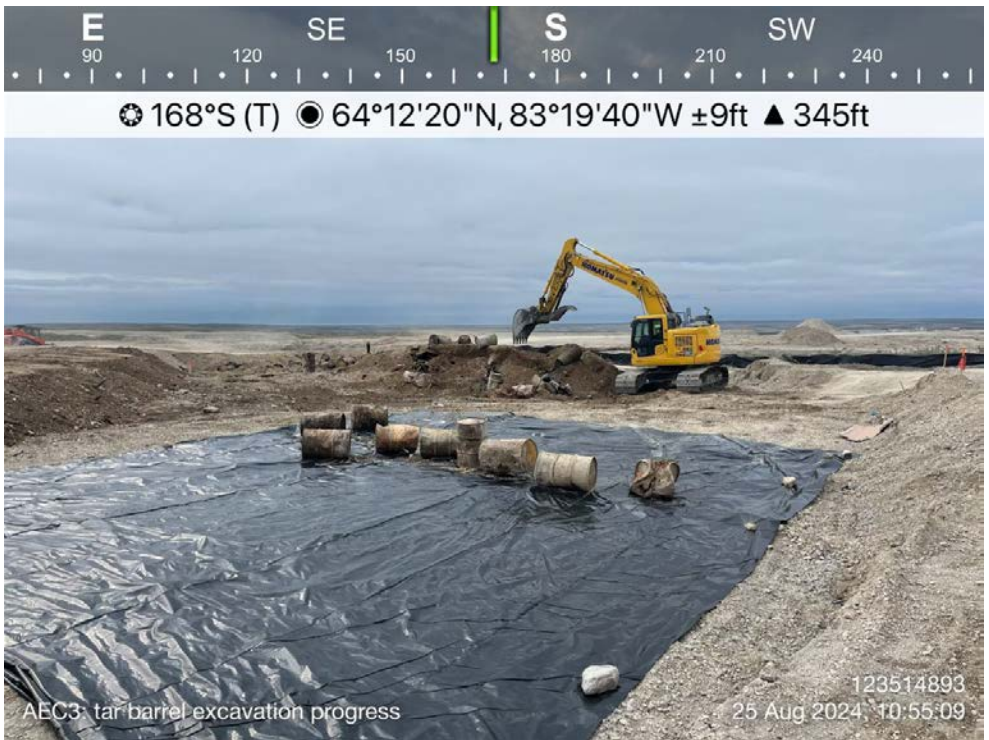
<p> E 90 120 150 180 210 240 SE S SW ☼ 168°S (T) ● 64°12'20"N, 83°19'40"W ±9ft ▲ 345ft 123514893 25 Aug 2024 10:55:09 </p>		
Photo Location: AEC 3			
Direction: S			
Survey Date: 8/26/2024			
Comments: Tar barrels recovered from the tar barrel cache in 03-BDA-002.			
Photograph ID: 34

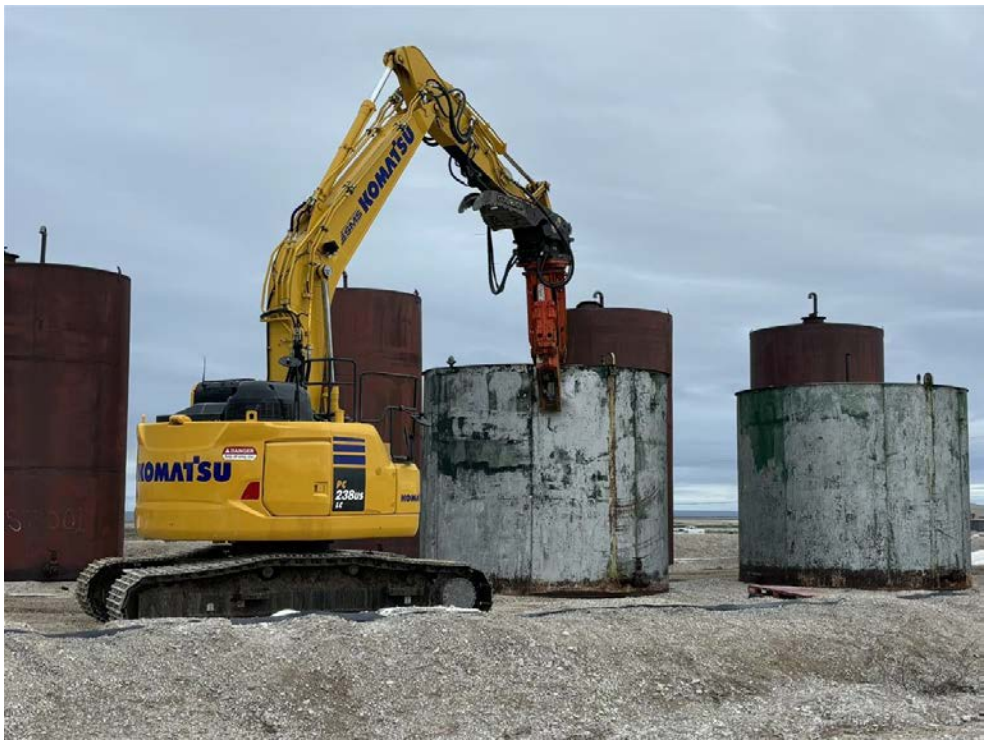
Photo Location: AEC 6 (Tank Farm)			
Direction: S			
Survey Date: 7/6/2024			
Comments: Excavator equipped with mechanical shears decommissioning a green AST in the tank farm.

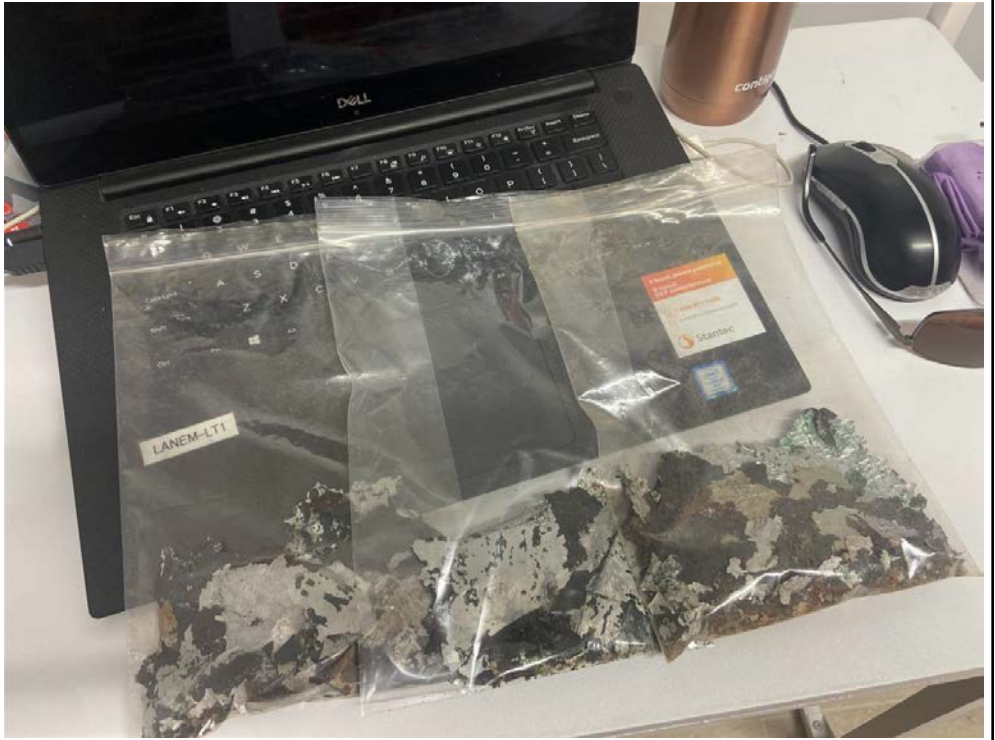
Photo Location: AEC 6 (Tank Farm)			
Direction: N/A			
Survey Date: 7/9/2024			
Comments: Sample collected of silver coating material found flaking off the green tank farm ASTs during decommissioning.			
Photograph ID: 58

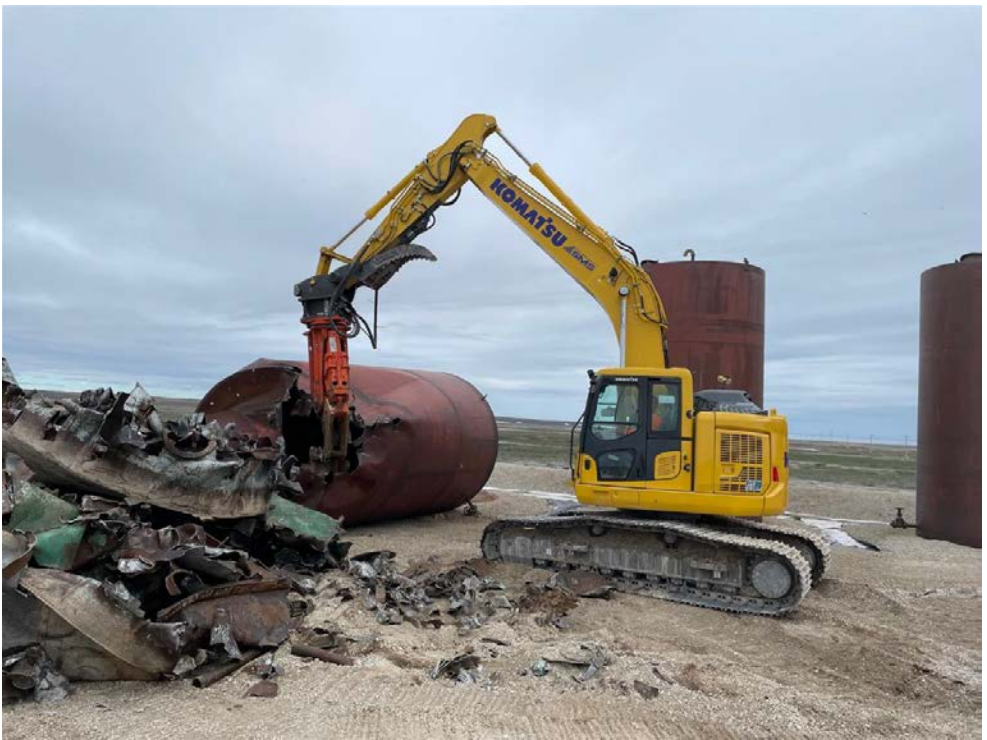
Photo Location: AEC 6 (Tank Farm)			
Direction: S			
Survey Date: 7/7/2024			
Comments: Excavator equipped with mechanical shears decommissioning a rust AST in the tank farm.

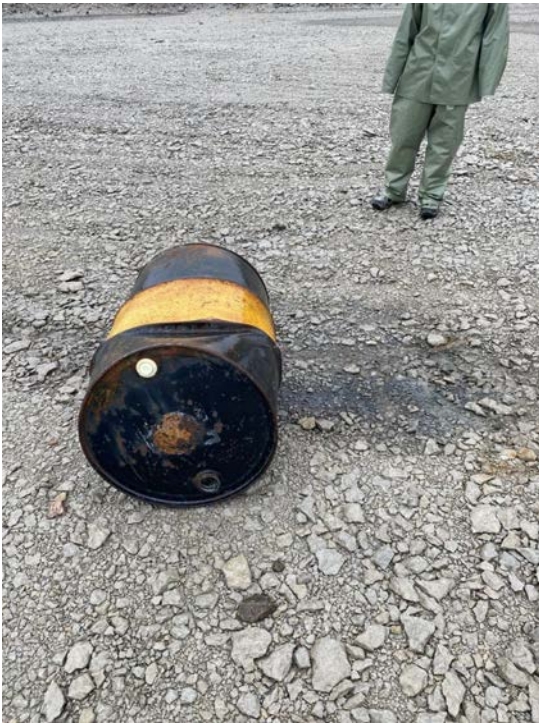
Photo Location: AEC 12 (CIAA)			
Direction: W			
Survey Date: 8/26/2024			
Comments: Partially full barrel and soil staining in AEC 12.			
Photograph ID: 88

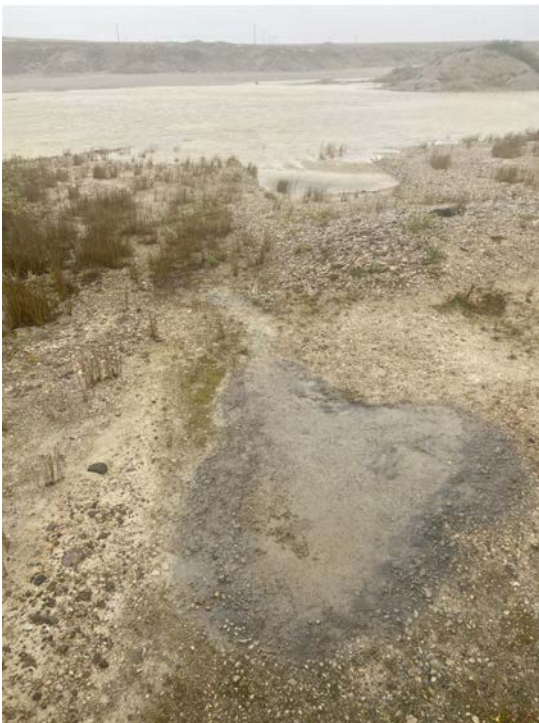
Photo Location: AEC 12 (CIAA)			
Direction: E			
Survey Date: 8/26/2024			
Comments: Soil staining in AEC 12.

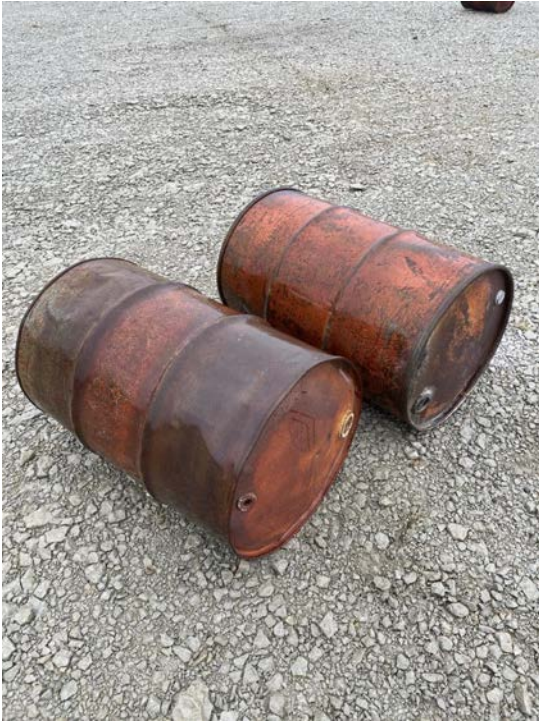
Photo Location: AEC 12 (CIAA)			
Direction: W			
Survey Date: 8/26/2024			
Comments: Partially full barrels in AEC 12.			
Photograph ID: 90

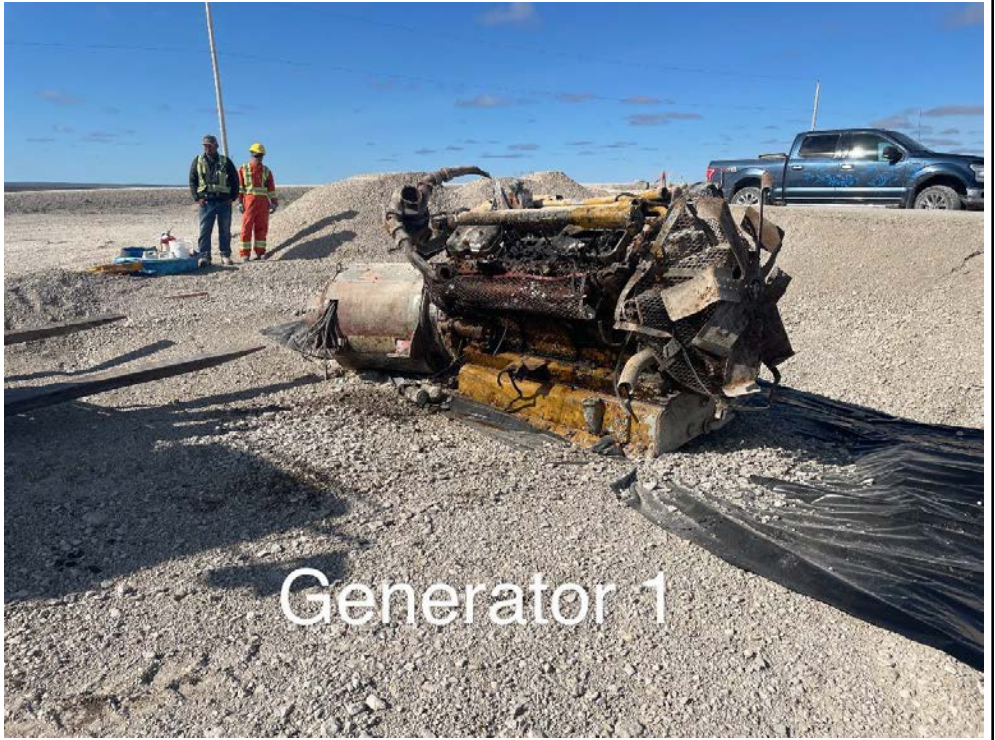
Photo Location: GMD-B			
Direction: N			
Survey Date: 8/16/2024			
Comments: View of first of three unearthed generators in GMD-B.			
Photograph ID: 98

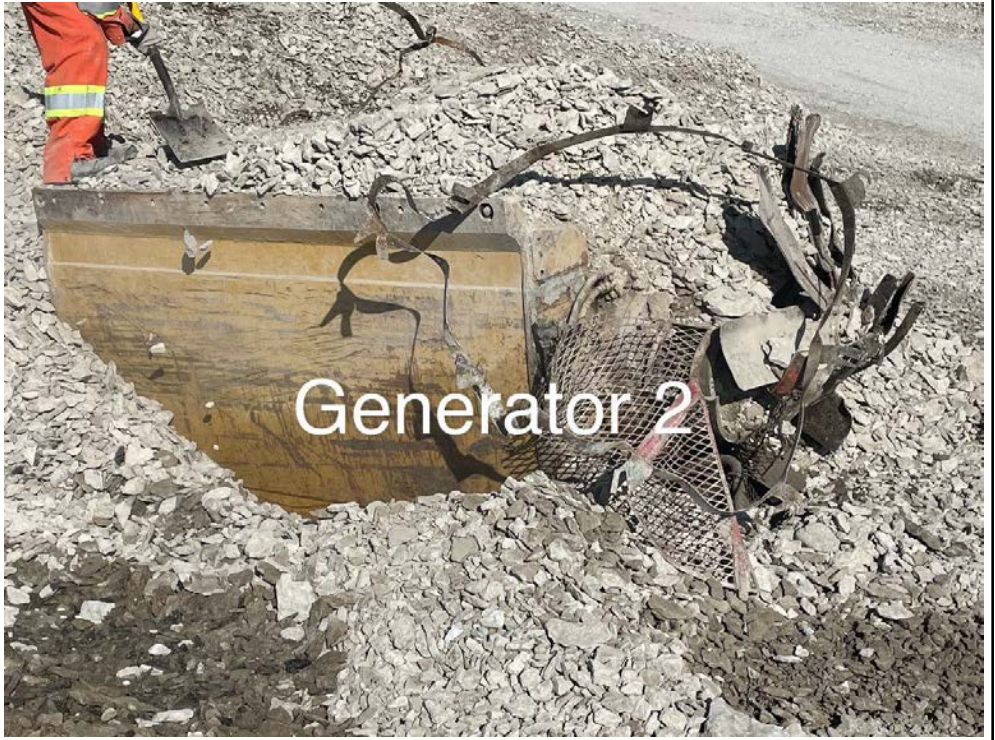
Photo Location: GMD-B			
Direction: N/A			
Survey Date: 8/16/2024			
Comments: View of second generator in GMD-B prior to being fully uncovered.
