February 6, 2002

Reference F90132

2001 Tailings Dam Inspection Cullaton Lake Gold Mine, Nunavut

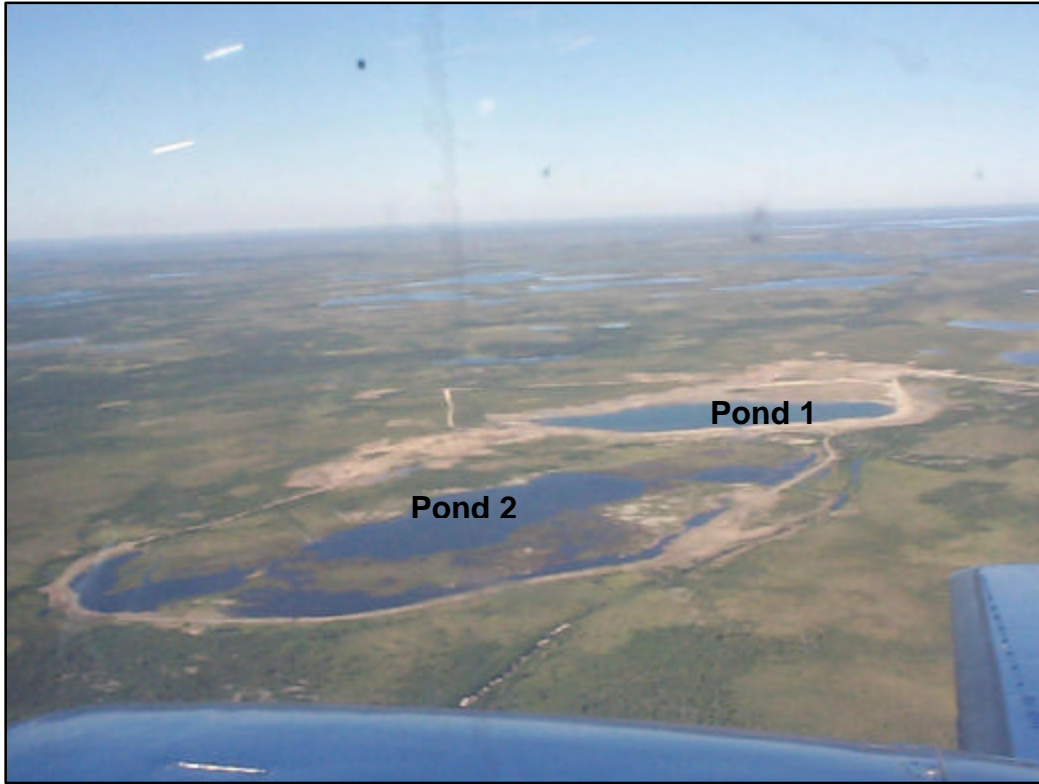
The field inspection was carried out by Mr. Demetri Georgiou, P.Eng. on July 26, 2001, as was the previous one in 1999. Photos 1 and 2, attached, show oblique views of the site taken from the air on the date of the site inspection, July 26, 2001. The tailings area has been covered with local till as reported in Trow's previous reports. Vegetation on the till covered tailings is small and sparse.

Photo 1: Cullaton Lake Tailings Facility – looking west

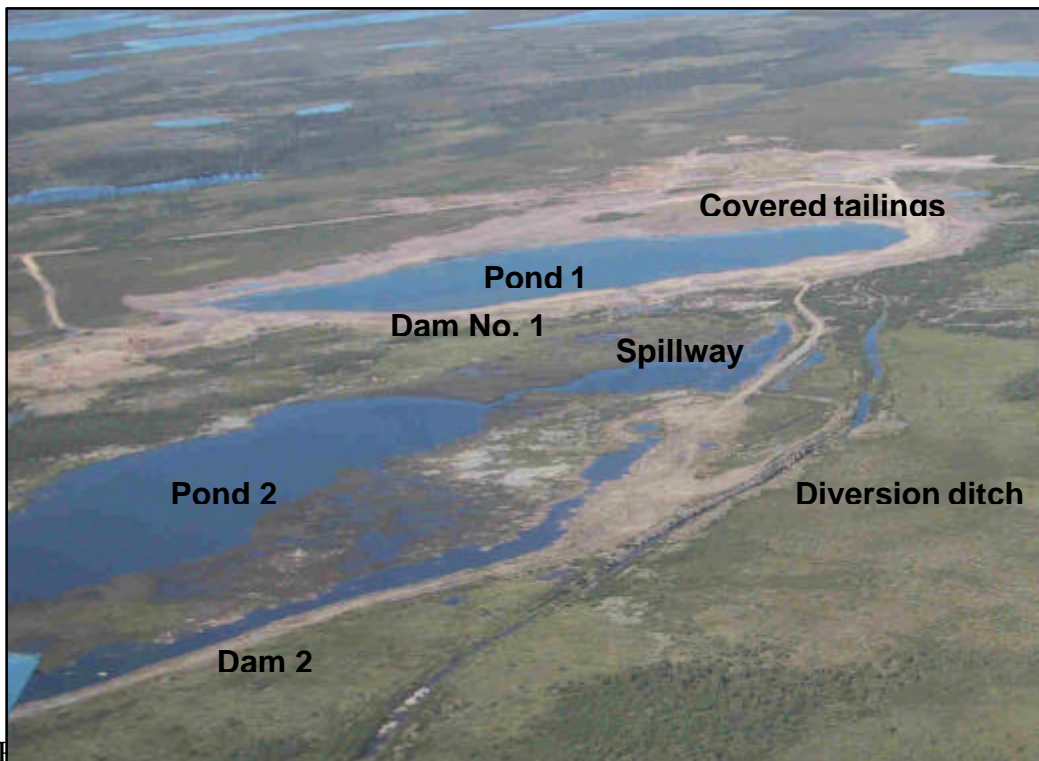
Photo 2: Cullaton Lake Tailings Facility – showing features

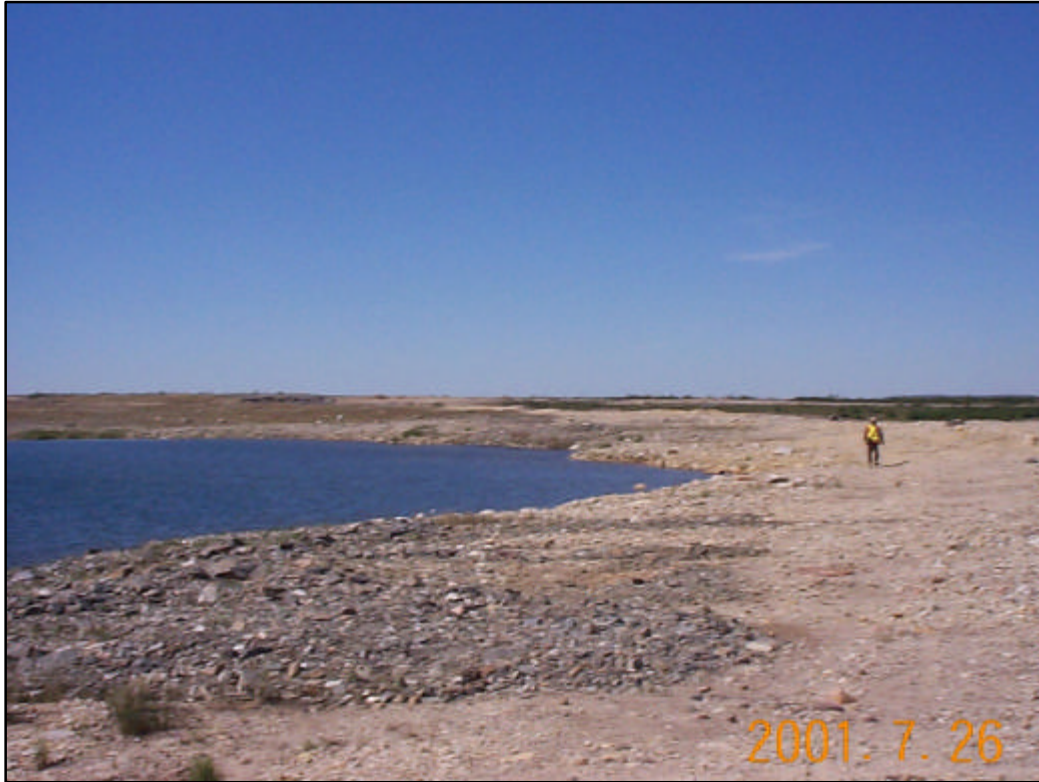
Photos 3 and 4 show views of the dam. Typically, the embankment which is constructed principally with local cohesionless till, is irregular in section and surface grade. Average side slopes of the upstream and downstream sides were typically about 3H:1V and 6H:1V, respectively. The downstream side was estimated to be as steep as about 3H:1V in a few areas. The dam height ranges up to about 4 m but averages 2 m to 3 m in height. Some small erosion scars were observed on both the upstream and downstream sides. This is likely due to adjustment of the fill that was placed several years ago during the flattening of the side slopes.

The crest width varies but is in the order of 15 m. No seepages were observed on the day of inspection.

Based on our 2001 as well as previous inspections and involvement with the project, the dam is not in any distress and is considered to be stable.

Photo 3: Dam No. 1 - looking along crest

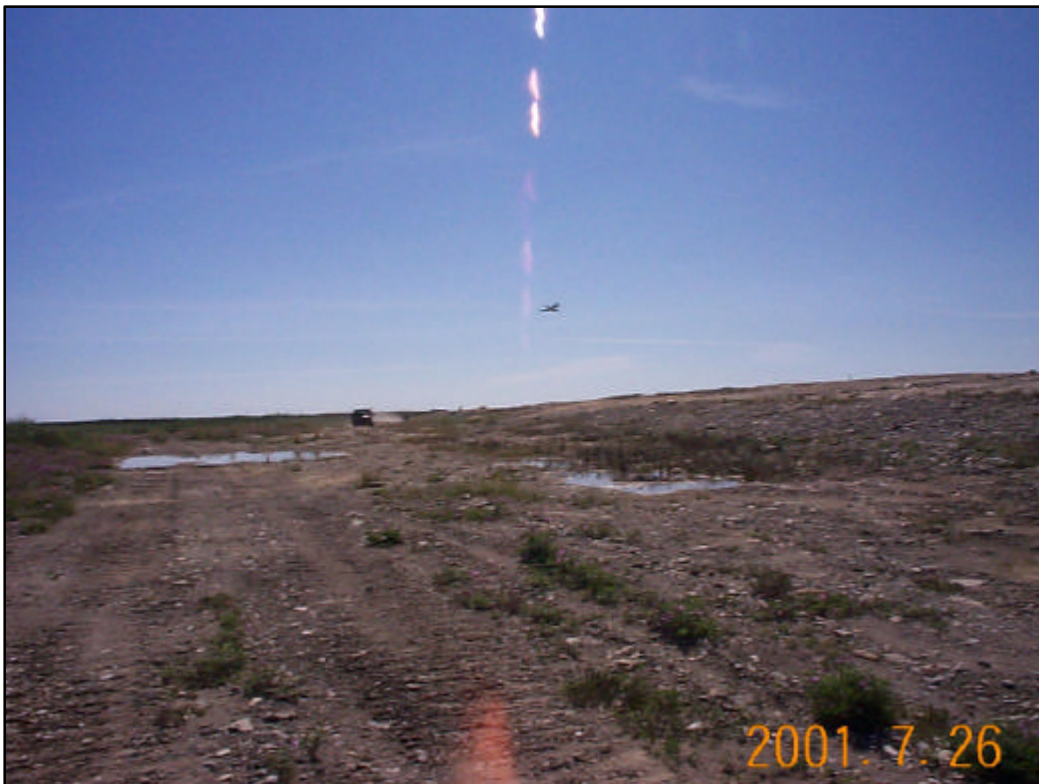
Photo 4: Dam No. 1 – looking south on downstream side

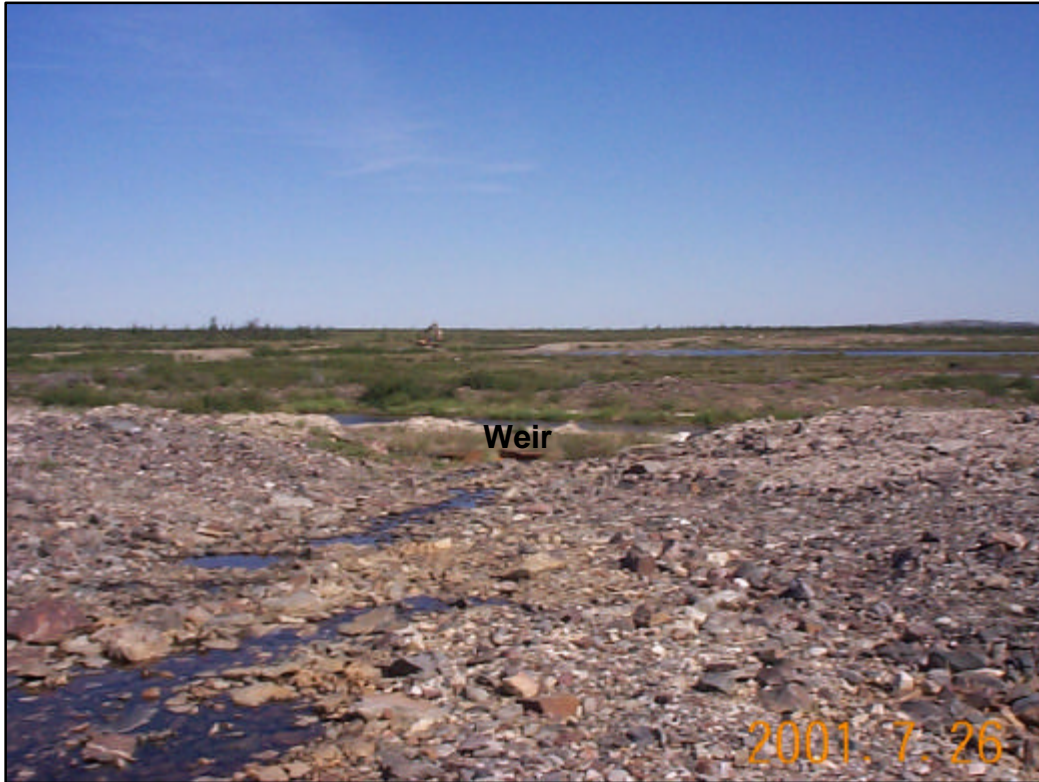
Based on hand level surveying, the pond level was at an elevation of about 94.0 m, approximately at the spillway invert level and minor flow (a trickle) was occurring over the spillway, as can be seen in Photo 5. Photo 6 shows the weir and a trickle through the rockfill. This is approximately the same water level that was observed in the 1994 and 1996 examinations when the levels were at about 94.0 m, and slightly higher than the 93.7 m estimated in 1999. The water level conforms to the design elevation at closure, such that the tailings in the pond remain submerged. Within the tailings pond itself, no unsubmerged tailings were observed.

Photo 5: Dam No. 1 spillway channel – looking downstream to Pond 2

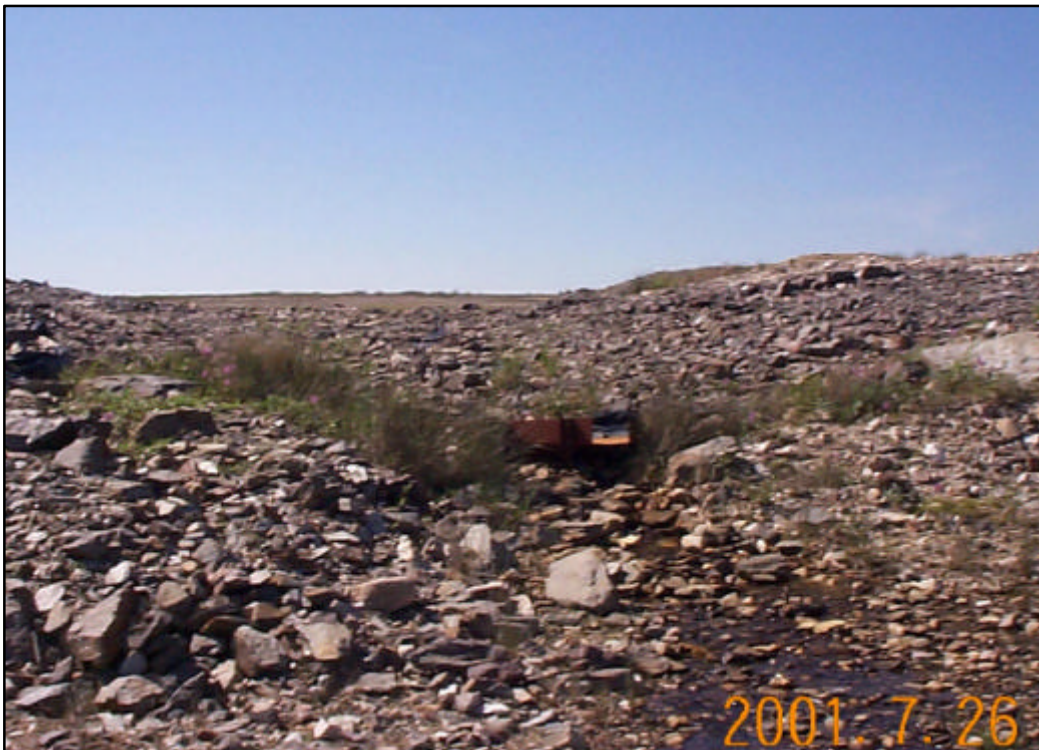
Photo 6: Dam No. 1 spillway channel and weir - looking upstream

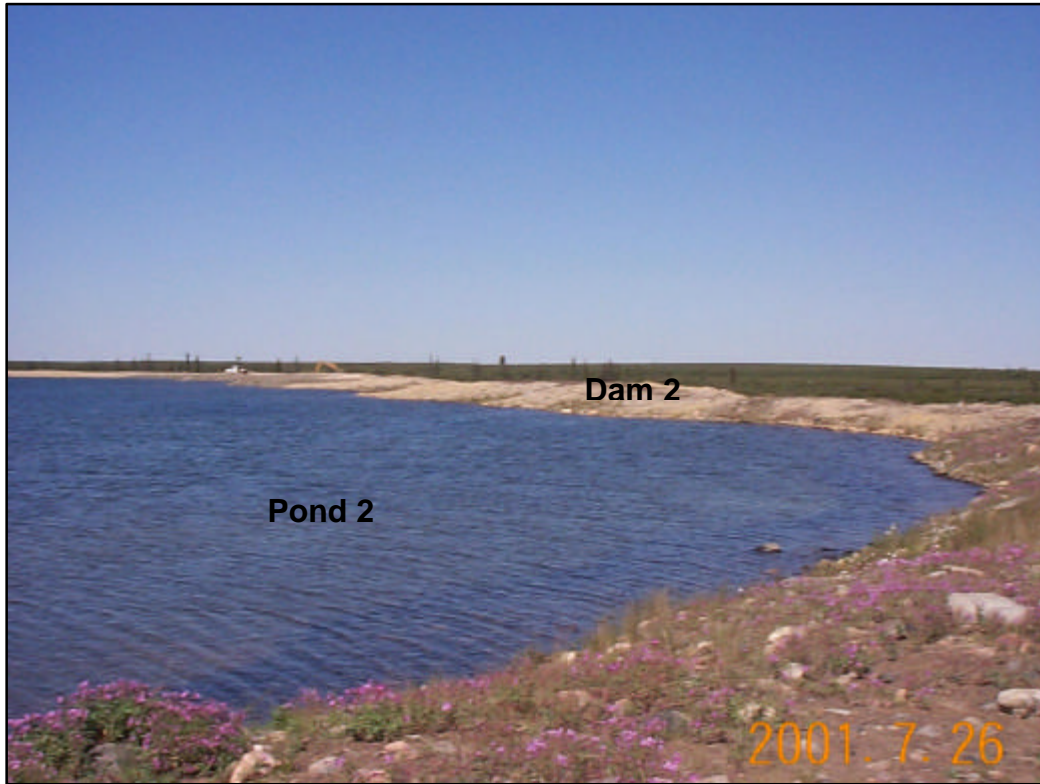
Photos 7 and 8 show views of the dam. As with the No. 1 dam, the principal construction material is local cohesionless till. The dam section and surface grade is irregular, although less so than the No. 1 dam. The crest width varies but is in the order of 15 m. No seepages were observed on the day of examination. Based on our 2001 as well as previous inspections and involvement with the project, the dam is not in any distress and is considered to be stable.

Photo 7: Dam No. 2 – looking north-northwest

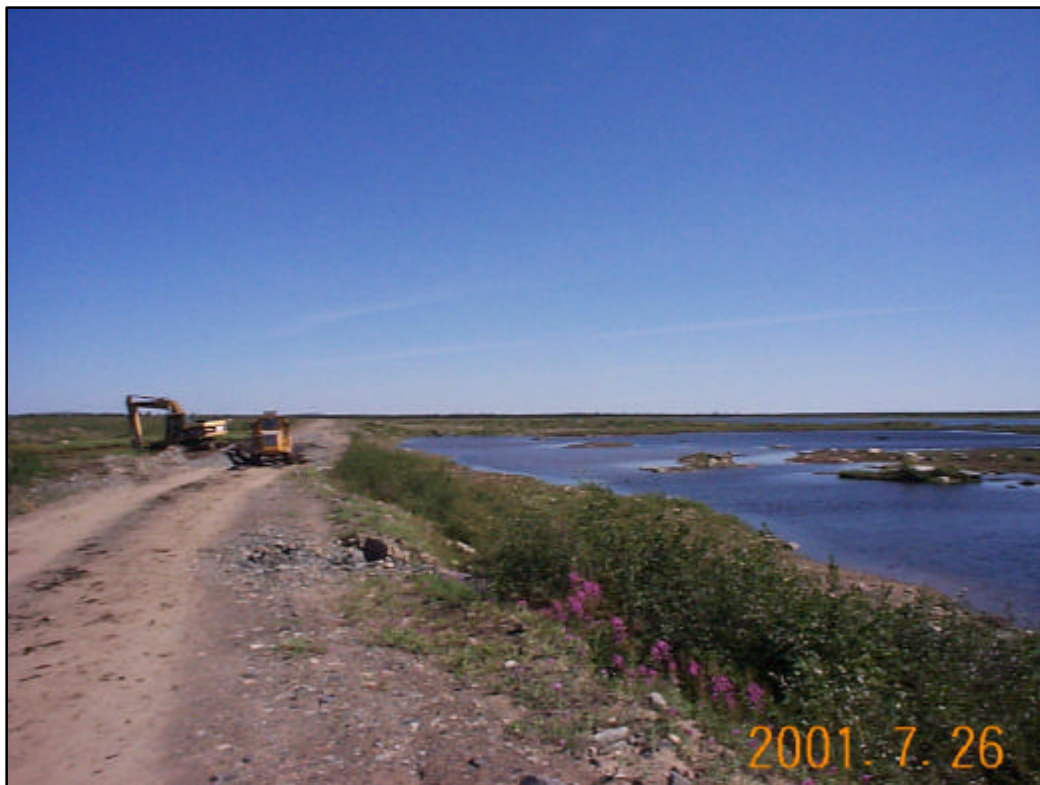
The equipment (excavator and bulldozer) seen in Photo 8 were being operated by the mine closure contractor (Ledcor). Dam No. 2 was being graded in the photo. The mine closure contractor has since permanently demobilized the equipment.

Photo 8: Dam No. 2 – looking south-southeast
