## MEMORANDUM

**PROJECT NO.:** MESH #M028-002  
**DATE:** September 28, 2007  
**TO:** David Abernethy and Jim Rogers (INAC)  
**FROM:** Shannon Shaw, MESH Environmental Inc.  
**RE:** Cullaton Lake Project Site Inspection, July 5<sup>th</sup>, 2007

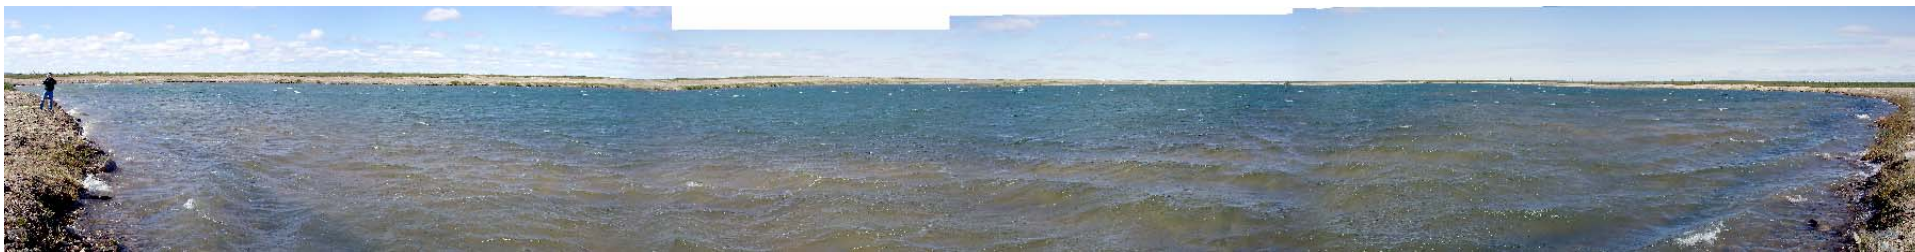
At the time of the inspection, water from the tailings facility was flowing out of the facility via the spillway. The water at this location had a pH of 7.9 and an EC of 0.6 mS/cm. Photo 1 provides a panoramic view of the water covered tailings taken from the spillway. Along the dam, areas constructed of quartzite are easily contrasted with volcanoclastic and iron formation materials based on colour. Quartzite in the dam was light orangey-white in colour and durable, while the metasediments were predominantly dark grey to reddish grey. Sulphides were present in much of the quartzite predominantly as veins and stringers and often iron stained, producing orangish-red colouration (Photo 2). Photo 3 provides a view of the dam looking northward showing the spillway in the lower portion of the photo. As indicated by the colour differentiation, the rock in the spillway was predominantly volcanoclastics and iron formation rock, with some visible sulphides (pyrite). Rock type differentiation was also evident vertically in the dam (Photo 4) with the darker areas being comprised largely of metasediment rock and the lighter areas containing significant quartzite rock.

Photo 1. Panoramic photo of water covered tailings in TSF taken from the spillway.

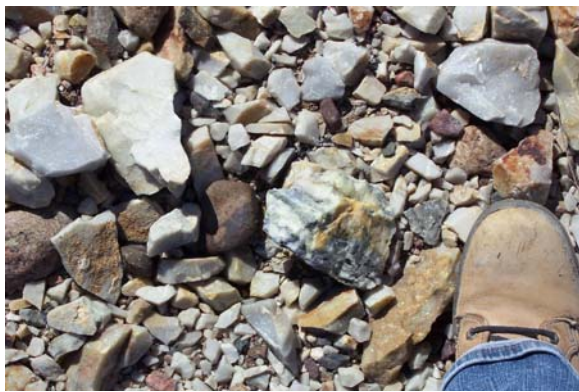
Photo 2. Typical composition of north end of dam construction material, note sulphide-rich quartzite locally stained.

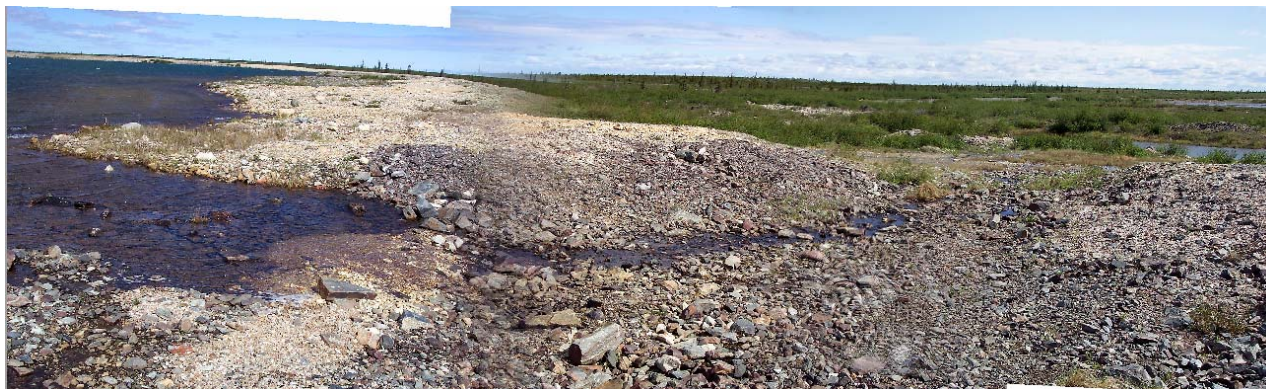
Photo 3. Panoramic photo of the spillway, water flow was noted, pH=7.9, EC=0.6 mS/cm.

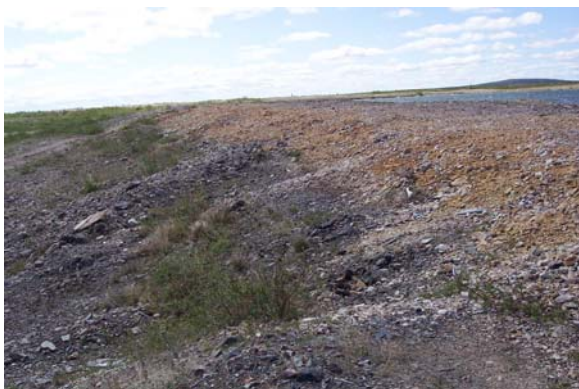
Photo 4. Photo of tailings dam, southeast end, note constructed of meta-volcanics (below) and quartzite (orange, above).

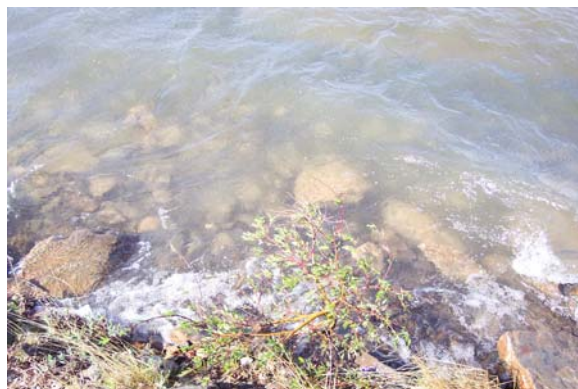
South of the spillway along the tailings dam, field measurements of the water cover on the tailings indicated pH of 8.1 and EC of 0.7 mS/cm (Photo 5). The wave action due to the wind was significant, with the predominant wind direction to the south. The turbidity in the water column was unexpectedly minimal given these conditions. Visibility in the pond was estimated to be to a depth of  $\sim 0.5\text{m} \pm 0.25\text{m}$ . The water level was relatively high as would be expected at that time of the year due to spring thaw. The location of tailings under the water cover could be estimated based on the distinct colouration of the Shear Zone tailings (orangey-red). While not easily quantified, in areas it looked as

though there were tailings present in less than 1m water cover depth. Minor degrees of bottom suspension (i.e. suspension near the bottom, but not to surface) were observed, but again it was difficult to quantify with confidence.

Photo 5. Edge of water cover, southeast end of TSF, pH=8.1, EC=0.7 mS/cm.

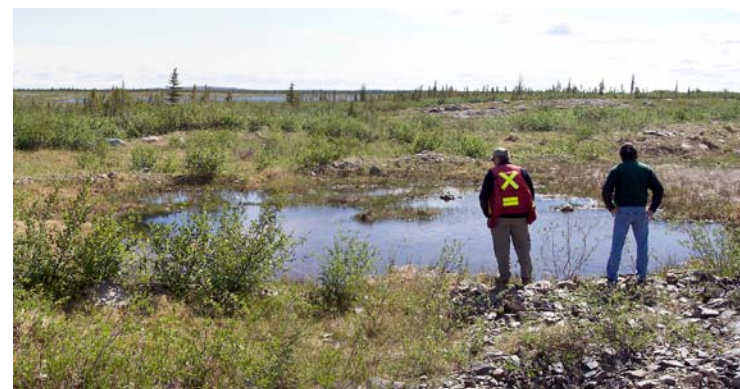
On the southeast end of the dam, another pond was inspected (Photo 6). It is not clear whether this is a seepage pond per se, or not. There was an older sampling station marked there, but the label could not be read. The pH of the pond water was 8.2 and the EC was 1.8 mS/cm, higher than measured elsewhere in and around the tailings facility.

Photo 6. Ponded water south of TSF, pH=8.2, EC=1.8 mS/cm.

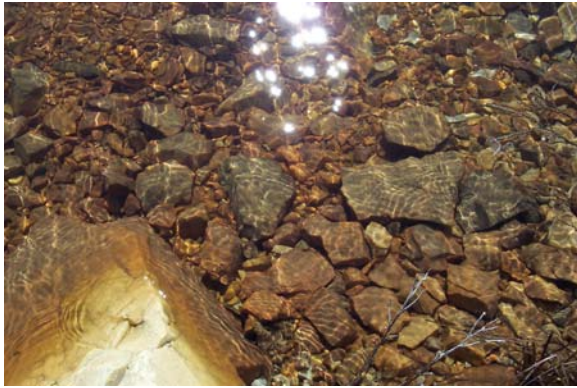
On the north-eastern portion of the dam, in an area previously reported as having shown signs of tailings resuspension and iron staining (H. Hartmeier, pers. comm.), there were no current indications of tailings near the surface, although the water level was likely higher on this trip than when the previous observations were made. The water cover in this area had a field pH of 8.0 and an EC of 0.7 mS/cm. The dam material in contact with the water was comprised of quartzite that was significantly stained orangey-red (Photo 7). It seemed probable that the source of the staining was from sulphides within the quartzite itself, with the greater amount of staining potentially a factor of the seasonal wetting and drying of the quartzite near the water level.

Photo 7. Area of surface stained quartzite rock at water level on north end of dam.

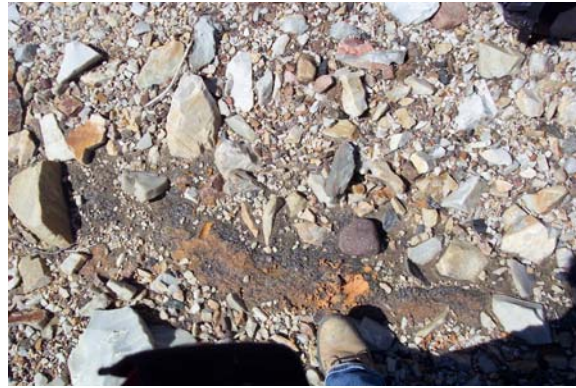
On the northern portion of the facility, on the upstream portion of the dam, 'patches' or 'strips' of exposed tailings could occasionally be seen. These patches were in general approximately 30 cm wide and up to 2 m in length. A sample of orange (Shear Zone) tailings was collected from one of these exposures (labeled CL-TL-01). The tailings sampled were silty sand, moist and orangey-red in colour with a very thin veneer of black staining on the surface of the tailings (Photos 8 and 9). This may be a Mn oxide coating or a bio-coating of some form. The geochemical test results of this sample are discussed in detail on page 8 of this memo. Based on the general shape and spacing of the exposed areas of tailings along this portion of the dam, it is considered possible that these tailings were from a previous beach horizon that may have been at one point covered with rock and subsequently exposed during reclamation by the teeth of an excavator (Photo 10). There was no visible evidence of staining in the area around the exposed patches; however the cover depth was obviously less than 1 m thick in this

portion of the facility and tailings in this zone are likely susceptible to seasonal freeze-thaw and oxidation processes.

Photo 8. Exposed tailings along upstream side of north end of dam

Minor maintenance efforts on areas of localized exposed tailings (e.g. recontouring and recovering) may be warranted and some consideration to options for the management of the source of the ARD pond at Shear Zone could be given. Both these issues would likely be included in a risk assessment, should one be conducted as was recommended in the BGC 2006 Site Inspection Report and Mine Closure Review (BGC, 2007). It would also be advantageous to compile and cross reference historic water quality data with that currently being collected including the production of a proper site map with water sampling stations indicated.

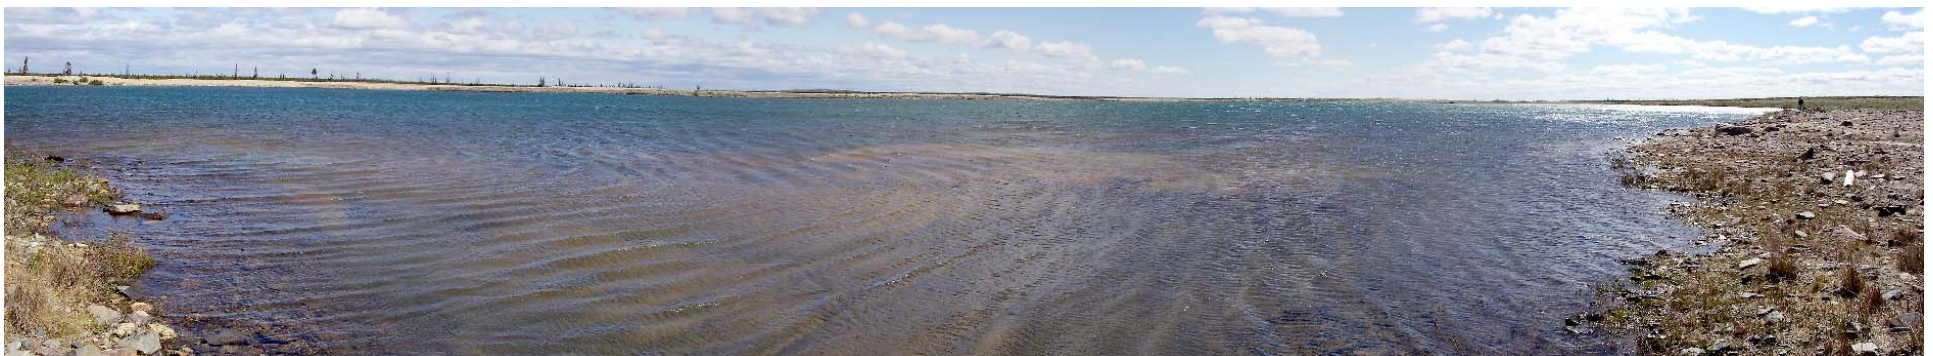
Inspection of the transition zone between the water cover tailings and the till cover (beach) tailings proved unsuccessful (Photo 11). The water level in the pond was high enough that the tailings in this transition zone were not accessible for sampling. It appeared however that there were tailings, predominantly grey (or B Zone) tailings, within approximately 0.5m to 1m of the water level.

Photo 11. Panoramic photo of water covered tailings in TSF taken from northwest transition zone area (i.e. till versus water cover).

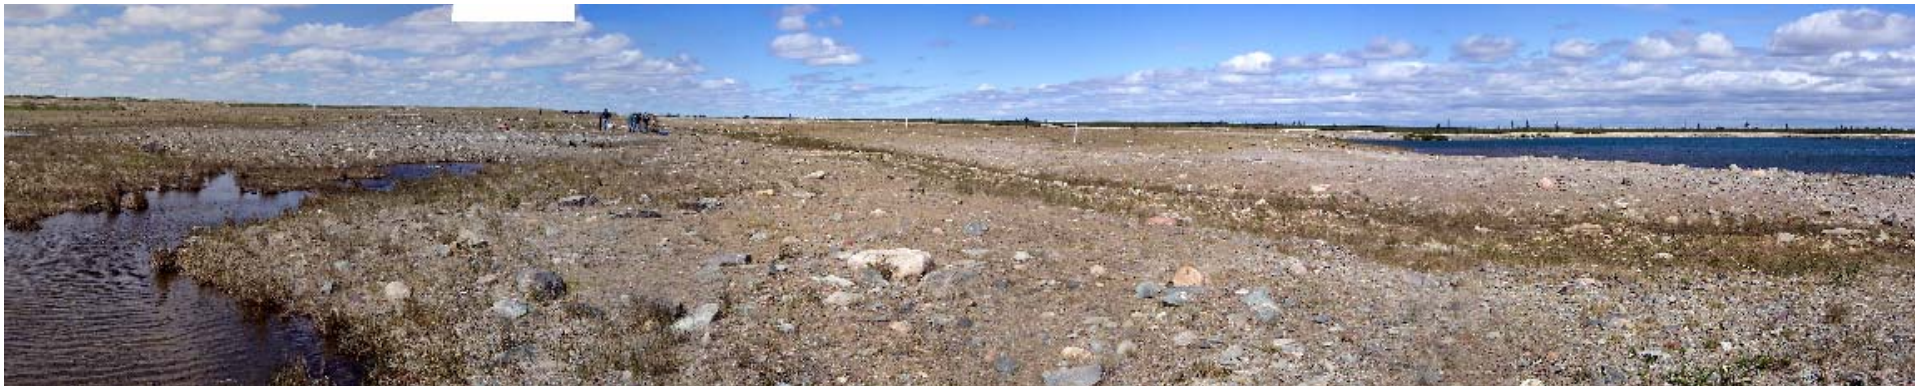
The till cover showed no signs of staining and there were no exposed patches of tailings seen on the main beach part of the facility (Photo 12). A few standing ponds of water on the covered beach were present in the drainage swales. Water in two of these ponds reported field pH values of 8.2 and 8.4 and EC values of 3.9 and 4.6 mS/cm, possibly indicating that while buffered, the water in contact with the till has a higher conductivity and therefore total dissolved solids content associated with it, as compared to the water within the water cover and the ponds surrounding the tailings facility. This may be influenced by effects of evapo-concentration within standing water ponds on the till cover.

Photo 12. Panoramic photo of till covered tailings in TSF taken from central location of beach near water – till cover transition zone. Standing ponded water on top of till cover ranged in pH from 8.2 to 8.4 and EC ranged from 3.9 to 4.6 mS/cm.

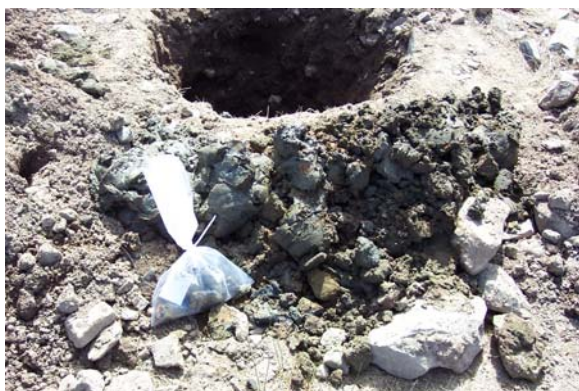
A hole dug by Ron Aubry and Kolby Ozerkevich of Barrick through the cover down to frozen surface was available for inspection (Photos 13 and 14). It indicated 0.9m of till cover and 0.3m of thawed tailings above the frozen horizon. The tailings were comprised predominantly of dark grey (B Zone) tailings with a thin layer (5 cm) of orange (Shear Zone) tailings immediately above the frozen base. A sample was collected (labeled CL-TL-02) consisting most substantially of B Zone tailings. The sample was silty and moist to wet with a greater moisture content nearer the frozen horizon. Geochemical results of that sample are discussed on page 8 of this memo.

Photo 13. Photo showing tailings excavated from beneath the till cover, predominantly B zone tailings (grey). Tailings sample collected.

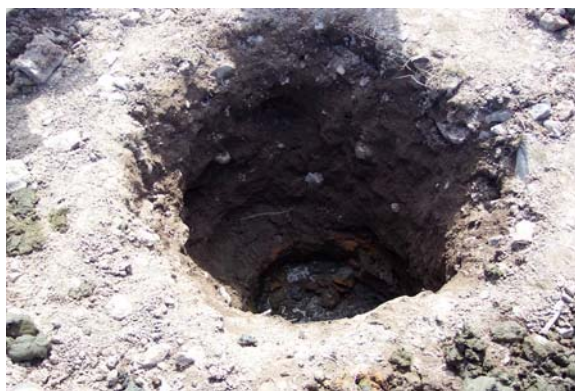
Photo 14. Hole through till cover to tailings beneath consisting of approximately 90 cm of till overlying 30 cm of unfrozen tailings (predominantly B zone tailings with thin (~5cm) layer of Shear zone tailings immediately above frozen layer).

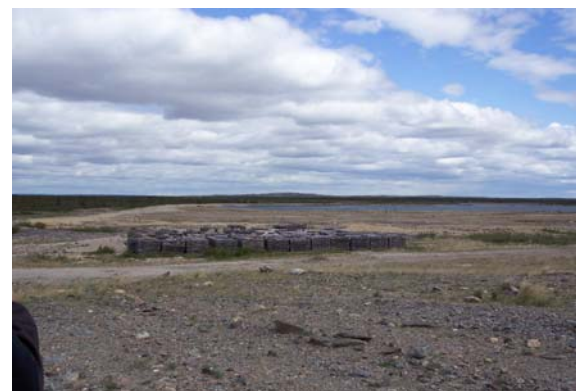
The mill complex area was also inspected. The foundation of the old mill building is now being used to store core (Photo 15). Behind the old foundation are three larger piles of rock. The intent of these rock piles is unclear, although they may have been used to

Photo 15. Photo looking eastward across tailings beach to water cover in background, note core storage on old mill foundation in foreground.

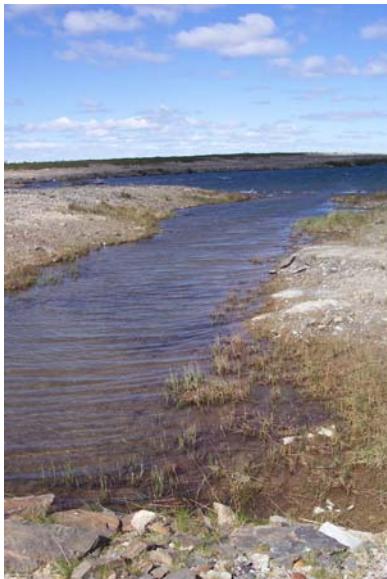
On the south end of the tailings facility there is an old ditch that previously connected the quarry with the tailings facility (Photo 16). This no longer functions as a ditch as it appears that water flow was in the opposite direction than originally intended (i.e. currently would flow from the tailings facility to the quarry pond). The water on the tailings facility side of the cut-off had a pH of 8.1 and an EC of 0.7 mS/cm, similar to that measured elsewhere in the water cover. The quarry pond itself (Photo 17) reported a pH of 7.9 and an EC of 0.1 mS/cm.

Photo 16. Excavated ditch previously connecting TSF with quarry pond.

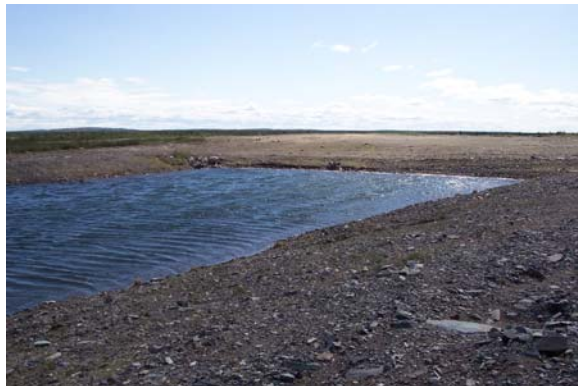
Photo 17. Quarry pond, pH=7.9, EC=0.1 mS/cm.

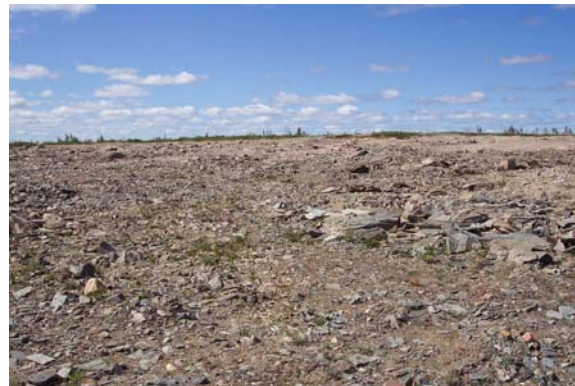
While the quarry cover showed some signs of subsidence, there were no noted obvious signs of ARD/ML from the cover itself, or seepage through the cover. Surface staining was not apparent and no 'patches' of surface precipitates were identified (Photo 18).

Photo 18. Covered quarry area.

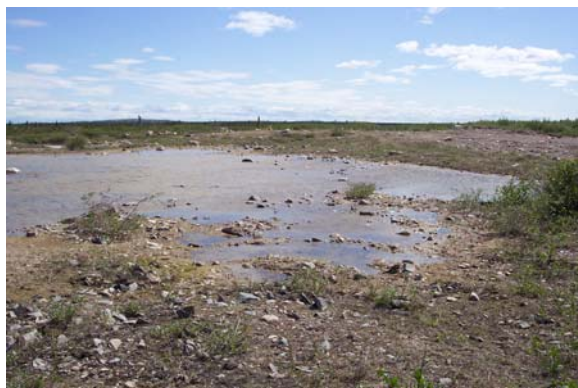
To the south of the quarry was an area that appears to have possibly been used as a source of topsoil for other reclamation activities. Some silt on the bedrock was evident and may be a source of suspended solids if eroded. A pond draining this area however showed no indication of this at present, such as elevated conductivity or turbidity, and had a pH of 7.9 and an EC of 0.0 mS/cm (Photo 19).

Photo 19. Ponded water at south end of the quarry/topsoil stripped area, pH=7.9, EC=0.0 mS/cm.

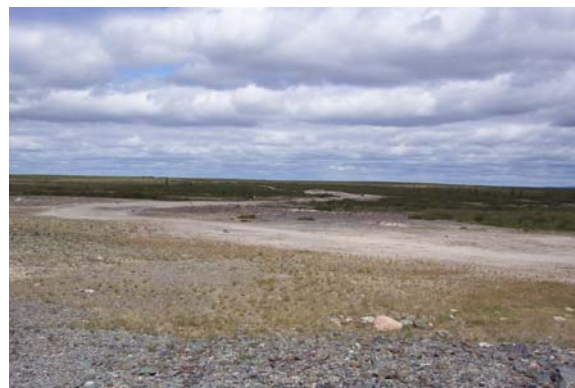
The B Zone portal area currently consists of two piles of rock, one piled against the portal and the other piled over the raise (Photo 20). There is a substantial amount of rock spread on the ground in the general area of the portal, including what could have been potentially low grade ore or waste rock. No water was available for sampling in this vicinity and again, other than in-situ sulphide oxidation and weathering, no signs of ARD/ML were seen such as seepage or impaired vegetation (Photos 21 and 22).

Photo 20. Photo looking towards B zone portal from area immediately west of old mill area.

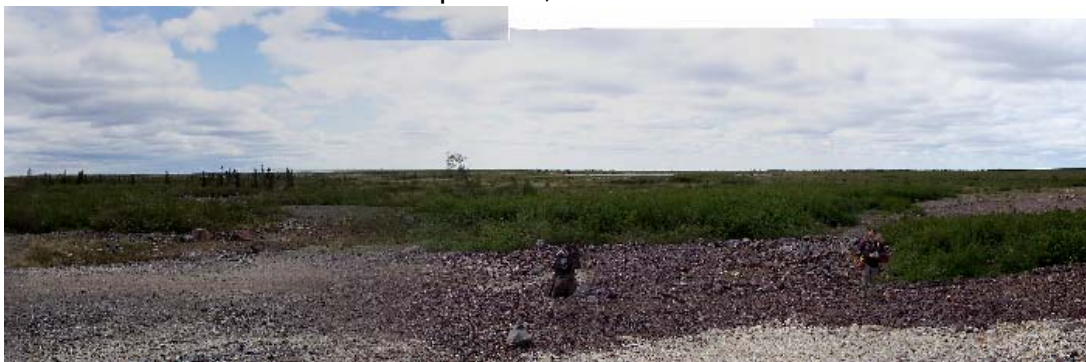
Photo 21. Panoramic photo of B zone portal area, showing remnant rock in vicinity of old raise.

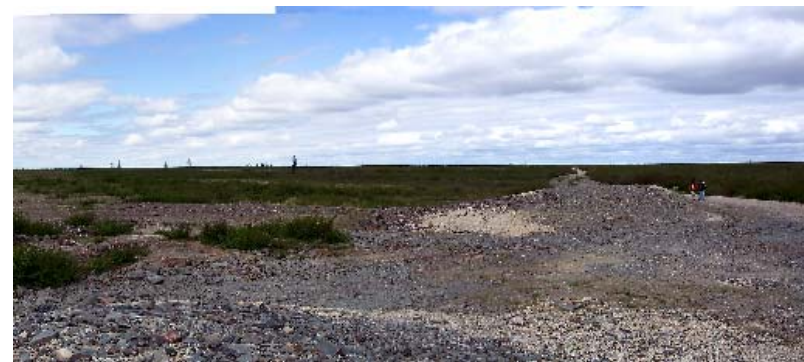
Photo 22. Panoramic photo of B zone portal area, showing backfilled portal and road towards Shear Zone.

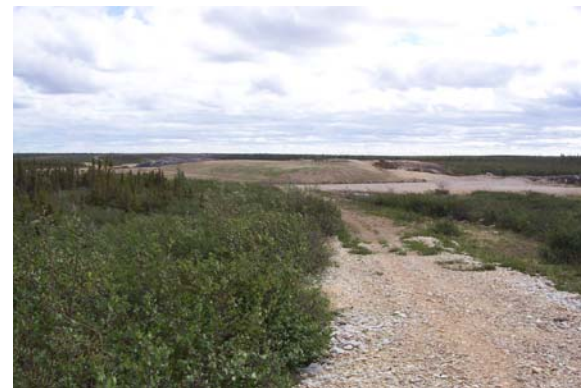
The cover on the encapsulated waste rock dump was grassed, and the grass appeared to be in good condition. Very minor erosion rilling was evident and no signs of upward migration of salts, seepage or exposure of waste rock through the cover were seen. Minor 'stains' of puddles or seeps from the encapsulated waste rock dump within and immediately below the berm surrounding the waste rock dump were evident, but no water was present on the day of the inspection (Photos 25, 26 and 27).

Photo 25. View of encapsulated waste rock dump looking south.

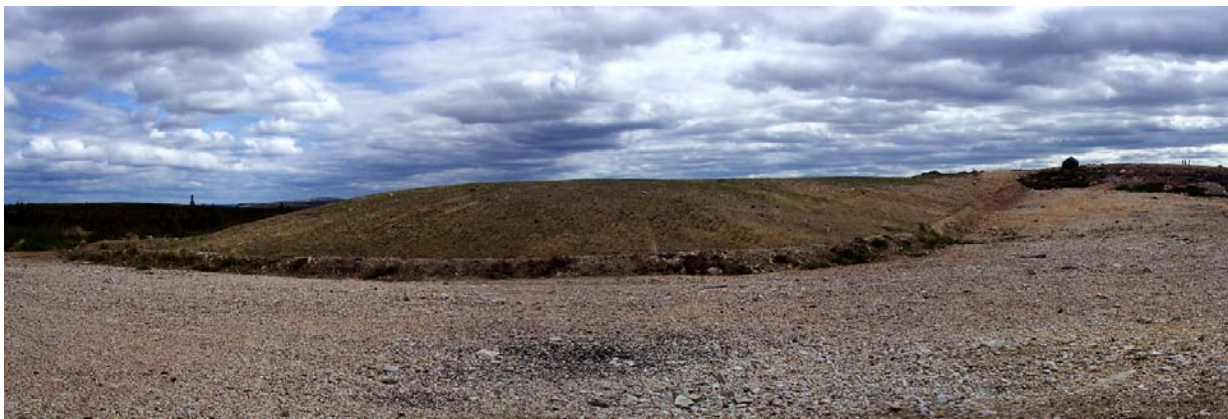
Photo 26. Panoramic photo of north end of encapsulated waste rock dump.

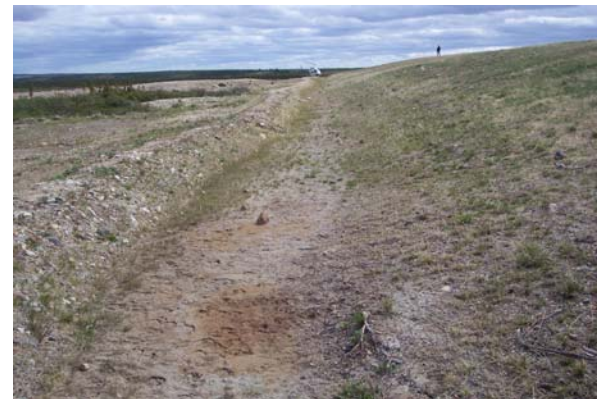
Photo 27. Looking south along west side of encapsulated waste rock dump.

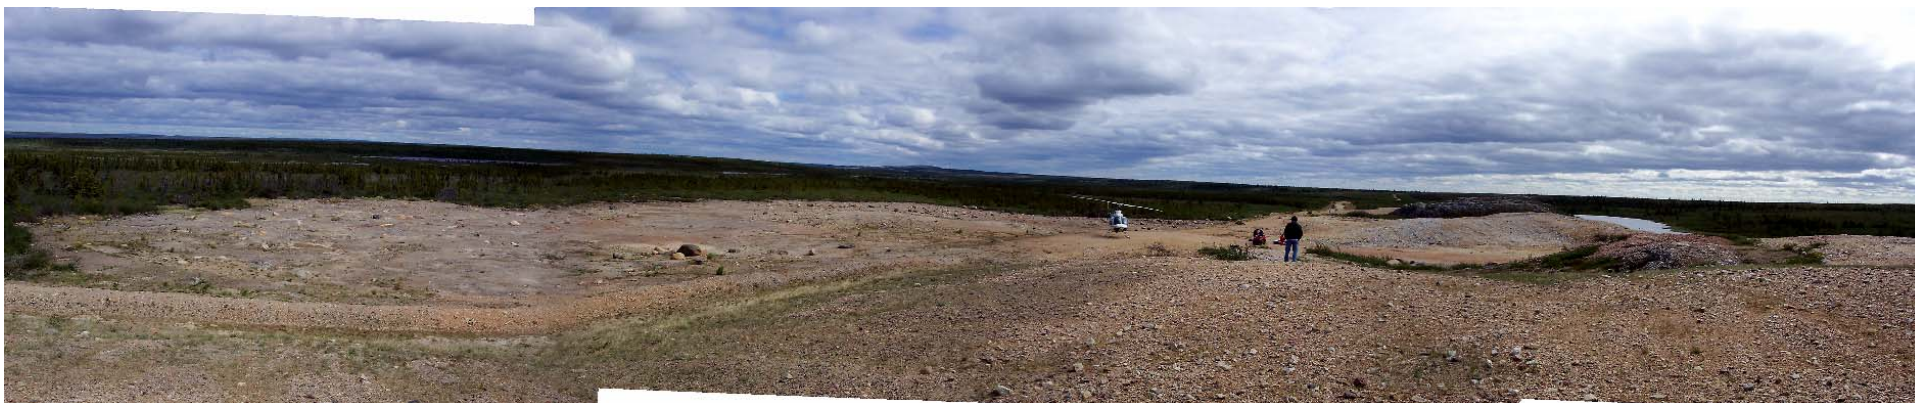
The area where the waste rock dump used to be located is shown in Photo 28. Surface staining is still evident within the old footprint area; however there were no signs of impact beyond the original dump footprint and no water available for sampling.

Photo 28. Panoramic photo of shear zone area looking over old waste rock dump area (left side) and quartzite pile (right side).

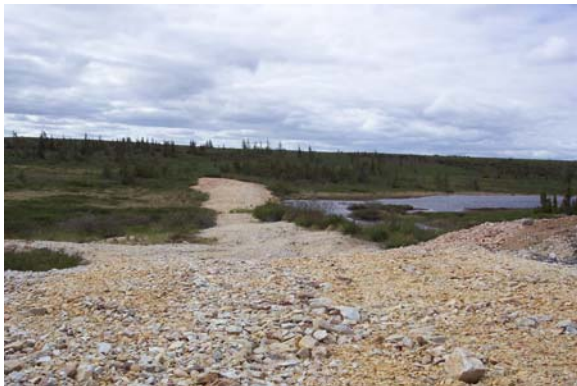
The rock pad around the portal area (seen in Photo 28), as well as a diversion structure in Shear Lake just north of the encapsulated waste rock dump (Photo 29) were comprised substantially of quartzite that was sulphidic and quite stained. This appeared to be similar in composition to the quartzite pile immediately south of the portal area.

Photo 29. Dam in north end of Shear Lake constructed of pyritic quartzite.

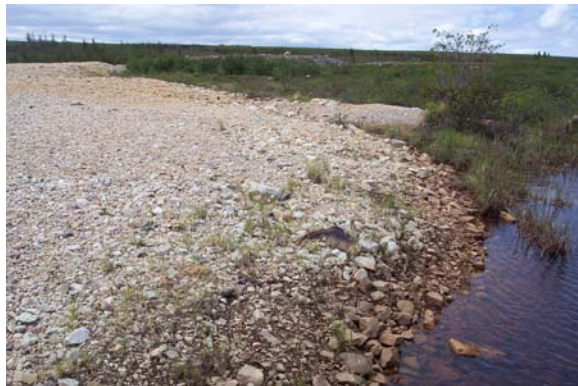
A pond north of the general footprint of the Shear Zone area, created by the base and the road impeding flow, had a field pH of 5.5 and an EC of 0.0 mS/cm. The rocks along the edge of this pond were quartzite that was highly stained red (Photos 30 and 31). Surface evidence (accumulation of 'fines' and 'staining') of standing water between this ponded water and the northeast corner of the encapsulated waste rock dump was seen. It is possible therefore that this ponded water on occasion flowed onto the Shear Zone area and may have been sampled and erroneously identified as waste rock dump seepage in the past (Paul Brugger, pers. comm.).

Photo 30. Ponded water on northeast end of Shear zone area.

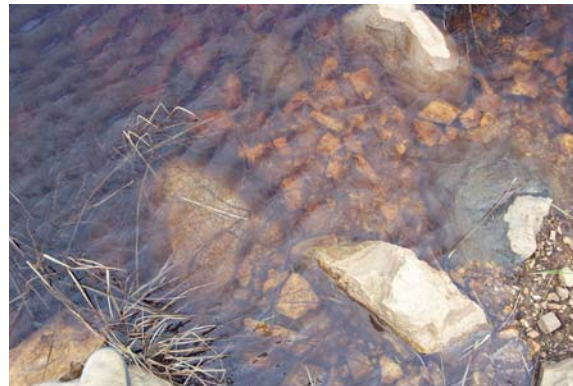
Photo 31. Close-up of ponded water, pH=5.5, EC=0.0 mS/cm.

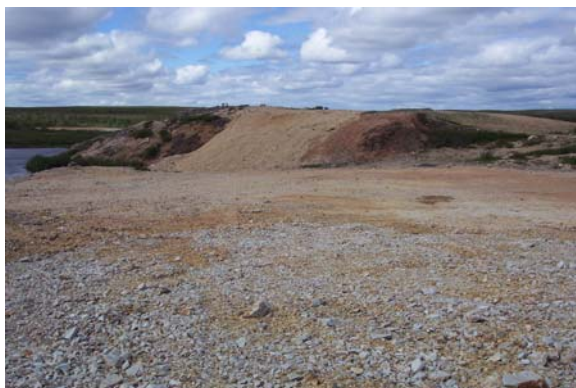
The field pH of Shear Lake itself immediately west of the portal area was 6.1 and an EC of 0.0 mS/cm. Again, immediately at the bank of Shear Lake and into the lake as far as could be seen was a substantial amount of quartzite rock with heavy red staining (Photos 32, 33 and 34).

Photo 32. Overview of backfilled Shear zone portal (note backfill is pyritic quartzite).

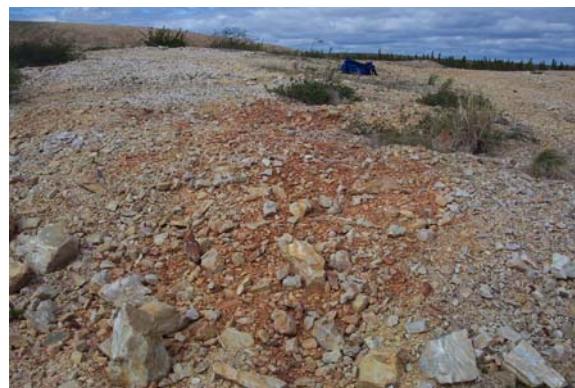
Photo 33. Localized 'heavy' iron staining on area of pyritic quartzite.

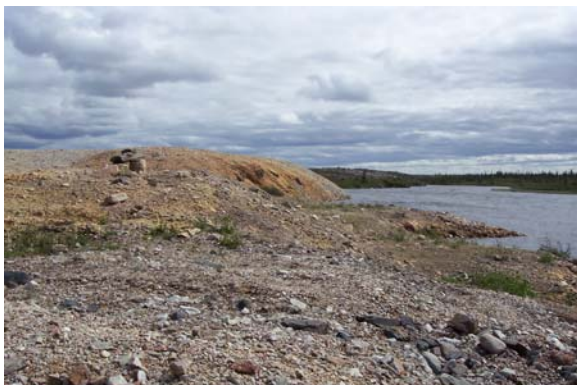
Photo 34. Photo looking south on eastern side of pyritic quartzite 'pile' adjacent to quartzite outcropping.

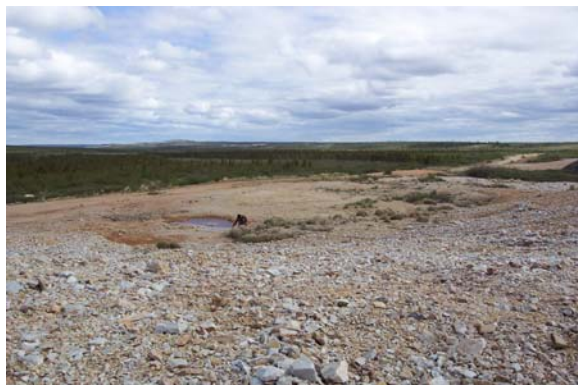
A pond that appeared to be seepage from the quartzite pile was evident and reported a field pH of 2.4 and EC of 2.9 mS/cm. The area around the pond was highly stained, and a seepage pathway from the quartzite to the pond could be delineated based on higher degrees of surface staining (Photos 35 and 36).

This cannot be said of the immediate footprint area around Shear Zone. The sulphidic quartzite pile appears to be producing acidity and does not contain any buffering capacity with which to neutralize acidity produced. This has resulted in the acidic pond adjacent to this pile with elevated concentrations of parameters of concern. It is not apparent however whether this pond drains and therefore impacts the surrounding area. There does not appear to be any surface evidence of flow from the pond into the local vicinity.

Photo 35. Photo looking south from top of quartzite pile, acidic pond being sampled in left-centre of photo.

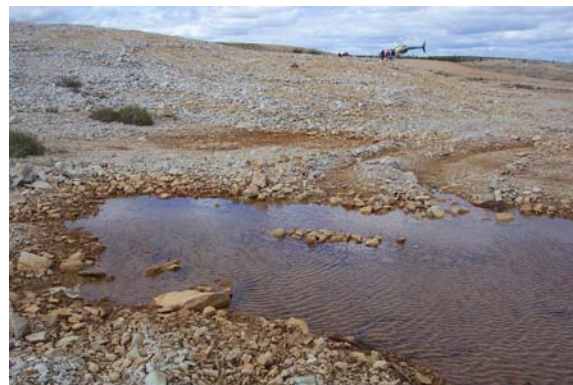
Photo 36. Acidic seep pond at bottom of quartzite 'pile'.
