WATER LICENCE INSPECTION FORM

Licensee	Licensee Representative
1BR-CUL1118	Paul Brugger
Licence No. / Expiry	Representative's Title
July 21st, 2024	Closure Properties Manager
Land / Other Authorizations	Land / Other Authorizations
065G07001, 065G07002, 065G08001	CROWN
Date of Inspection	Inspector
June 27 th , 2016	WRO C. Wilson
Activities Inspected	
<input type="checkbox"/> Camp <input type="checkbox"/> Drilling <input type="checkbox"/> Mining <input type="checkbox"/> Construction <input checked="" type="checkbox"/> Reclamation <input type="checkbox"/> Fuel Storage	
<input type="checkbox"/> Roads/Hauling <input type="checkbox"/> Other: <input checked="" type="checkbox"/> Other:

Photo Log, June 27th, 2016

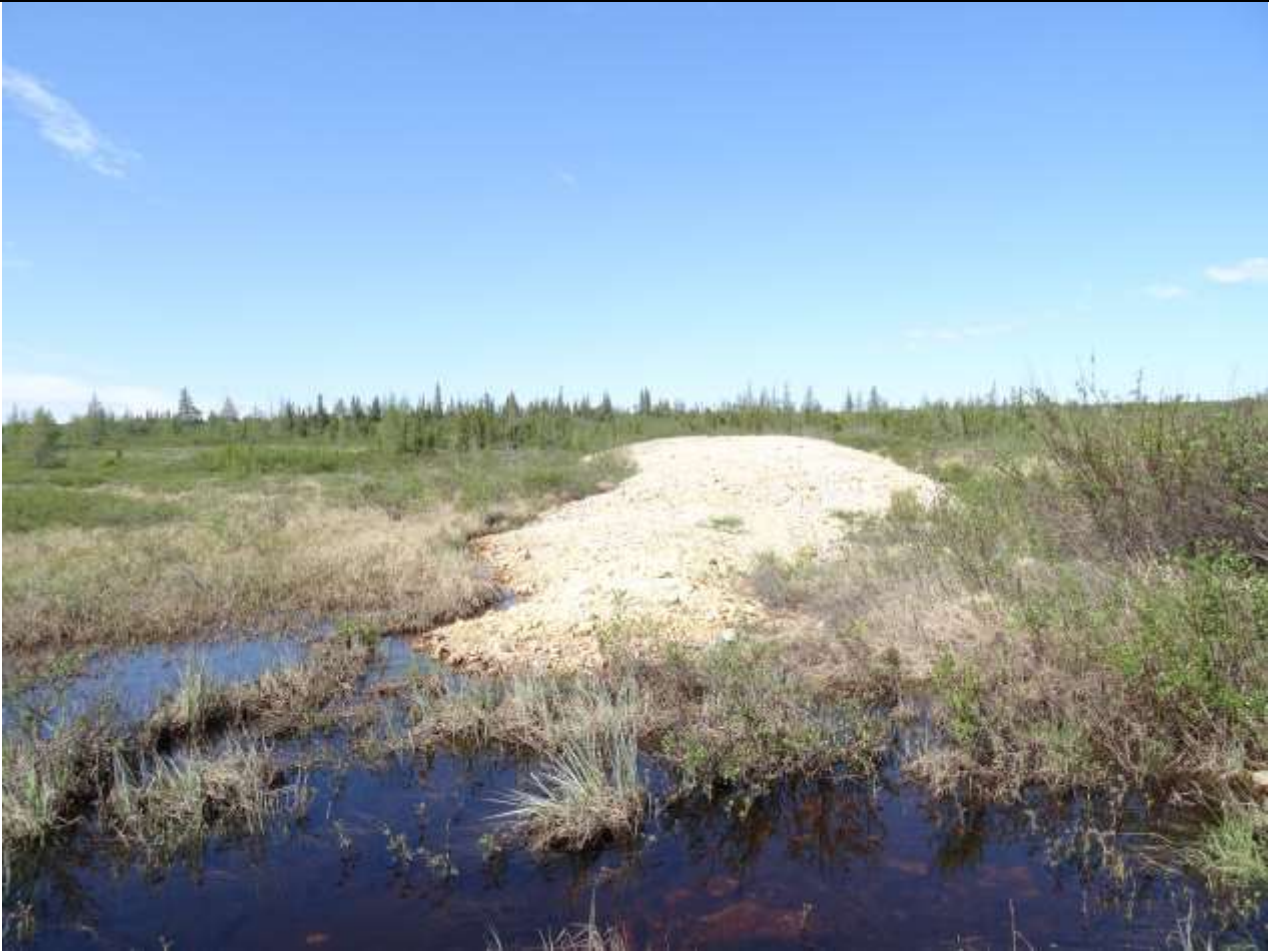
Date:	Authorization Number:	Camera/Model:	Inspector
June 27th, 2016	1BR-CUL1118	Sony DSC-HX50V Cyber shot	WRO Wilson
Photo No.		Lat/Long (DD.MM.SS.SS, NAD83)	
Photo 1		N61° 18' 24.73" W98° 30' 23.23"

Description:
Facing West: Remnants of the Shear Lake diversion Dam, stagnant water in the breached portion of the dam.

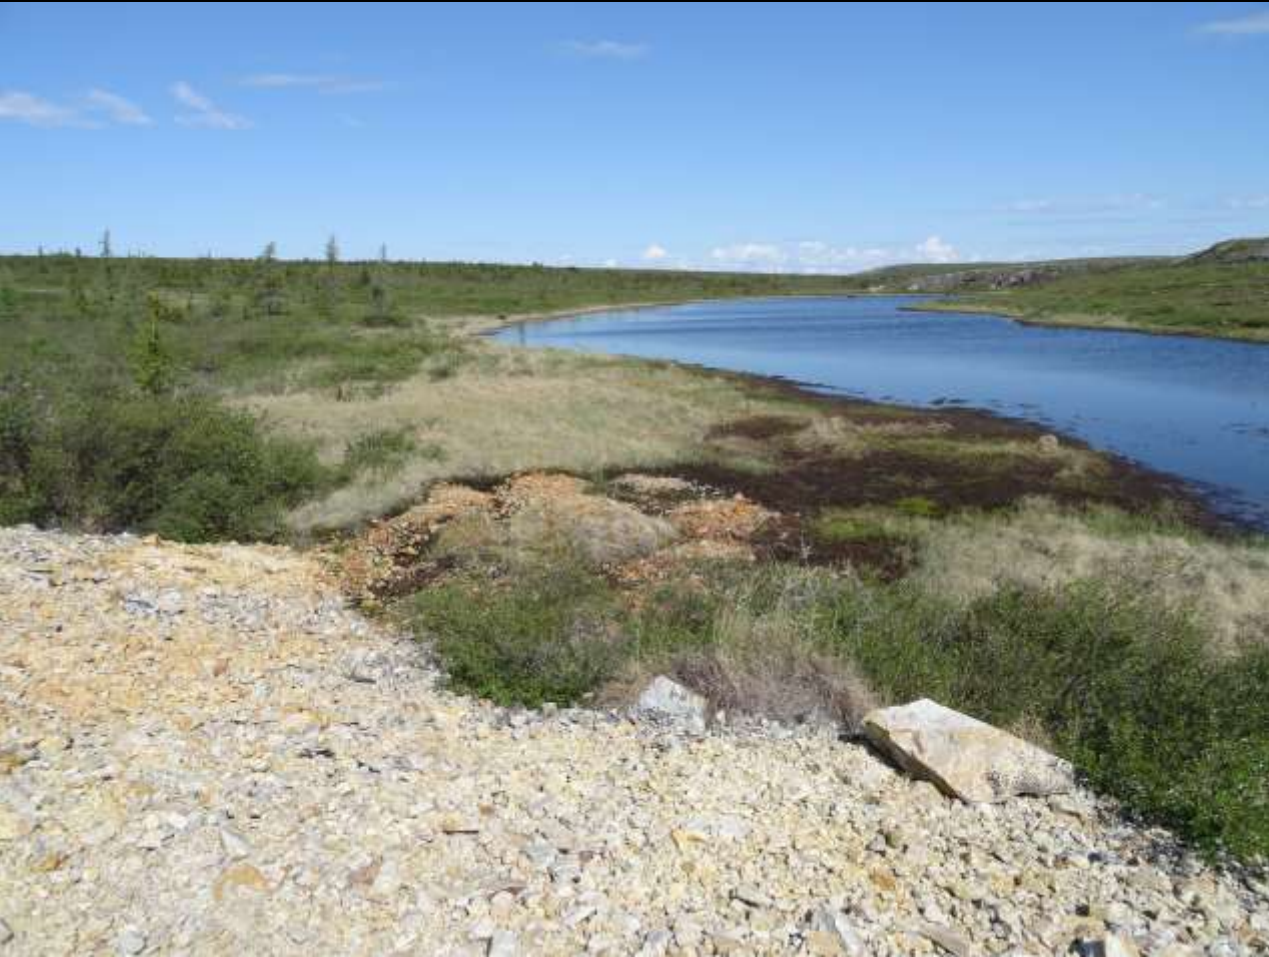
Locations name:	Lat/Long (DD.MM.SS.SS, NAD83)
Photo 2	N61° 18' 25.08", W 98° 30' 26.580"

Description
Looking North from Shear Lake diversion Dam

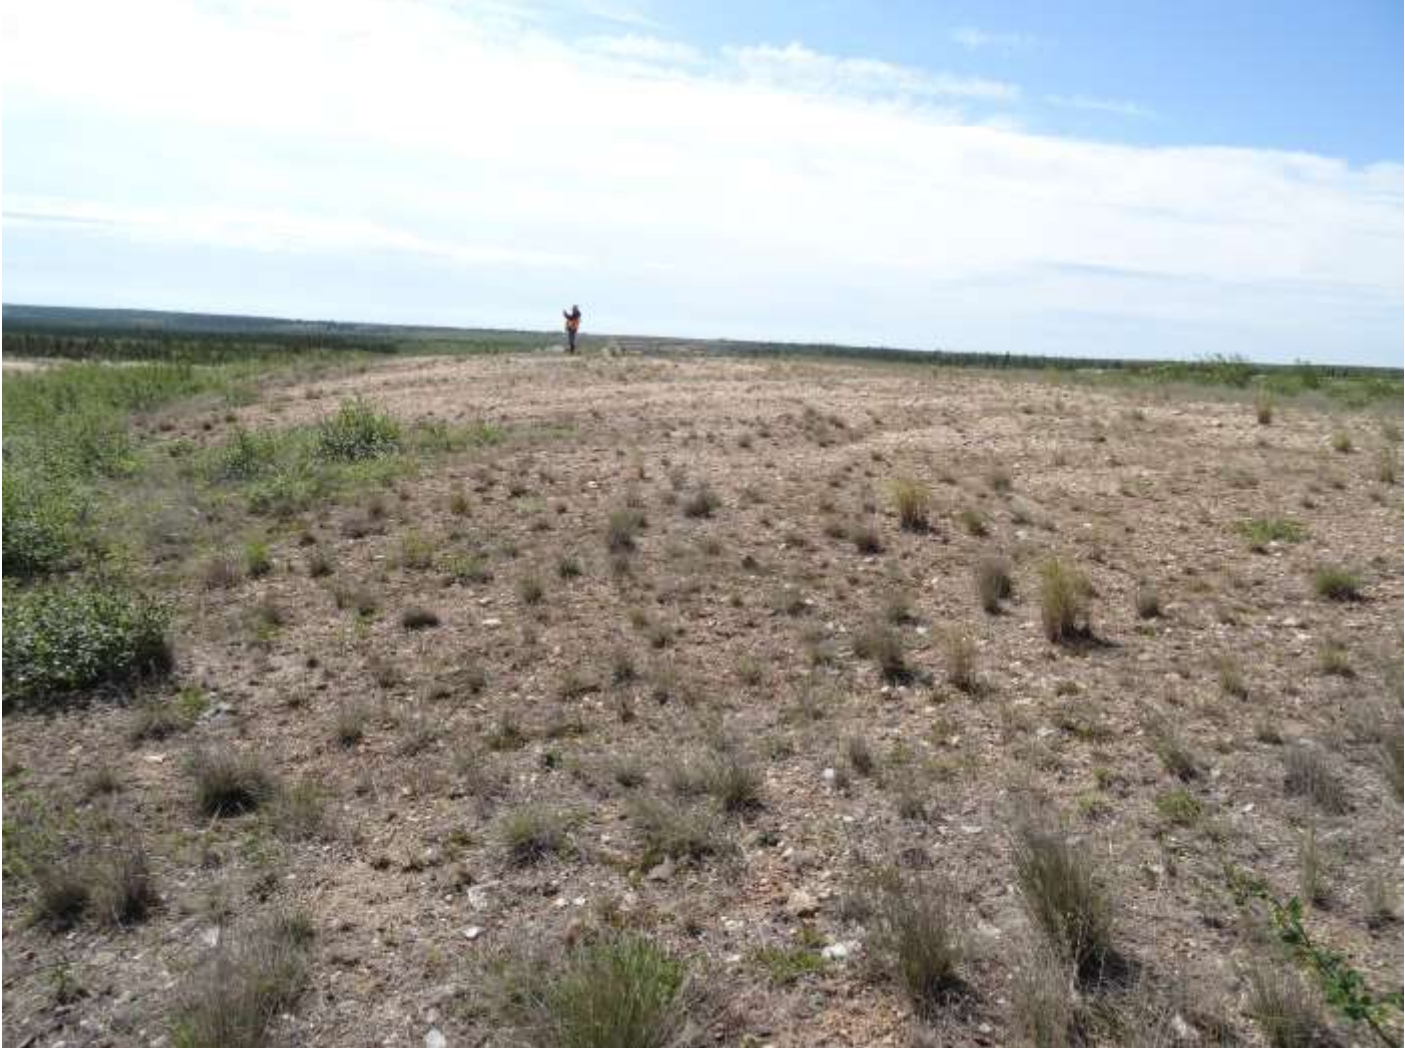
Locations name:	Lat/Long (DD.MM.SS.SS, NAD83)
Photo 3	N61° 18' 21.79", W 98° 30' 13.15"

Description
Facing South from Encapsulated Waste Rock: Top surface of waste rock pile

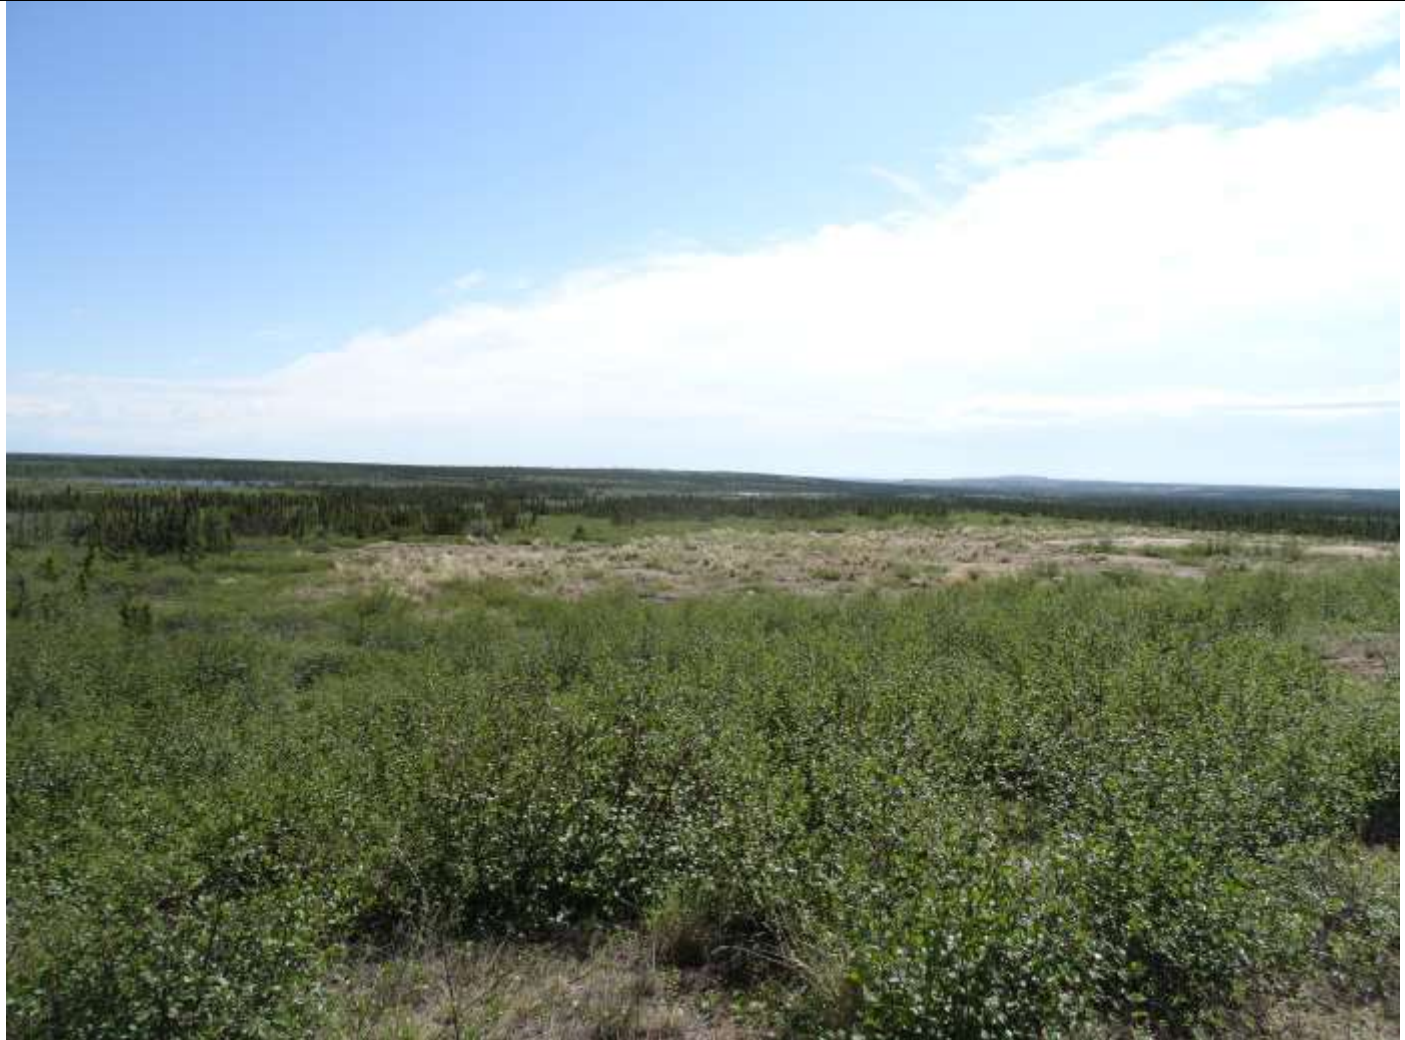
Locations name:	Lat/Long (DD.MM.SS.SS, NAD83)
Photo 4	N61° 18' 21.78", W 98° 30' 13.13"

Description
Facing East from Encapsulated Waste Rock: Regrowth on the PAG waste rock storage area identified in 2001

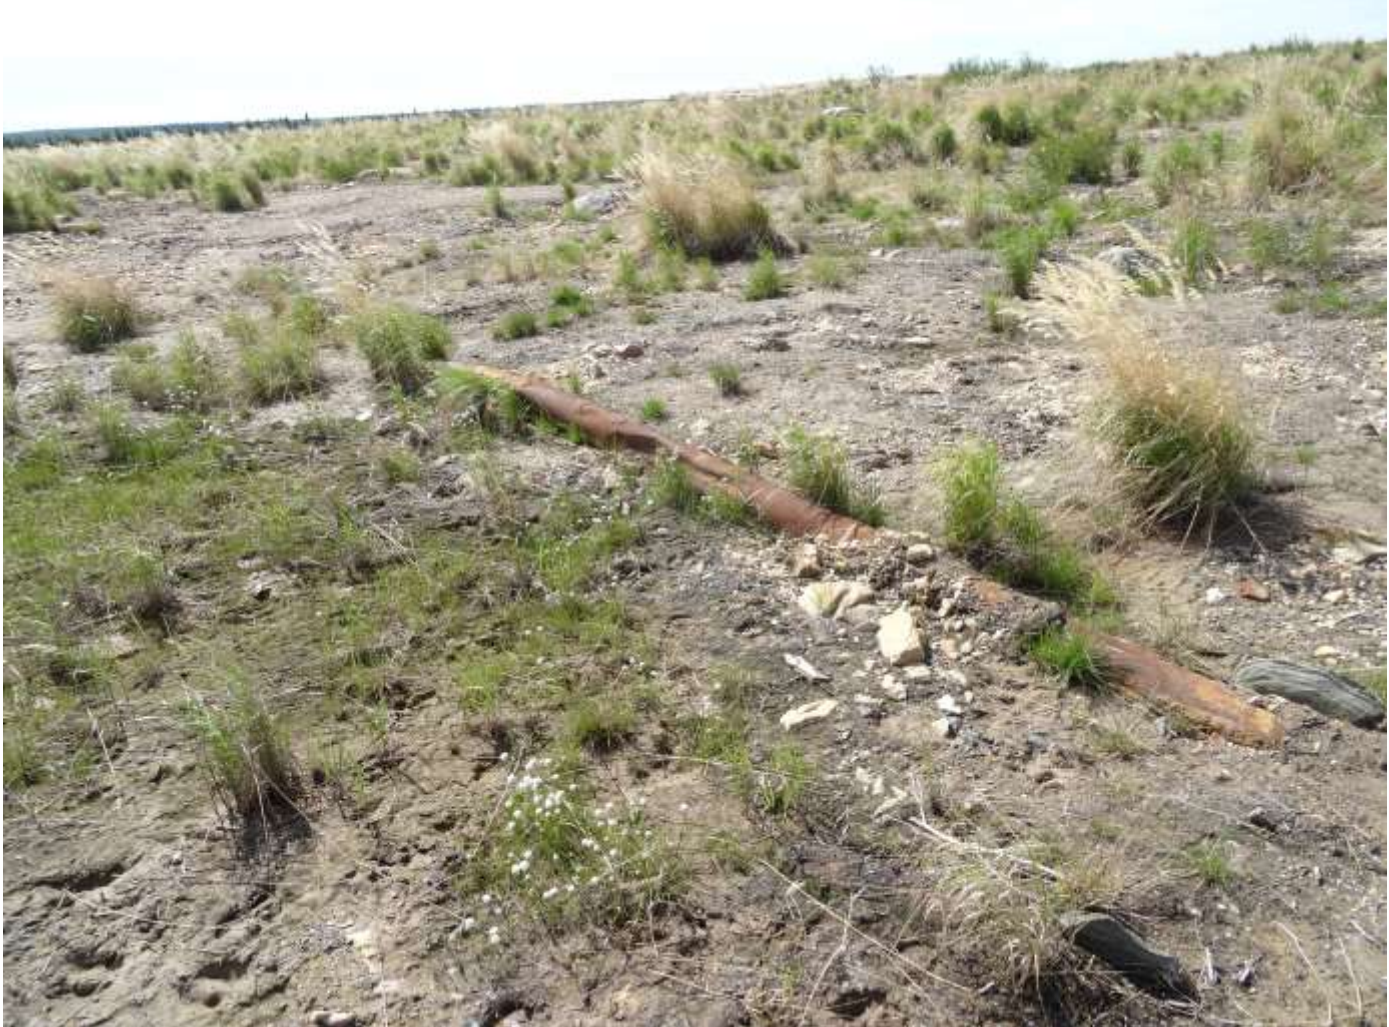
Locations name:	Lat/Long (DD.MM.SS.SS, NAD83)
Photo 5	N61° 18' 22.15", W 98° 30' 7.68"

Description
Facing East North East: Bulky metal located in old waste rock storage area

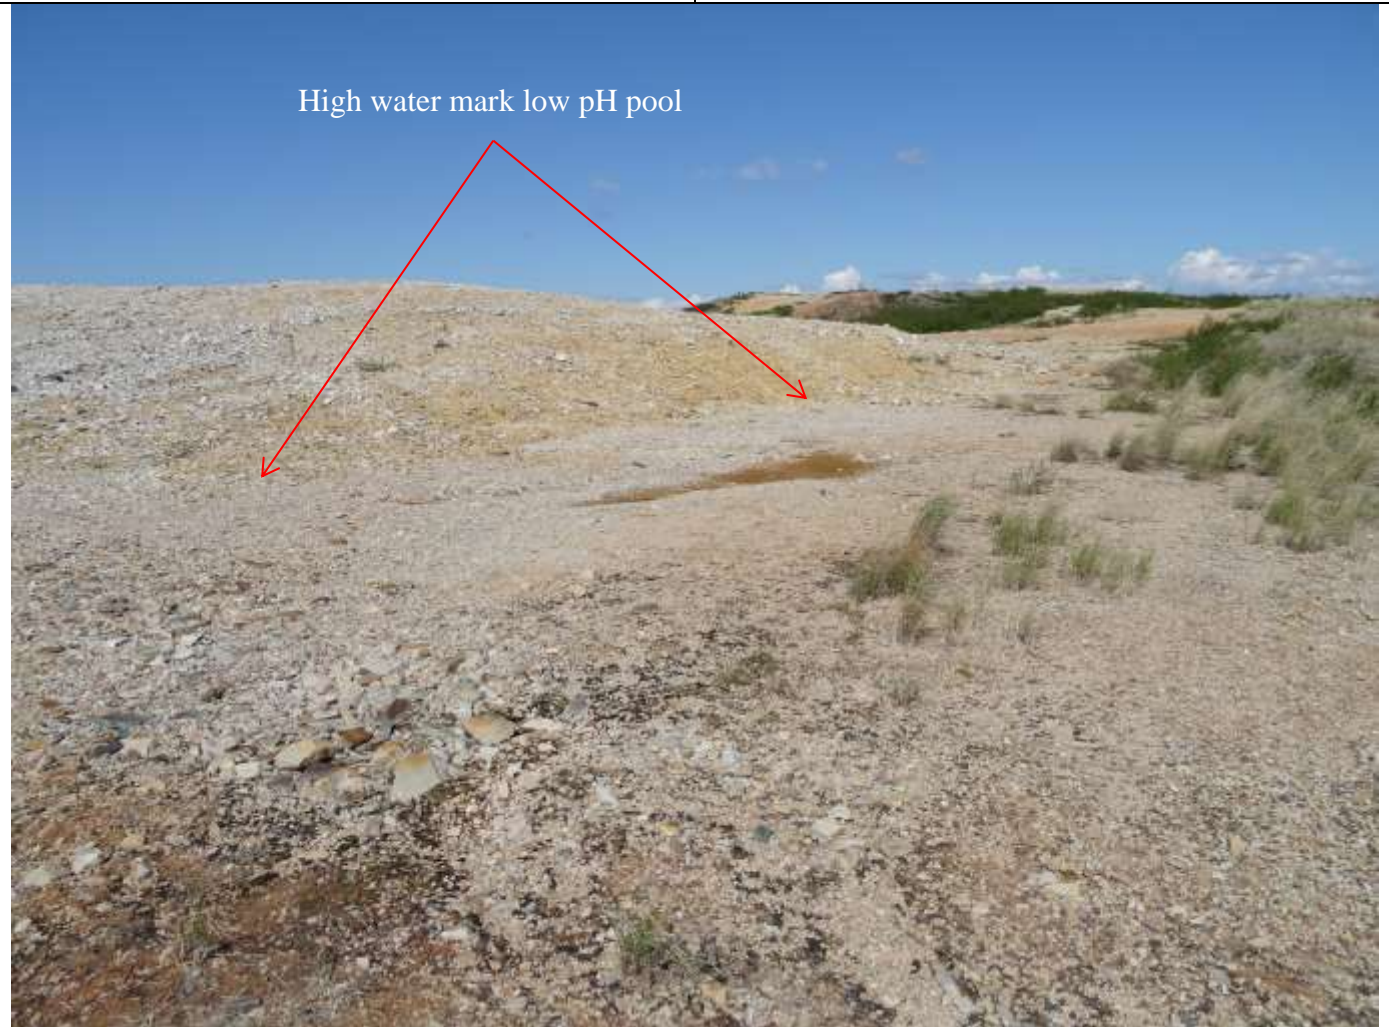
Locations name:	Lat/Long (DD.MM.SS.SS, NAD83)
Photo 6	N61° 18' 16.48", W 98° 30' 7.39"

Description
Facing North West: Appears to be a high water mark of the low pH pool

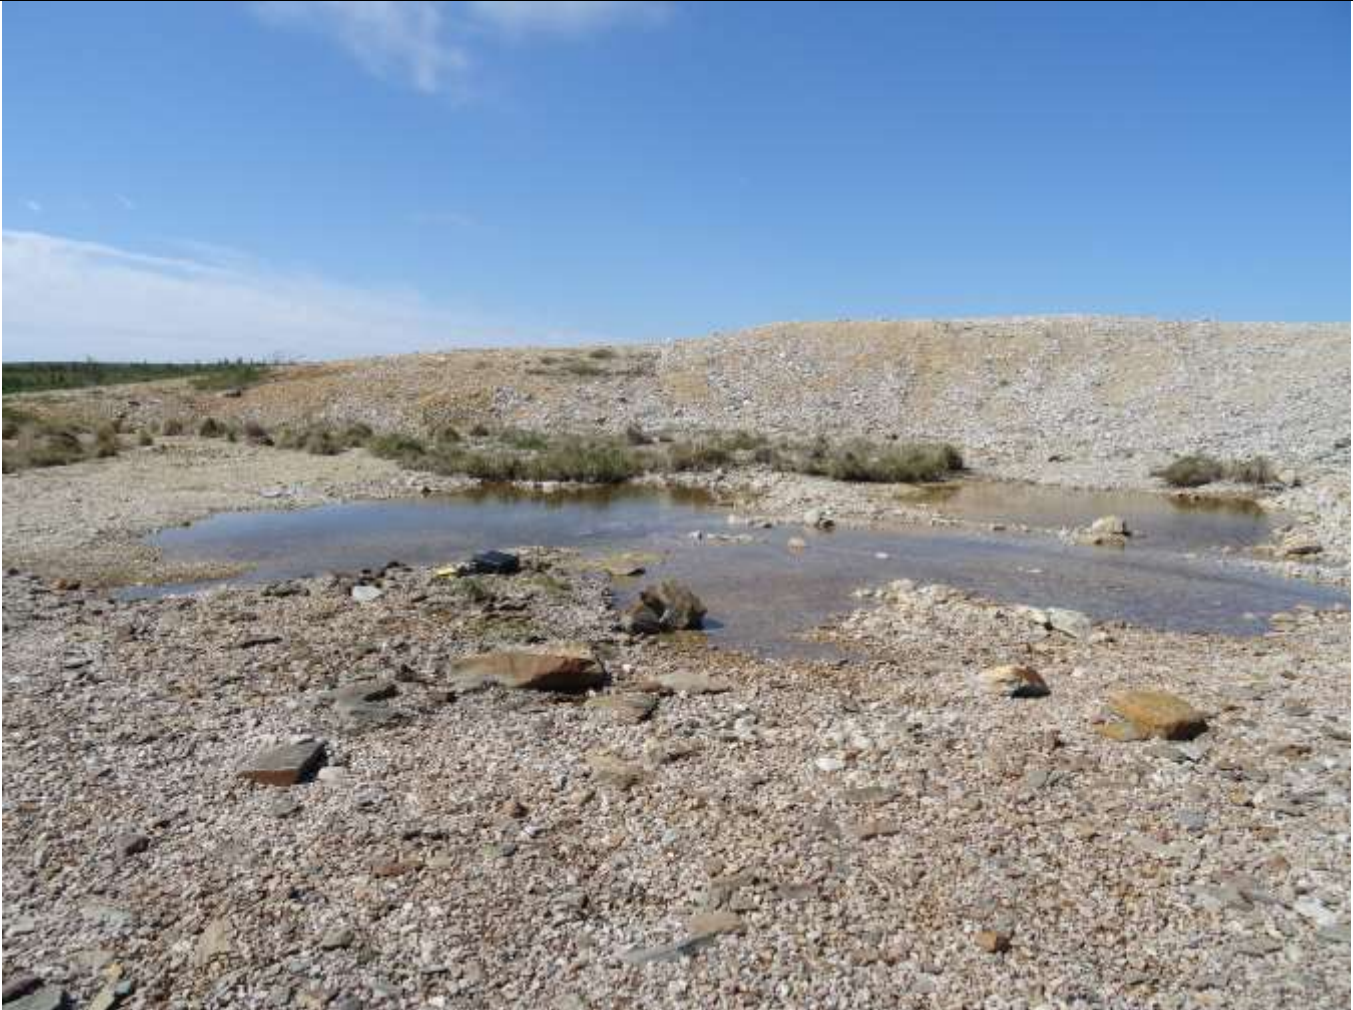
Locations name:	Lat/Long (DD.MM.SS.SS, NAD83)
Photo 7	N61° 18' 16.36", W 98° 30' 7.66"

Description
Facing West: Low pH pool

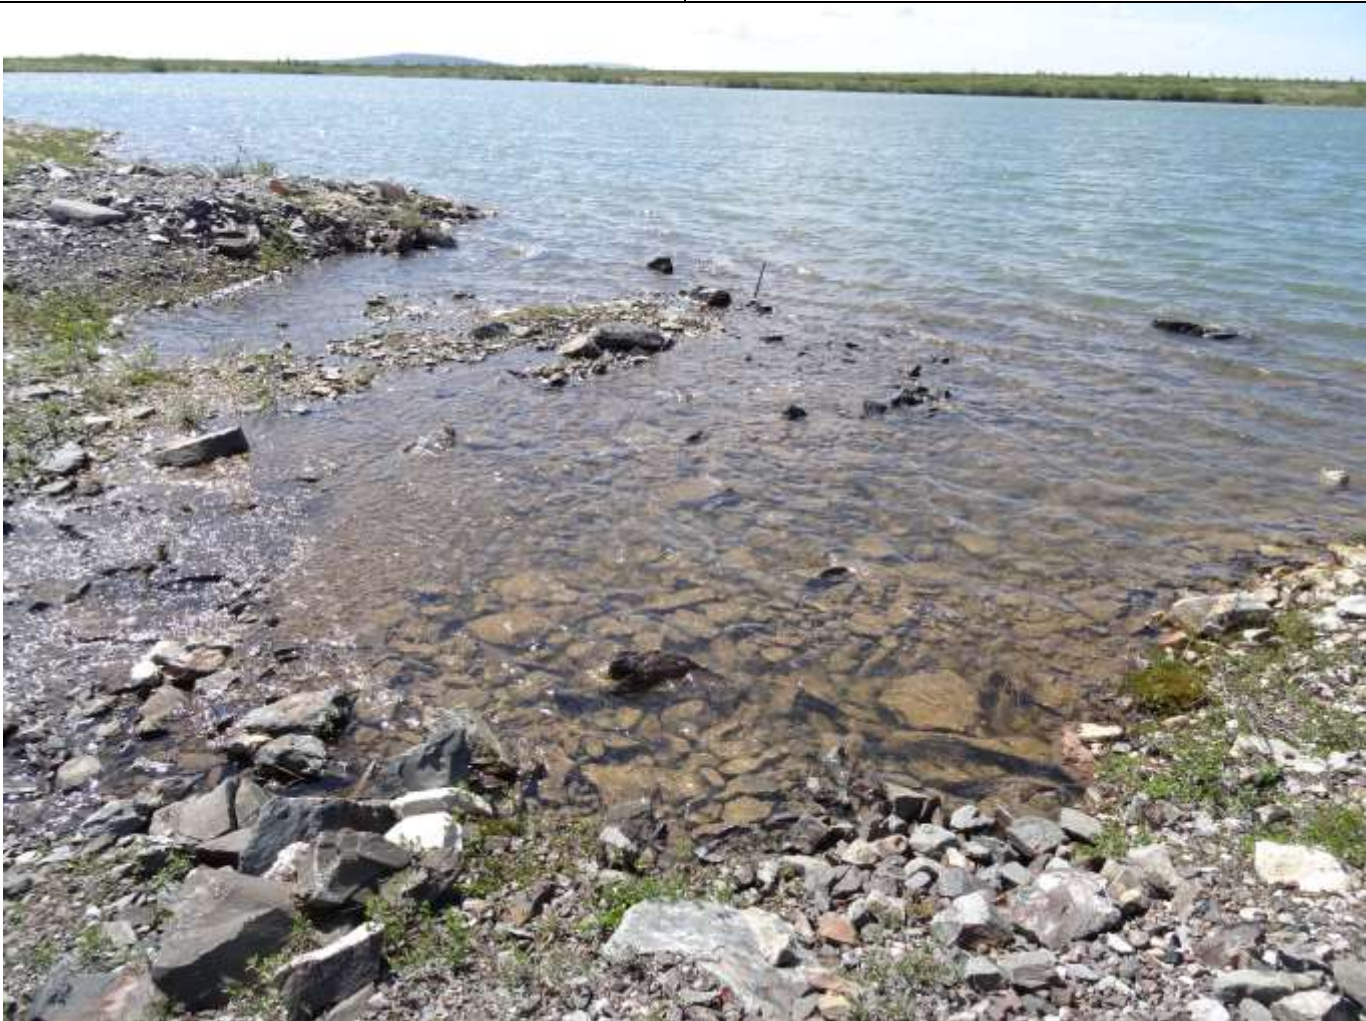
Locations name:	Lat/Long (DD.MM.SS.SS, NAD83)
Photo 8	N61° 15' 59.33", W 98° 29' 23.63"

Description
Facing South: Tailing Pond # 1 spill way facing west: Sampling station 940-18 marker
