Notes of Site Visit

Cullaton Lake Mine

July 24, 1999
ORIGINAL

**Prepared for
Nunavut Water Board**

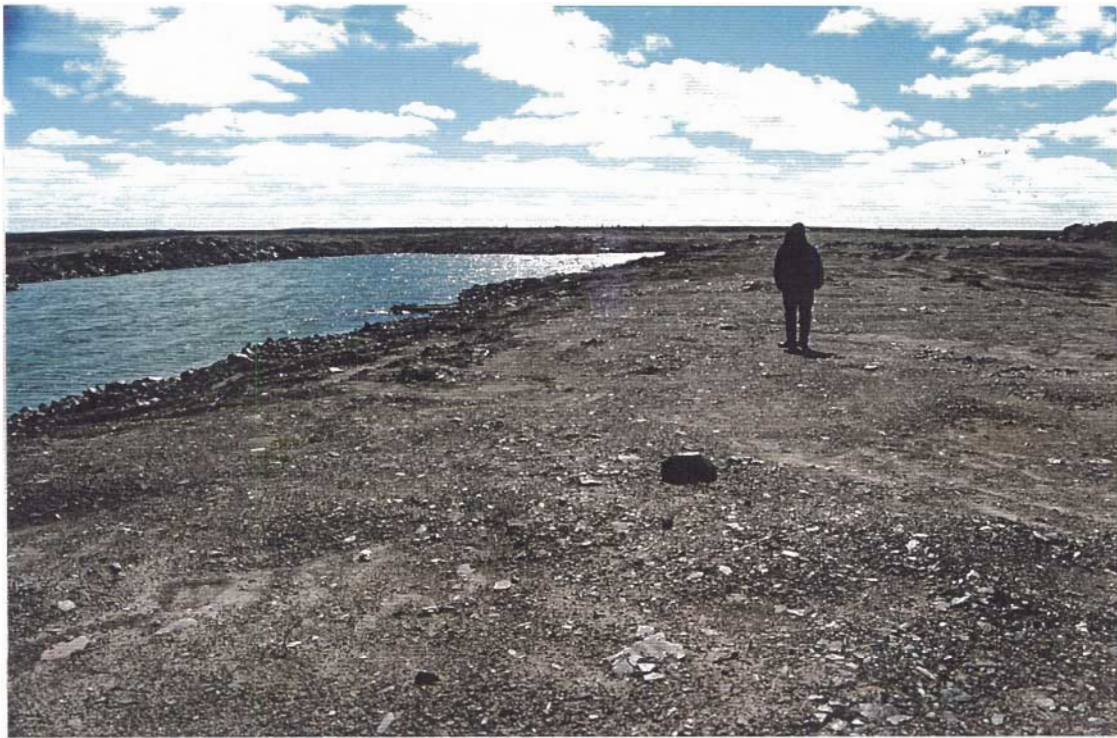
The landfill is located in a quarry located to the south of Tailings Pond 1. The quarry was used by the mine to provide supplementary rockfill for construction. Demolition debris from the minesite is buried in the quarry and covered with till. The east portion of the quarry is filled with water to a depth of about 3 m. Along the shoreline, rockfill has been placed as erosion protection for the till covering. However, due to the large voids left when the construction debris was placed, the till covering has settled or collapsed, exposing pieces of metallic debris, especially along the shoreline.

Quarry site, located south east of Tailings Pond #1. Used for disposal of demolition debris from mine and mill buildings. Covered with till. Rockfill along shoreline.

The voids in the landfill material may result in additional areas of settlement and collapse, particularly along the shoreline area. These areas pose a man-made hazard for future use of the site and should be repaired. Additional rockfill should be placed along the shoreline area to provide sufficient cover over the exposed areas and to accommodate future settlements until the till cover has become stabilized.

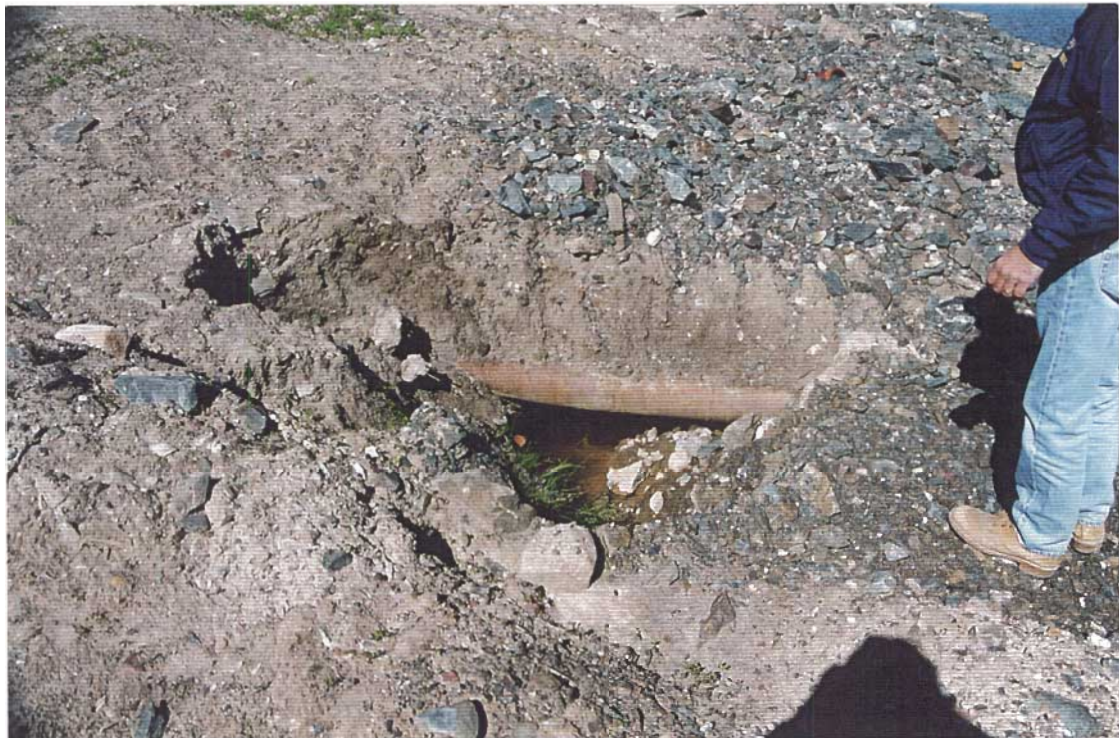
Collapse of till cover over demolition debris along west shoreline of Quarry.

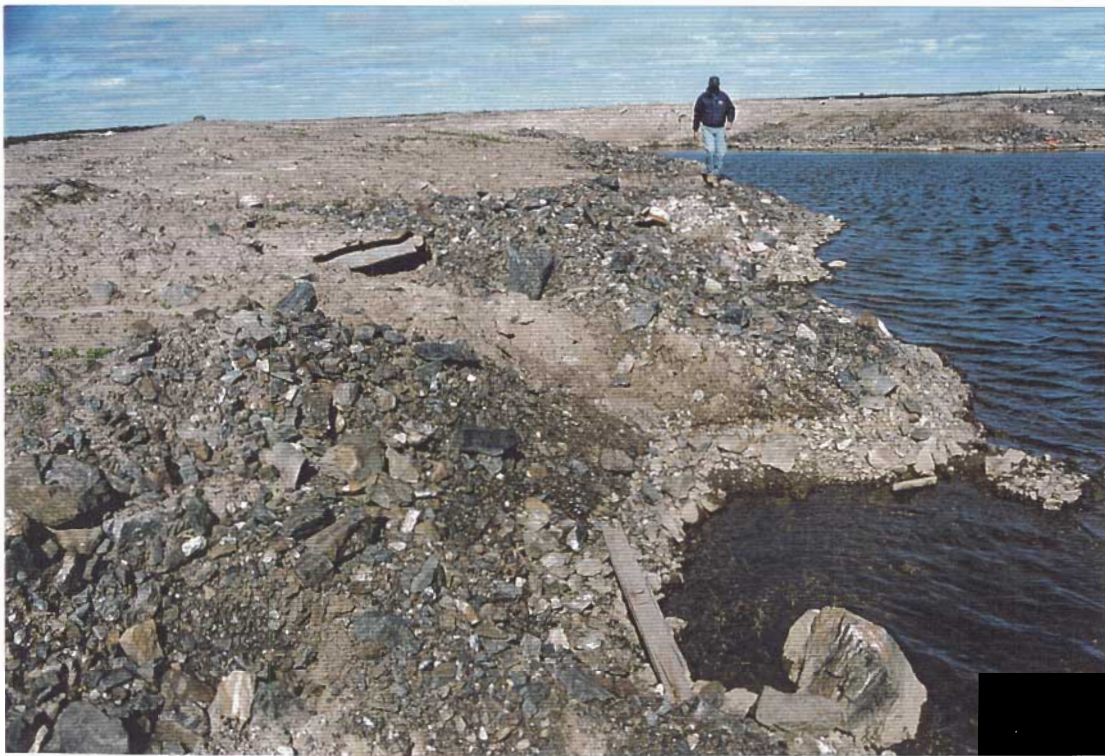
Protruding pieces of metal demolition debris buried in landfill area in quarry.

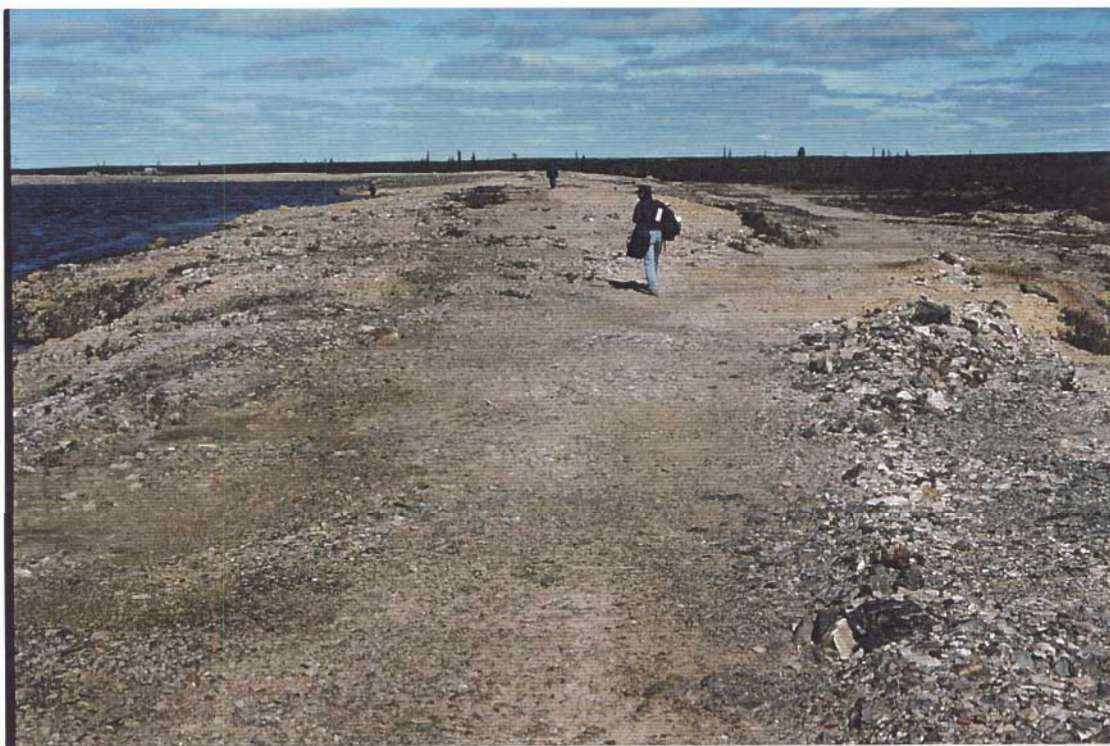
The top 1.5 m of the dike had been removed for site contouring purposes in 1994. The exposed top of the dike is composed of a well graded compacted sand-gravel-cobble mix, with the maximum grain size of about 30 cm and most of the material being gravel sized or less. The materials consist mainly of blasted rock, predominantly the orthoquartzite member of the host rocks. The material which

There is a concern about the reduction in the height of the dike by 1.5 m. Without further details on how the dike was constructed, the main concern is the lack of frost protection for the dike. Since there is only 1 m of freeboard, and the depth of the active zone at this site is likely to be at least 1.2-1.5 m, the water seeping through the dike will be subject to seasonal freezing effects. The formation and collapse of ice lenses in the dike embankment may lead to long term degradation of the structure. It would be helpful to ask Homestake for any technical documentation such as drawings and reports which describe the design and construction of the dike and the technical basis behind the trimming of the crest.

South abutment of dike of Tailings Pond #1, upper 1.5m of dike has been removed for contouring.

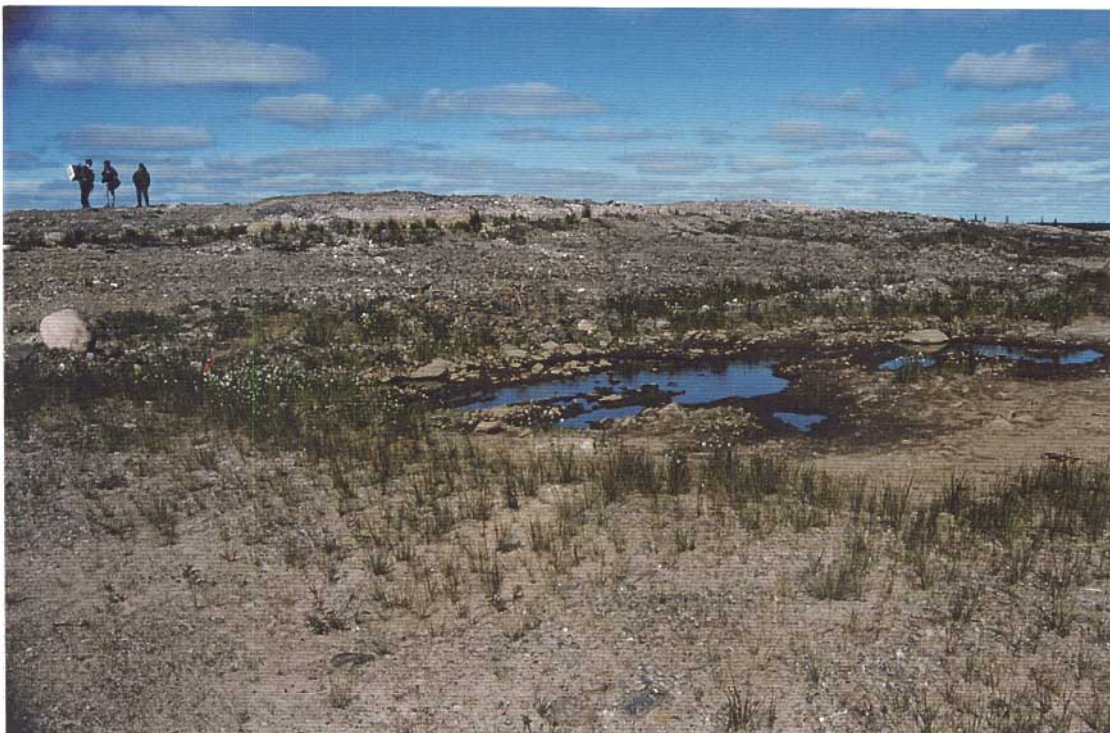
A zone of seepage was noted near the south abutment, consisting of an area of ponded water about 6-7 m across at the downstream toe of the dike. At this point the dike is about 4 m high and has a flat downstream slope, estimated to be at about 5H:1V. There is no sign of active seepage and the water appears to be clear. The ponded water is one of the water quality monitoring stations.

According to DG and JP there is some debate as to whether this water is in fact seepage through the dike. To be on the safe side, Homestake has been taking water quality samples to check if there are any contaminants present related to the tailings disposal. None have been found. As part of the final site abandonment, it is recommended that this area be blanketed with a free draining sand and gravel filter covered with rockfill to a depth of at least 1m to prevent any possibility of degradation due to seepage effects in the future.

Seepage zone through #1 tailings dike near south abutment. Water sampling point.

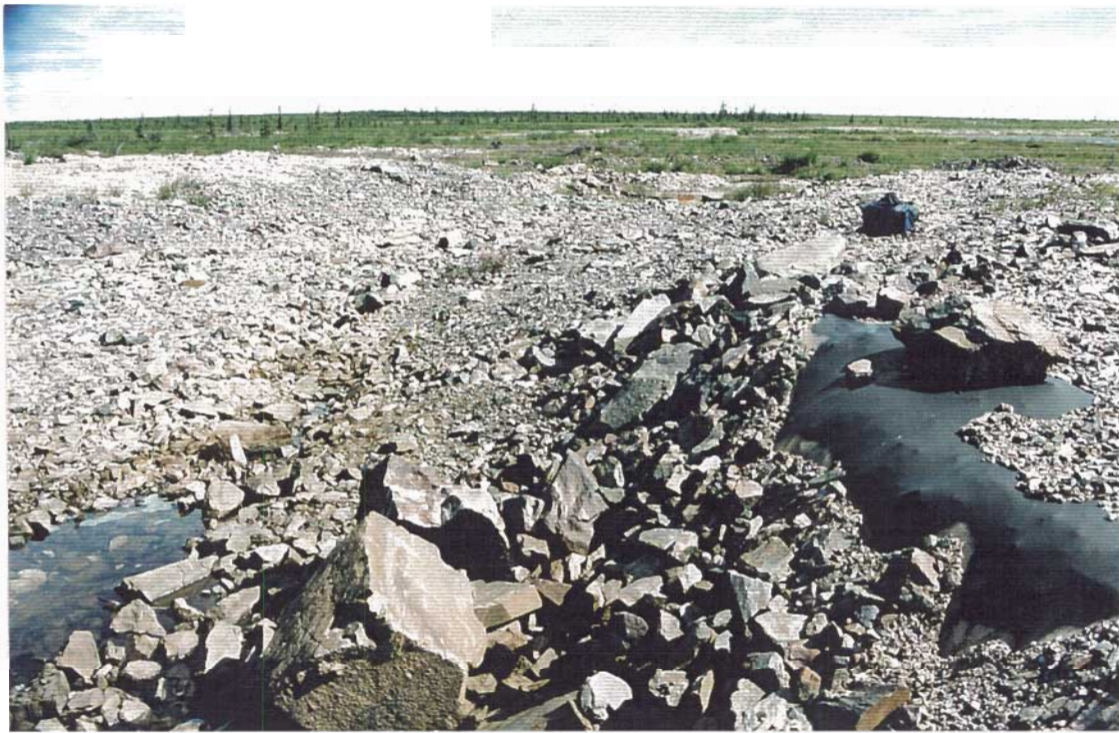
The spillway breach through the dike consists of a 5 m wide by 1 m deep channel cut through the crest of the dike. In 1994, the water level in Tailings Pond 1 was lowered by 150-300 mm. The spillway was cut to maintain about 1 m of freeboard. The base of the spillway cut has been lined with a High Density Polyethylene (HDPE) liner and covered with rockfill. At the downstream end of the spillway, a small steel flow measuring weir was installed. According to JP and DG, flow through the spillway occurs only during the spring freshet and typically fills the channel to a depth of about 150 mm. Flow measurements by means of the weir are ineffective because most of the flow bypasses under or around the weir, through the rockfill.

Spillway breach in #1 Tailings Pond dike – approximately 1m deep below crest level. Partially exposed HDPE liner on right.

The HDPE liner under the weir has also been disturbed by water flows and should be repaired. The HDPE liner is also partially exposed near the upstream end of the spillway. The liner appears to have been placed directly on the underlying rockfill with no sandy cushion to prevent punctures. For the long term performance of the spillway, it is recommended that this area be repaired.

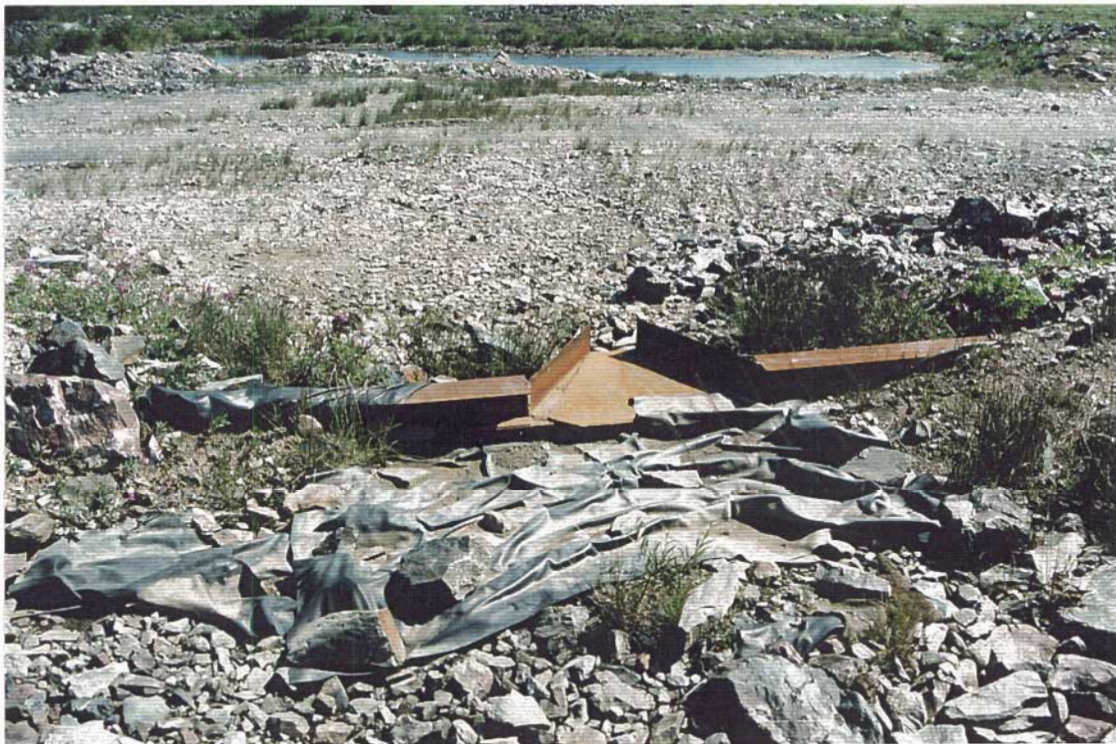
Flow measurement weir at downstream end of spillway breach. Normal spring freshet flow is up to 6" (150mm) depth in channel. Most of the flow by-passes the weir through rockfill underneath. Note disturbed geomembrane liner.

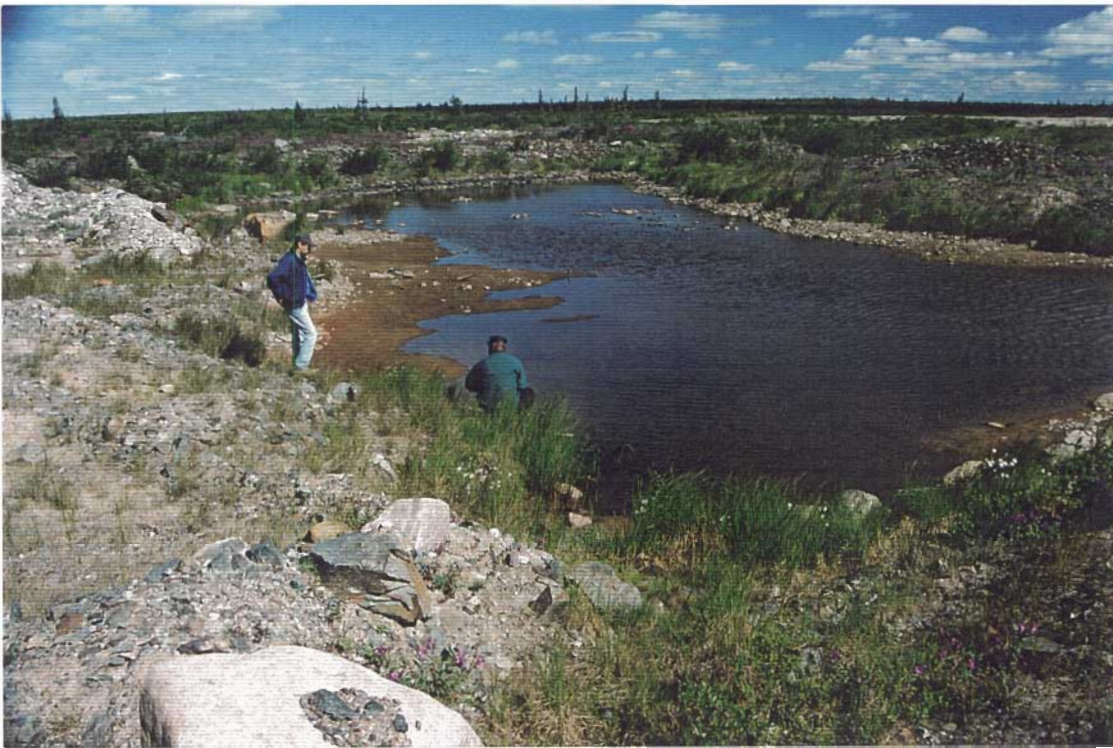
A small amount of gulleying has occurred where the spillway discharges along the downstream slope of the dike. A stilling basin area has been excavated beyond the downstream toe, which holds the water prior to seeping or flowing toward the holding area in tailings Pond 2 to the east.

Excavated stilling basin area at downstream toe of spillway. Water sampling point.

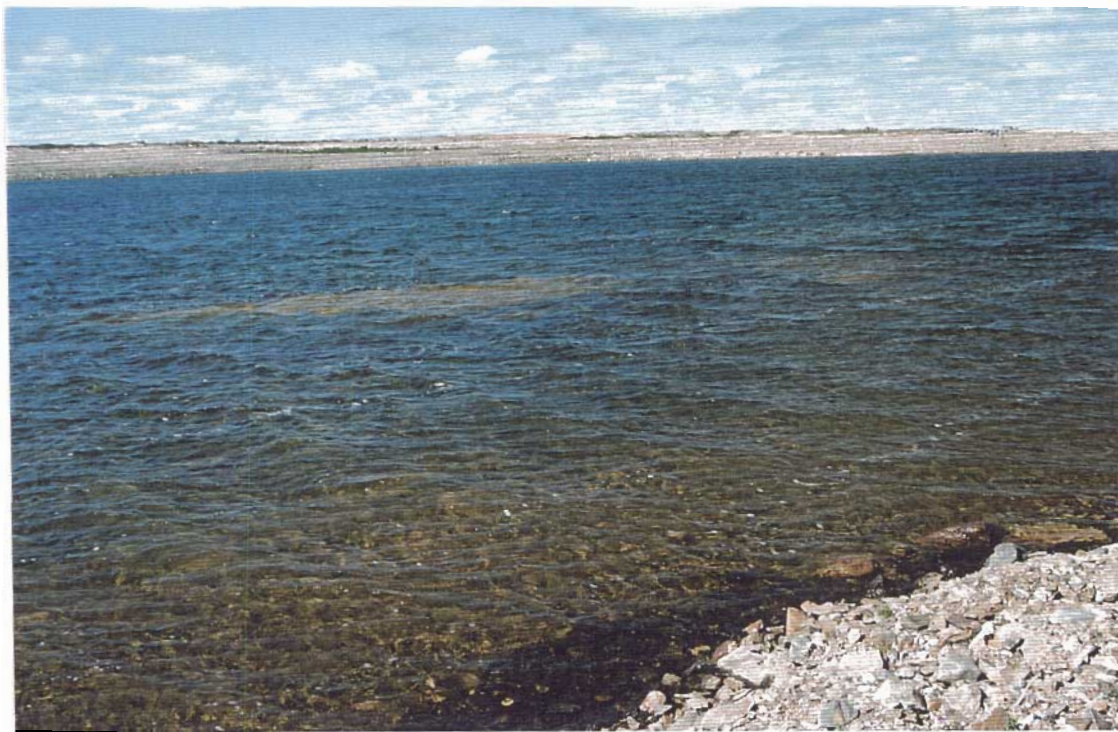
JP pointed out that the tailings were being re-suspended by wave action, resulting in a migrating zone of flocculated tailings, which may be washed out of the tailings pond area during the spring freshet.

Wind induced waves in tailings ponds with shallow water covers (<2 m) can re-suspend tailings and increase oxygen transfer, especially if breaking waves occur. The re-suspended tailings may become oxidized and release metals and acidity more than the tailings at rest.

Flocculated tailings in suspension due to wind and wave action forming shallows in Tailings Pond #1 near spillway. These materials have potential to spill out during annual freshet.

The suspended tailings driven by wind and wave action may spill outside the tailings containment area during the spring melt. It is important therefore to check the water balance for the tailings pond to make sure that the existing water levels will be maintained for the long term and that excessive spillway discharges do not occur which could erode the dike, or result in more tailings outside the diked area. The chemistry of the suspended tailings should also be checked to evaluate the impact of minor releases. Water quality monitoring should also be done of the spillway discharge during the spring freshet flow period.

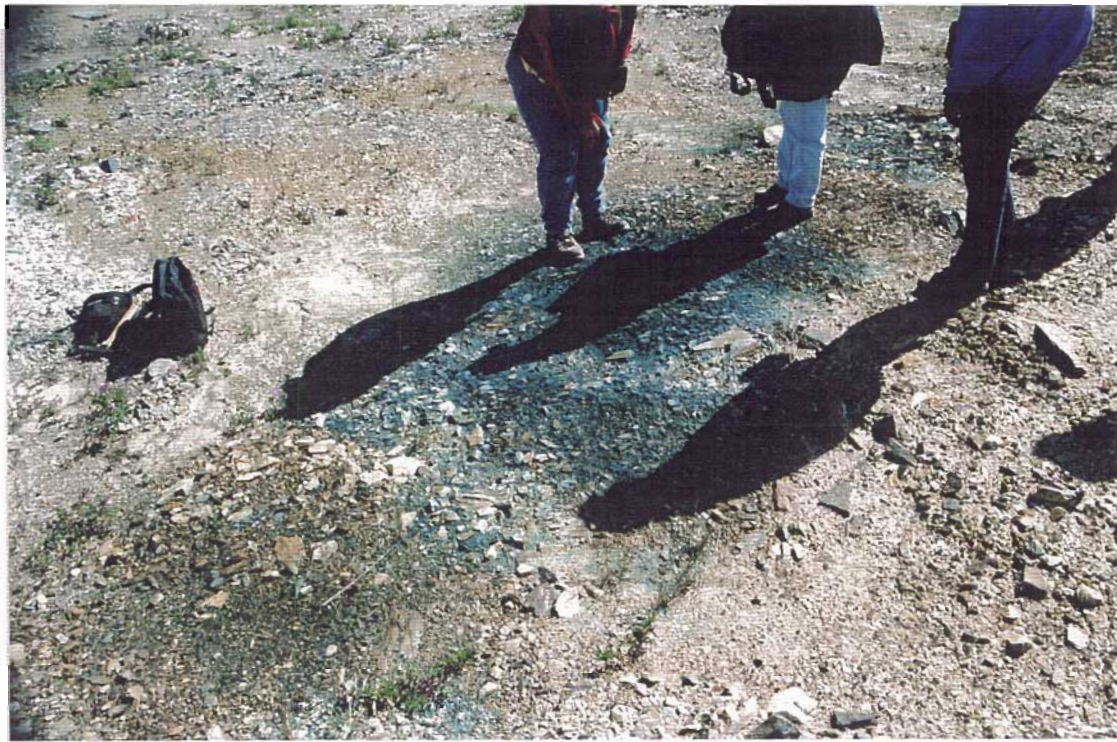
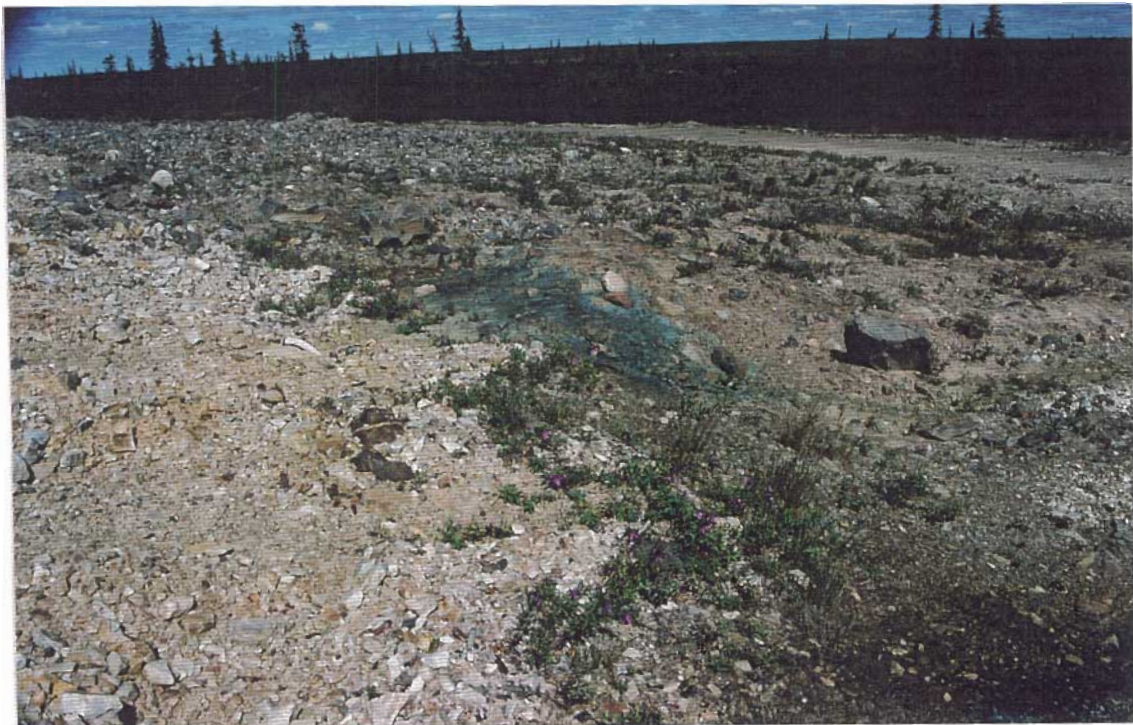
Near the north end of the dike, the crest width increases to about 21 m. In this area, patches of bluish greened stained ground (see photos) were noted on the downstream slope of the dike. SM of Homestake took samples of this material for analysis.

Blue stained area along downstream side of tailings dike on north side.

Patches of blue stained ground along north side of tailings dike.

Homestake should report to the Board as to results of the analysis of this material and recommendations for clean up.

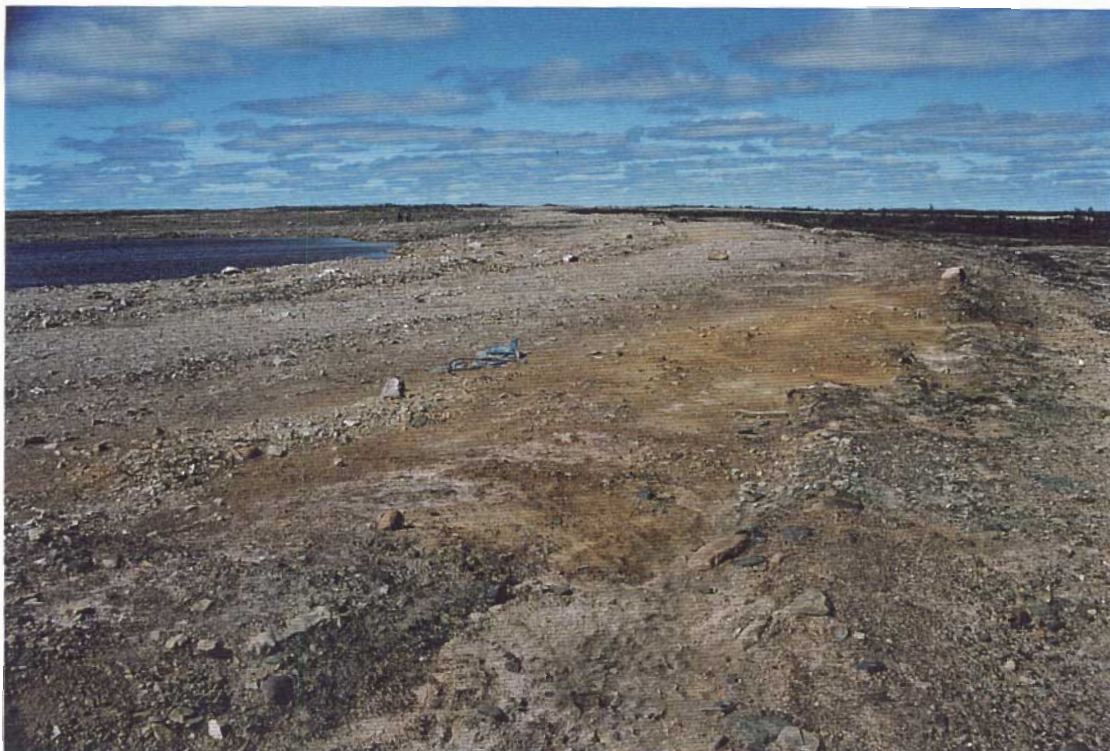
Area of oxidized sulphide bearing waste rock and blue stained patches on north side of Tailings Pond #1.

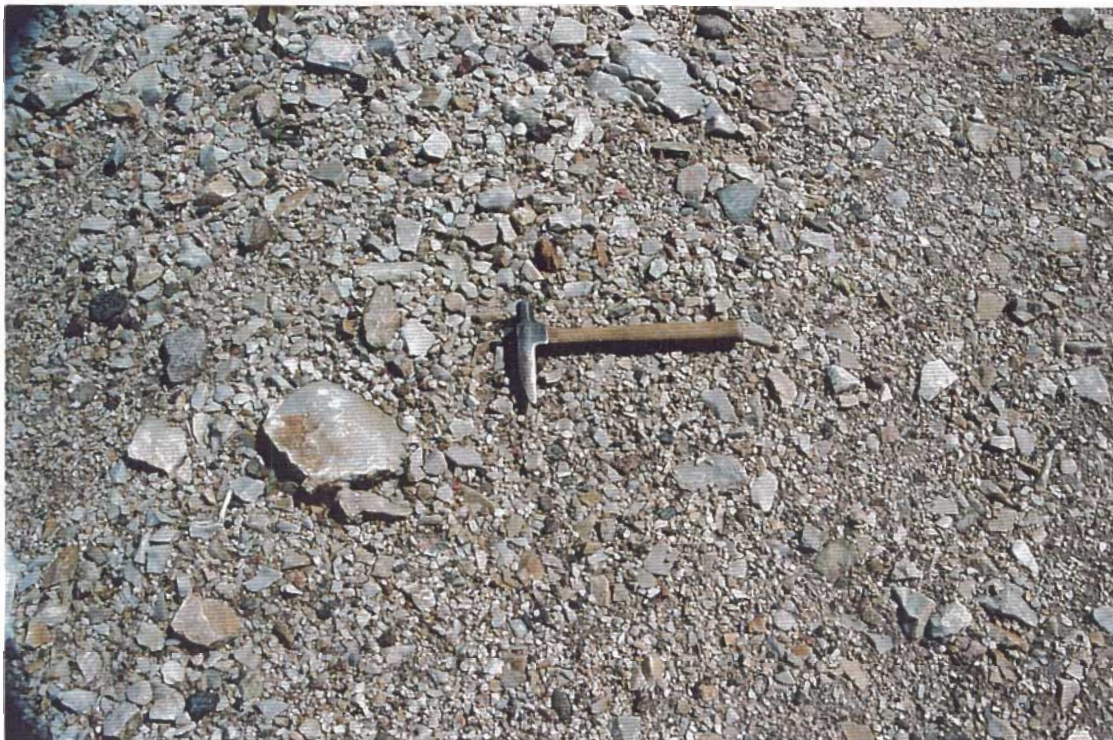
Consistency of typical materials exposed in crest of tailings dike.
Mainly quartzite rockfill – well graded from about 30cm to sand size.

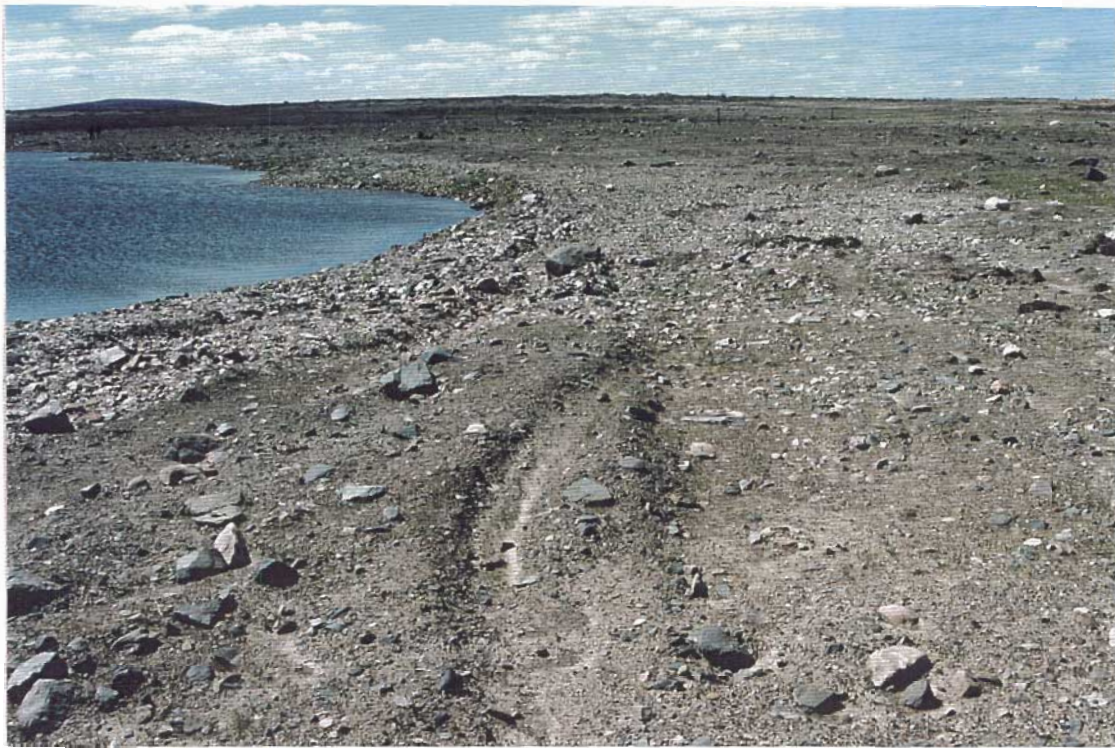
The above water portion of the tailings are found in the north and west sides of the tailings pond. These have been covered with till and have been monitored with piezometers and thermistors since 1994 to check on the development of permafrost.

Till covered tailings area. Black pipes visible in background contain piezometers and thermistors.

The temperature data for the thermistors and piezometric data should be included with the annual geotechnical inspection carried out by Trow, which should be sent to the Board. I would like to see the latest set of readings as well as copies of the previous inspection reports.

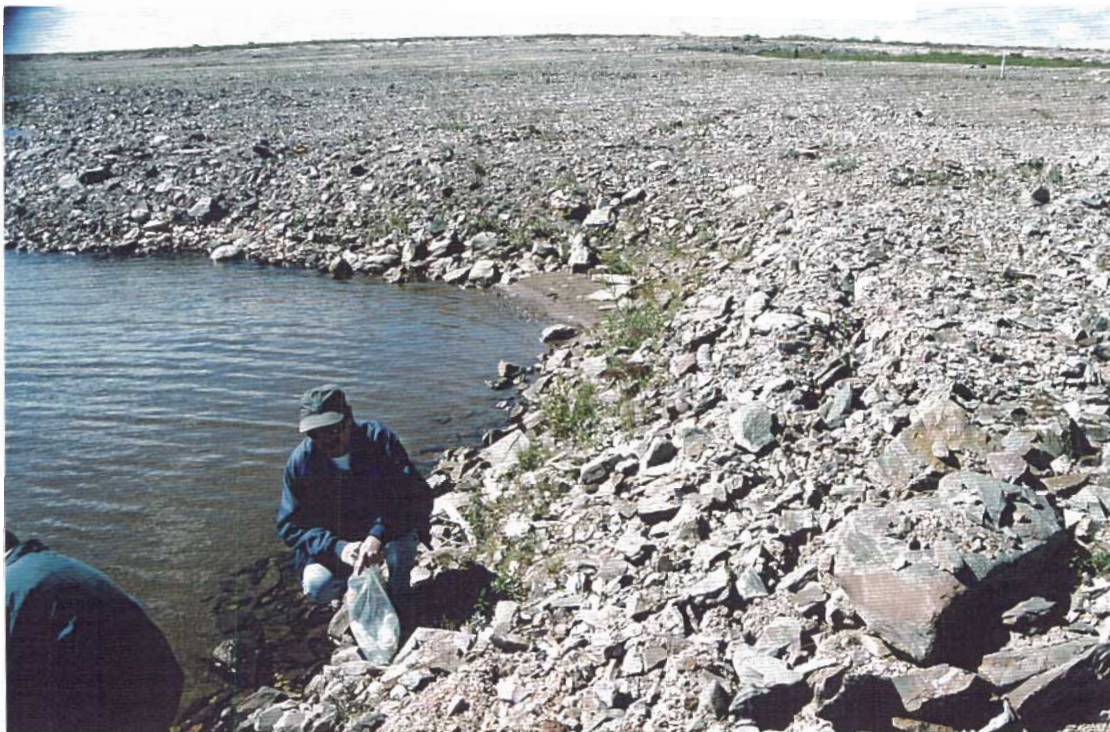
The covered area looks level with no anomalous settled or heaved areas. A small beach along the edge of the covered area shows there is about 1 m of till cover over the tailings (see photo).

West shoreline of tailings pond #1, small area of exposed tailings on beach, covered by till and rock fill.

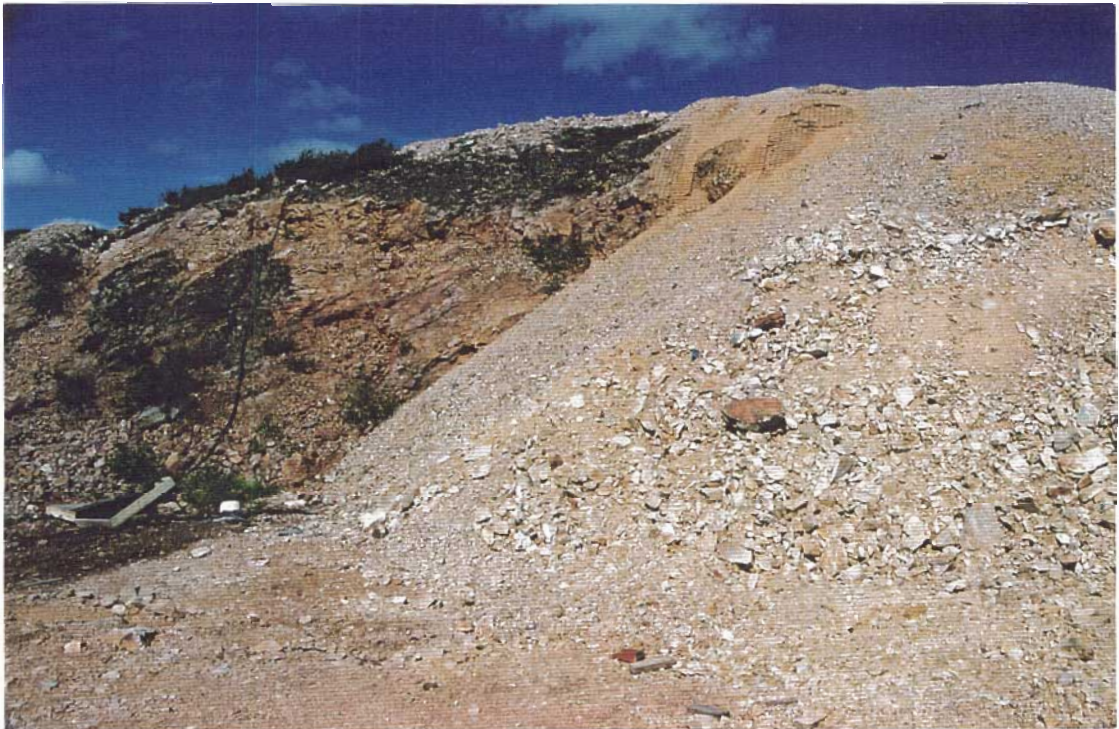
Bunkhouse/office trailers and miscellaneous equipment which is being dismantled for offsite transport remain at the Shear Lake site. The portal to the underground mine workings has been backfilled and covered with rockfill. Waste rock dumps exist along the shoreline of Shear Lake and along the east side of the site along the road to the airstrip. The waste rock is composed mainly of the sheared orthoquartzite rock unit which contains oxidized pyrite, giving it a rusty colour. According to SM, there is no acid producing potential associated with this rock.

Shear Lake Zone – portal area covered with waste rock.
