Nunavut Water Board

Notes of Site Visit Cullaton Lake Property, Nunavut August 24, 2001

September, 2001

**Acres International Limited
Winnipeg, Manitoba**

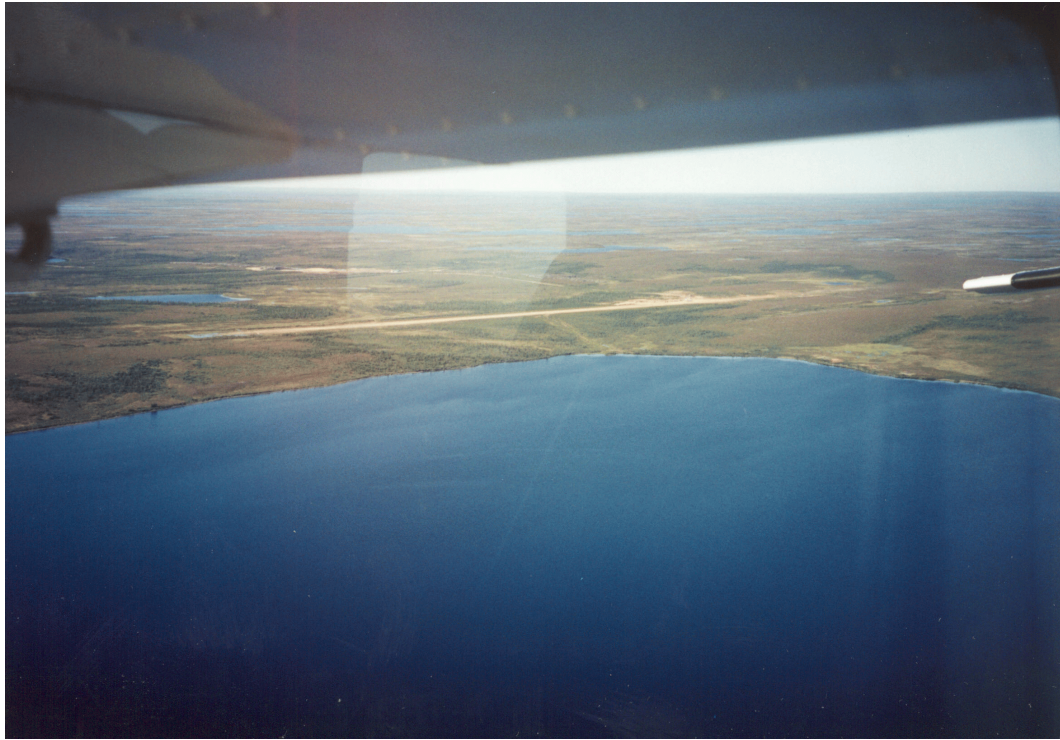
Photographs which were taken in the airstrip area are presented in Appendix A (Photos 1 to 9 inclusive). Part of the airstrip is located directly south of Cullaton Lake, approximately 400m from the lake (Photo 1). The airstrip itself appears to be in good condition. At the time of the site visit, it was observed that the airstrip was not equipped with a windsock or runway lights. It is understood that when the mine is finally abandoned, the airstrip will be left in its present condition.

Photo 1. An aerial view of the airstrip. Photo is looking to the south to southwest. The large body of water in the foreground is Cullaton Lake.

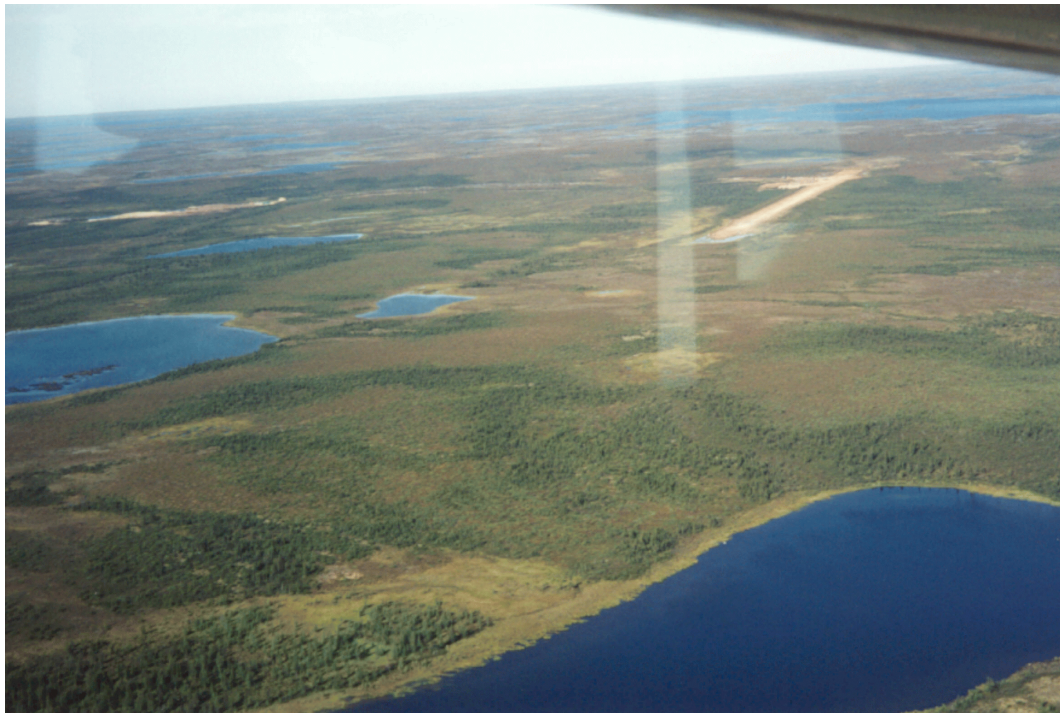
Photo 2. Another aerial view of the airstrip, taken from the east. Cullaton Lake is further to the right (not shown). The Shear Lake area is located on top left corner (open area in the photo).

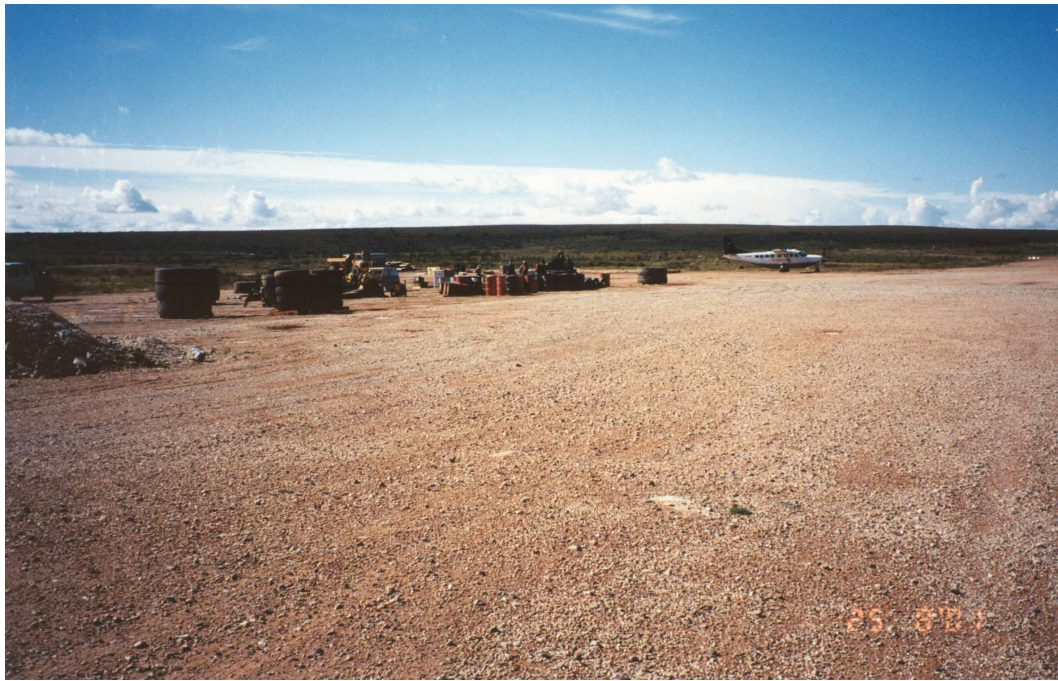
Photo 3. General view of part of the runway, and the loading/unloading storage area on the southwest corner of the runway.

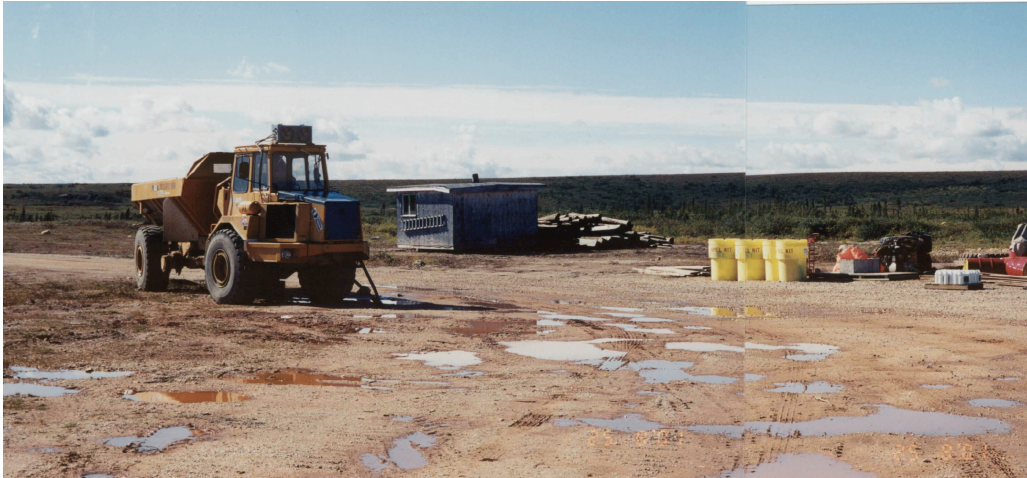
A shack and some piles of wood are located to the southwest of the airstrip, and along the side of the access road to the mine (Photo 5). Mr. Betts mentioned that the shack and the wood will be left at the site for the use of local hunters and trappers, and could also be used as an emergency shelter.

Photo 5. Access road from the airstrip to the mine. The shack and the piles of timber behind it will be left for the local trappers.

- < Remove all of the structures in the camp. Burn all the solid waste/garbage from the camp, and bury the camp's sewage in a trench.
- < Leave the shack and wood supplies for emergency use by the local trappers and hunters.

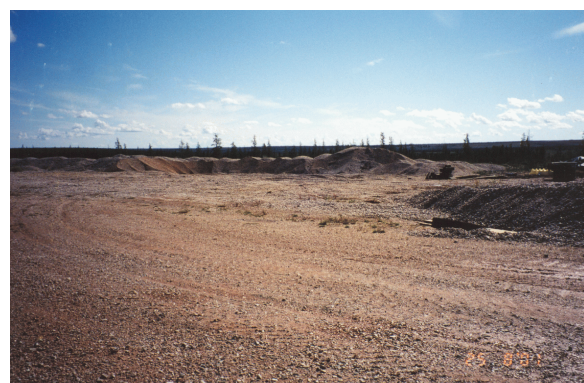
Photo 9. Granular stockpiles , just south of the working area of the airstrip.

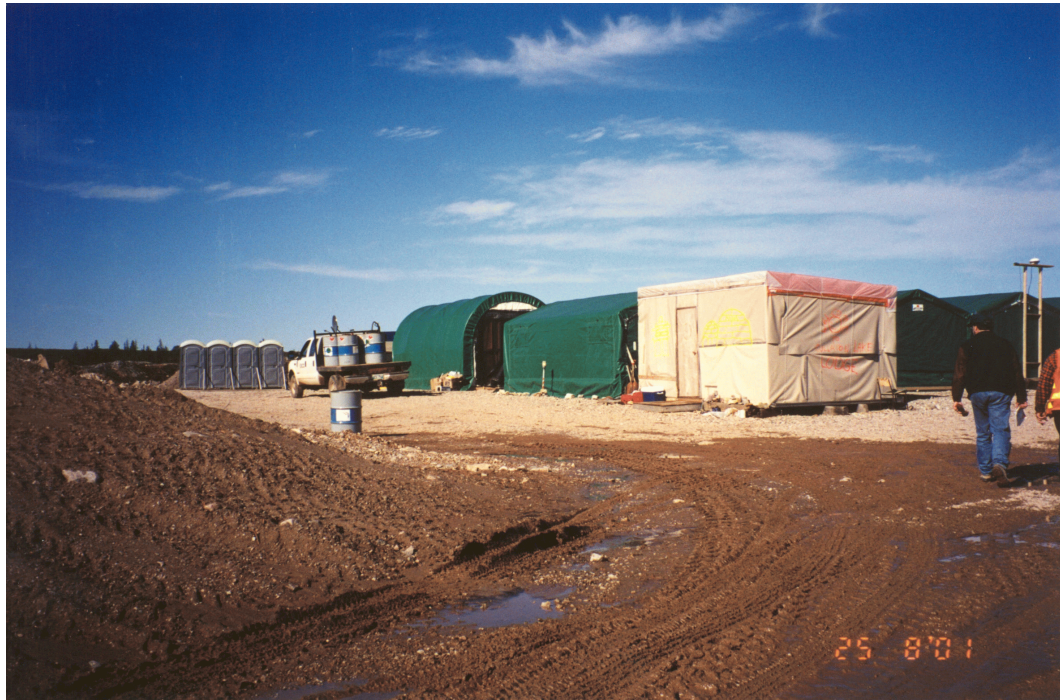
Photo 12. Front view of the Homestake's camp. Newly constructed capped berm containing waste rock is on the left (south of the camp site). Shear Lake is behind the campsite.

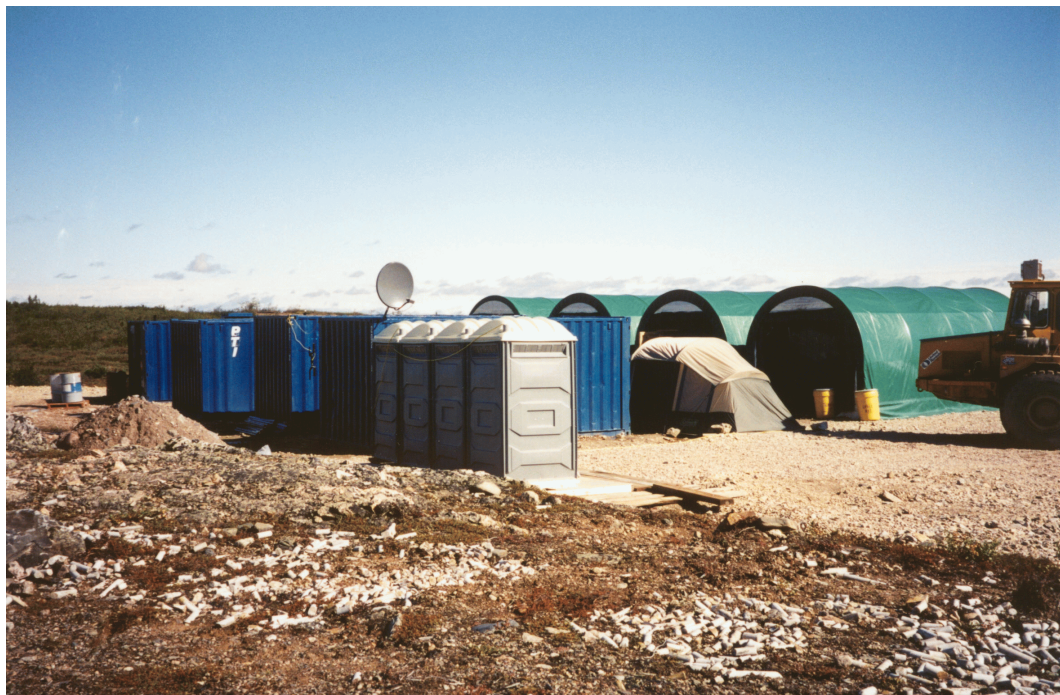
Photo 13. The back side of the camp. Blue containers are used for refrigerated food storage, water purification plant and diesel generator. Green tents are for kitchen, dining room, laundry, recreation facilities, and for living quarters.

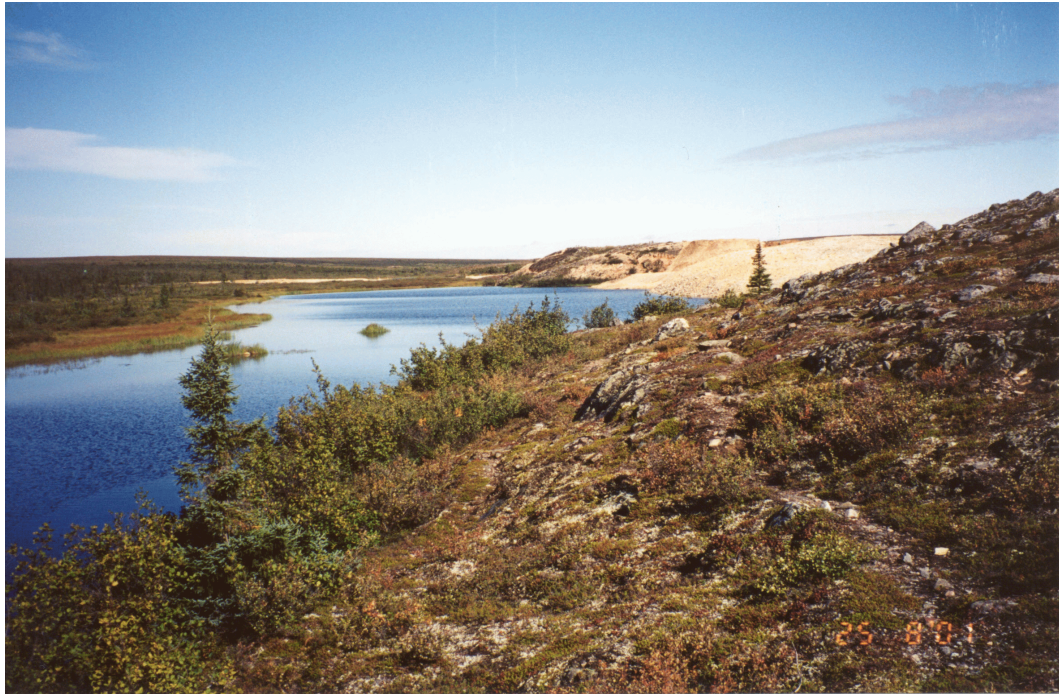
The camp operation did not appear to be producing any disturbance on Shear Lake (Photos 14 and 15). Water was withdrawn from the lake for camp usage using a portable water pump. The mine portal at Shear Lake (Photos 22 and 23) had been blocked and covered with granular fill. Some structures, such as the old camp building, miscellaneous old equipment and parts, and an old yellow bus, which were shown in some of the photos taken during the 1999 site visit had been removed and cleared. This area was relatively clean and free from any debris. Some landscaping work had been carried out in this area as part of the reclamation work.

Photo 14. Shear Lake. Photo is looking north. Note the light colour area on the top left side is the location of the old mine portal. Campsite is further to the north of the mine portal.

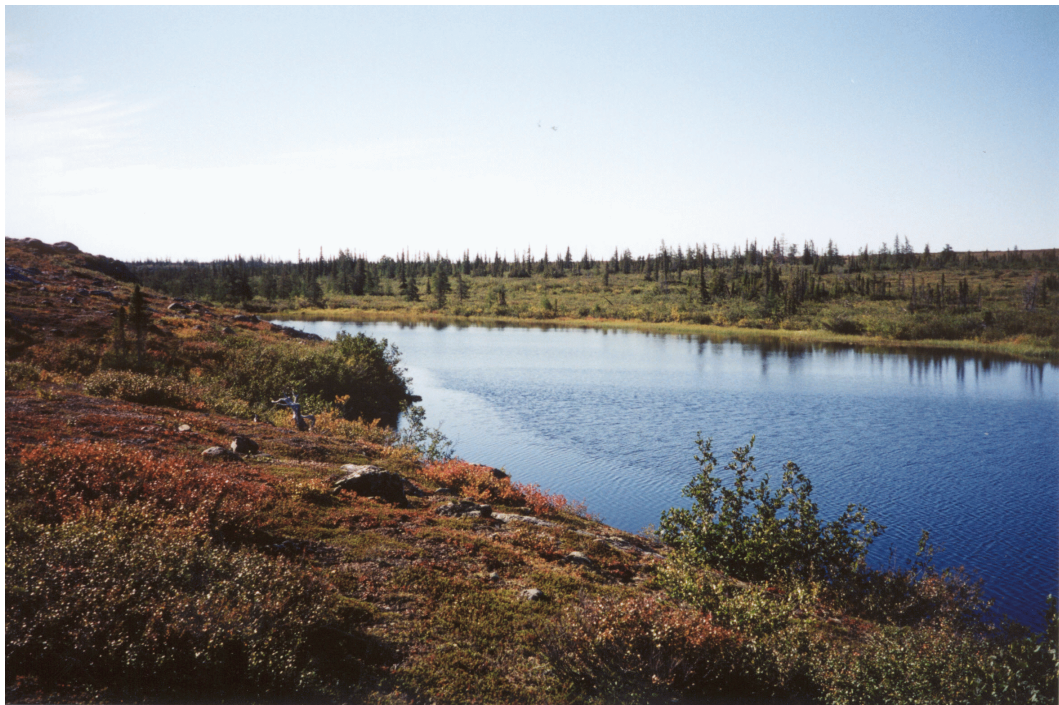
Photo 15. Another photo of Shear Lake, looking to the south. The area between the lake and the access road / waste rock stockpile consists of bedrock outcrop (left side of photo).

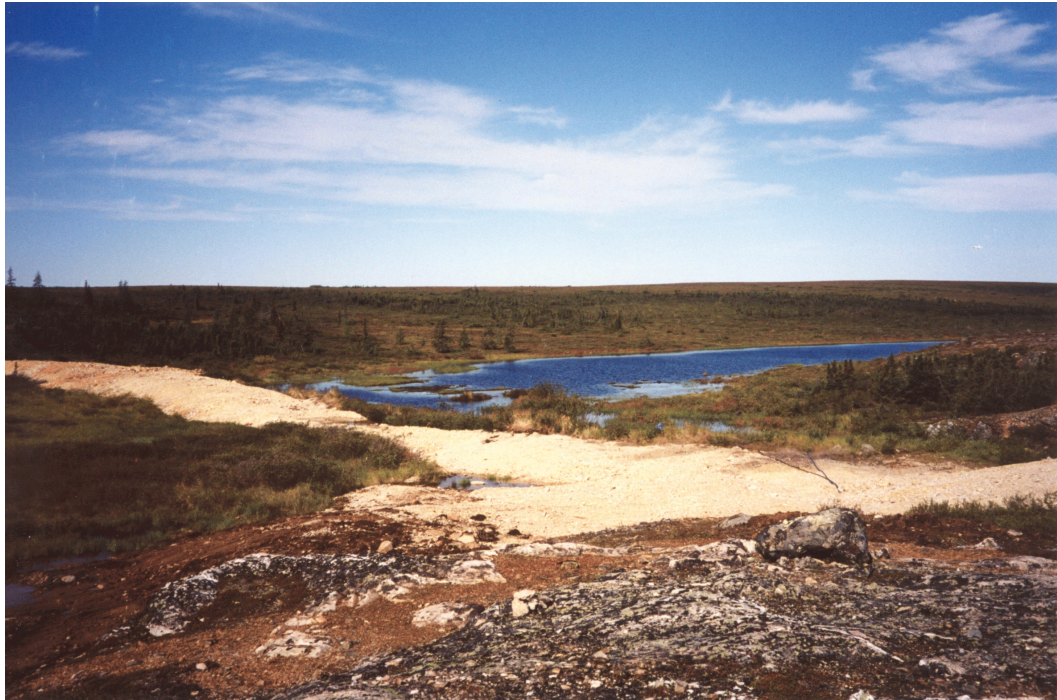
The old gravel dam which separates the Shear Lake and another water body located to the north of the lake (Photos 16 and 17) was not disturbed and remained in similar condition as before. It is understood that the dam was constructed prior to the dewatering activities in 1984.

Photo 16. Old gravel dam separating Shear Lake and another body of water to the north of the Lake. Photo is looking north/northwest.

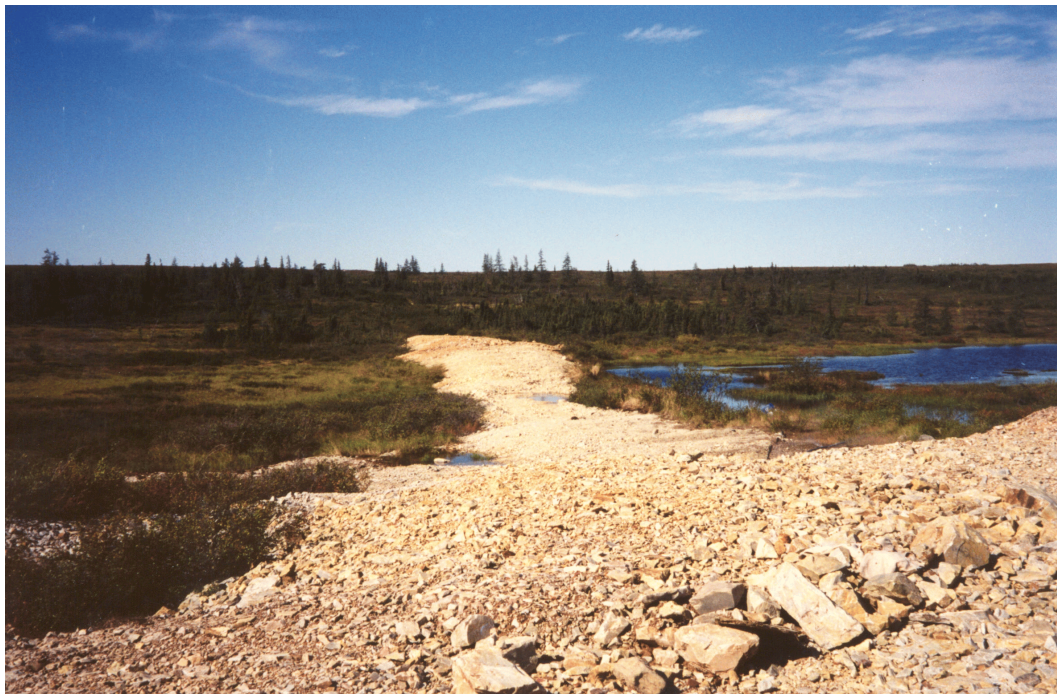
Photo 17. Close up view of the old gravel dam, north of the Shear Lake. This area is located behind the campsite.

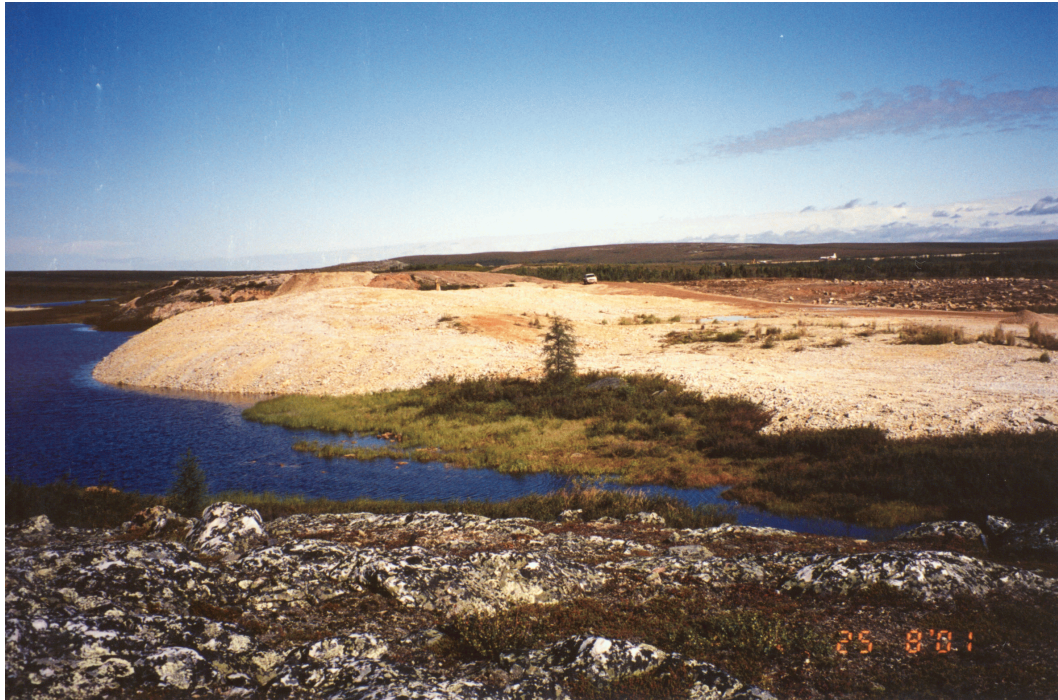
The drainage creek from the lake is shown on Photos 18 to 21 inclusive. The water in the creek crosses the access road through four, 6 in. diameter culvert pipes under the roadway. At the time of the site visit, however, the drainage water overflowed the roadway, as the water level at Shear Lake was relatively higher than normal. The region had experienced some heavy rainfalls prior to the site visit date. Mr. Millward indicated that they plan to retrieve all the culvert pipes under the access road, as they withdraw from the site.

Photo 18. A creek which drains the water from Shear Lake and flows eastward through a series of small lakes until it reaches Kognak River. Old mine portal is in the background. Access road is on the right side. Photo is looking north.

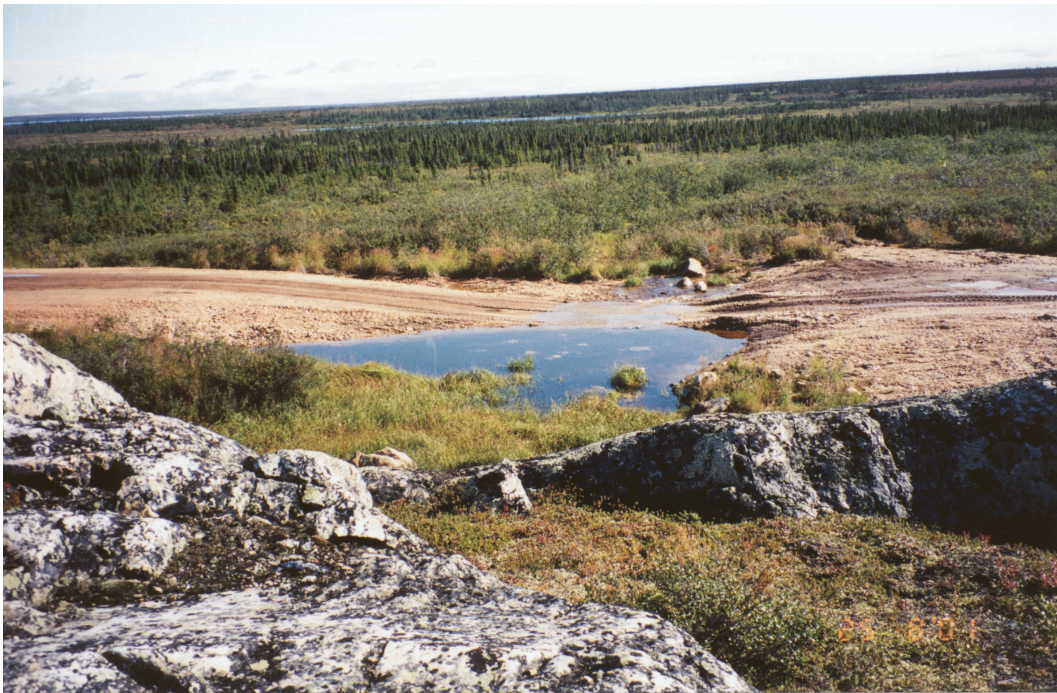
Photo 19. The same creek as in Photo 18 as it crosses the access road. Photo was taken from the rock outcrop located east of the lake and looking east/northeast.

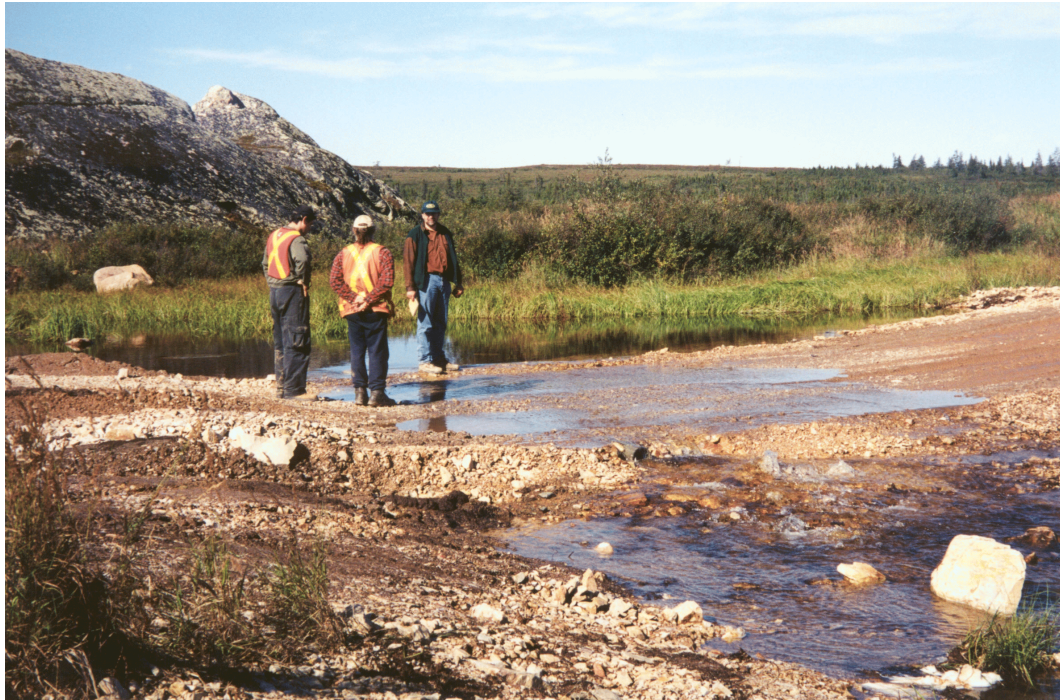
Photo 20. Close up view of the drainage creek from Shear Lake, as it crosses the access road. Photo is looking to the west.

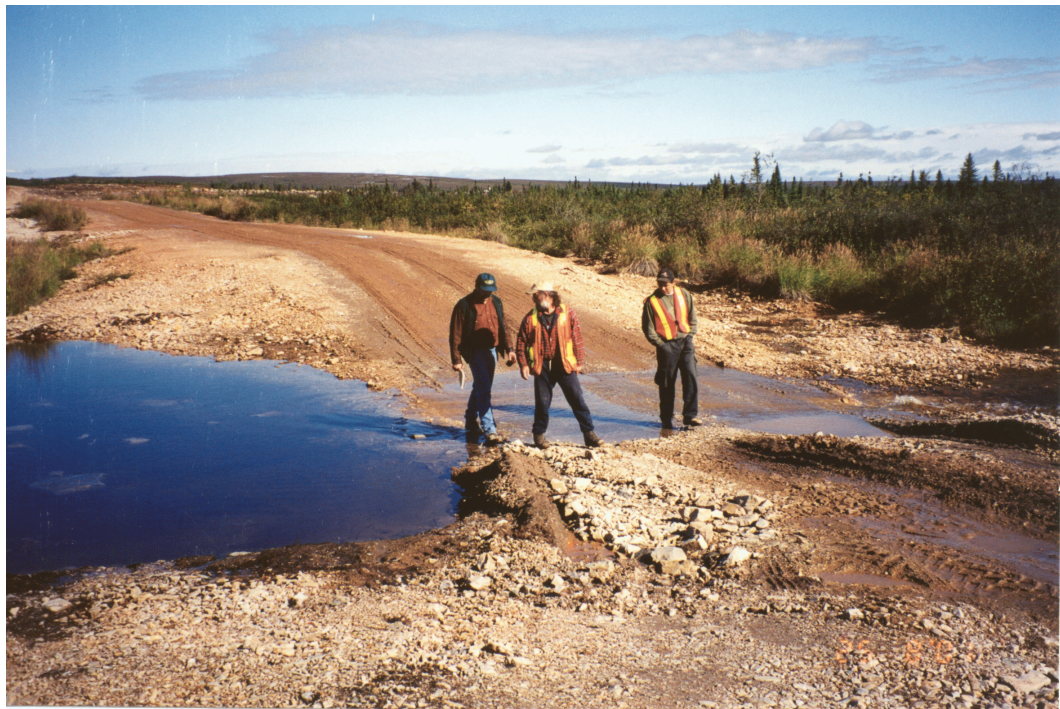
Photo 21. Another view of the creek which crosses the access road. The water level was relatively high due to recent rainfall. Usually water crosses under the access road through three to four 6in. dia. culvert pipes.

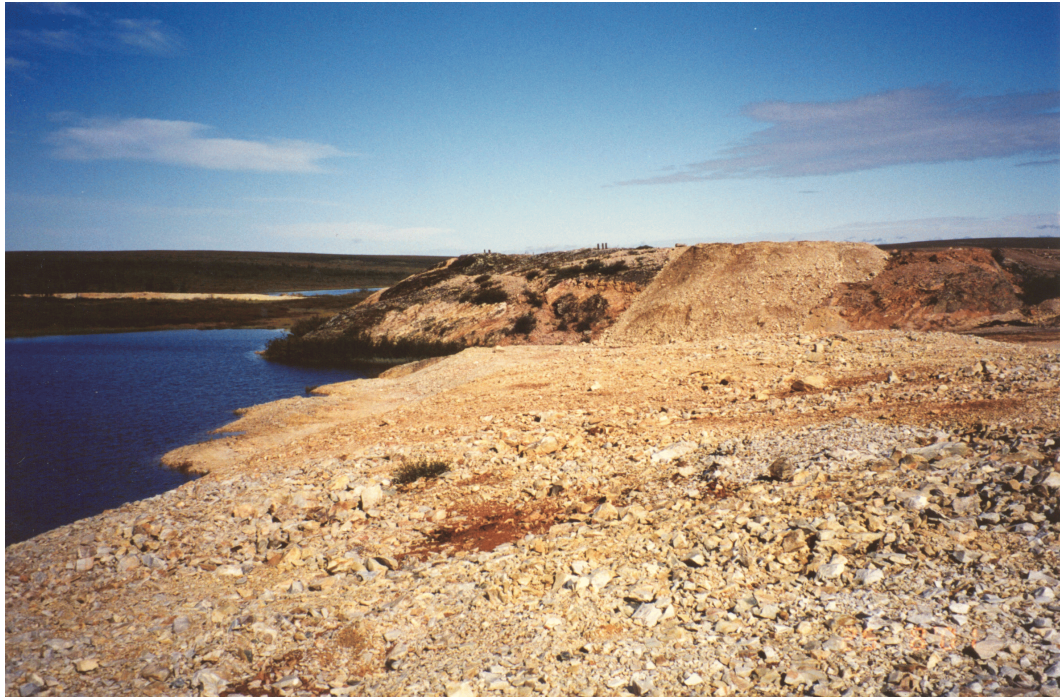
Photo 22. Shear Lake's old mine portal, which has been completely blocked off. Photo is looking north.

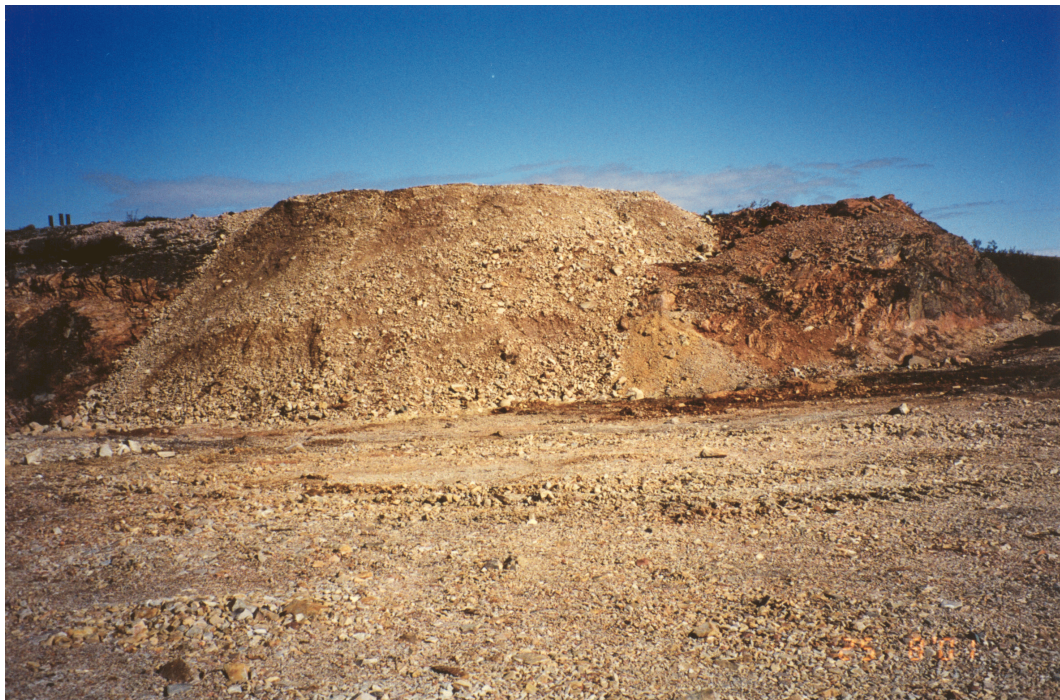
Photo 23. A close up view of the blocked mine portal. The area has been cleaned and contoured. The new capped waste rock pile/berm is located to the north of the mine portal area. Photo is looking north.

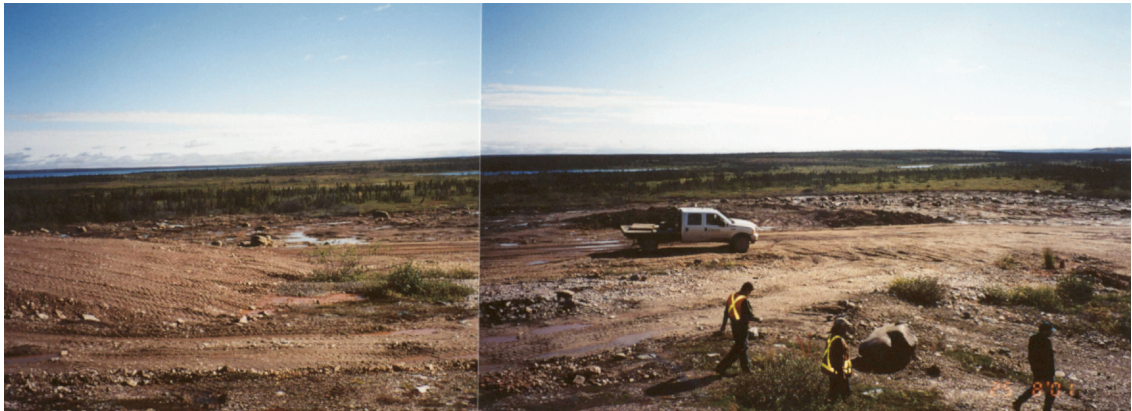
Photo 24. Previous location of waste rock pile (on the other side of the access road). Photo is looking east. The newly constructed capped waste rock pile is located on the left, and west side of the access road.

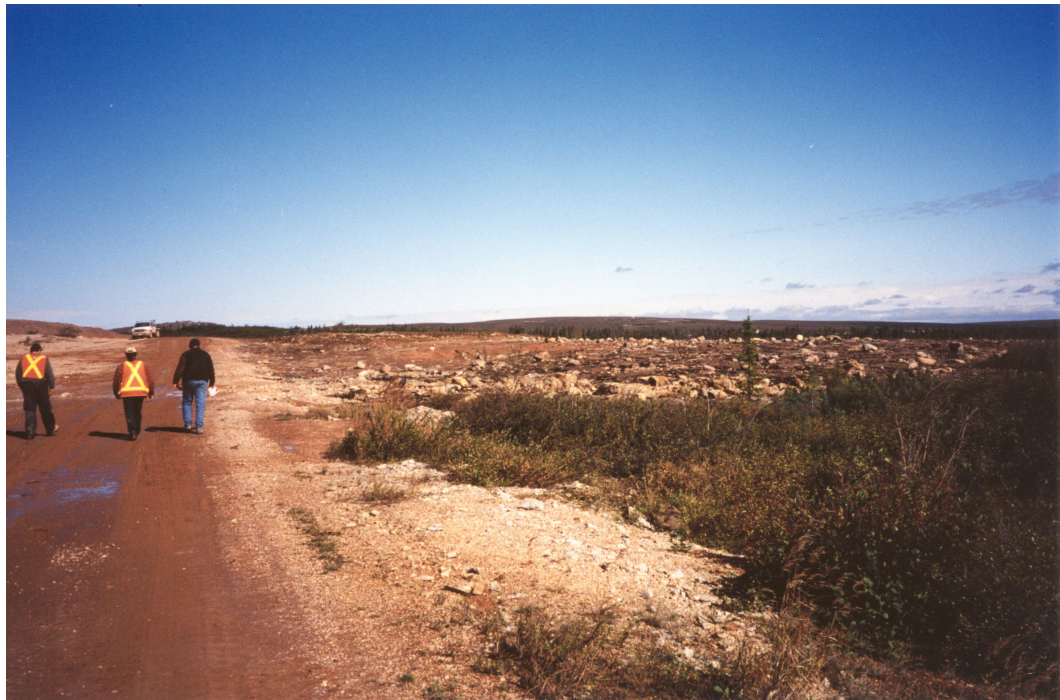
Photo 25. Old waste stock pile (right side - east of the road). Photo is looking north. Waste rock has been removed to the east side of the road. Note that some natural boulders were left at the old site.

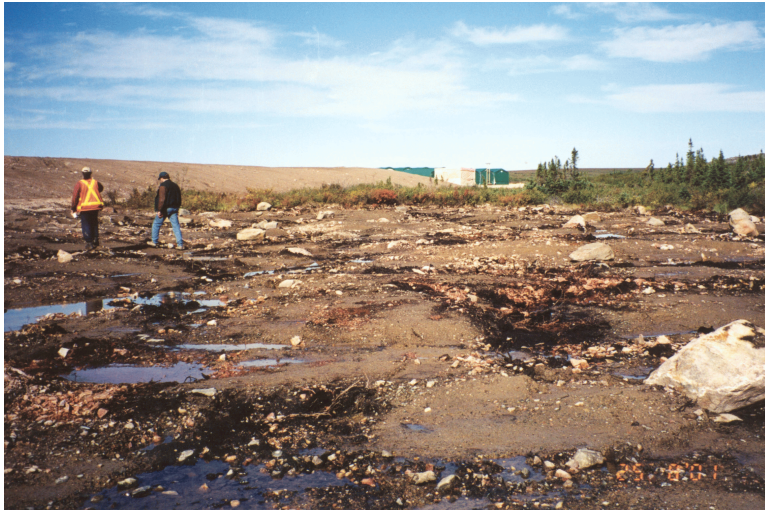
Observations at the location of the old waste stock pile showed that there was no waste rock at depths below the ground surface. Photos 26 to 28 show that a layer of dark peat was encountered at the base of the stockpile at approximately the same level with the original ground surface level in the surrounding area.

Photo 26. Old waste rock area. Photo is looking north/northwest. The newly constructed waste rock pile is on the background left. Camp is located adjacent to and north of the new pile.

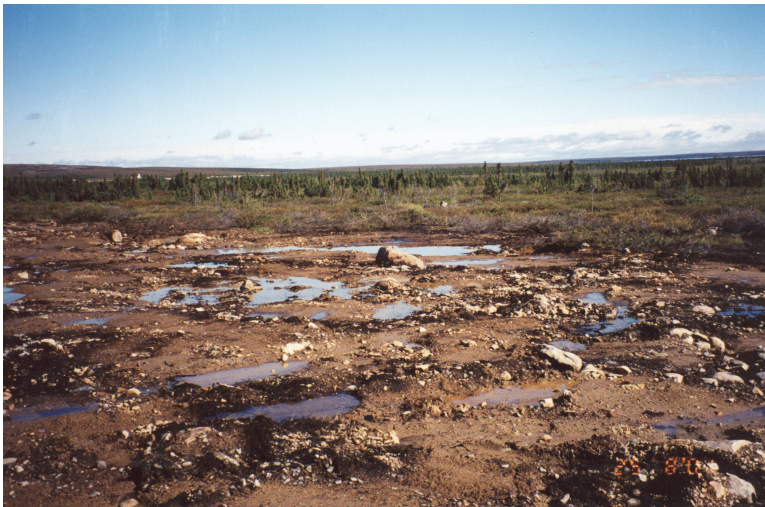
Photo 27. Another view of the old waste rock area. Natural cobbles and boulders were left on side. Photo is looking to the east.

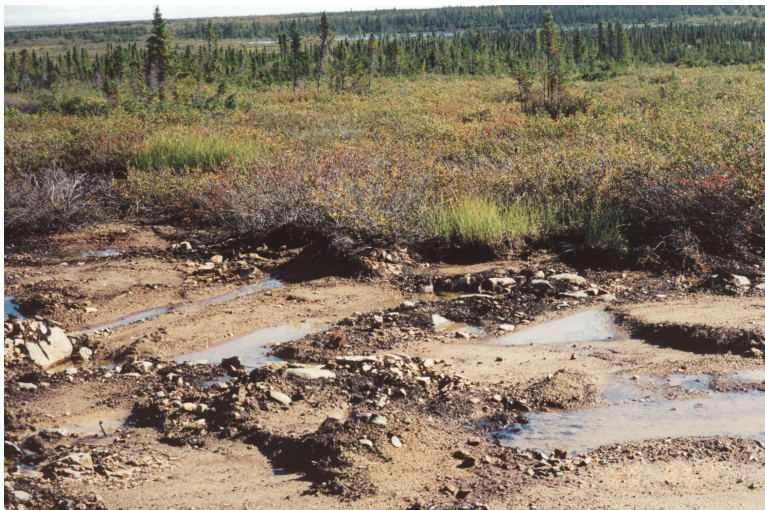
Photo 28. Close up view of the base area where the old waste rock was stockpiled. Notice the dark colour peat layer above the native soil.

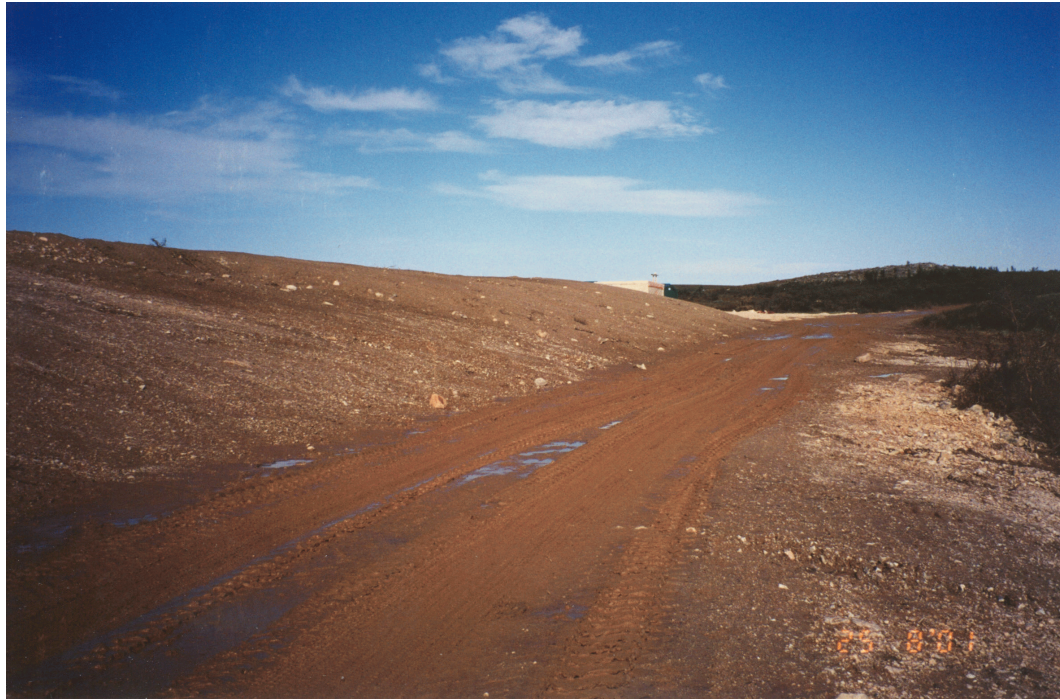
Photo 29. Newly built waste rock pile. The pile was capped with till fill materials. Photo is looking to the north, with access road separating the location of the new and old waste rock stockpiles. Part of the camp can be seen at the middle right side of the photo.

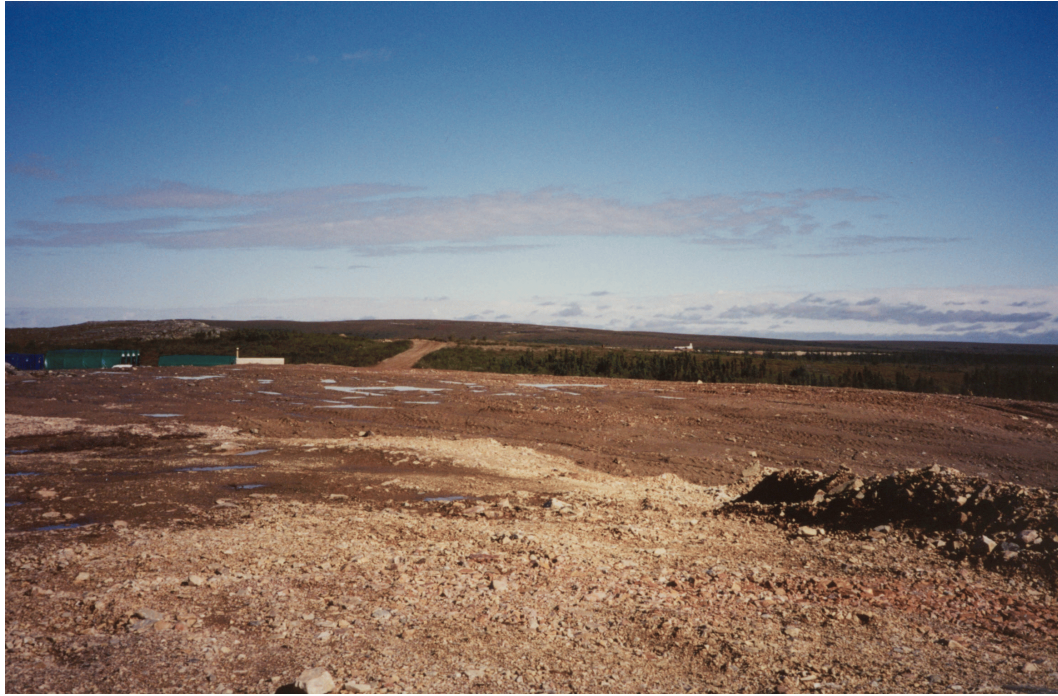
Photo 31. A view of the crest of the capped waste rock pile. Photo is looking to the north/northeast. Notice the contact between the new fill (darker brown) and the rock outcrop in the foreground.

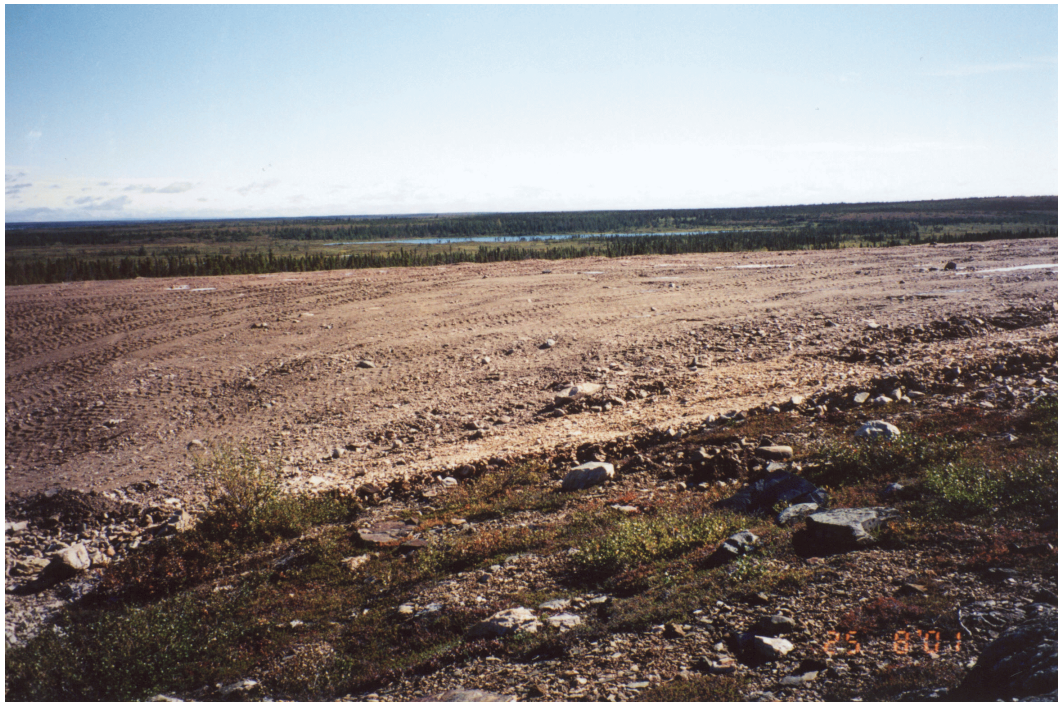
Photo 32. Another close up view of the crest of the new waste rock pile, showing the contact between the fill and the rock outcrop. Photo is looking east.

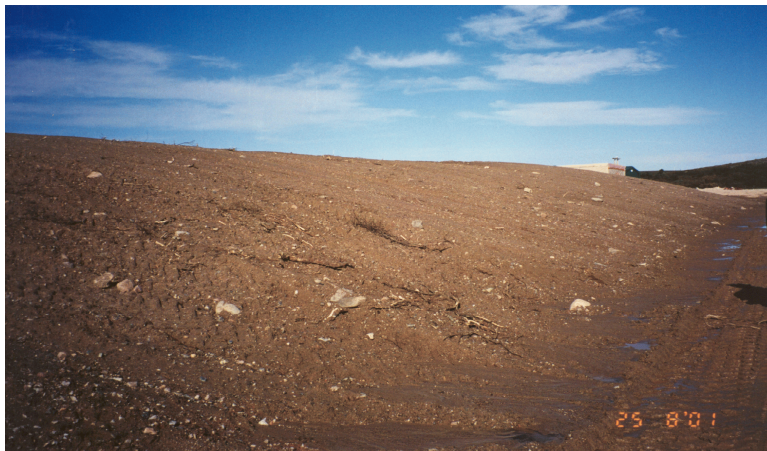
Some minor erosion was noted to have occurred along the side slopes of the finished berm. (Photos 35 and 36). The site of the old waste rock area was cleared, and freed of all waste rock materials. Cobble and boulder size stones were left in the area, so that it would remain to have a natural appearance. Mr. Millward indicated that they might place some patches of grass taken from the surrounding area to facilitate growth of vegetation in the old stock pile area. To confirm that traces of metal or chemical concentrations from the old and new stock piles do not leach into the creek, some chemical test will be required on water samples taken from the lake and the drainage creek areas.

Photo 35. East slope of the new
waste rock pile. Photo shows
the northern portion of the pile,
where capping materials contain
more silt (silt till).

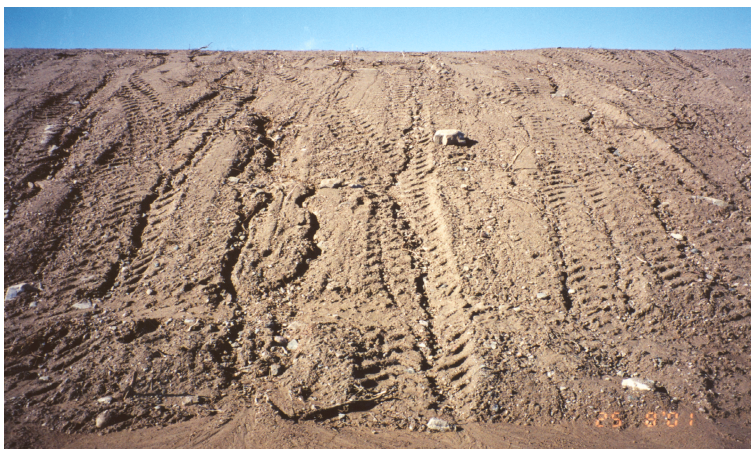
Photo 36. Close up view of the silt
till capping materials. Note the
degree of compaction, and some
erosion from the water runoff.

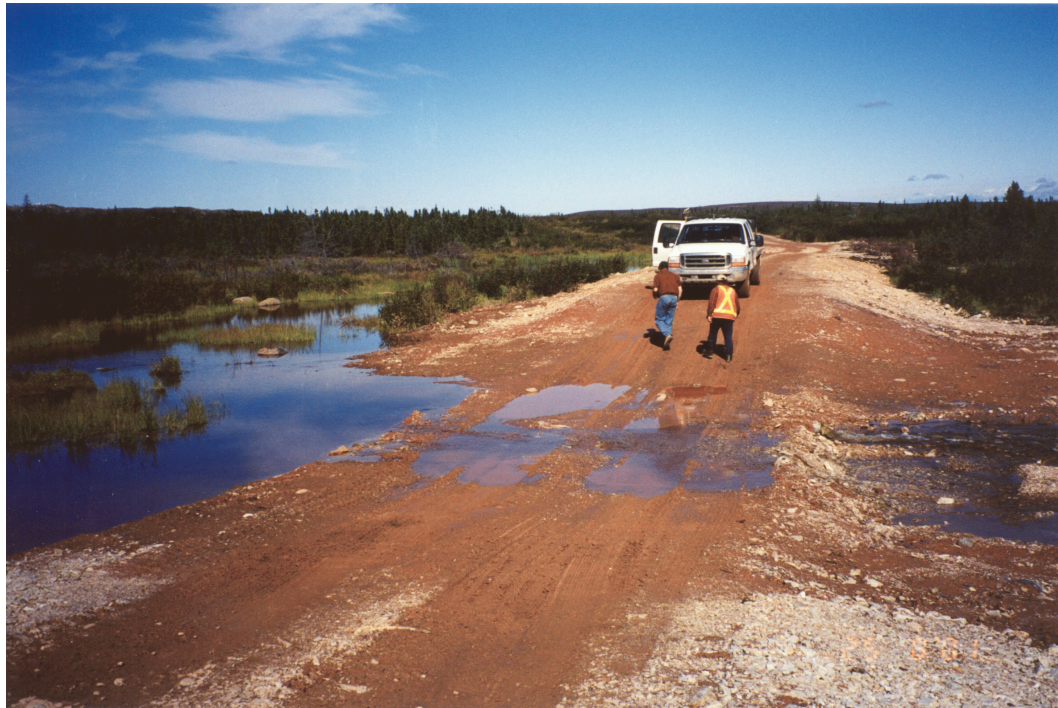
Photo 41. One of the six creek crossings along the access road between Shear Lake and the B-zone mine complex. Water level was relatively high due to recent heavy rainfalls.

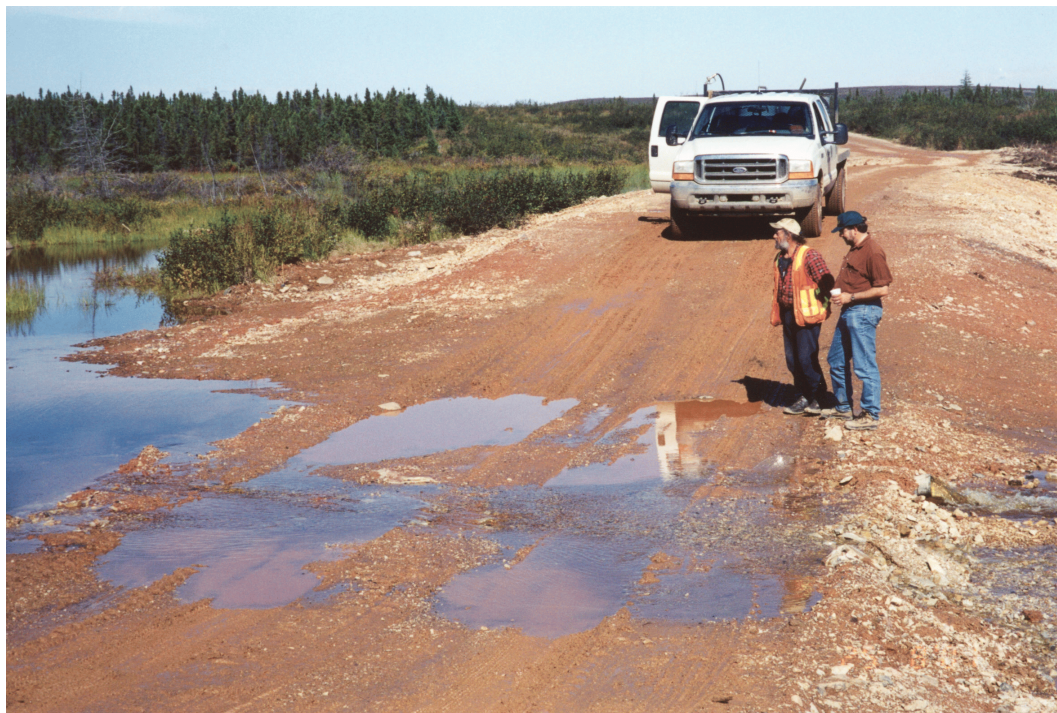
Photo 42. Close up view of the creek crossing. Photo is looking north. Note the existing 6in. dia pipes under the road (generally 3 to 4 culvert pipes per road crossing).

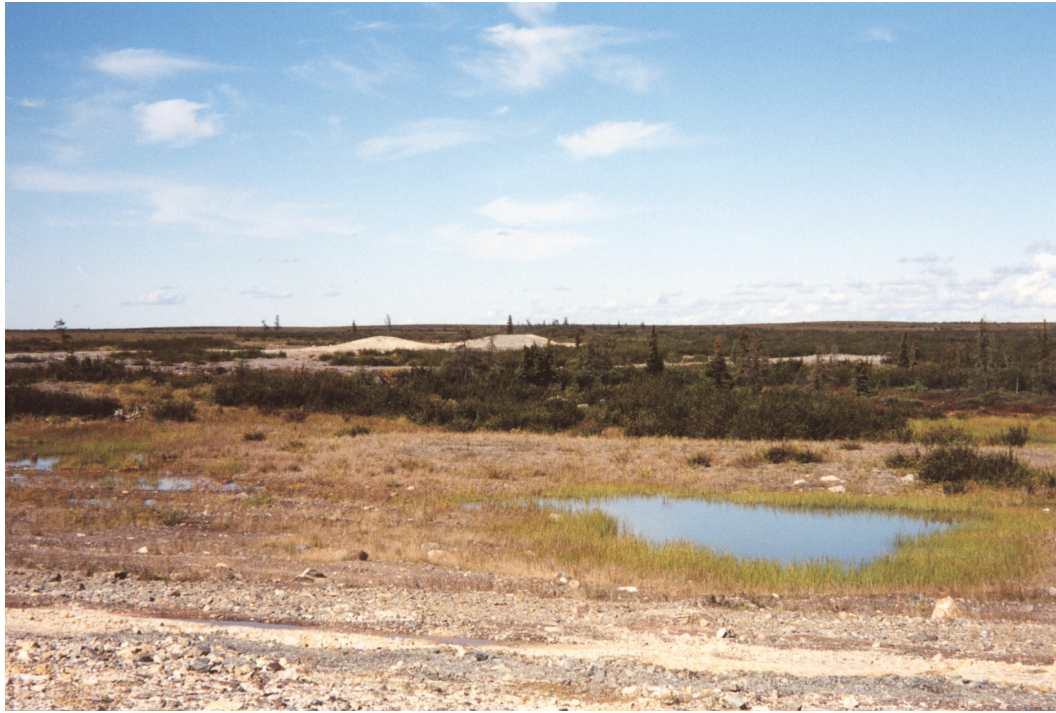
fill materials. All that remain are the two granular mounds where these two structures were formerly located (Photos 43 and 44). Other structures, such as the concrete pads and footings, remnants of buildings, waste materials (such as old tanks, machinery parts, etc) had all been cleared from the site. Mr. Millward mentioned that the concrete pads and footings, old tanks, etc were broken apart or cut into pieces and buried in the quarry pit.

Photo 43. Two “berms” where the B-zone mine’s portal (left) and ventilation outlet (right) used to be located. Photo was taken from Tailings Pond No.1 area, looking west.

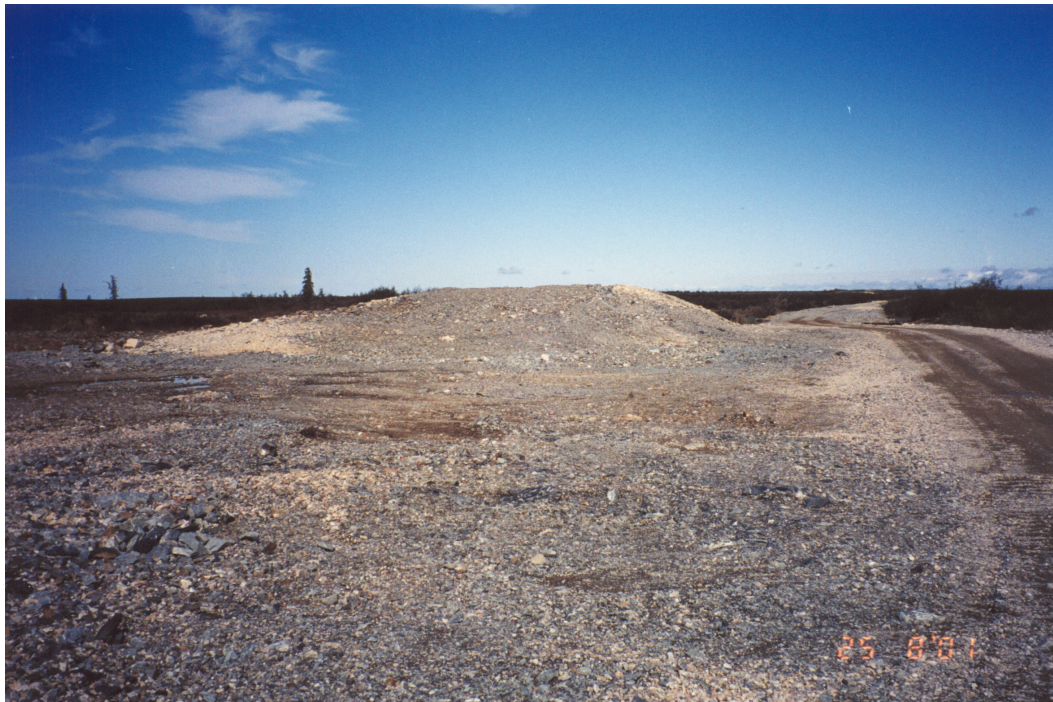
Photo 44. Close up view of one of the two “berms”. The ventilation outlet has been blocked, backfilled with granular materials and contoured.
