Nunavut Water Board

Notes of Site Visit Cullaton Lake Property, Nunavut August 24, 2001

September, 2001

**Acres International Limited
Winnipeg, Manitoba**

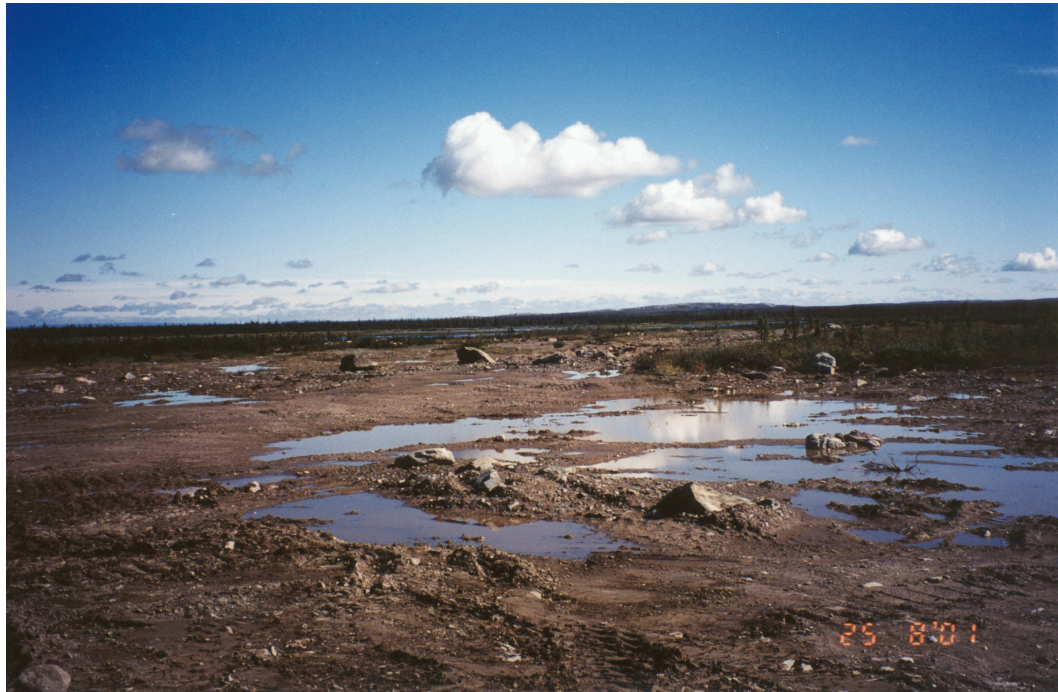
Photo 50. General view of the area located south of the Quarry Pit. Photo is looking southeast. The area was generally clear and free from debris.

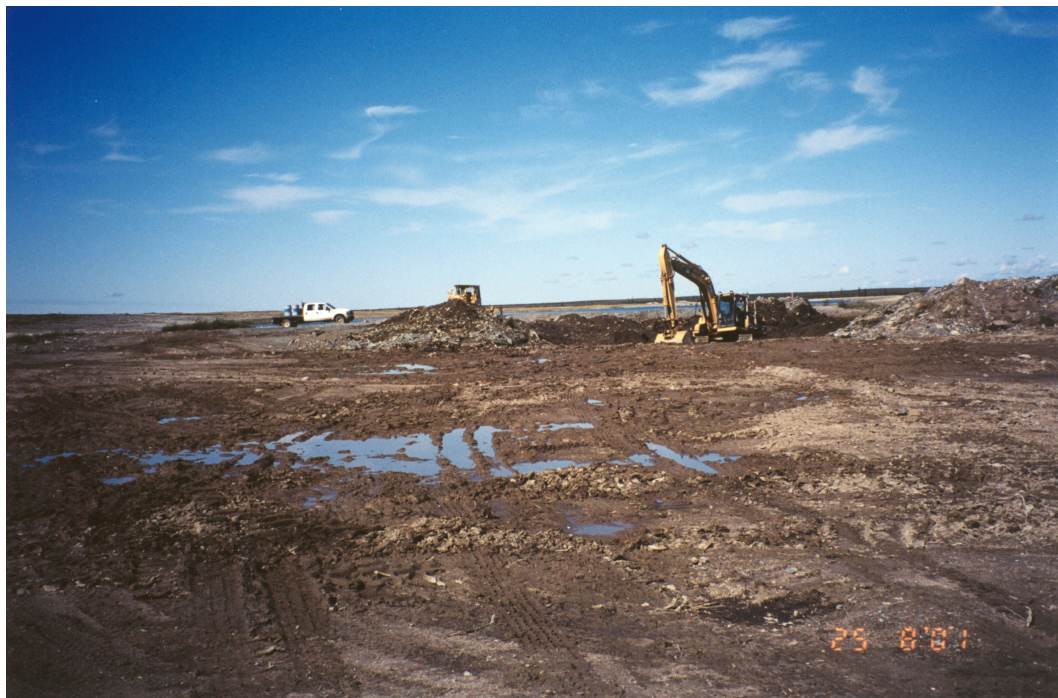
Photo 51. A portion of the Quarry Pit was used to bury crushed, inert waste materials, such as concrete rubble, steel plates, steel structures, etc. The backhoe was utilized to bury the last pieces of waste materials : an old bus and a burn box.

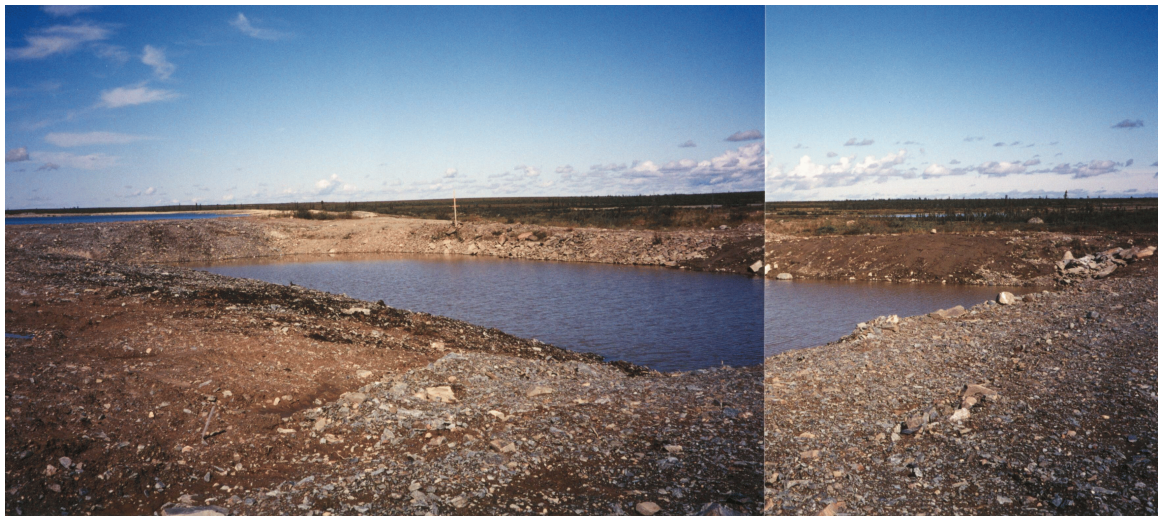
Photo 53. A close up view of the Quarry Pit pond. Notice the work to tidy up the side slopes of the pond. Photo is looking north/northeast. Tailings Ponds No. 1 and No. 2 are on the horizon (Pond No. 1 - left, Pond No. 2 - right)

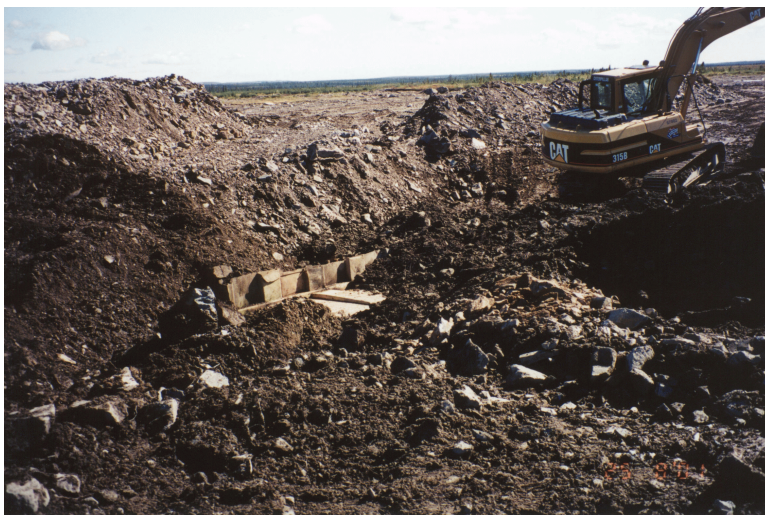
Photo 55. Close up of the burn box, buried in the Quarry Pit. The area would be tidied up and grass seeded.

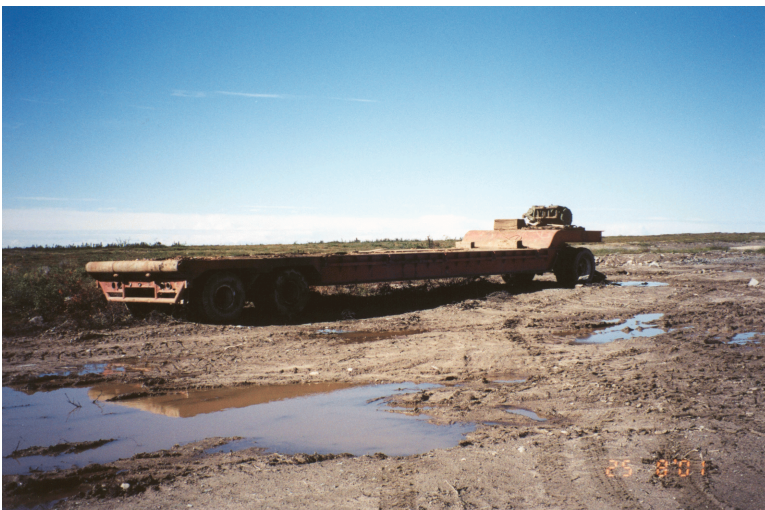
Photo 56. A flat bed left at the Quarry Pit area. It will be hauled to the airstrip and removed from the site as part of the demobilization.

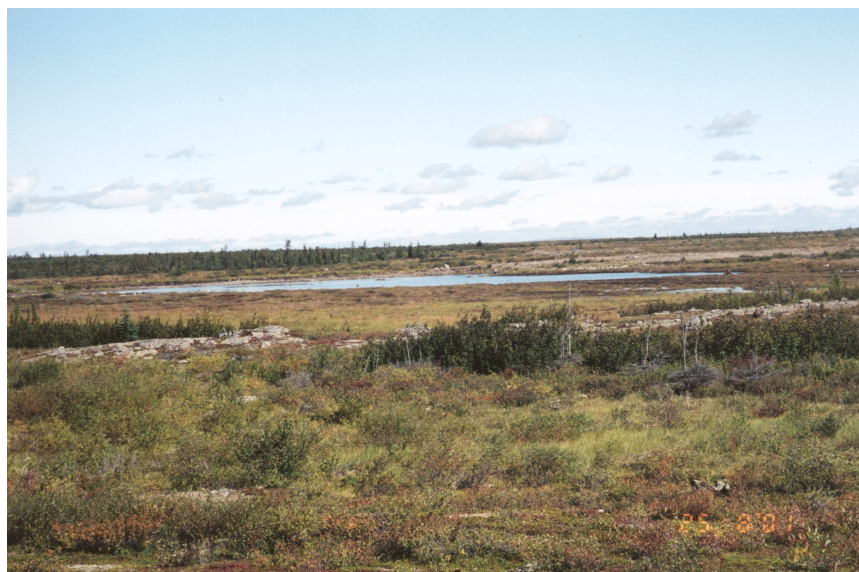
A site visit was not carried out to the Tailings Pond No. 2 area (Photo 59) because of limited time. In addition, recent heavy rainfalls had made any vehicle access difficult, and may have lead to further damage to the area. There is no reclamation work carried out in this area for the 2001 program. As part of the water license requirements which were regulated by NWB, Trow Consulting Engineers, which is the geotechnical consultant to Homestake had carried out a dam inspection earlier this year.

Photo 59. Tailings Pond No. 2 area, taken from an area between Pond No. 1 and the Quarry Pit pond.

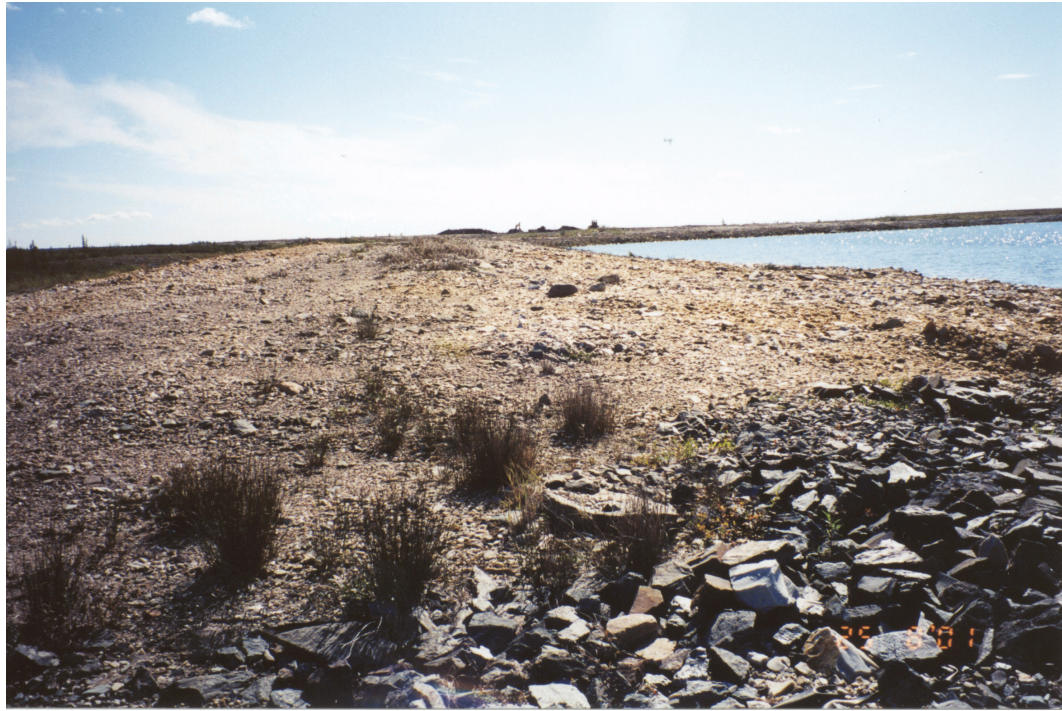
The condition of the dam at Tailings Pond No. 1 was generally satisfactory. The dam has a wide crest, and has a relatively flat downstream slope. Occasional areas of grass and weeds grow along the crest and downstream slope of the dam. It was observed that the pond appeared to have adequate freeboard. No sign of distress, slumping or stability problems were observed along the dam. No seepage nor erosion were noticeable during the site visit. The downstream toe area of the pond showed some depressions filled with water, but no seepage was evident in these areas. These water puddles were assumed to be formed from recent rainfalls in the area. Photos 57 to 68 were taken in the tailings pond area.

Photo 60. Typical crest of the Tailings Pond No. 1 dam. Photo is looking south, from northwest corner of the pond.

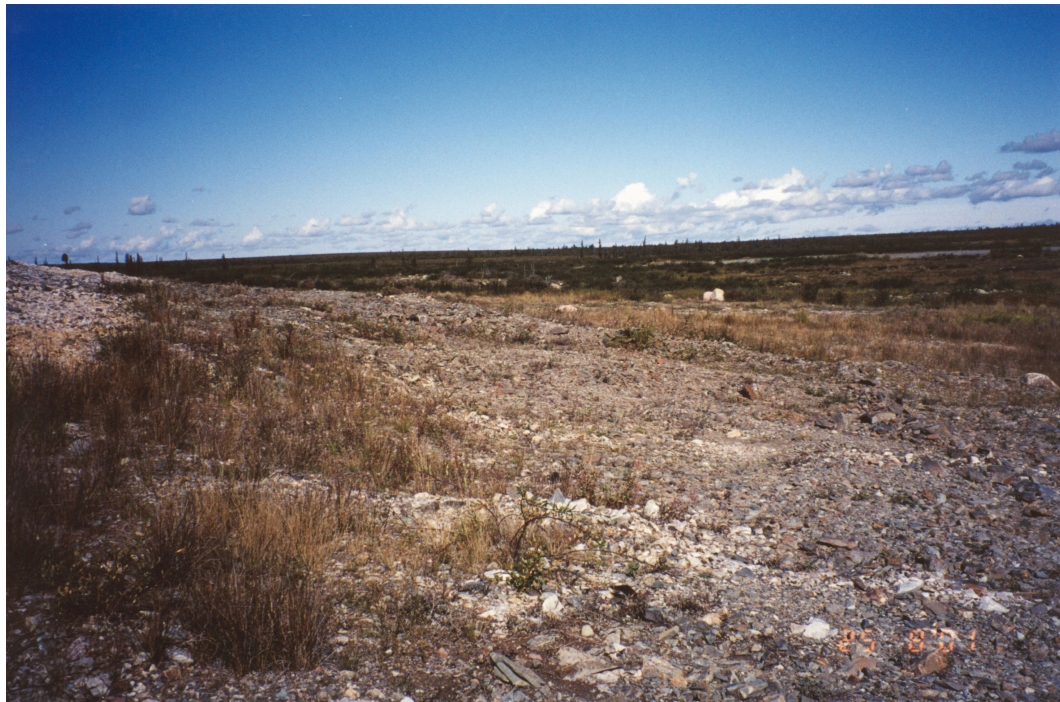
Photo 61. Downstream slope of Tailings Pond No. 1 dam along the south end of the pond. Photo is looking north and Tailings Pond No. 2 is on the right.

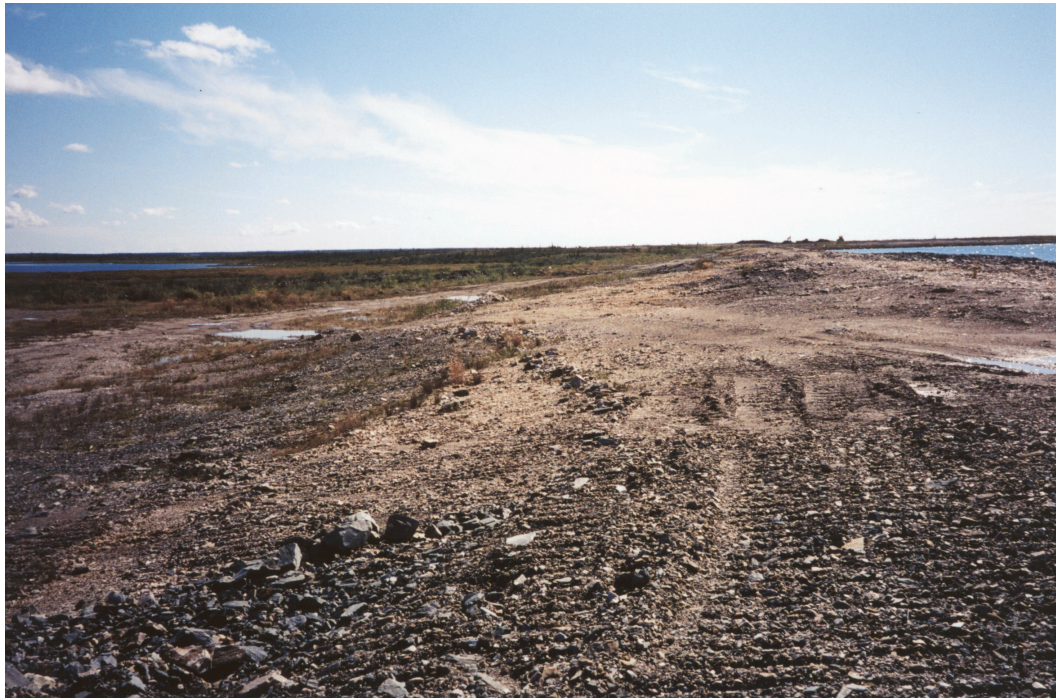
Photo 62. Downstream slope of Tailings Pond No. 1 dam. Water puddles were from recent rainfall.

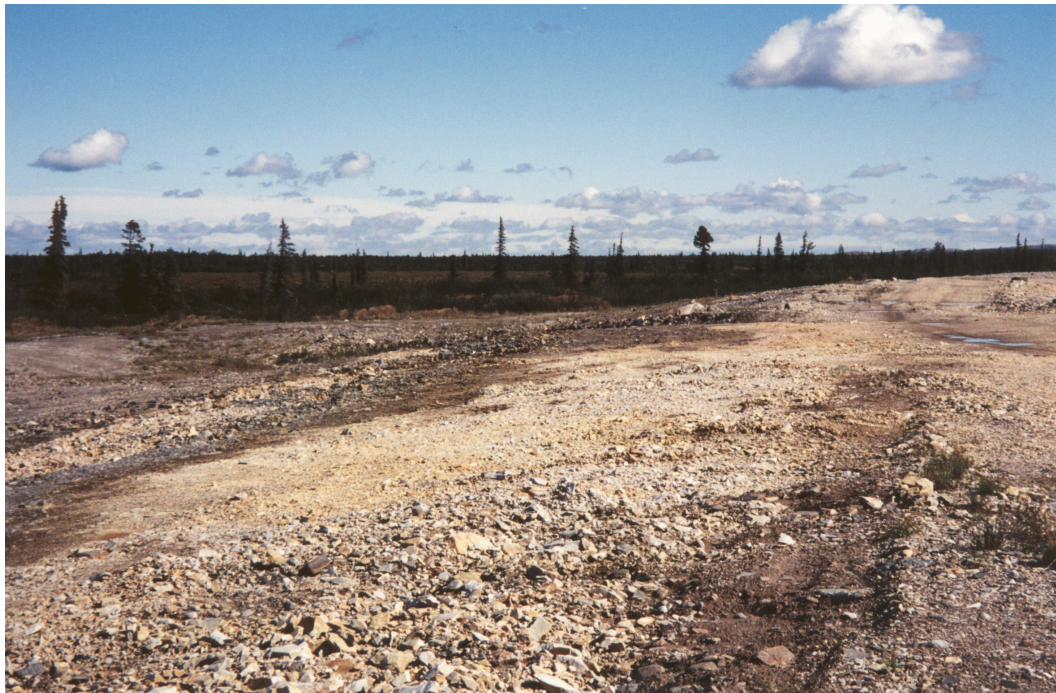
Photo 63. Another view of the downstream slope of Tailings pond No.1 dam. The crest of the dam was generally wide, and the downstream slope was relatively flat.

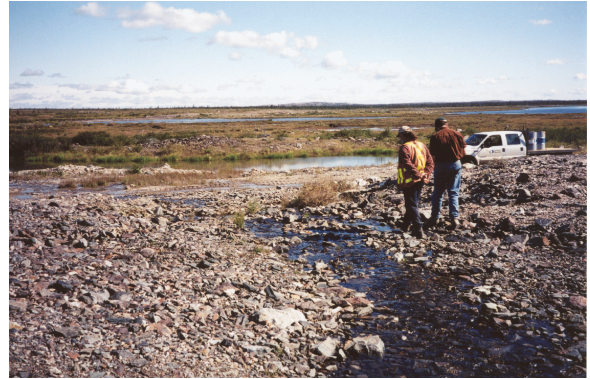
Photos 64 to 68 show the spillway conditions at Tailings Pond No. 1. Water was flowing through the spillway at the time of the site visit. The steel weir which had previously been placed at the downstream end of the spillway had been removed. Some exposed geomembrane was still visible in this area (Photo 68), and Homestake stated that they plan to cover the geomembrane before they move off the site.

Photo 65. Spillway channel. Photo is looking downstream.

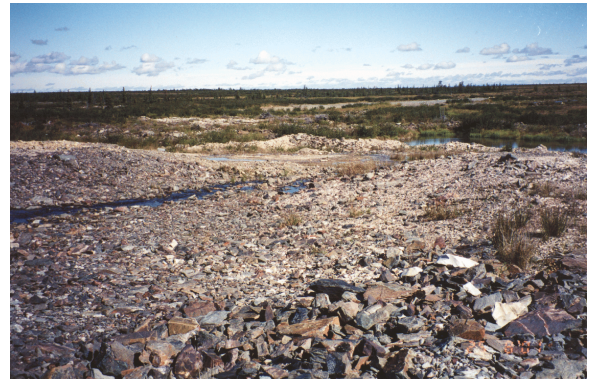
Photo 67. Another view of the spillway channel, looking downstream.

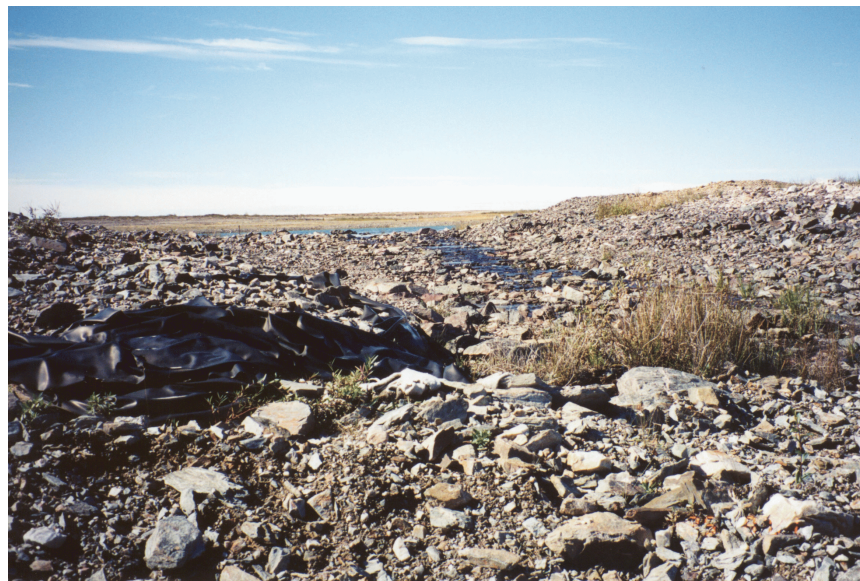
Photo 68. Spillway channel. Photo is looking upstream, showing water flow from the pond. Note the exposed piece of geomembrane. The steel weir formerly located in this area had been removed.
