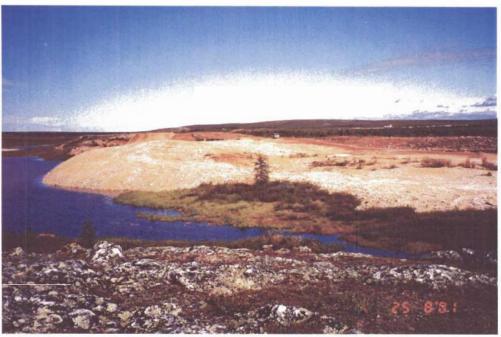
Photo 18. A creek which drains the water from Shear Lake and flows eastward through a series of small lakes until it reaches Kognak River. Old mine portal is in the background. Access road is on the right side. Photo is looking north.

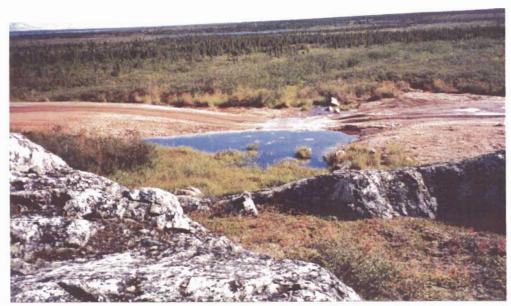
Photo 19. The same creek as in Photo 18 as it crosses the access road. Photo was taken from the rock outcrop located east of the lake and looking east/northeast.

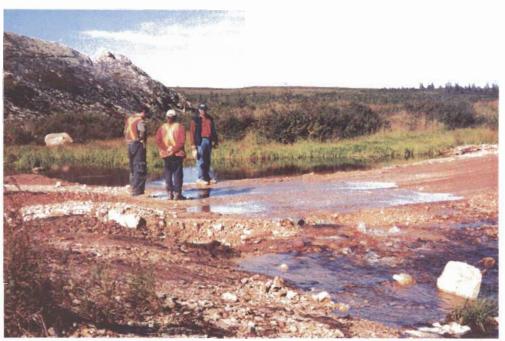
Photo 20. Close up view of the drainage creek from Shear Lake, as it crosses the access road. Photo is looking to the west.

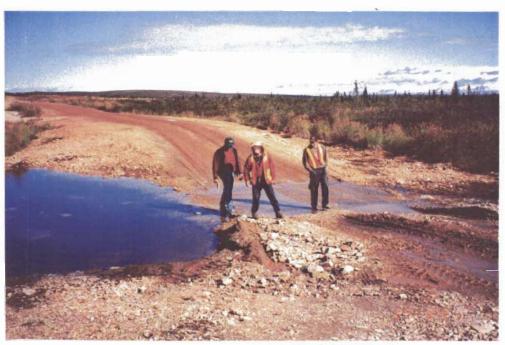
Photo 21. Another view of the creek which crosses the access road. The water level was relatively high due to recent rainfall. Usually water crosses under the access road through three to four 6in. dia. culvert pipes.

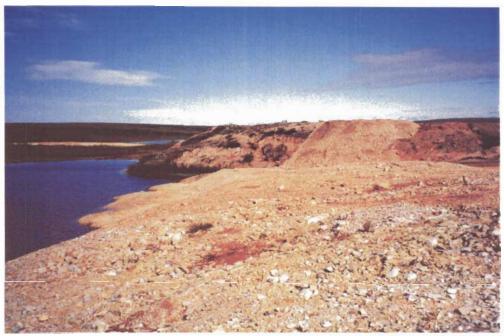
Photo 22. Shear Lake's old mine portal, which has been completely blocked off. Photo is looking north.

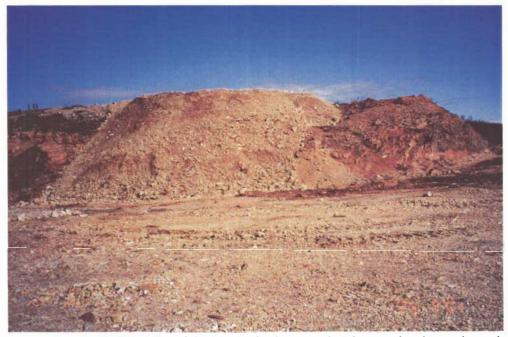
Photo 23. A close up view of the blocked mine portal. The area has been cleaned and contoured. The new capped waste rock pile/berm is located to the north of the mine portal area. Photo is looking north.

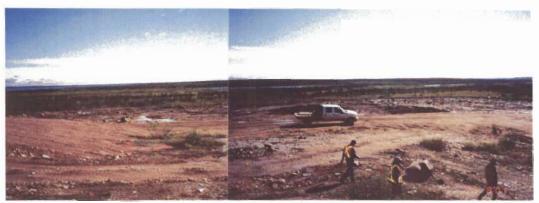
Photo 24. Previous location of waste rock pile (on the other side of the access road). Photo is looking east. The newly constructed capped waste rock pile is located on the left, and west side of the access road.

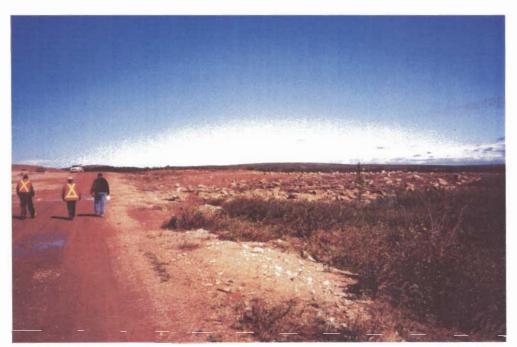
Photo 25. Old waste stock pile (right side - east of the road). Photo is looking north. Waste rock has been removed to the east side of the road. Note that some natural boulders were left at the old site.

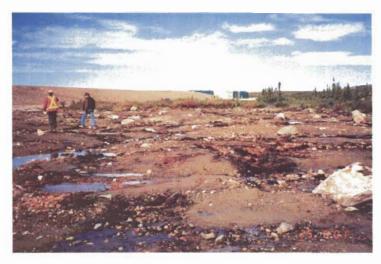
Photo 26. Old waste rock area. Photo is looking north/northwest. The newly constructed waste rock pile is on the background left. Camp is located adjacent to and north of the new pile.

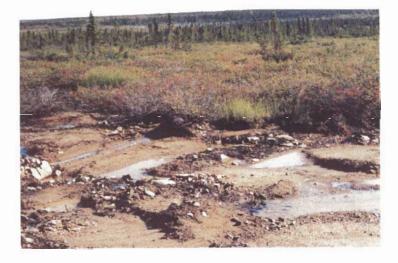
Photo 28. Close up view of the base area where the old waste rock was stockpiled. Notice the dark colour peat layer above the native soil.

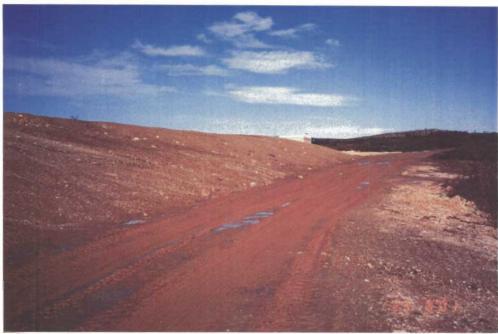
Photo 29. Newly built waste rock pile. The pile was capped with till fill materials. Photo is looking to the north, with access road separating the location of the new and old waste rock stockpiles. Part of the camp can be seen at the middle right side of the photo.

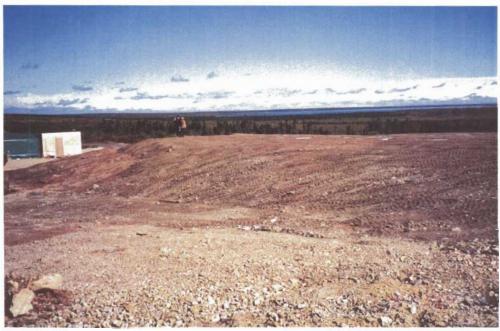
Photo 30. New waste rock pile. Photo is looking east/northeast. Note one of the living quarters at the campsite (white structure).

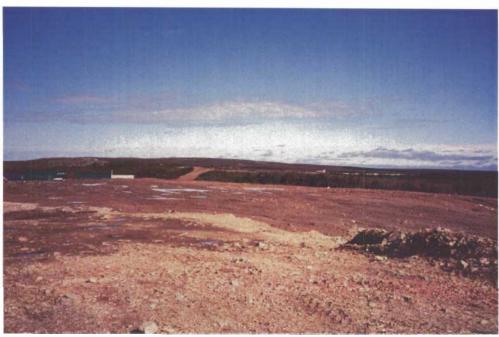
Photo 31. A view of the crest of the capped waste rock pile. Photo is looking to the north/northeast. Notice the contact between the new fill (darker brown) and the rock outcrop in the foreground.

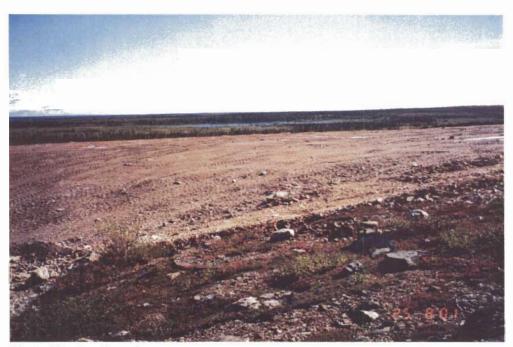
Photo 32. Another close up view of the crest of the new waste rock pile, showing the contact between the fill and the rock outcrop. Photo is looking east.
