Nunavut Water Board

Cullaton Lake Property - B-zone Mine and Mill Complex Area

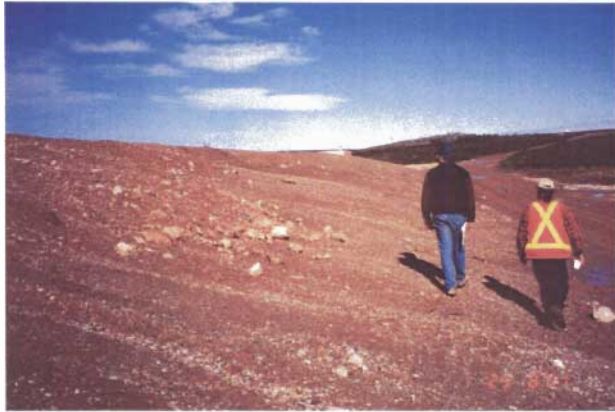
Photo 33. East slope of the new waste rock pile. Photo is looking north.

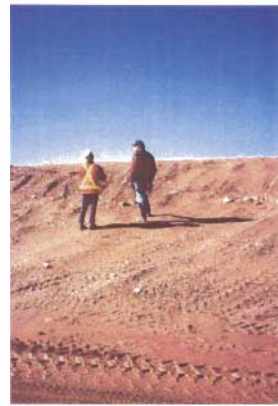
Photo 34. Another view of the east slope of the new pile.

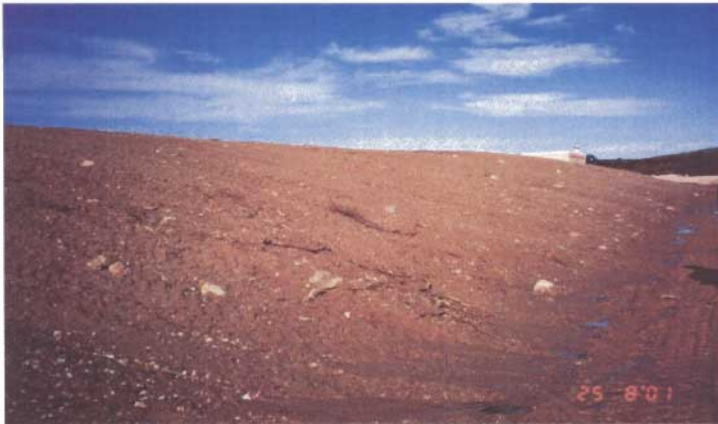
Photo 35. East slope of the new waste rock pile. Photo shows the northern portion of the pile, where capping materials contain more silt (silt till).

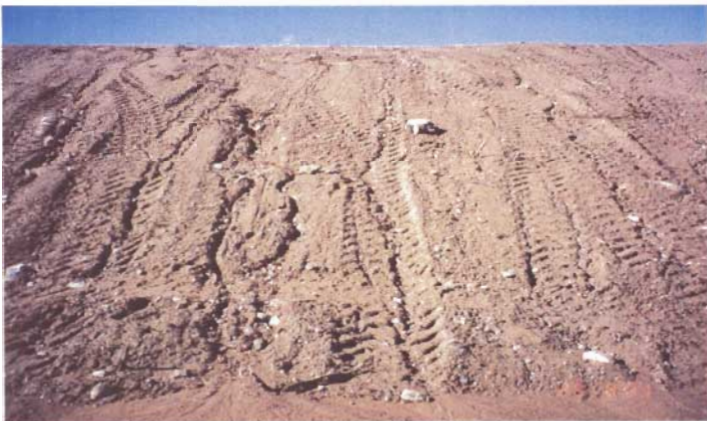
Photo 36. Close up view of the silt till capping materials. Note the degree of compaction, and some erosion from the water runoff.

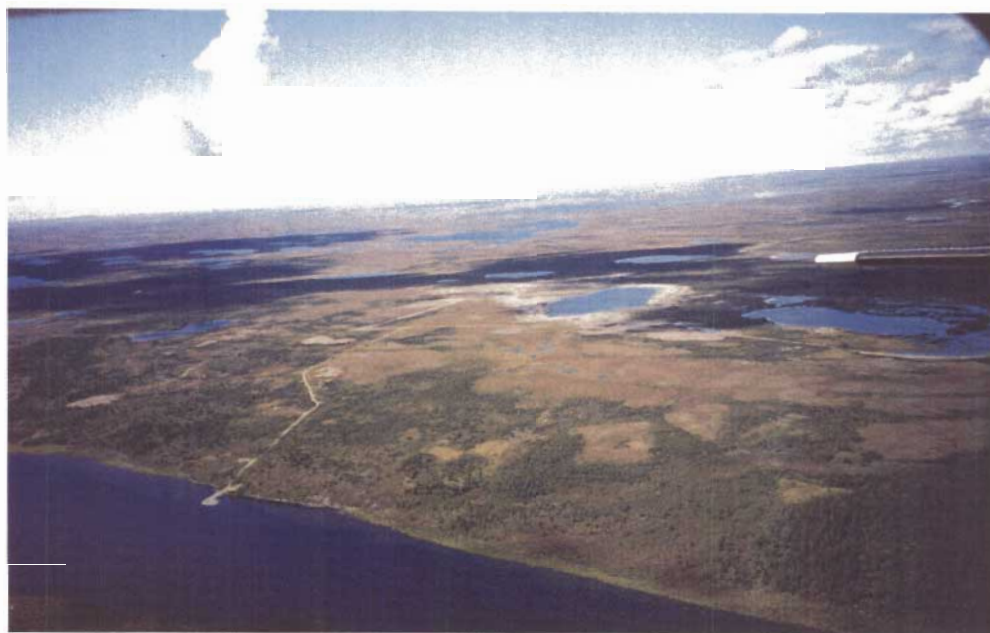
Photo 37. Aerial view of the B-zone mine and mill complex. Tailings Pond No. 1 is in the centre, and Tailing Ponds No. 2 on the centre right corner. Kognak River is on the bottom left corner. Photo is looking north to northwest.

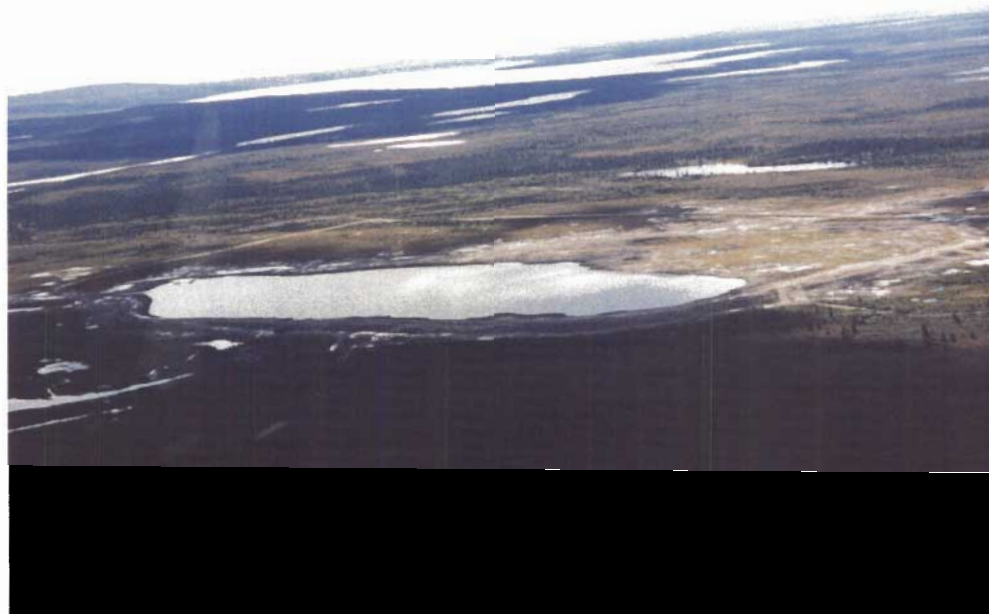
Photo 38. Aerial view of Tailings Pond No. 1. Photo is looking south /southwest. The main B-zone mine complex is located on centre right of the photo.

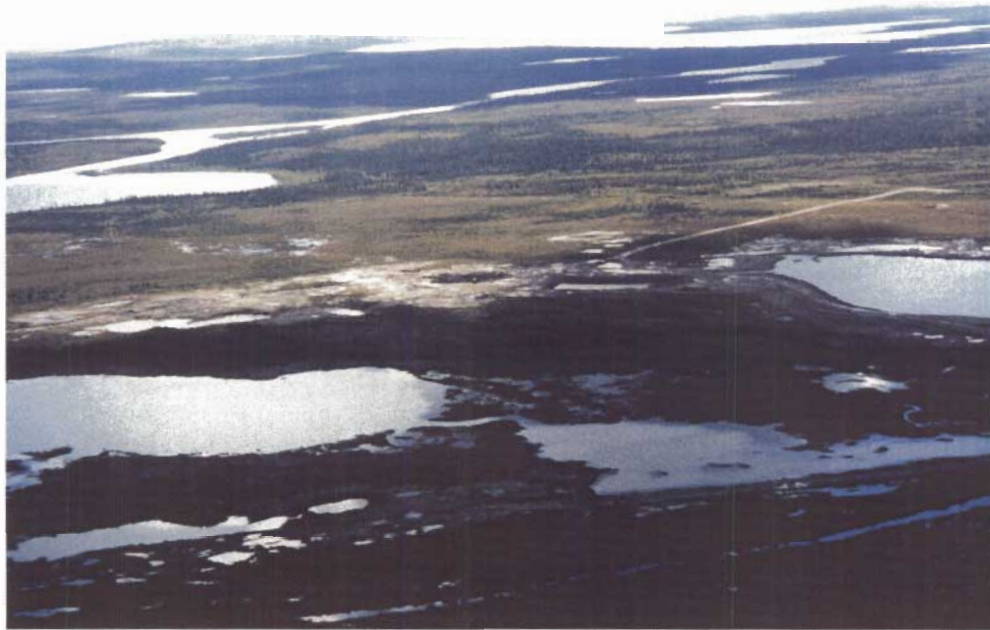
Photo 39. Aerial view of the Quarry Pit area (centre), with part of the Tailings Pond No. 1 (centre-right), and Tailing Ponds No. 2 (bottom). Kognak River is running across on top of the photo. Photo is looking southwest.

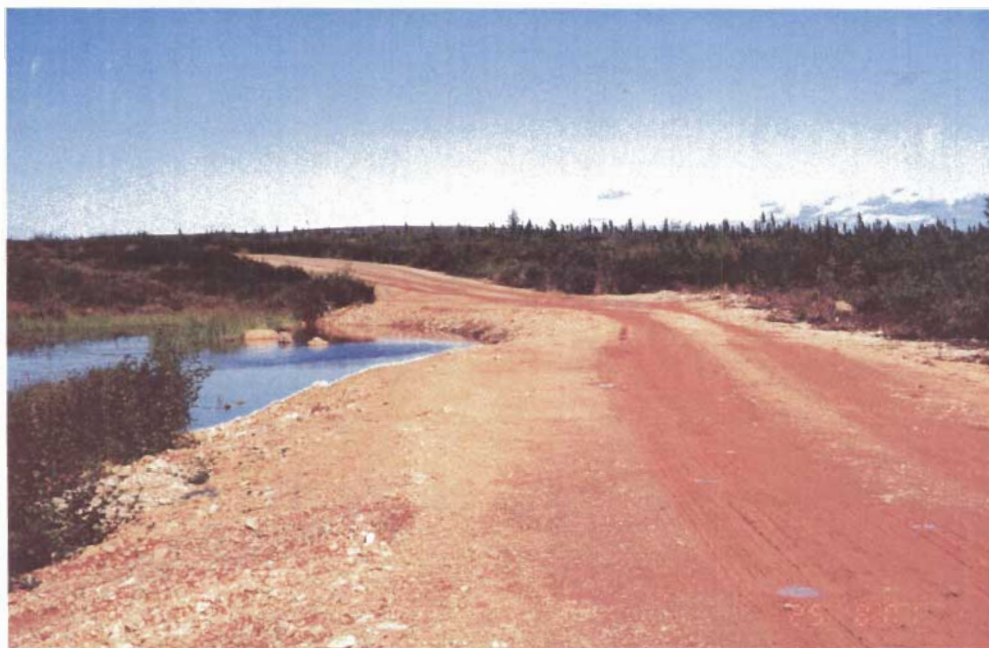
Photo 40. Typical photo of the access road connecting the airstrip, Shear Lake , and the B-zone main mine complex.

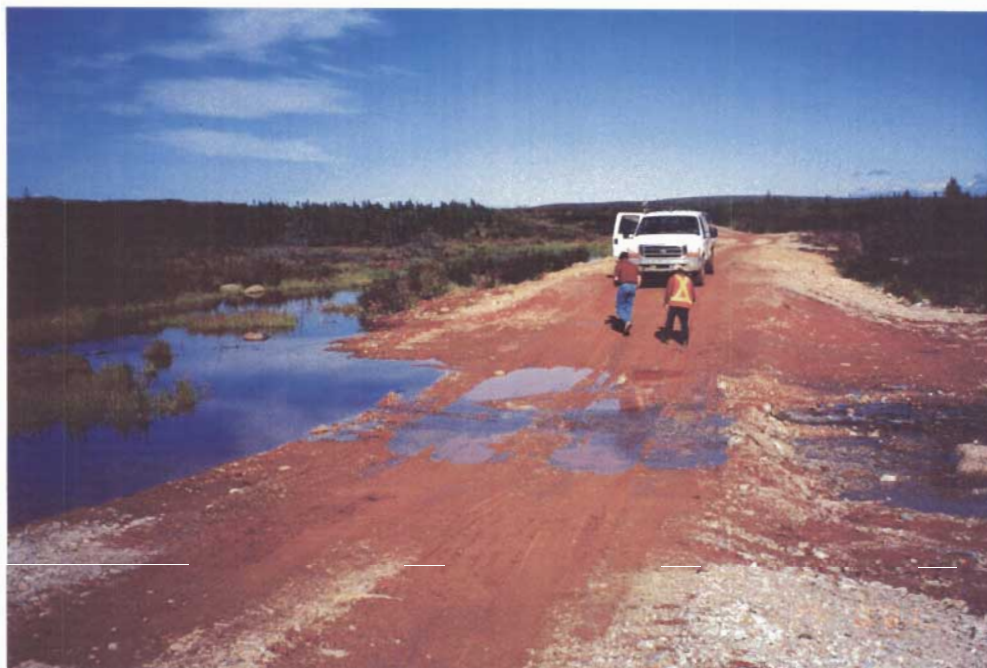
Photo 41. One of the six creek crossings along the access road between Shear Lake and the B-zone mine complex. Water level was relatively high due to recent heavy rainfalls.

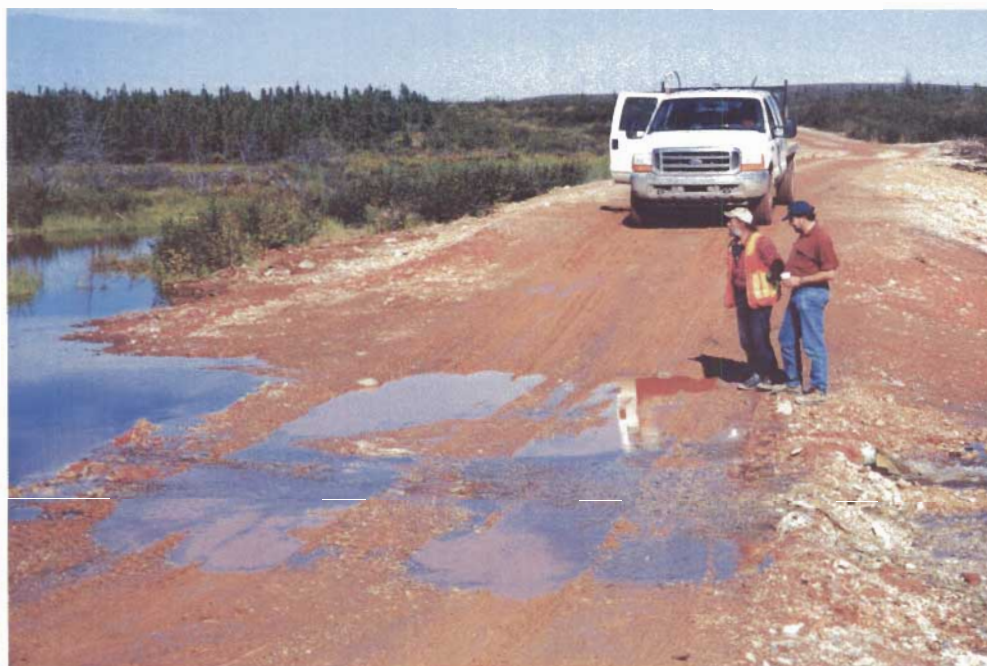
Photo 42. Close up view of the creek crossing. Photo is looking north. Note the existing 6in. dia pipes under the road (generally 3 to 4 culvert pipes per road crossing).

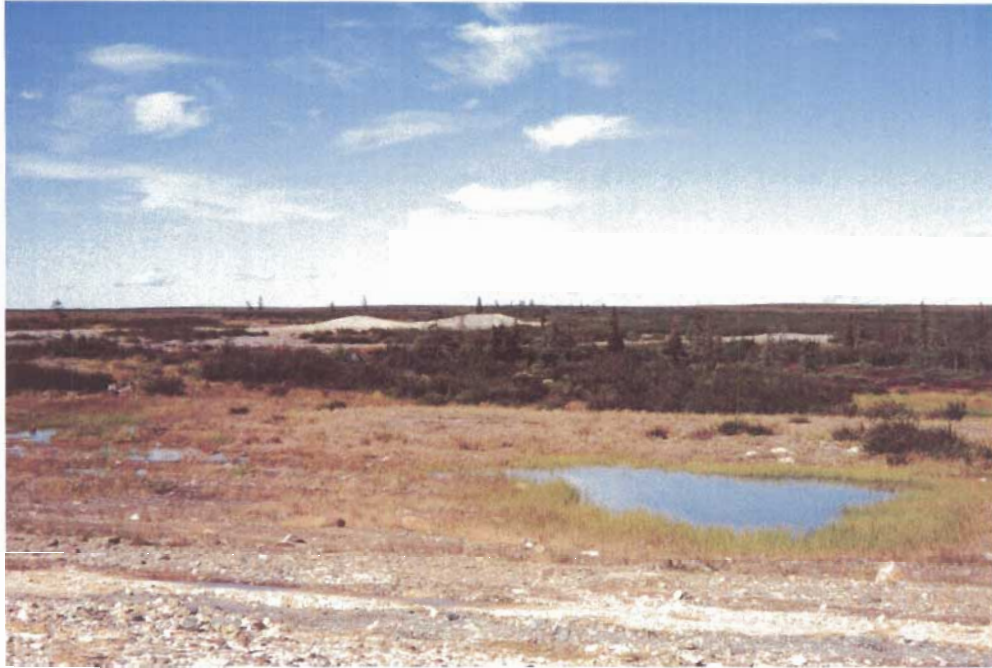
Photo 43. Two “berms” where the B-zone mine’s portal (left) and ventilation outlet (right) used to be located. Photo was taken from Tailings Pond No.1 area, looking west.

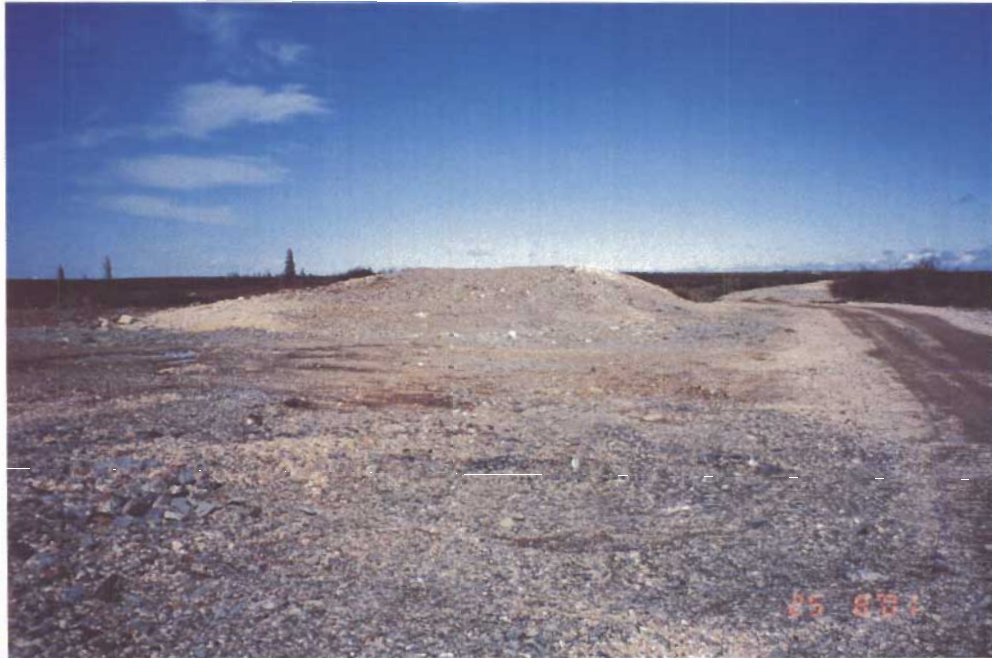
Photo 44. Close up view of one of the two “berms”. The ventilation outlet has been blocked, backfilled with granular materials and contoured.

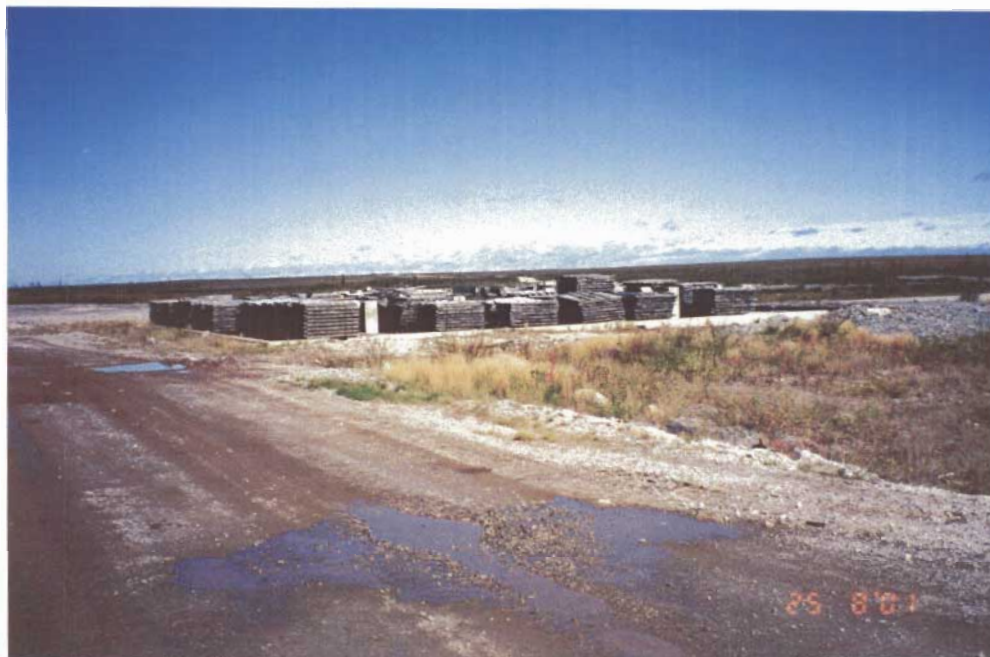
Photo 45. B-zone mine main complex. Core boxes which were stacked up and laid on top of the concrete bases, where fuel storage tanks used to be located.

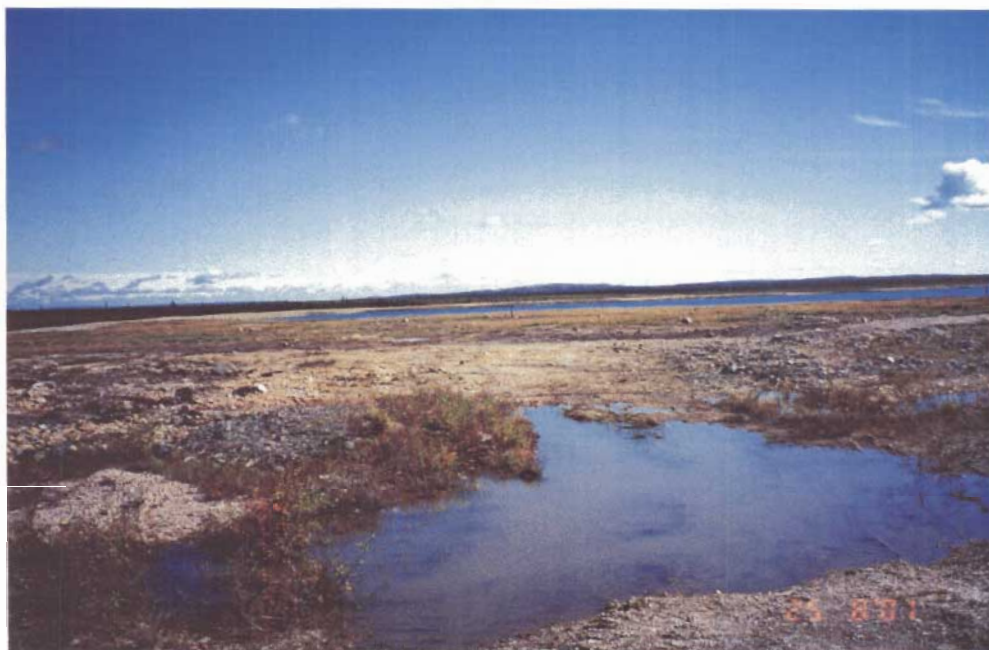
Photo 46. Dry tailings area which is located west of Tailings Pond No. 1 (in the background). Thermo couples and some piezometers were located in this area.

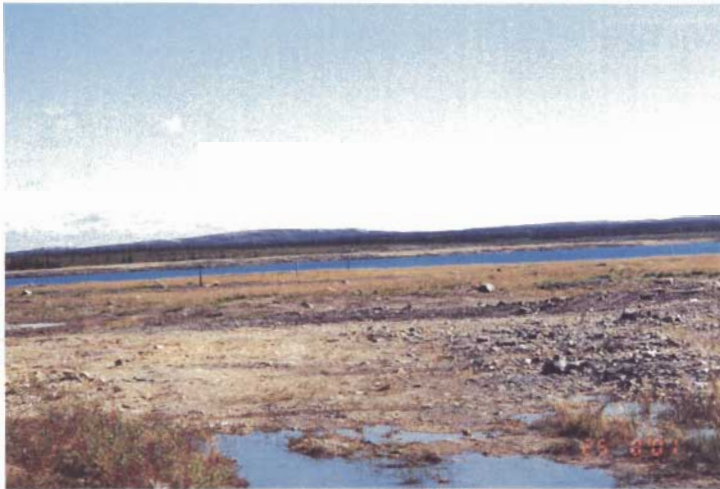
Photo 47. Dry tailings area adjacent to Tailings Pond No.1. The area was seeded with arctic grass. Photo was taken from the core boxes area.

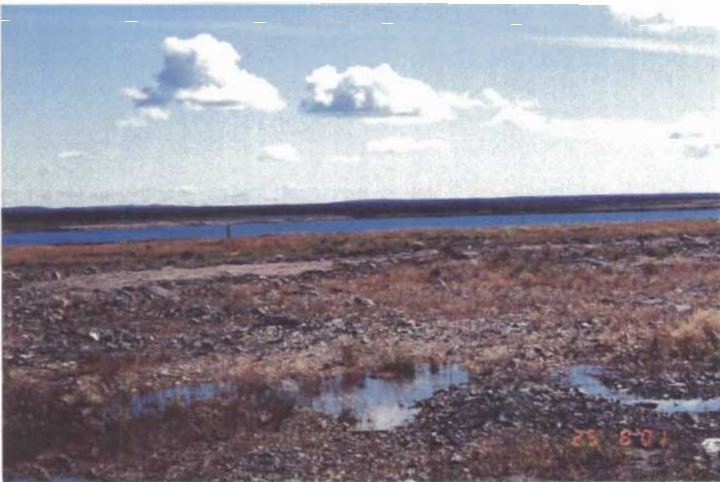
Photo 48. Close up view of the dry tailings area. Tailings Pond No. 1 is in the background.

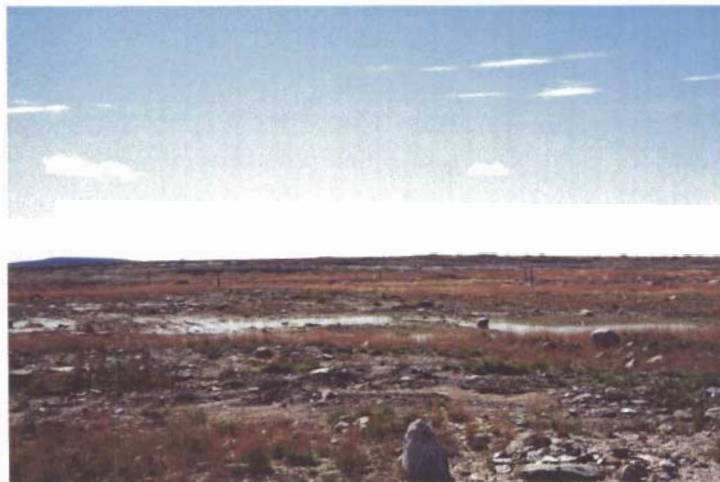
Photo 49. Another view of the dry tailings area. Black pipes show the location of the thermocouples.

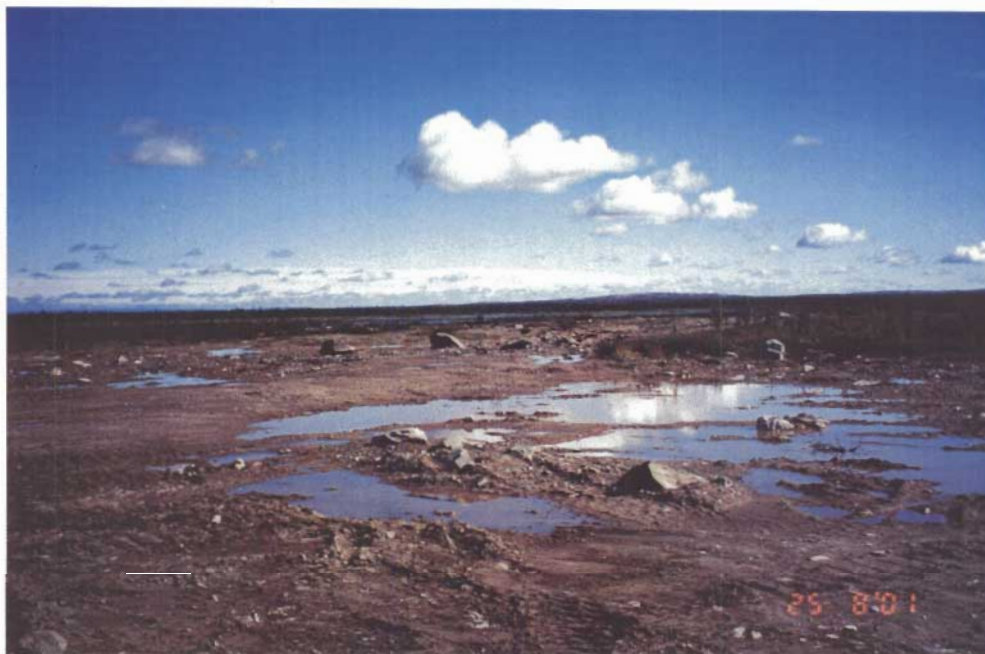
Photo 50. General view of the area located south of the Quarry Pit. Photo is looking southeast. The area was generally clear and free from debris.

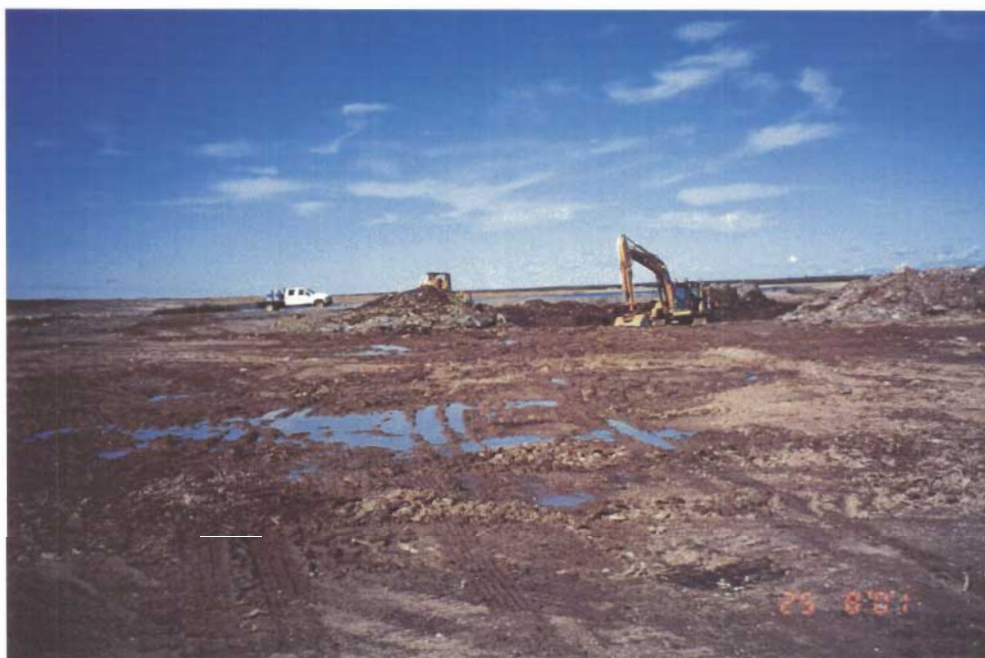
Photo 51. A portion of the Quarry Pit was used to bury crushed, inert waste materials, such as concrete rubble, steel plates, steel structures, etc. The backhoe was utilized to bury the last pieces of waste materials : an old bus and a burn box.
