Nunavut Water Board

Cullaton Lake Property - B-zone Mine and Mill Complex Area

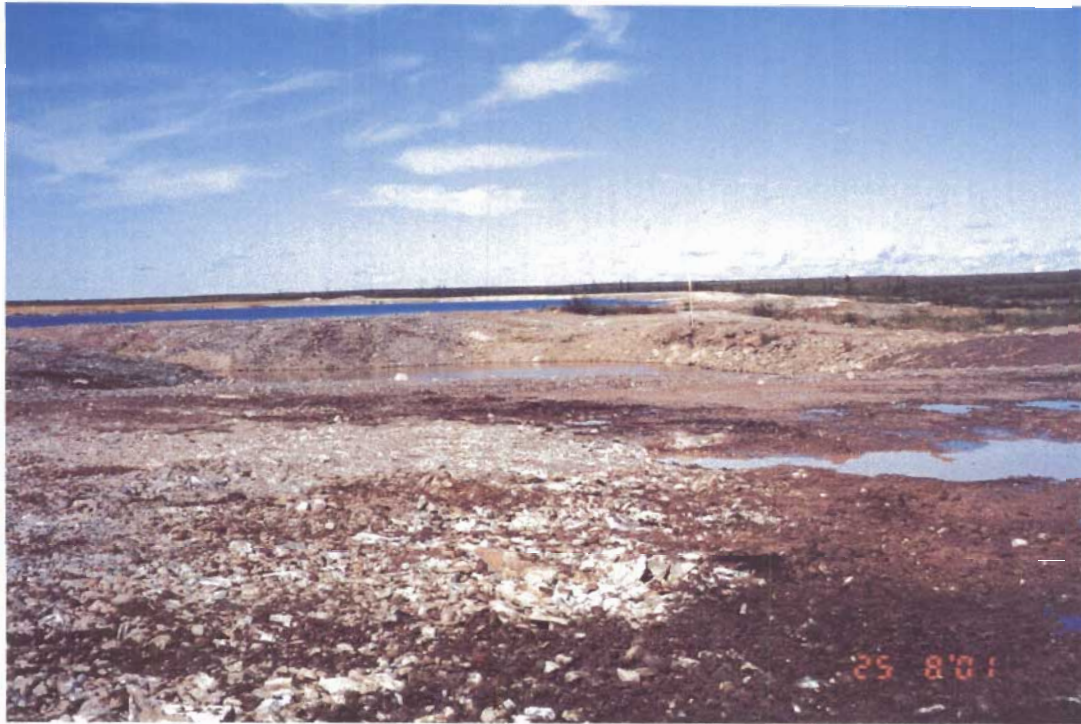
Photo 52. The north portion of the Quarry Pit, where it will be left as a pond. Tailings Pond No. 1 is in the background.

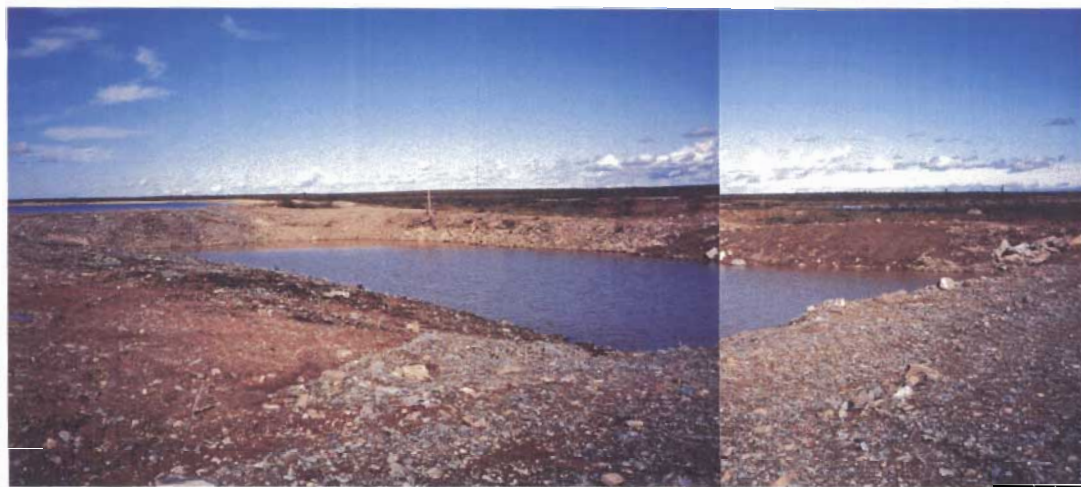
Photo 53. A close up view of the Quarry Pit pond. Notice the work to tidy up the side slopes of the pond. Photo is looking north/northeast. Tailings Ponds No. 1 and No. 2 are on the horizon (Pond No. 1 - left, Pond No. 2 - right)

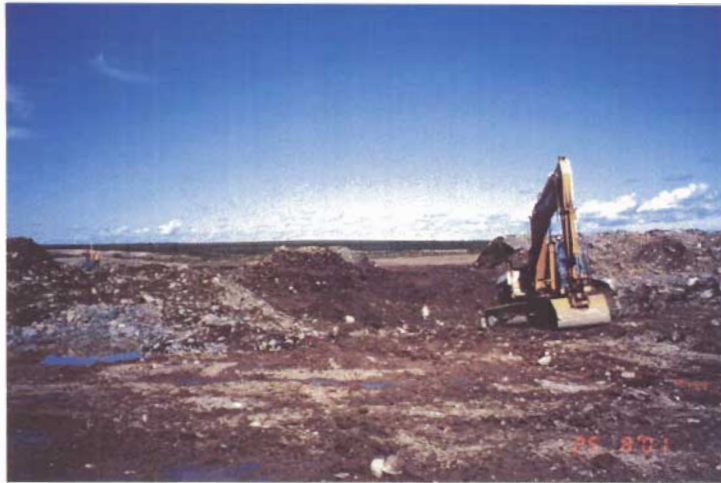
Photo 54. Burial of inert waste materials in the southern portion of the Quarry Pit.

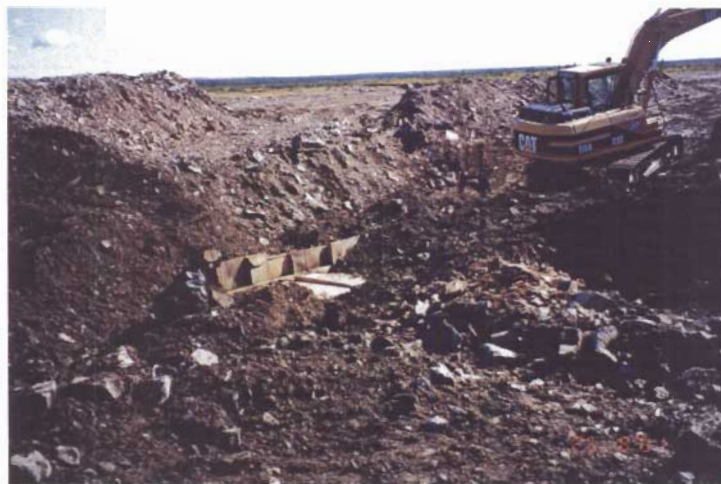
Photo 55. Close up of the burn box, buried in the Quarry Pit. The area would be tidied up and grass seeded.

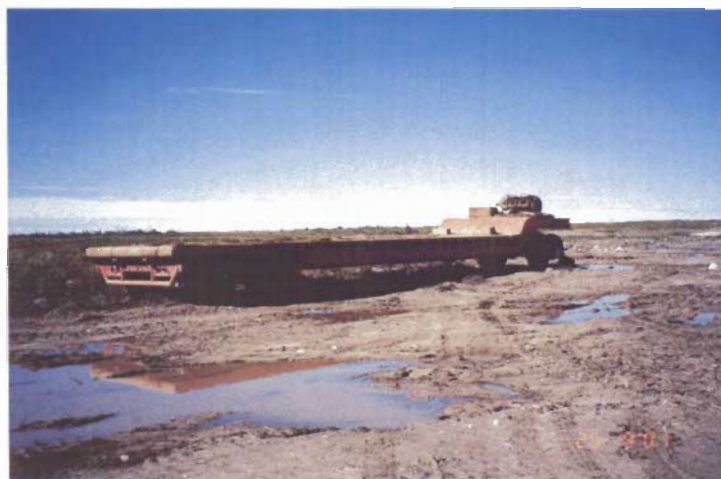
Photo 56. A flat bed left at the Quarry Pit area. It will be hauled to the airstrip and removed from the site as part of the demobilization.

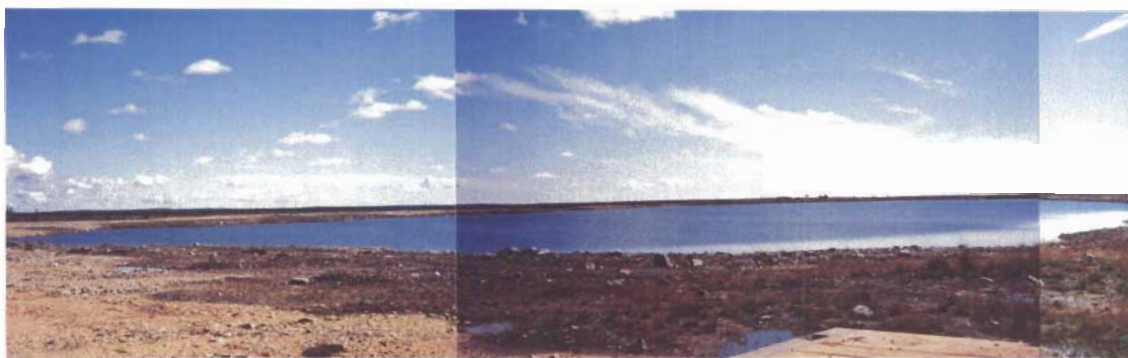
Photo 57. A view of Tailings Pond No. 1. Photo is looking west/northwest

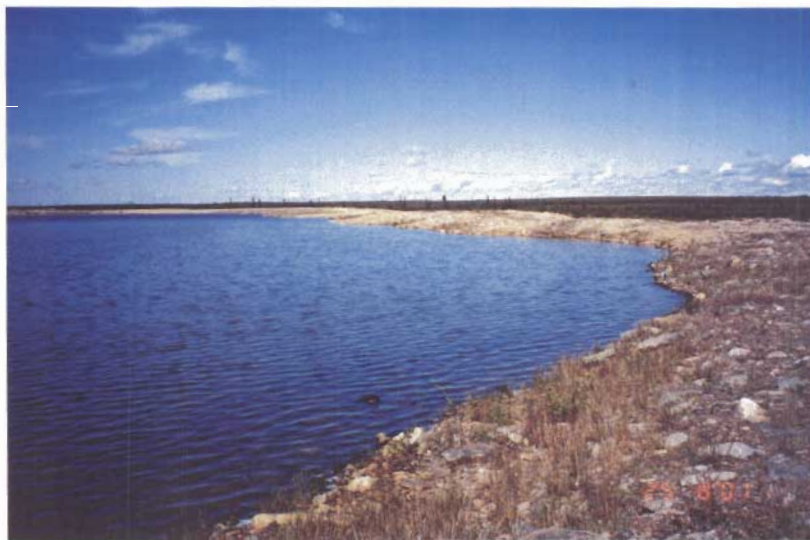
Photo 58. Upstream slope of Tailings Pond No. 1. Photo was taken from the south end.

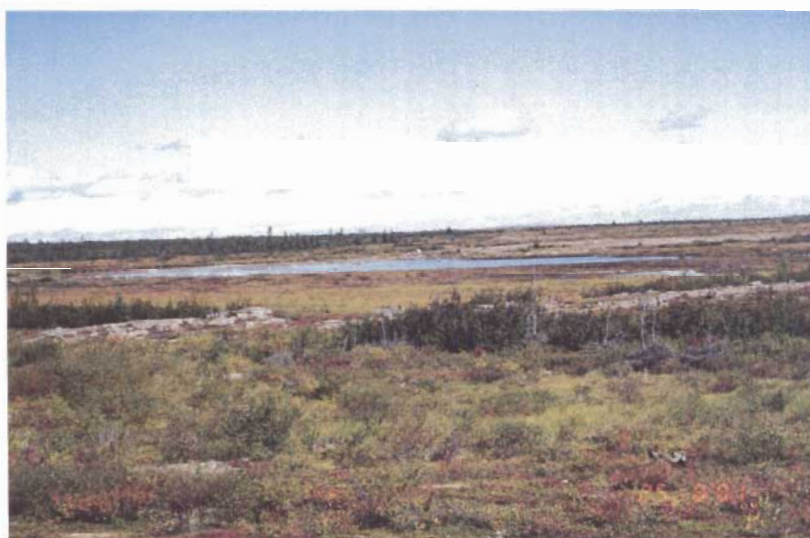
Photo 59. Tailings Pond No. 2 area, taken from an area between Pond No. 1 and the Quarry Pit pond.

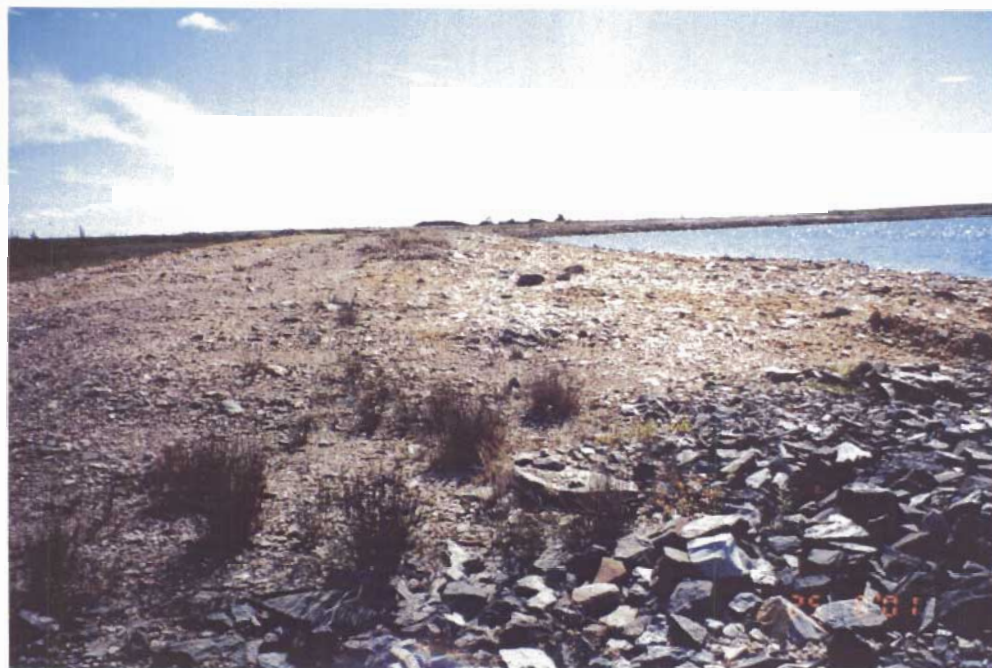
Photo 60. Typical crest of the Tailings Pond No. 1 dam. Photo is looking south, from northwest corner of the pond.

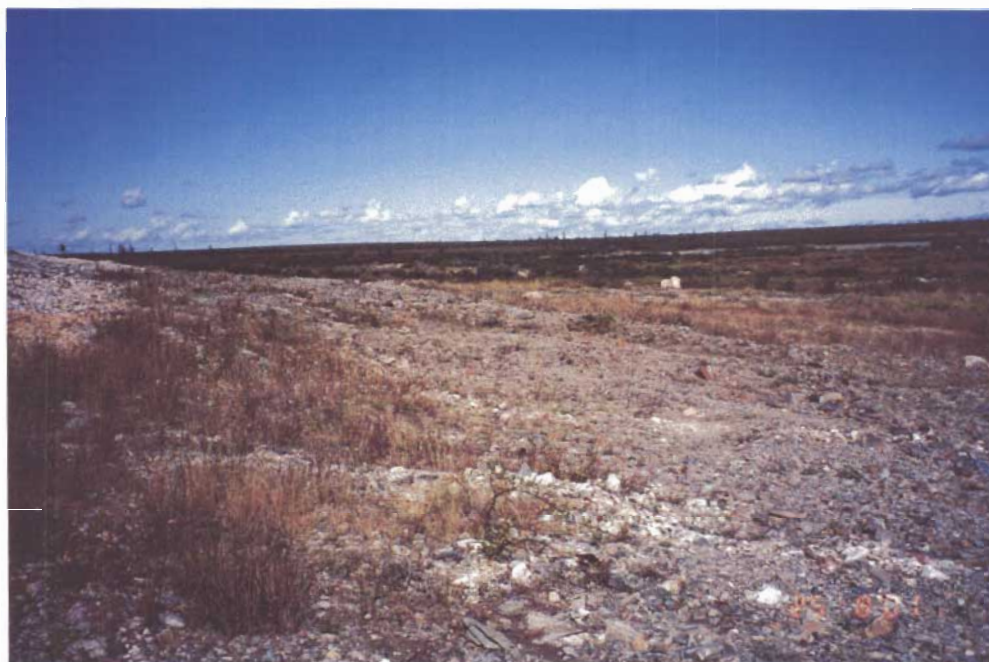
Photo 61. Downstream slope of Tailings Pond No. 1 dam along the south end of the pond. Photo is looking north and Tailings Pond No. 2 is on the right.

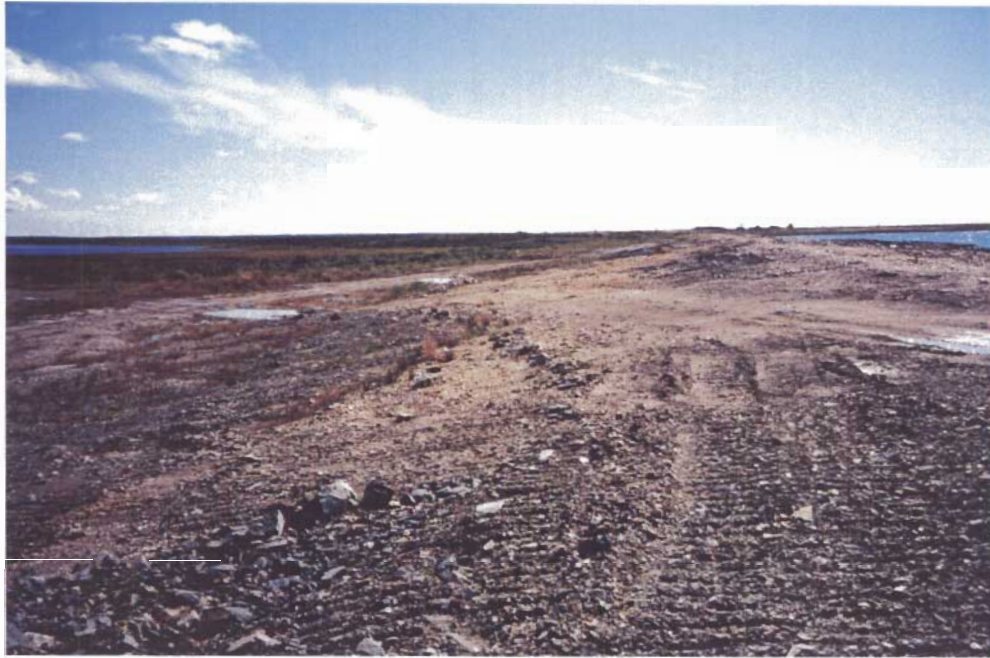
Photo 62. Downstream slope of Tailings Pond No. 1 dam. Water puddles were from recent rainfall.

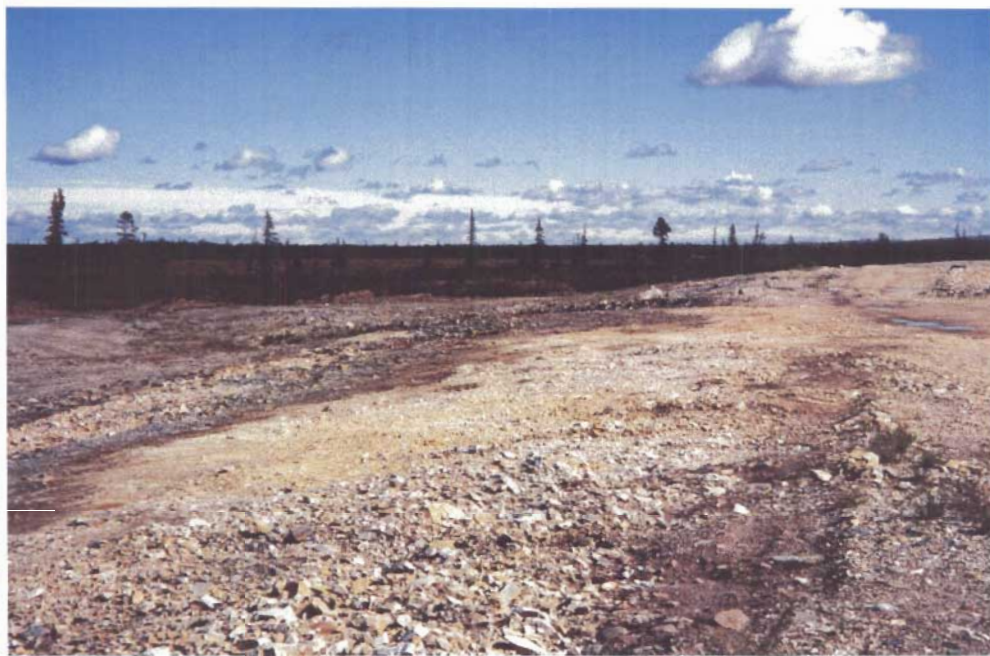
Photo 63. Another view of the downstream slope of Tailings pond No.1 dam. The crest of the dam was generally wide, and the downstream slope was relatively flat.

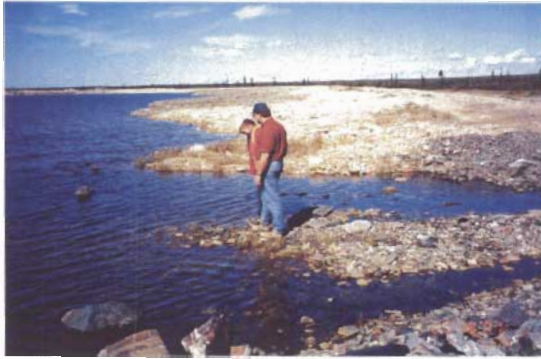
Photo 64. Water entering the spillway at the upstream side of Tailings Pond No. 1

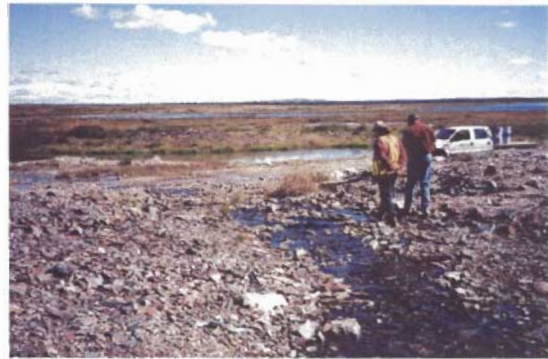
Photo 65. Spillway channel. Photo is looking downstream.

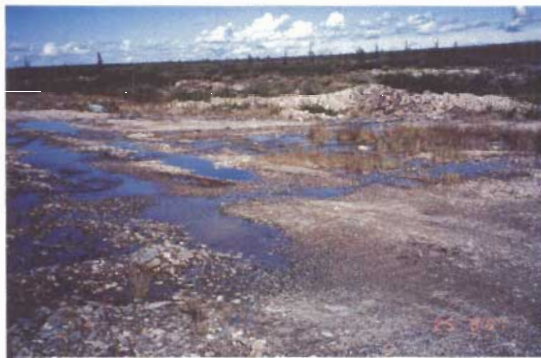
Photo 66. Water flowing downstream of the pond's spillway channel.

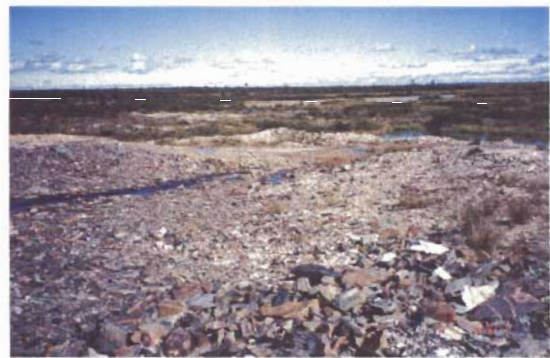
Photo 67. Another view of the spillway channel, looking downstream.

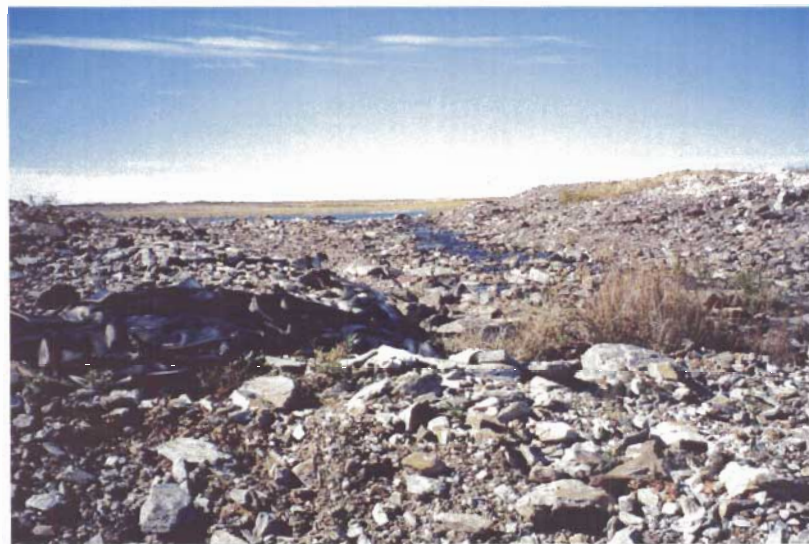
Photo 68. Spillway channel. Photo is looking upstream, showing water flow from the pond. Note the exposed piece of geomembrane. The steel weir formerly located in this area had been removed.

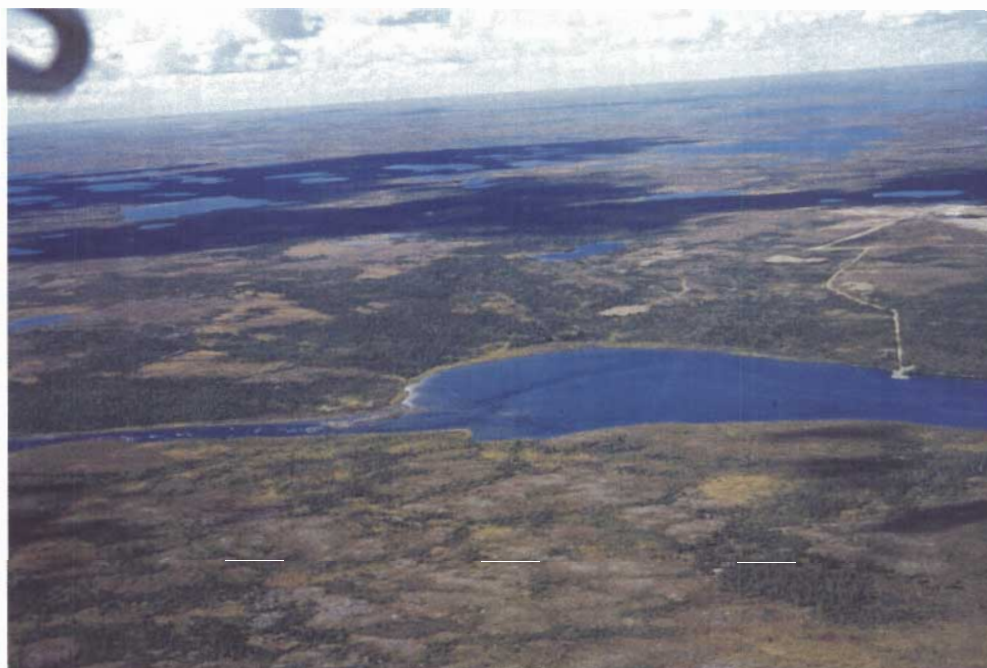
Photo 69. An aerial view of the Kognak river. Water flows from left to right. Notice the access road (also the old water line) from the B-zone mine complex to the river.

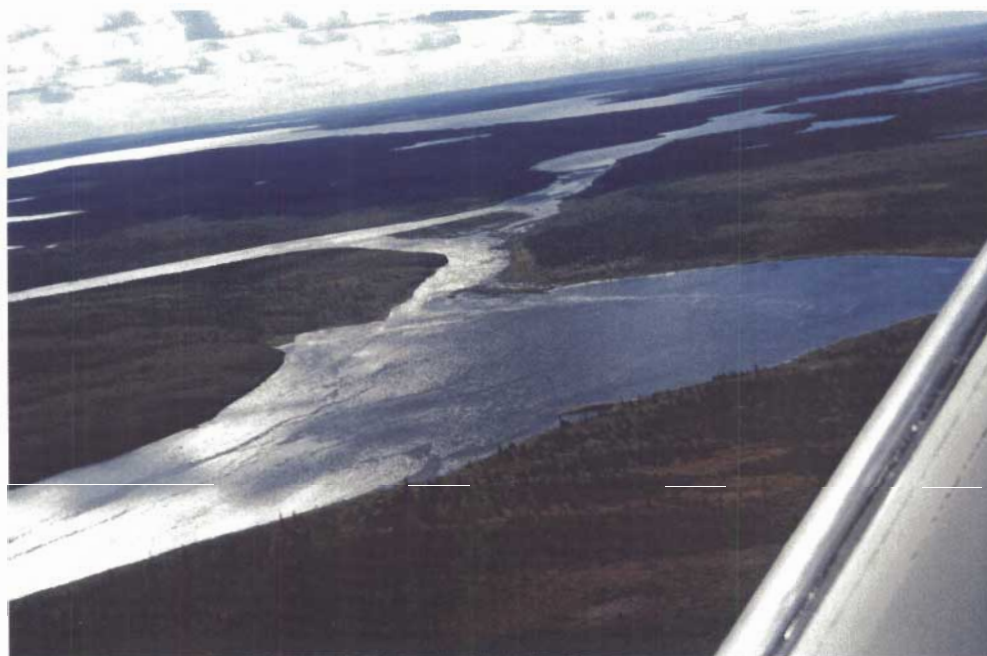
Photo 70. A close up view of the Kognak River. Water rapids are located at the end of the river constriction (centre of photo). An old camp is located to the north of the rapids. Photo is looking south.

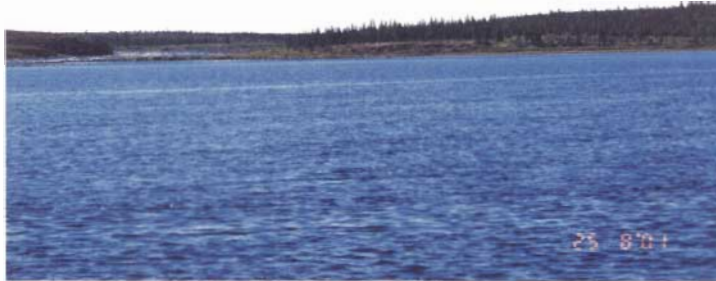
Photo 71. Kognak River. Photo was taken from the demolished pump house area, looking west. River rapids are on the left, and the old camp area is to the right of the rapids.

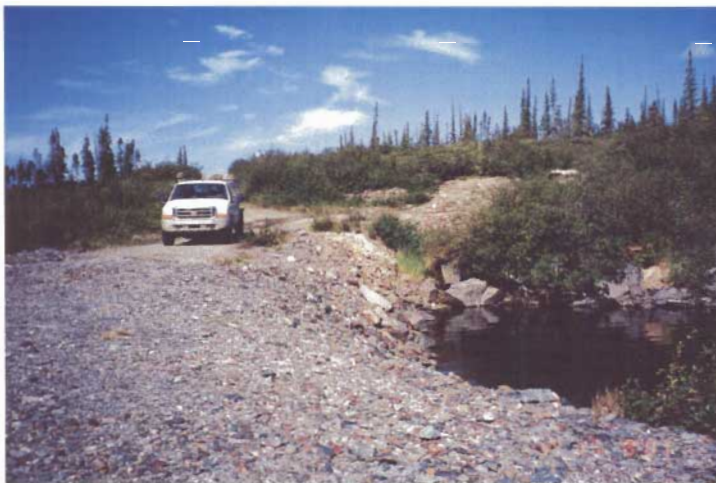
Photo 72. The access road to Kognak River. The demolished pump house is on a cleared area located on the centre right.

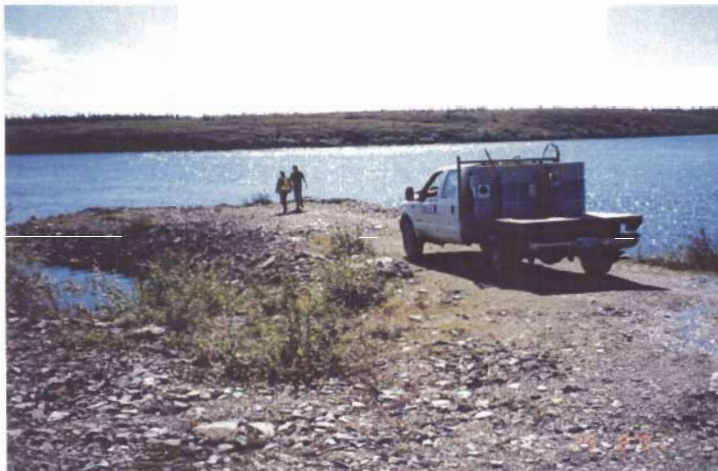
Photo 73. Kognak River at the water intake for the mine. Photo is looking south.
