CULLATON LAKE GOLD MINES LTD

WATER LICENCE N6L2-0940

**ANNUAL
WATER LICENCE REPORT
1996**

March 1997

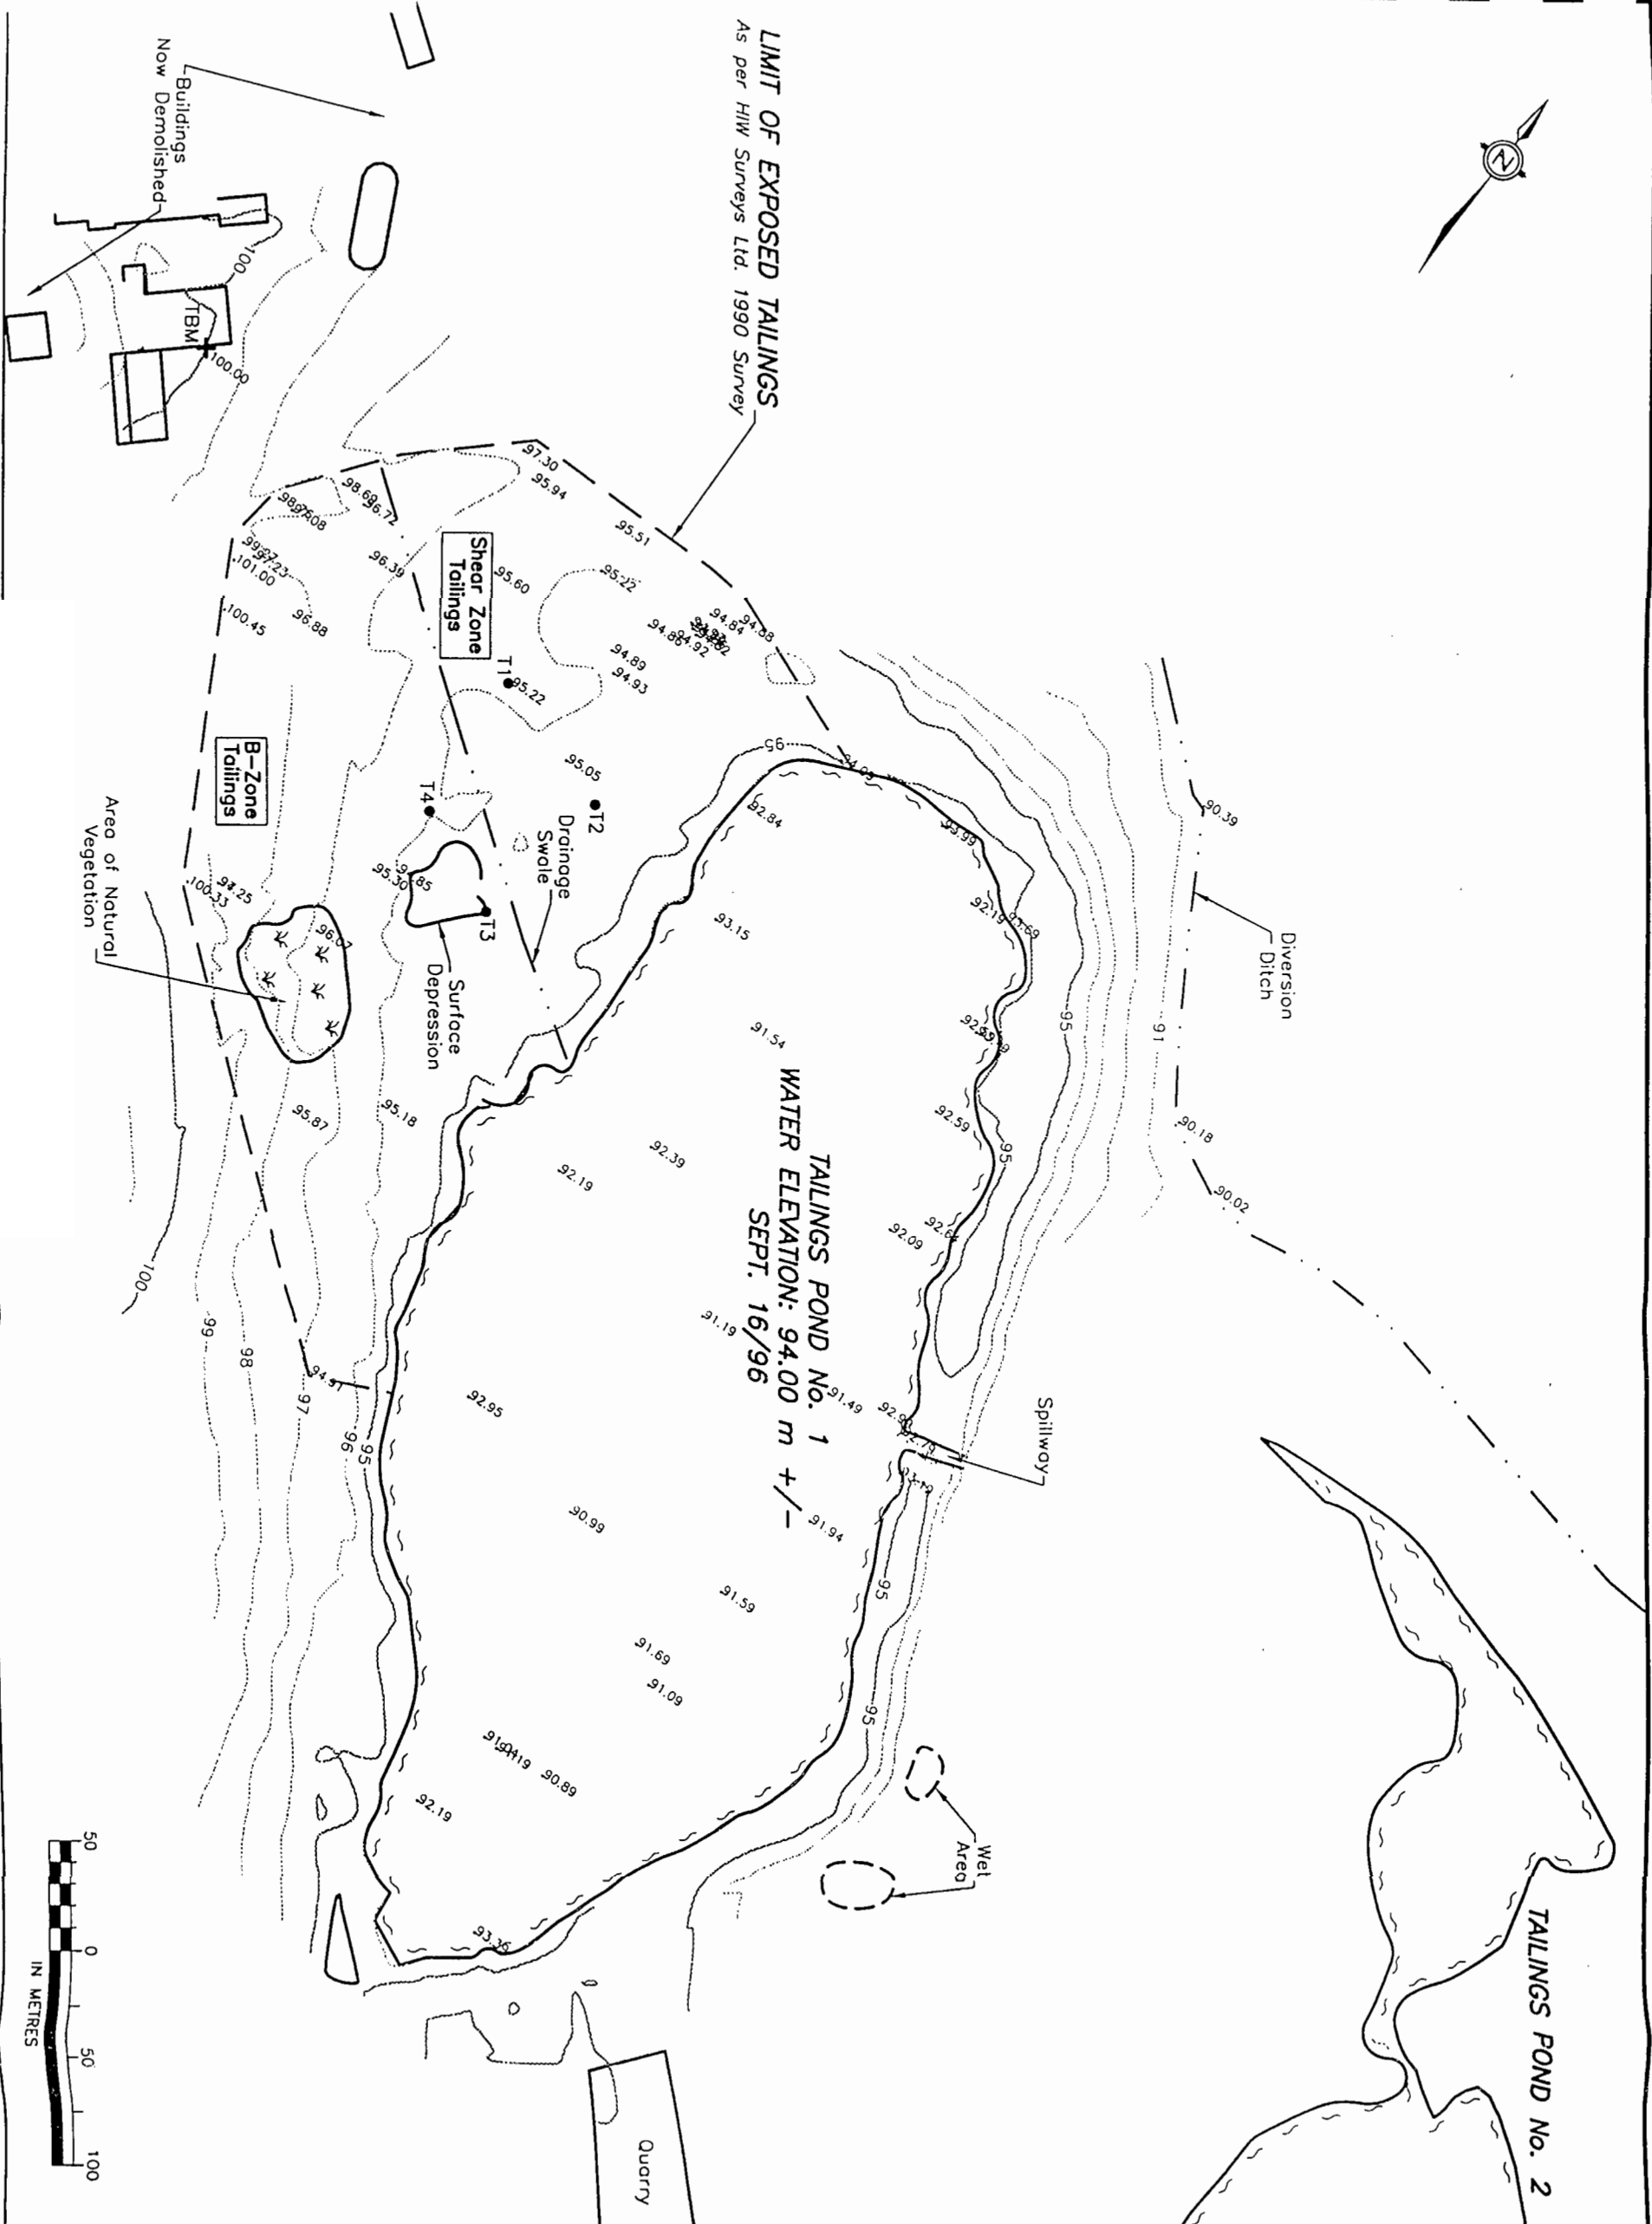
Client:		Homestake Conado
Project:		Cullaton Lake Gold Mine
Title:		Tailings Pond Area No. 1
Project No.	Dwg. No.:	1
F-90132-B/E		
Drawn By:	Reviewed By:	
DT		
Date:		Nov. 27/96
Scale:		1:3000

A visual examination around Tailings Area No. 1 was carried out. The containment dam appears to be in good condition with no signs of distress or erosion. Some small wet areas were present on the downstream toe at the south end of the tailings area. However, it is unclear if the wet areas are due to seepage or the large amount of rainfall which had fallen prior to this site visit. There is no evidence of soil loss in these wet areas and they do not appear to present any instability to the dam. The approximate location of these wet areas are shown on Drawing No. 1.

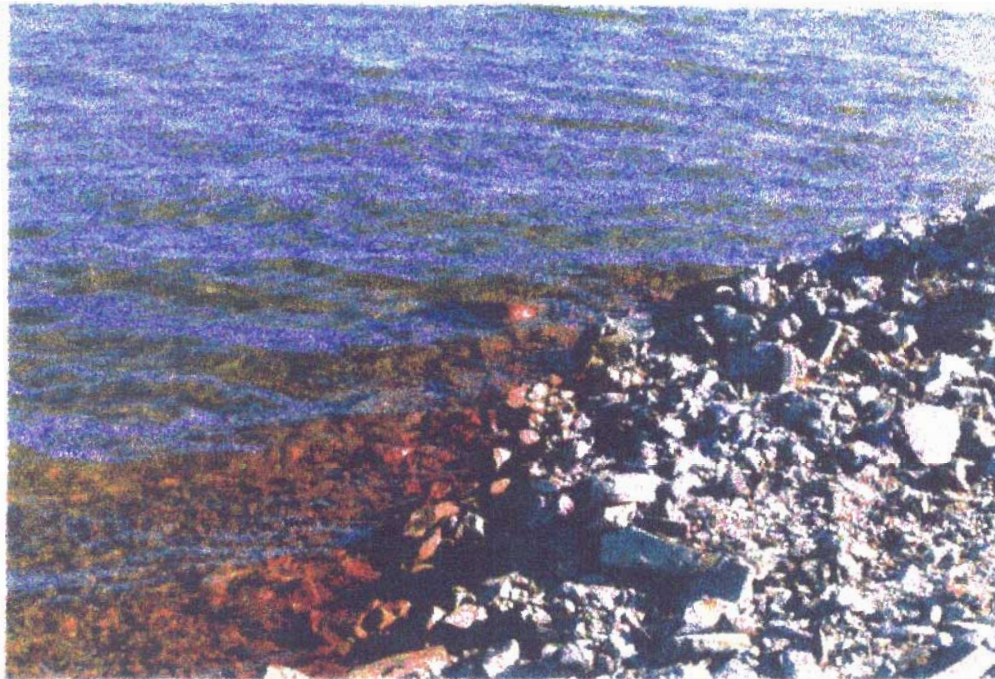
Figure 1: Tailings near surface at west shoreline

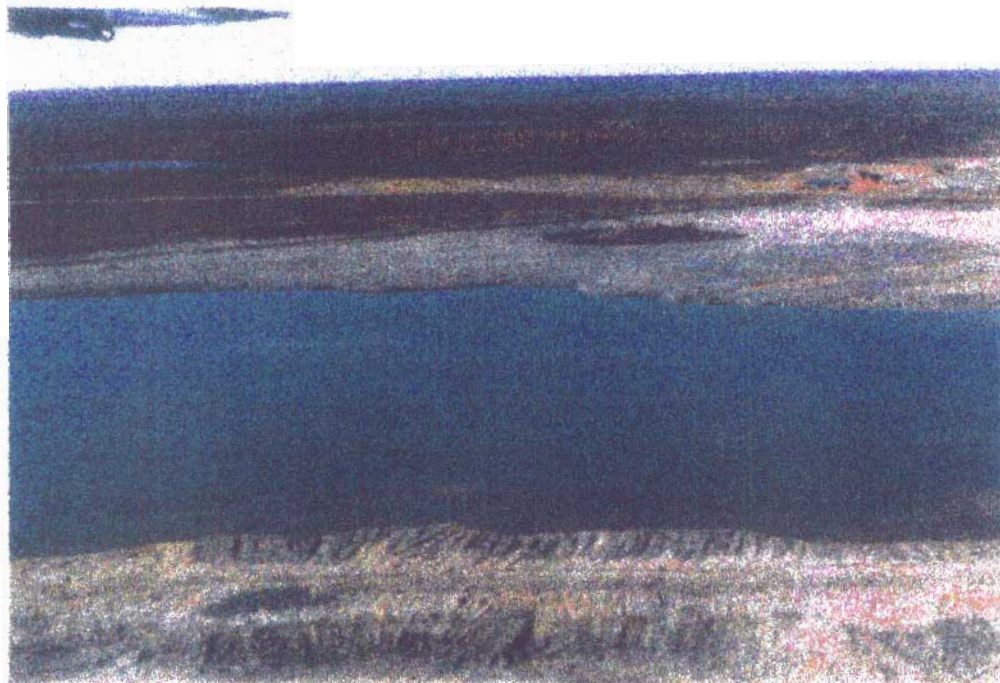
Figure 2: Tailings near surface of water, aerial view looking west.

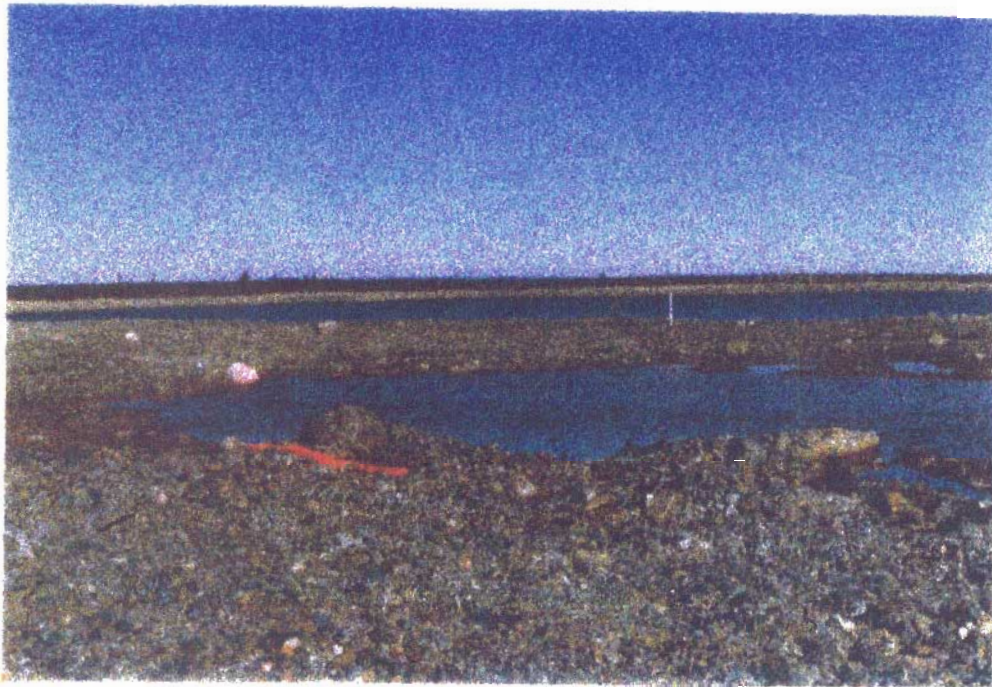
The overall average cover thickness based on observed data is considerably less than the designed thickness of 1.5 m. Two small areas located on the tailings impoundment exhibited bare tailings with no cover. One area was comprised of exposed tailings with partially established vegetation. This area was located on the "B" Zone tailings. The second area was located on the Shear Zone tailings and was comprised of exposed tailings with minor water ponding.

Figure 3: Surface depression in B-zone covered tailings area

2. During our September site inspection at our Cullaton Lake property, it was discovered that the cover on the tailings was not as deep as we had previously believed. In order to address this deficiency, we intend to remove more material from Dam 2 (our A & R Plan outlined the removal of material from Dam 2 and the placement of that material over the tailings in Pond 1) and cover the tailings with this additional material. This work was started in 1996 and will be completed during the 1997 work season.

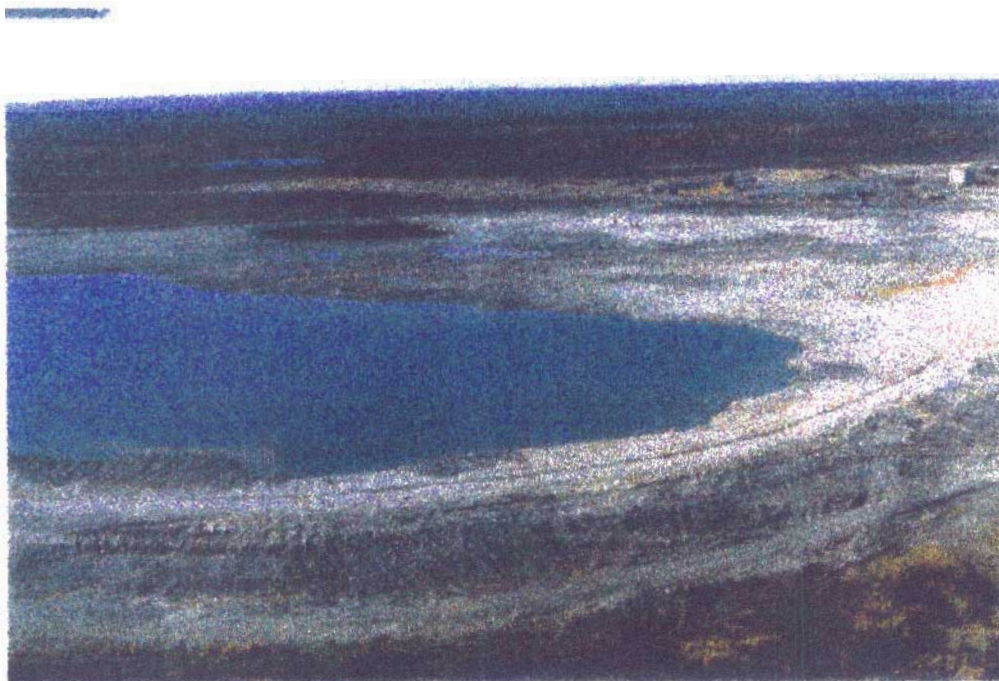
Figure 4: Aerial view of surface depression in B-zone covered tailings area.
