CULLATON LAKE GOLD MINES LTD WATER LICENCE N6L2-0940

ANNUAL
WATER LICENCE REPORT
1997

PREPARED BY:
HOMESTAKE CANADA INC
P.O. BOX 11115, 1100 - 1055 WEST GEORGIA STREET
VANCOUVER, B.C.
V6E 3P3

February 1998

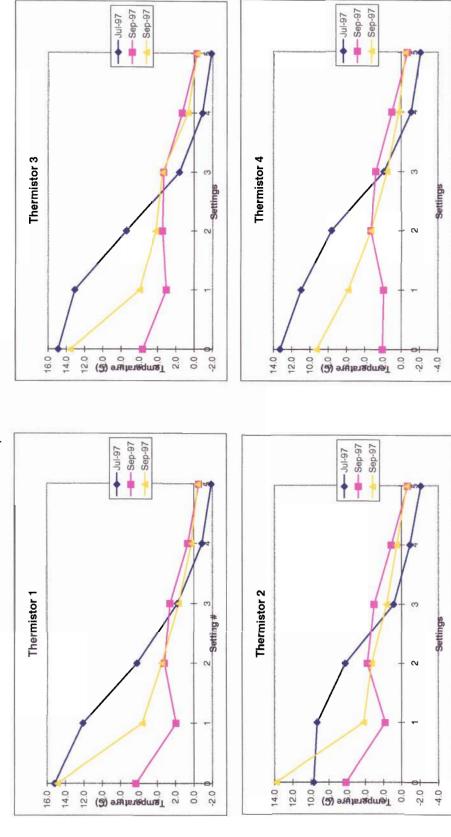
TEMP. A CULLATON LAKE THERMISTORS (1991 TO 1997)

Thermistor readings (Station 940-21) have been taken during the spring and late summer months since 1991. Readings from 1992 to 1994 show an upward trend in the permafrost levels. In 1995 the level remained steady. At the end of the 1996 summer season, the depth of the active zone remained stationary with respect to 1995 readings. Additional cover was placed on the tailings in 1997. During this summer of disturbance, the thermistor readings remained stationary when compared to 1995 and 1996 data (see Appendix 1 for thermistor readings). As a result of the placement of additional cover on the tailings, we hope to see a resumption of the previous upward trend in permafrost levels with 1998 thermistor results.
