# CULLATON LAKE GOLD MINES LTD

## WATER LICENCE NWB1CUL9902

### ANNUAL WATER LICENCE REPORT 1999

PREPARED BY:  
HOMESTAKE CANADA INC  
P.O. BOX 11115, 1100 - 1055 WEST GEORGIA STREET  
VANCOUVER, B.C.  
V6E 3P3

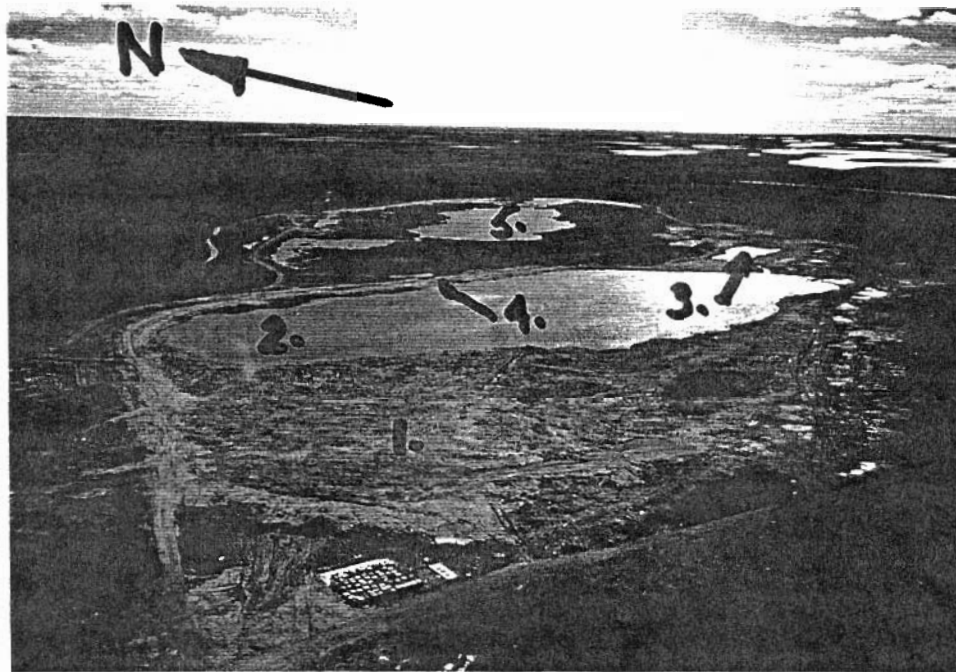
Photo 1. Oblique view of tailings impoundment looking east.

1. Covered Tailings, 2. Pond, 3. Quarry, 4. Dam 1 and Spillway 1, 5. Pond 2

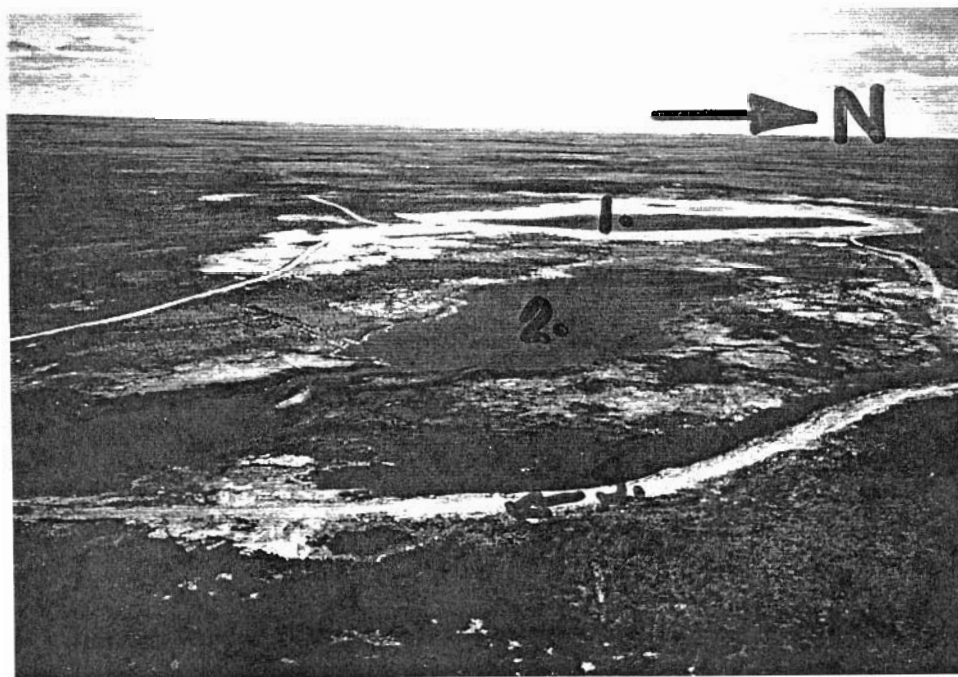
Photo 2. Oblique view of tailings impoundment looking west.

1. Pond 1, 2. Pond 2, 3. Dam 2 & Spillway 2

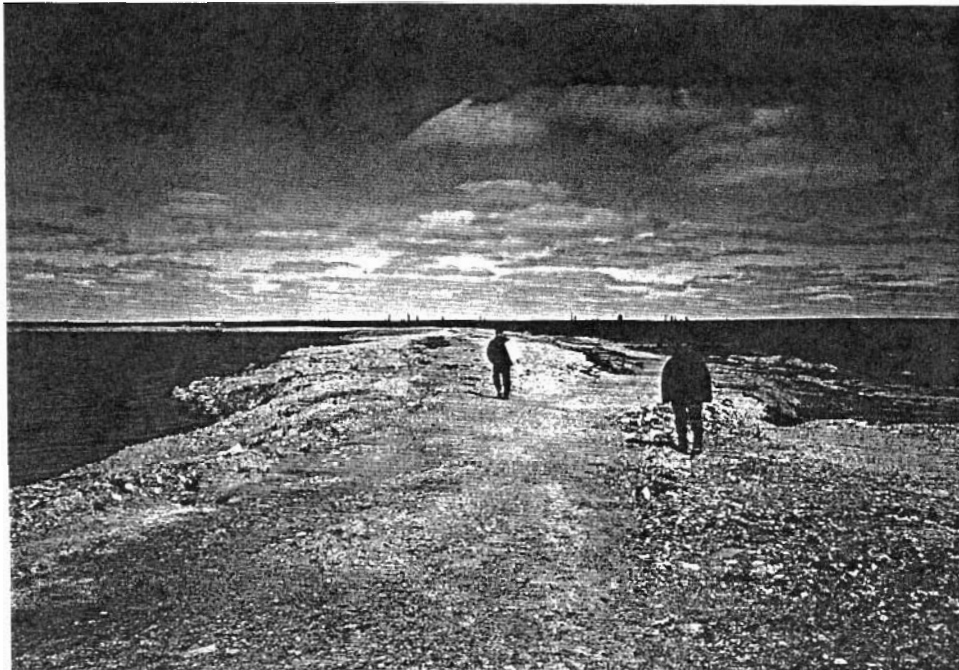
Photos 3 and 4 show views of the dam and spillway, respectively. Typically, the embankment which is constructed principally with local cohesionless till, is irregular in section and surface grade. Average side slopes of the upstream and downstream sides were typically about 3H:1V and 6H:1V, respectively. Some small erosion scars were observed on both the upstream and downstream sides. This is likely due to adjustment of the fill that was placed several years ago during the flattening of the side slopes. The crest width varies but is in the order of 15 m. No seepages were observed on the day of inspection. Based on our 1999 examination and our previous involvement with the project, the dam is considered to be stable.

Photo 3. Tailings Dam No. 1 looking north.

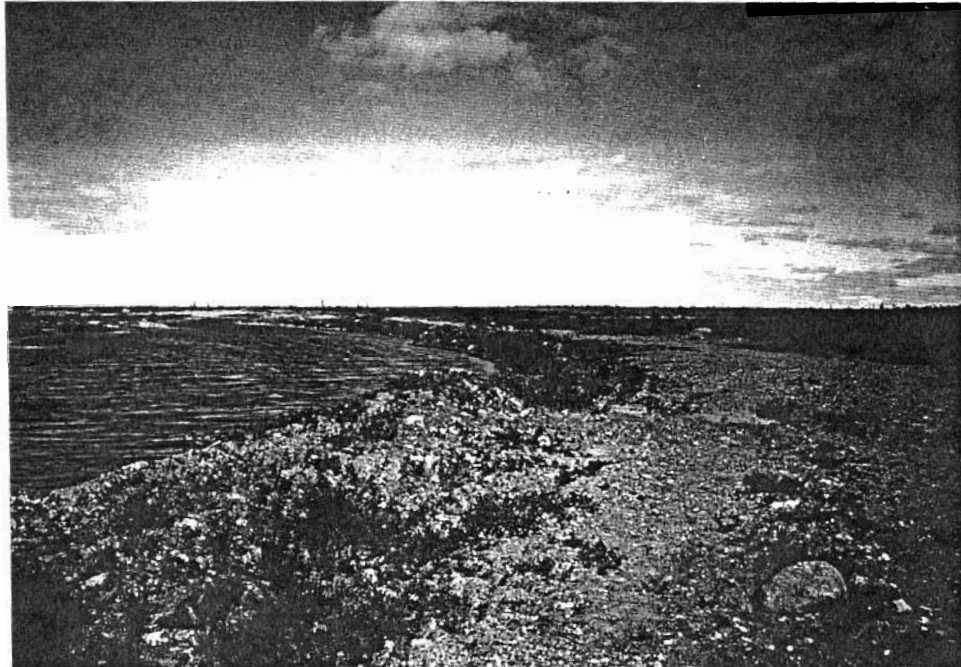
Photos 5 and 6 show views of the dam and spillway, respectively. As with the No. 1 dam, the principal construction material is local cohesionless till. The dam section and surface grade is irregular, although less so than the No. 1 dam. The crest width varies but is in the order of 15 m. No seepages were observed on the day of examination. Based on our 1999 examination and our previous involvement with the project, the dam is considered to be stable.

Photo 5. Tailings Dam No. 2 looking north, north of Spillway.

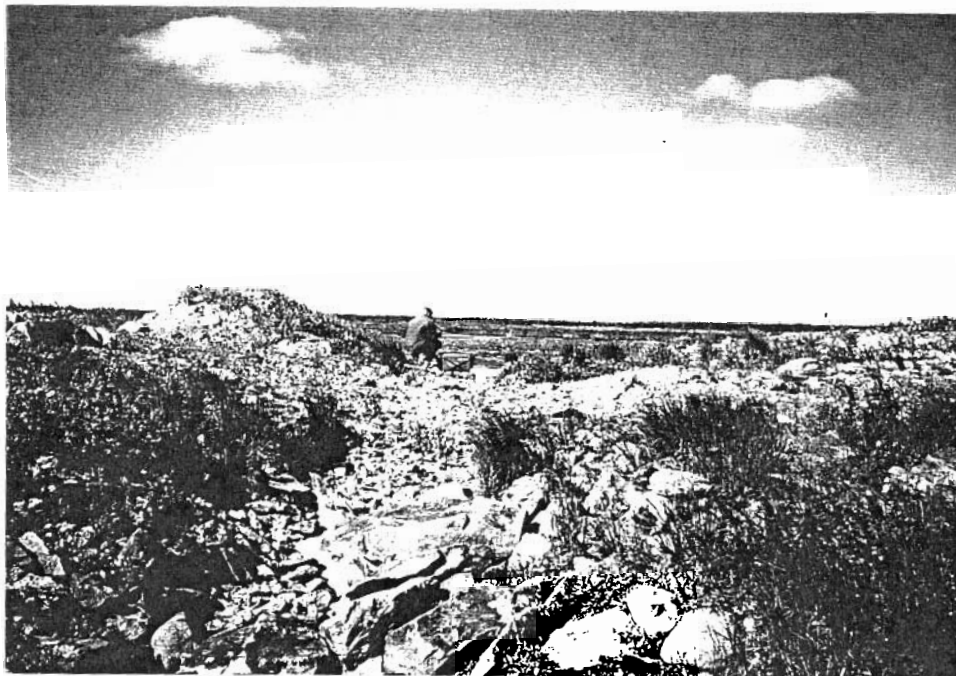
Photo 6. Spillway No. 2 looking upstream (west).

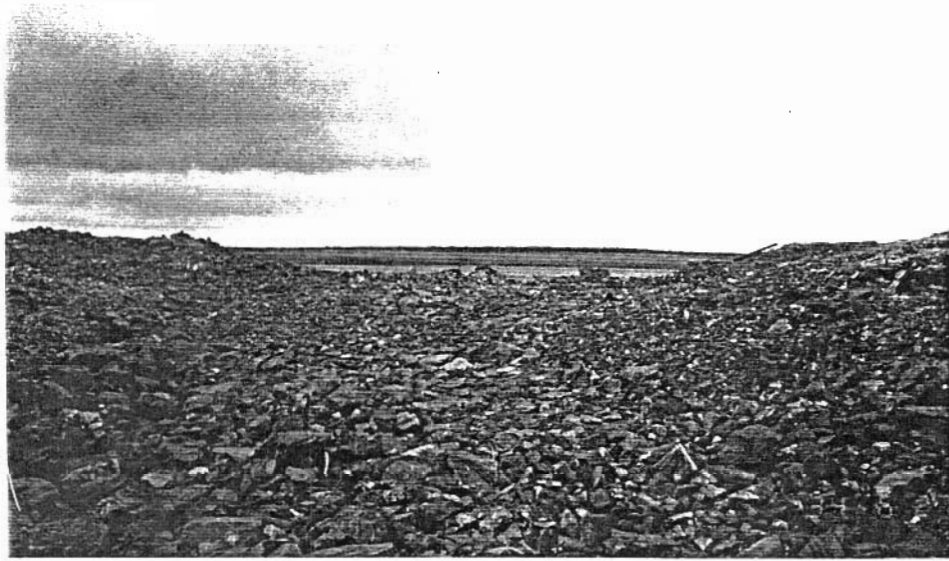
The spillways at each of the two dams appear to be in good condition. However, some levelling of some small rock piles immediately adjacent to the spillway in Dam No. 2 would provide a better appearance and provide better control of surface runoff. A slight trickle of water was noted through the rock fill in the spillway on Dam No. 1. Photographs, No.s 1 and 2 show the conditions of the two spillways.

**Photograph No. 1**  
**Spillway at Tailings Dam No. 1**

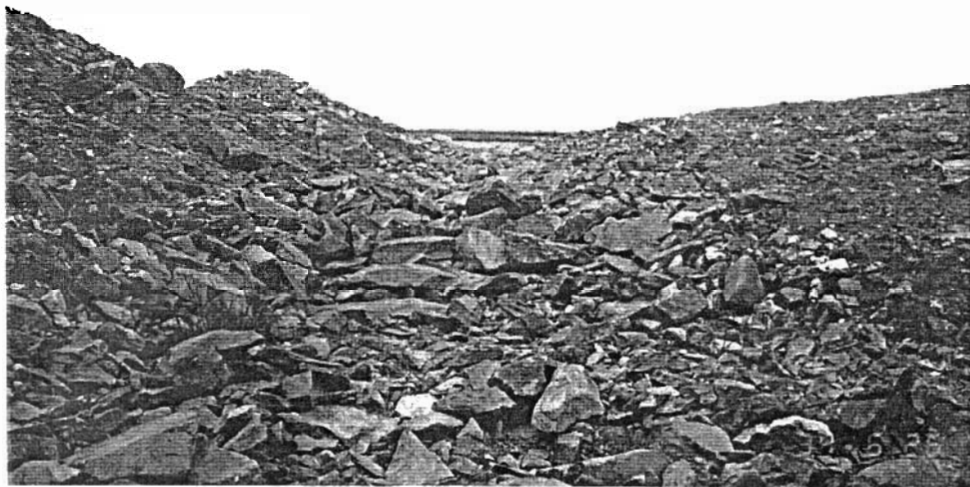
**Photograph No. 2**  
**Spillway at Tailings Dam No. 2**

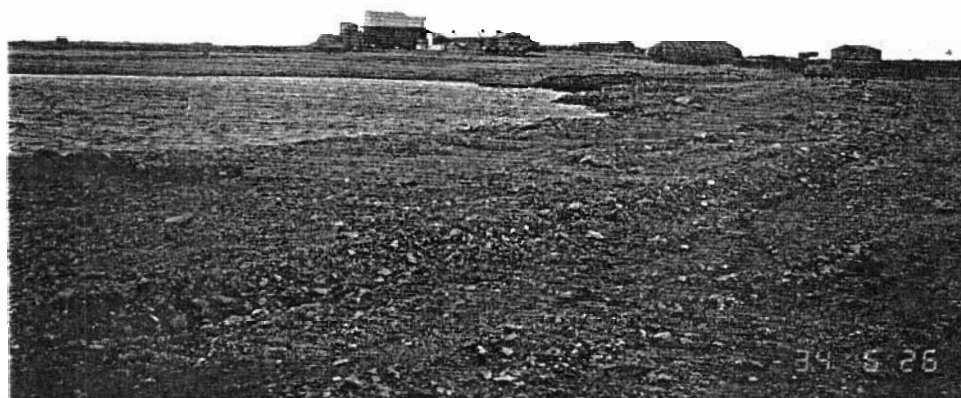
**Photograph No. 3**  
**Covered Tailings at Tailings Pond No. 1**  
**View Looking South**

It appears that some thaw settlement may have occurred in the B-zone covered tailings area. The area was ponded with water and stained reddish brown during this site visit. The settled area is shown on Photographs 3 and 4.

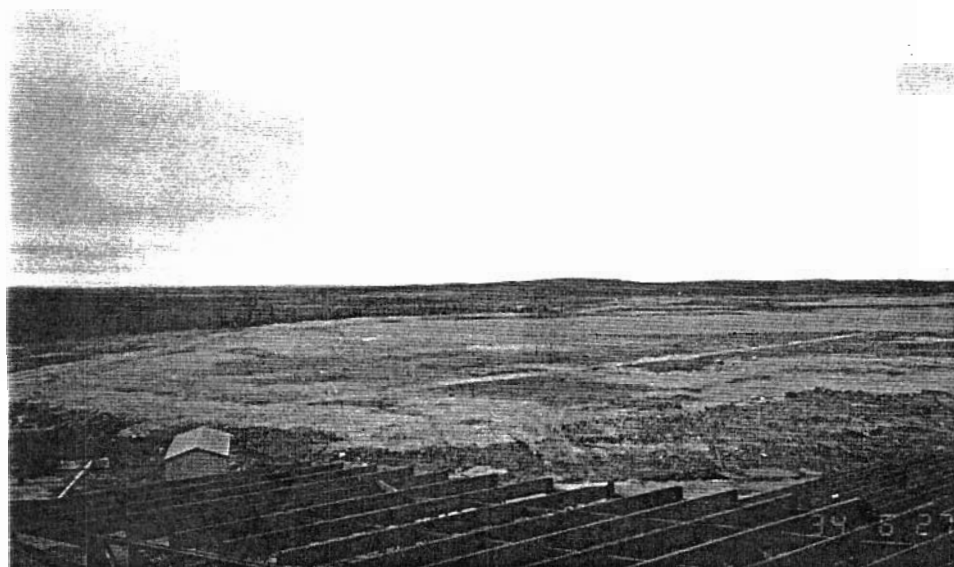
**Photograph No. 4**  
**Covered Tailings at Tailings Pond No. 1**  
**View Looking North**

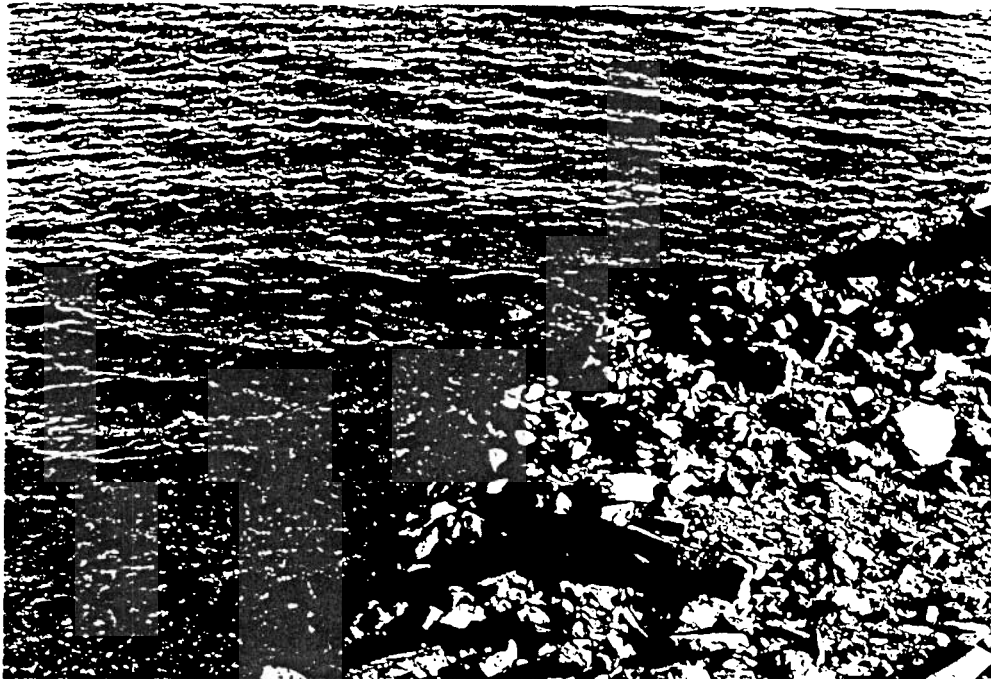
Figure 1: Tailings near surface at west shoreline.

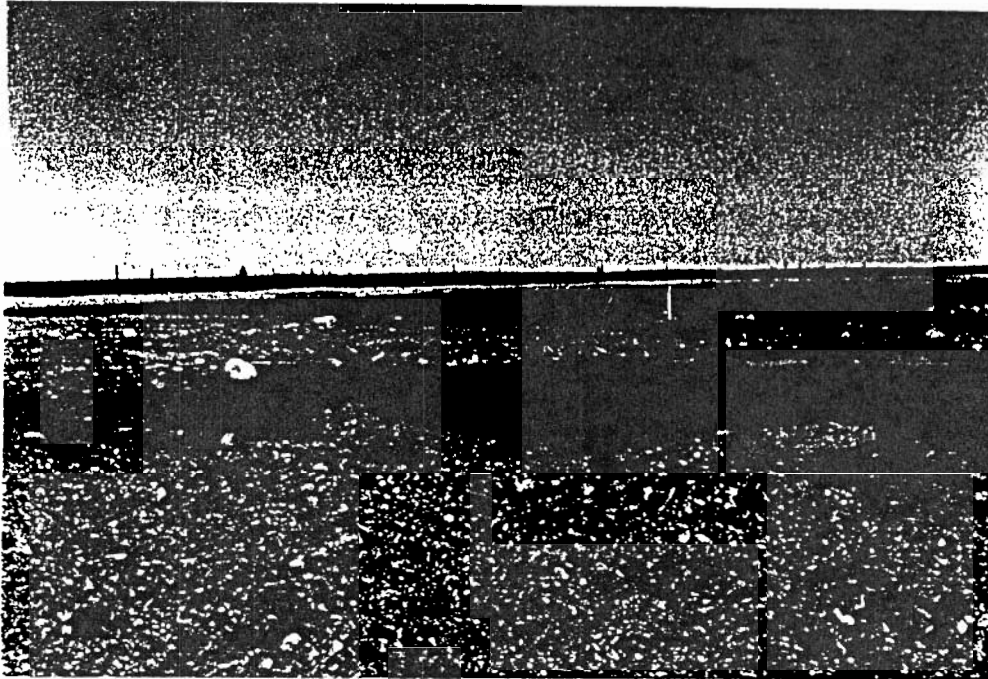
Figure 3: Surface depression in B-zone covered tailings area.

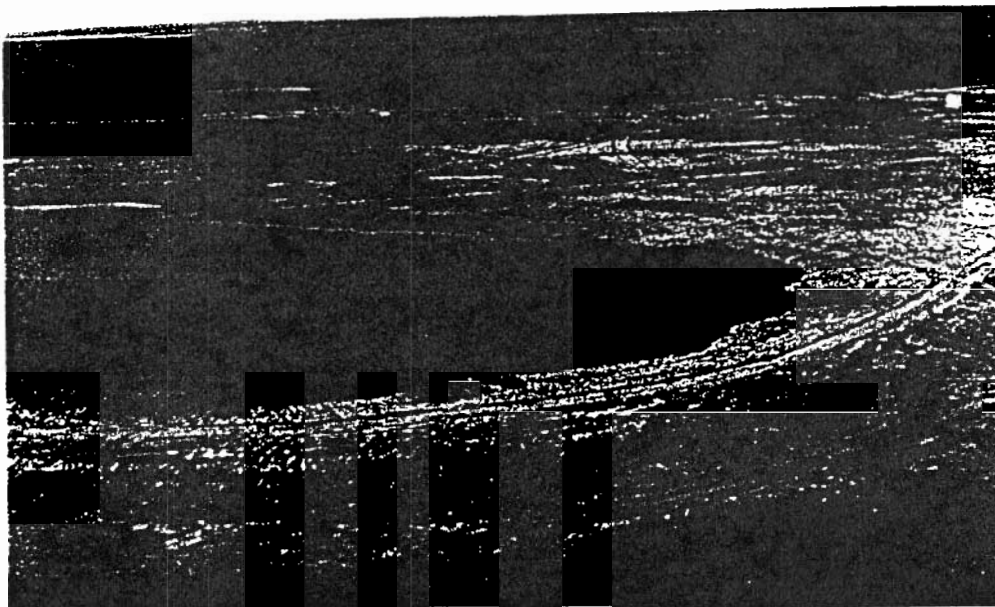
Figure 4: Aerial view of surface depression in B-zone covered tailings area.

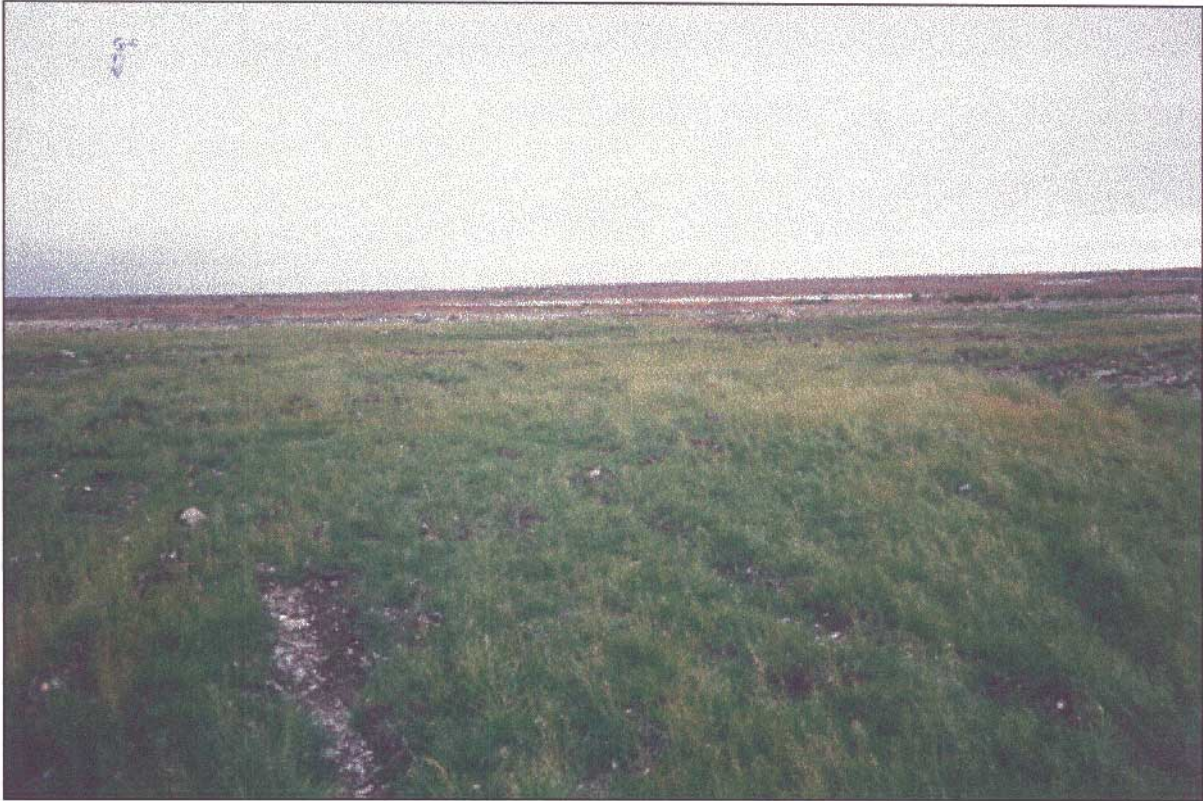
Grasses on the former mill site, looking toward the tailings area.

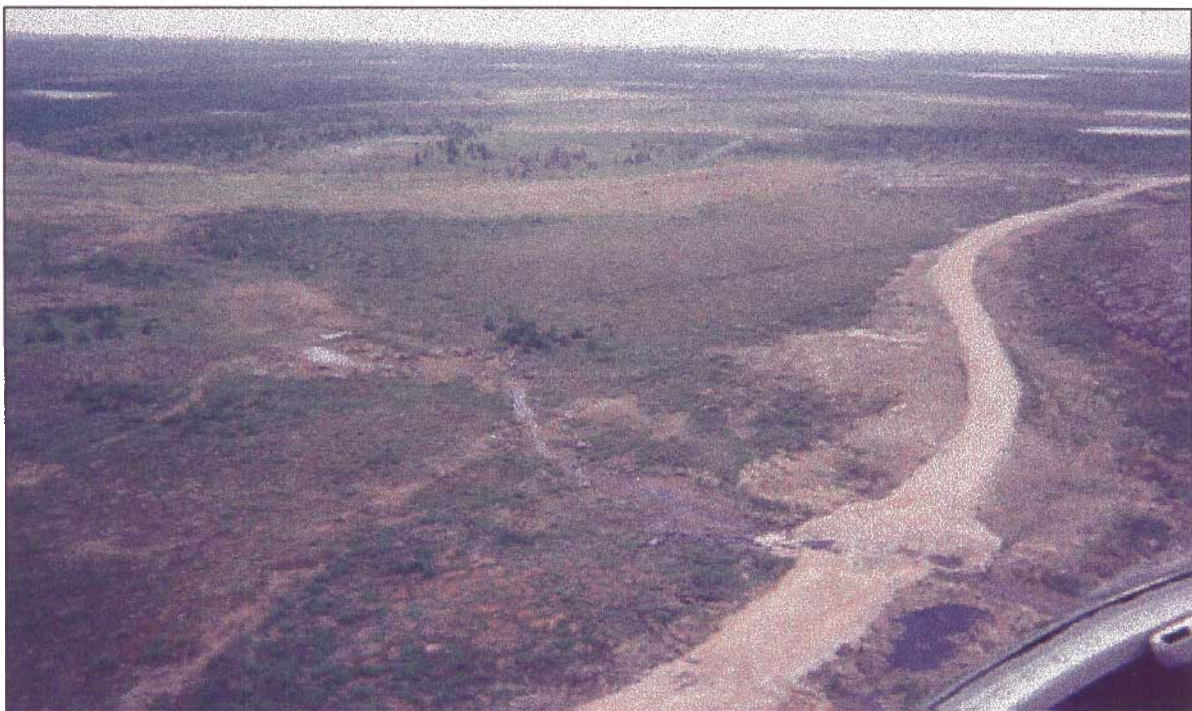
Culvert removed from roadways.

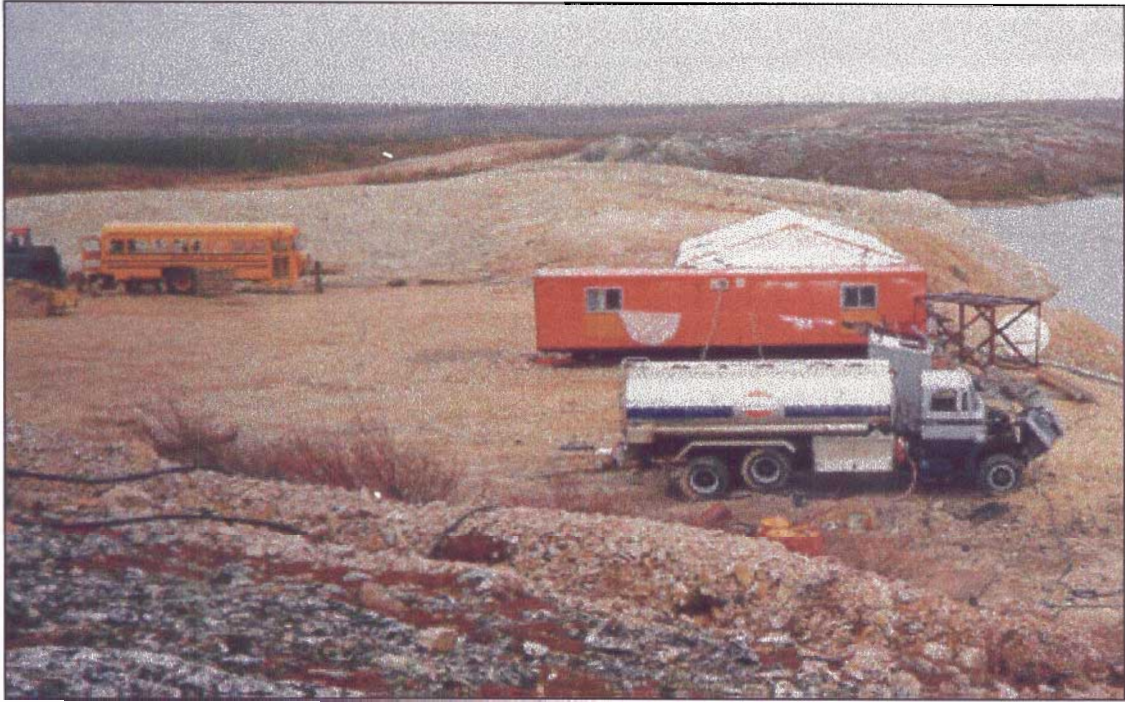
Shear Lake camp remains on site.
