CULLATON LAKE GOLD MINES LTD

WATER LICENCE NWB1CUL9902

ANNUAL WATER LICENCE REPORT 2000

March 2001

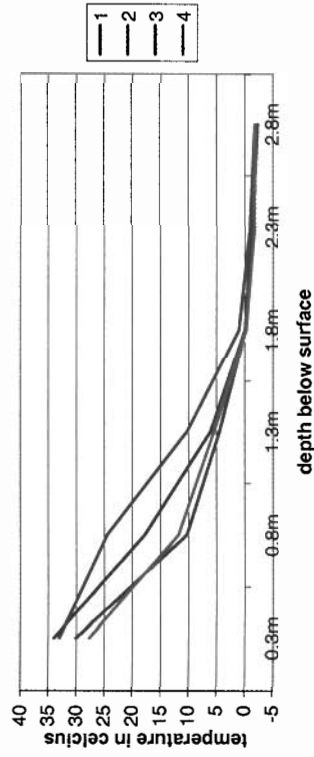
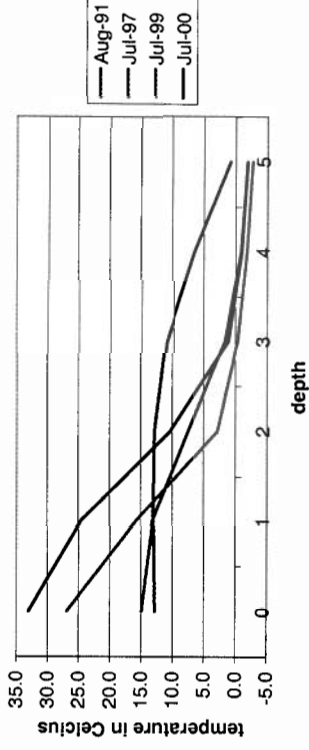
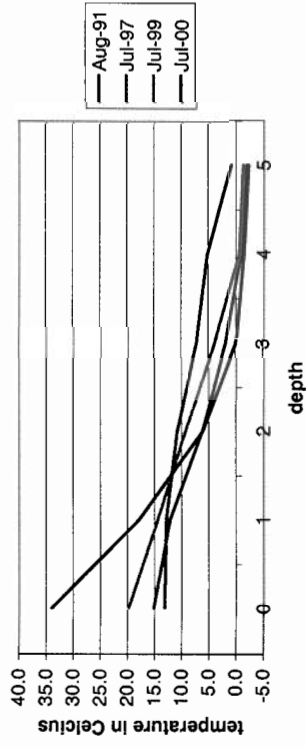
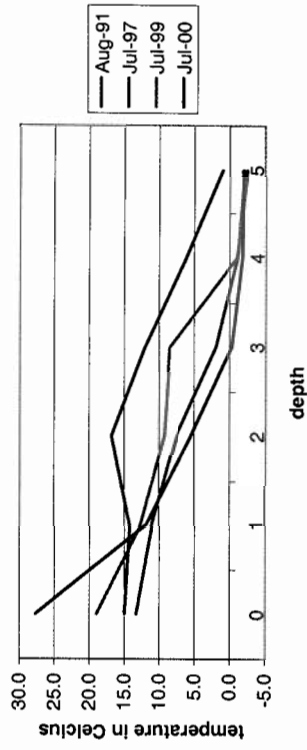
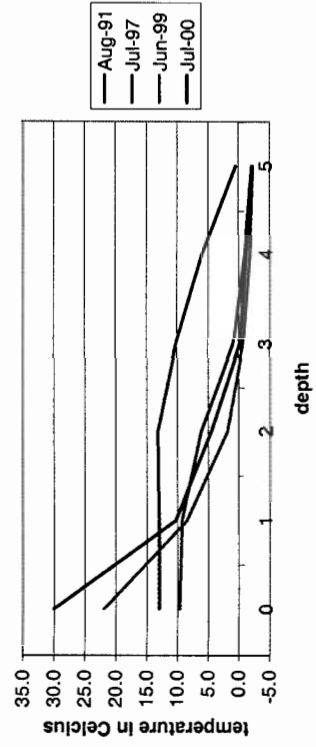
Thermistor Readings 2000

Thermistor readings in 1998 and 1999 indicated that the summer thaw zone in the tailings has remained static at 0.7 metres. The Thermistors were read once in 2000 with similar results (see Appendix 1 for results).

Although the entire tailings mass has not become encapsulated in permafrost, placement of cover has been a partially successful experiment. Instead of the top 1.4 m of tailings material thawing each summer, as was happening before any cover was placed, now only the top 0.7 m of tailings material thaws for a short period each year. It is anticipated that, as the vegetation becomes more dense over the covered tailings, the permafrost level may resume its upward trend.

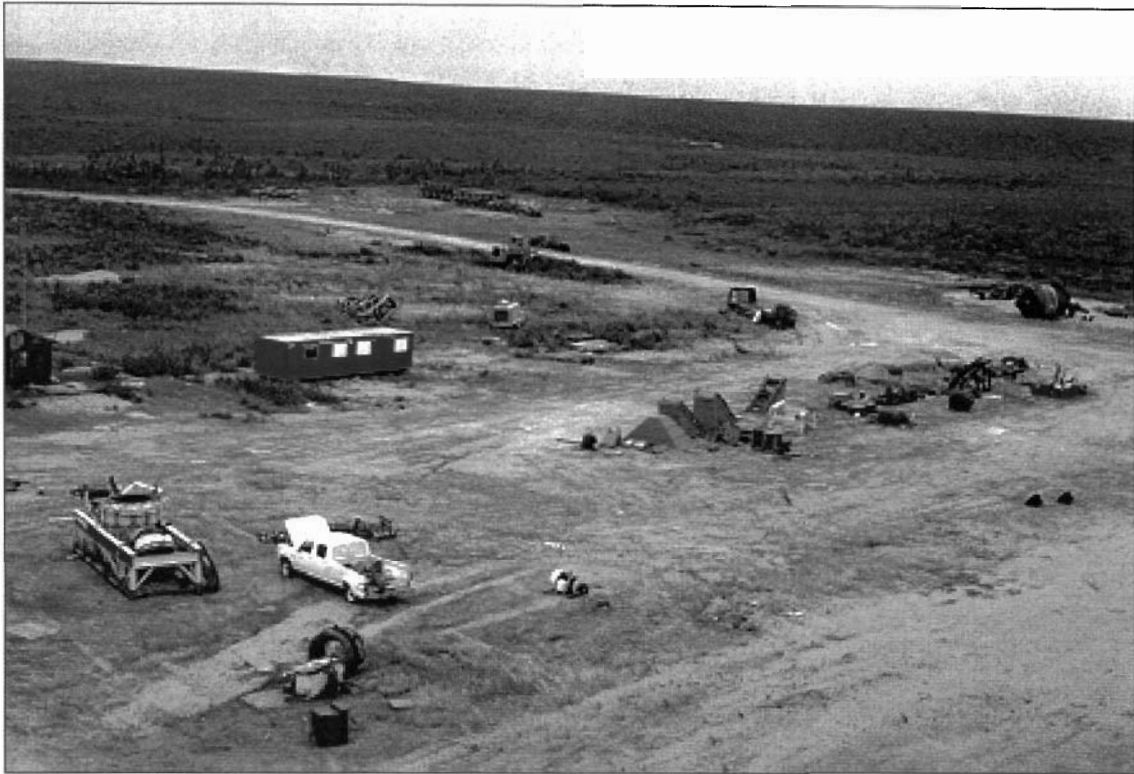
Non-salvageable materials at the airstrip

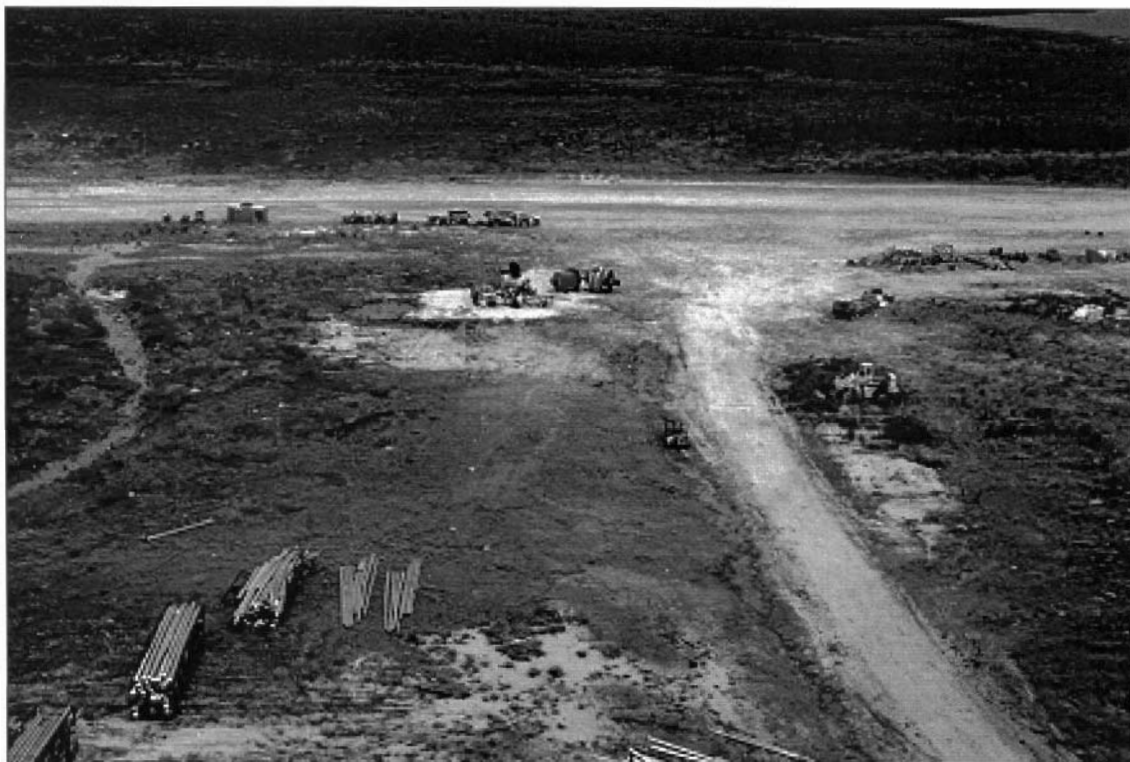
Non-salvageable materials at the airstrip

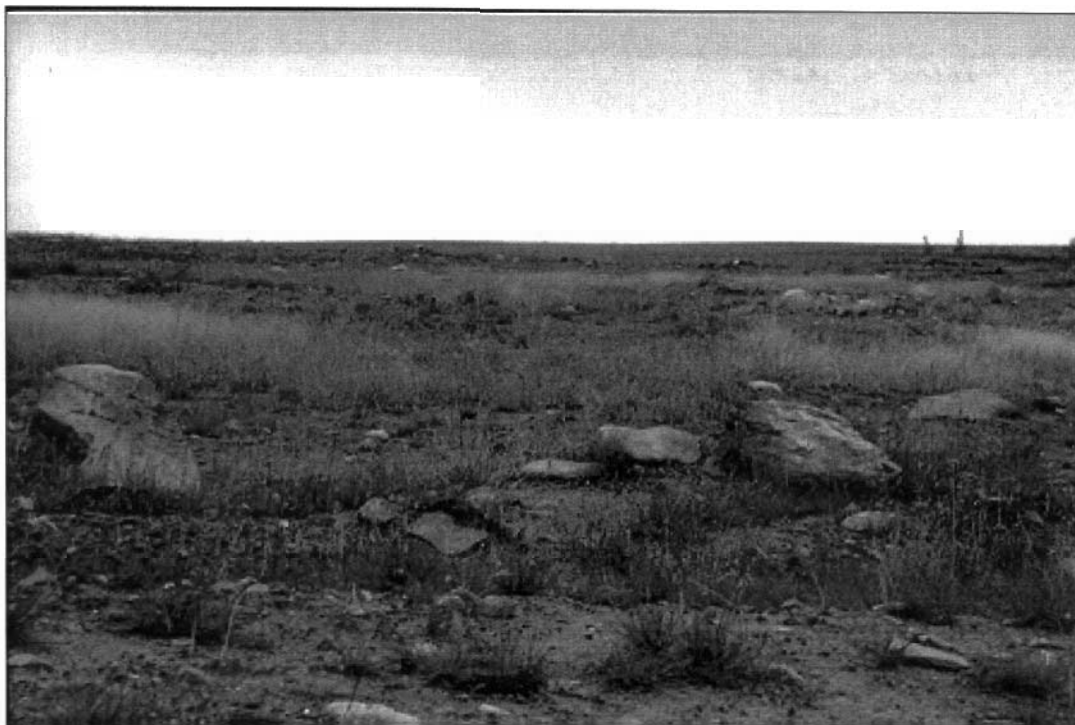
The 2000 site inspections identified a number of grass species established on the tailings cover. The grasses were more abundant in the protected furrows and tracks. Vegetation growth in 2000 was without the assistance of fertilizer.

Tailings area revegetation – Fall 2000

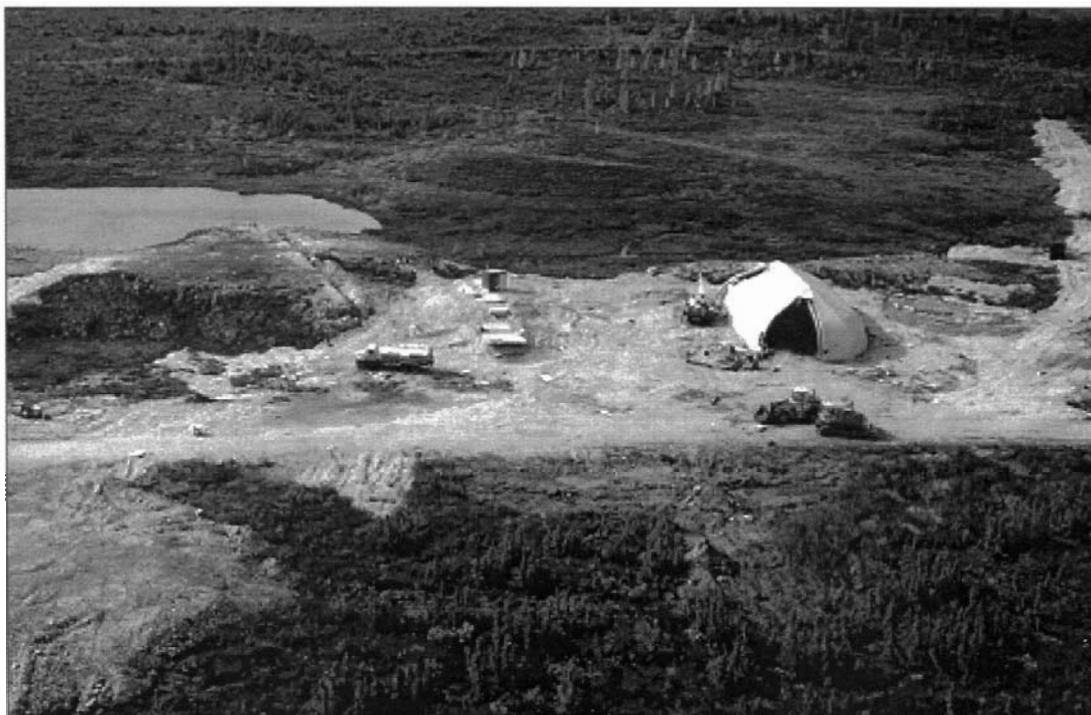
Non-salvageable equipment and scrap remains at the Shear Lake camp and will be removed and disposed of during final cleanup.

An area of Potentially Acid Generating (PAG) waste rock was identified at this site in 2000. Tests are currently underway to characterize the rock, and an application for a modification to the current Water Permit, to allow placement of this rock in a small, non-fish bearing lake, was submitted to the NWB in February 2001.

Shear Lake site requires cleanup

If permission is received to proceed, PAG waste rock located at the Shear Lake site will be disposed of underwater.
