CULLATON LAKE GOLD MINES LTD.

WATER LICENSE NWB1CUL0207

ANNUAL WATER LICENSE REPORT 2004

MARCH 2005

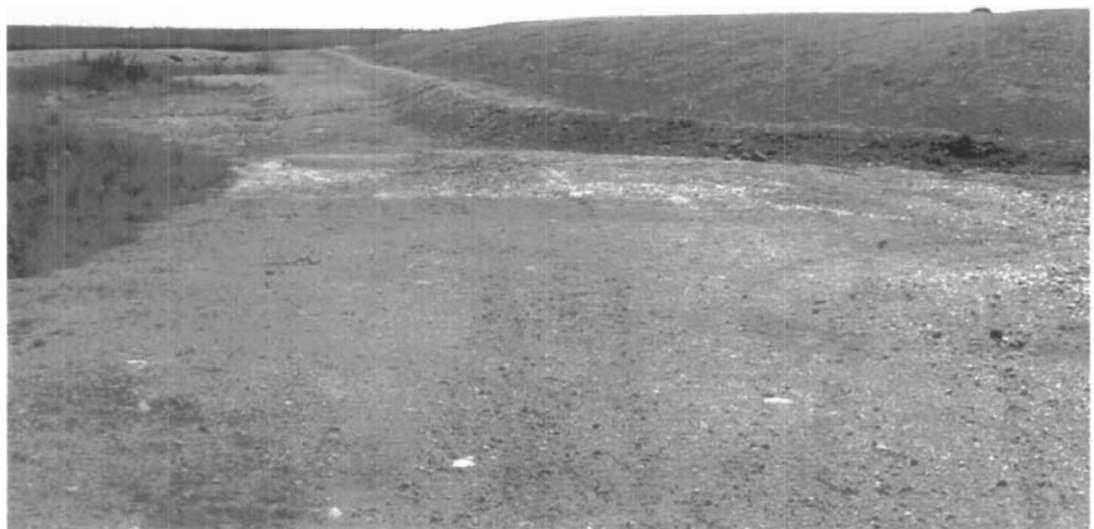
A minor amount of seepage was noted flowing into grassland across the access road northeast of the encapsulated waste rock (see photo 2, Appendix 1). It is felt that the seepage was due to spring run-off infiltrating the waste rock cover, in turn due to lack of an established vegetative cover. No damage to the receiving grassland was observed.

Station 940-25 (Seepage from Shear Lake Encapsulated Waste Rock) - Duplicate water samples were collected on July 7 from minor seepage flowing into grassland on the east side of the structure (i.e. the seepage was not reporting to Shear Lake). All parameters were below the limits prescribed in the Water License with the exception of field measured pH. However, laboratory pH returned a value within the limits prescribed in the Water License. It is felt that the discrepancy is due to field equipment accuracy. A more accurate unit will be used in future programs.

Photo 2: Area of seepage at northeast corner of encapsulated waste rock, July 7, 2004

- Shear Lake Encapsulated Waste Rock:

Although Barrick acknowledges that artificially introducing vegetation is not required pursuant to the Final Abandonment and Restoration Plan, it is felt that establishing a healthy vegetative cover earlier than natural infestation will create the desired conditions for containing the waste rock sooner. This should reduce the observed seepage substantially if not totally. The arctic seed mix previously recommended by the NWB will be used.

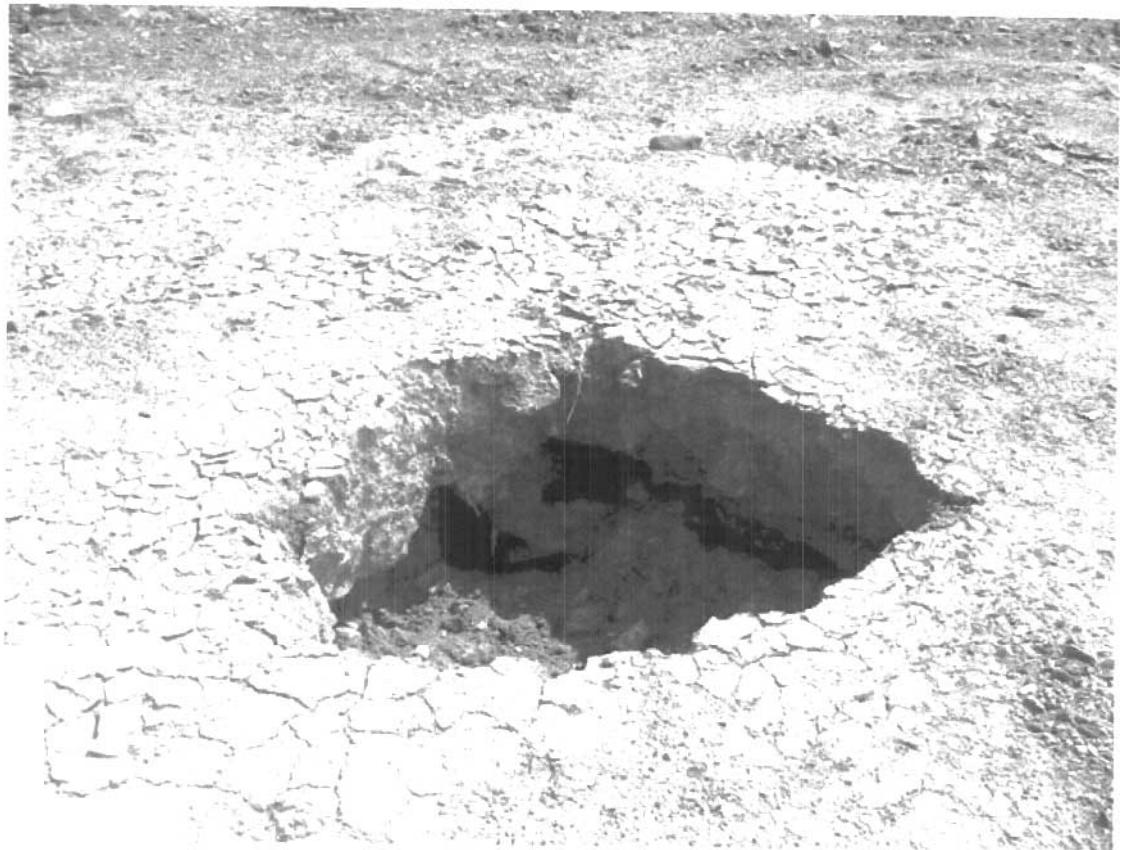
A minor amount of settlement is present in one location on the quarry pit landfill cover (see photo 3, Appendix 1).

Photo 3: Minor settlement in quarry pit cover, July 7, 2004

- Quarry Pit Cover:

Minor ground settlement will be repaired on the quarry pit cover.

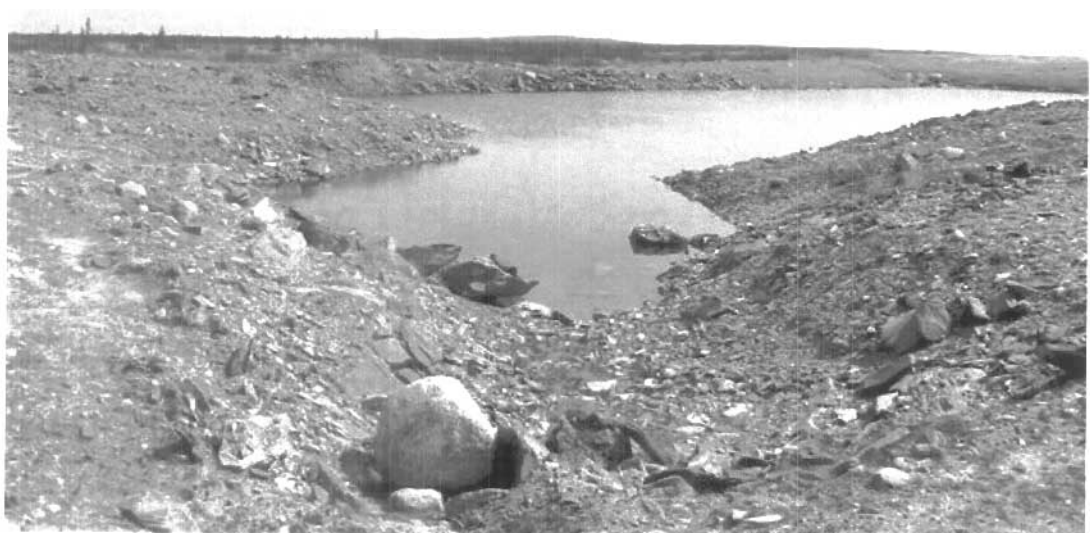
Photo 4: Flooded portion of Quarry Pit, looking southeast, July 7, 2004

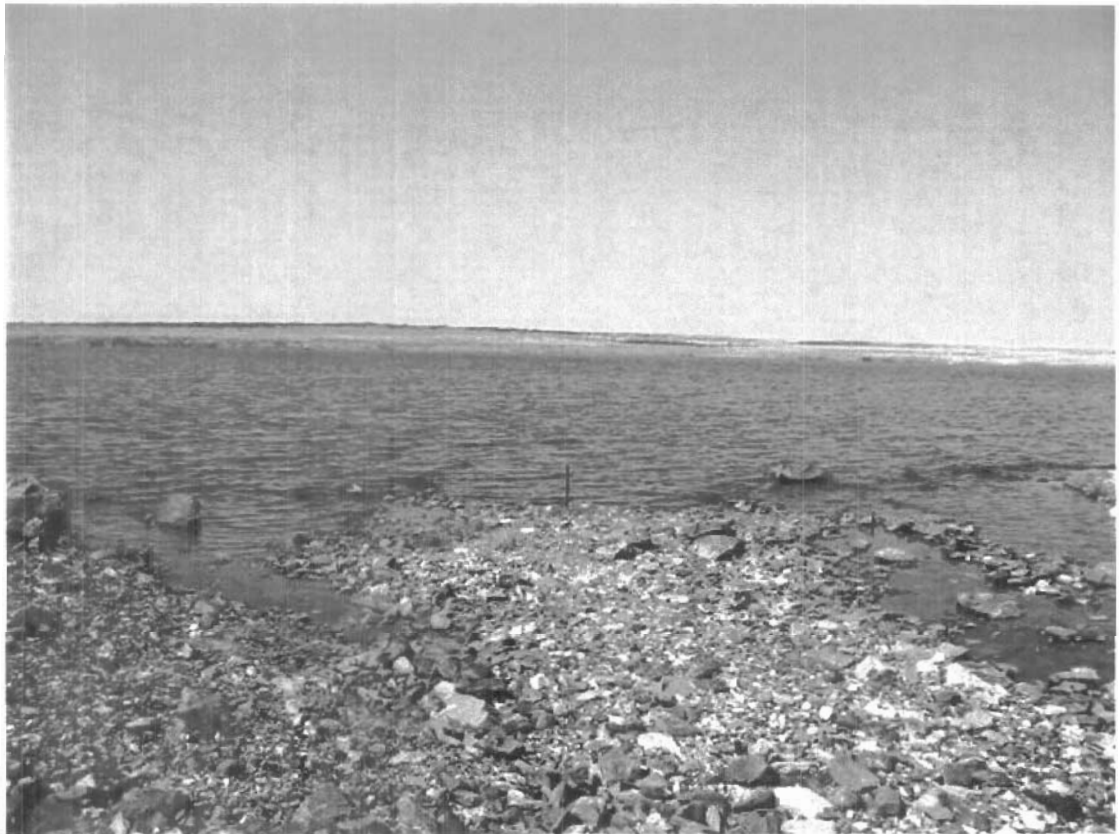
Photo 5: Flooded portion of Tailings No.1 Pond, looking northwest from spillway, July 7, 2004
