CULLATON LAKE GOLD MINES LTD.

WATER LICENSE NWB1CUL0207

ANNUAL WATER LICENSE REPORT 2004

MARCH 2005

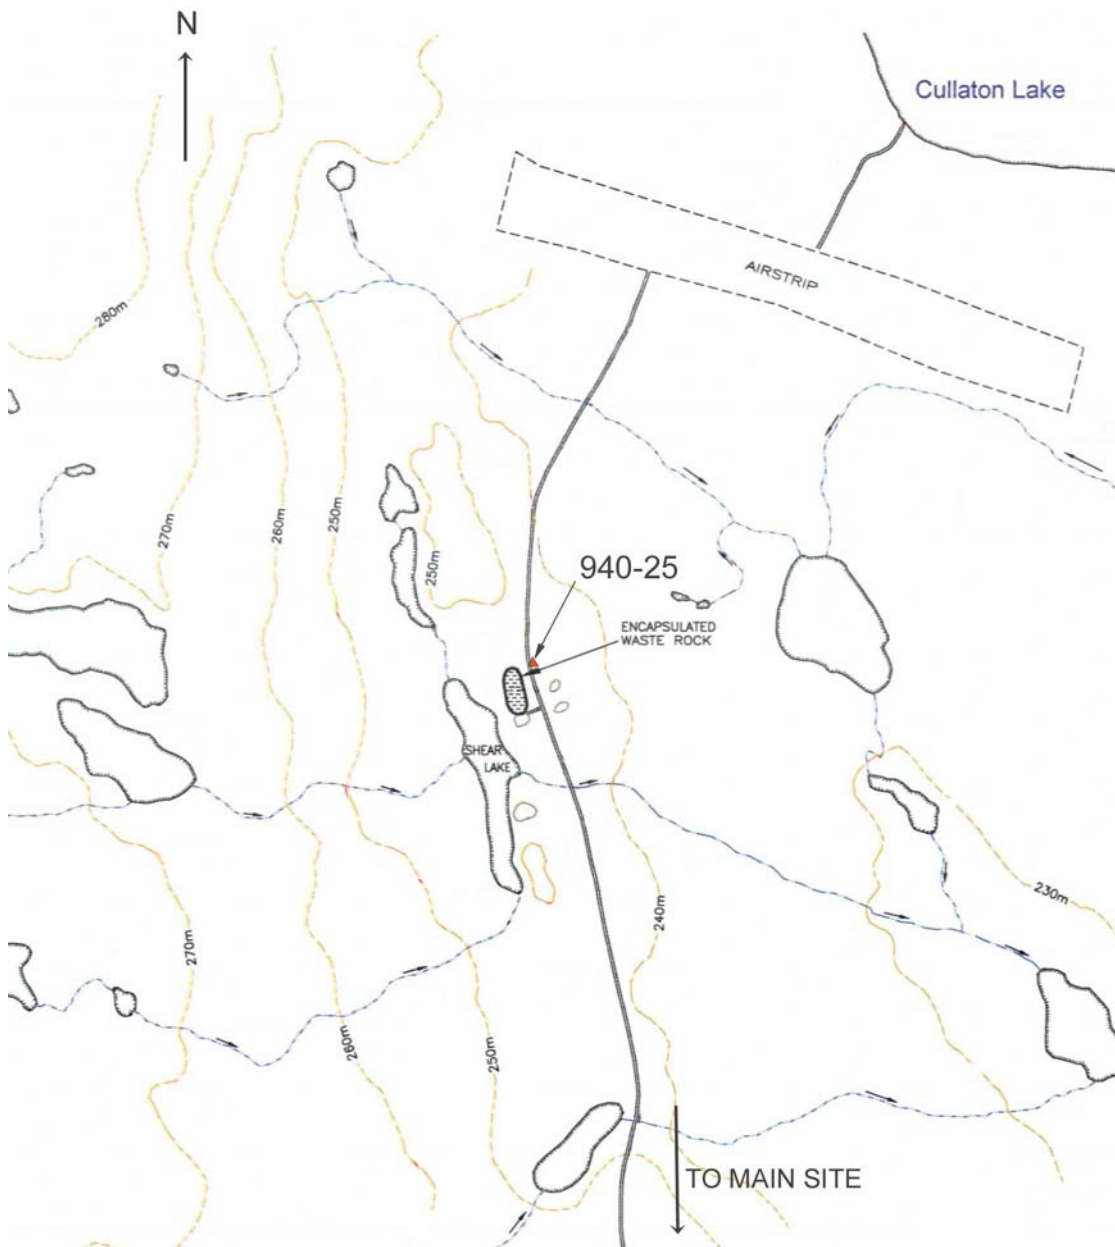
Figure 2: Cullaton Lake Shear Lake site showing features and water sampling station (not to scale).

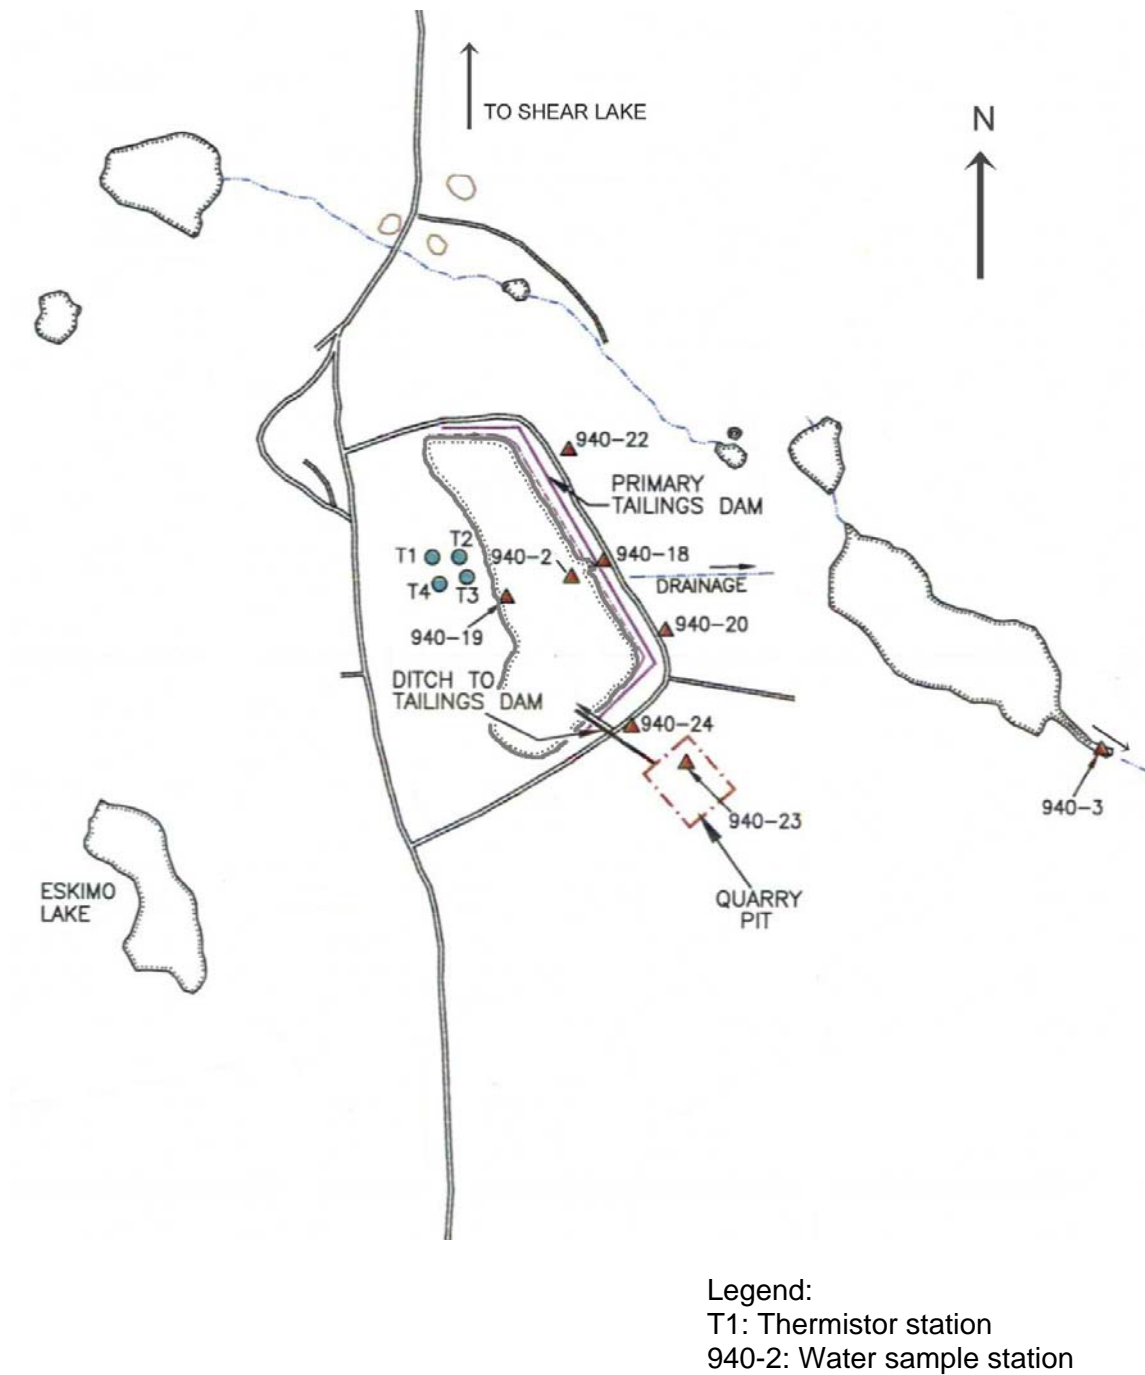
Figure 3: Cullaton Lake main site showing features, water sampling and thermistor stations (not to scale).

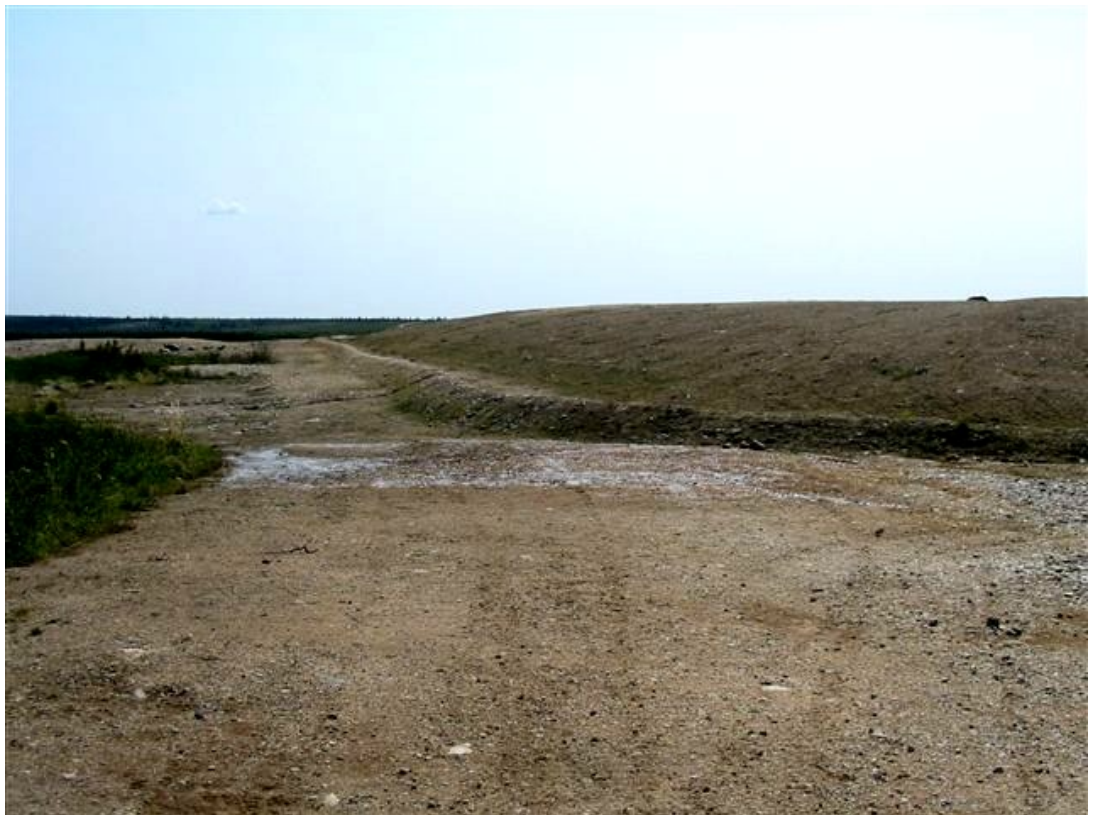
A minor amount of seepage was noted flowing into grassland across the access road northeast of the encapsulated waste rock (see photo 2, Appendix 1). It is felt that the seepage was due to spring run-off infiltrating the waste rock cover, in turn due to lack of an established vegetative cover. No damage to the receiving grassland was observed.

Photo 2: Area of seepage at northeast corner of encapsulated waste rock, July 7, 2004

- Shear Lake Encapsulated Waste Rock:

Although Barrick acknowledges that artificially introducing vegetation is not required pursuant to the Final Abandonment and Restoration Plan, it is felt that establishing a healthy vegetative cover earlier than natural infestation will create the desired conditions for containing the waste rock sooner. This should reduce the observed seepage substantially if not totally. The arctic seed mix previously recommended by the NWB will be used.

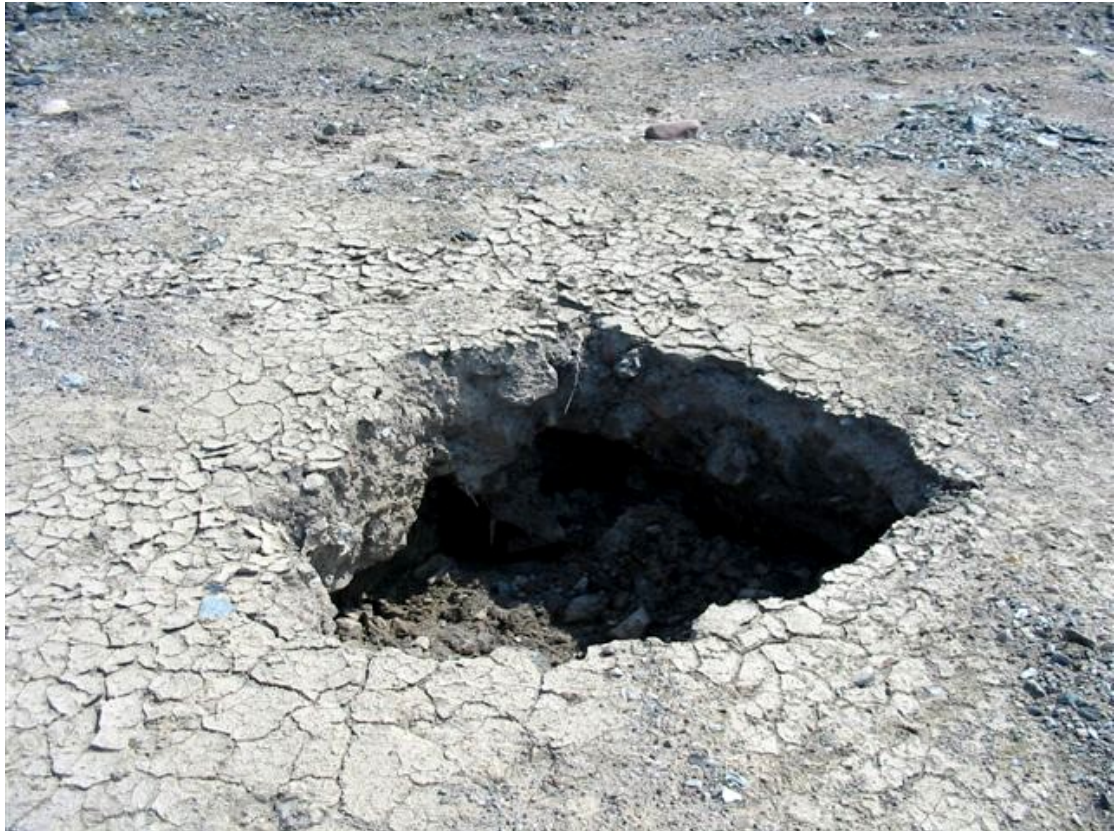
A minor amount of settlement is present in one location on the quarry pit landfill cover (see photo 3, Appendix 1).

Photo 3: Minor settlement in quarry pit cover, July 7, 2004

- Quarry Pit Cover:

Minor ground settlement will be repaired on the quarry pit cover.
