CULLATON LAKE GOLD MINES LTD.

WATER LICENCE NWB1CUL0207

ANNUAL WATER LICENCE REPORT 2005

MARCH 2006

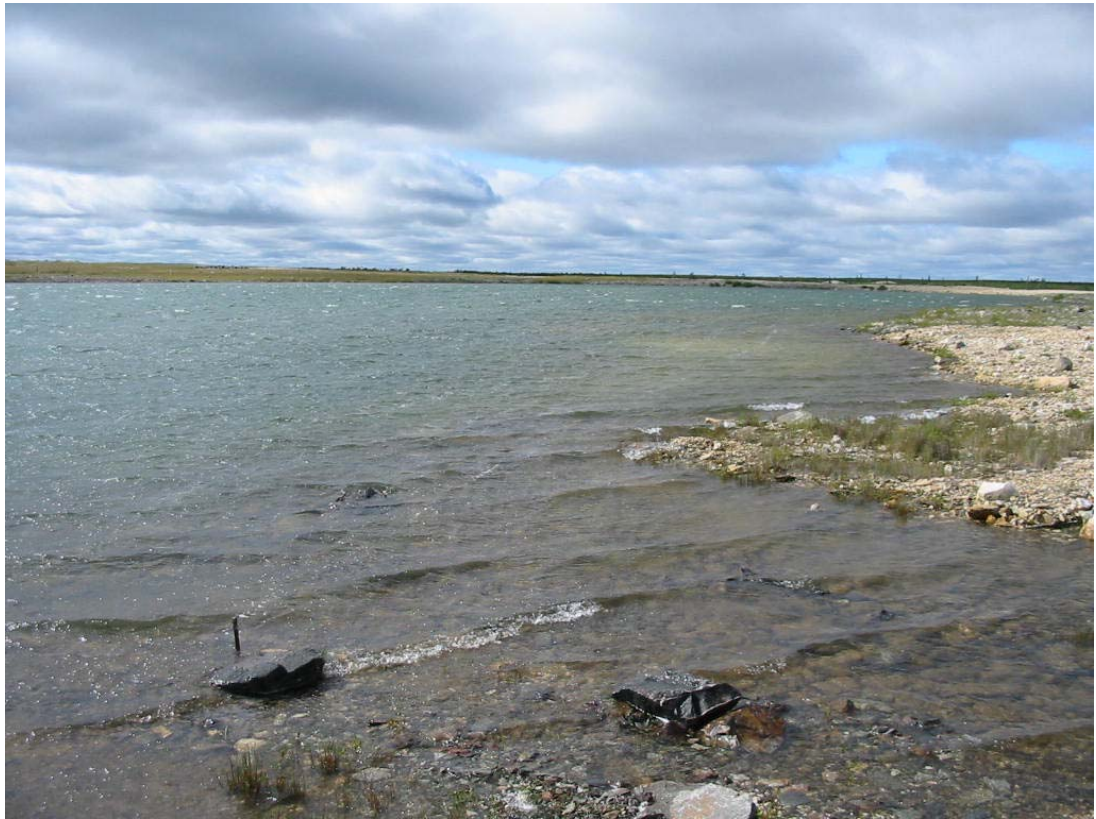
Photo 3: Flooded portion of Tailings No.1 Pond, looking northwest from spillway, August 4, 2005

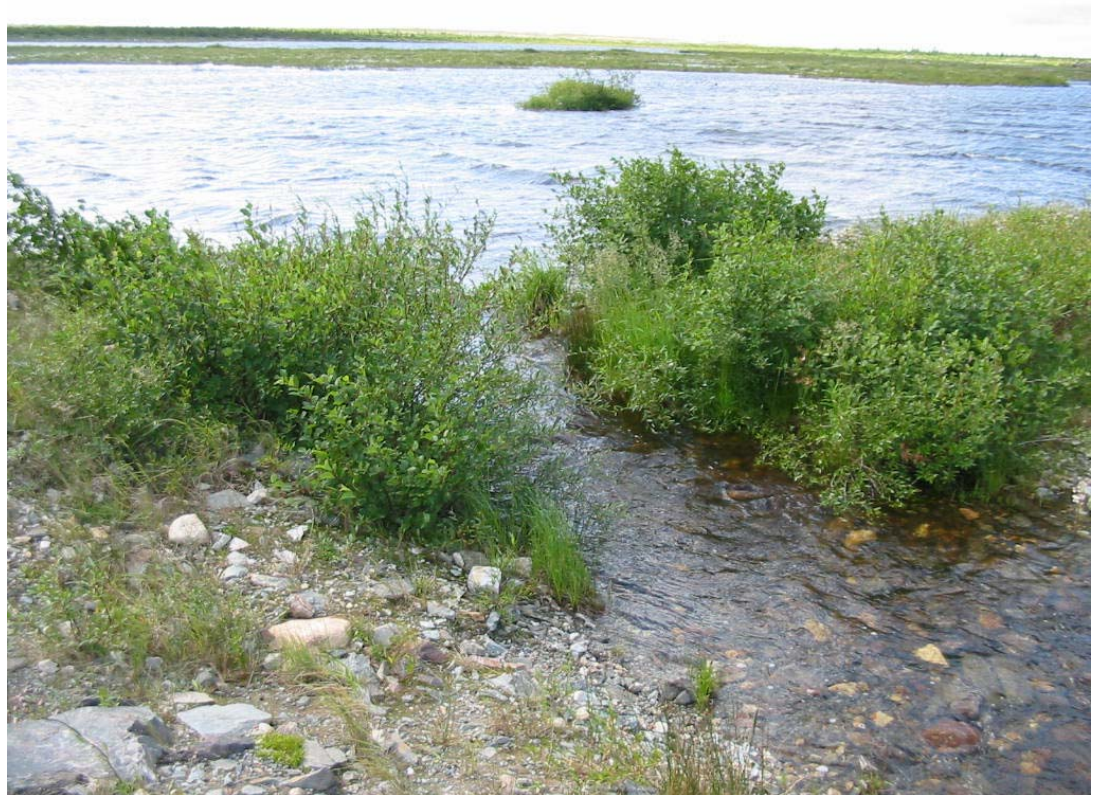
Photo 4: Flooded portion of former polishing pond, looking west from spillway, August 4, 2005

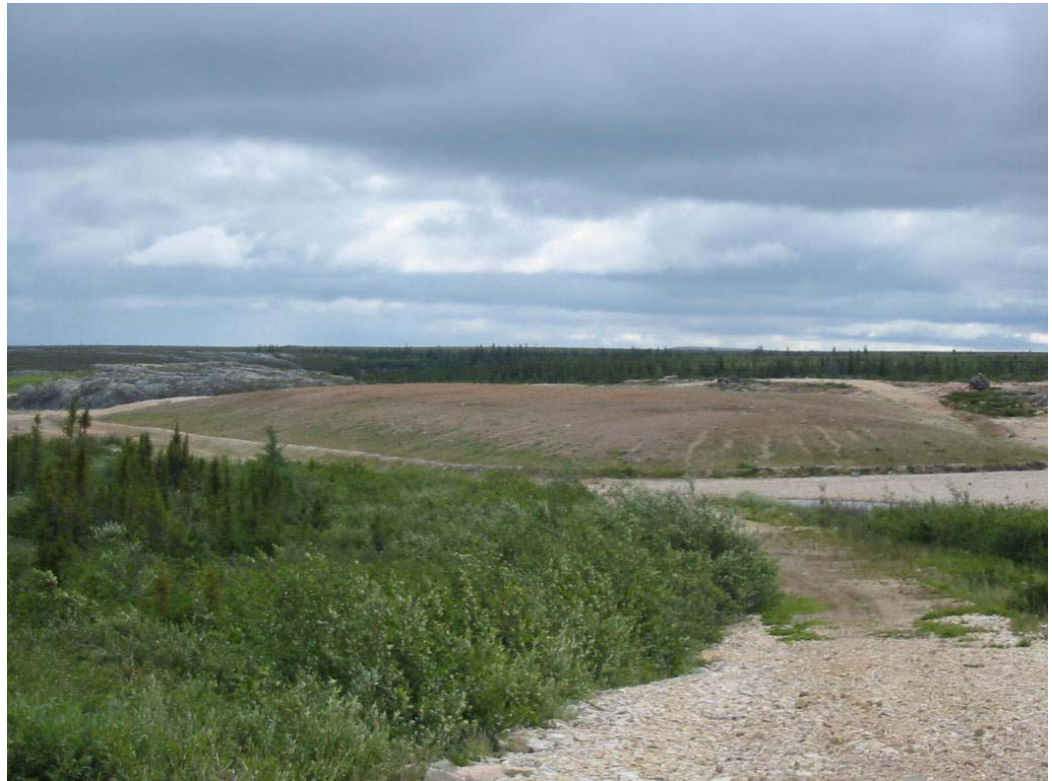
The cover was lightly scarified before, in between and after the applications of fertilizer and seed. In addition, minor erosion scars noted during the 2004 inspection on the cover

Photo 8: Encapsulated Waste Rock at Shear Lake following the application of additional seed and fertilizer. The erosion scars are visible in the foreground due to being filled in with lighter coloured granular road material.

flanks were filled in with granular road material to provide protection from further erosion (see Photo 8, Appendix 1).

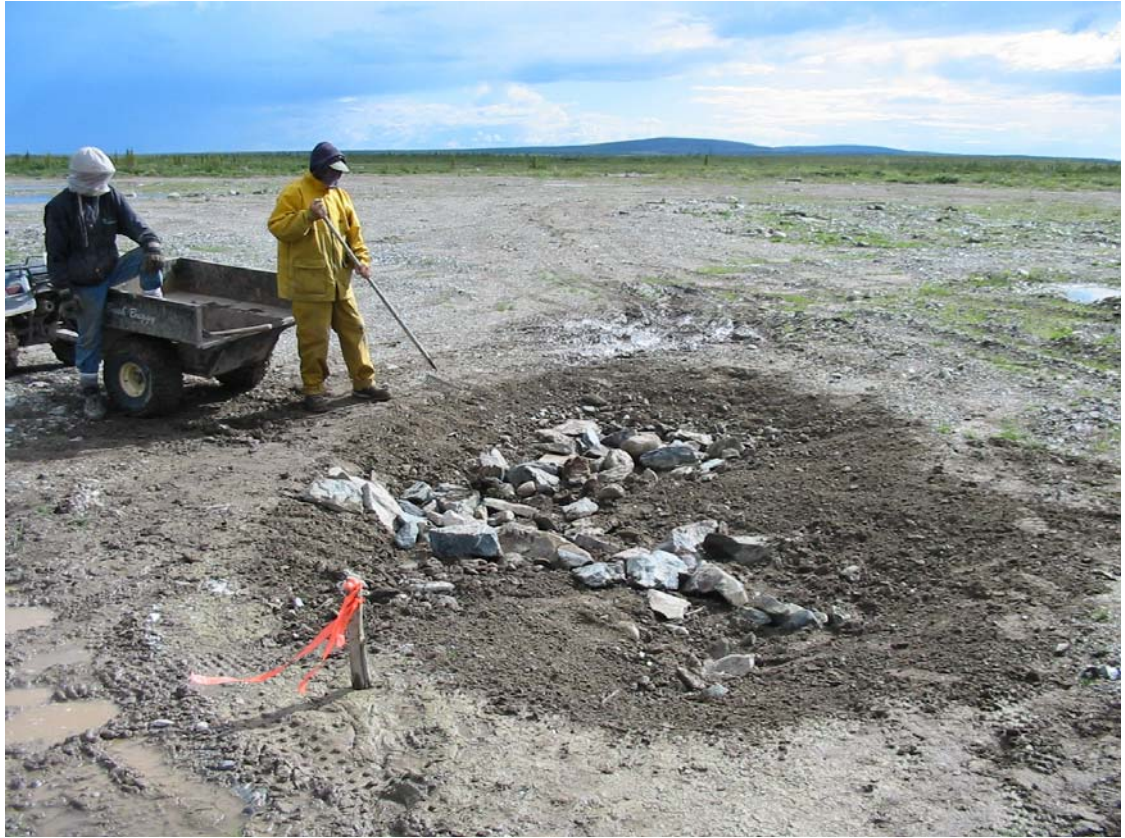
Photo 9: Minor settlement in quarry pit cover filled in August 4, 2005

Minor settlement on the quarry pit cover was filled in (see Photo 9, Appendix 1).
