CULLATON LAKE GOLD MINES LTD.

WATER LICENCE NWB1CUL0207

ANNUAL WATER LICENCE REPORT 2006

February 2007

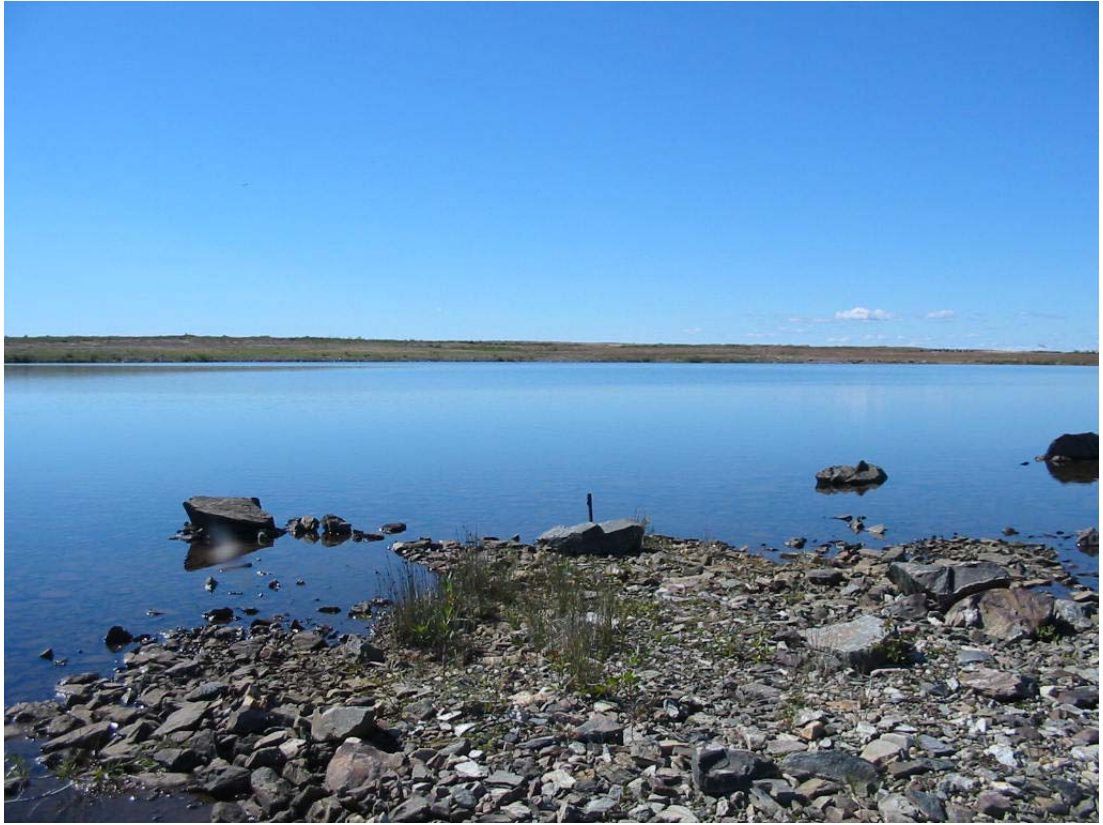
Photo 3: Flooded portion of Tailings No.1 Pond, looking northwest from spillway, August 2, 2006

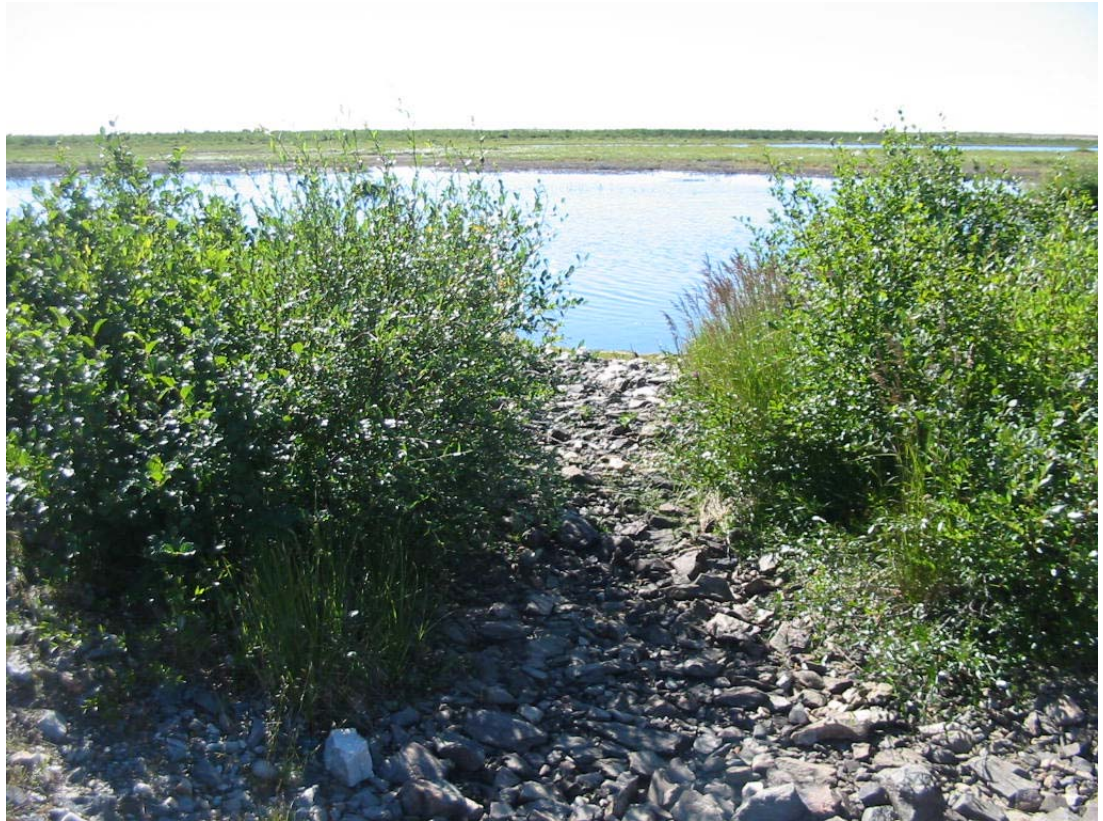
Photo 4: Flooded portion of former polishing pond, looking west from spillway, August 2, 2006

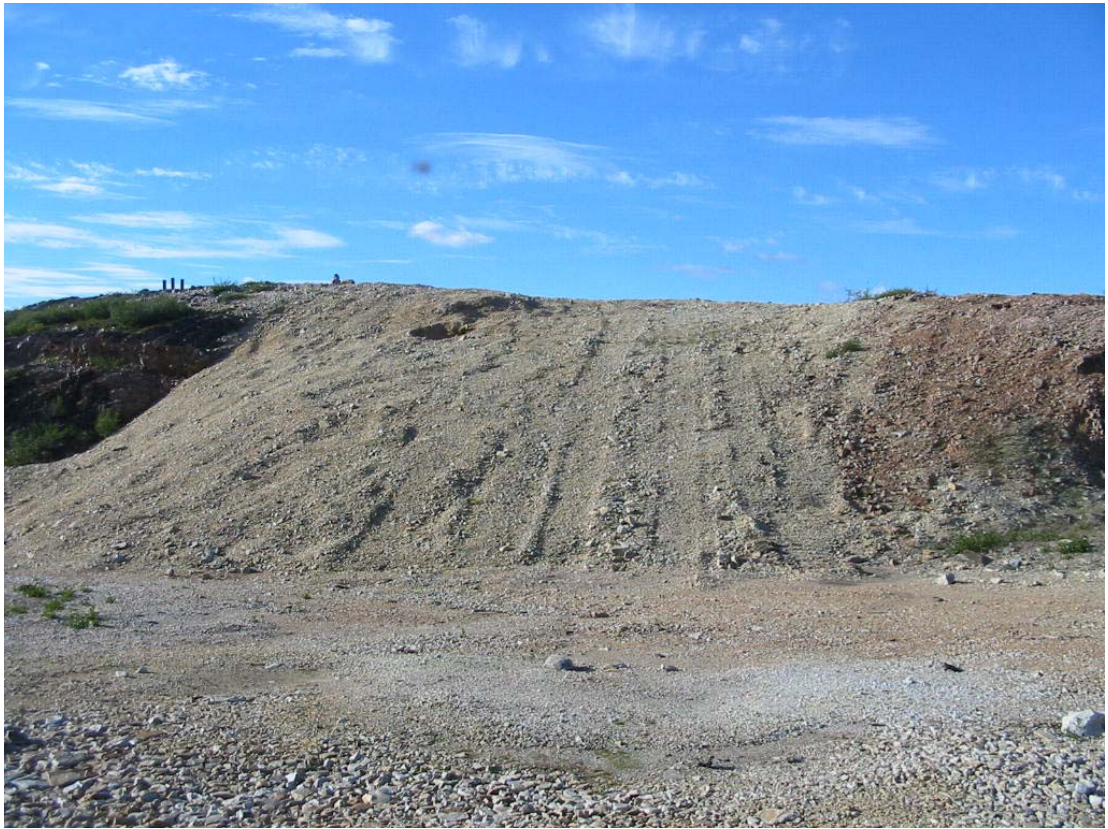
Some additional minor settlement was observed in areas previously filled and at the Shear Lake Portal (see Photos 5 and 9).

Photo 5: Former Shear Lake Portal, August 2, 2006

The 2007 program will consist of a site inspection, water quality and thermistor monitoring, tailings dam geotechnical inspection and EWR cover stability inspection. The program is tentatively scheduled to occur during the first week of August. During the site inspection, some minor final top dressing will be completed manually at previously filled areas of settlement and at the Shear Lake portal.

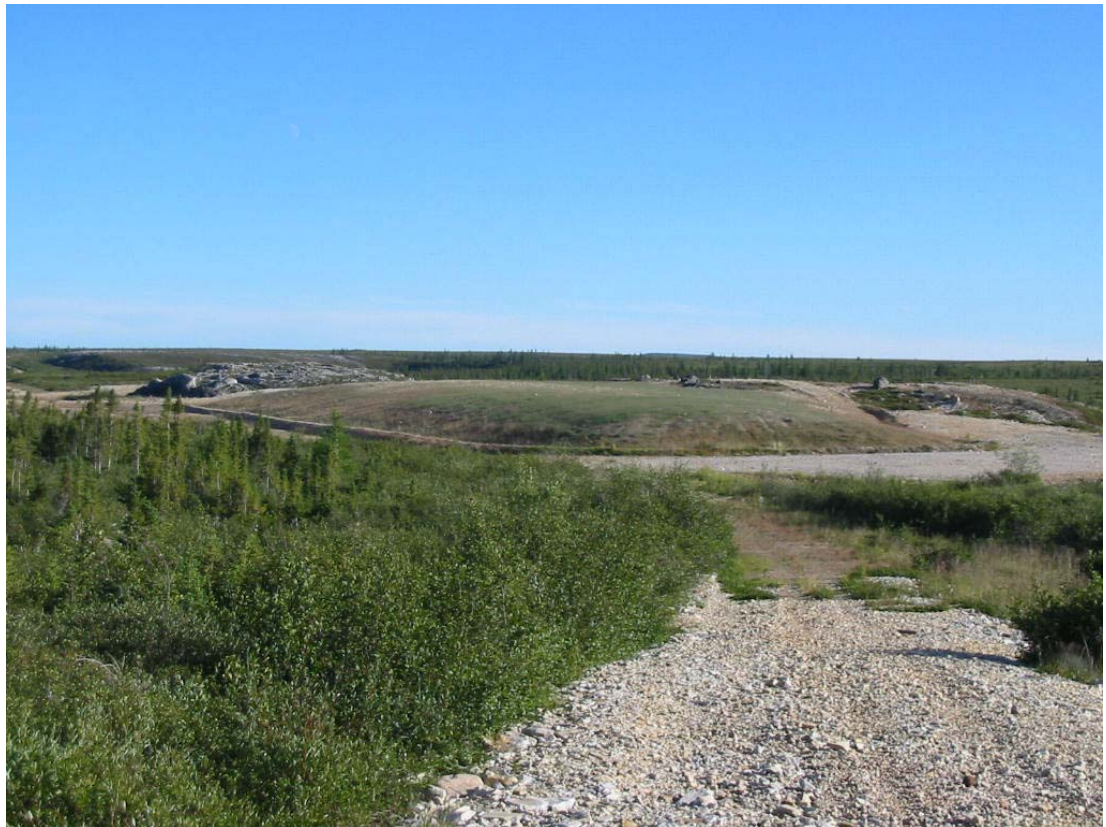
Pursuant to Licence Amendment No.1 date June 6, 2005, Part C, Item 1(e), the condition of the encapsulated waste rock cover at Shear Lake is to be monitored by the geotechnical engineer for erosion until vegetation is sufficiently established so as to stabilize the cover. At the time of the 2006 site inspection, the engineer noted that, while there are some sparse areas, the vegetation resulting from the 2005 seed and fertilizer application is helping to reduce erosion. A recommendation for additional monitoring was also made.

Photo 8: Encapsulated Waste Rock at Shear Lake 1 year after the application of additional seed and fertilizer. Erosion scars are visible due to being filled in with lighter coloured granular road material.

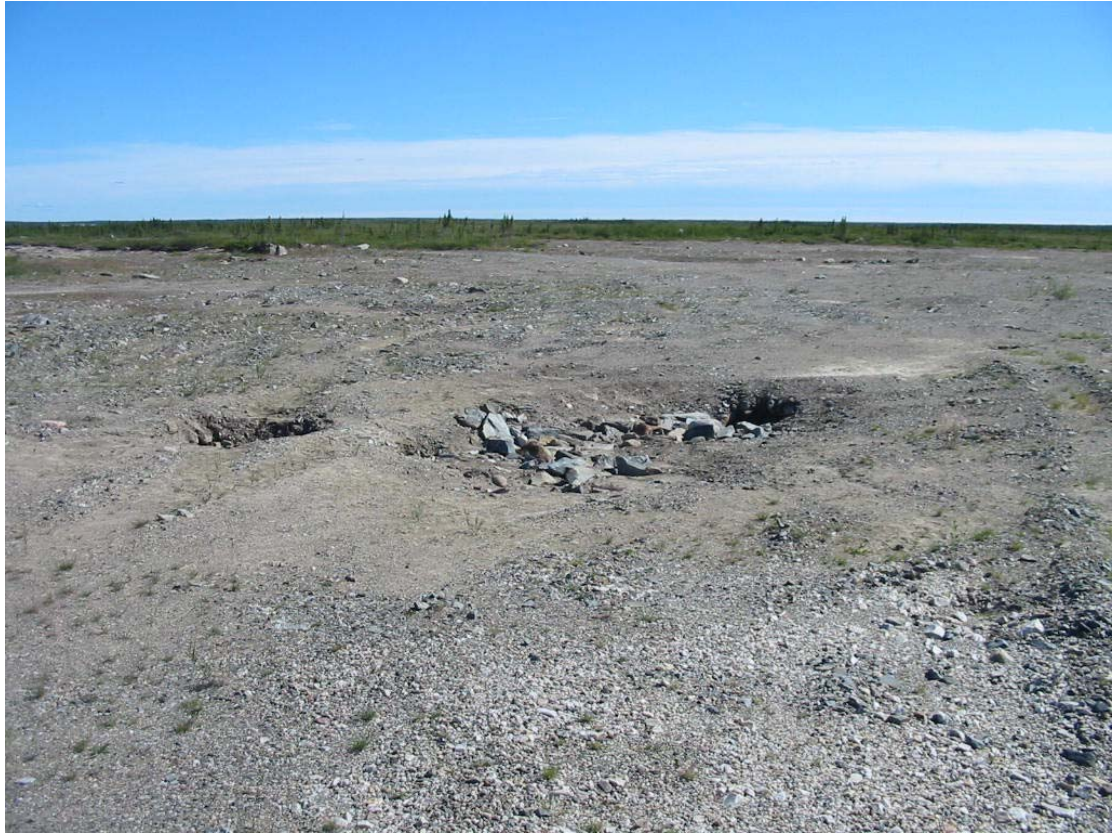
Photo 9: Minor settlement in quarry pit cover 1 year after being filled in on August 4, 2005
