**CULLATON LAKE GOLD MINES LTD.**

**WATER LICENCE 1BR-CUL0911**

**ANNUAL WATER LICENCE REPORT 2008**

**March 2009**

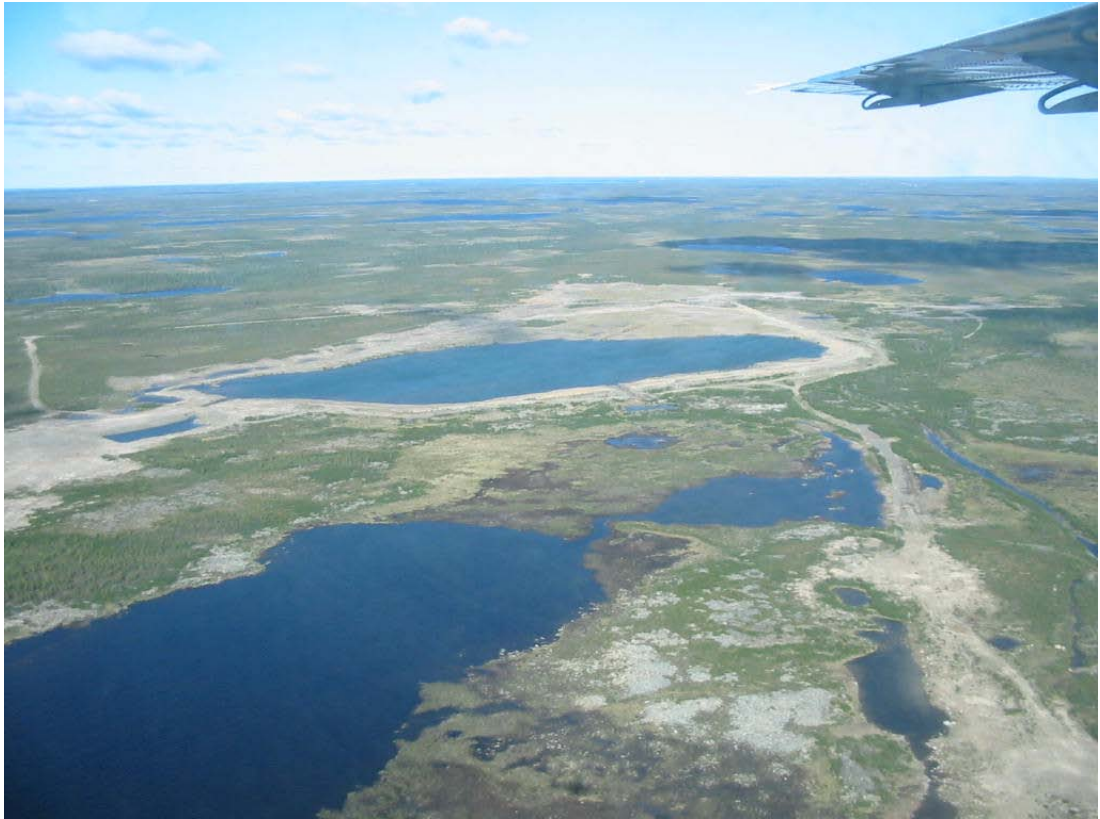
Photo 1: Cullaton Lake main site, looking west, July 5, 2007

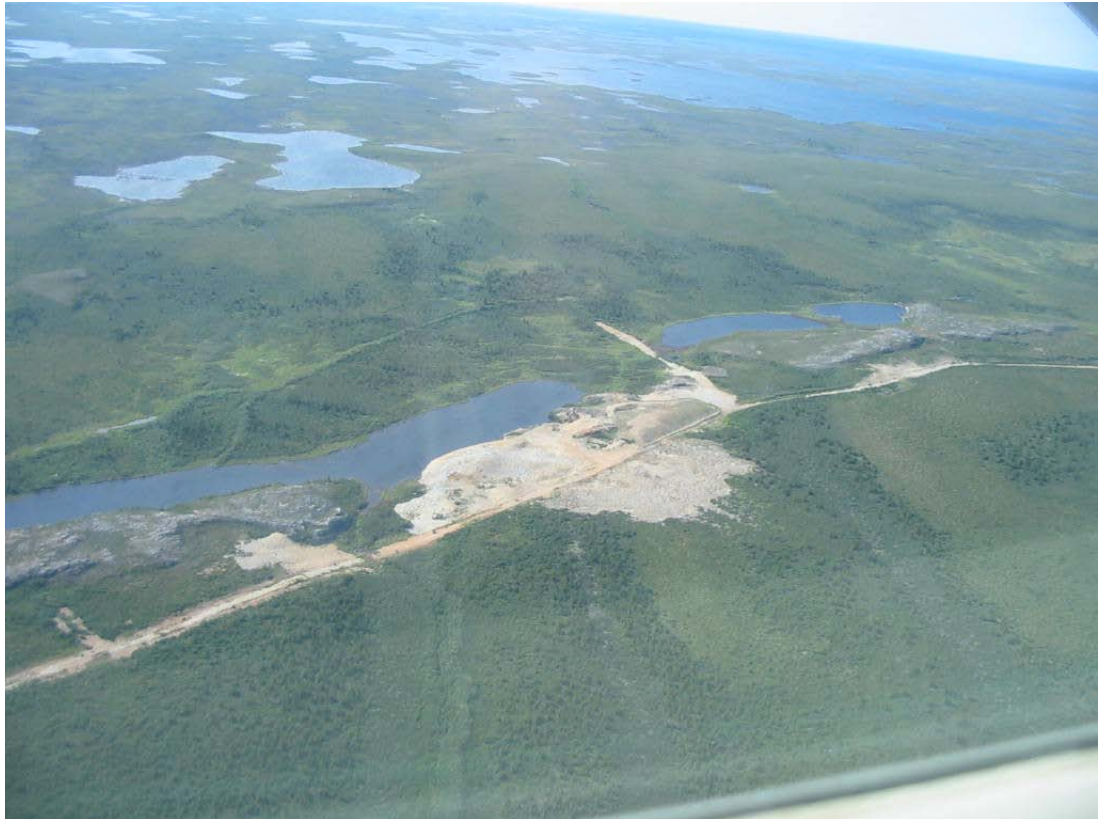
Photo 2: Shear Lake site, looking northwest, August 3, 2008

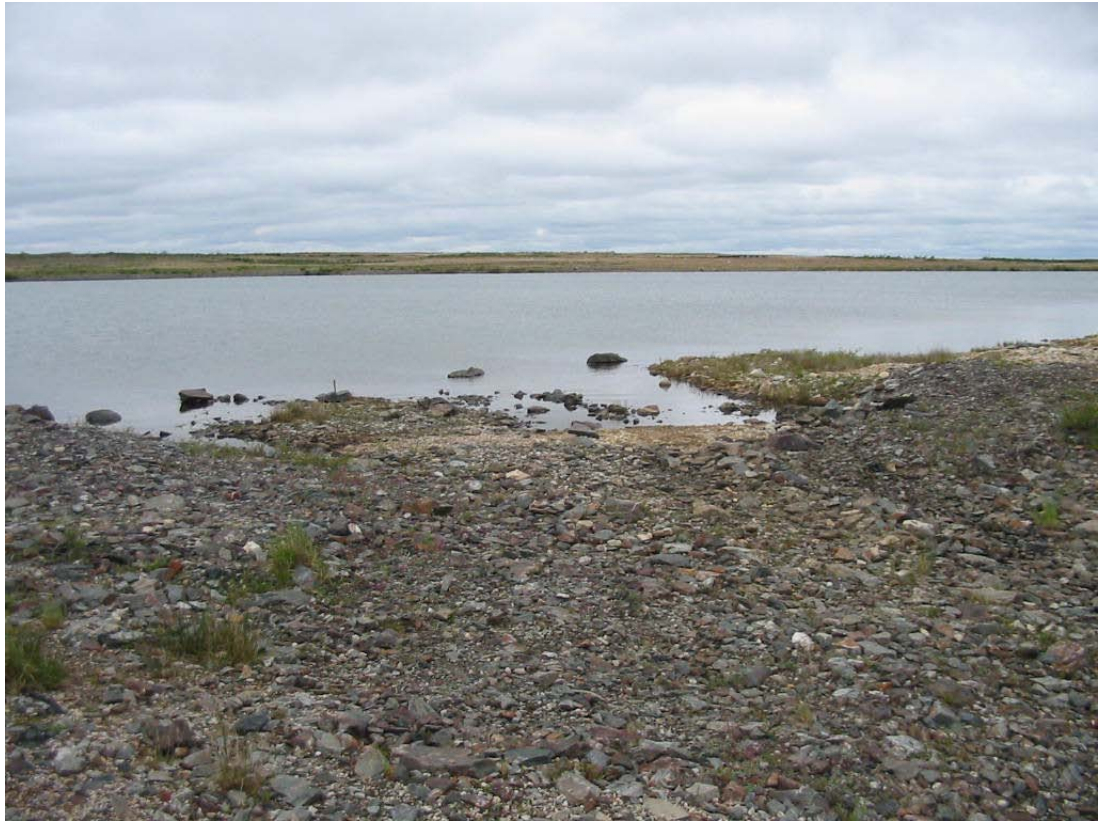
Photo 3: Flooded portion of Tailings No.1 Pond, looking northwest from spillway, August 3, 2008

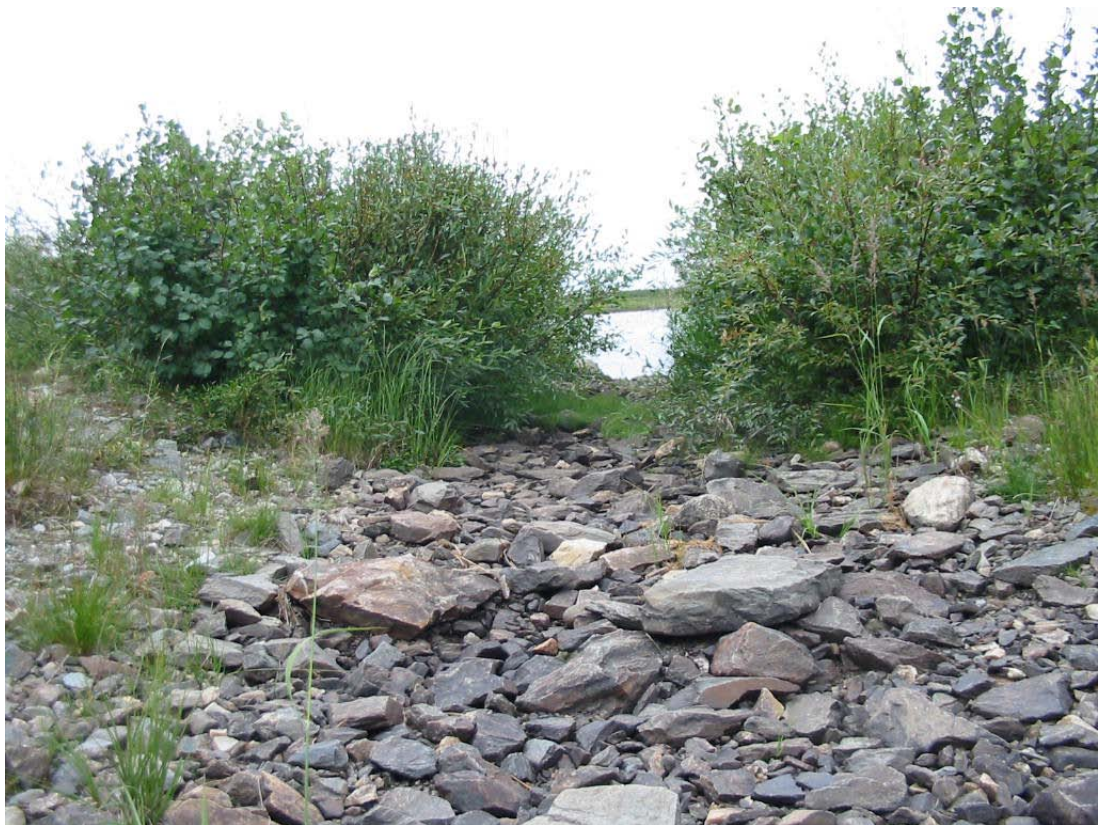
Photo 4: Flooded portion of former polishing pond, looking west from spillway, August 3, 2008

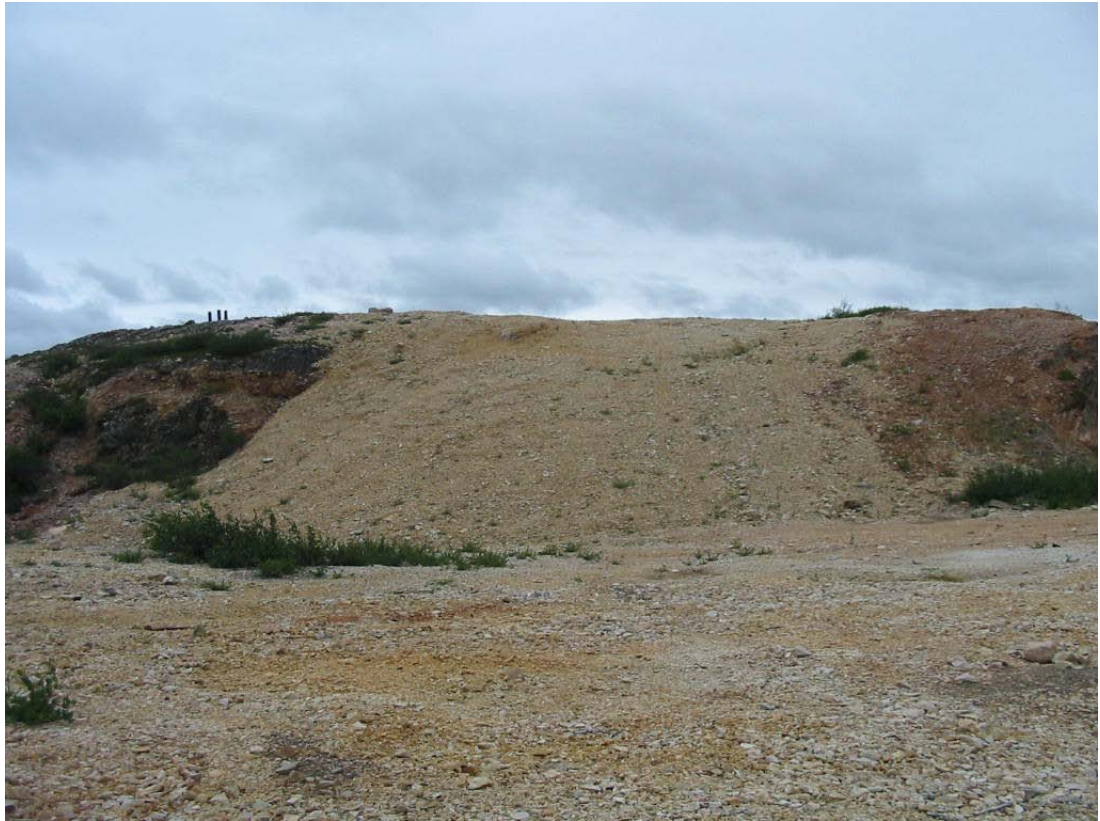
Photo 5: Former Shear Lake Portal, August 3, 2008.

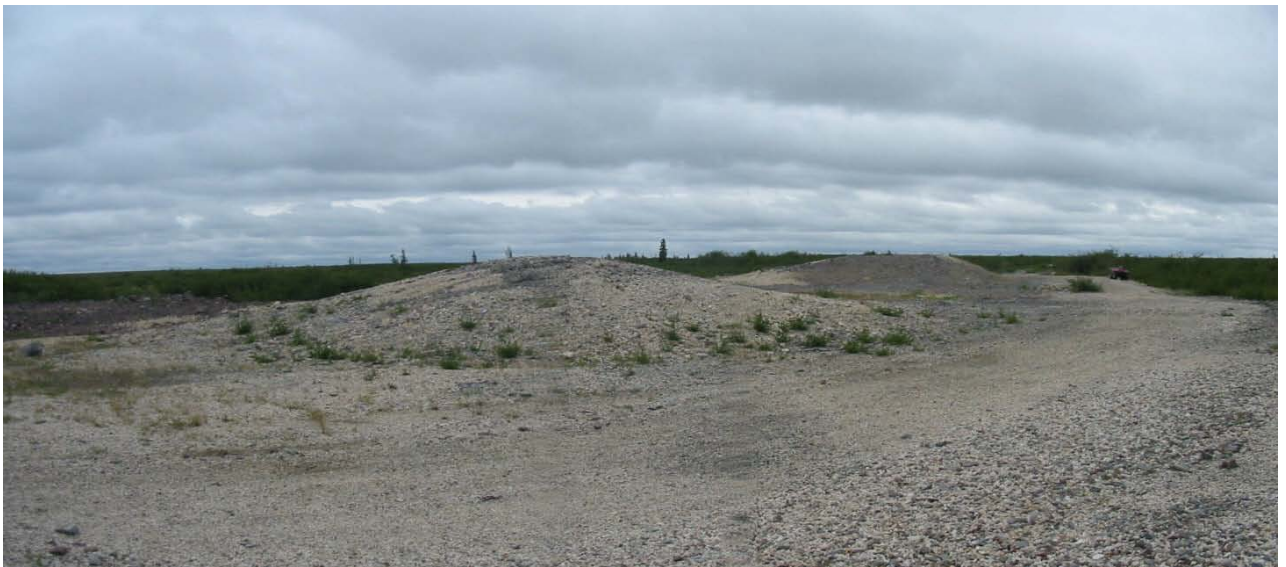
Photo 6: Former B Zone Portal and Fresh Air Raise, looking north on August 3, 2008.

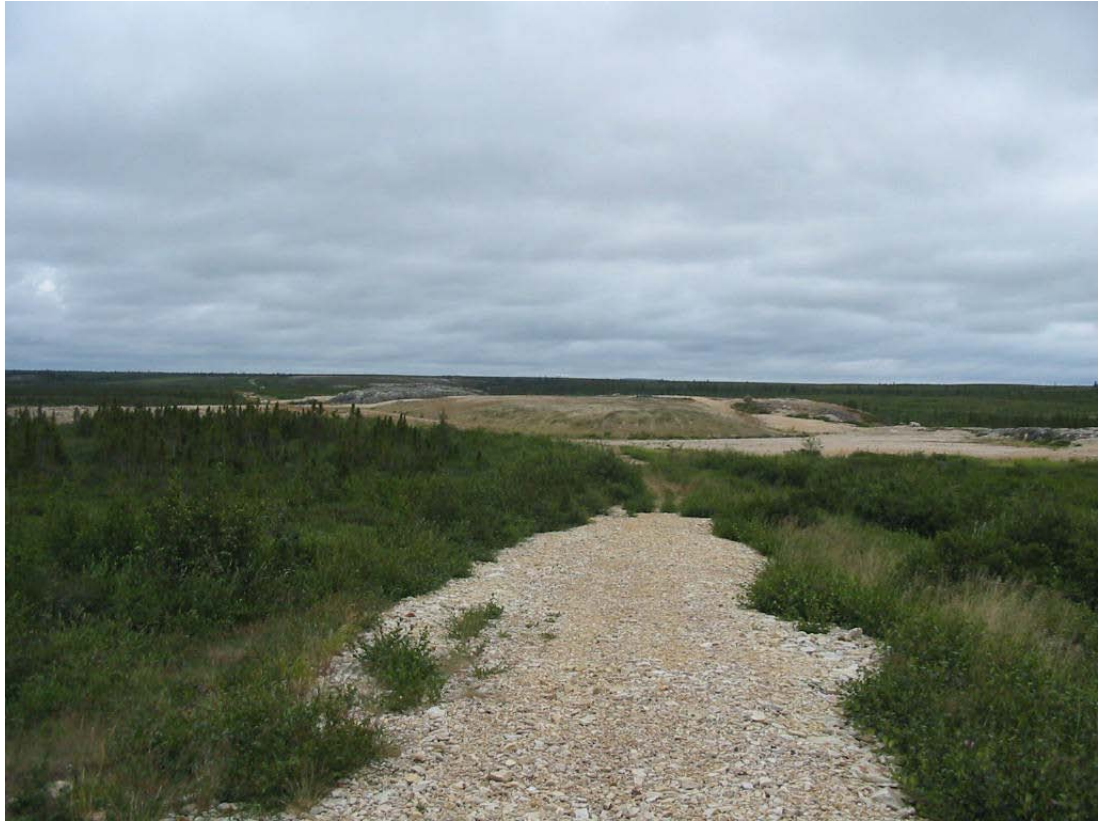
Pursuant to Licence No. NWB1CUL0207 amendment No.1 date June 6, 2005, Part C, Item 1(e), the condition of the encapsulated waste rock cover at Shear Lake is to be monitored by the geotechnical engineer for erosion until vegetation is sufficiently established so as to stabilize the cover. At the time of the 2008 site inspection, the engineer noted the vegetation continues to take hold and is helping to reduce erosion. A recommendation for additional monitoring was also made.

Photo 7: Encapsulated Waste Rock at Shear Lake 3 years after the application of additional seed and fertilizer. Erosion scars are visible due to being filled in with lighter coloured granular road material.

Minor maintenance activities including additional top dressing at previously filled areas of settlement and erosion channel repair as required.

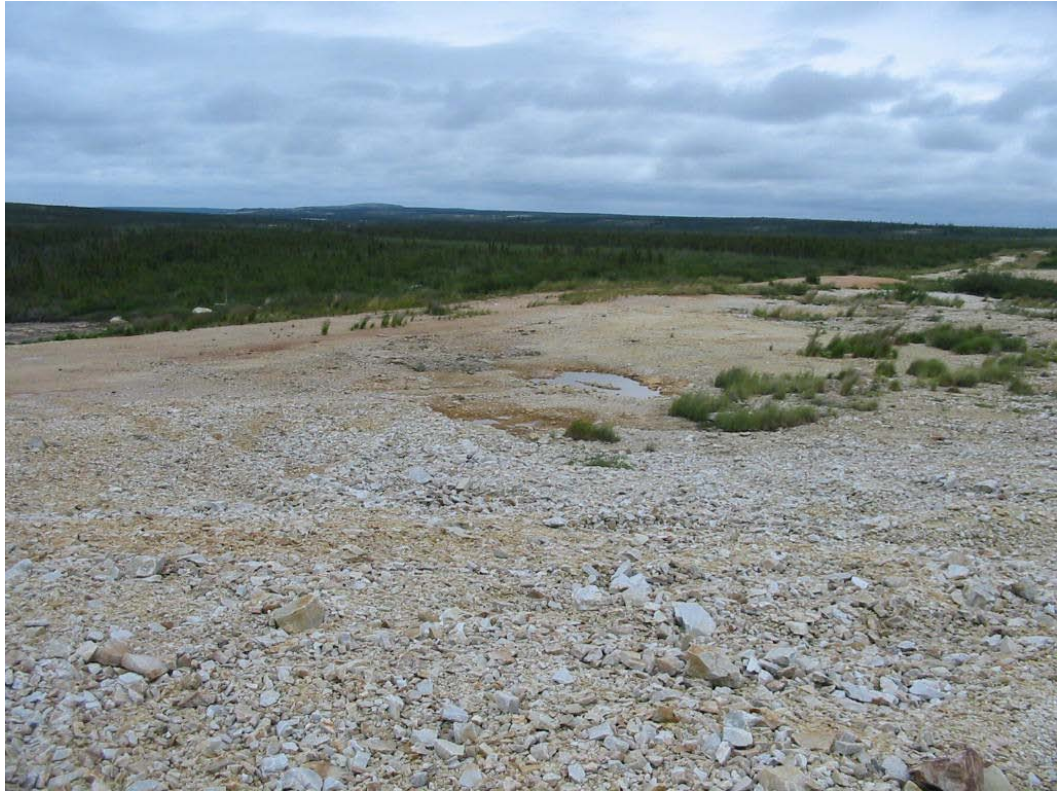
Photo 8: South side of former Shear Lake complex on August 3, 2008, with low pH pool in centre of photo.

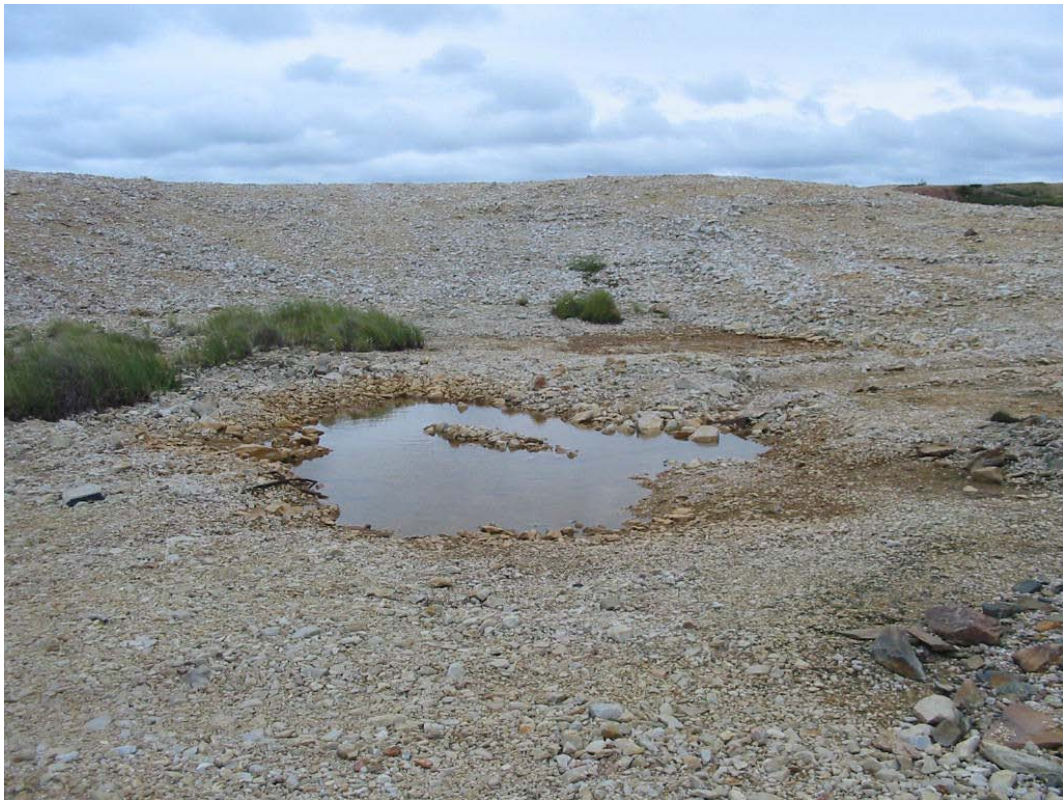
Photo 9: Low pH pool looking northwest on August 3, 2008.

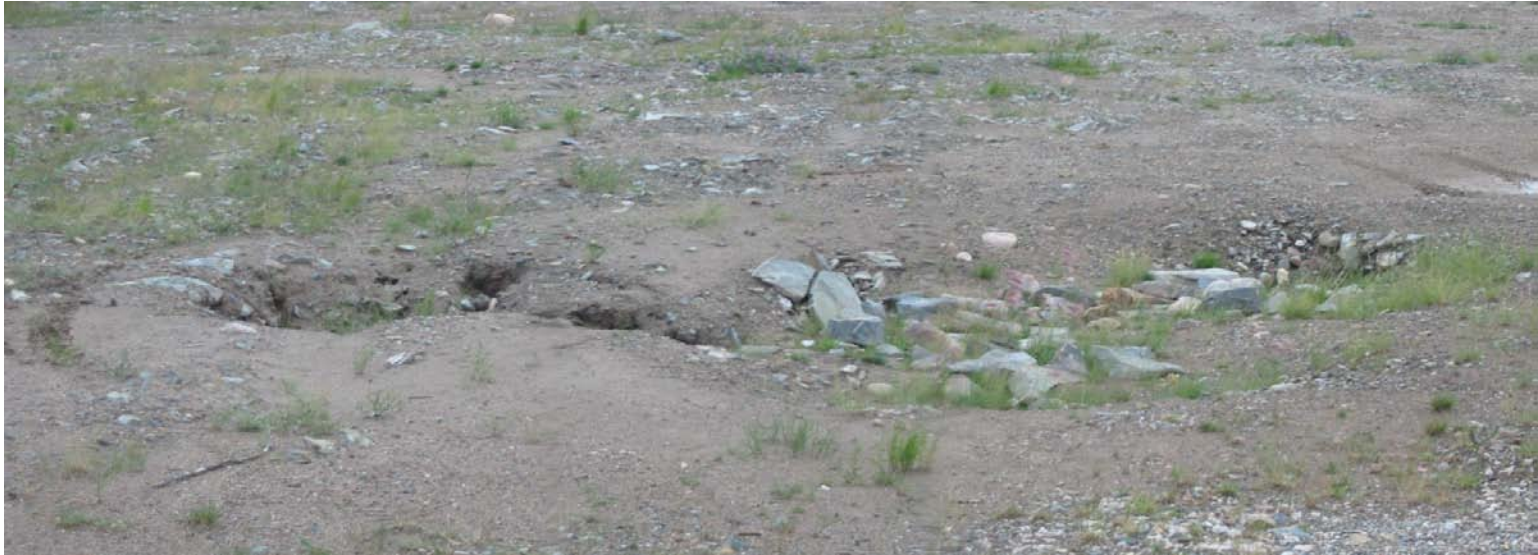
Photo 10: Minor settlement in quarry pit cover on August 3, 2008, 3 years after being filled in August, 2005.

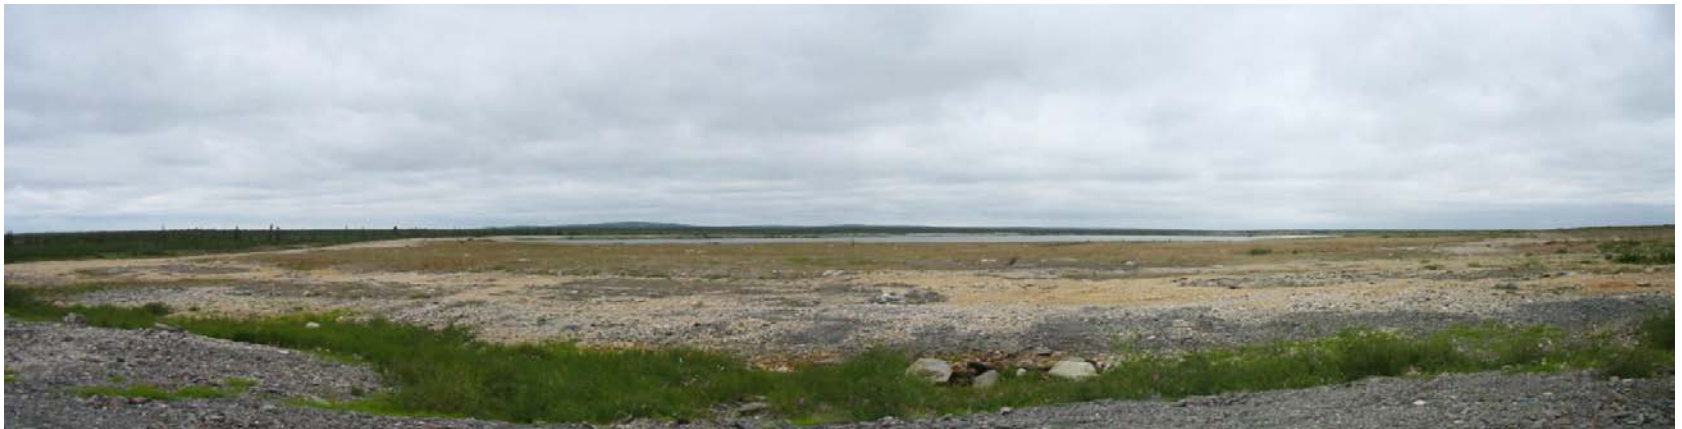
Photo 11: Tailings cover, looking east on August 3, 2008.

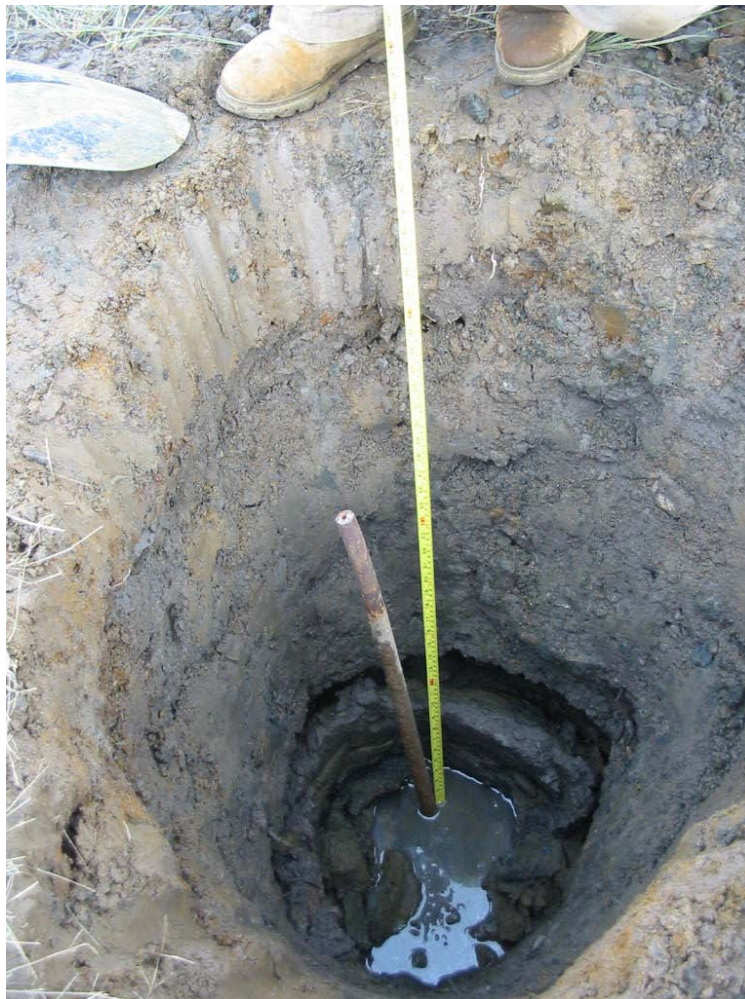
Based on the test pit finding, the permafrost was found at a depth of 2.0m on September 2, 2008. The thawed upper 20cm of tailings was unsaturated. The thawed lower 90cm of tailings was saturated (see field notes and photo in Appendix 3).

1.1m – 2m: saturated tailings

**2m: Permafrost**

Test pit excavated at T4 on September 2, 2008, showing till cover / tailings interface and water level.
