CULLATON LAKE GOLD MINES LTD.

WATER LICENCE 1BR-CUL0911

ANNUAL WATER LICENCE REPORT 2009

**By P.J. Brugger and Associates
171 Copper Cliff Rd E
Neebing, ON
P7L 0B6**

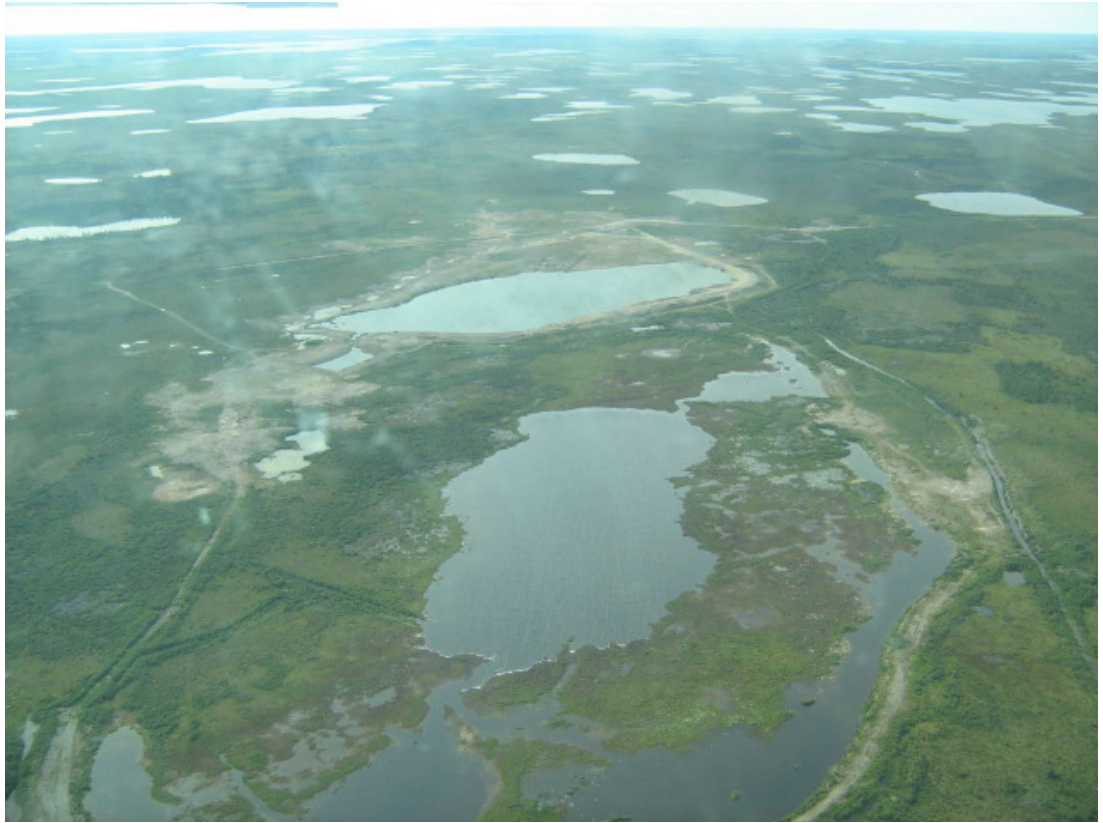
Photo 1: Cullaton Lake main site, looking west, August 5, 2009

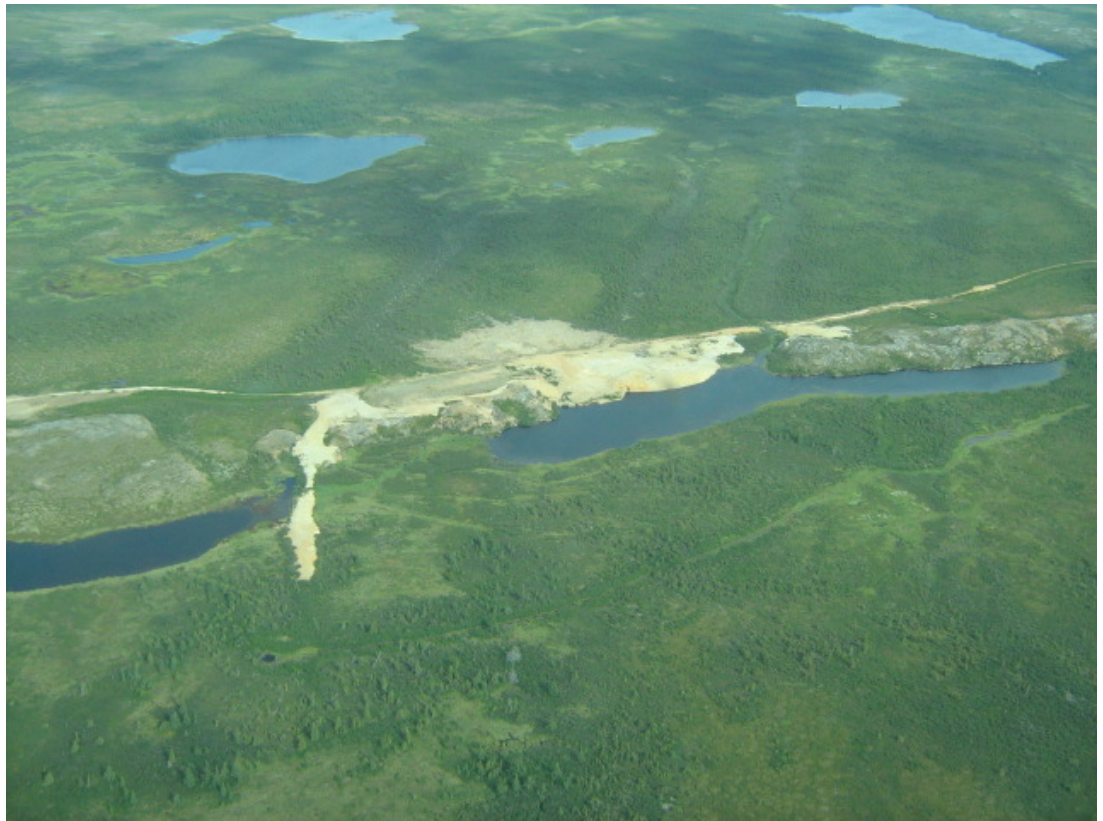
Photo 2: Shear Lake site, looking southeast, August 5, 2009

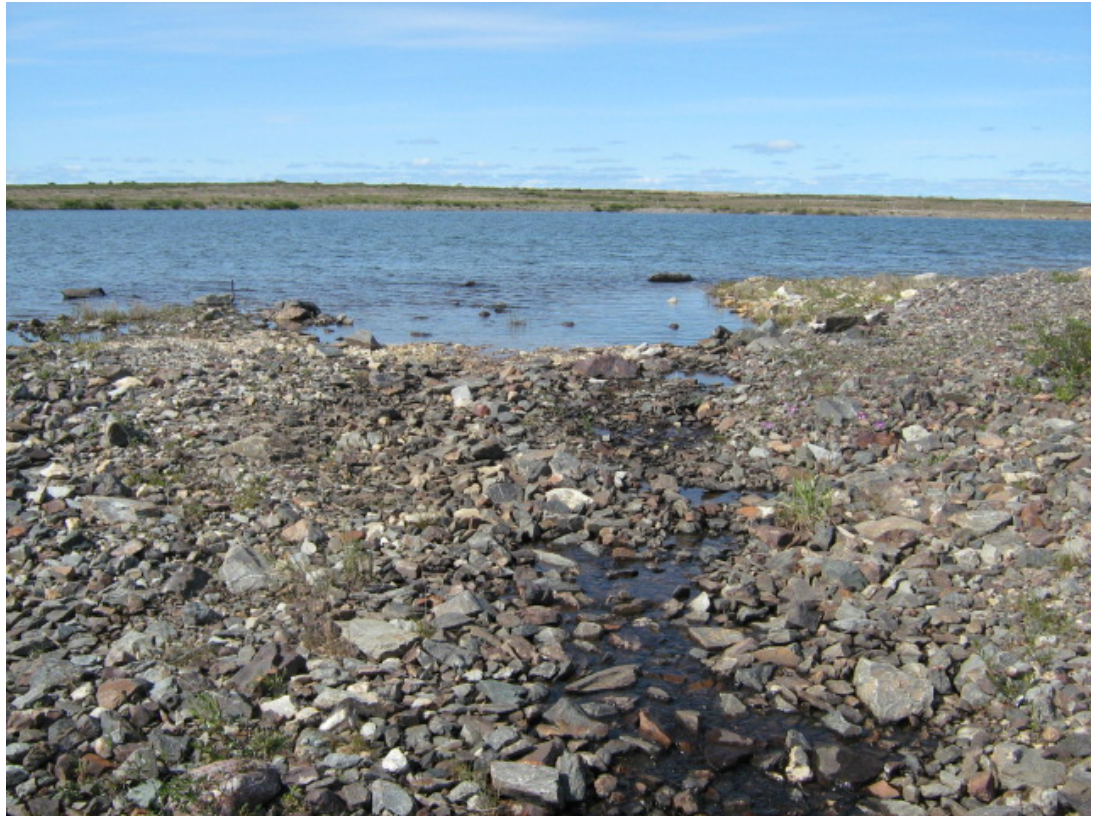
Photo 3: Flooded portion of Tailings No.1 Pond, looking northwest from spillway, August 5, 2009

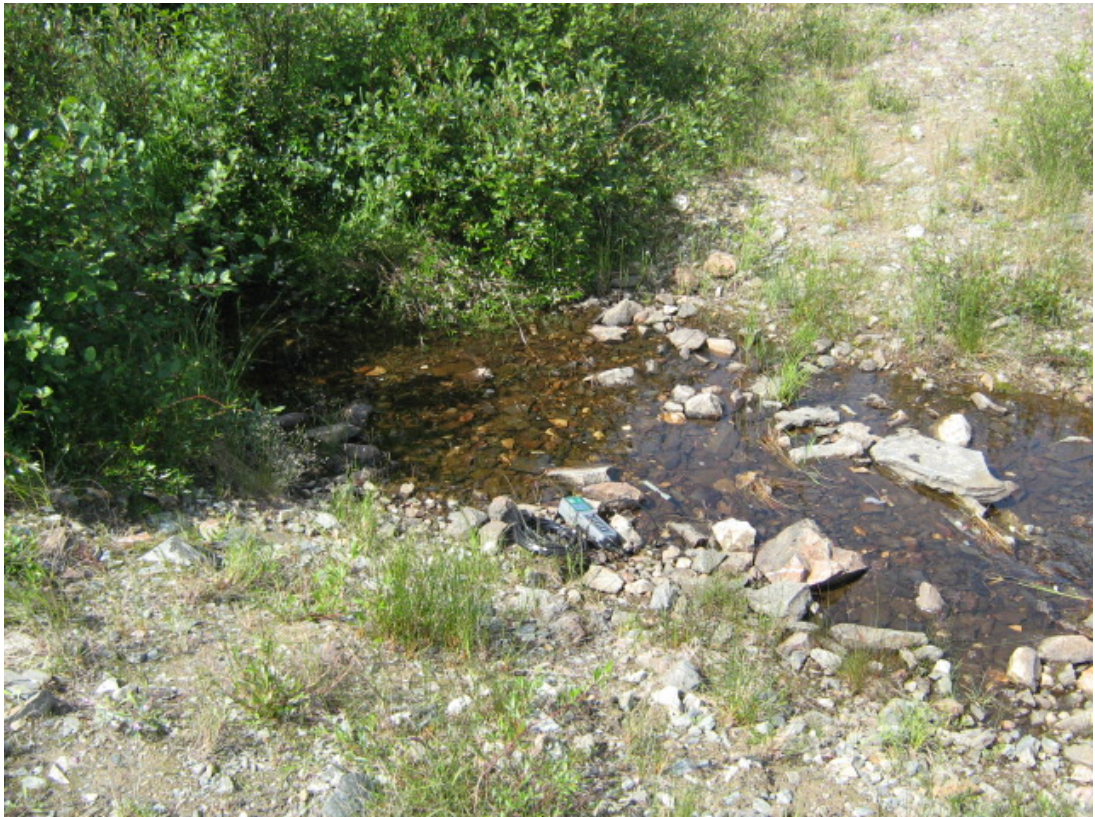
In summary the report indicates that the tailings dam remains stable. Continued monitoring for erosion in the No. 1 Spillway channel is also recommended.

Photo 4: Spillway flowing at outlet of former polishing pond, August 5, 2009

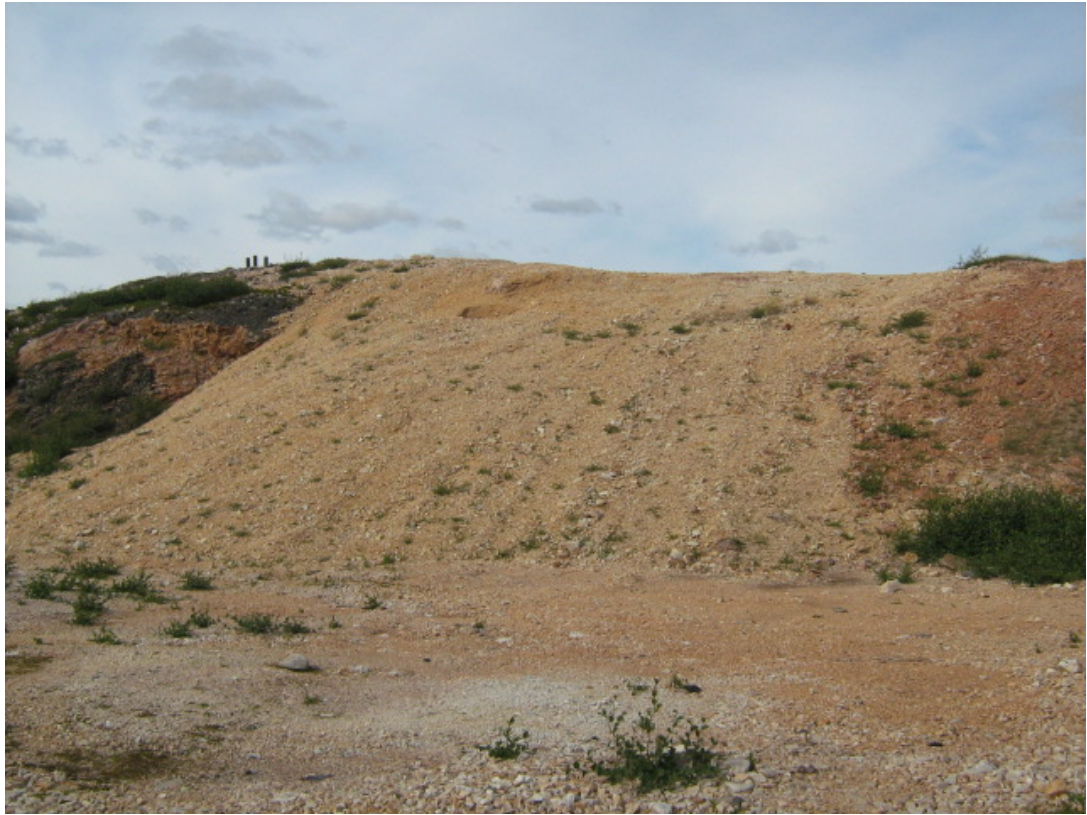
A minor amount of subsidence was noted at the Shear Lake portal over the area of previously observed (2006) subsidence. The area was refilled during the August 27th trip.

Photo 5: Former Shear Lake Portal, August 5, 2009.

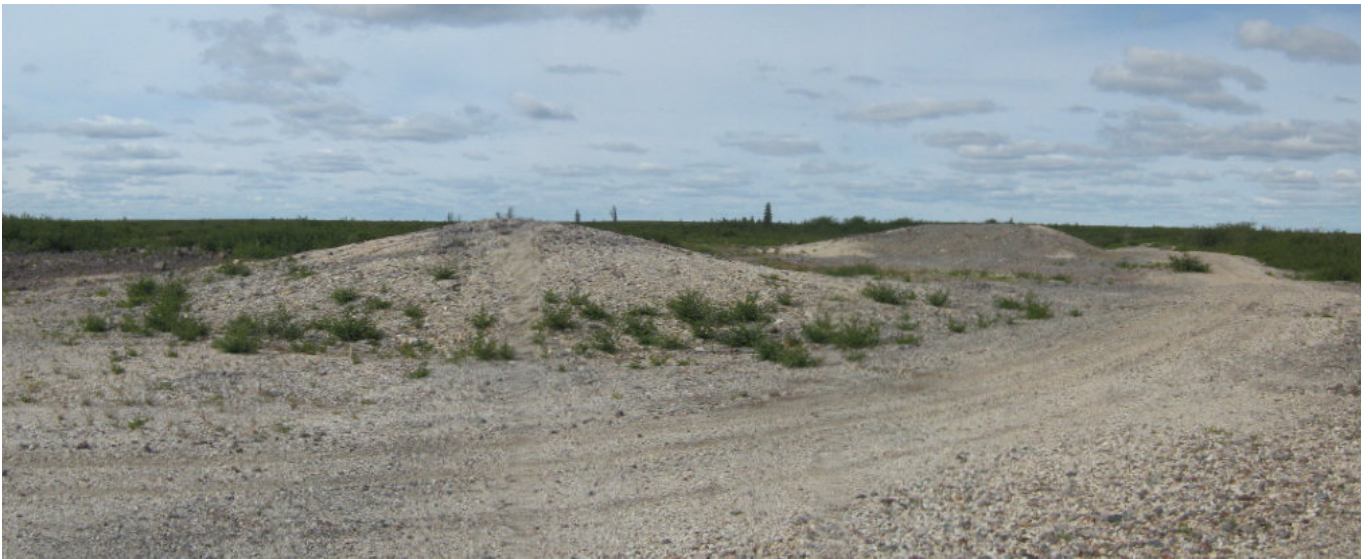
Photo 6: Former B Zone Portal and Fresh Air Raise, looking north on August 5, 2009.

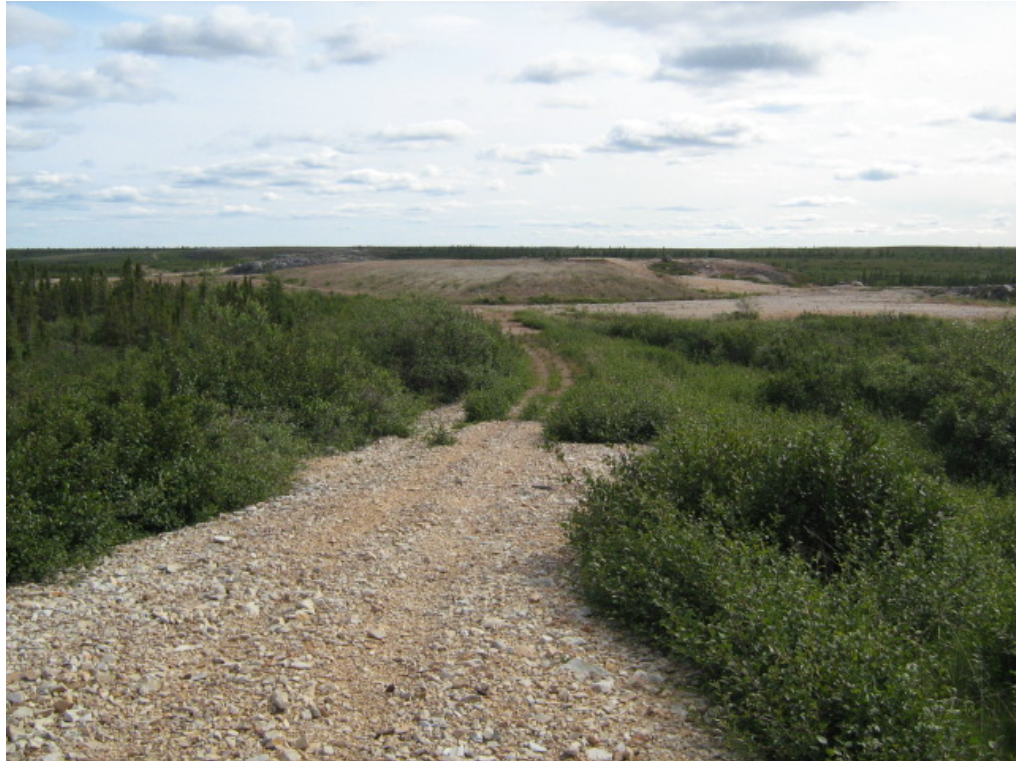
Pursuant to Part D, Article 8e of the Water Licence, the condition of the encapsulated waste rock cover at Shear Lake is to be monitored by the geotechnical engineer for erosion until vegetation is sufficiently established so as to stabilize the cover. At the time of the 2009 site inspection, the engineer noted the vegetation continues to take hold and is helping to reduce erosion. A recommendation for additional monitoring was also made.

Photo 7: Encapsulated Waste Rock at Shear Lake 4 years after the application of additional seed and fertilizer. Erosion scars are visible due to being filled in with lighter coloured granular road material.

In addition to the above, minor maintenance activities will be performed, including additional top dressing at previously filled areas of settlement and erosion channel repair as required.

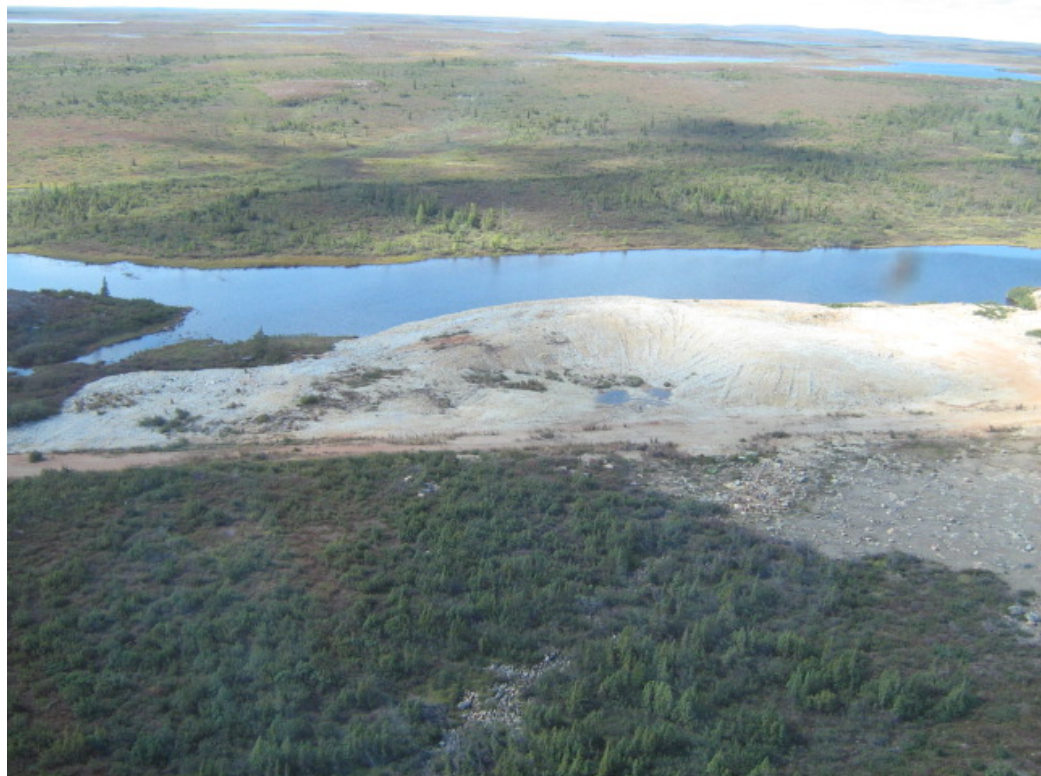
Photo 8: South side of Shear Lake area on August 27, 2009, with low pH pool in centre of photo.

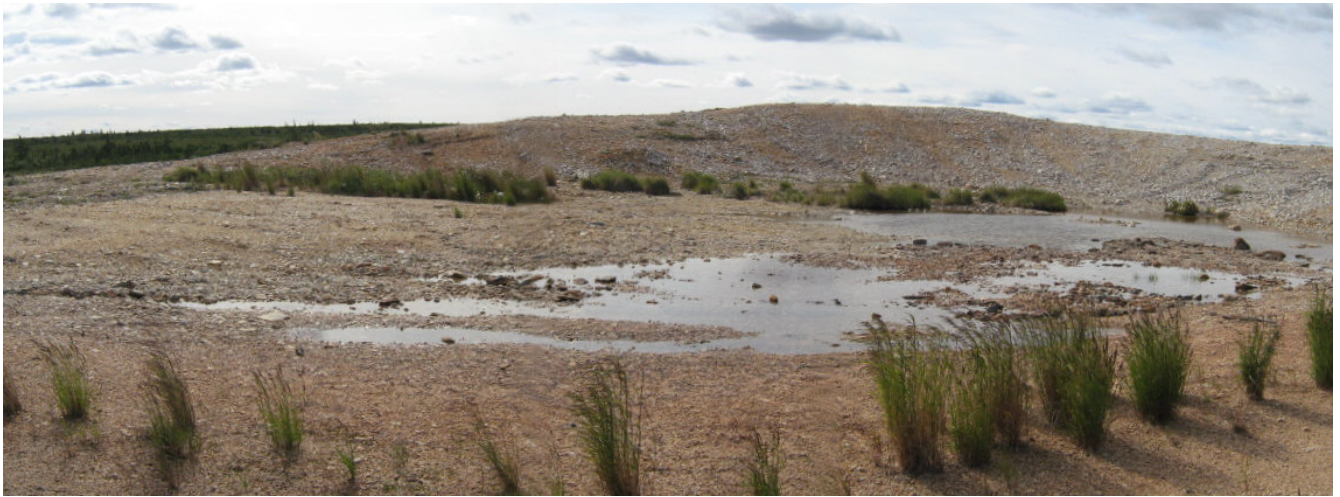
Photo 9: Low ph pool, looking northwest on August 5, 2009

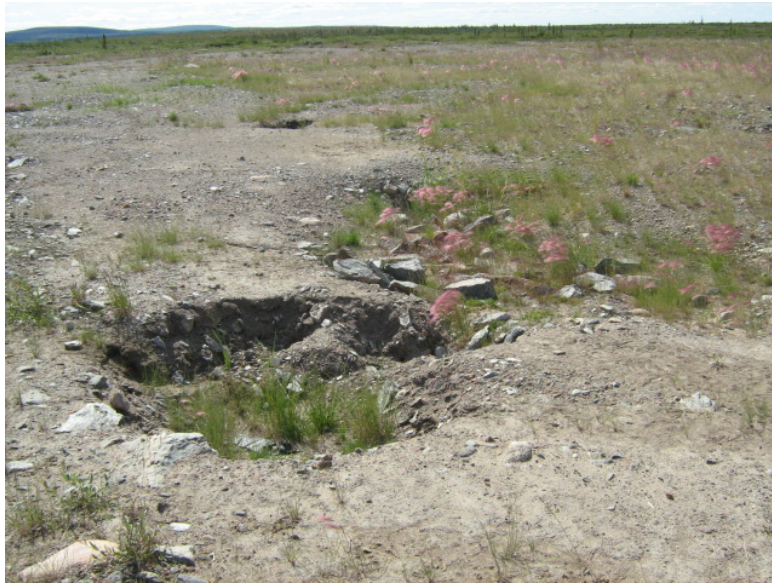
Minor subsidence on the quarry pit landfill continues. Most of the affected areas are occupied by arctic ground squirrels.

Photo 10: Minor settlement in quarry pit cover on August 5, 2009, 4 years after being filled in August, 2005.

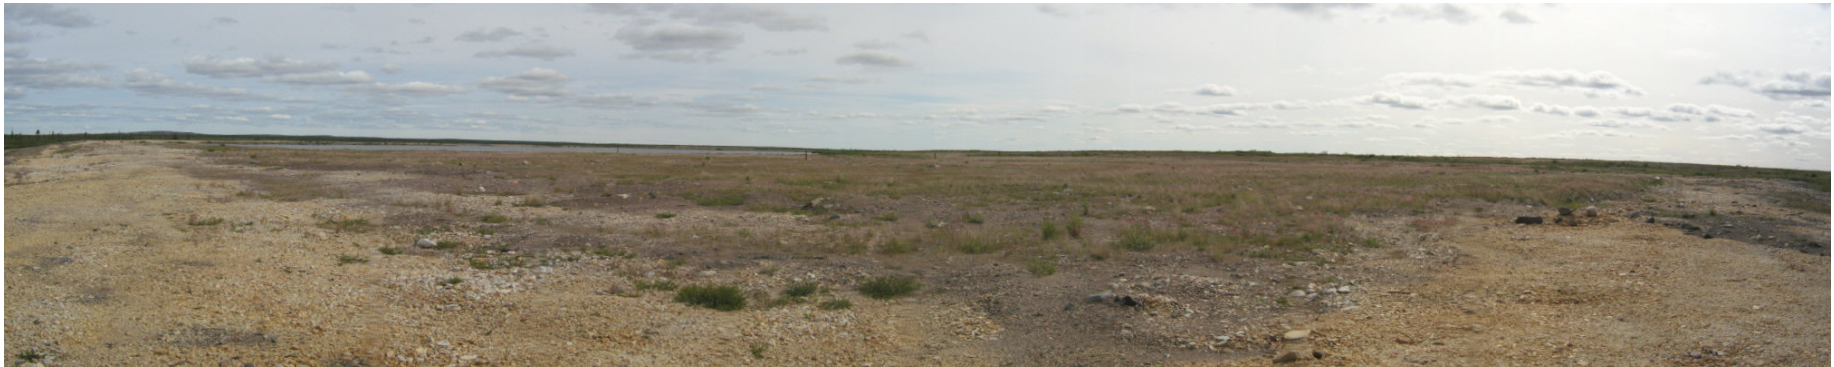
Photo 11: Tailings cover, looking southeast on August 5, 2009.

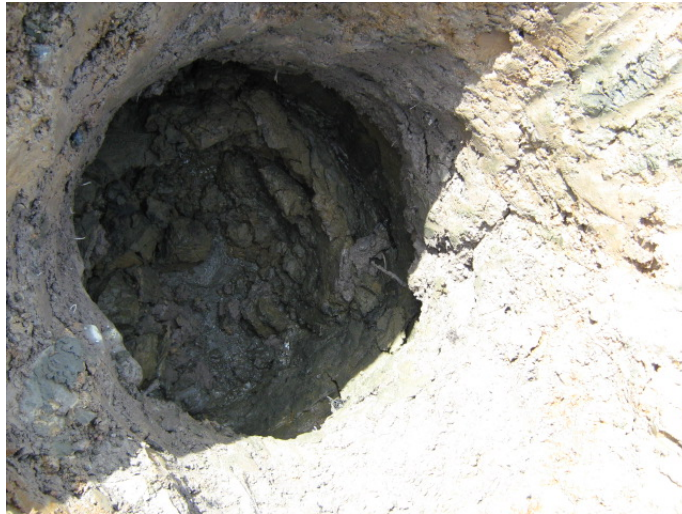
Based on the test pit finding, the permafrost was found at a depth of 1.2m on August 5, 2009. The till cover is 90cm thick at this location. The thawed 30cm of tailings above the permafrost was saturated (see field notes and photos in Appendix 3).

Test pit excavated at T4 on August 5, 2009, showing till cover / saturated tailings interface.

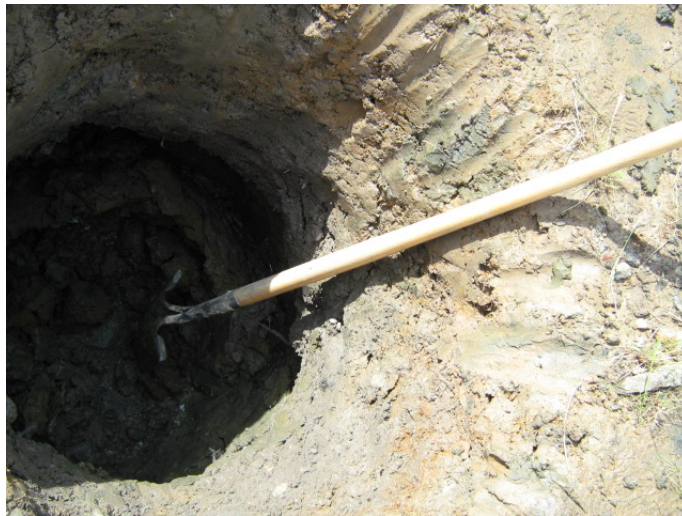
1.2m: Permafrost

Test pit excavated to permafrost at 1.2m
