## CULLATON LAKE GOLD MINES LTD. WATER LICENCE 1BR-CUL1118

#### **ANNUAL WATER LICENCE REPORT 2010**

**BARRICK GOLD INC.**

March 2011

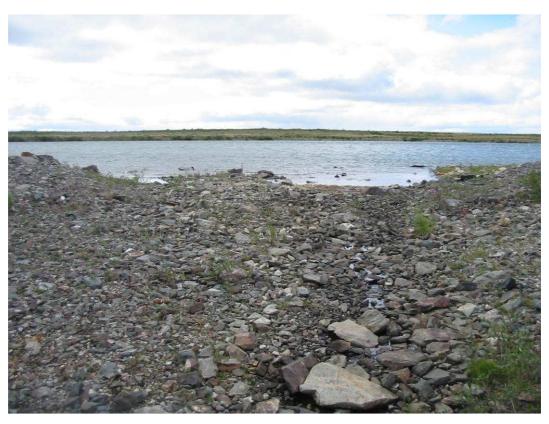
Photo 3: Tailings No.1 Pond spillway invert, looking west on August 4, 2010

In summary the report indicates that the tailings dam remains stable. Continued monitoring for erosion in the No. 1 Spillway channel is also recommended.

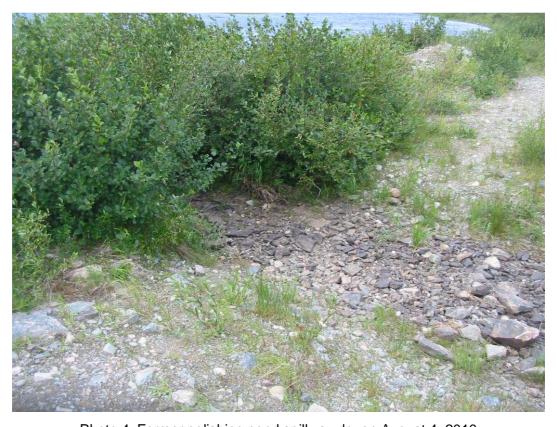
Photo 4: Former polishing pond spillway dry on August 4, 2010

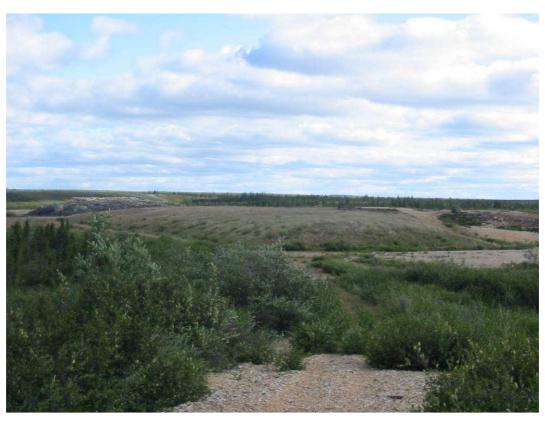
Photo 7: Encapsulated Waste Rock at Shear Lake 5 years after the application of additional seed and fertilizer.

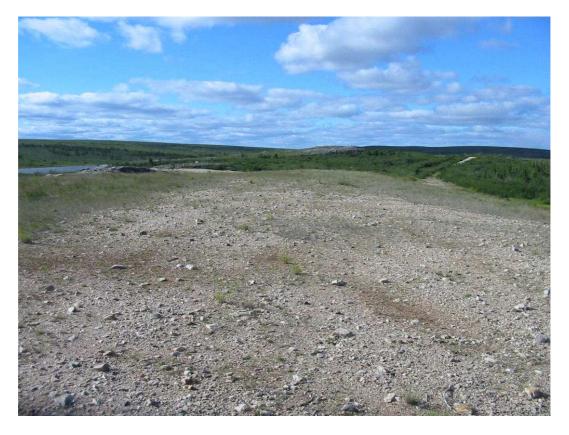
Pursuant to Part D, Article 8e of then current Water Licence 1BR-CUL0911, the condition of the encapsulated waste rock cover at Shear Lake is to be monitored by the geotechnical engineer for erosion until vegetation is sufficiently established so as to stabilize the cover. At the time of the 2010 site inspection, the engineer noted the vegetation continues to take hold and is helping to reduce erosion. A recommendation for additional monitoring was also made.

Photo 8: Encapsulated Waste Rock cover top, looking north on August 4, 2010.

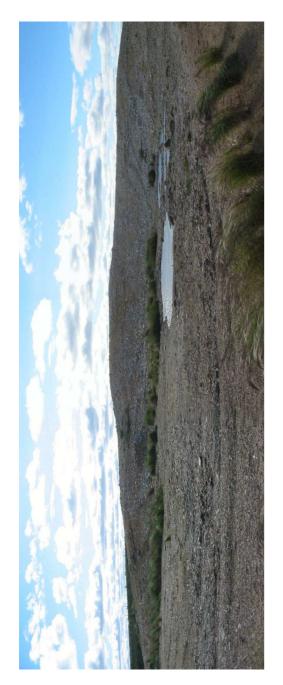
Photo 9: Shear Lake low pH pool on August 4, 2010.

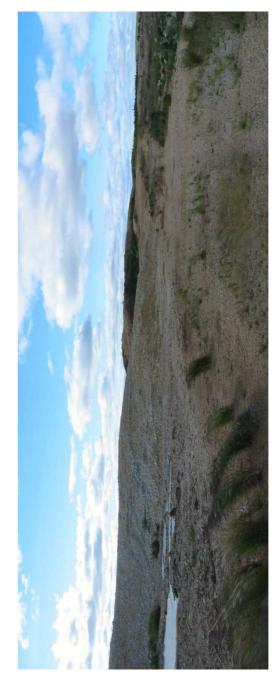
Photo 10: Downstream side of low pH pool dry on August 4, 2010.

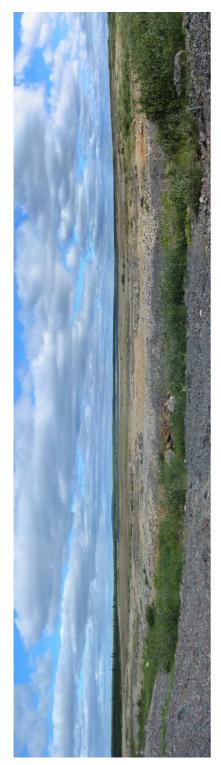
Photo 11: Tailings cover, looking southeast on August 4, 2010.

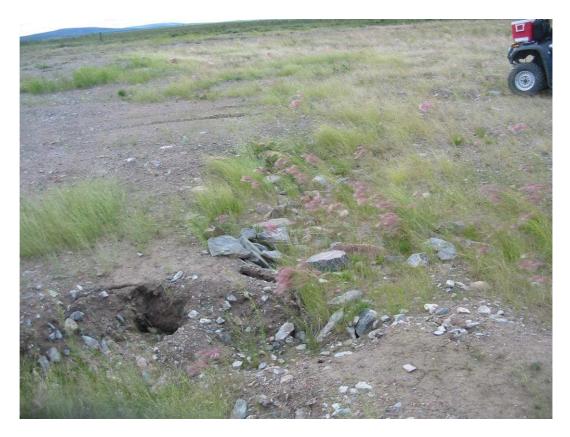
Photo 13: Previously filled subsidence area on August 4, 2010.

In addition to the above, minor maintenance activities will be performed, including additional top dressing at previously filled areas of settlement and erosion channel repair as required.

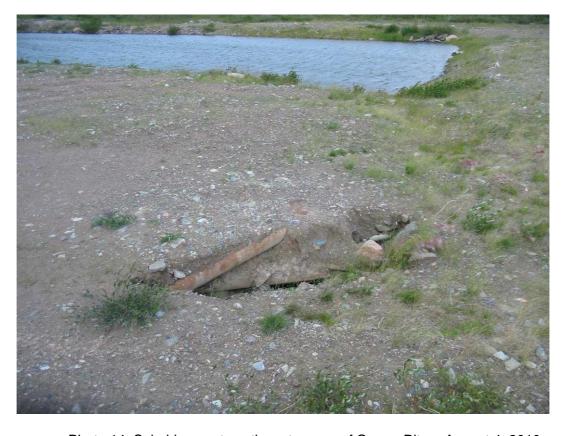
The minor subsidence areas on the quarry pit landfill remain largely unchanged. Most of the affected areas are occupied by arctic ground squirrels.

Photo 14: Subsidence at southwest corner of Quarry Pit on August 4, 2010.

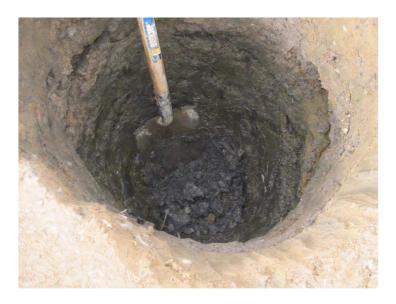
Based on the test pit finding, the permafrost was found at a depth of 1.4m on August 4, 2010. The till cover is 90cm thick at this location. The thawed 50cm of tailings above the permafrost was saturated (see field notes and photos in Appendix 3).

Test pit excavated at T4 on August 4, 2010, showing till cover / saturated tailings interface.

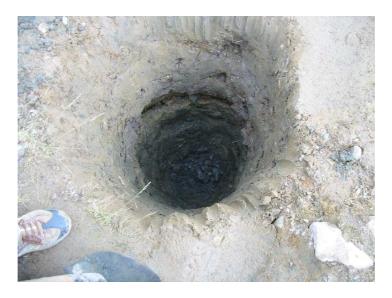
Test pit excavated to permafrost at 1.4m

Pursuant to Part F Item 1 of new Water Licence 1BR-CUL1118, research into replacing the non-functioning thermistors will be initiated in 2011, to determine if they can be successfully replaced without being susceptible to frost heave.
