### CULLATON LAKE GOLD MINES LTD. WATER LICENCE 1BR-CUL1118

### **ANNUAL WATER LICENCE REPORT 2011**

**BARRICK GOLD INC.**

**March 2012**

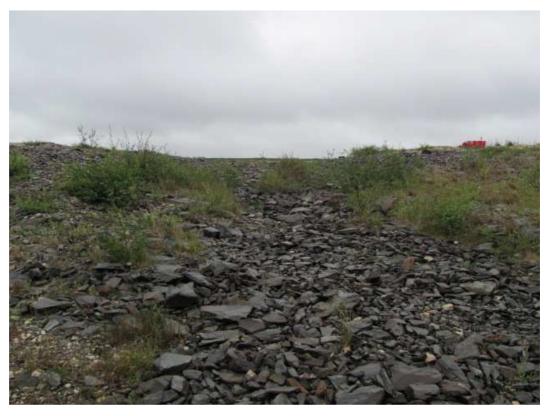
Photo 3: Tailings No.1 Pond spillway invert, looking west on August 4, 2011

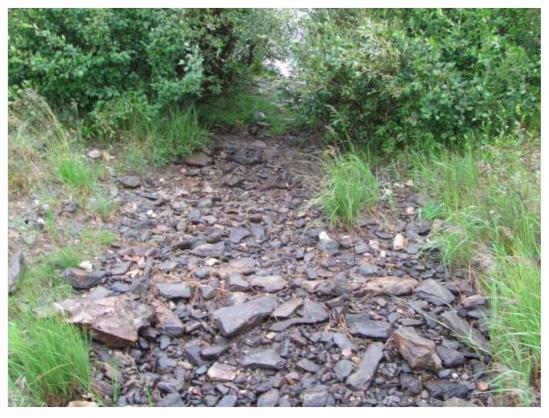
Photo 4: Former polishing pond spillway dry on August 4, 2011

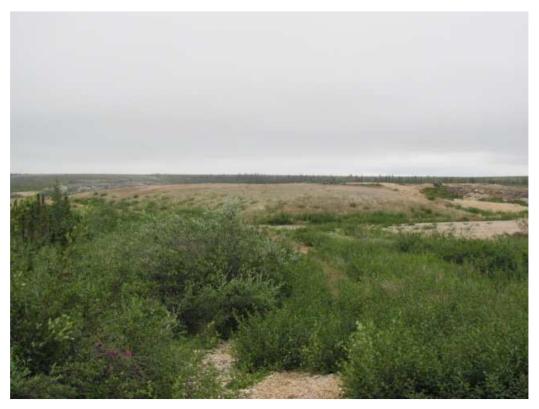
Photo 7: Encapsulated Waste Rock at Shear Lake 6 years after the application of additional seed and fertilizer.

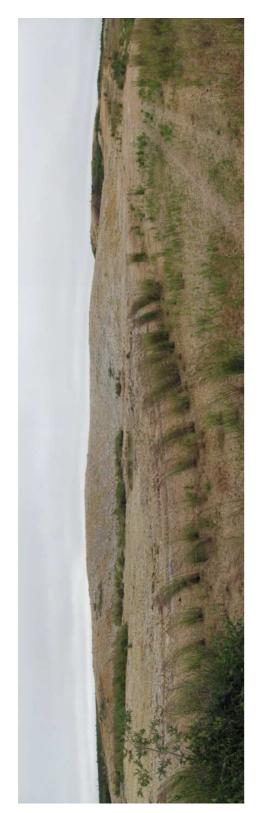
Photo 8: Shear Lake low pH pool area dry on August 4, 2011.

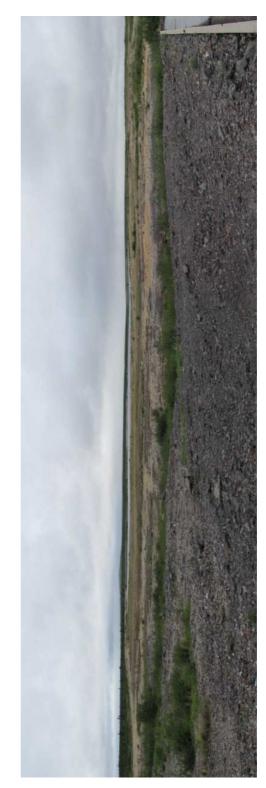
Photo 9: Tailings cover, looking southeast on August 4, 2011.

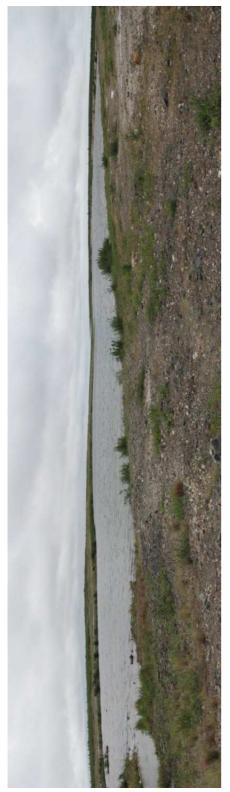
Photo 10: Tailings No 1 Pond, looking southeast from cover on August 4, 2011.

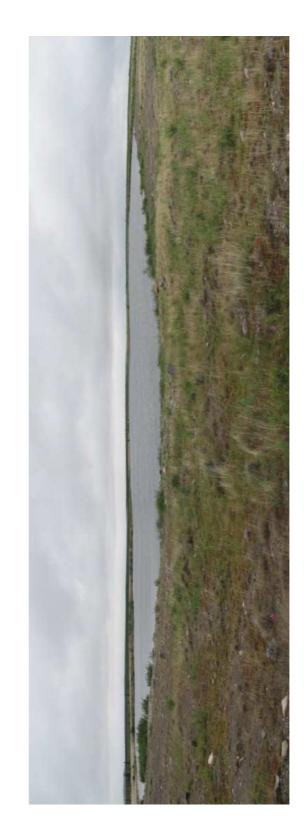
Photo 11: Tailings No. 1 Pond looking northwest on August 4, 2011.

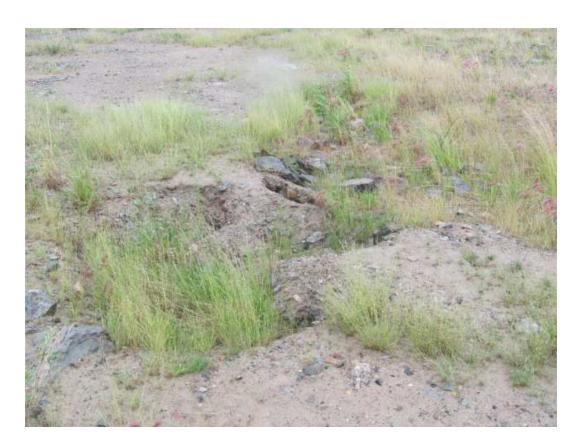
The minor subsidence areas on the quarry pit landfill remain largely unchanged. Most of the affected areas are occupied by arctic ground squirrels.

Photo 12: Previously filled subsidence area on August 4, 2011.

In addition to the above, minor maintenance activities will be performed, including additional top dressing at previously filled areas of settlement and erosion channel repair as required.

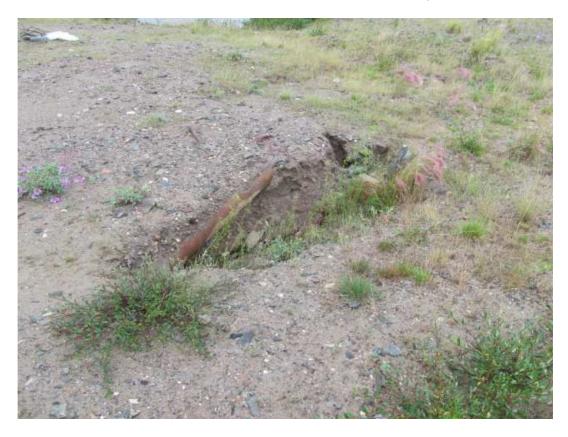
Photo 13: Subsidence at southwest corner of Quarry Pit on August 4, 2011.

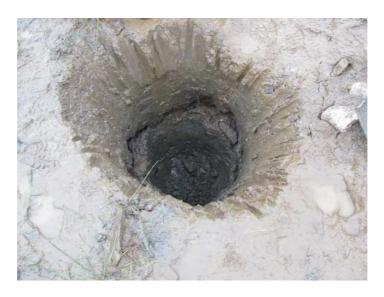
Based on the test pit finding, the permafrost was found at a depth of 1.4m on August 4, 2011. The till cover is 90cm thick at this location. The thawed 50cm of tailings above the permafrost was saturated (see field notes and photos in Appendix 3).

0.9m - 1.4m: saturated tailings

1.4m: Permafrost

Test pit excavated at T4 on August 4, 2011, showing till cover / saturated tailings interface.
