CULLATON LAKE GOLD MINES LTD.

WATER LICENCE 1BR-CUL1118

ANNUAL WATER LICENCE REPORT 2012

March 2013

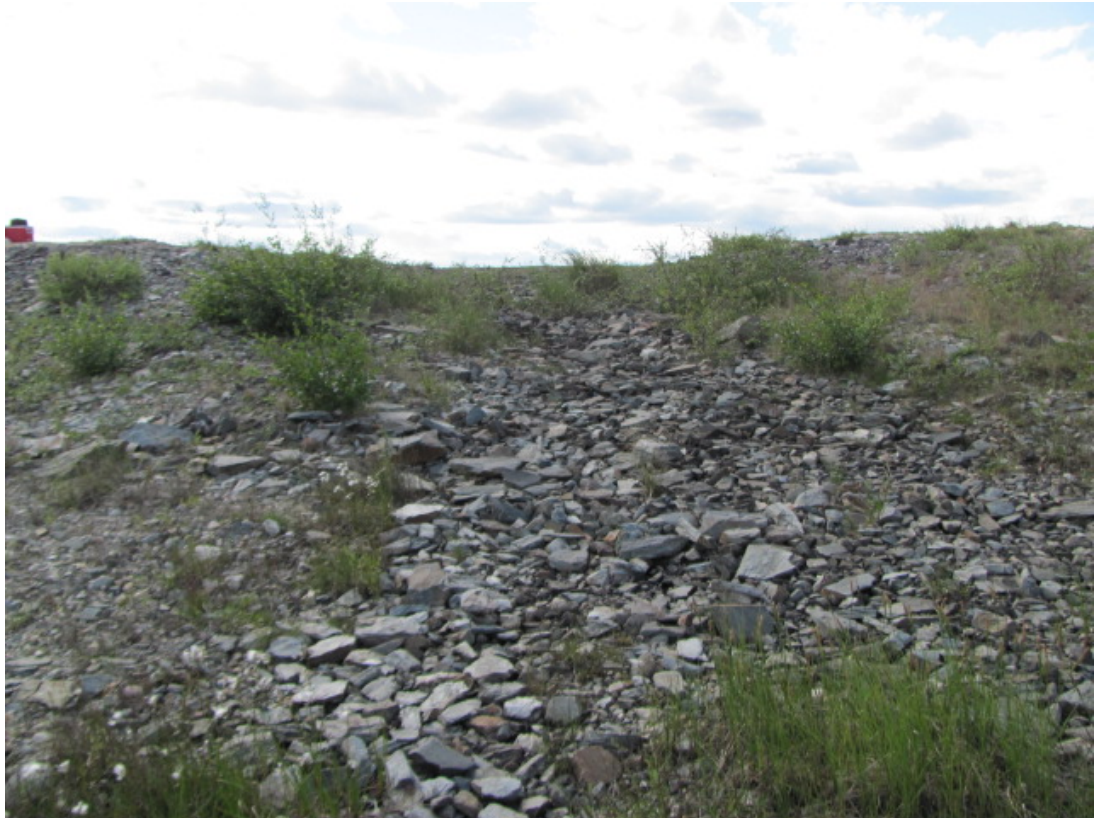
Photo 3: Tailings No.1 Pond spillway invert, looking west on August 2, 2012

In summary the report indicates that the tailings dam remains stable. Continued monitoring for erosion in the No. 1 Spillway channel is also recommended.

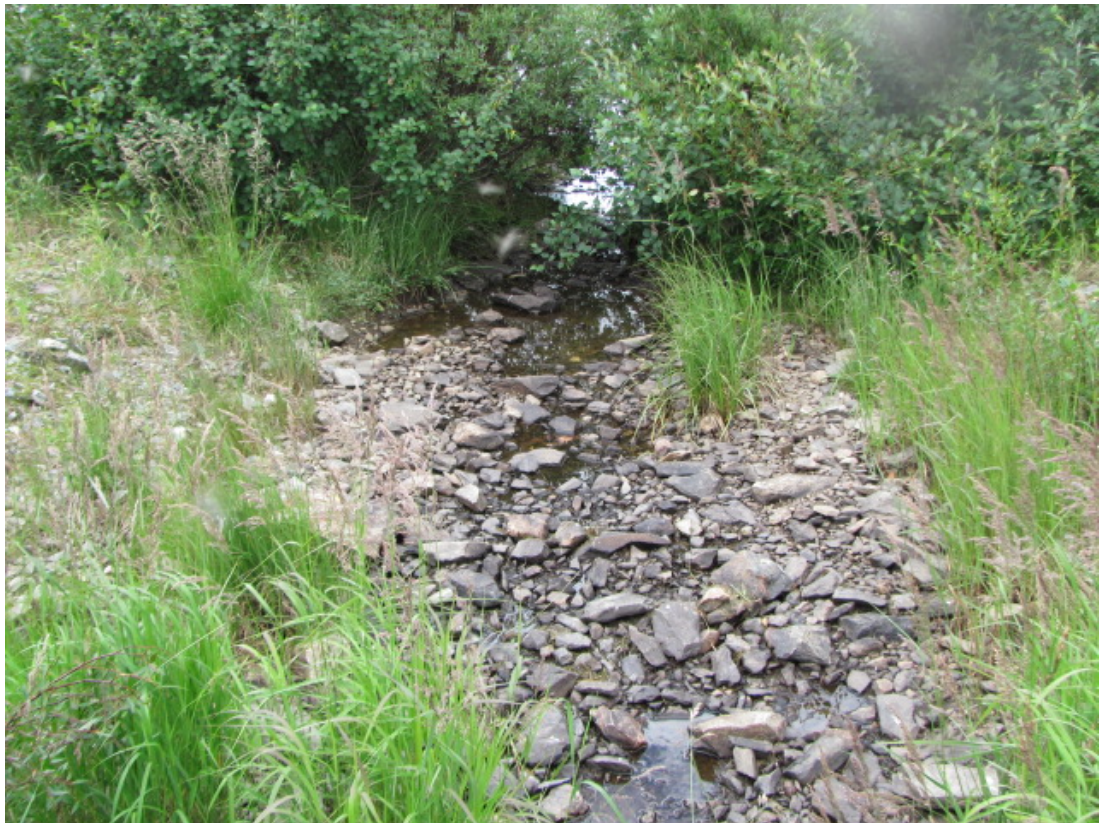
Photo 4: Former polishing pond spillway dry on August 2, 2012

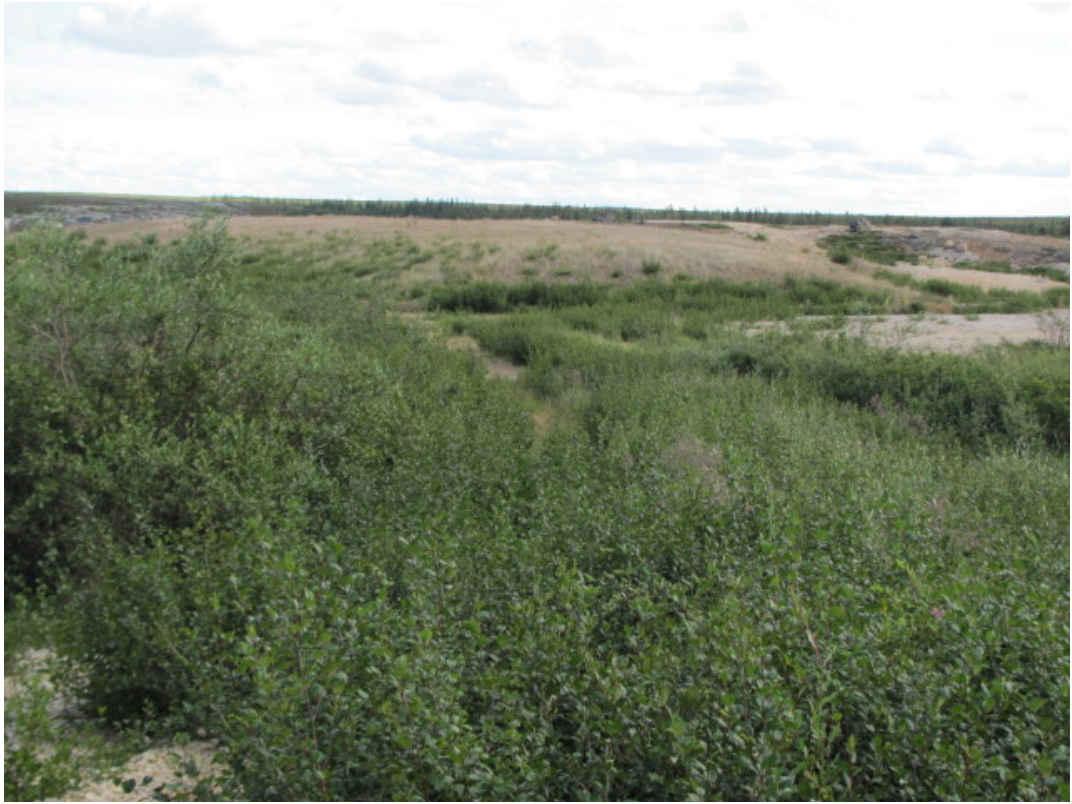
Pursuant to Part D, Article 8e of Water Licence 1BR-CUL1118, the condition of the encapsulated waste rock cover at Shear Lake is to be monitored by the geotechnical engineer for erosion until vegetation is sufficiently established so as to stabilize the cover. At the time of the 2012 site inspection, the engineer noted the vegetation continues to take hold and is helping to reduce erosion. A recommendation for additional monitoring was also made.

Photo 7: Encapsulated Waste Rock at Shear Lake 7 years after the application of additional seed and fertilizer.

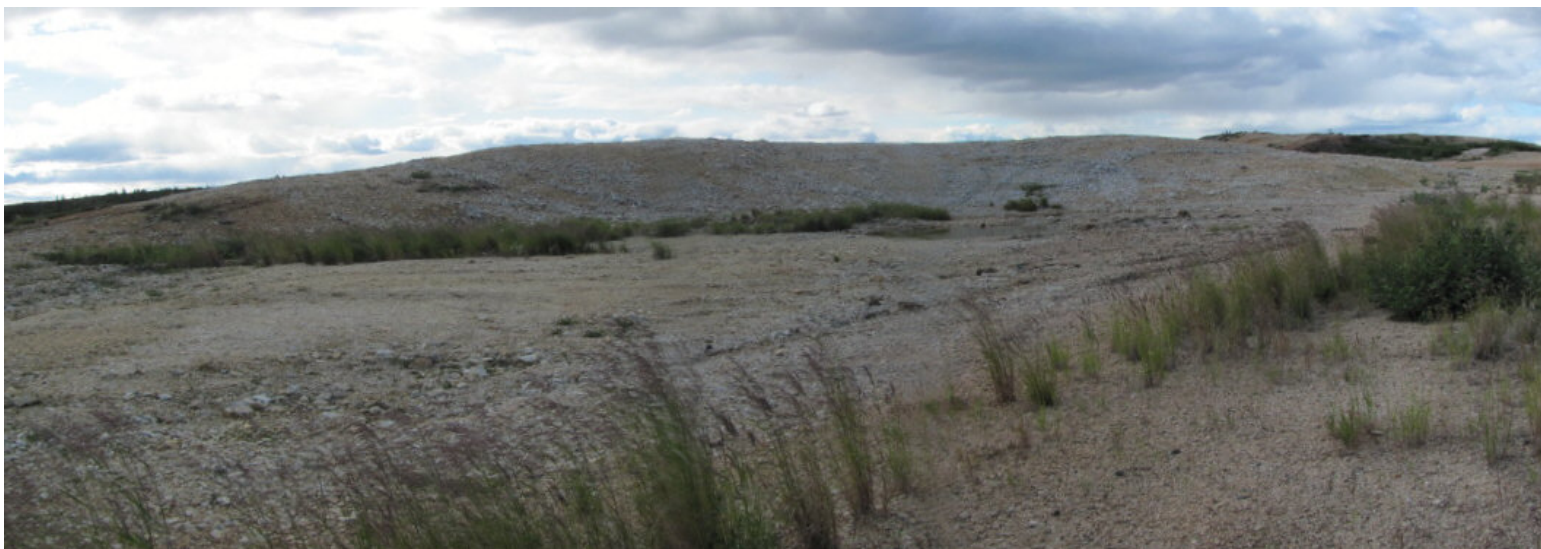
Photo 8: Shear Lake low pH pool area dry on August 2, 2012.

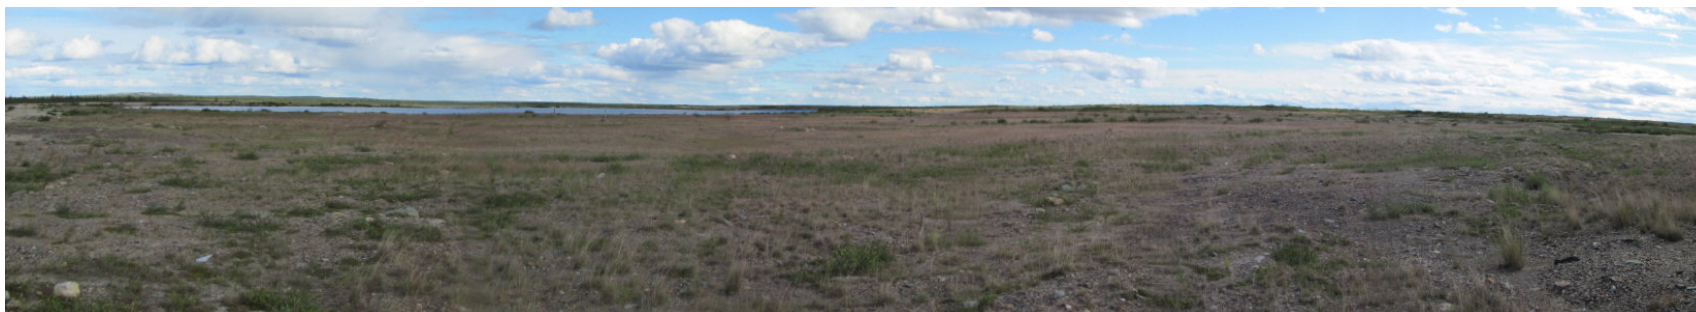
Photo 9: Tailings cover, looking southeast on August 2, 2012.

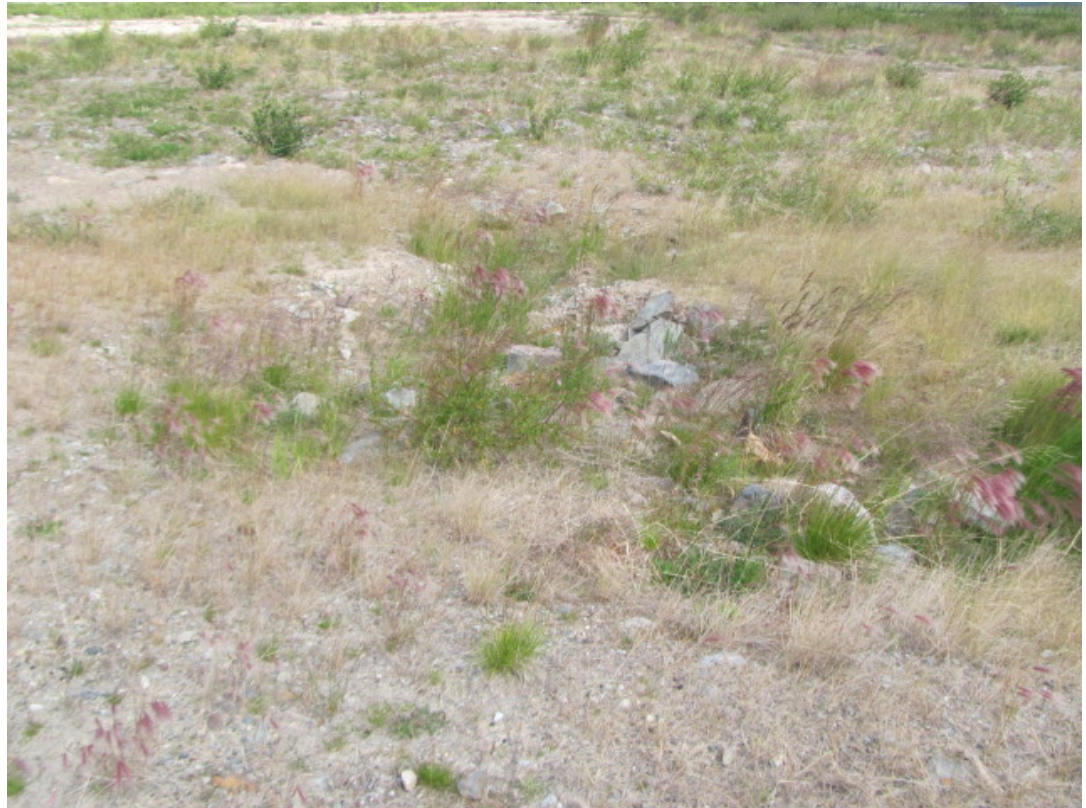
Photo 12: Previously filled subsidence area on August 2, 2012.

In addition to the above, minor maintenance activities will be performed, including additional top dressing at previously filled areas of settlement and erosion channel repair as required.

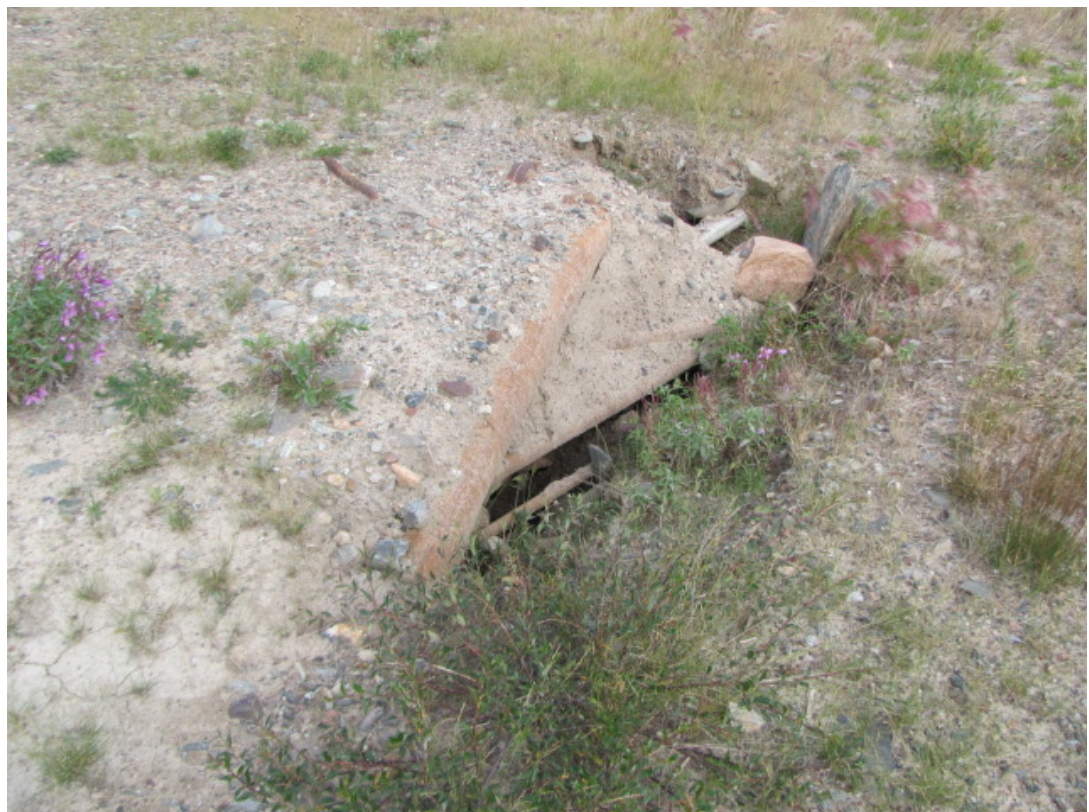
The minor subsidence areas on the quarry pit landfill remain largely unchanged. Most of the affected areas are occupied by arctic ground squirrels.

Photo 13: Subsidence at southwest corner of Quarry Pit on August 2, 2012.

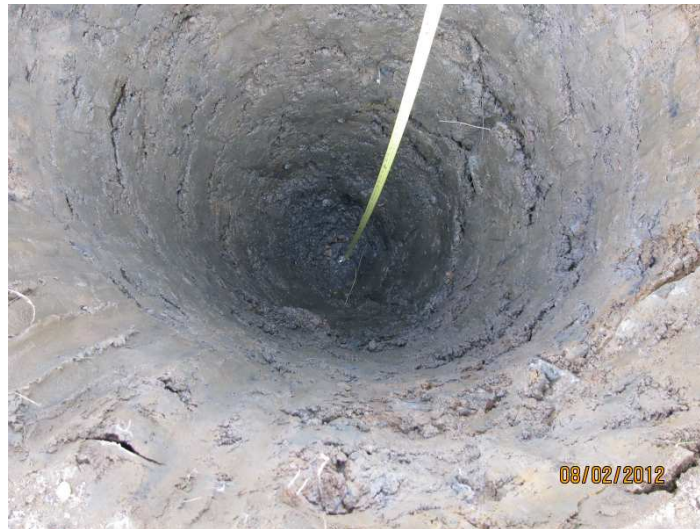
Based on the test pit finding, the permafrost was found at a depth of 1.35m on August 2, 2012. The till cover is 90cm thick at this location. The thawed 45cm of tailings above the permafrost was saturated (see field notes and photos in Appendix 3).

0 – 0.9m: till cover
0.9m – 1.35m: saturated tailings
1.35m: Permafrost

Test pit excavated at T4 on August 2, 2012, showing till cover / saturated tailings interface.

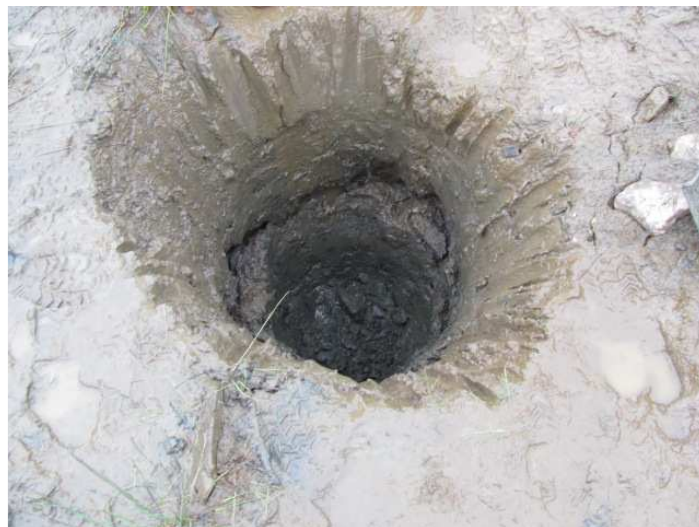
August 4, 2011 test pit

0 -0.9m: till cover
0.9m -1.4m: saturated tailings
1.4m: permafrost
