CULLATON LAKE GOLD MINES LTD.
WATER LICENCE 1BR-CUL1118

ANNUAL WATER LICENCE REPORT 2013

BARRICK GOLD INC.

March 2014

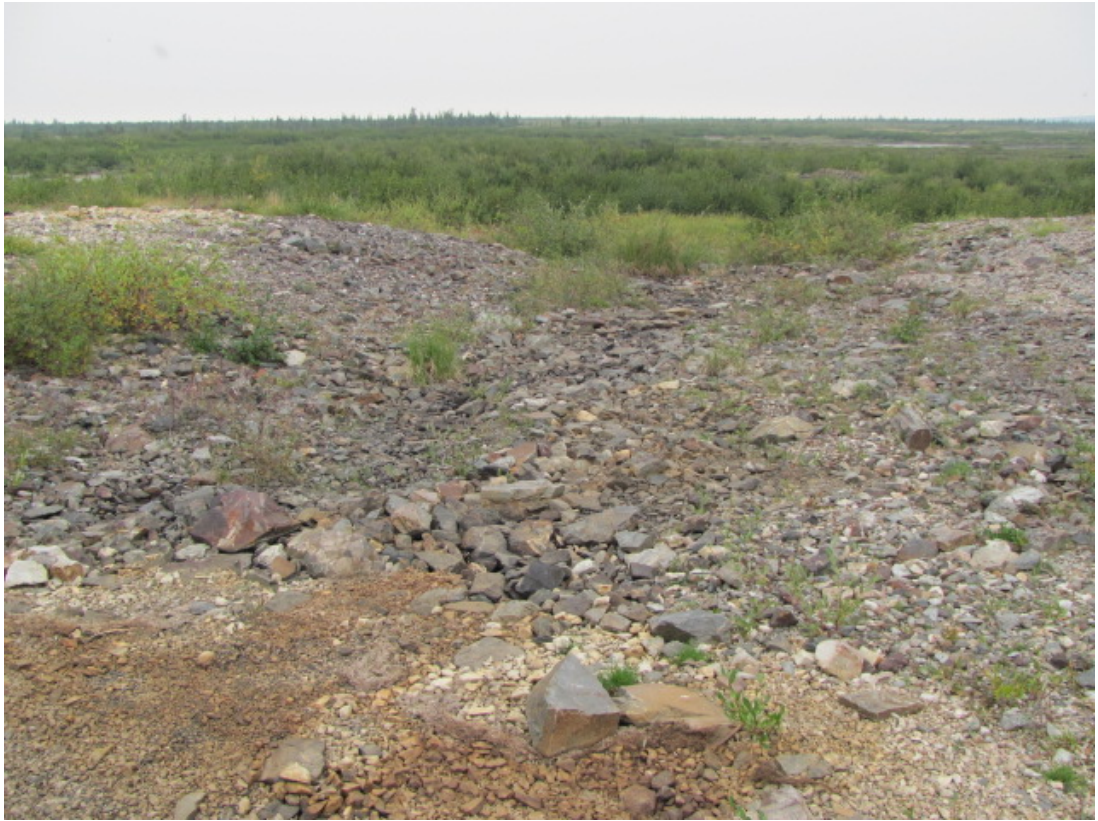
Station 940-18 (Tailings Pond No. 1 spillway) – There was very little standing water in the collection pool below the spillway on August 15, 2013 and consequently no samples were collected.

Photo 3: Tailings No.1 Pond spillway invert dry on August 15, 2013

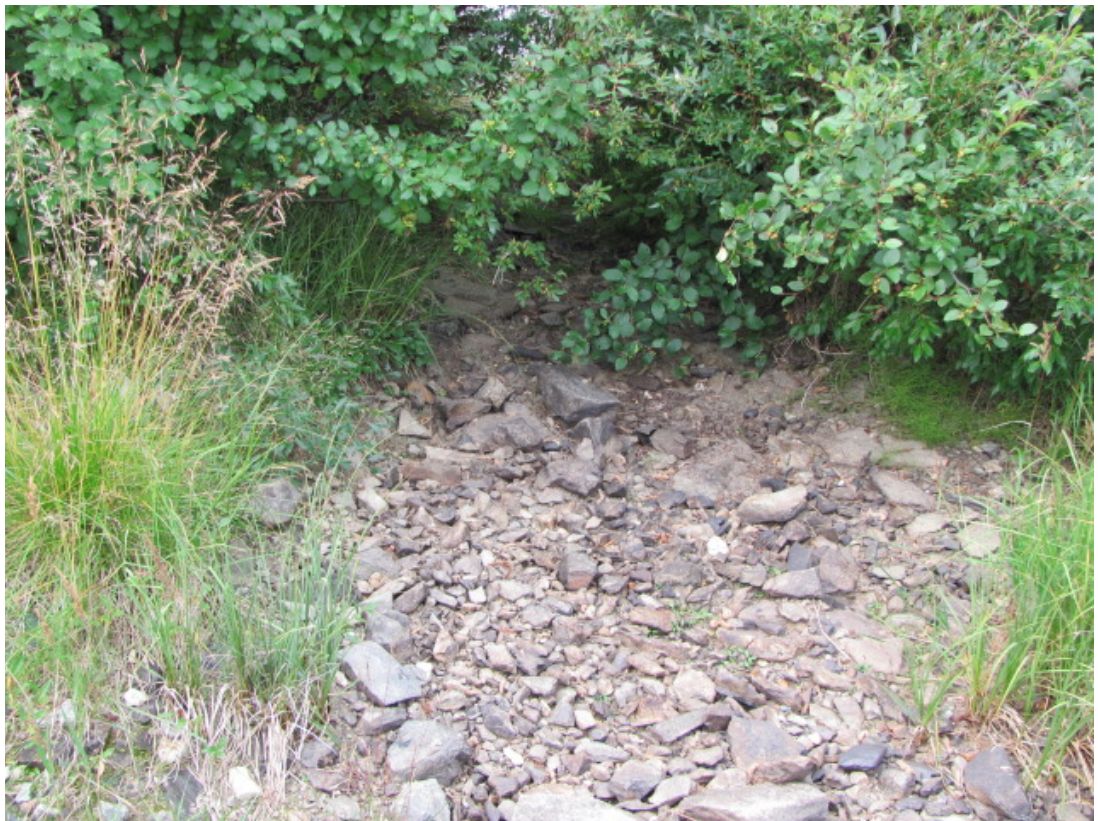
Photo 4: Former Tailings (polishing) Pond No. 2 spillway dry on August 15, 2013

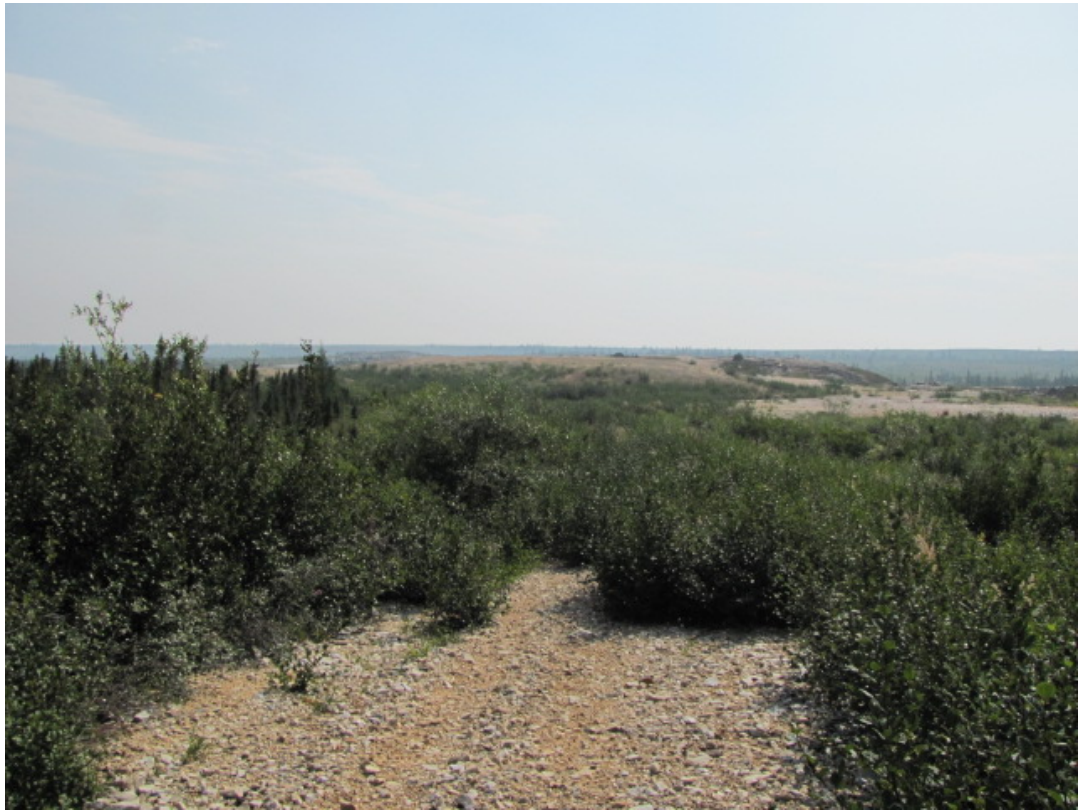
Pursuant to Part D, Article 8e of Water Licence 1BR-CUL1118, the condition of the encapsulated waste rock cover at Shear Lake is to be monitored by the geotechnical engineer for erosion until vegetation is sufficiently established so as to stabilize the cover. At the time of the 2013 site inspection, the engineer noted the vegetation continues to take hold and is helping to reduce erosion. A recommendation for additional monitoring was also made.

Photo 7: Encapsulated Waste Rock at Shear Lake 8 years after the application of additional seed and fertilizer.

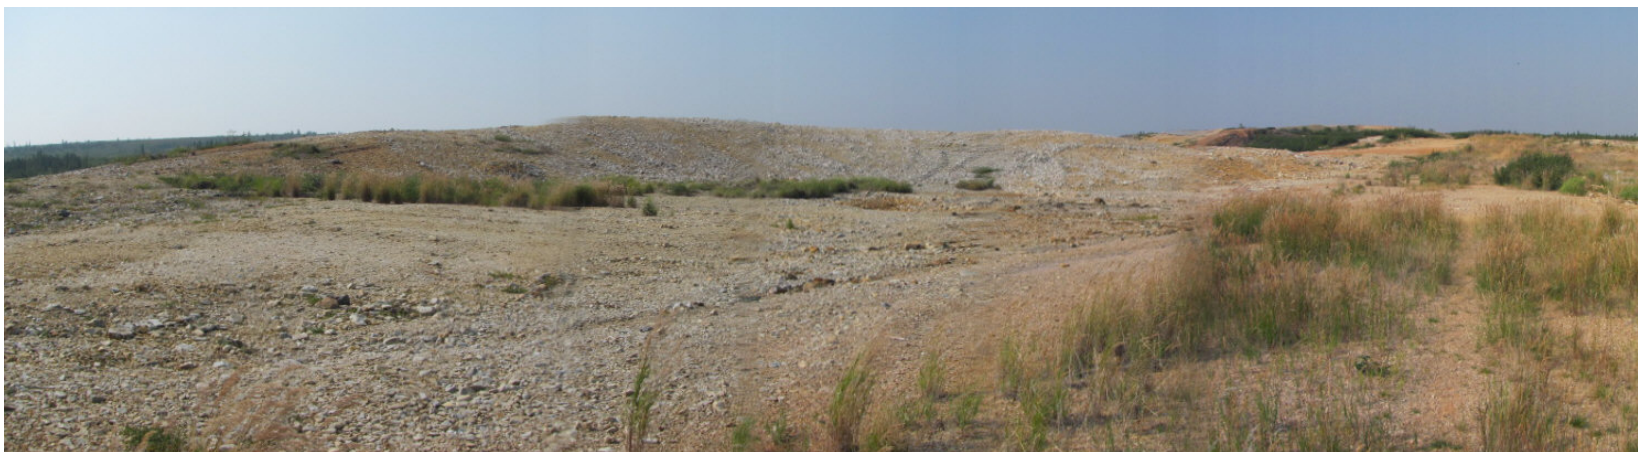
Photo 8: Shear Lake low pH pool area dry on August 15, 2013.

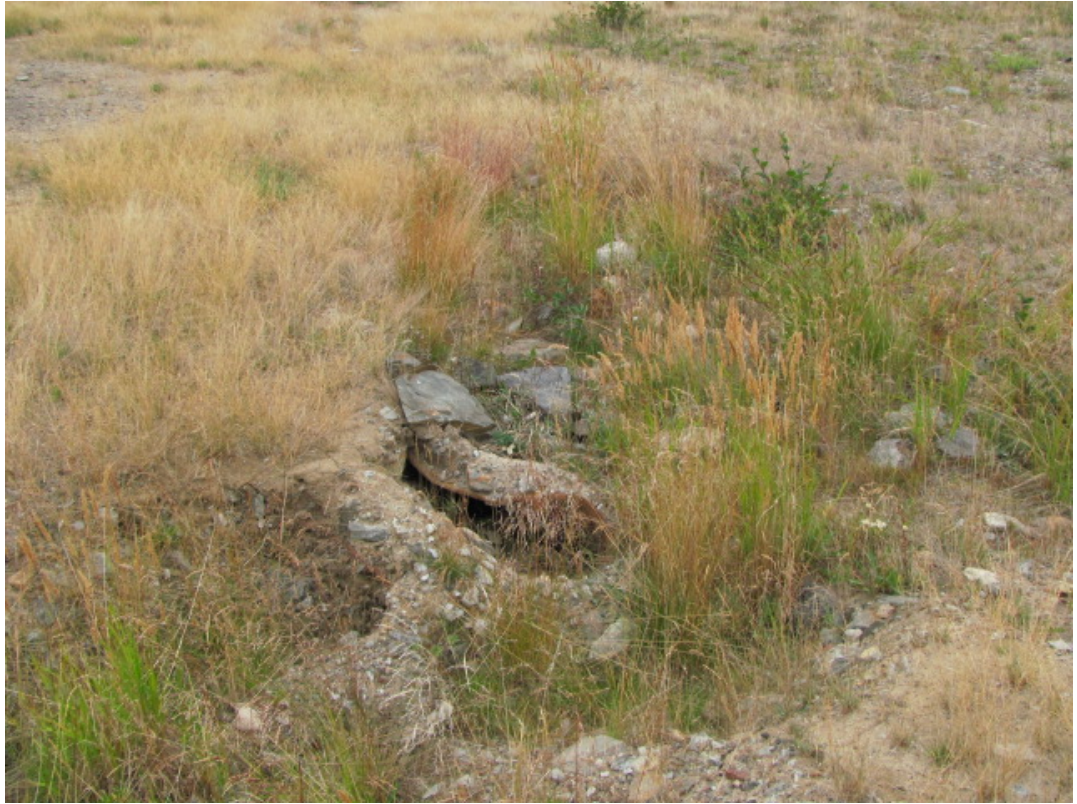
The minor subsidence areas on the quarry pit landfill remain largely unchanged. Most of the affected areas are occupied by arctic ground squirrels.

Photo 12: Subsidence area next to Quarry Pit pond on August 15, 2013.

In addition to the above, minor maintenance activities will be performed, including additional top dressing at previously filled areas of settlement and erosion channel repair as required.

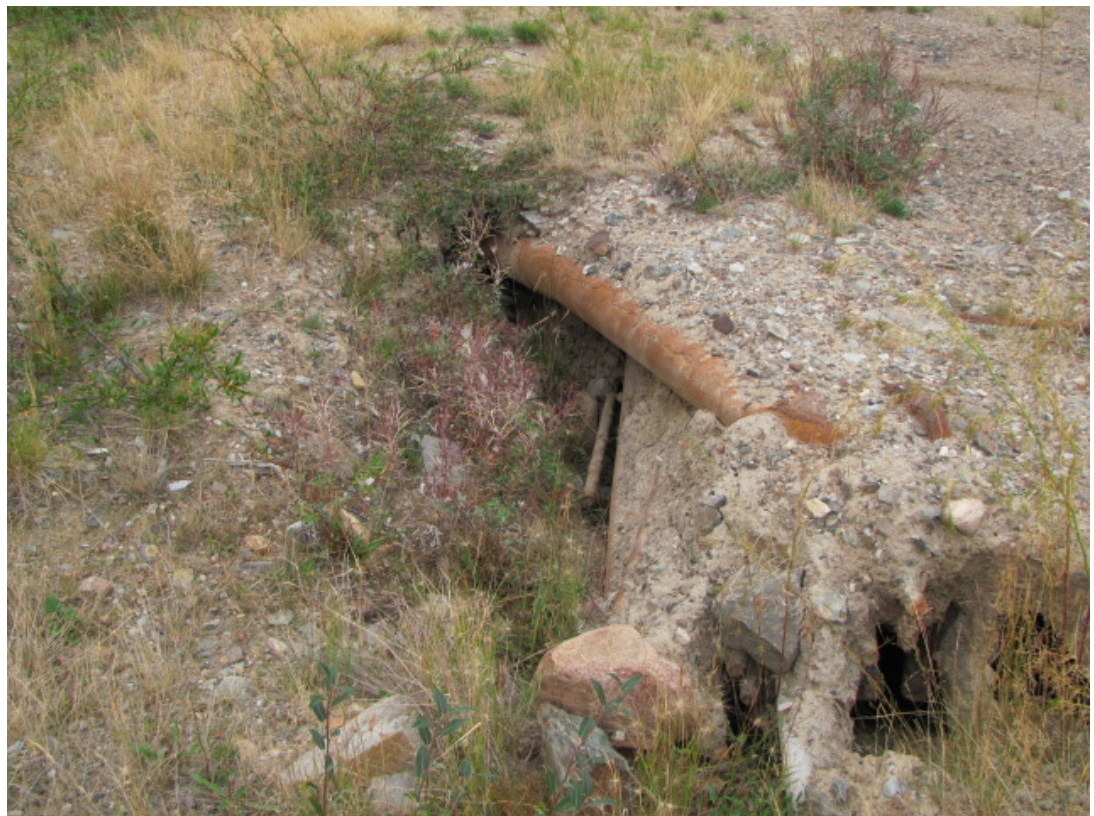
Photo 13: Subsidence at southwest corner of Quarry Pit pond on August 15, 2013.

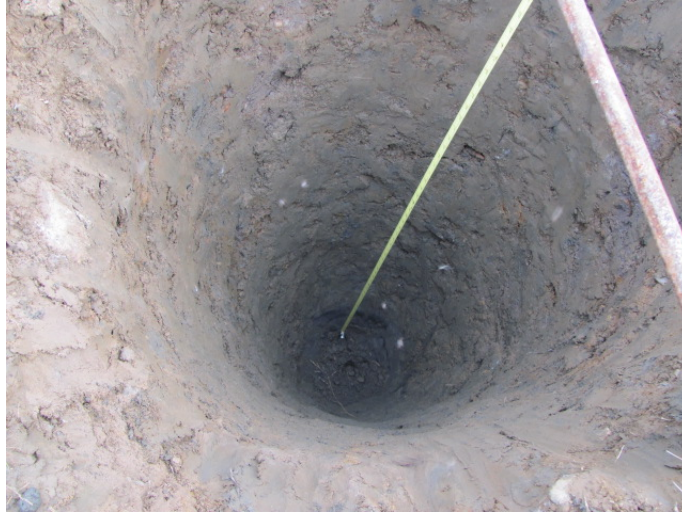
Based on the test pit finding, the permafrost was found at a depth of 1.4m on August 15, 2013. The till cover is 90cm thick at this location. The thawed 50cm of tailings above the permafrost was saturated (see field notes and photos in Appendix 3).

Test pit excavated at T4 on August 15, 2013, showing till cover / saturated tailings interface.

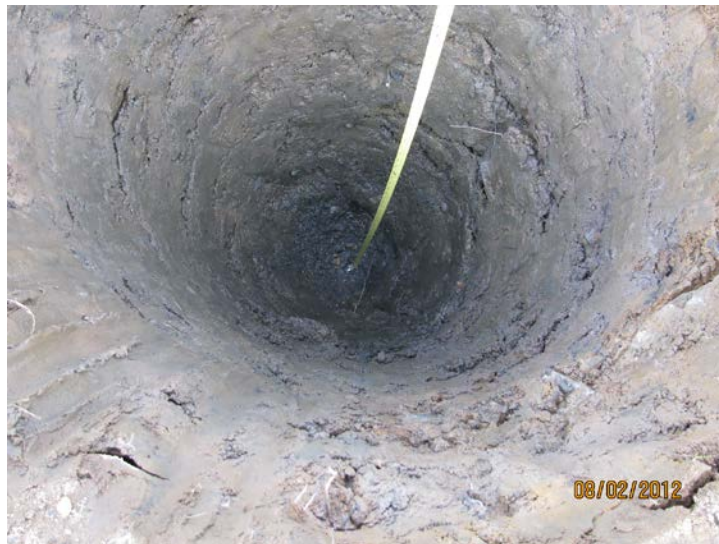
August 2, 2012 test pit - permafrost at 1.35m
