CULLATON LAKE GOLD MINES LTD.
WATER LICENCE 1BR-CUL1118

ANNUAL WATER LICENCE REPORT 2015

BARRICK GOLD INC.

By P.J. Brugger and Associates
1084 County Rd 8
Campbellford, ON
K0L 1L0

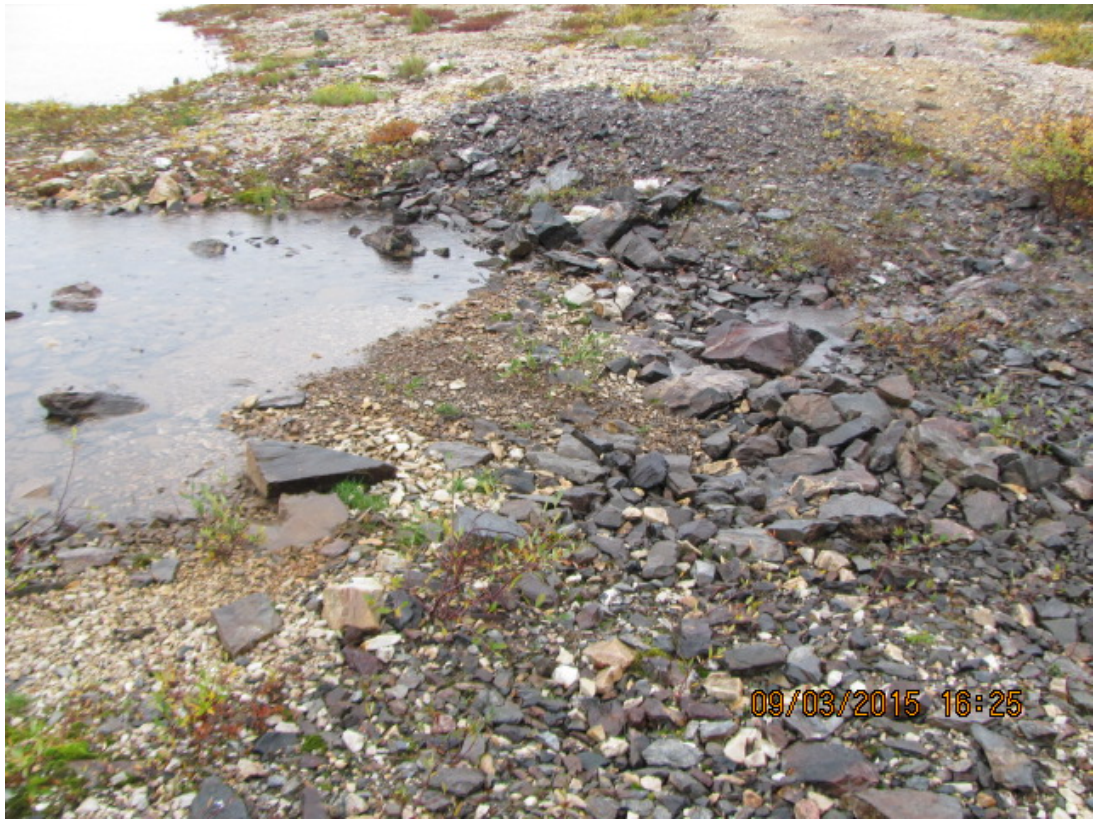
Photo 3: Tailings No.1 Pond spillway invert on September 3, 2015

In summary, the report indicates that the tailings dam remains stable. Continued monitoring for erosion in the No. 1 Spillway channel is also recommended.

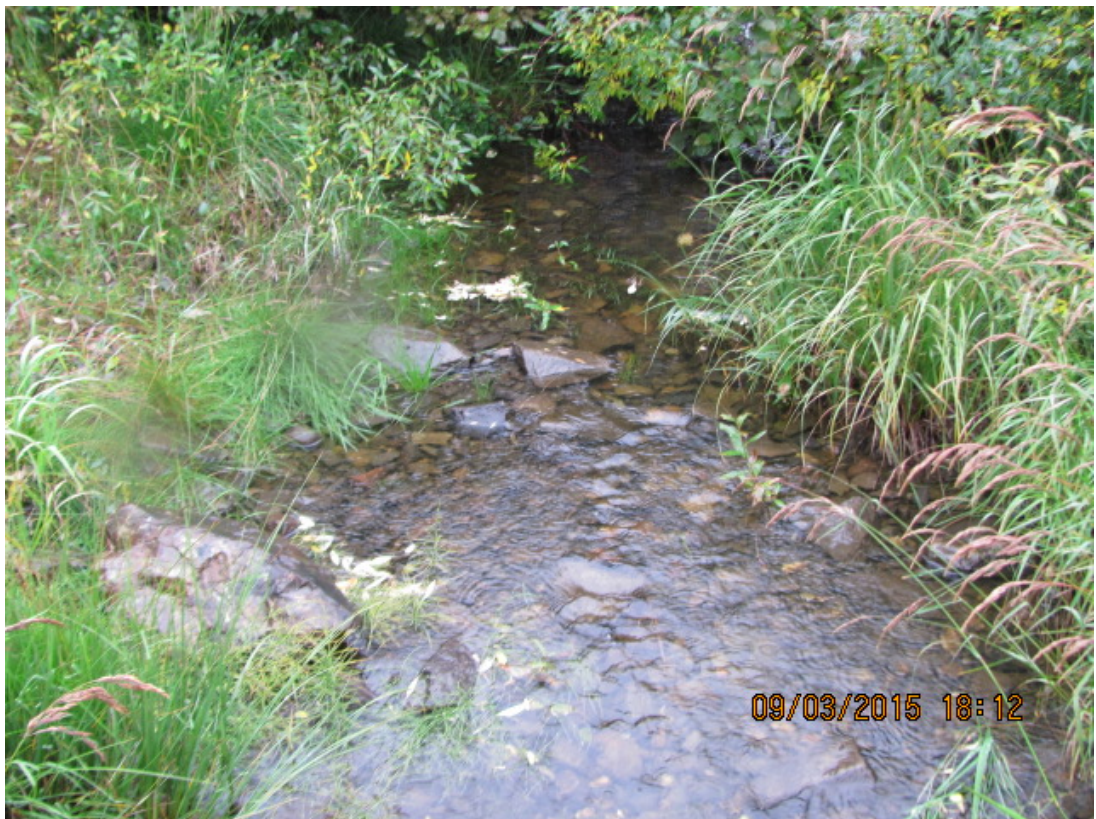
Photo 4: Former Tailings Pond No. 2 spillway flowing on September 3, 2015

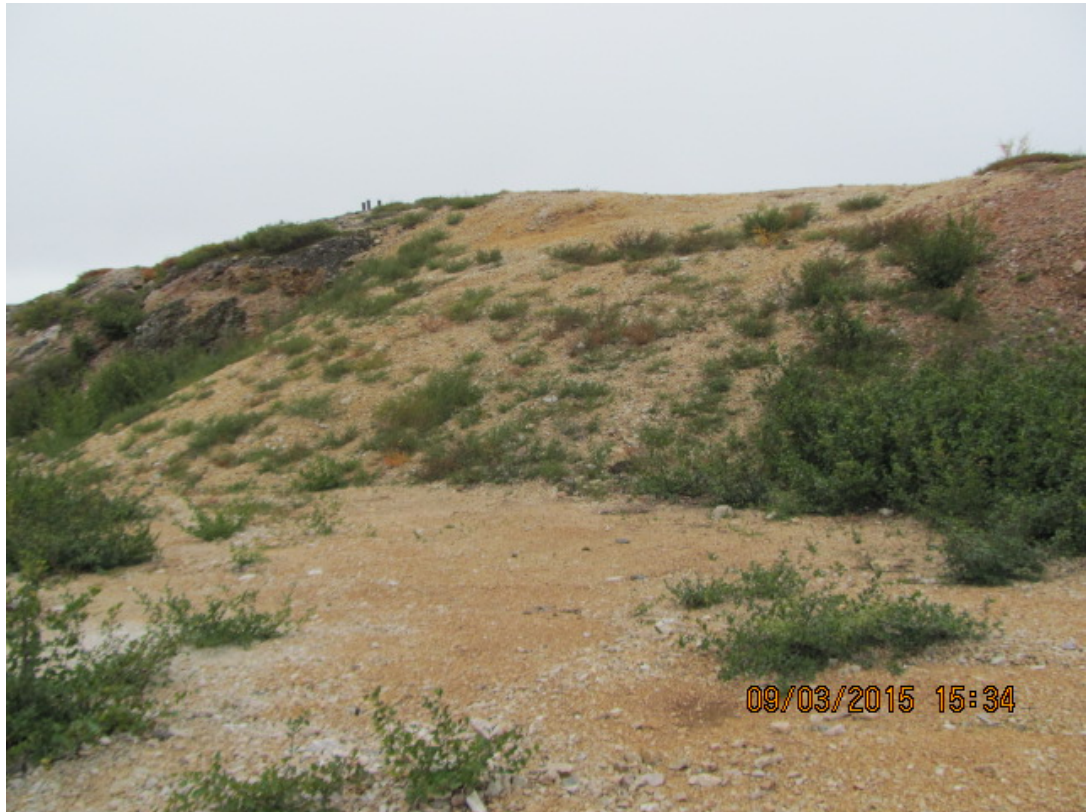
Photo 5: Former Shear Lake Portal, September 3, 2015.

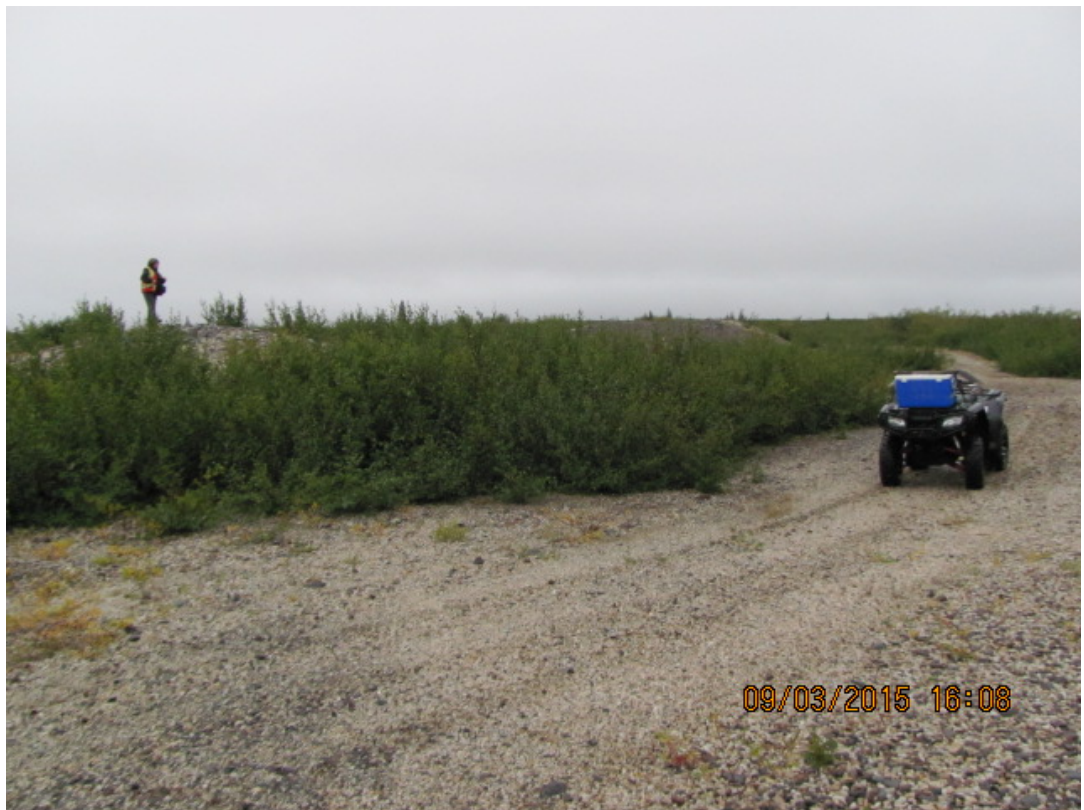
Photo 6: Former B Zone Portal and Fresh Air Raise, looking north on September 3, 2015.

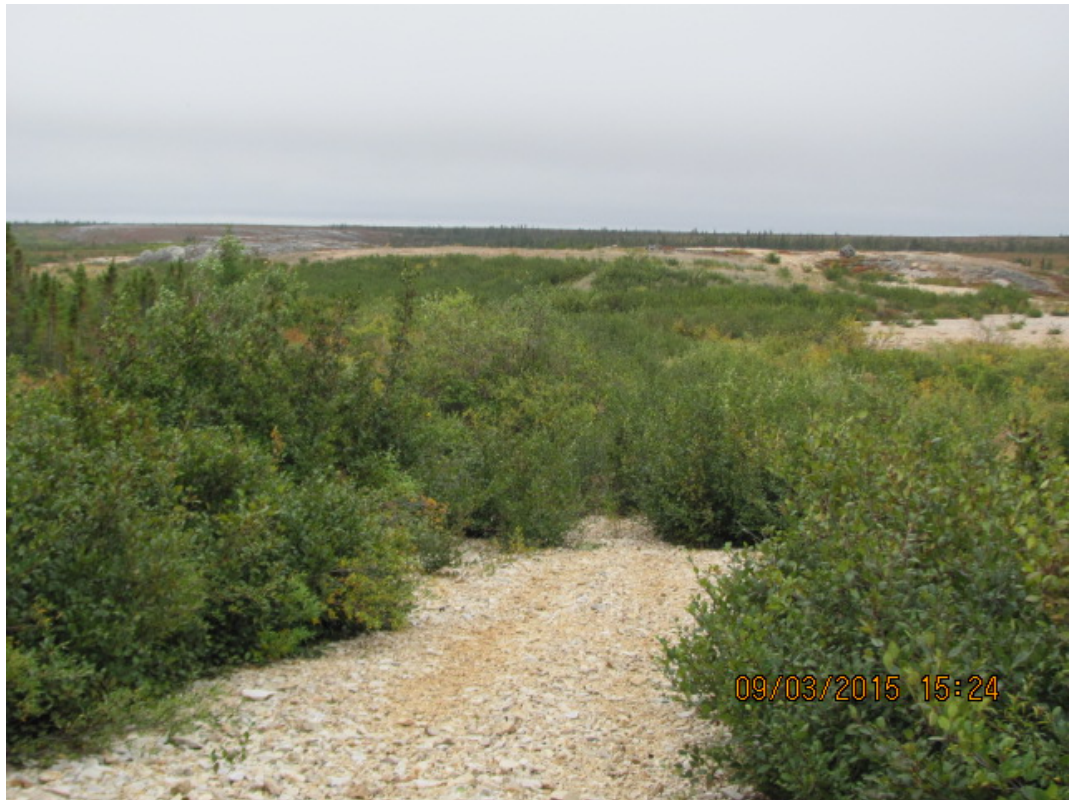
Photo 7: Encapsulated Waste Rock at Shear Lake 10 years after the application of additional seed and fertilizer.

Pursuant to Part D, Article 8e of Water Licence 1BR-CUL1118, the condition of the encapsulated waste rock cover at Shear Lake is to be monitored by the geotechnical engineer for erosion until vegetation is sufficiently established so as to stabilize the cover. At the time of the 2015 site inspection, the engineer noted the vegetation continues to take hold and is helping to reduce erosion. A recommendation for additional monitoring was also made.

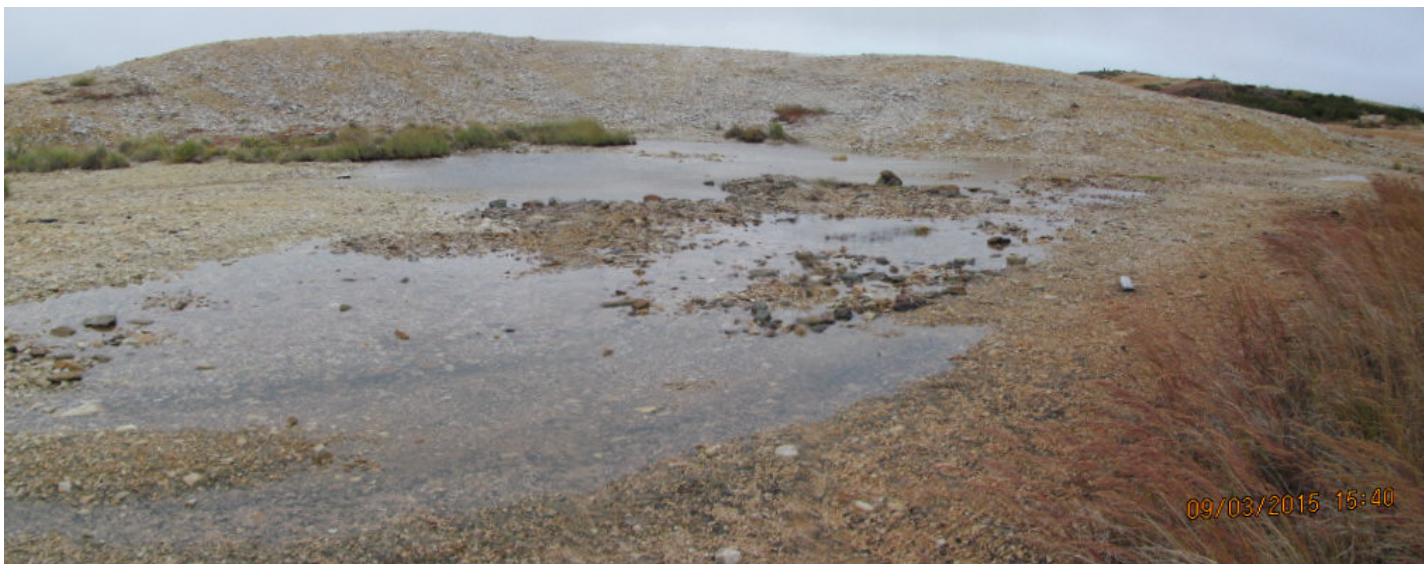
Photo 8: Shear Lake low pH pool area on September 3, 2015.

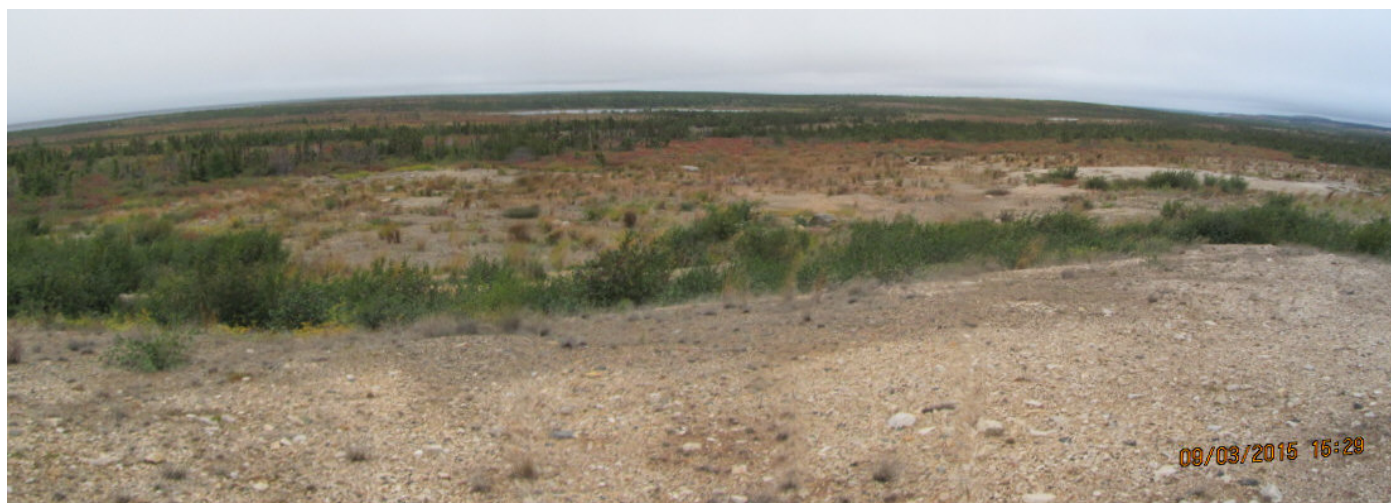
Photo 9: Vegetation on former low grade stockpile area at Shear Lake.

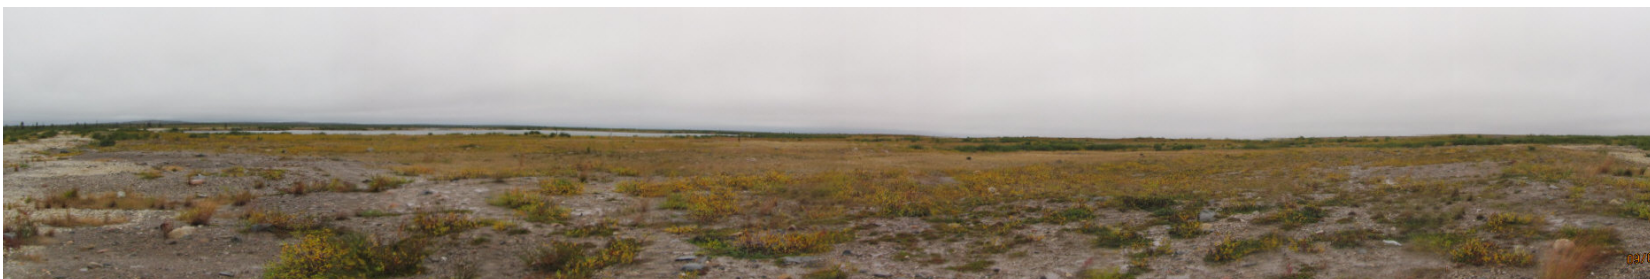
Photo 10: Tailings cover, looking southeast on September 3, 2015.

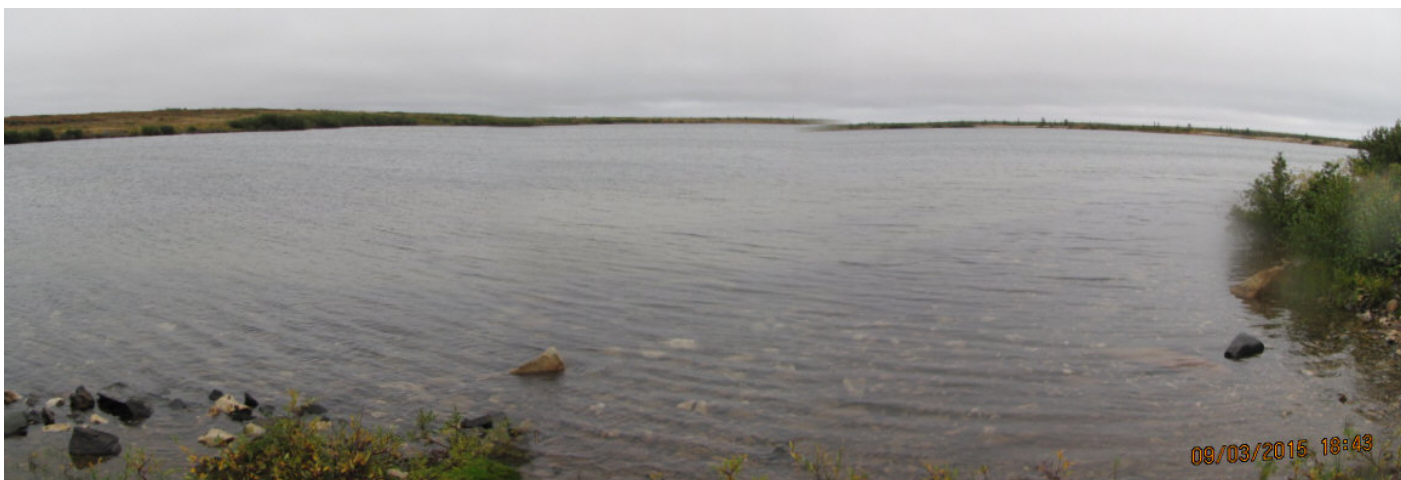
Photo 11: Tailings No. 1 Pond looking northwest on August 12, 2014.

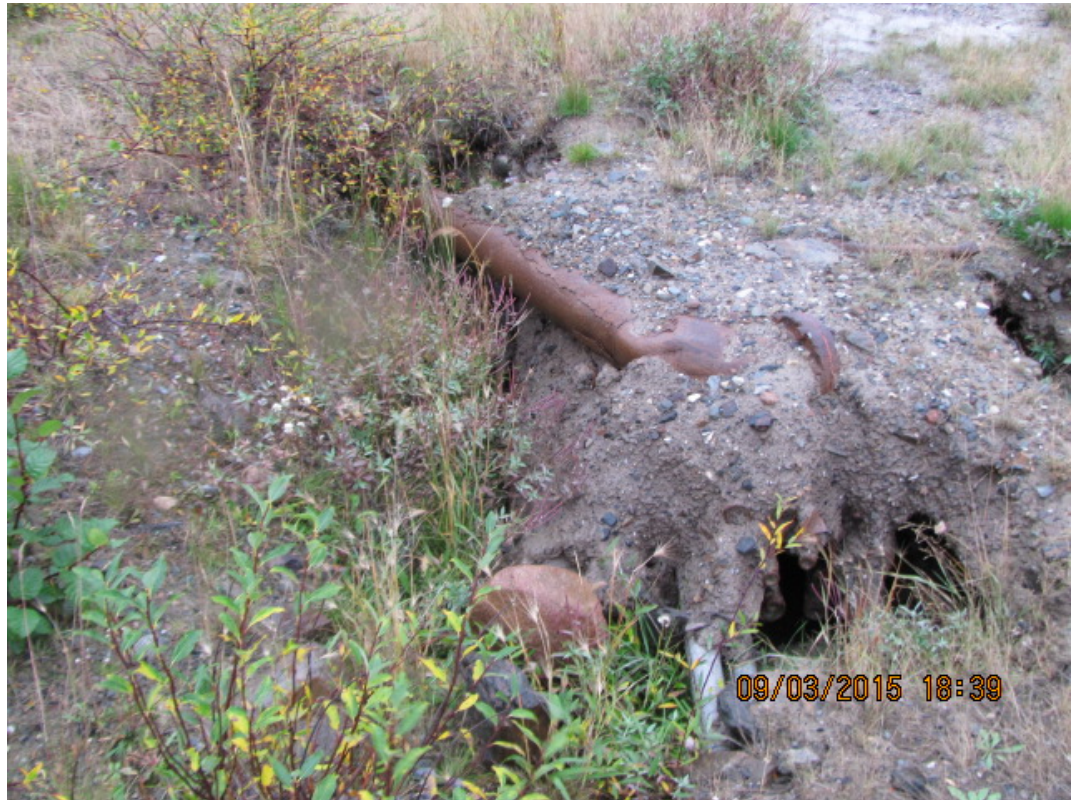
The minor subsidence areas on the quarry pit landfill remain largely unchanged. Most of the affected areas are occupied by arctic ground squirrels.

Photo 12: Subsidence area at southwest corner of of Quarry Pit pond on September 3, 2015.

In addition to the above, minor maintenance activities will be performed, including additional top dressing at previously filled areas of settlement and erosion channel repair as required. Regular maintenance of the airstrip will also continue in 2016 along with the removal of additional unauthorized third party fuel drums cached at the airstrip.

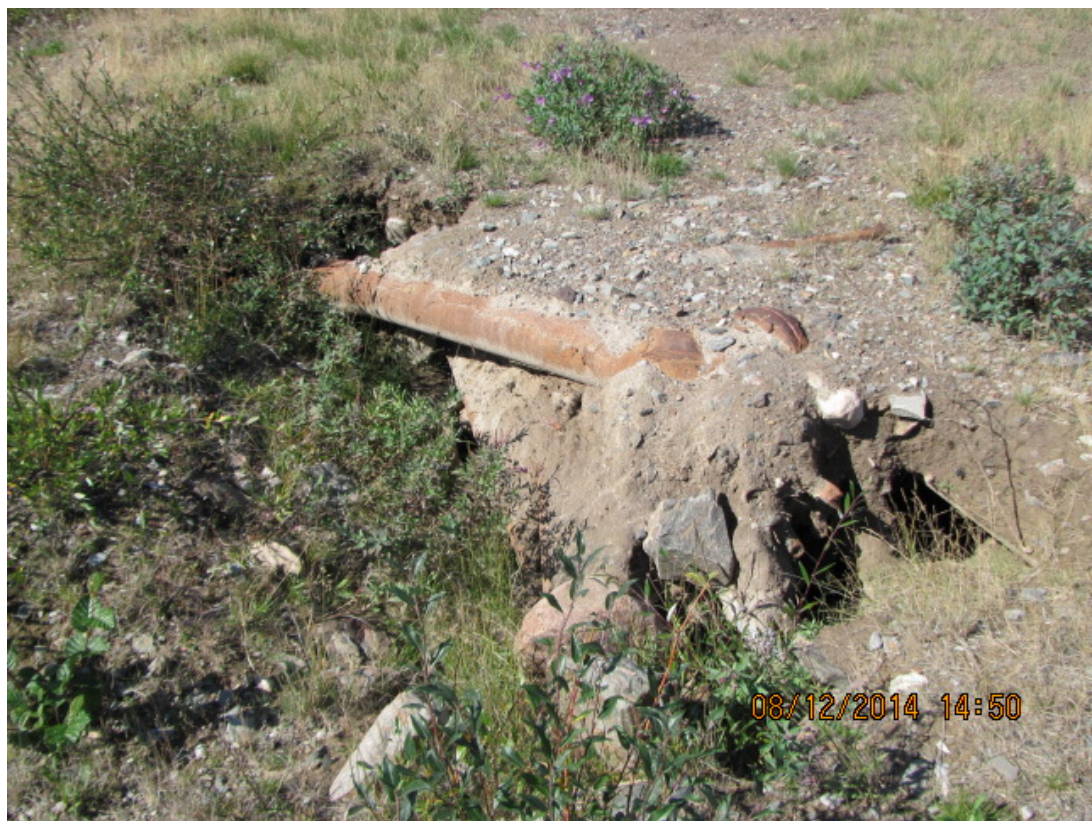
Photo 13: Subsidence at southwest corner of Quarry Pit pond on August 12, 2014.

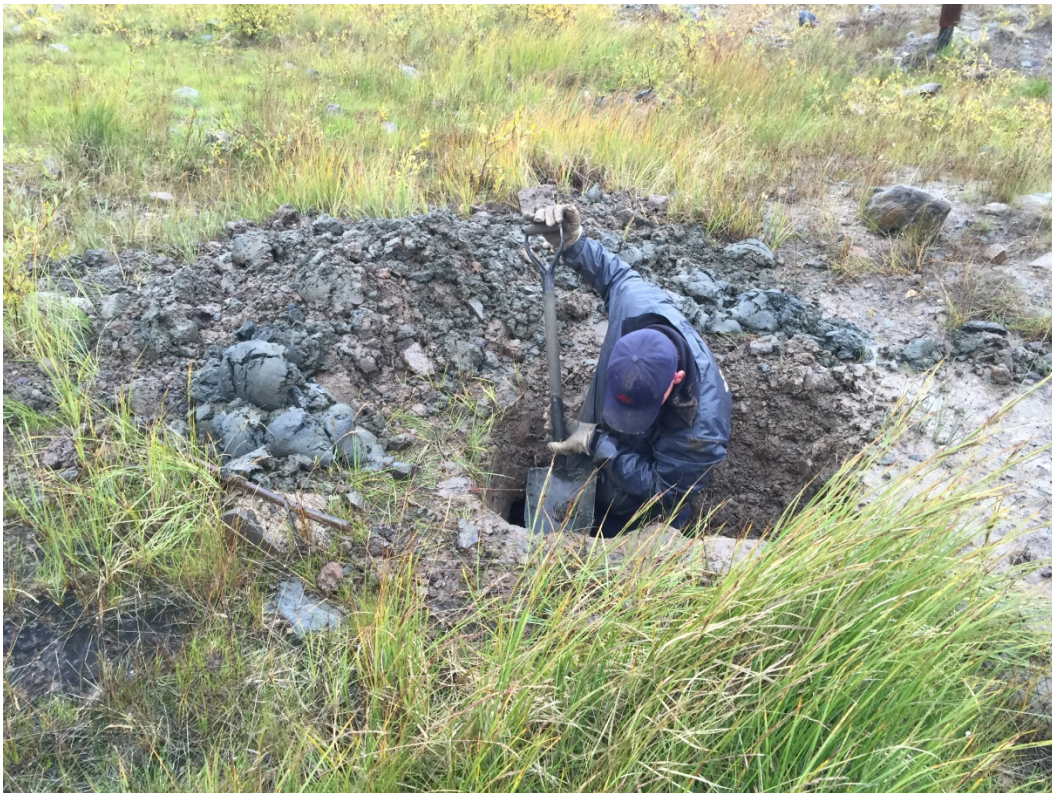
Based on the test pit finding, the permafrost was found at a depth of 1.42m on September 3, 2015. The till cover is 90cm thick at this location. The thawed 52cm of tailings above the permafrost was saturated (see field notes and photos in Appendix 3).

0.9m – 1.42m: saturated tailings

1.42m: Permafrost

September 3, 2015 test pit showing saturated tailings to the left of the pit.
