CULLATON LAKE GOLD MINES LTD.

WATER LICENCE 1BR-CUL1118

ANNUAL WATER LICENCE REPORT 2016

BARRICK GOLD INC.

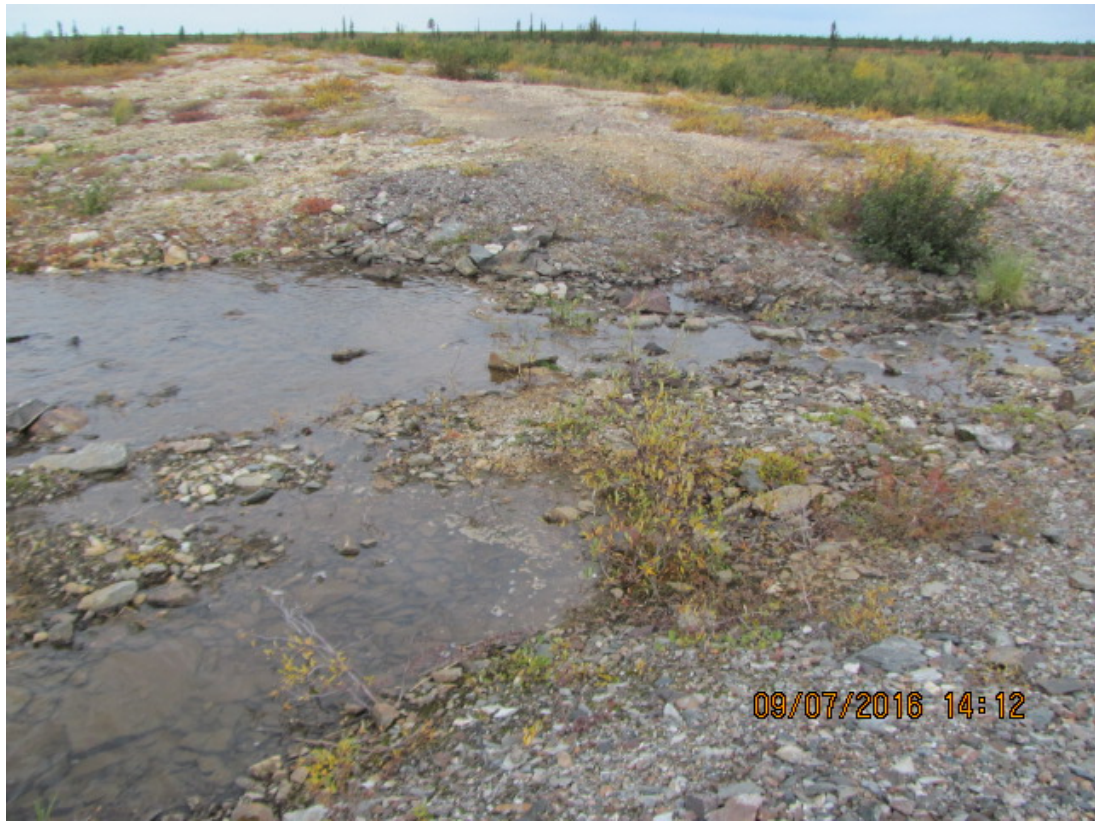
In summary, the report indicates that the tailings dam remains stable. Continued monitoring for erosion in the No. 1 Spillway channel is also recommended.

Photo 3: Tailings No.1 Pond spillway invert on September 7, 2016

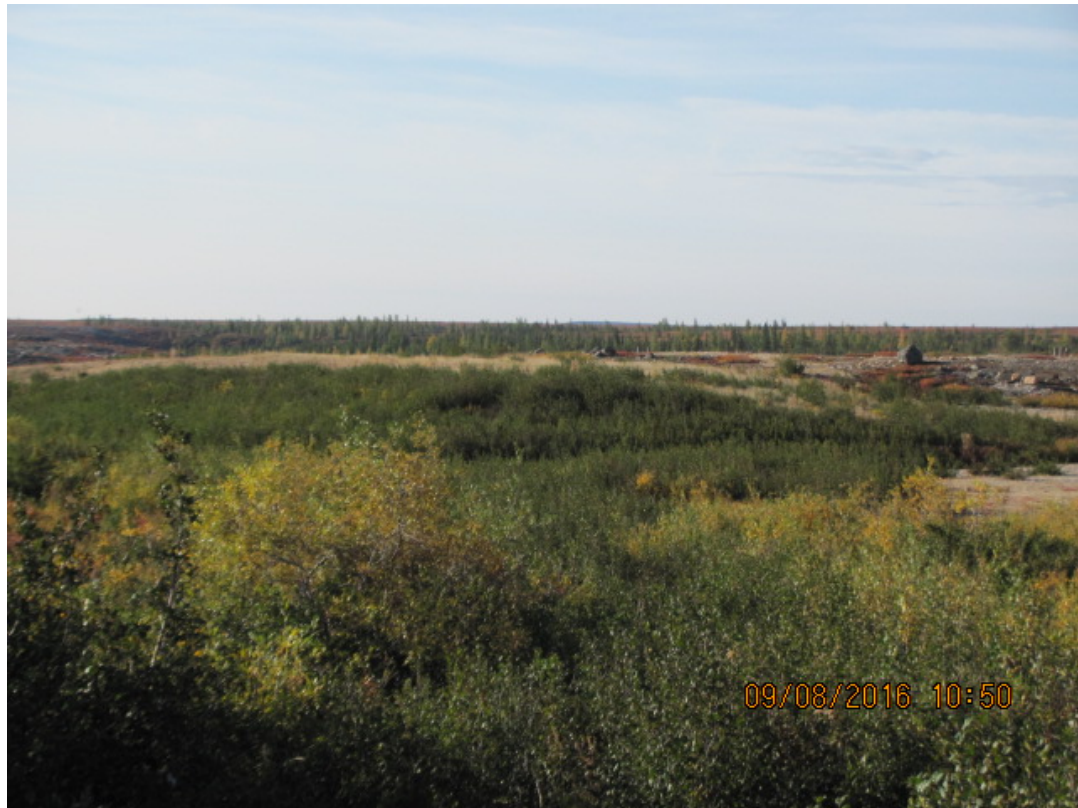
Pursuant to Part D, Article 8e of Water Licence 1BR-CUL1118, the condition of the encapsulated waste rock cover at Shear Lake is to be monitored by the geotechnical engineer for erosion until vegetation is sufficiently established so as to stabilize the cover. At the time of the 2016 site inspection, the engineer noted the vegetation continues to take hold and is helping to reduce erosion. A recommendation for additional monitoring was also made.

Photo 7: Encapsulated Waste Rock at Shear Lake 11 years after the application of additional seed and fertilizer.

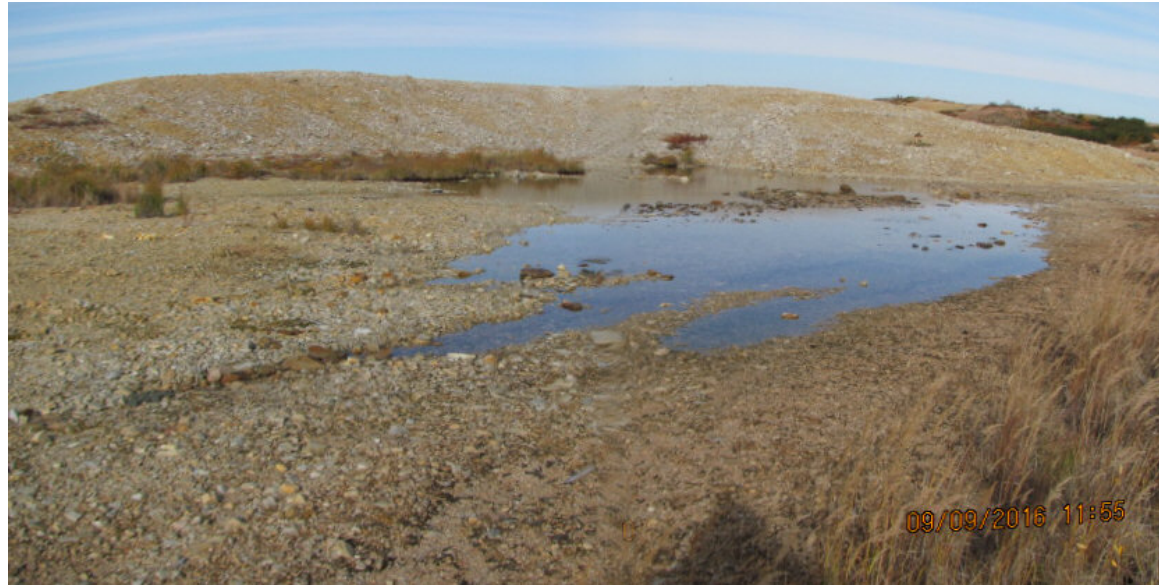
Photo 9: Shear Lake low pH pool area on September 9, 2016.

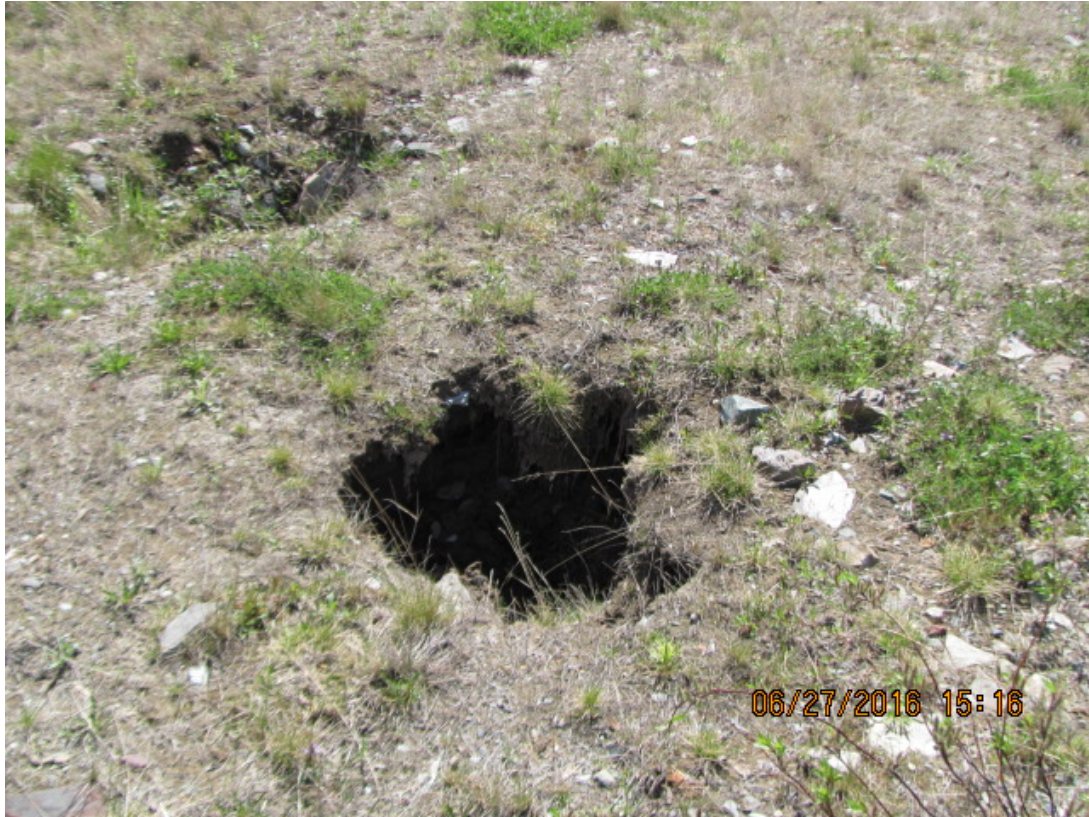
The minor subsidence areas on the quarry pit landfill remain largely unchanged. Two new minor subsidence areas were observed. Most of the affected areas are occupied by arctic ground squirrels.

Photo 11: New subsidence area in midsection of Quarry Pit landfill cover in June 2016.

- a visit in late June – early July (depending on weather) to collect surface water samples, perform airstrip and access road maintenance, collect additional remote refuse identified by INAC and perform aerial surveys to identify surface lease boundaries.
- a visit during the first week of September to perform the annual site inspection, water quality monitoring, tailings dam geotechnical inspection, initiate maintenance work on the Quarry Pit landfill cover and replace water quality station markers.

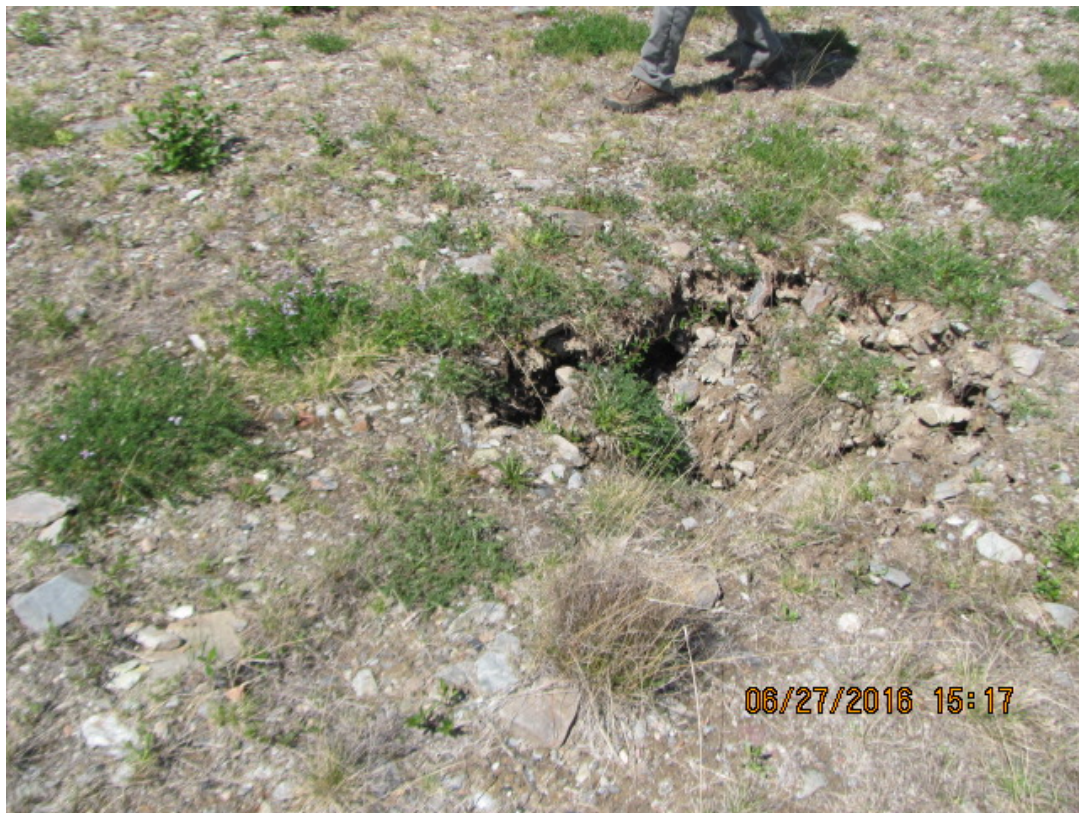
Photo 12: Subsidence at southeast corner of Quarry Pit landfill cover in June 2016.

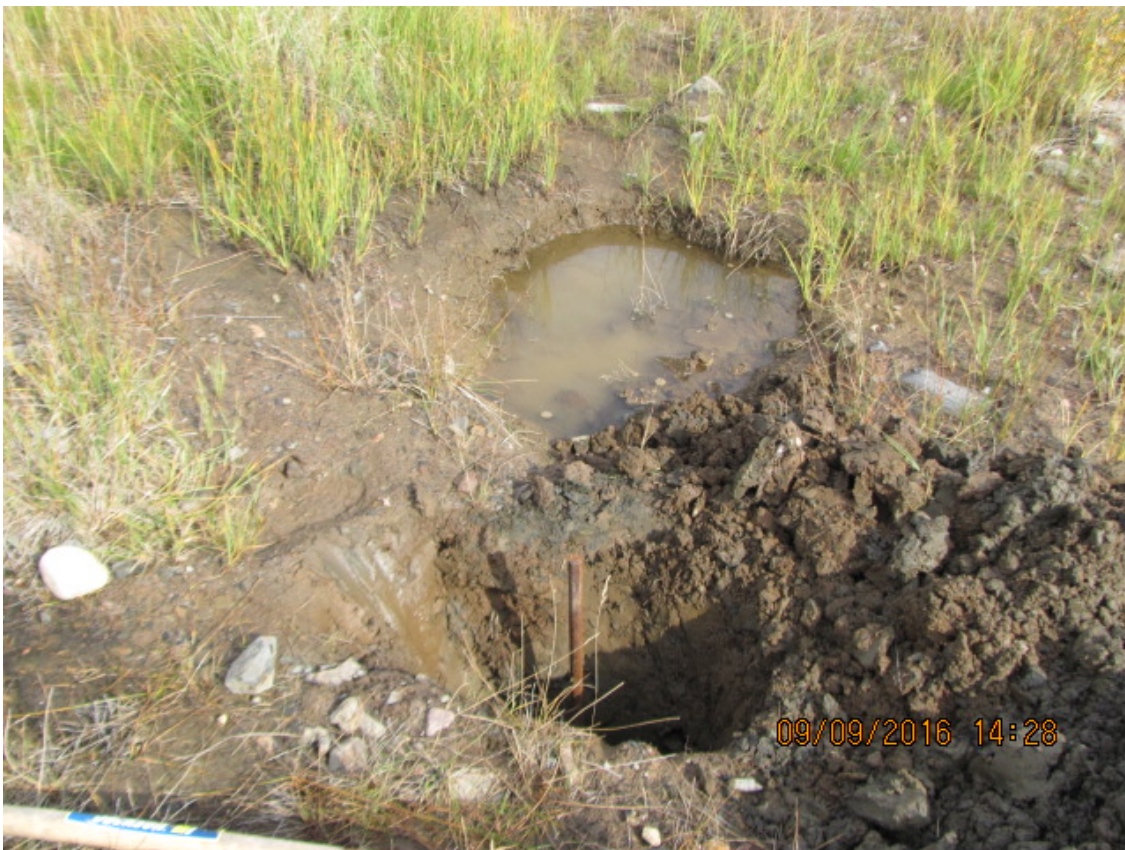
Based on the test pit finding, the permafrost was found at a depth of 1.27m on September 9, 2016. The thickness of the till cover is 90cm at this location. The thawed 37cm of tailings below the cover and above the permafrost was saturated (see field notes and photos in Appendix 3).

September 9, 2016 test pit next to (water ponded) 2015 pit with 1.27m probe bar.
