CULLATON LAKE GOLD MINES LTD. WATER LICENCE 1BR-CUL1118

ANNUAL WATER LICENCE REPORT 2017

BARRICK GOLD INC.

March 20, 2018

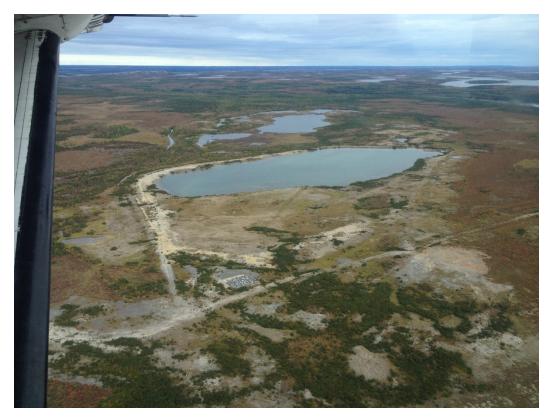
Photo 1: Cullaton Lake main site, looking south east on September 6, 2017.

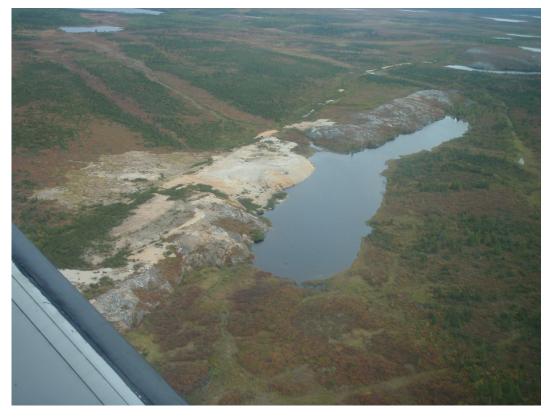
Photo 2: Shear Lake site, looking southeast with shrub covered EWR on the left.

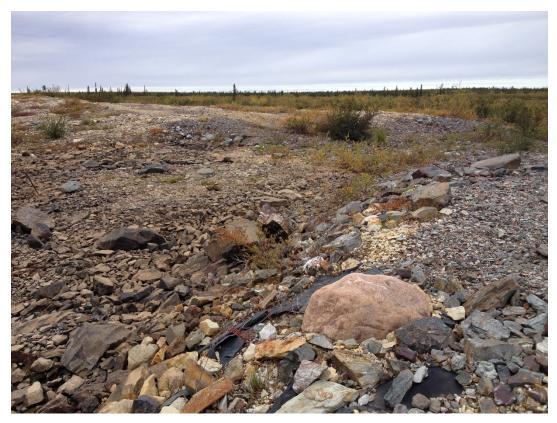
Photo 3: Tailings No.1 Pond spillway invert (dry) on September 6, 2017

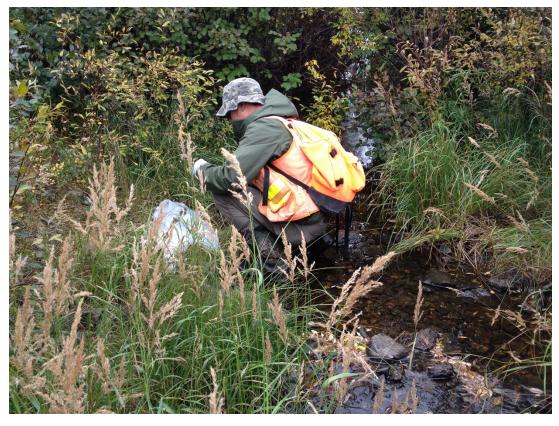
Photo 4: Former Tailings Pond No. 2 spillway flowing on September 6, 2017

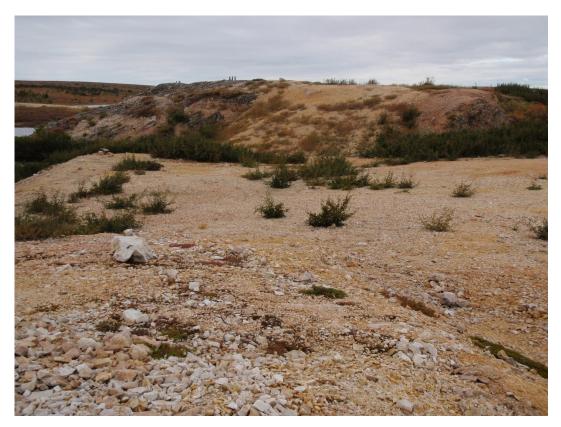
Photo 5: Former Shear Lake Portal on September 6, 2017.

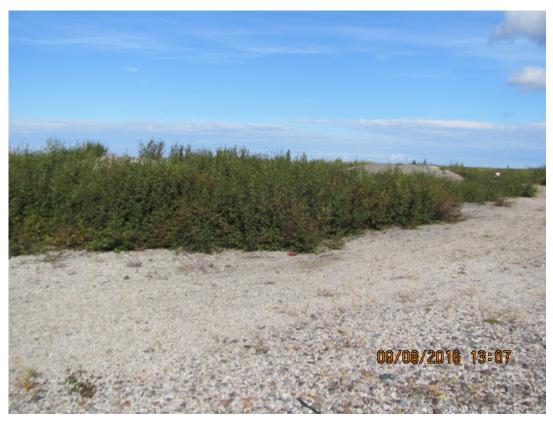
Photo 6: Former B Zone Portal and Fresh Air Raise, looking north (2016 photo).

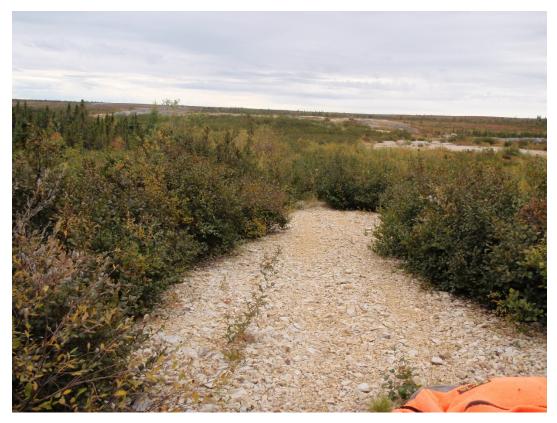
Photo 7: Encapsulated Waste Rock at Shear Lake 12 years after the application of additional seed and fertilizer.

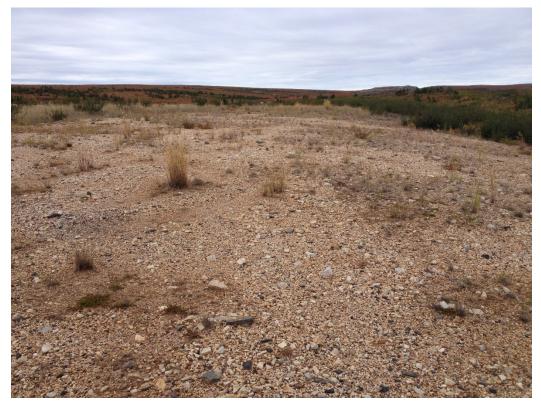
Photo 8: Encapsulated Waste Rock cover top looking north on September 6, 2017.

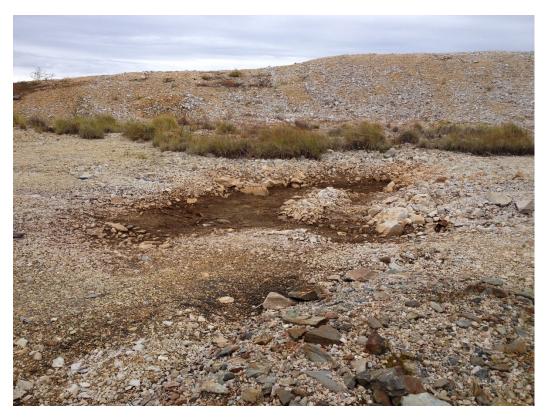
Photo 9: Shear Lake low pH pool area (dry) on September 6, 2017

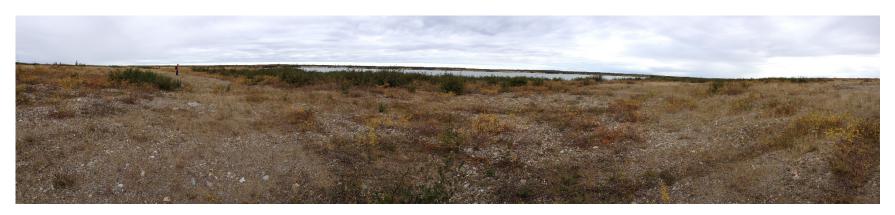
Photo 10: Tailings cover vegetation, looking southeast on September 6, 2017.

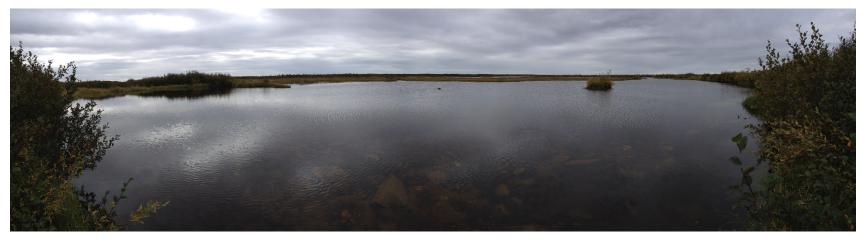
Photo 11: Former Polishing Pond looking west from T2 outlet.

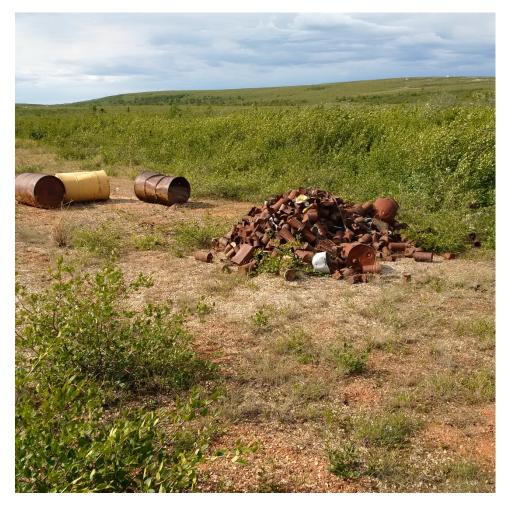
Photo 12: Refuse stored at airstrip in July for future removal.

The removal of additional unauthorized third-party fuel drums cached at the airstrip will continue as backhauls are made available.

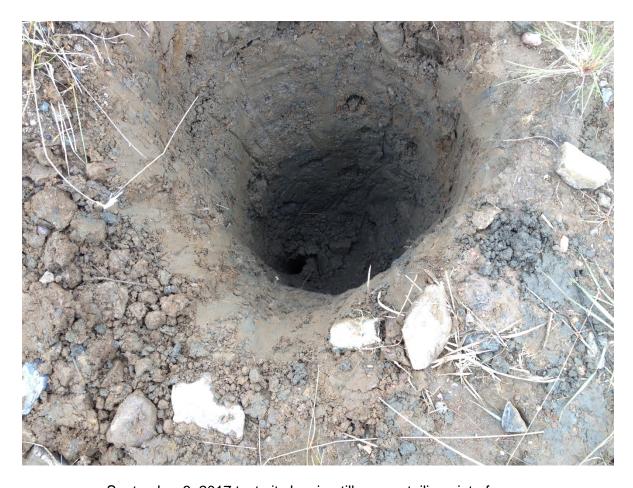
Based on the test pit finding, the permafrost was found at a depth of 1.3m on September 6th, 2017. The thickness of the till cover is 90cm at this location. The thawed 40cm of tailings below the cover and above the permafrost was saturated (see field notes and photos in Appendix 3).

0.9m - 1.3m: saturated tailings

1.3m: Permafrost

September 6, 2017 test pit showing till cover - tailings interface

Thermistors not read – all are inaccessible due to frost heaving.

Water Licence 1BR-CUL1118 included a recommendation by Environment Canada and INAC to replace the non-functioning tailings cover thermistors. As indicated in the new C&R Plan submitted on June 30th, 2017, Barrick proposes to complete a one-time replacement of the four thermistors on the tailings cover in 2018.
