CULLATON LAKE GOLD MINES LTD.

WATER LICENCE 1BR-CUL1118

ANNUAL WATER LICENCE REPORT 2018

March 2019

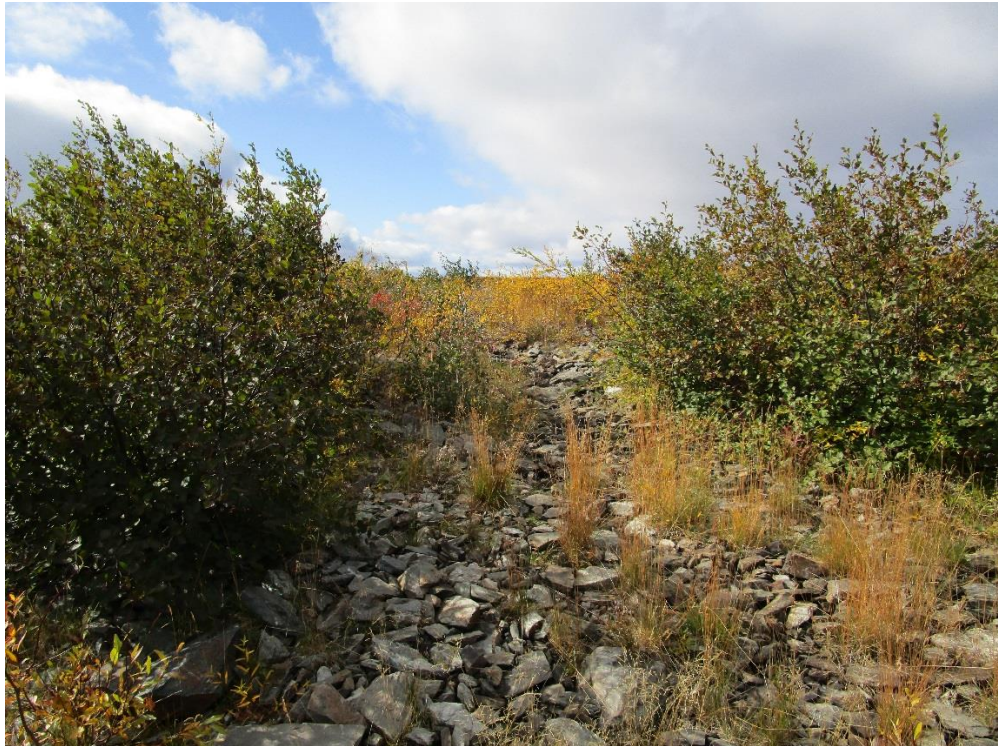
Photo 3: Tailings No.1 Pond spillway invert (dry) on September 12, 2018

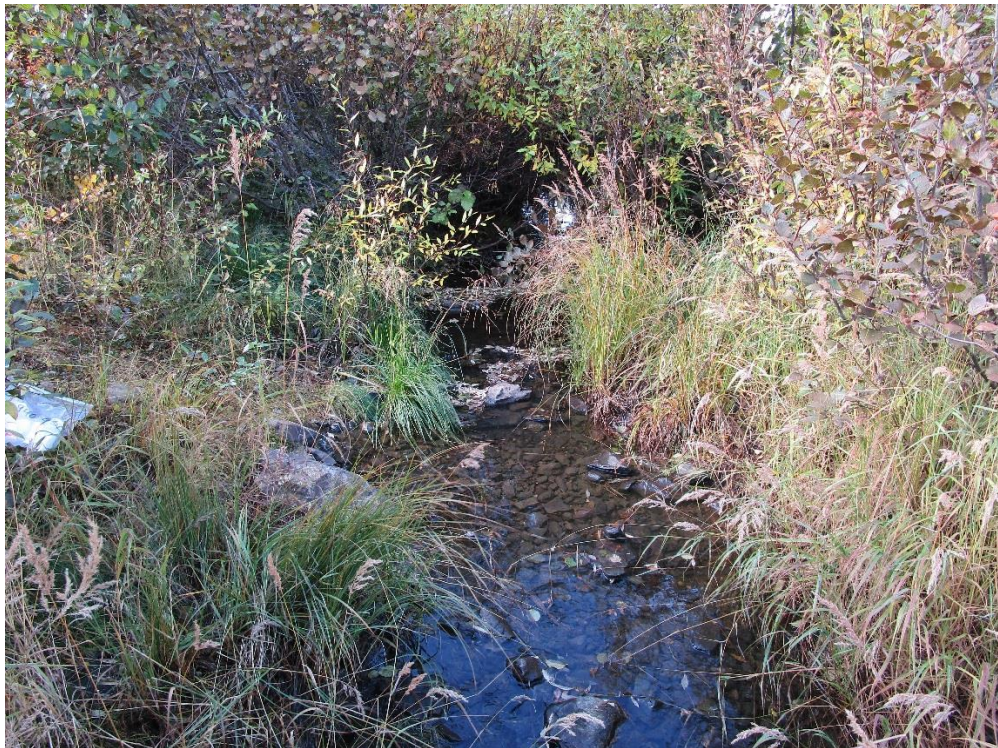
Photo 4: Former Tailings Pond No. 2 spillway flowing on September 12, 2018

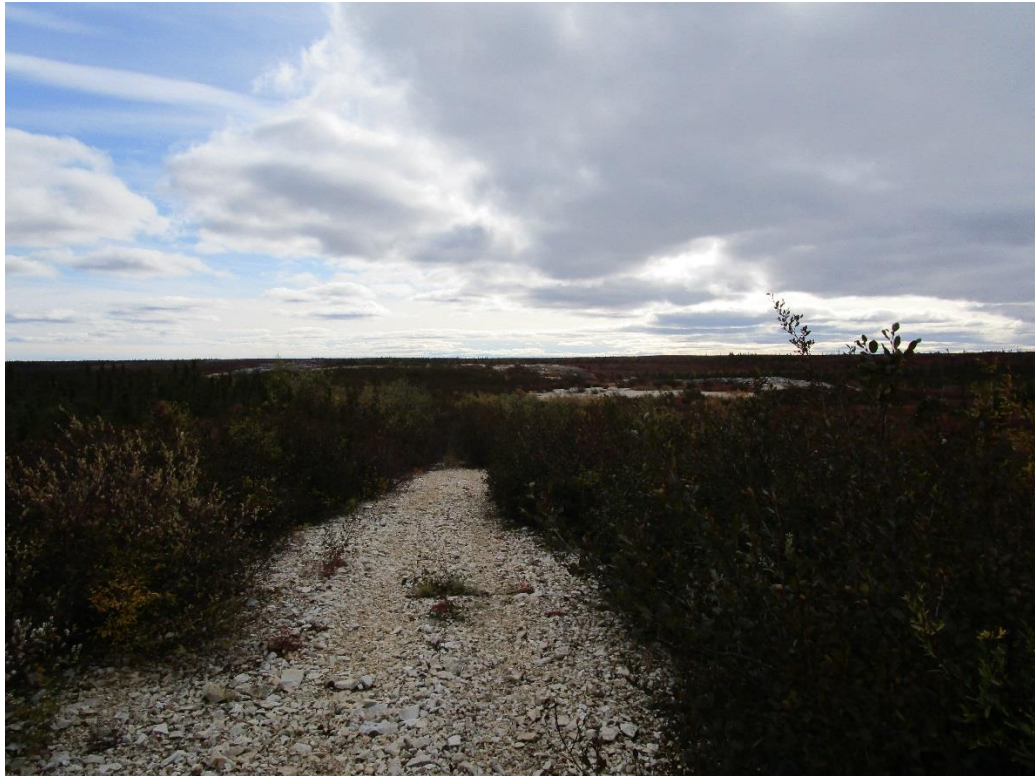
Photo 7: Encapsulated Waste Rock at Shear Lake 13 years after the application of additional seed and fertilizer.

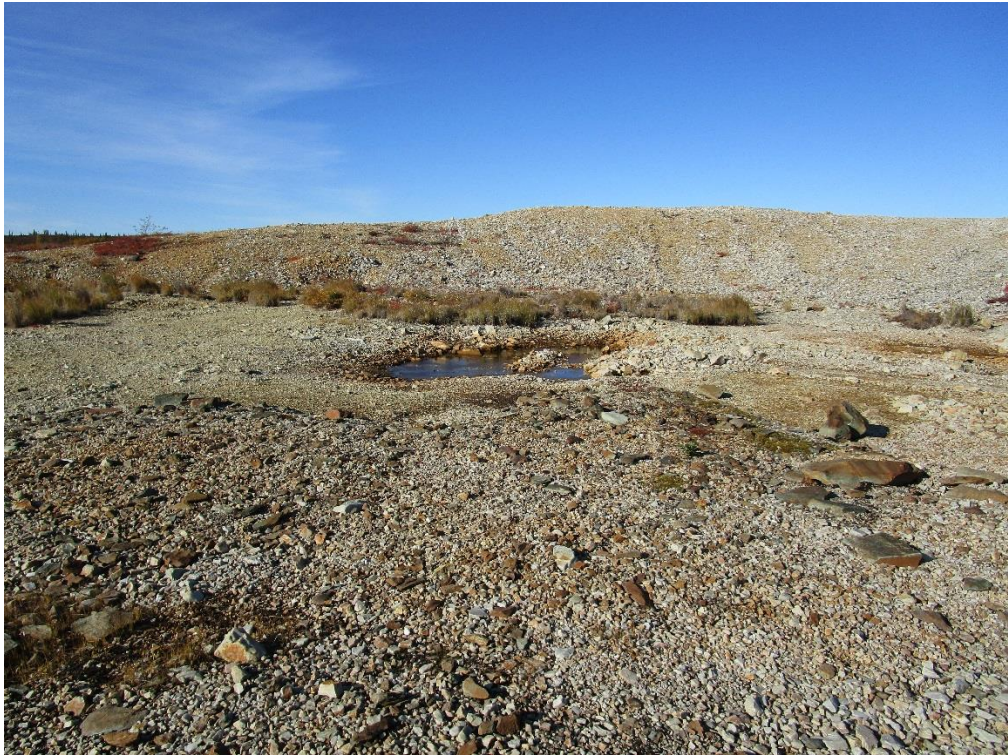
Photo 9: Shear Lake low pH pool area on September 12, 2018.

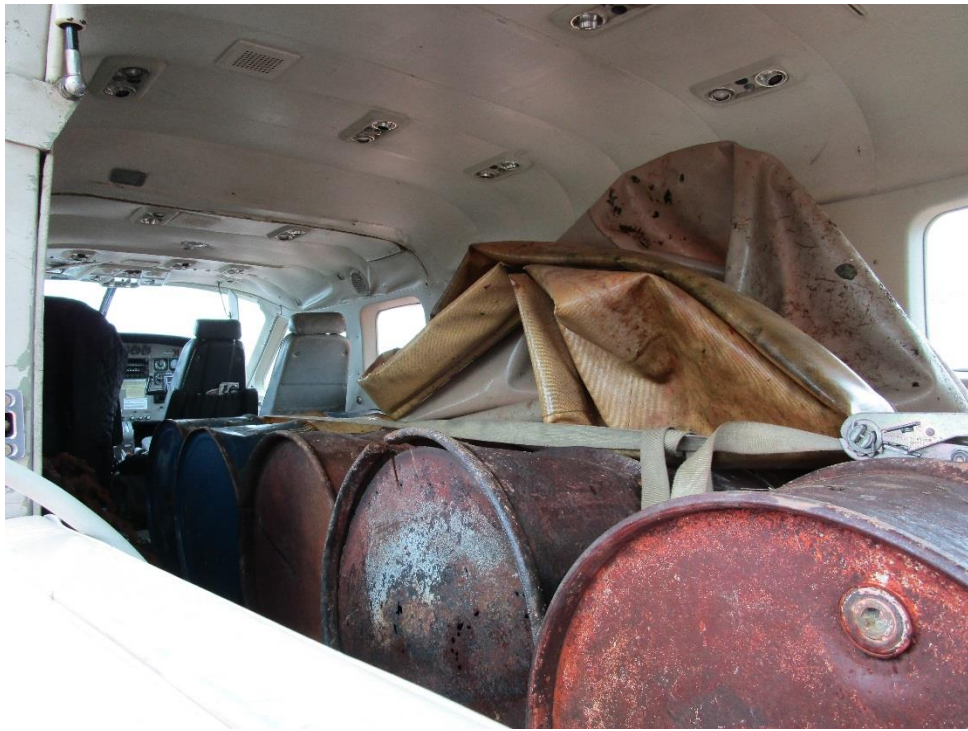
Photo 13: Scrap drums and abandoned spill pad loaded for removal.

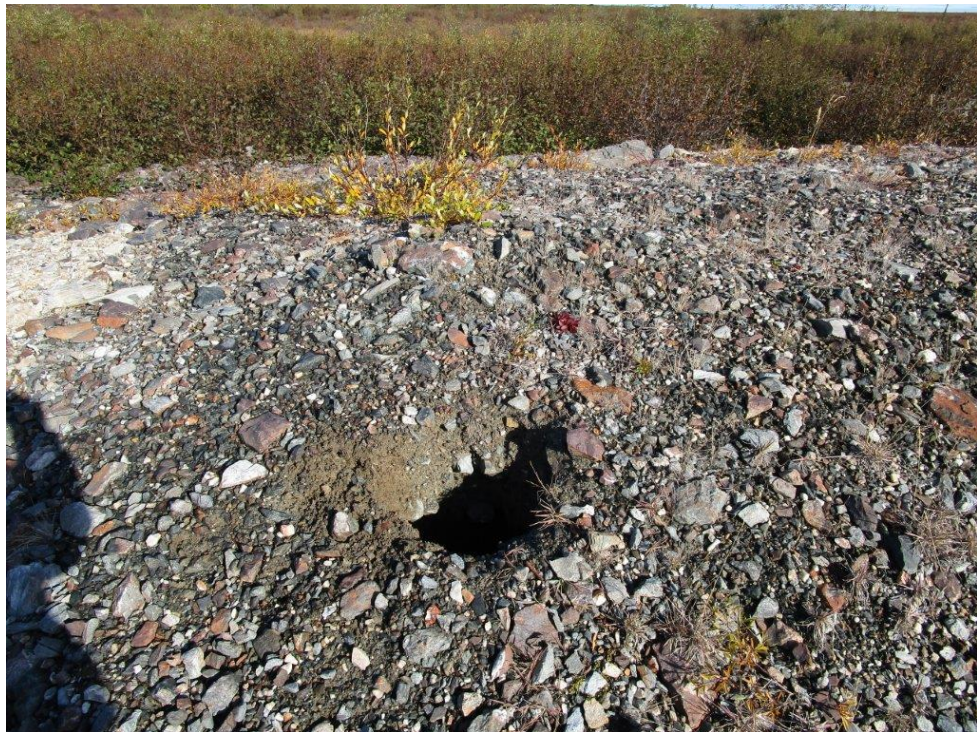
Minor subsidence was found on the B-Zone fresh air raise (see Photo 14, Appendix 1). The affected area was plugged with large waste rock and will be checked again in 2019.

Photo 14: Small are of subsidence at B-zone Vent Raise.

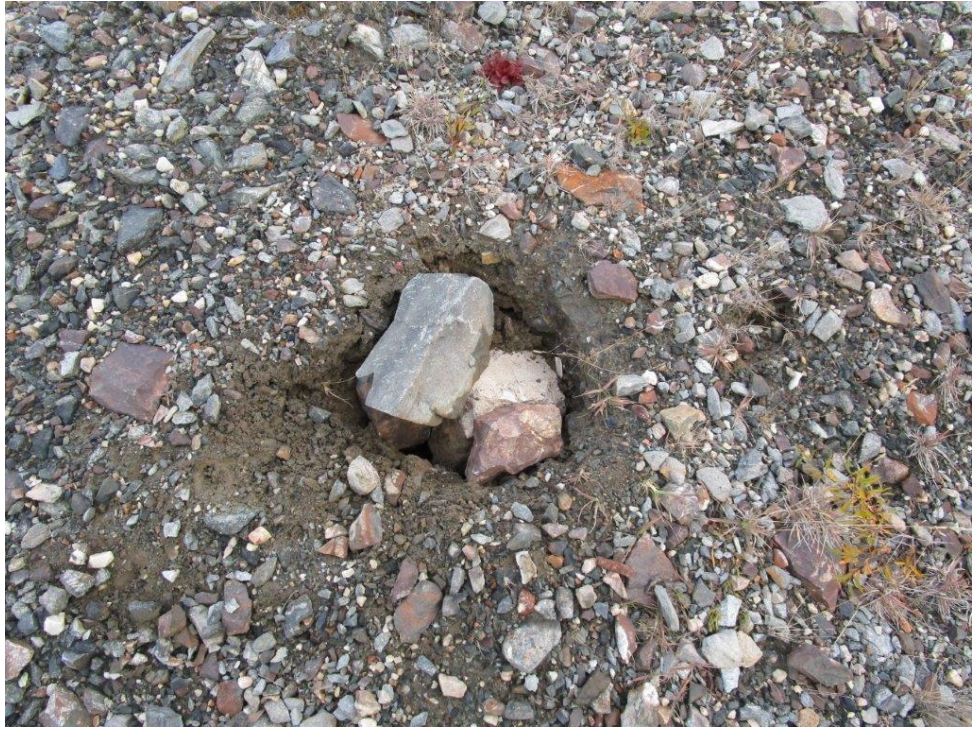
Photo: 15: Vent raise subsidence filled with waste rock.

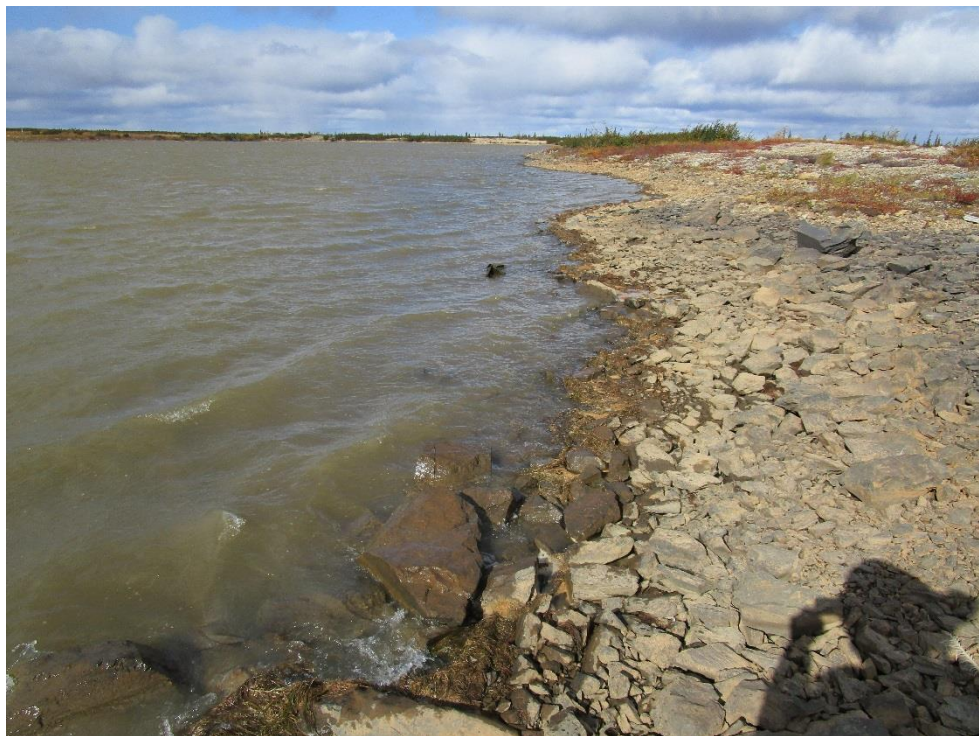
Station 940-2 (Tailings Pond No. 1 at discharge to Tailings Pond No. 2) – Duplicate water samples were collected on September 12th, 2018. Results indicated that all parameters were below the limits prescribed in the Water Licence with the exception of TSS. The concentration of TSS was 128 mg/L as compared to a limit of 25mg/l. Persistent strong winds during the week combined with very low water levels caused a considerable amount of suspended material to be present in the tailings pond water with resultant high turbidity (see Photo 16), which is reflected in the results.

Photo 16: Tailings Pond No. 1 low water and turbidity on September 12, 2018.

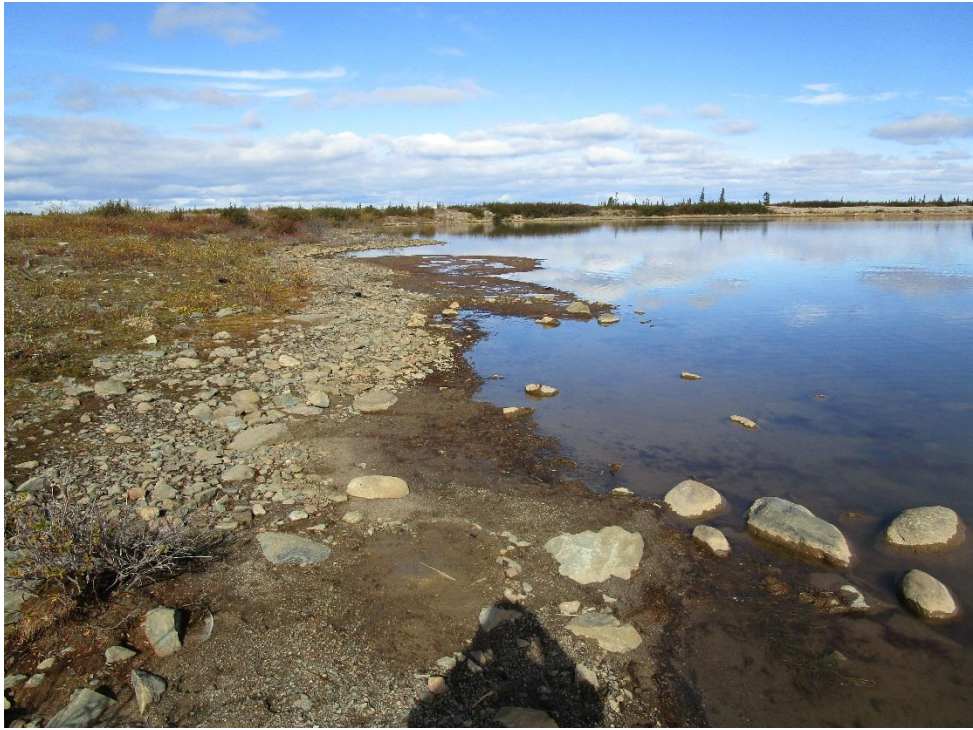
The Tailings Pond No. 1 water level continues to drop, likely due to prolonged drought conditions. The lower level has exposed some tailings beach along portions of the west side of the pond (see Photo 17).

Photo 17: Exposed tailings beach on west side of pond due to low water level.
