CULLATON LAKE GOLD MINES LTD.

WATER LICENCE 1BR-CUL1828

ANNUAL WATER LICENCE REPORT 2019

March 2020

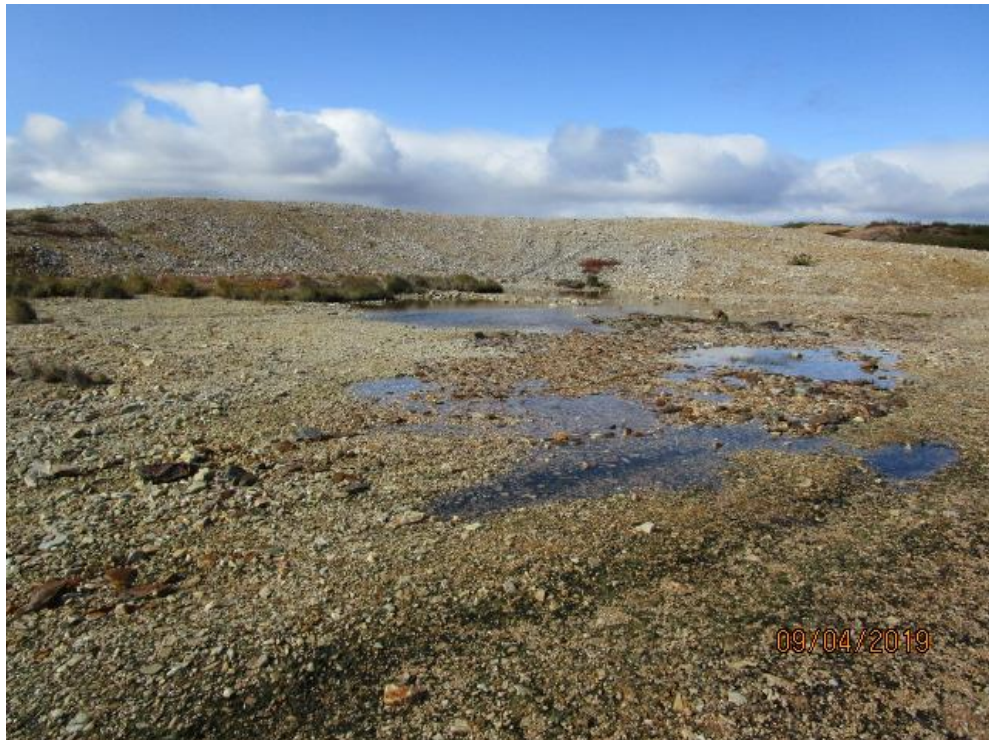
Photo 6: Shear Lake low pH pool area.

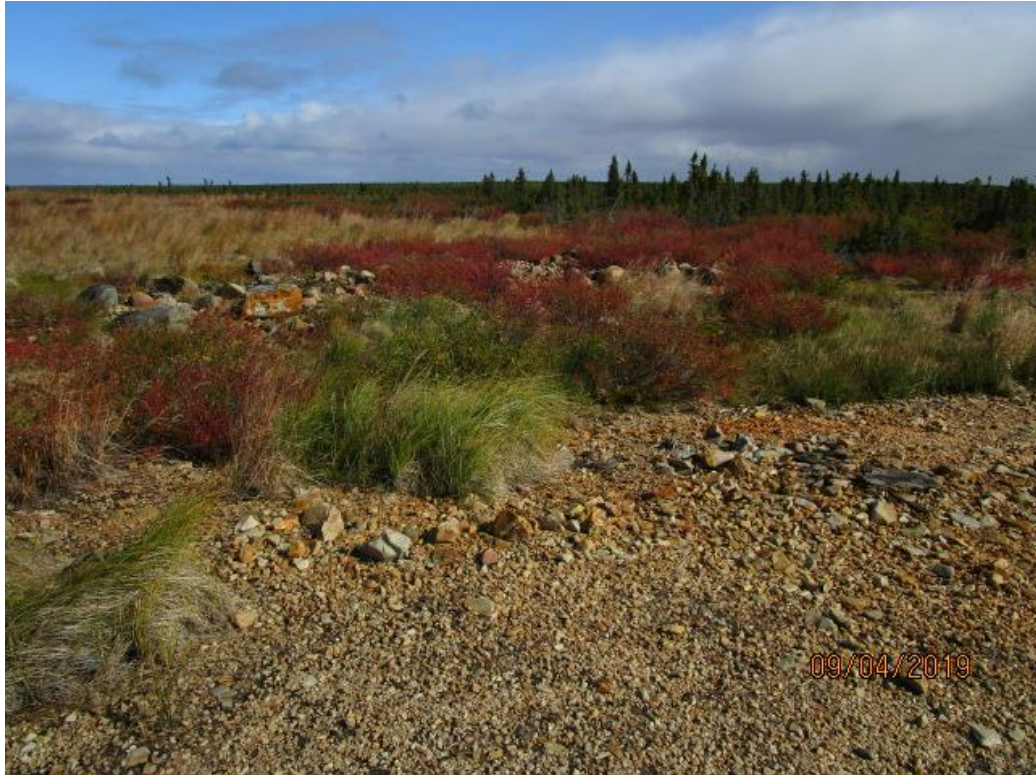
Photo 7: Healthy vegetation downstream of low pH pool.

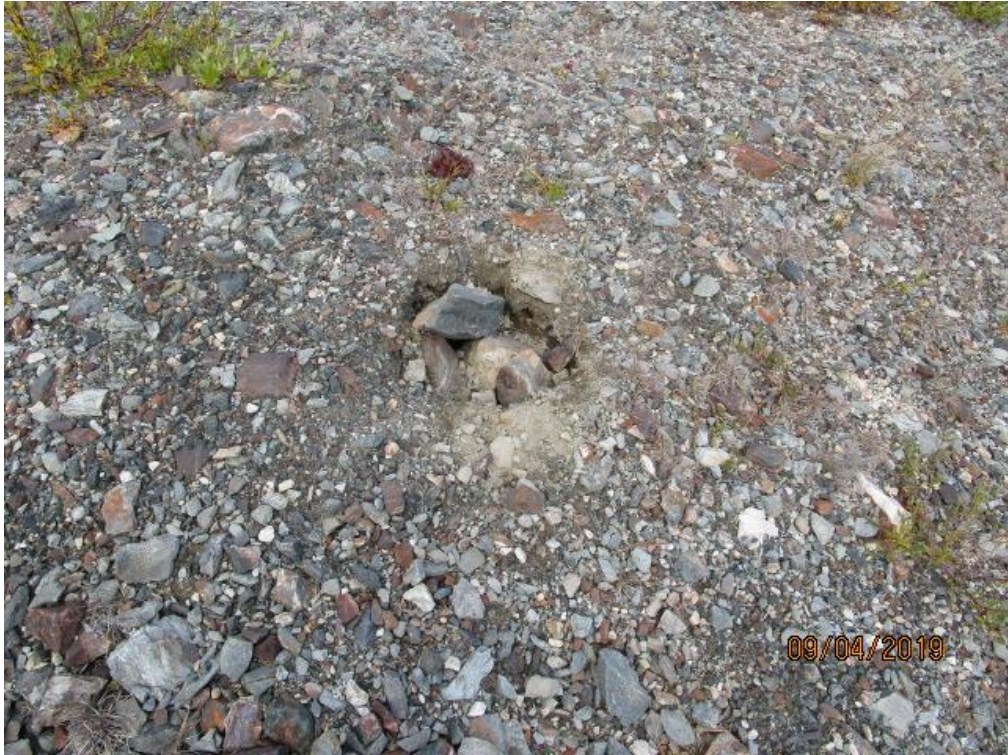
The minor subsidence found on the B-Zone fresh air raise remained unchanged from 2018 and was filled in (See Photos 11 and 12 in Appendix 1). The affected area will be monitored during future inspections until stability is confirmed.

Photo 11: Small area of subsidence at B-zone Vent Raise.

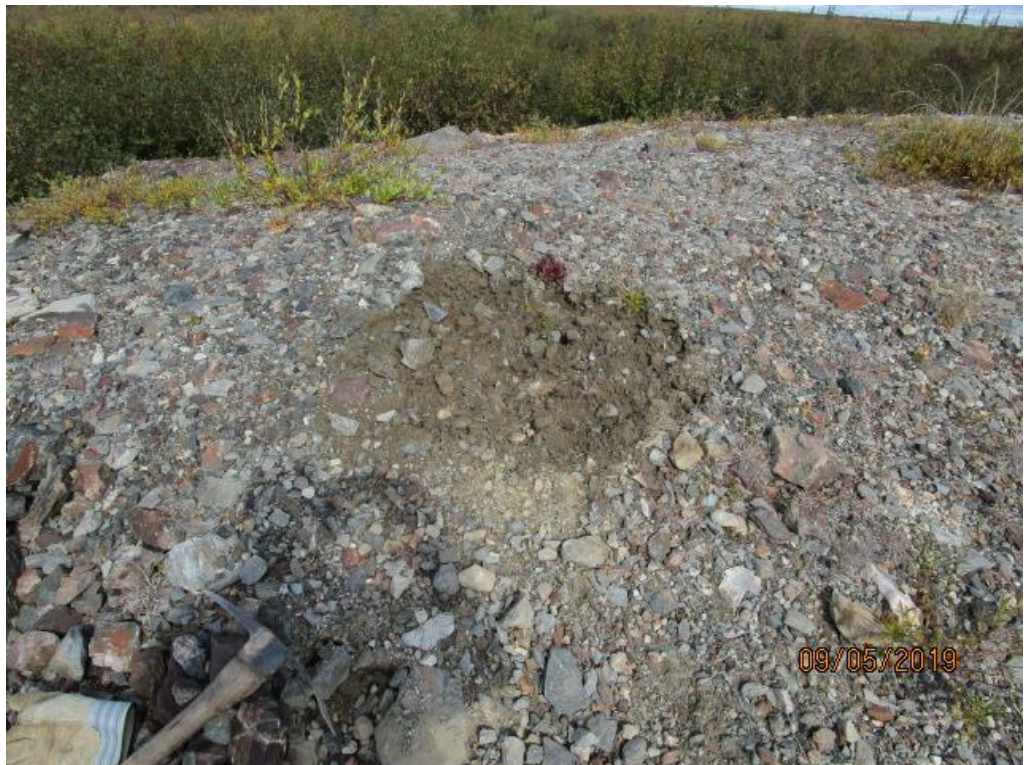
Photo 12: Affected area filled in.

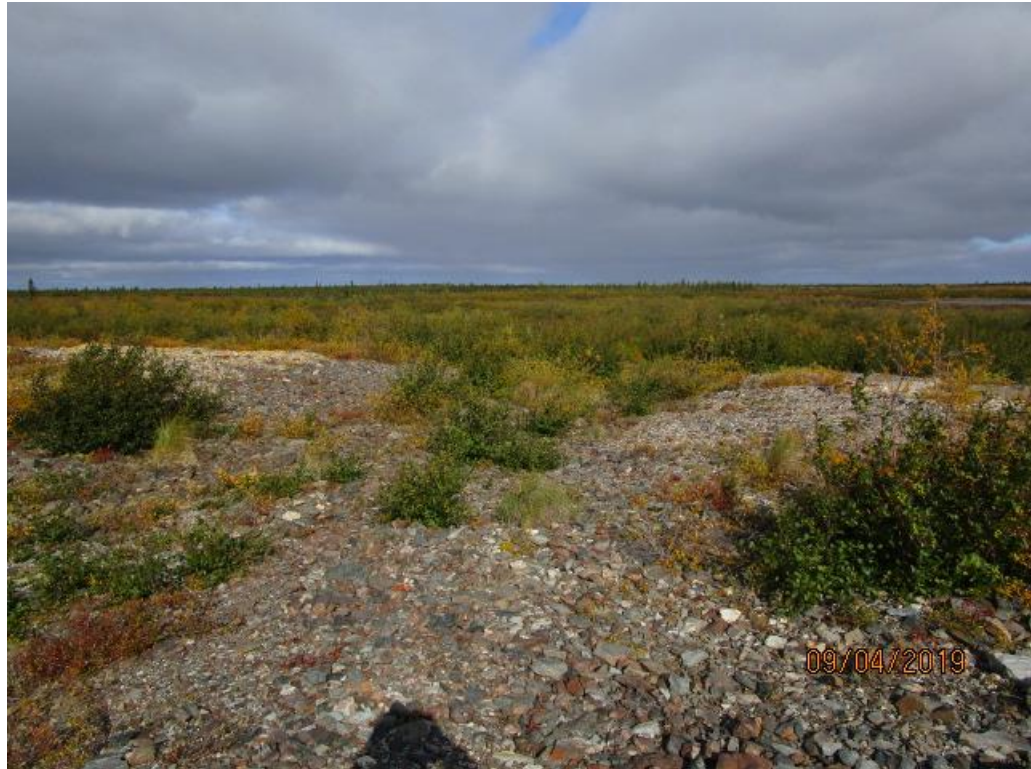
Photo 13: Tailings Pond No. 1 spillway (dry) looking downstream.

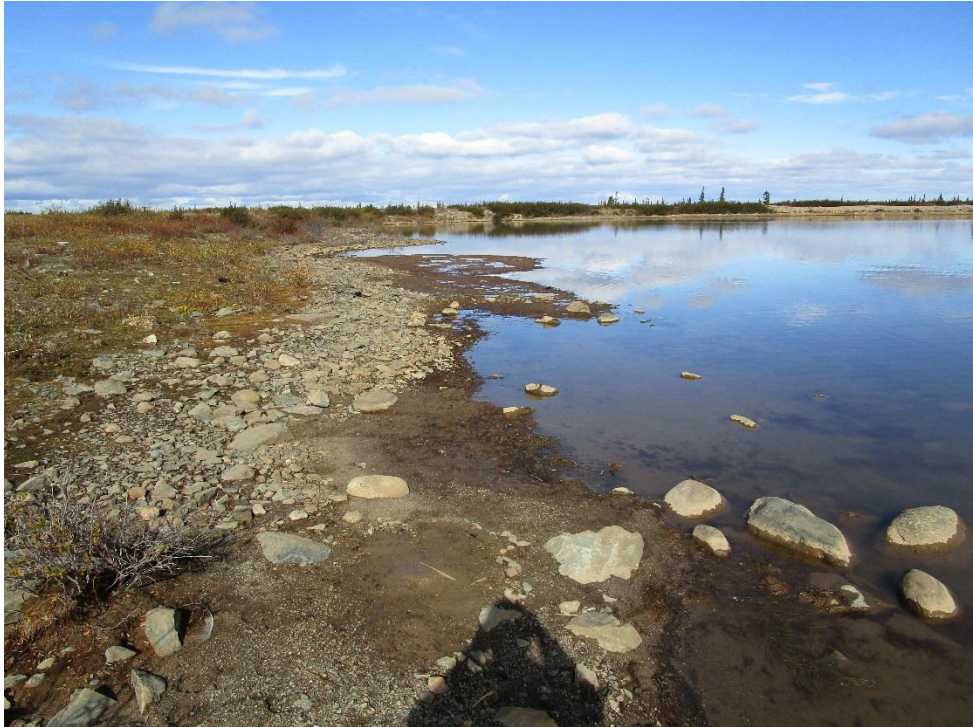
The Tailings Pond No. 1 water level has risen a few centimeters compared to 2018 (See Photos 15 and 16 in Appendix 1).

Photo 15: Exposed tailings beach on west side of pond in September 2018.

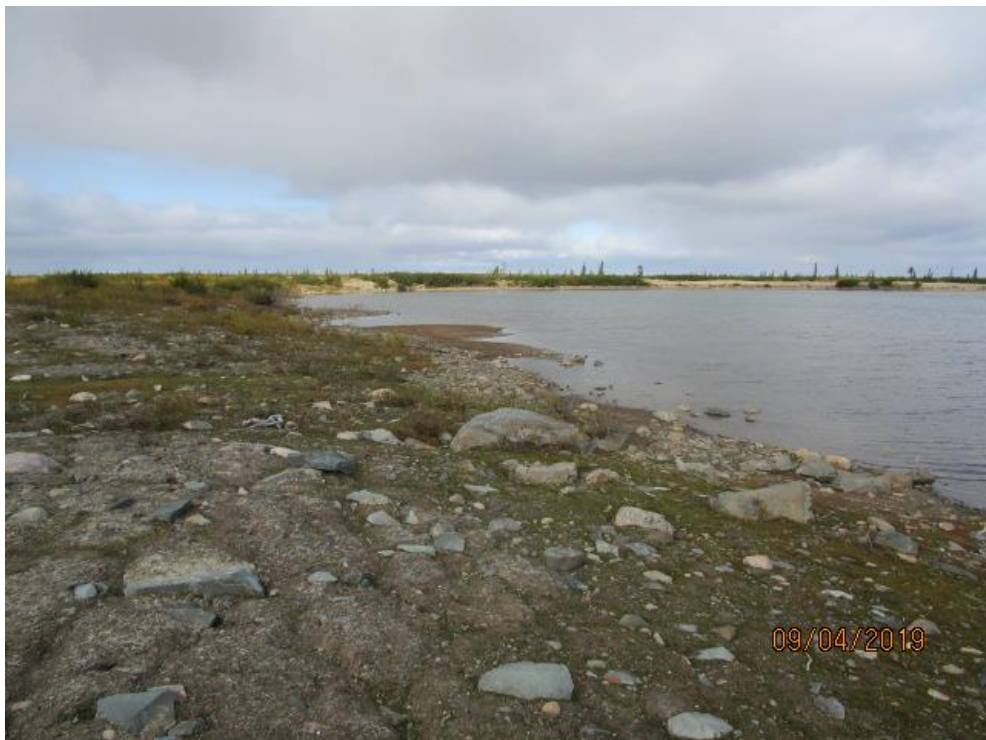
Photo 16: Exposed beach in September 2019. Water level is slightly higher.

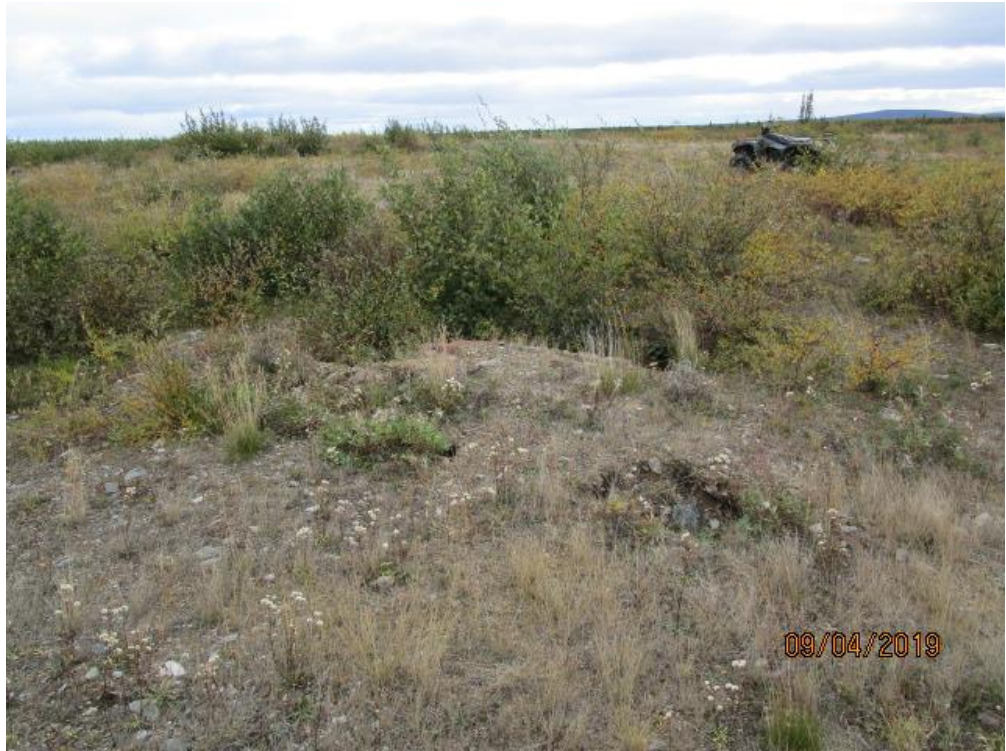
The minor subsidence areas on the quarry pit landfill remain largely unchanged. Most of the affected areas are occupied by arctic ground squirrels (See Photo 17 in Appendix 1).

Photo 17: Quarry Pit main subsidence area – no change from previous years.

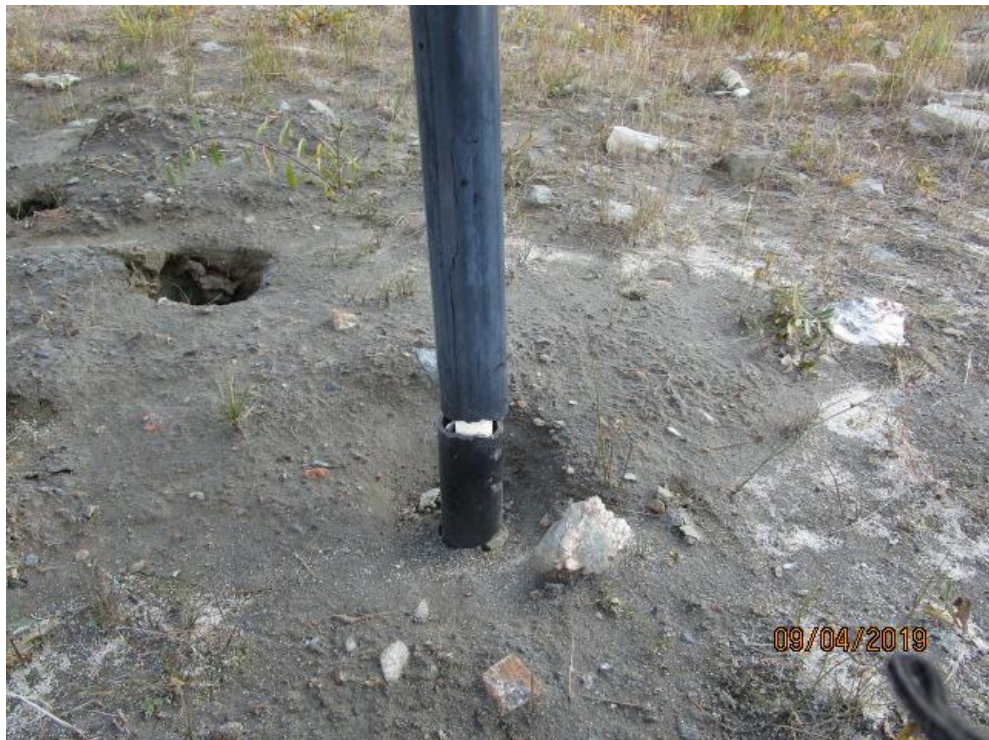
Two of the recently installed thermistors were found with cracked casings, from either wildlife activity or frost damage (See Photo 18 in Appendix 1).

Photo 18: Thermistor T-4 casing damage.

- The site remains in good condition.
- The tailings storage facility continues to remain stable. The water level in the pond remains low but has recovered slightly compared to 2018.
- The casings on the newly installed thermistors suffered damage during the previous winter. These will be repaired in 2020.

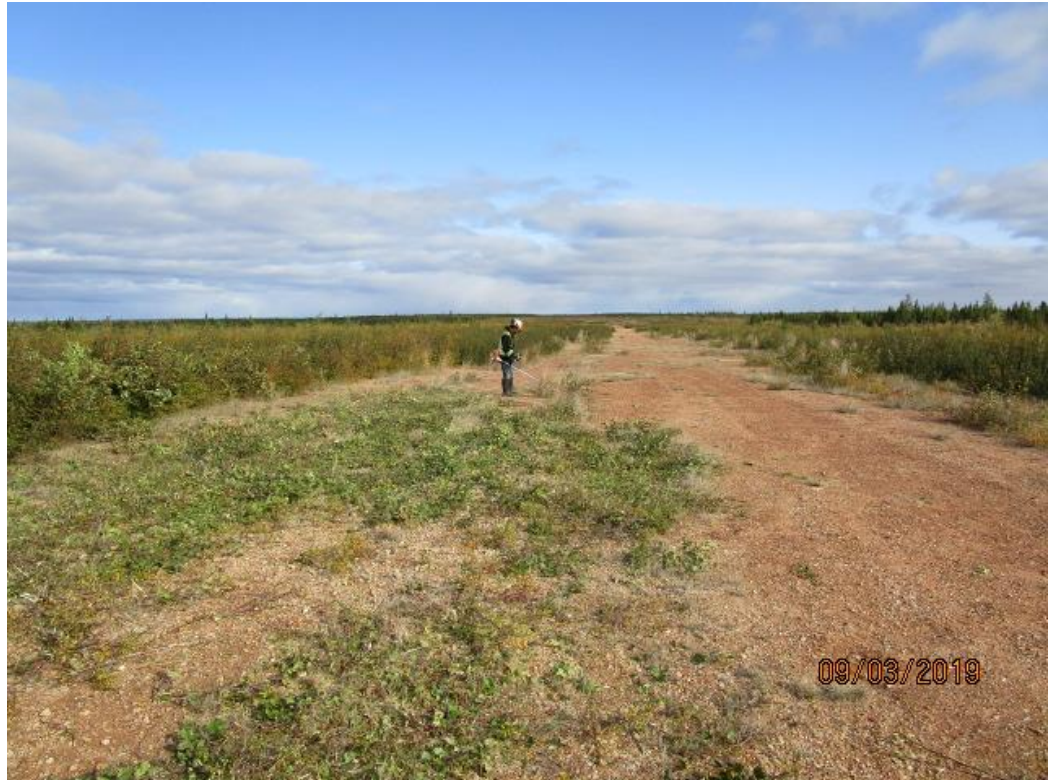
Photo 19: Airstrip brushing, mid-section looking east.

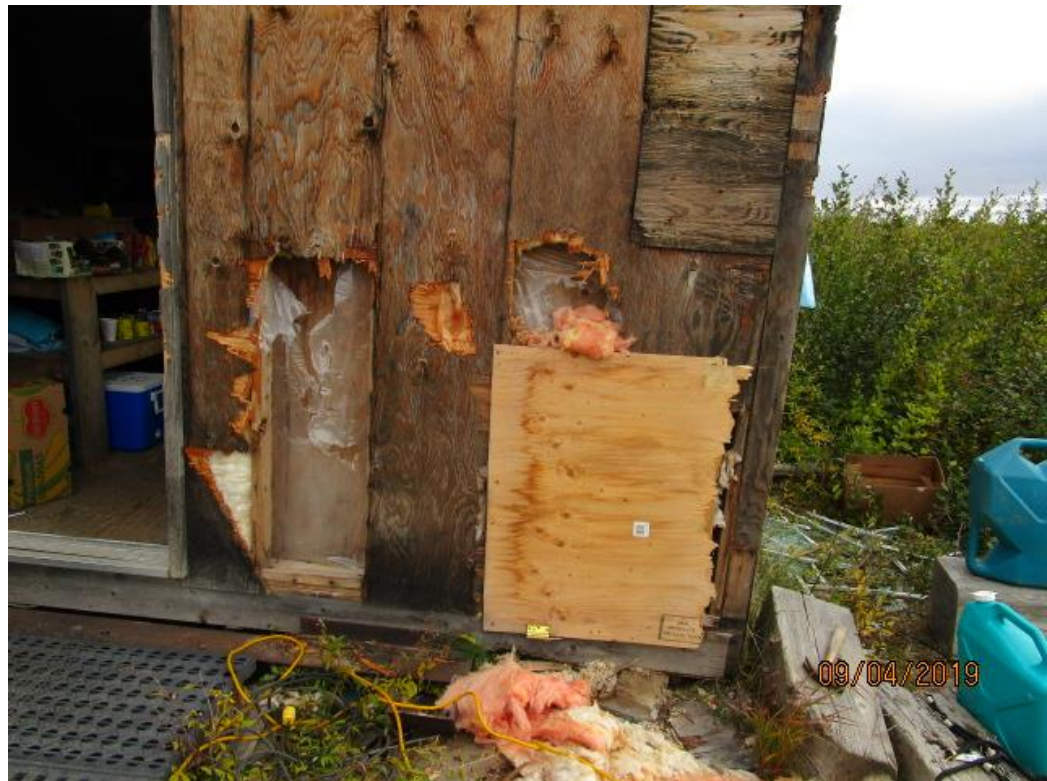
The survival shed suffered bear damage and needed considerable repairs (See Photo 22 in Appendix 1).

Photo 22: Cabin bear damage.
